The Alamosa River Watershed Restoration Project

Maintenance Project 2008

This report is Supplement to the

FINAL REPORT

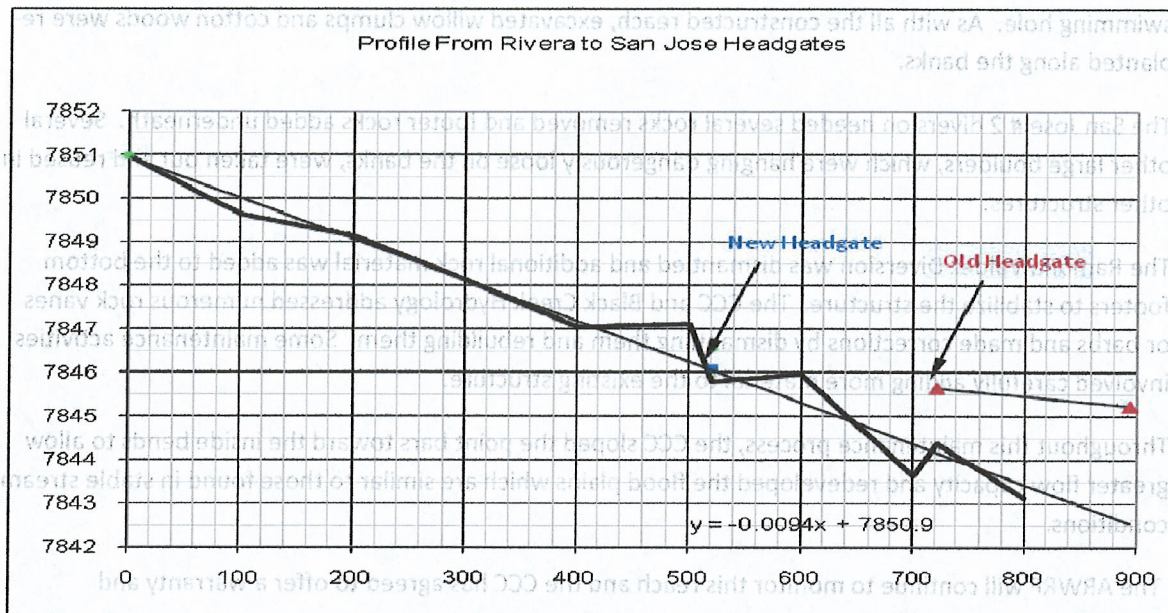
The San Jose # 1 had a long history of being unstable. Most diversion structures in the Alamosa River, when they were originally established, were placed on the outside bends to take advantage of natural stream dynamics. The San Jose # 1 was placed in the middle of a riffle section. Many problems are associated with this design flaw. First, it is difficult to maintain proper elevations of the bottom of the river and the bottom of the headgate, usually because of the aggregating of river cobble. The 2005 construction tried to build their structures while keeping the diversion within the riffle section, and it immediately failed during the first runoff. Another problem facing the San Jose #1 water users was the headgate was perched 2 feet above river bottom preventing them from taking advantage of lower stream flows (See Chart 1).

Chart 1: Profile around the San Jose Diversion. Note the elevation of the old location to river bottom vs. new location to river bottom.

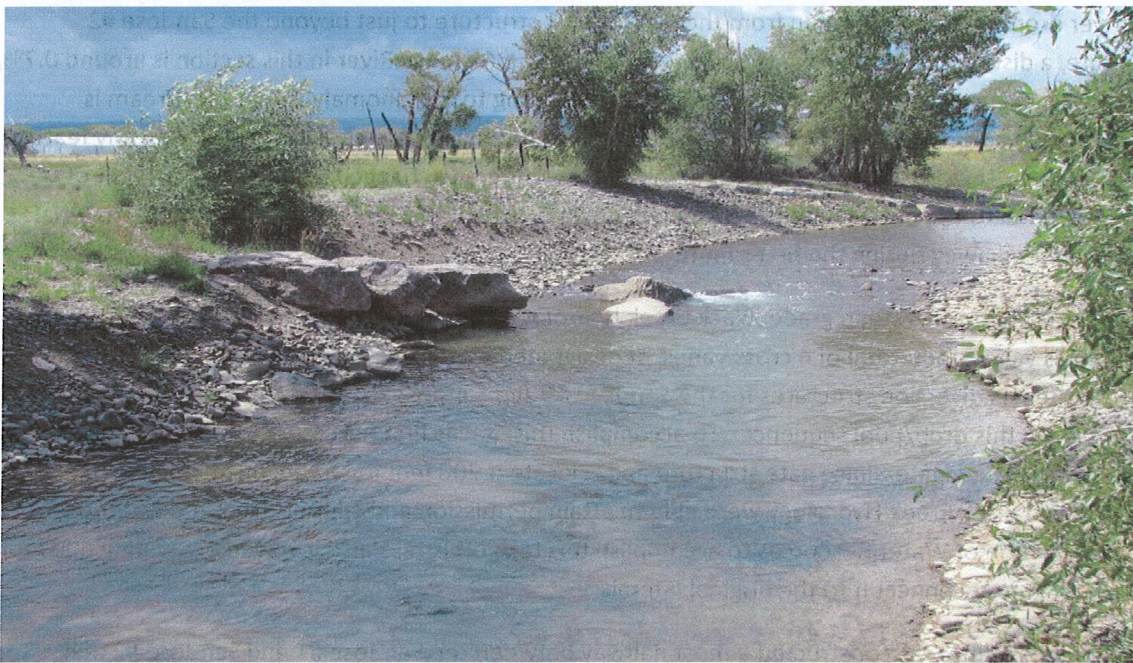
Figure 1 Structure failure near County Road 8

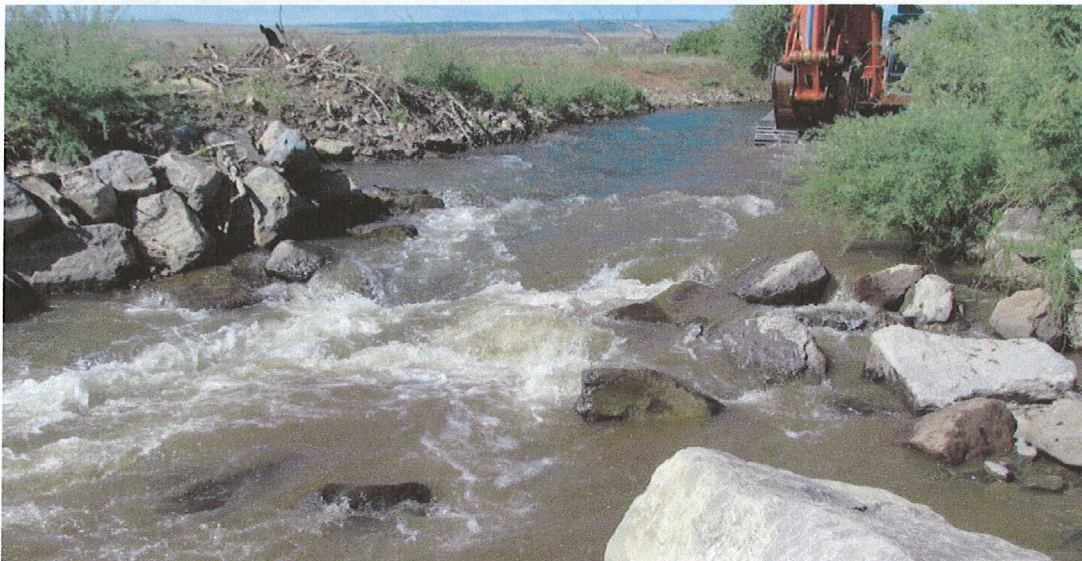
Figure 2. Before Photo. Emergency Repair. The San Jose #1 washing out during summer of 2008

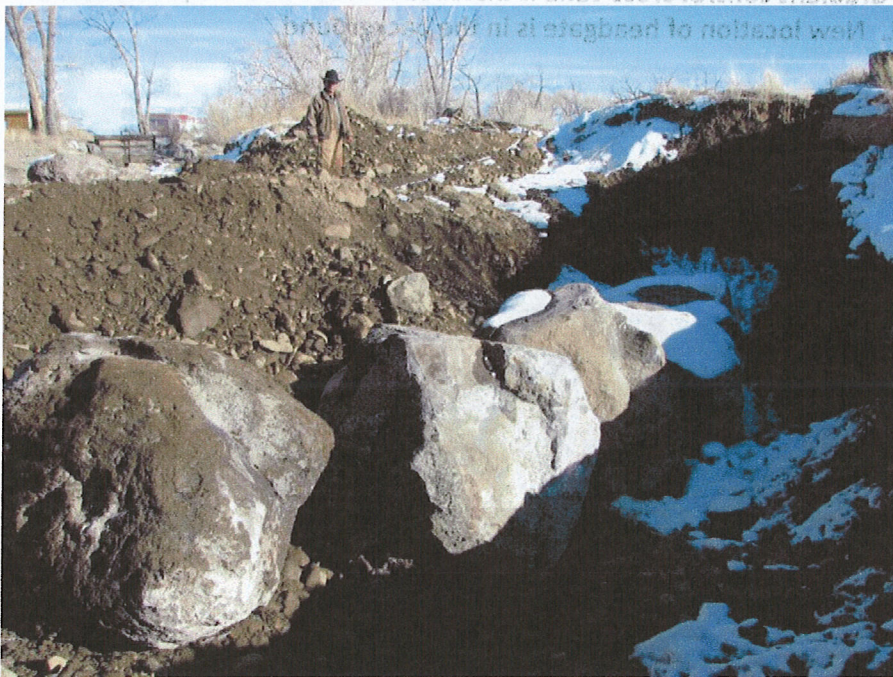
Figure 3: Building a gradient control cross vane. Setting in footer rocks at the old location of the San Jose #1.

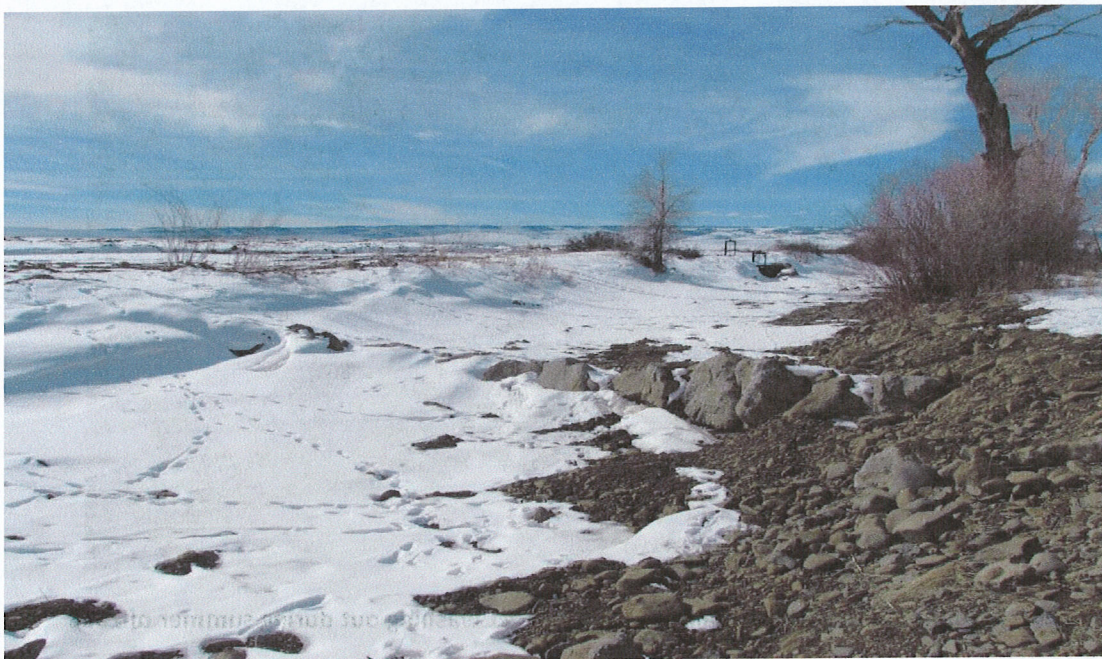
Figure 4: After Photo. Gradient control cross vane is installed in what was the previous location of San Jose #1. New location of headgate is in the background.

To compensate for this steep grade, Black Creek Hydrology designed a drop/pool sequence by adding 2 more cross vanes, for a total of 4 cross vanes, at designated elevations. Two of the cross vanes are incorporated as diversion structures for the San Jose #1 and San Jose #2. The San Jose #1 is the first cross vane in this drop/pool sequence. To accomplish this, it was first necessary to excavate the San Jose # 1 metal headgate/slucie gate structure and relocate it 200 feet upstream on an outside bend. The CCC and Black Creek Hydrology were able to attain permission and support from the water users and the Division of Water Resources to accomplish this task. This task also involved excavating 600 feet of new ditch to reconnect it to the original laterals.

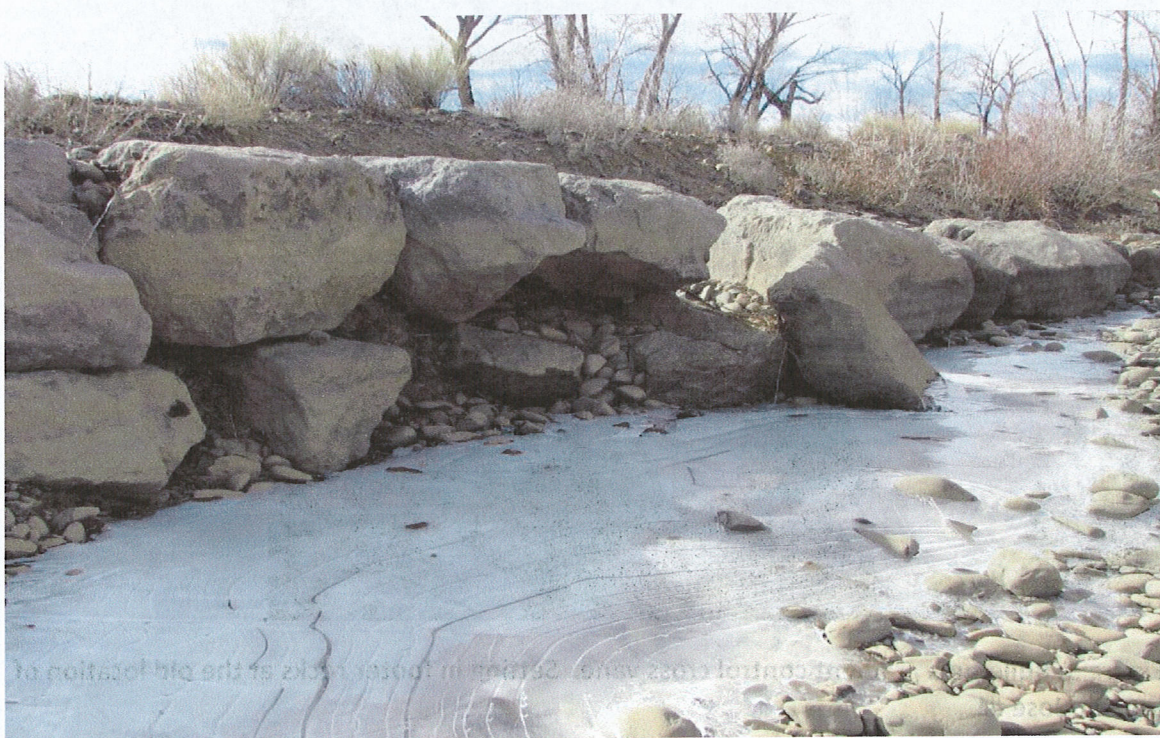
Figure 5: Failed Vane Structure

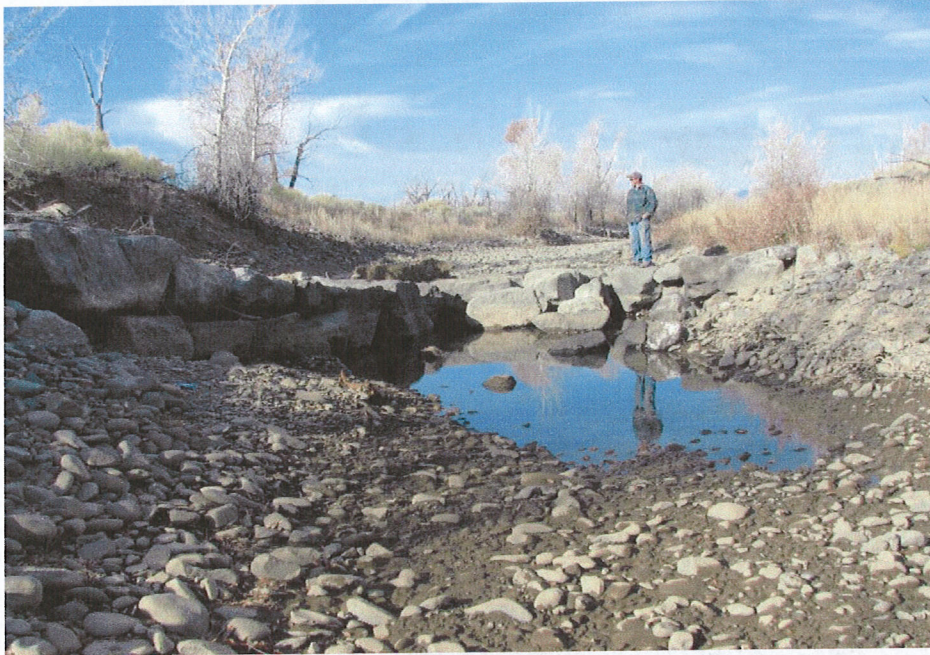
Figure 6: Ramona Valdez diversion.

The Ramona Valdez Diversion was dismantled and additional rock material was added to the bottom footers to stabilize the structure. The CCC and Black Creek Hydrology addressed numerous rock vanes or barbs and made corrections by dismantling them and rebuilding them. Some maintenance activities involved carefully adding more material to the existing structure.

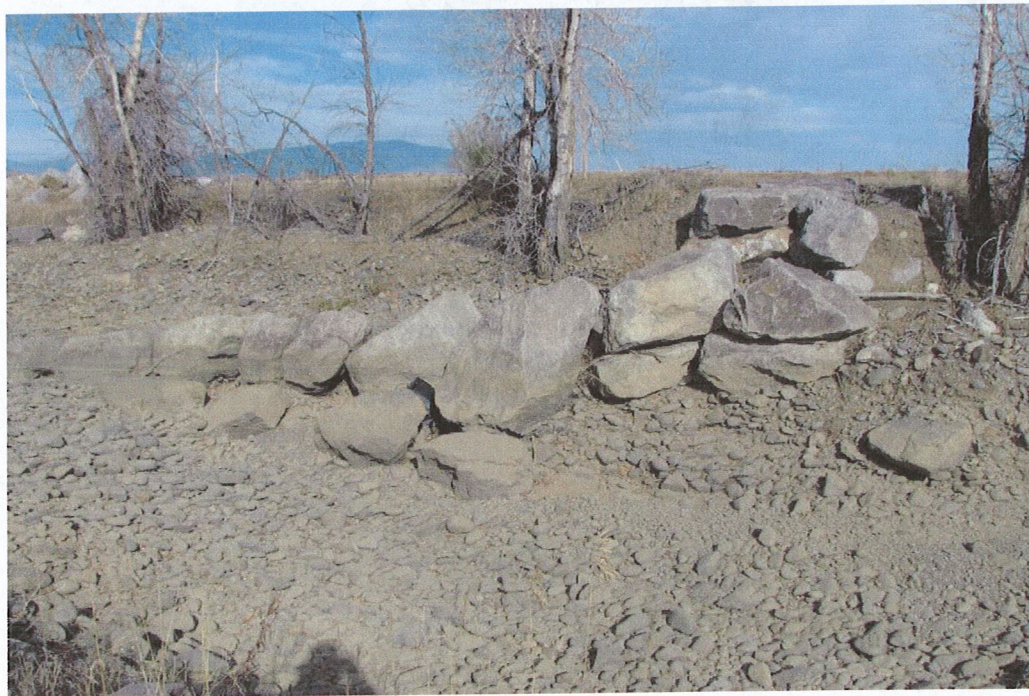
Figure 7: Failed Structure. Lack of proper footers.

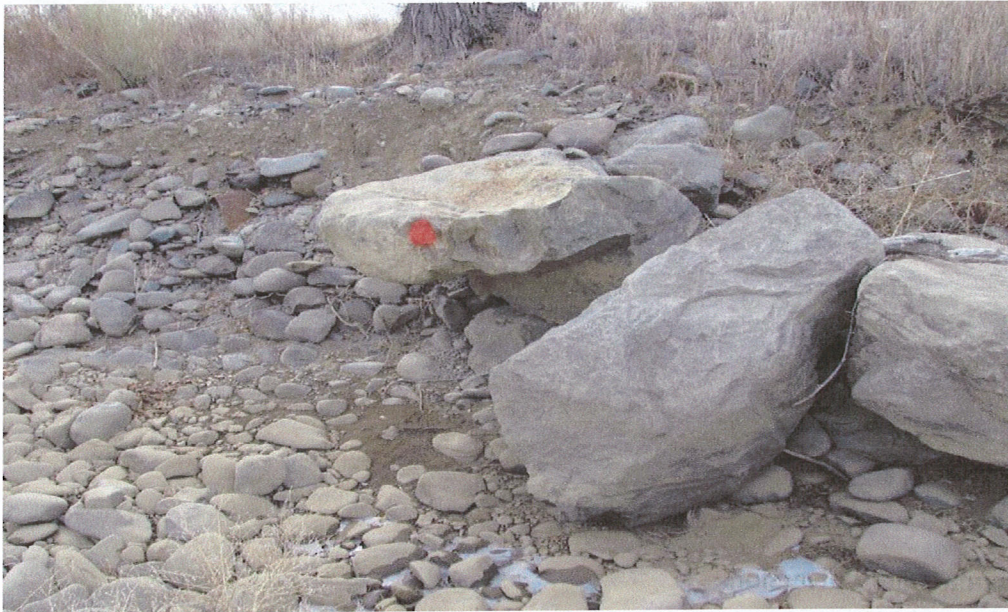
Figure 8: Failed Structure. Lack of footers.

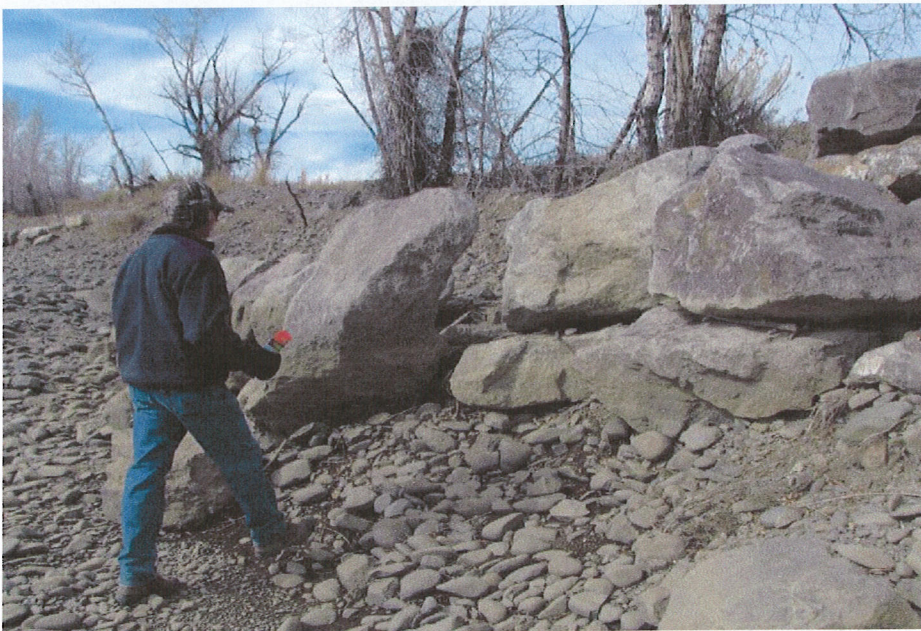
Figure 9: Failed Structure

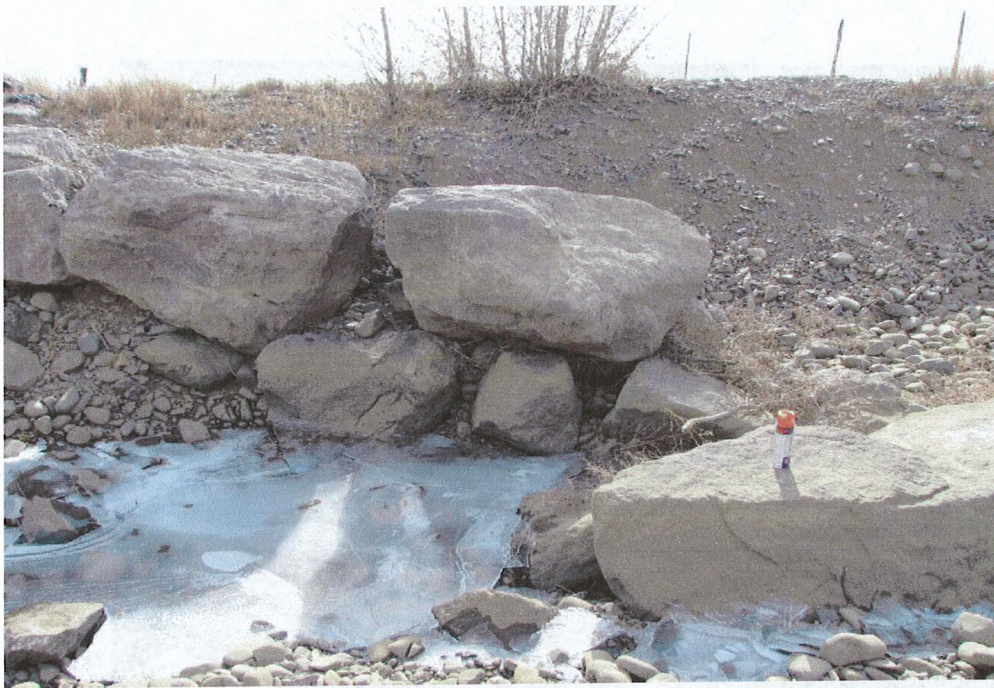
Figure 10: Lack of footers and gaps between rocks caused this failure.

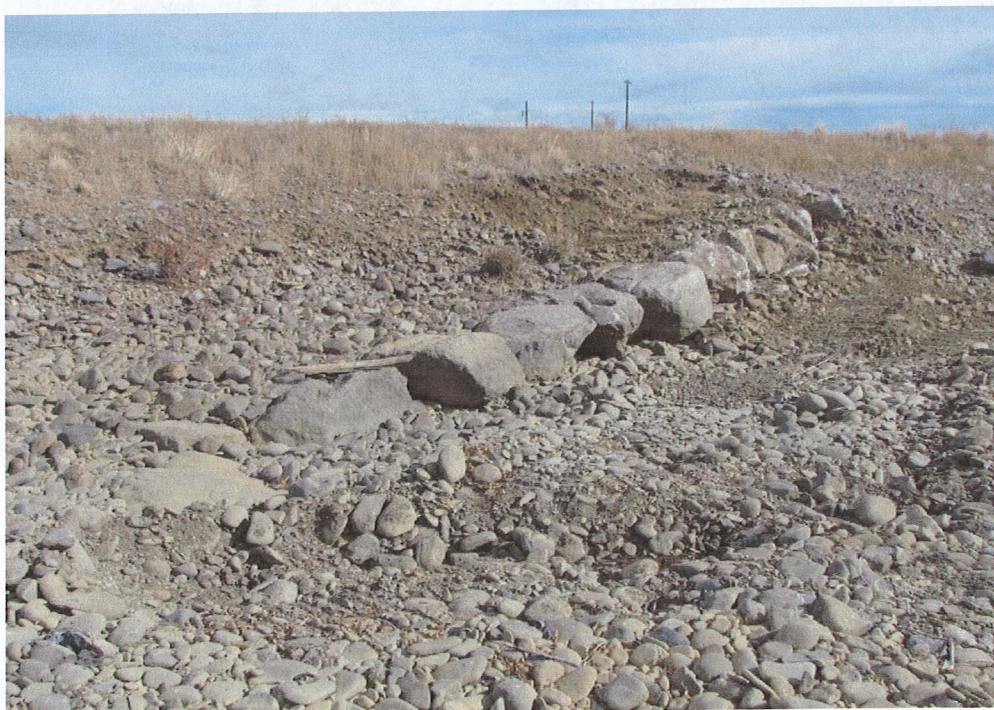
Figure 11: Example of reconstructed Vane Structure. One of many.

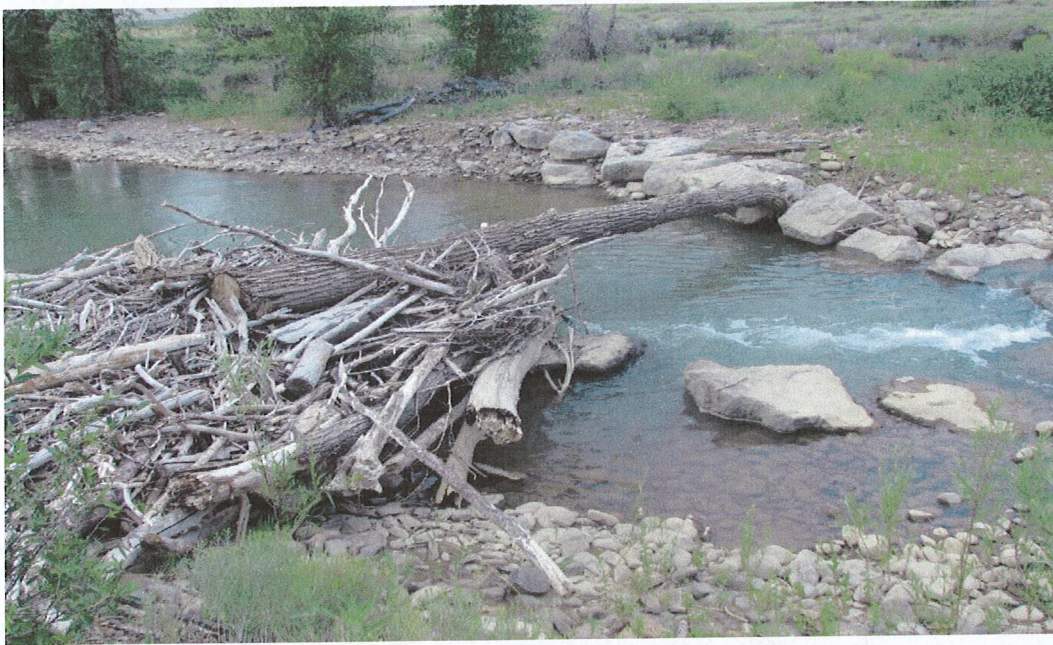
Figure 12: Rivera Irrigation Diversion. Lack of footers and gaps in-between rocks combined with the entire structure built narrow. Great fish habitat but poor irrigation diversion.

The Rivera Diversion, a junior right, was dismantled and lowered overall. It was designed as a diversion and as a grade control structure.

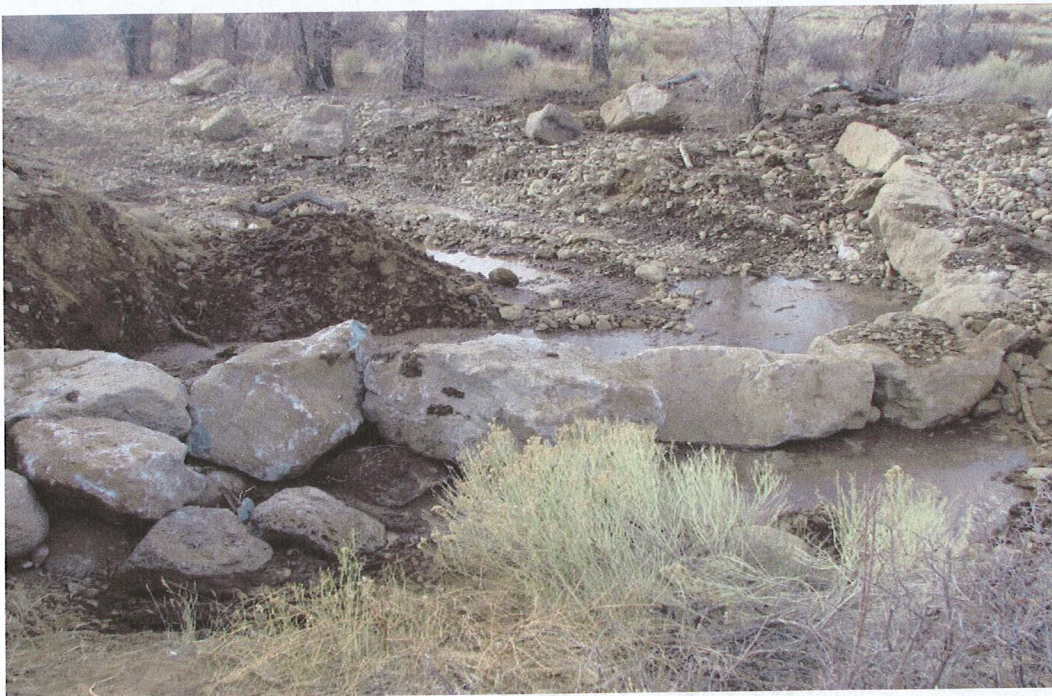
Figure 13: New Rivera structure before back filled.

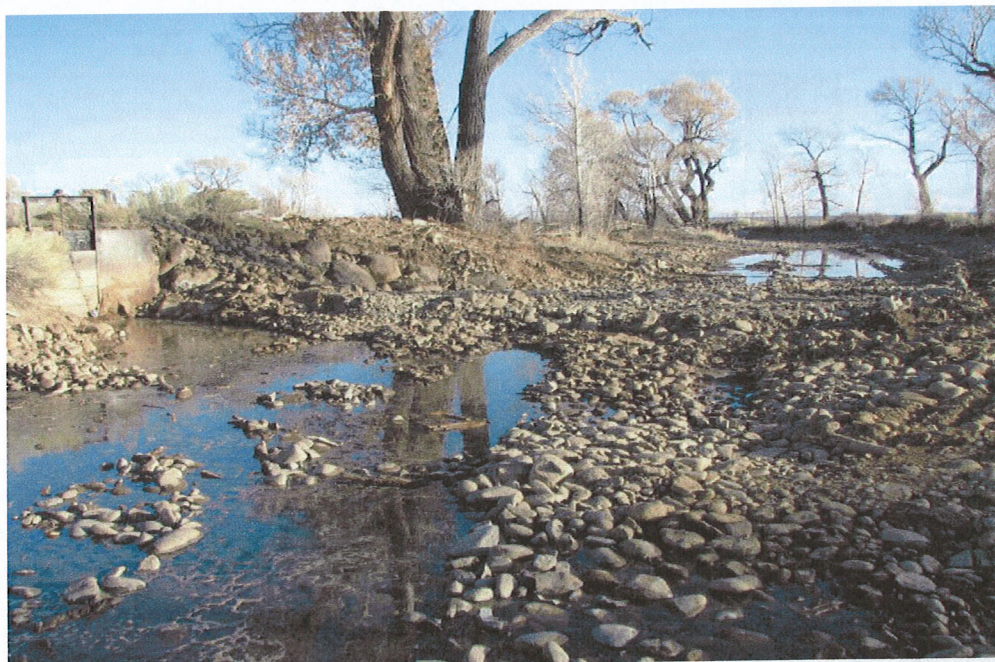
Figure 14: Rivera Structure completed and back filled.

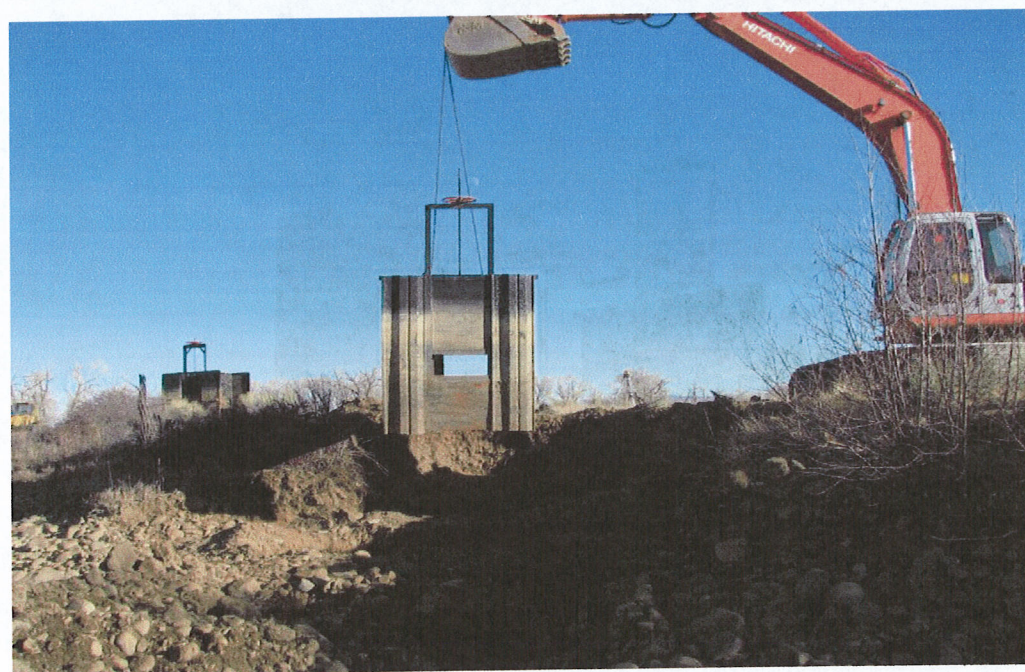
Figure 15: Re-setting the San Jose #1 head gate

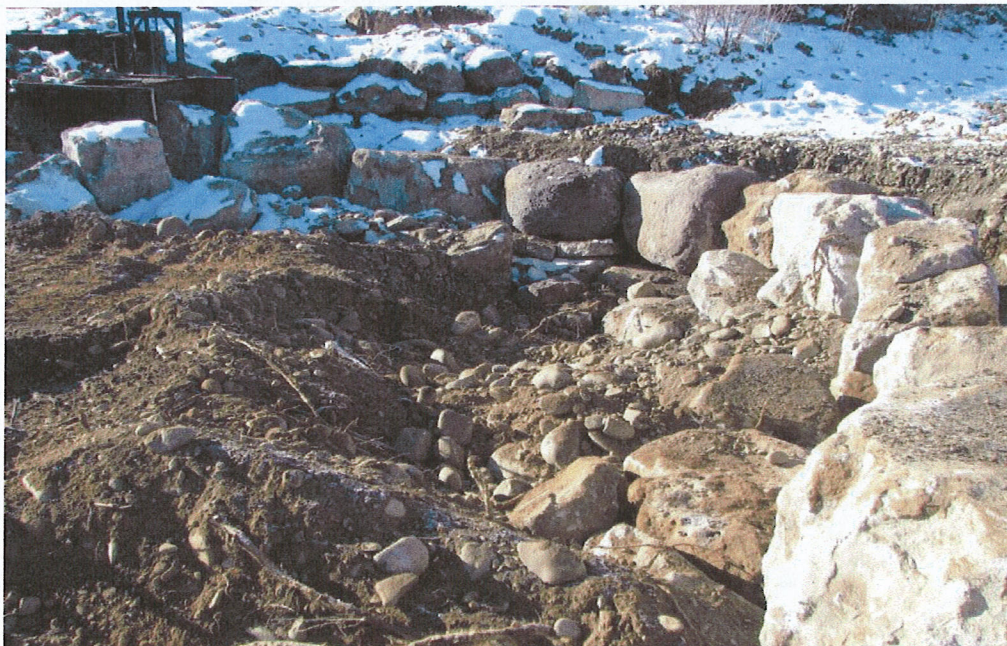
Figure 19: Completed Cross Vane on San Jose #1 prior to backfilling
