Lightner Creek Watershed Evaluation Report

**Lightner Creek Watershed Group
Durango & La Plata County**

**Basin Hydrology, Inc.
Durango, CO**

February 19, 2010

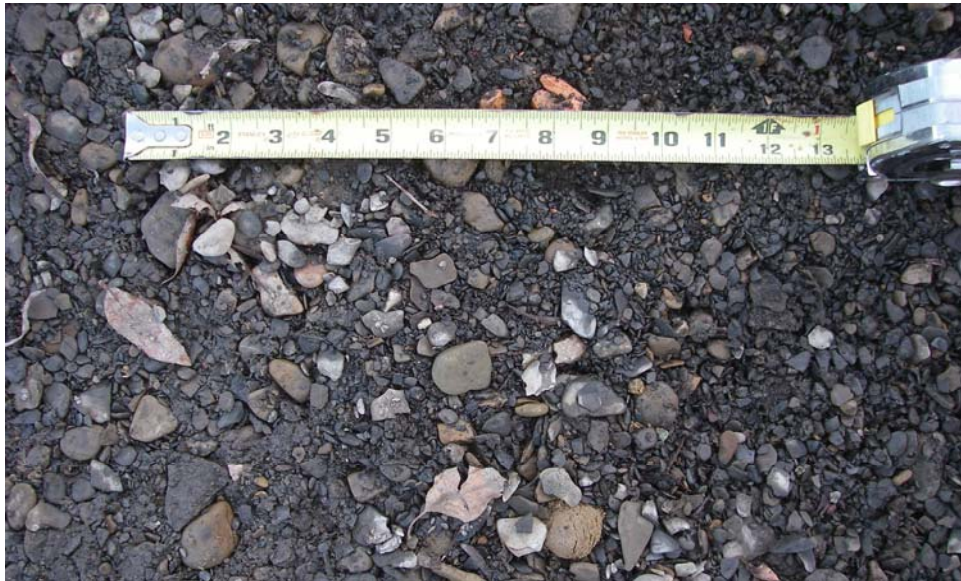
Photo 2. Depositional material in Lightner Creek at the Animas River.

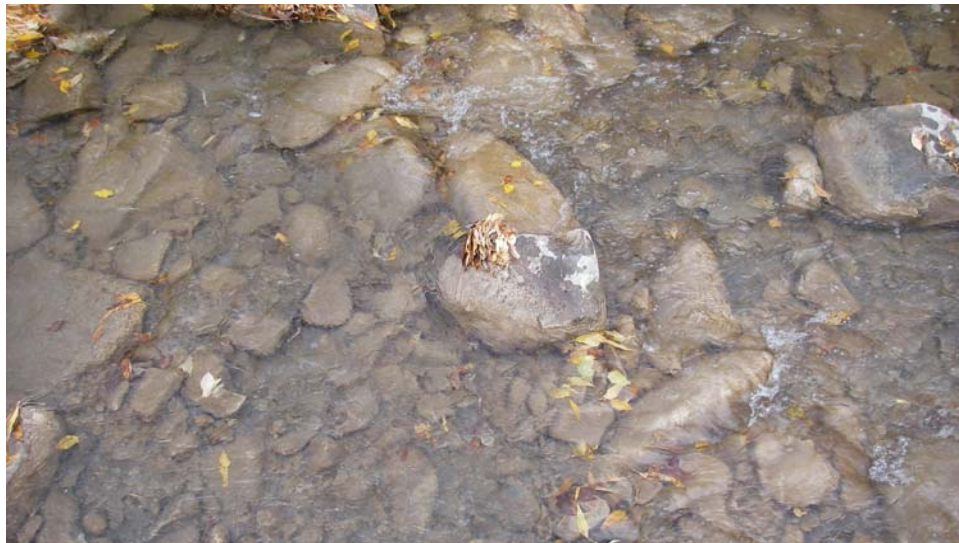
Photo 4. Channel bed at channel cross section site contains no significant amounts of shale materials.

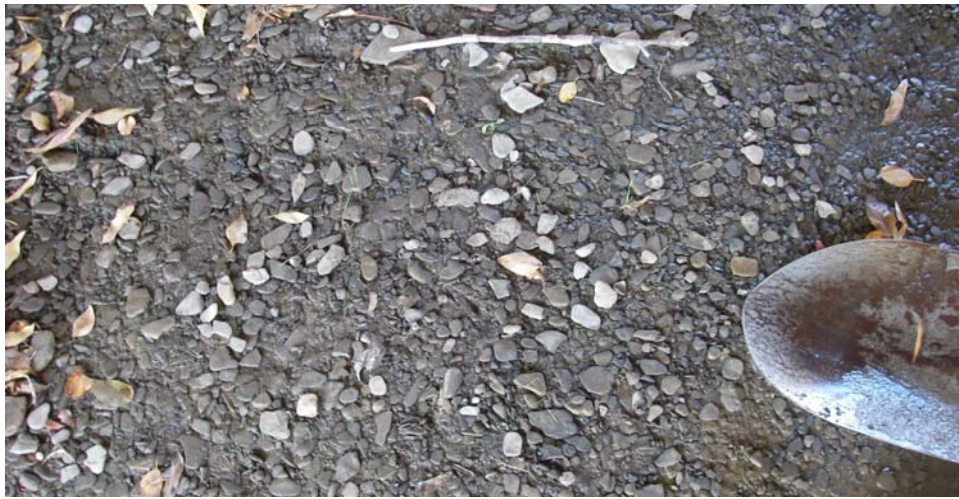
Photo 7. Depositional material (shale) in box culvert at Camper World entrance.

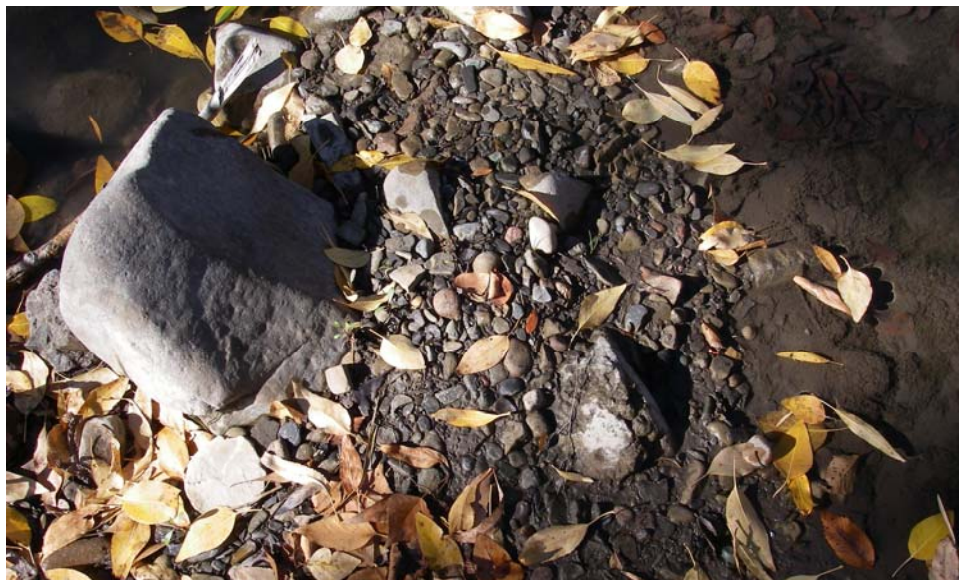
Photo 9. Typical bar material - shale (dominated by medium gravels and finer).

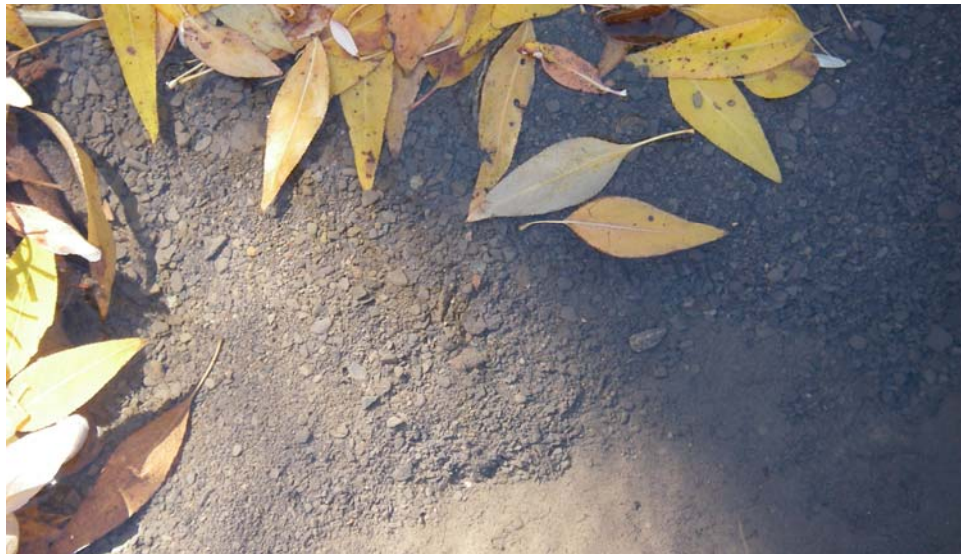
Photo 10. Typical “slack water” channel bed material - shale (fine gravels and sands).

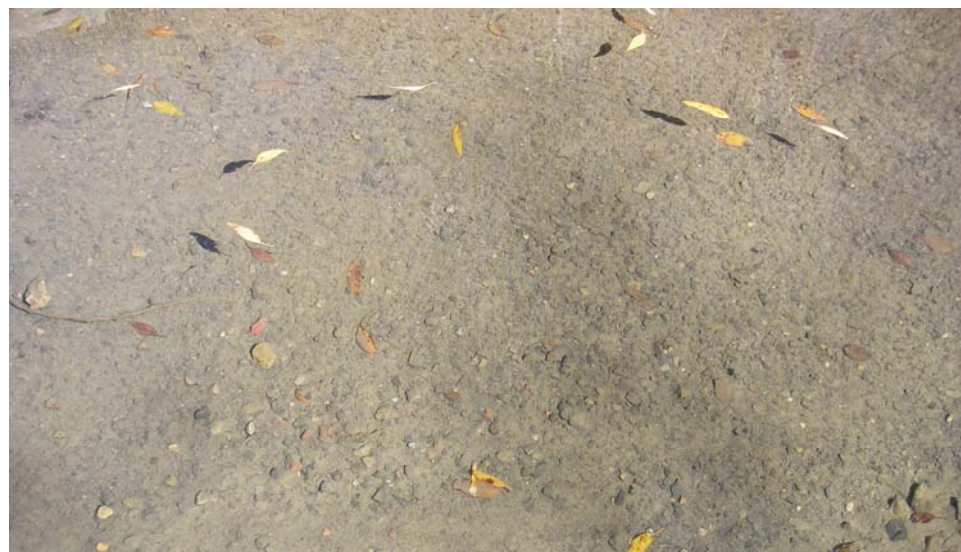
Photo 12. Lightner Creek channel bed at culvert outfall structure (predominately shale).

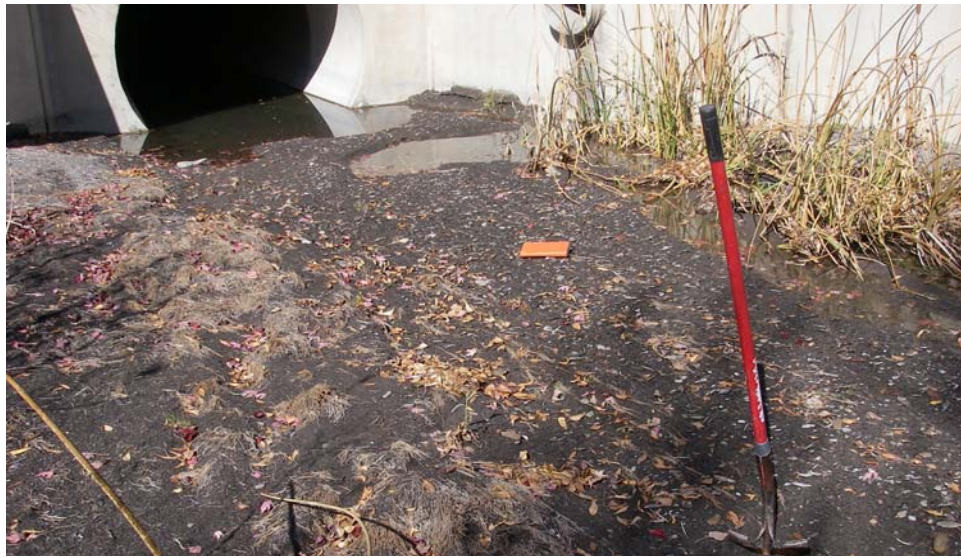
Photo 13. Depositional area at culvert outlet (predominately shale).

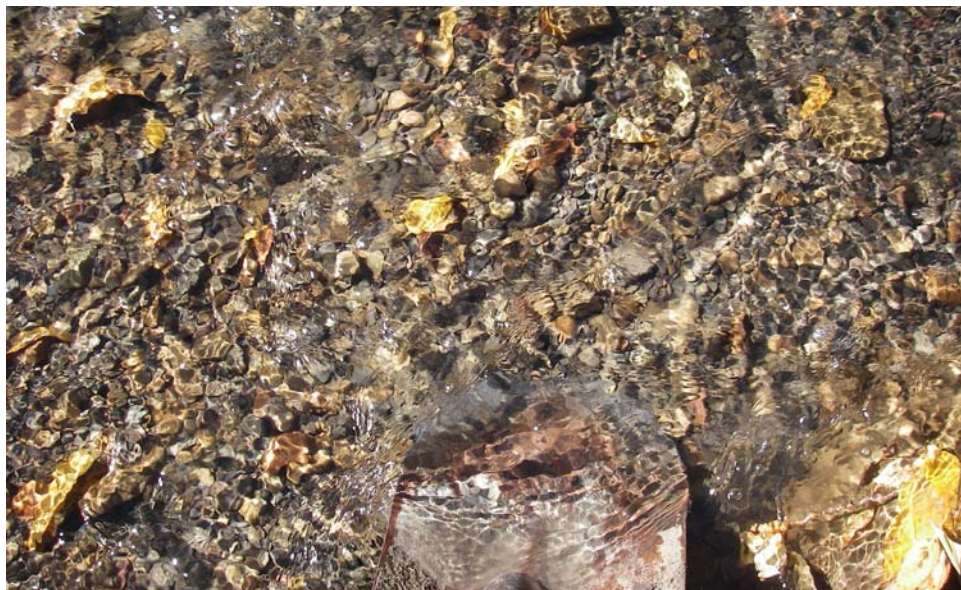
Photo 15. Channel bed ~ 100' upstream of Tech Center outfall (~30-40% reduction in shale material).

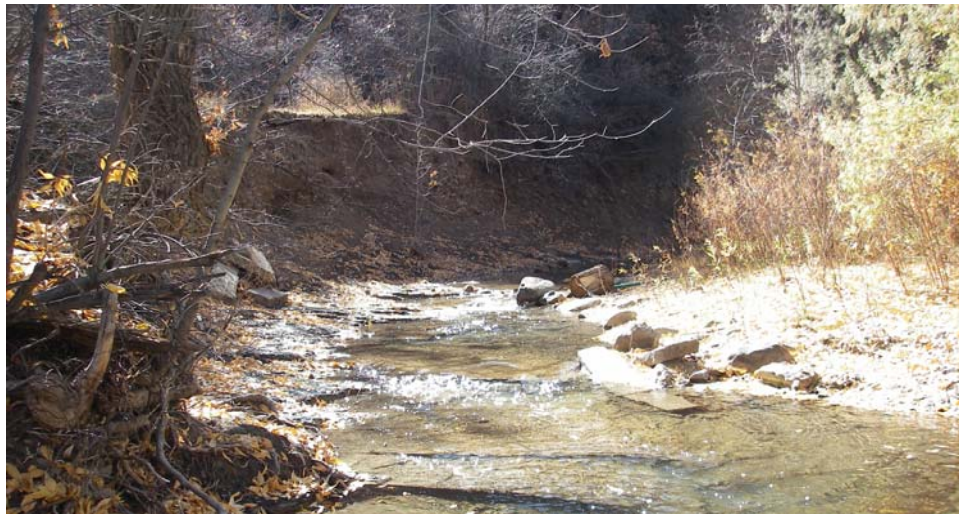
Photo 16. Upstream view of channel & eroding bank south of Jiffy Lube.

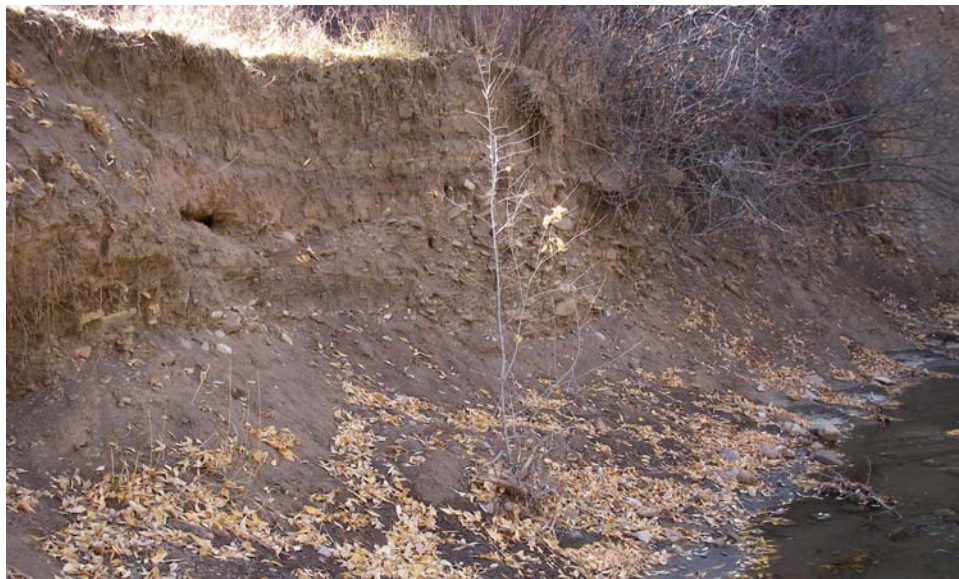
Photo 17. Upstream view of eroding colluvium bank south of Jiffy Lube.

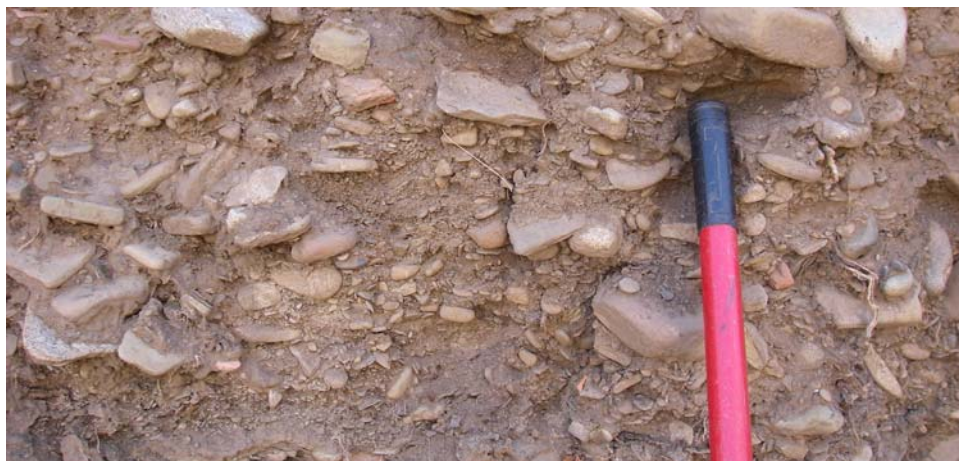
Photo 18. Close up of eroding colluvium bank south of Jiffy Lube.

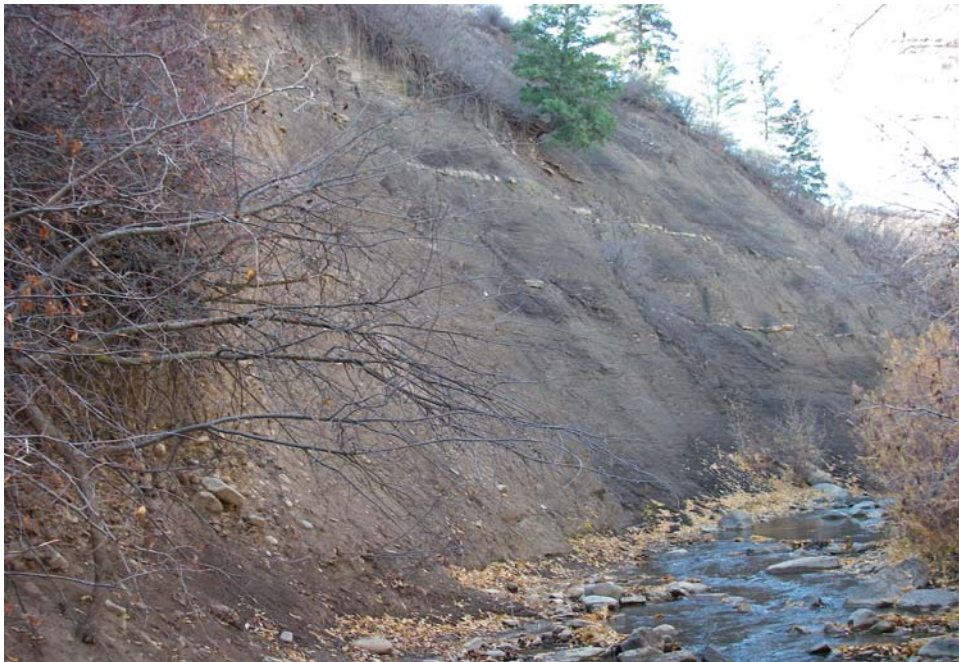
Photo 19. Large eroding shale slope immediately upstream of colluvium bank.

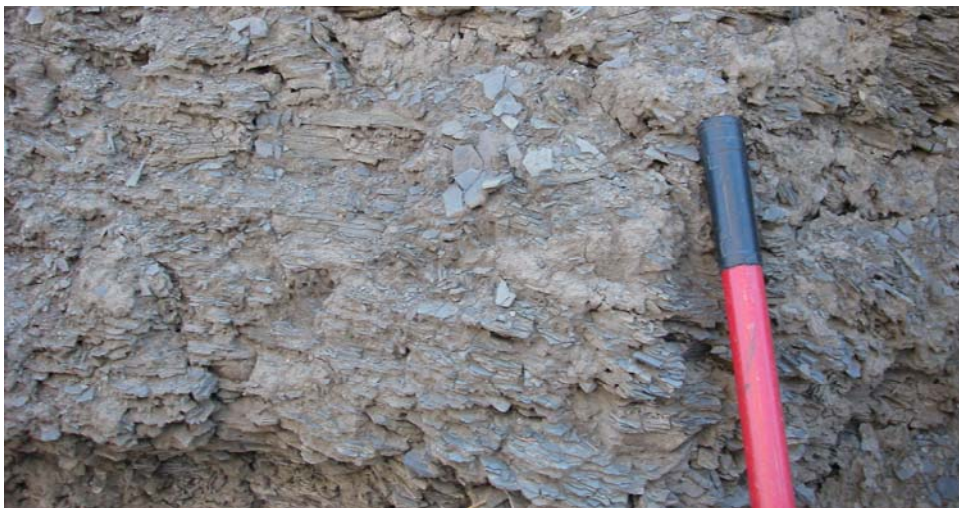
Photo 21. Close up of eroding shale slope south of Jiffy Lube.

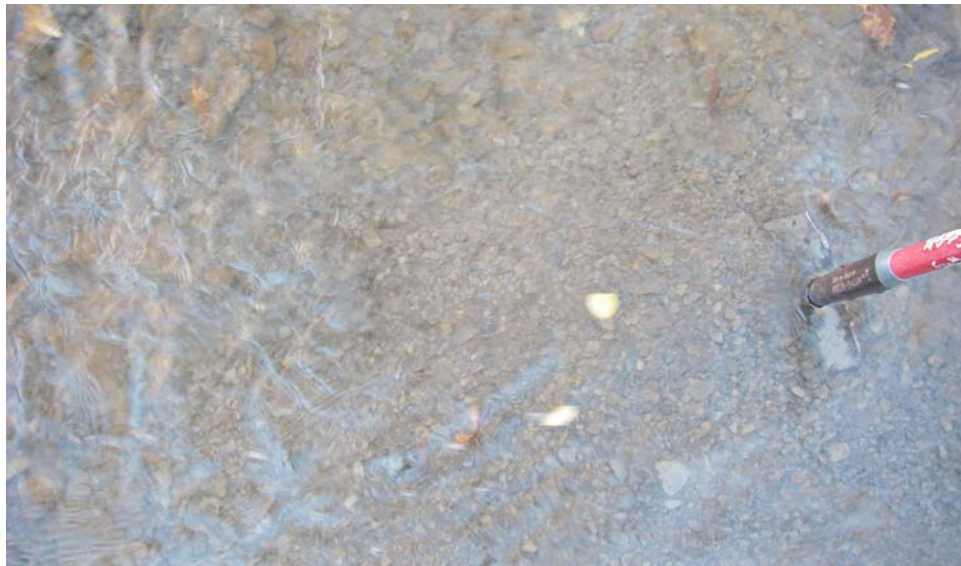
Photo 22. Channel bed composition (shale), where not bedrock, along shale slope.

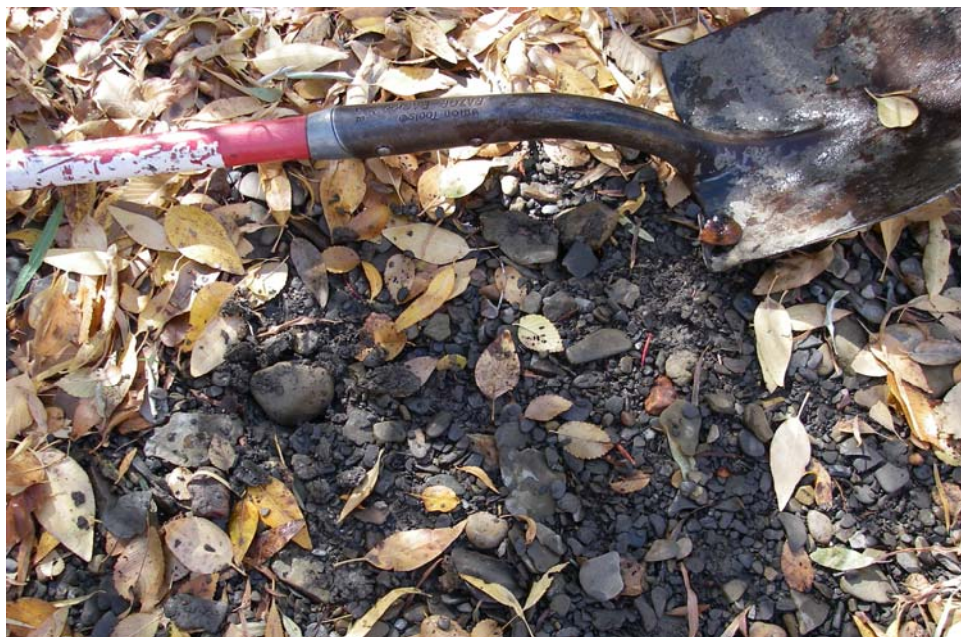
Photo 24. Bar materials (predominately shale) at Photo 23.

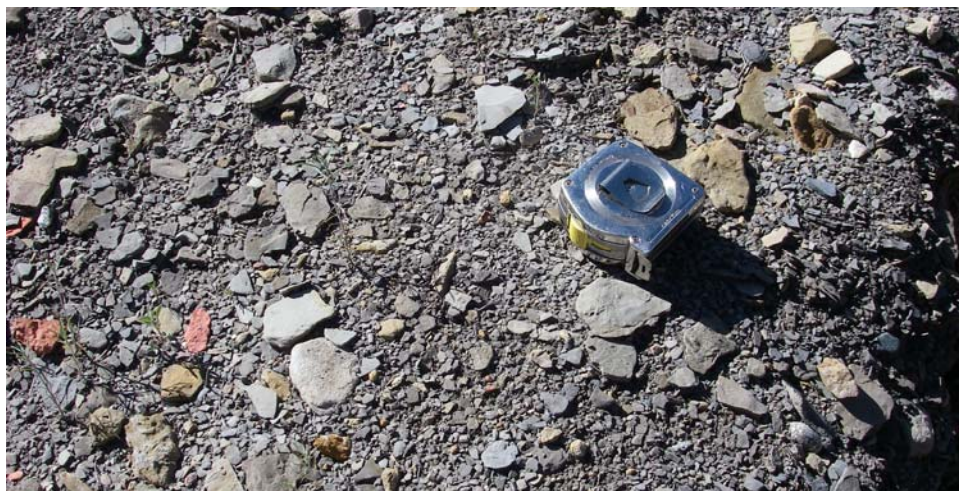
Photo 27. Composition (shale) of depositional features at Perins Canyon culvert.

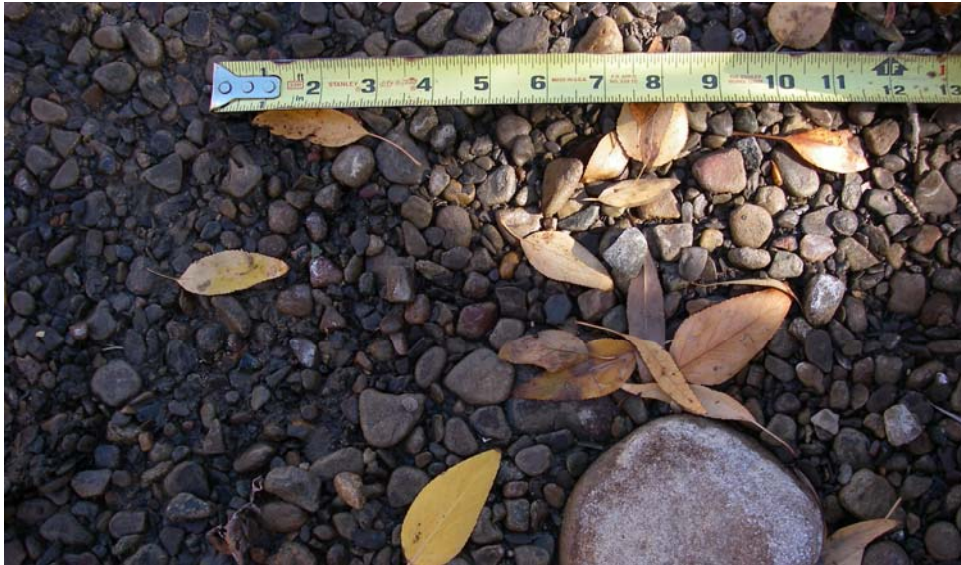
Perins Canyon to Nissan Dealer: (no channel evaluation forms completed) Between Perins Canyon Road and Bob's Truck Repair, the channel contains minimal shale material but is present in some back water areas (Photos 28-30). However, some flood plains within this reach contain moderate to large amounts of shale material (Photo 31). There are two small inflow channels that originate in shale dominated watersheds to the north. One channel exists on the east side of Animas Storage and the other is on the west side of Bob's Truck Repair (see Watershed Evaluation maps).

Photo 29. Bar composition ~ 100' upstream of Perins Canyon Road contains significantly less surficial shale material.

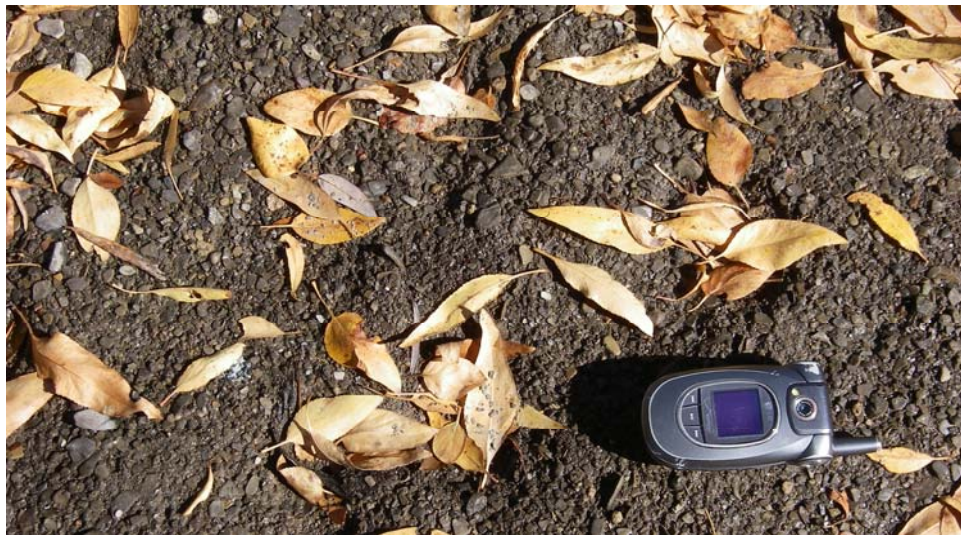
Photo 31. Bar composition (predominately shale) at Photo 30 at Photo 30.

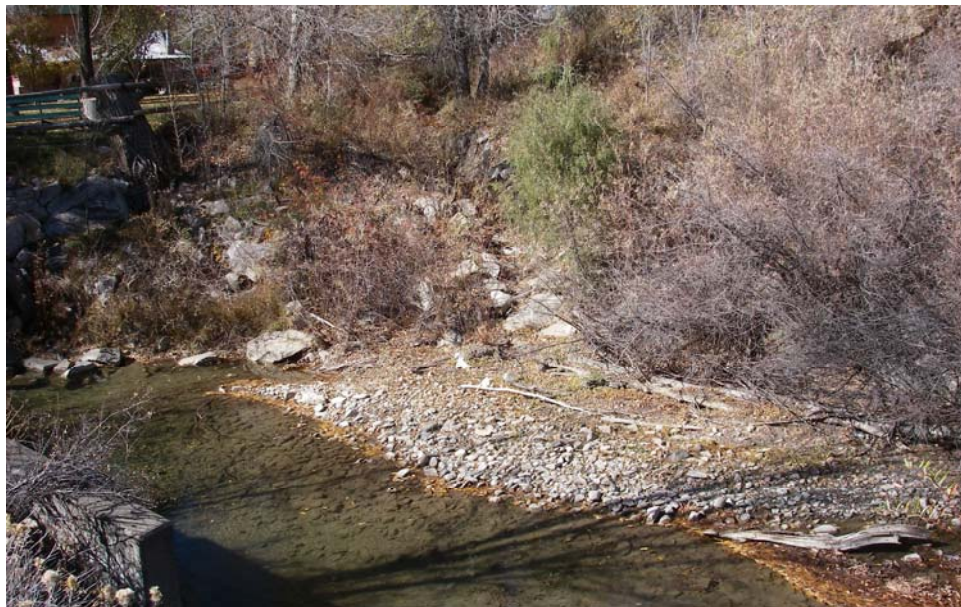
Buck Skillen provided a photograph (Photo 33, taken in March 2009) showing the drainage at Bob's Truck Repair with a significant accumulation of sediment that appears to be shale. Photo 32, taken in October 2009 at the same location, shows no perceptible evidence of sediment originating from this source. This is probably because high flows in Lightner Creek removed all but the coarsest of materials. Access to the watersheds on the north side of these two drainages was not pursued in order to assess present-day land use modifications and soils. Project aerial photography indicates that significant regrading has occurred directly north of these businesses but it is unclear if any drainage and erosion control improvements have been made.

Photo 32. Downstream end of Hwy 160 culvert. Confluence of Lightner Creek and small ephemeral channel along the west side of Bob's Truck Repair property.

Bob's Truck Repair Watershed: Until is known that this watershed is a significant source of sediment, and what type of drainage or sedimentation control facilities are present (or absent), no stabilization prescriptions can be provided. The next step for this site is to obtain permission to access the area and document conditions and existing control measures. Once these conditions are known, then stabilization recommendations can be proposed.

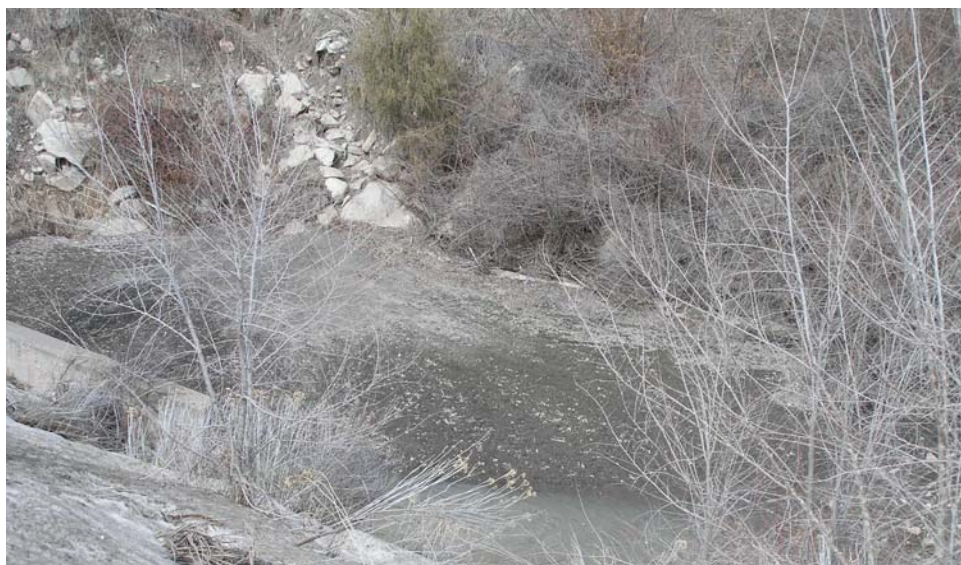
Photo 33. Same photo location as Photo 32 except this photo was taken on March 4, 2009. Note large shale deposition area present here but missing in Photo 32.

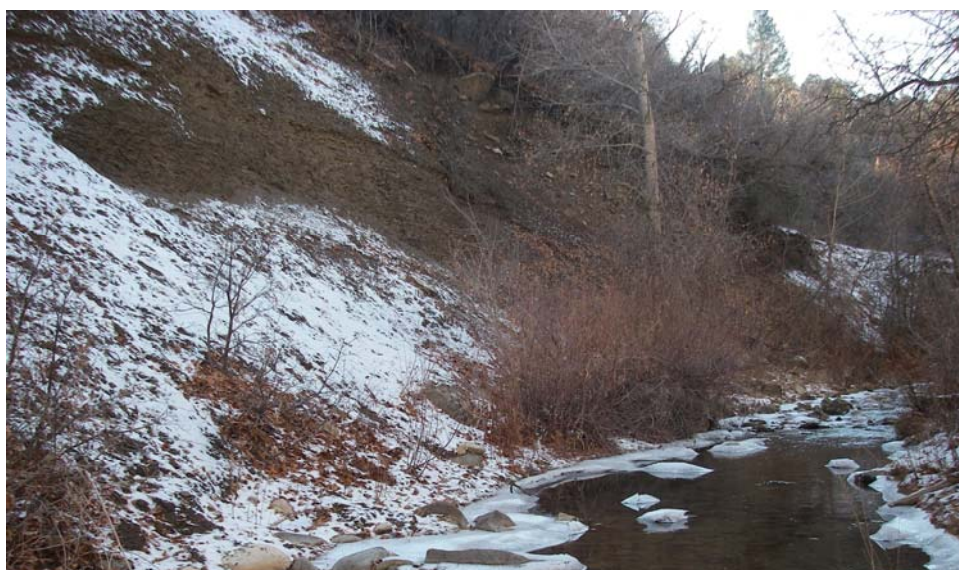
Photo 35. Upstream view of a steep shale slope south of the Exxon station.

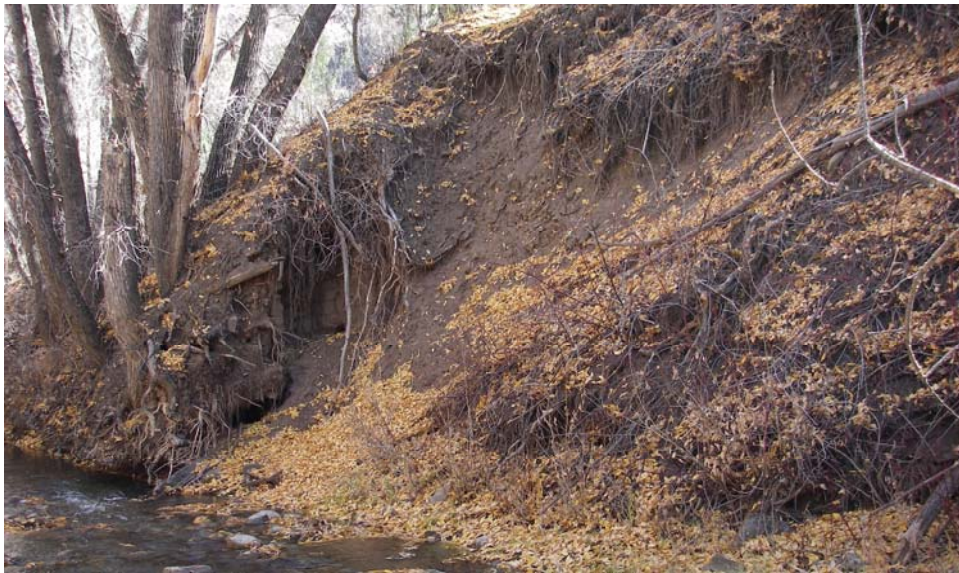
Photo 37. Downstream view of south eroding colluvium bank at channel stability evaluation site, south of Nissan dealer.

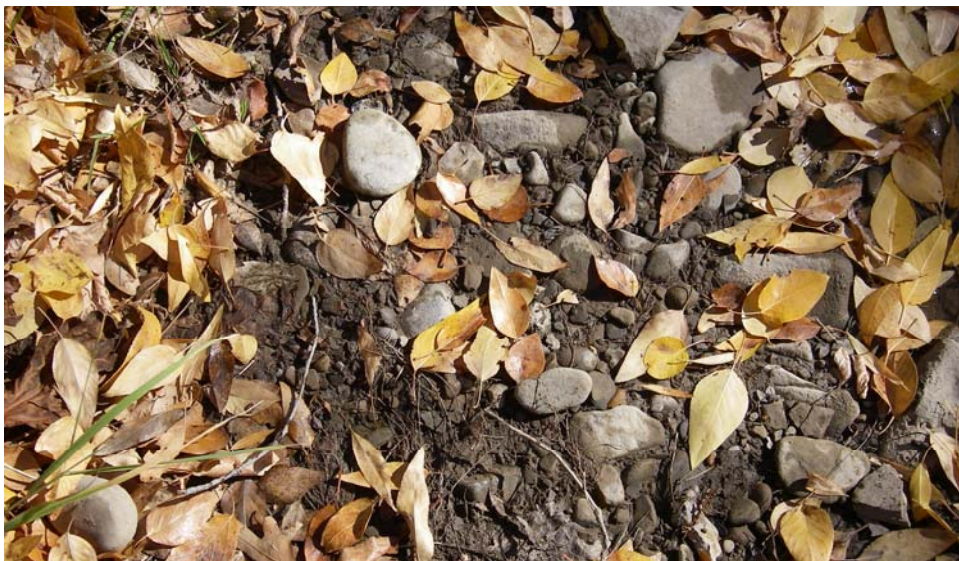
Photo 38. Bar south of Nissan dealer containing ~ 20% shale material. This site is above shale source areas identified in Photos 35 but below Photo 39.

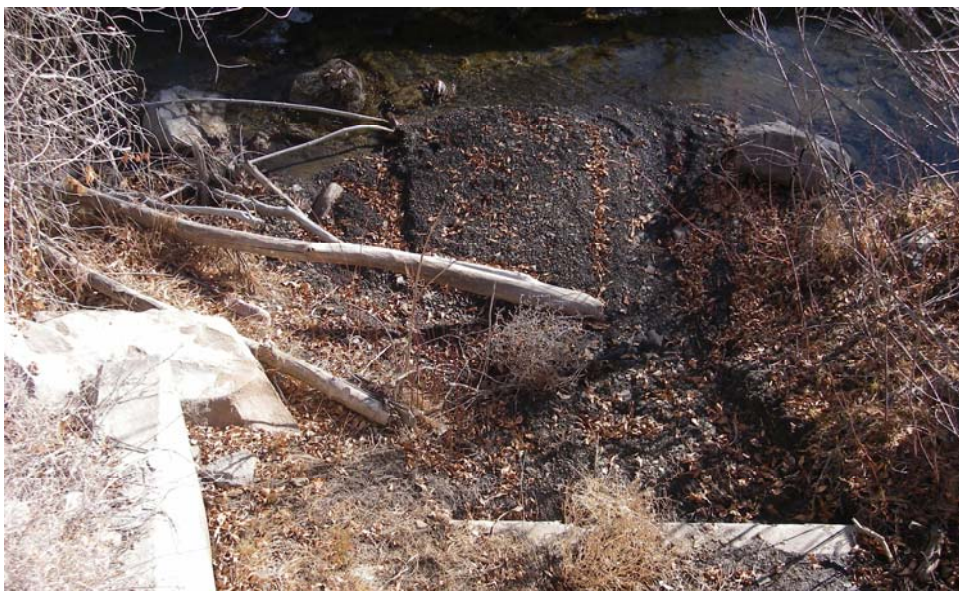
Photo 39. Lightner Creek at the downstream end of the Hwy 160/CDOT maintenance yard culvert contains predominately shale material.

CDOT Watershed: Until is known that this watershed is a significant source of sediment, and what type of drainage or sedimentation control facilities are present (or absent), no stabilization prescriptions can be provided. The next step for this site is to obtain permission to access the area and document conditions and existing control measures. Once these conditions are known, then stabilization recommendations can be proposed.

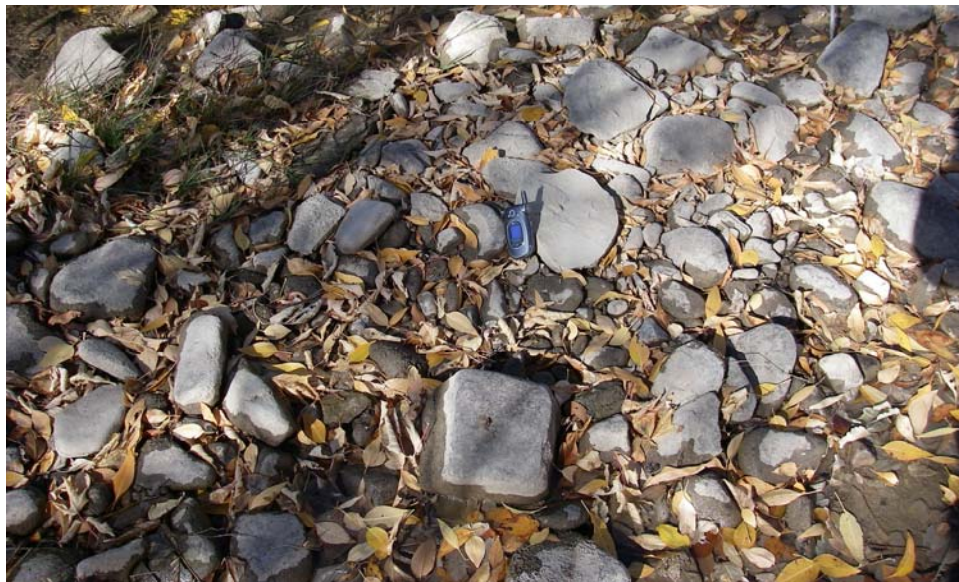
Channel inspections where Lightner Creek crosses from the north to the south side of Highway 160, at Lightner Creek Village, found little evidence of shale material (Photo 40) despite digging into bars and flood plain areas. If present, it represented less than 5% of the material present and was very small. The material at this location was slightly coarser than channel bed materials found in downstream reaches suggesting a change in dominant geologic composition and-or channel gradient.

Photo 40. Depositional material at Lightner Creek Village/Hwy 160 culvert outlet contains no apparent shale material.

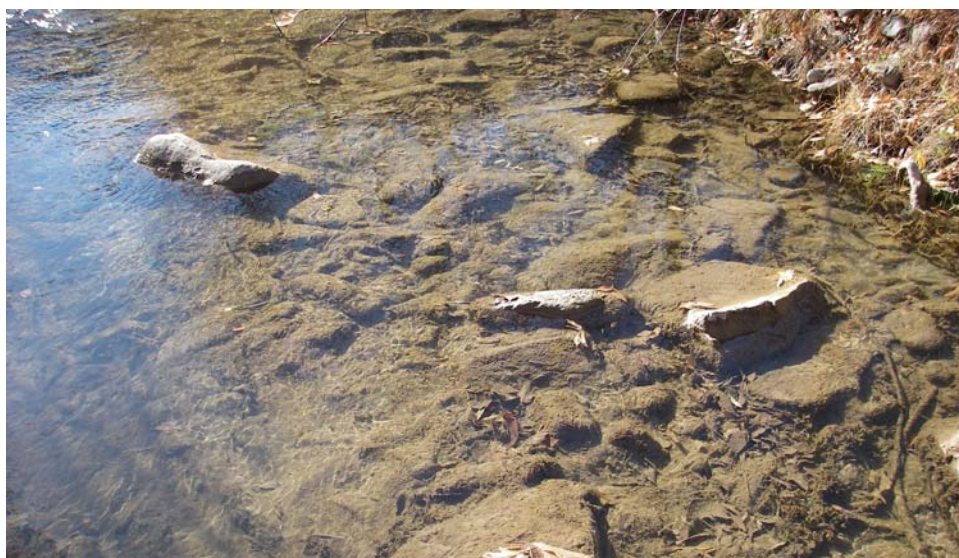
Photo 42. Channel bed with lots of fines at Wildcat Canyon – Lightner Creek confluence channel stability evaluation site.

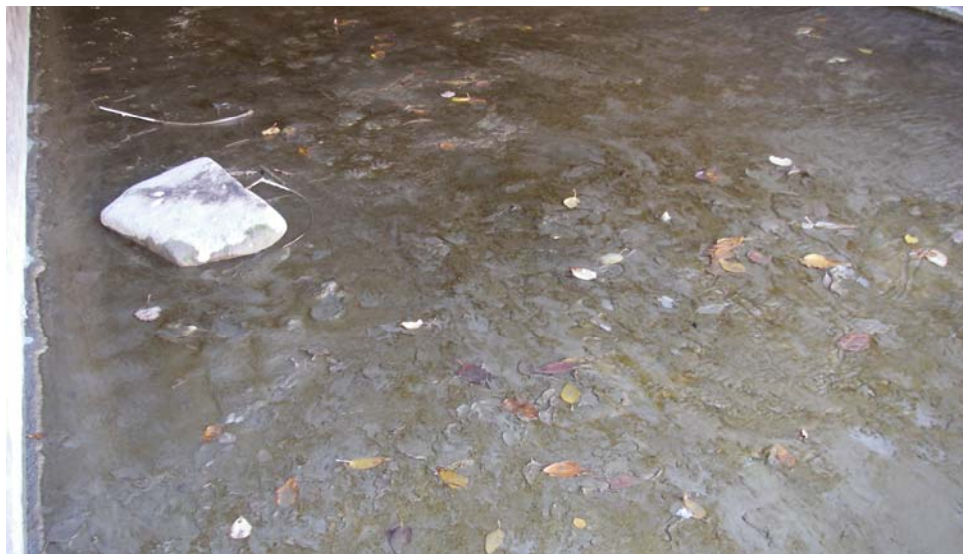
Photo 45. Upstream view of Wildcat Canyon/Hwy 160 culvert outlet (lots of fines with no shale material apparent).

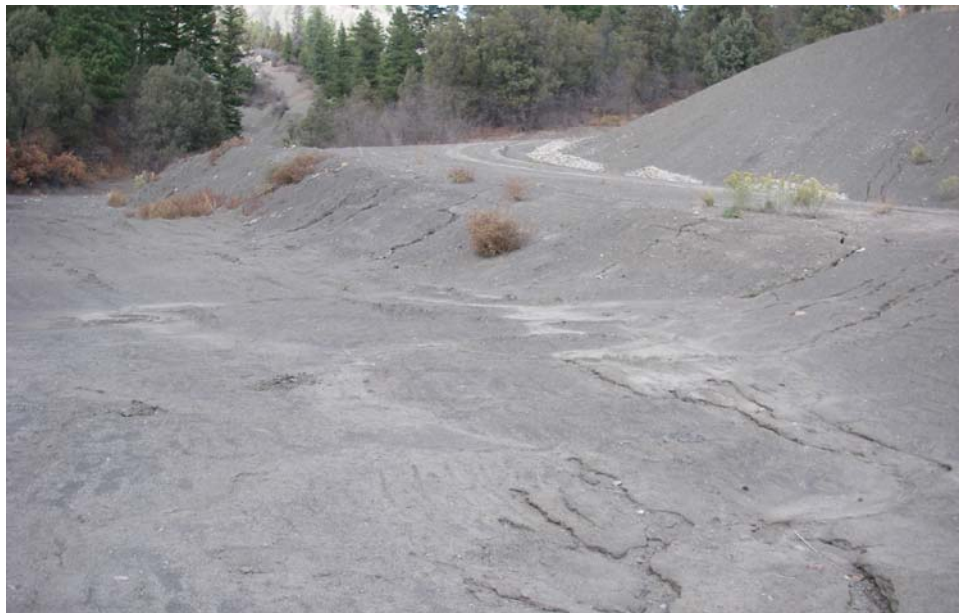
Photo 50. Upstream view from sedimentation basin showing road and slope sediment sources areas.

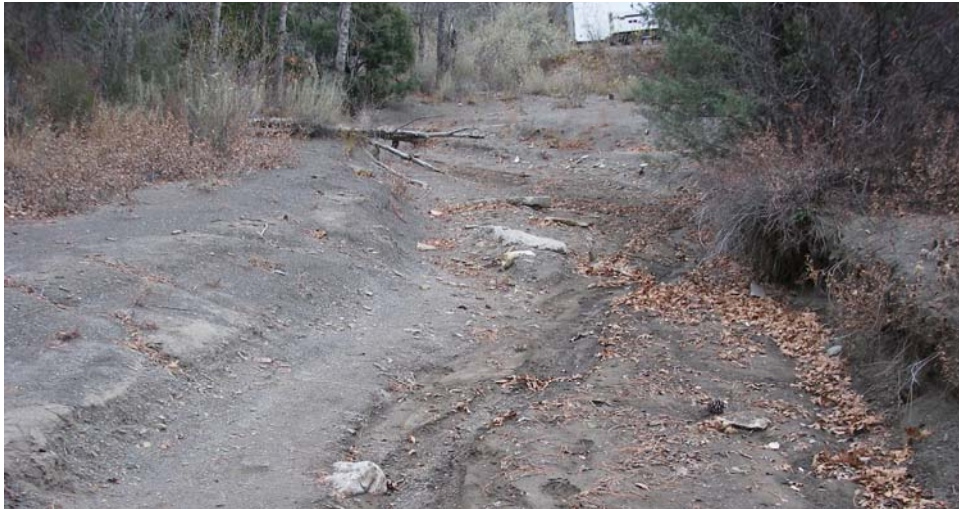
Lower Perins Canyon: The Lower Perins Canyon site was chosen to characterize the relatively undisturbed condition of the Perins Canyon channel (Photo 54). Between this site and Lightner Creek, the channel has been altered to accommodate roads and multifamily housing (Photo 53). Above this site to the end of the road, there are low density single family residences within the valley bottom. Land use modifications associated these residences include culverts for driveways and channel encroachments to accommodate garages, storage areas, etc. (Photos 55-58). The end of the road is at the dashed sub watershed boundary shown on the Watershed Evaluation: Perins Canyon & Tech Center map. Although access was not pursued above the end of the road, it is assumed the upper watershed is in its natural condition and dominated by steep shale slopes.

Photo 54. Upstream view of Perins Canyon channel at downstream end of single family residential area and at channel stability and sediment size analysis site. At least 95% shale composition.

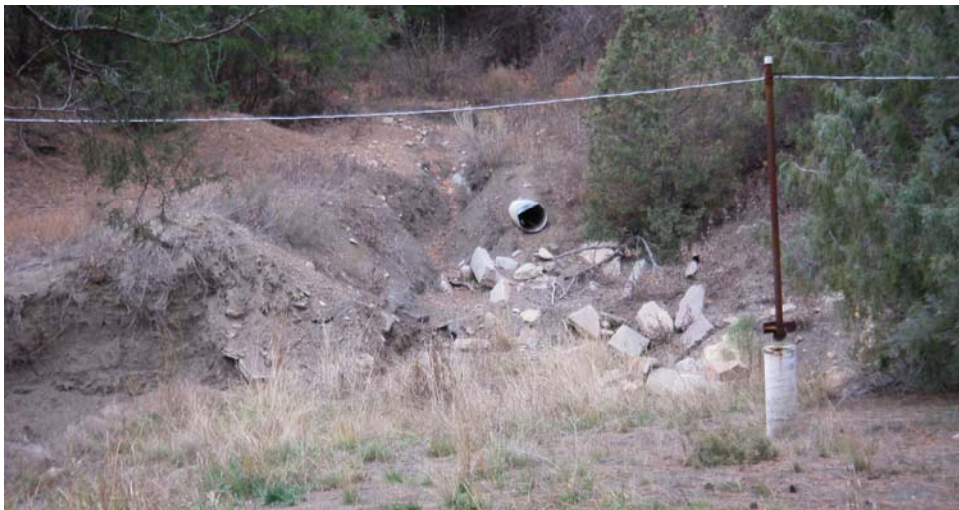
Photo 55. Point-source for erosion due to headcutting (probably due to drainage modifications).

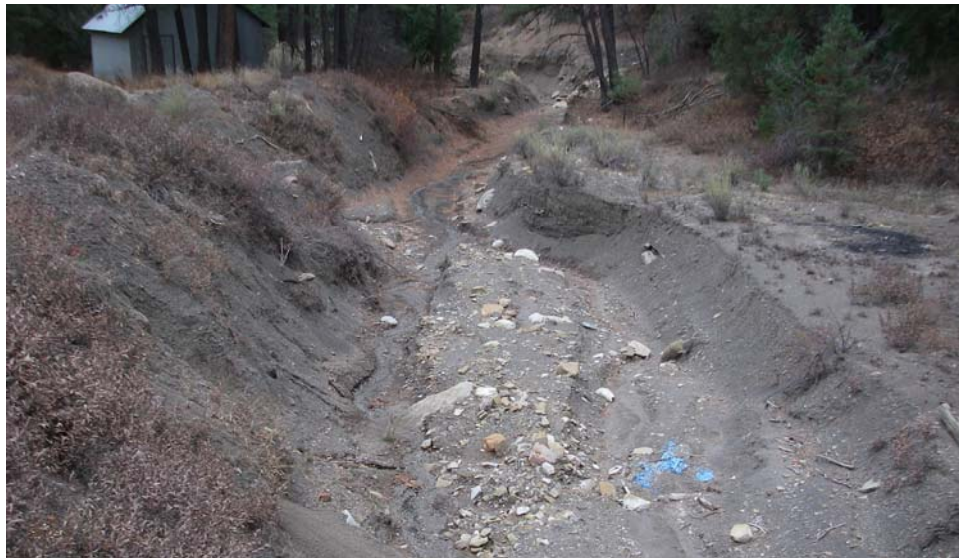
Photo 56. Downstream view below driveway culvert showing highly incised channel due to excavation and berming activities (> 95% shale).

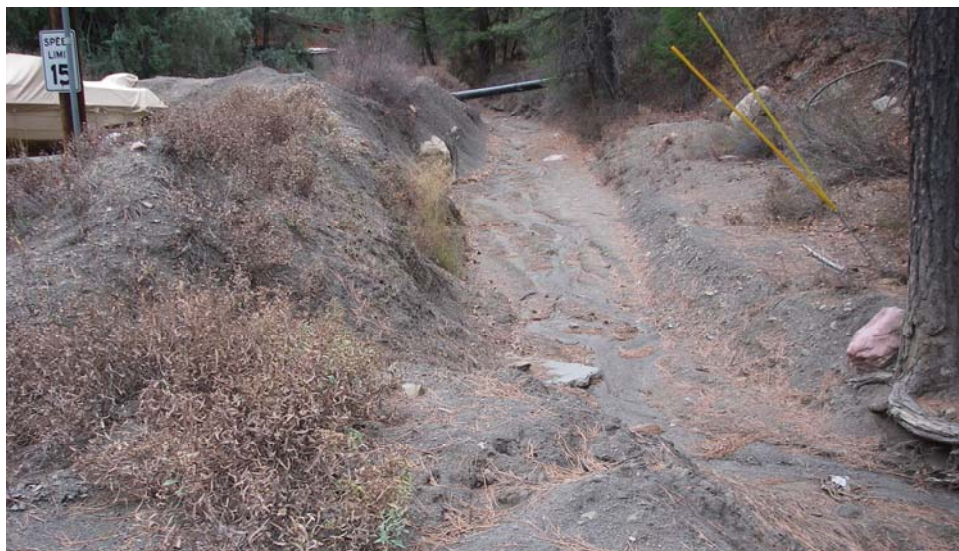
Photo 57. Downstream view showing highly incised channel due to excavation and berming activities (> 95% shale).

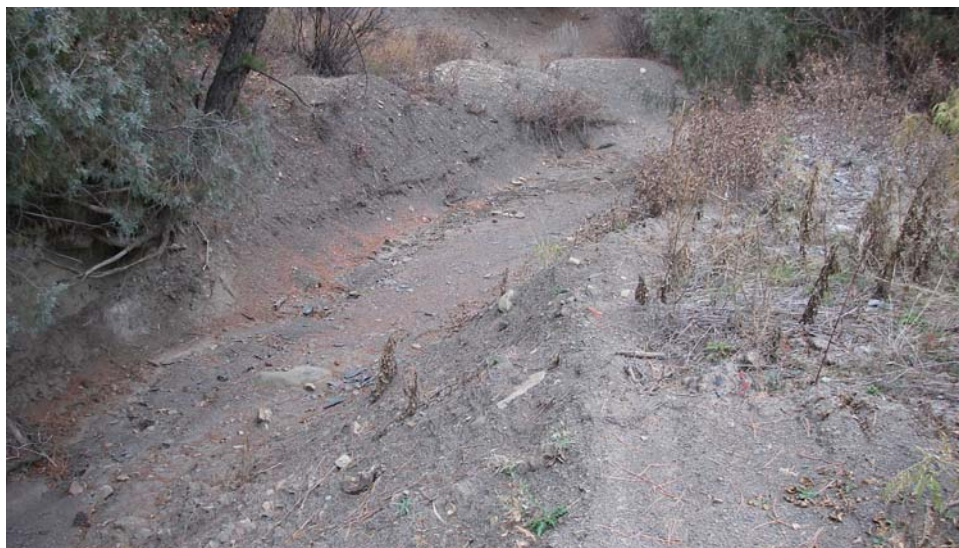
Photo 58. Upstream view showing highly incised channel due to excavation and berming activities (> 95% shale).
