# *Ridgway Ditch & Otonowanda Reservoir*

## **Feasibility Study**

*Town of Ridgway  
Ouray County, Colorado*

***January, 2011***

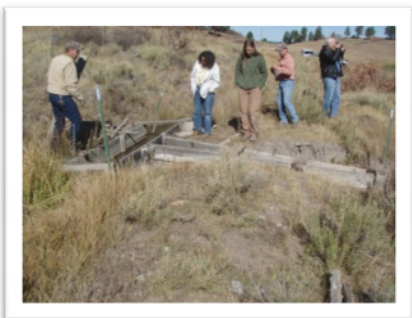
PHOTO 3 LAKE OTONOWANDA  
INLET STRUCTURE

Currently, the Ridgway Ditch delivers water to Lake Otonowanda through an aging wooden structure located on the south west side of the reservoir. This structure allows water to be diverted into the reservoir through an unprotected, earthen channel or continue down the ditch to the pipeline. The condition of this structure and the channel are considered poor. The general configuration of the structure is acceptable, but the wooden materials are deteriorating, and the

channel is eroding. We recommend replacing this structure with a precast concrete diversion that will allow for more precise control and measurement of diversions into Lake Otonowanda. The structure should have stop logs to raise the water surface elevation and force water through a gated outlet into the reservoir. Water passing through the gated outlet will be measured using a v-notch weir before it falls into the channel. The channel between the diversion structure and the reservoir is very steep and prone to erosion; this channel should be lined with riprap or piped to the reservoir bottom to prevent further erosion. A schematic of a concrete diversion structure is included in Appendix E.

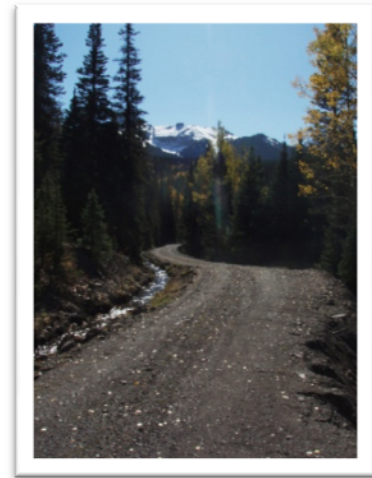
PHOTO 4 RIDGWAY DITCH  
STATION 11+00

The Moderately High or High, and Moderately Slow to Slow soil categories are encountered near the headgate, between stations 0+00 and 70+00. Between stations 70+00 and Lake Otonowanda, the soils are predominantly in the Slow category. Observations made during a site visit indicated that the ditch bottom was composed of heavy clay between stations 180+00 to 230+00. The upper reaches of the ditch contained a gravel bottom primarily composed of materials imported by water diversions from Beaver Creek. These gravels are excavated out as needed which would also remove any natural seal that would form from the finer sediments in the ditch. This seal, however, may not ever build up to a significant amount due to the granular nature of the sediments on Beaver Creek and the higher velocities in the Ridgway Ditch.

Two permanent methods of addressing seepage in the ditch would include piping the ditch or installing a synthetic liner in the open ditch. In order to determine the necessary pipe and liner size a profile of the ditch was generated using data from the National Elevation Dataset (NED). The NED is published by the U.S. Geological Survey and has a resolution of 10 meters. A survey of the ditch centerline would be required during final design of any lining or piping project. The ditch profile and approximated ditch slopes are shown below in Figure 6. A design flow of 7 cfs was selected to evaluate the alternatives since this was the highest diversion amount on recent records and this also is the combined decreed diversion of the water rights decreed for domestic uses.

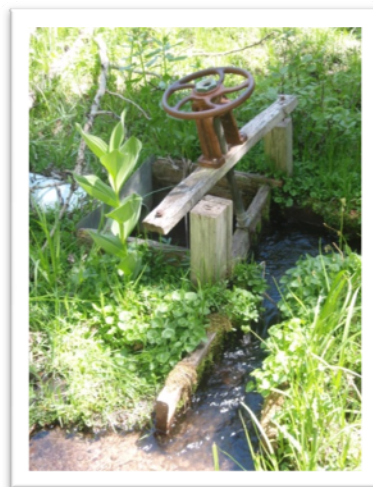
PHOTO 7 AUSTIN SPRING  
SPLITTER BOX

The Austin Spring is decreed for 0.13 cfs, and water records have not been filed with the state. The water from Austin Spring is split before it enters the ditch, with a portion of the flow bypassing the ditch through a pipe elevated above the ditch. We recommend using a 90 degree V-notch with a depth of at least one foot. This will allow measurement of up to 2.5 cfs, which should be more than sufficient. The V-notch could be constructed out of 1/4" to 3/8" steel sheet material and driven or buried in the ground 18" or more, depending on the local soil conditions. The installed weir should maintain at least 6" of space between the base of the notch and the downstream ground level. The area downstream of the weir should be lined with small rock to prevent erosion. The plate will need to

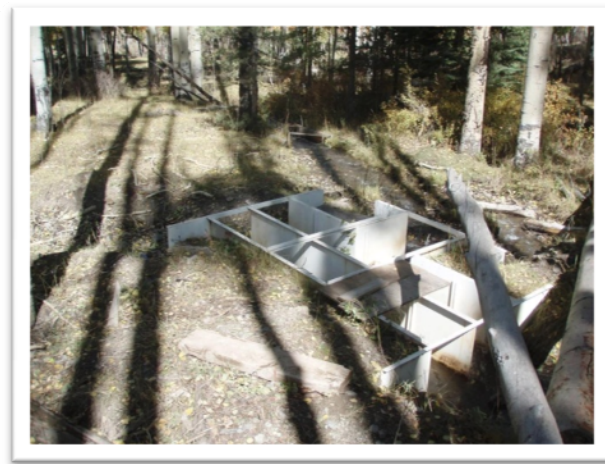
PHOTO 8 UPPER ORTMAN SPLITTER BOX

Historically flows have been divided at this diversion with approximately  $\frac{1}{3}$  of the flow going to irrigate the Ortman's land, and  $\frac{2}{3}$  continuing down the ditch to Lake Otonowanda. A splitter box was installed at this location to control the amount of flow going in each direction. We recommend installing a flume upstream of the diversion and modifying the operation of the splitter boxes to allow for an approximate measurement of the flows in both directions.

In addition, this splitter box could be reconfigured to allow the percentage of flow passing in each direction to be estimated. First, the area upstream of the entrance to the box needs to be cleaned out, and the banks raised as necessary to bring them level with the top of the box. This will allow for a calm pool to form upstream of the diversion. Second, stop logs should be added to the left channel to eliminate that potential flow path. Third, the stop logs in the right channel should be modified to insure that water does not leak between or around them. A sheet of plastic attached to the front of the stop logs could accomplish this. The stop logs in this channel can be adjusted to divide the flow as desired. By measuring the distance from the top of the box to the stop logs, the percentage of water being diverted in each direction can be determined, and an approximate flow assigned. These measurements need only be taken when the stop logs are adjusted. The following schematic illustrates modification to the operation of the splitter box.

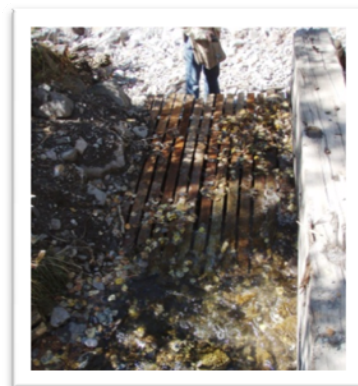
PHOTO 9 RIDGWAY DITCH  
HEADGATE SCREEN

The existing diversion structure is a Tyrolean style intake which is well suited for high mountain streams that carry a large amount of debris during spring runoff. The intake grate is situated on the bottom of the main channel and consists of upside down rails welded together. Town staff recently rebuilt this grate and the spacing on the rails is approximately  $\frac{1}{2}$ " however this varies due to the amount of wear on the rail edges. The remaining structure is composed of wood timbers. Water falling through the intake grate enters a rectangular channel with an inoperable swing gate. The swing gate was historically used to flush sediment from the box. At the end of this box stop logs can direct water back to Beaver Creek or into the Ridgway Ditch. The 30" Parshall flume is located approximately 100 ft downstream of the wooden channel.

Recommended improvements to the existing structure would include replacing the existing grate and installing an adjustable gate on the structure to control flows into the Ridgway Ditch. The existing grate is composed of light crane rails placed side by side and upside down. The grate is approximately four feet wide and eight feet long. We estimate that of the 32 square feet of grate only 18 square feet actually lies above the channel below. This configuration has worked well in the past, however, the rail edges have become worn which has widened the gap between rails and allowed more sediment to pass through the screen and into the ditch. Replacing this screen with a prefabricated profile bar screen with smaller openings could remove a greater amount of sediment from the flow entering the ditch. This grate would be sized to pass a flow rate in excess of the decree to allow for some clogging between maintenance visits. We estimate that a new grate could keep out materials greater than  $\frac{1}{8}$ " in diameter. The smaller openings in the grate may be more prone to icing during the winter and the old rack, or something similar, may need to be installed during the winter season. Other modifications to the existing structure would be required to allow the grate to attach to it securely; however, we would need to pull out the old grate to

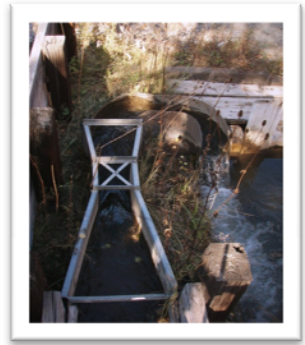
PHOTO 12 HAPPY HOLLOW  
HEADGATE FLUME

At the Happy Hollow Diversion there is currently a 9" Parshall flume in an unconventional configuration. It appears that the exit conditions are satisfied, but it appears that water is entering the flume too quickly, creating waves at the staff gage. In addition, the flume is located immediately downstream of an existing sluice gate which would affect the readings, however, it is our understanding that this gate is not used. This may contribute to inaccurate readings. This could be helped by installing a stilling well on the existing Parshall flume, but space is limited around the flume. A tube could be run out from the side of the flume to an area downstream where there is adequate space to install the stilling well. The trench for the tube would need to be hand dug due to the close proximity of other parts of the diversion structure. Installing a stilling well is only necessary if a data recorder will be installed. Because of the close proximity of this diversion to Town, and the relatively low fluctuations in flow, a data recorder is probably not necessary.

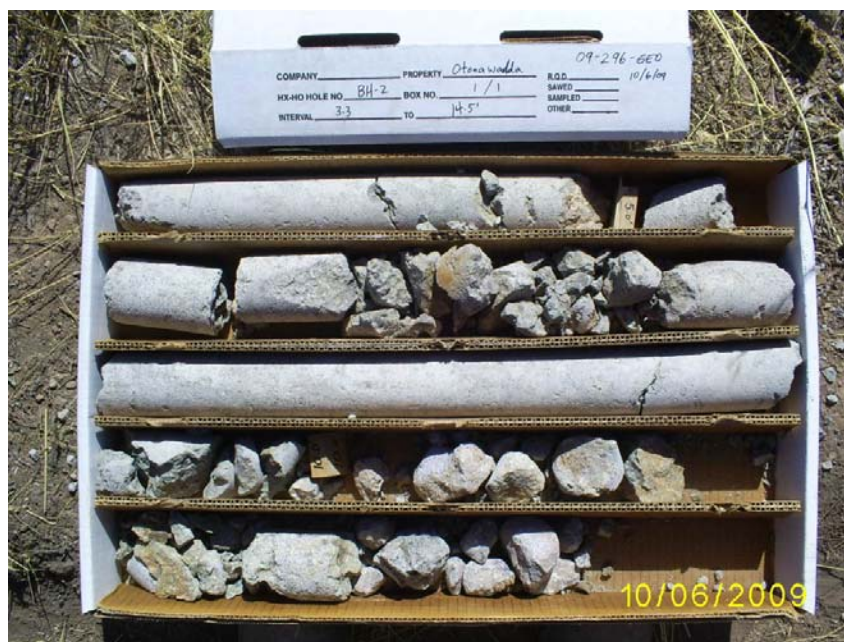
**Recovered core from BH#2 (3.3-14.5 feet). The gravel-sized pieces of rock are indicative of highly fractured, and possibly more weathered bedrock zones.**

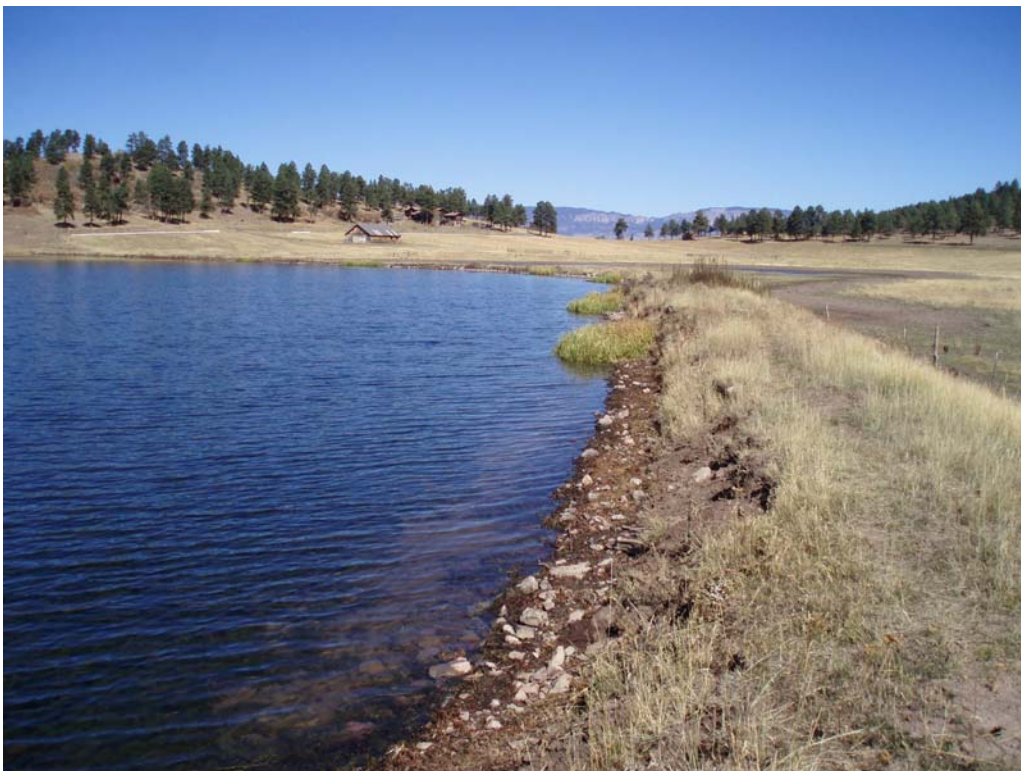
Typical shoreline along dike on east side of reservoir. Note wave action has eroded the dike and only patches of wetland fringe can persist here.

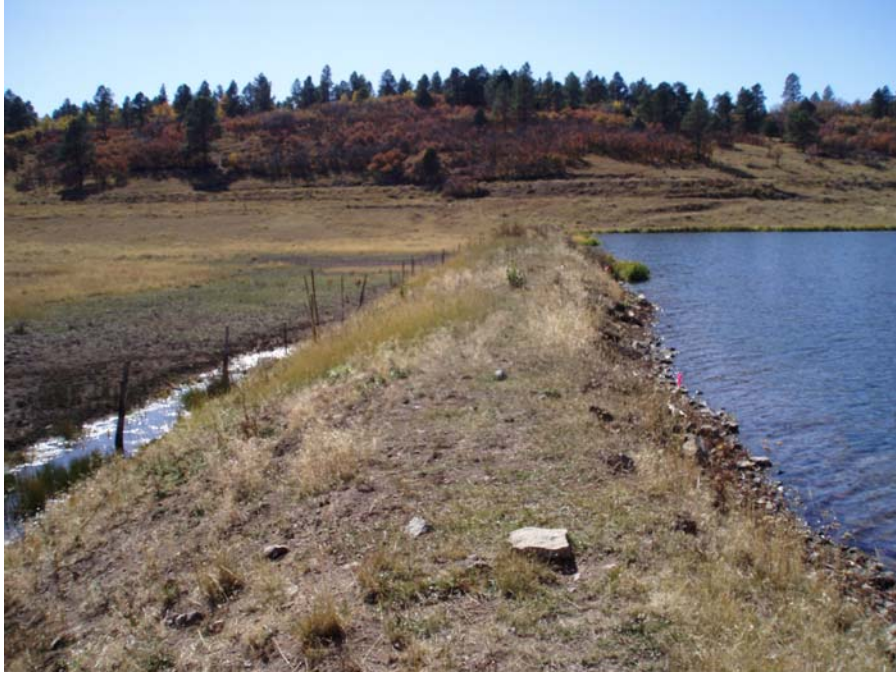
Existing dam/dike for the Reservoir. The intent was to contain water on Town property and not allow flooding onto adjacent private land. The dam is in need of repairs.

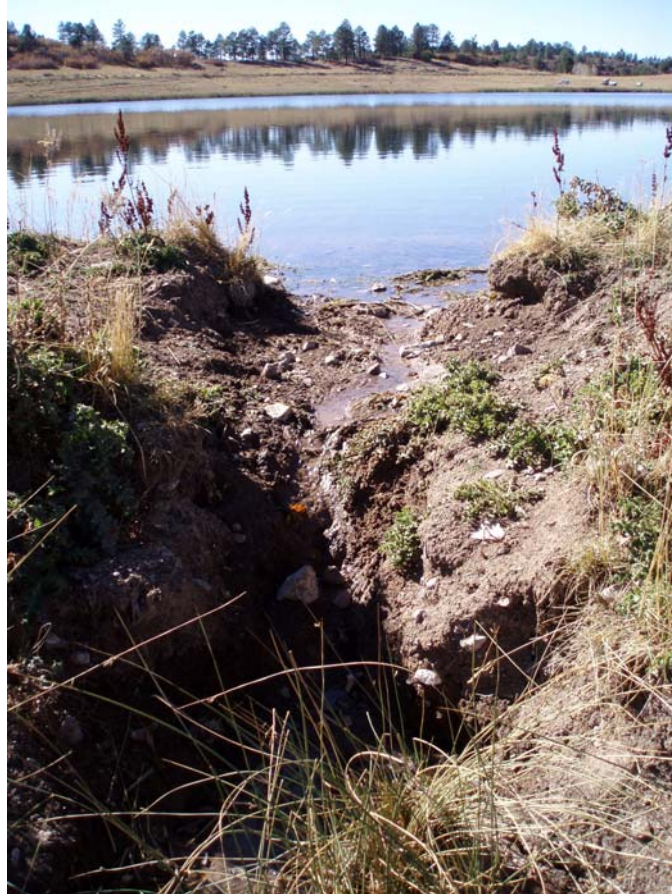
Photo of one of four breach locations along the existing dam. The breaches allow water to spill onto the adjacent property when the reservoir is full or during storms with wave action, extending the created wetland area beyond the Town property.

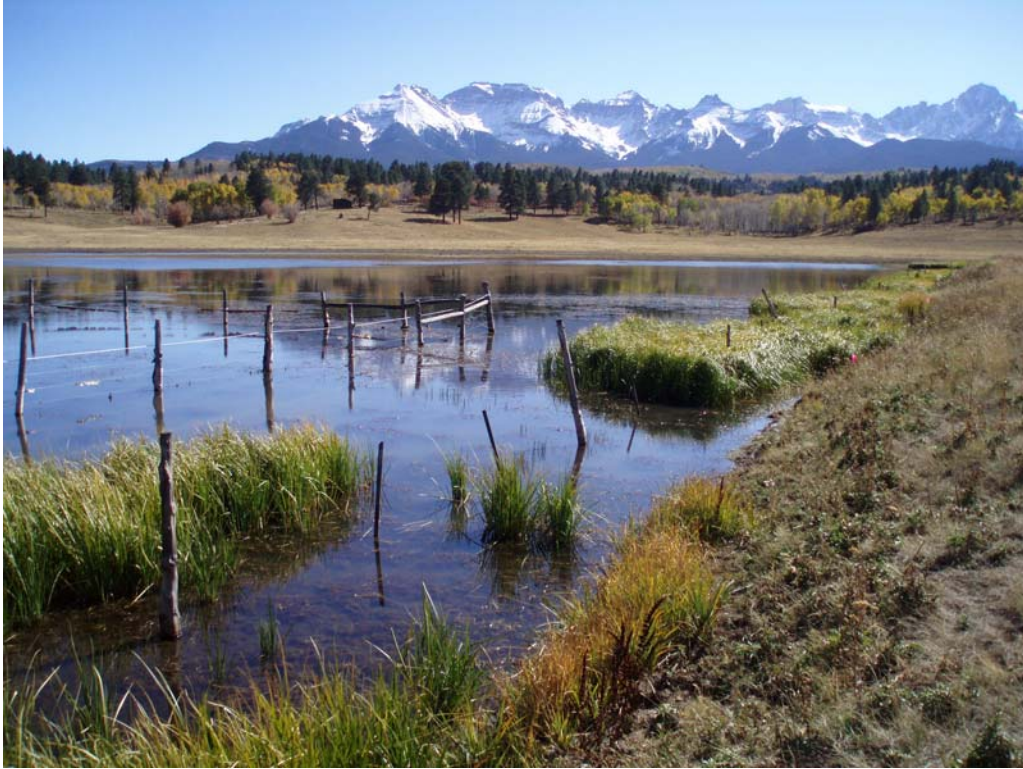
View below dike onto adjacent private land. Note flooded corrals and pasture due to dam breaches and leaks.
