SUBJECT: **Agenda Item 11, January 23-24, 2012 Board Meeting**
South Platte River Boat Chute Modification

WHITEWATER ON THE SOUTH PLATTE RIVER **SAFETY AND PERCEIVED SAFETY FOR THE NON-BOATING PUBLIC**

Ben Nielsen, EIT, LEED AP¹ – McLaughlin Whitewater Design Group
Joe Busto² – Colorado Water Conservation Board

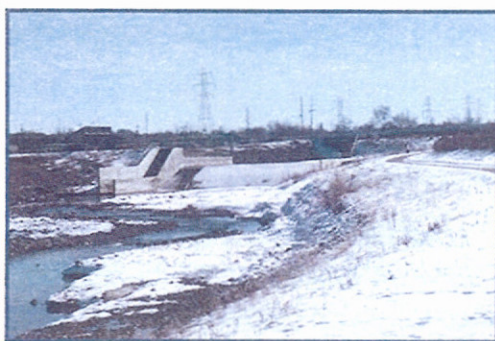
Figure 1: Original Diversion Dam at Union Avenue Circa 1984

In the early 1980's the USACE built a low head dam to create a raw water diversion for the City of Englewood. The project included an ogee crest type dam structure with a 13 foot vertical drop, abutment walls on both sides of the river at the dam crest, concrete wing walls extending downstream of the dam, buried riprap, and a sluicing radial gate. Shortly after completion of the project, multiple drownings occurred resulting in the removal and redesign of the diversion.

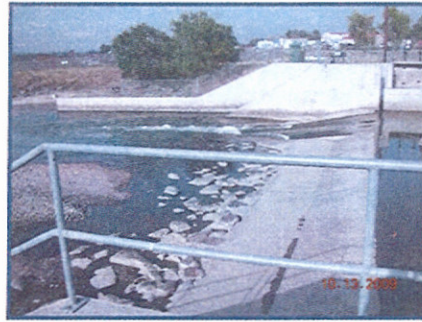
Figure 3: Concrete Wall Downstream of Drop #1 River Right

- Ingress and egress appears restricted due to vertical concrete wing walls downstream of Drop #1 along both banks.
- An eddy exists at river right between Drop #1 rapids and a vertical concrete wall. Pool depths at this location are over six feet.
- Existing signage is in need of maintenance/ replacement.
- Adjacent access improvements most likely increased the usage of the whitewater park by boaters and non-boaters.

Removal of the existing concrete walls in Pool #1 is an integral part of this project. The walls were constructed in 1984 as part of the original USACE diversion dam project. Their primary function was to provide erosion protection for the banks along the downstream pool. Although the walls still provide erosion protection today, they are excessive since the modification of the original dam in 1992 reduced the drop height by approximately 10 feet. The walls have a total height of twenty feet, which is mostly buried below the river bottom. Exposure of the walls varies depending on sedimentation. At the time of survey for this project, wall exposure at river right and river left were approximately 9.5 and 6 feet, respectively. A sluicing gate exists at the crest of Drop #1 at river right which discharges along a wall section to be removed.

The primary objective of the wall removal design was to improve the ingress and egress at Pool #1. An eddy exists between the rapid from Drop #1 and the concrete wall at river right. This creates an impediment to exiting the water due to an induced recirculating current and the obvious difficulties with climbing a vertical wall. In addition, the river is greater than six feet deep at this location during low flows. Removal of the wall will expand the eddy out along the bank where it is shallower and exiting the river is less difficult. At higher flows the wall at river left would also hinder egress from Pool #1, therefore removal of a section of this wall was designed.

- Improvements need to focus on non-boater users (such as tubers) while not adversely affecting boatability.
- Improvements should target flows during expected usage- approximately 200 – 2000 cfs.
- Remove vertical concrete wing walls downstream of Drop #1 to improve ingress and egress access.
- Add rock structures along both river banks in Pool #1 to reduce eddy velocities and improve egress.
