SUBJECT: **Agenda Item 11, January 23-24, 2012 Board Meeting
South Platte River Boat Chute Modification**

WHITEWATER ON THE SOUTH PLATTE RIVER **SAFETY AND PERCEIVED SAFETY FOR THE NON-BOATING PUBLIC**

Ben Nielsen, EIT, LEED AP¹ – McLaughlin Whitewater Design Group
Joe Busto² – Colorado Water Conservation Board

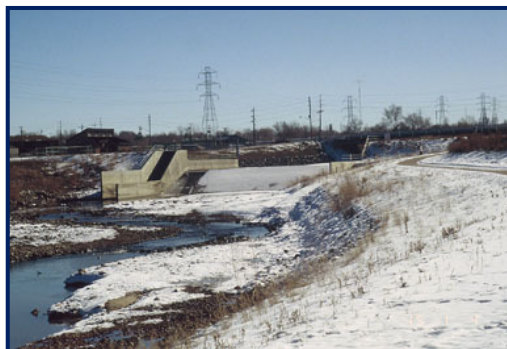
Figure 1: Original Diversion Dam at Union Avenue Circa 1984

In the early 1980's the USACE built a low head dam to create a raw water diversion for the City of Englewood. The project included an ogee crest type dam structure with a 13 foot vertical drop, abutment walls on both sides of the river at the dam crest, concrete wing walls extending downstream of the dam, buried riprap, and a sluicing radial gate. Shortly after completion of the project, multiple drownings occurred resulting in the removal and redesign of the diversion.

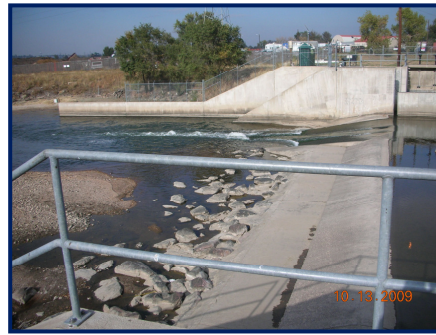
Figure 3: Concrete Wall Downstream of Drop #1 River Right

- Ingress and egress appears restricted due to vertical concrete wing walls downstream of Drop #1 along both banks.
- An eddy exists at river right between Drop #1 rapids and a vertical concrete wall. Pool depths at this location are over six feet.
- Existing signage is in need of maintenance/ replacement.
- Adjacent access improvements most likely increased the usage of the whitewater park by boaters and non-boaters.

The primary objective of the wall removal design was to improve the ingress and egress at Pool #1. An eddy exists between the rapid from Drop #1 and the concrete wall at river right. This creates an impediment to exiting the water due to an induced recirculating current and the obvious difficulties with climbing a vertical wall. In addition, the river is greater than six feet deep at this location during low flows. Removal of the wall will expand the eddy out along the bank where it is shallower and exiting the river is less difficult. At higher flows the wall at river left would also hinder egress from Pool #1, therefore removal of a section of this wall was designed.

- Improvements need to focus on non-boater users (such as tubers) while not adversely affecting boatability.
- Improvements should target flows during expected usage- approximately 200 – 2000 cfs.
- Remove vertical concrete wing walls downstream of Drop #1 to improve ingress and egress access.
- Add rock structures along both river banks in Pool #1 to reduce eddy velocities and improve egress.
