December 29, 2011

Re: 2011 Monitoring Report for the Phase 2A and 2B Edwards Eagle River Restoration Project in Eagle County, Colorado, Corps File No. SPK-2008-00608

EAGLE RIVER PHASE 2B 2011 MONITORING REPORT VEGETATION TREATMENTS

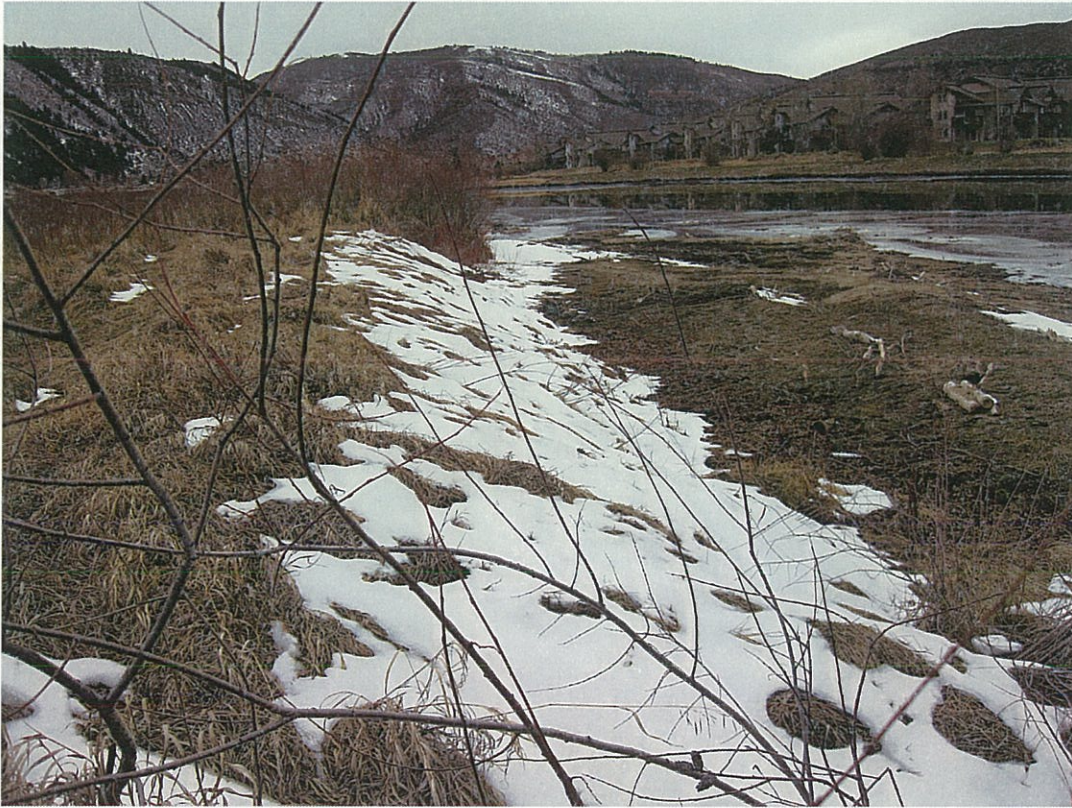
Point 2BV8L: 11-11-11 Treatment area 2B-1 looking upstream, after smashbank treatment.

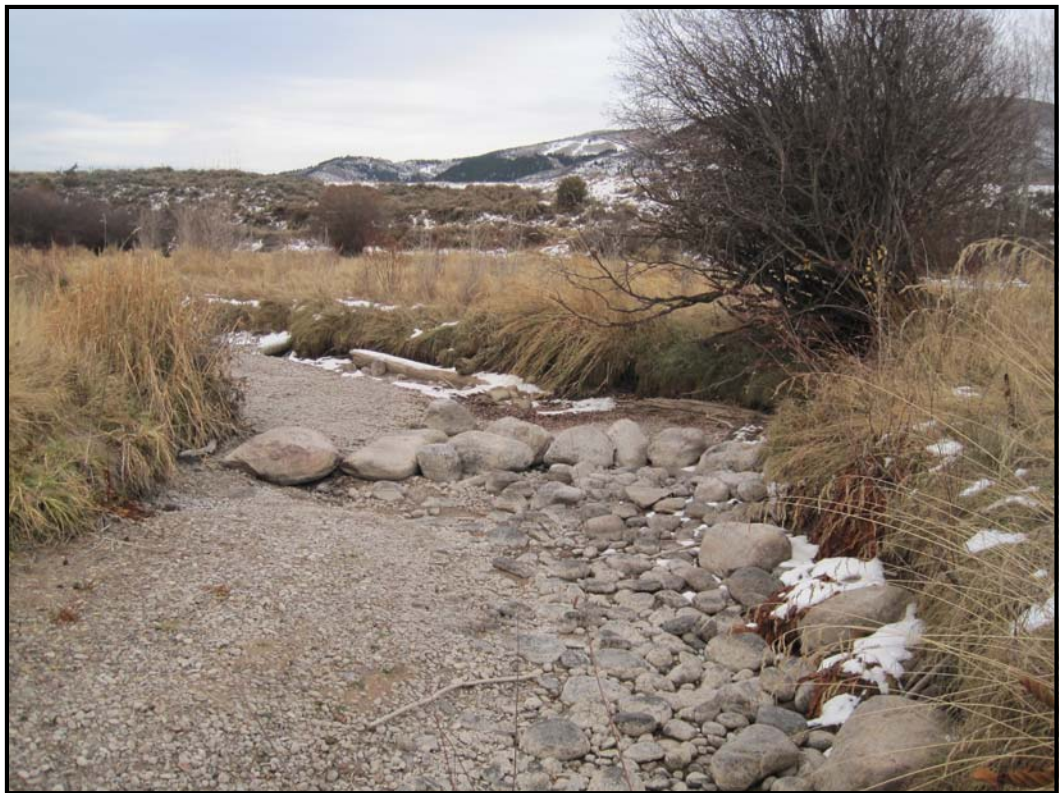
Point 1S6L: 11-11-11 Reach 5, left bank, looking upstream to existing grade control augmentation. Habitat logs are also visible.

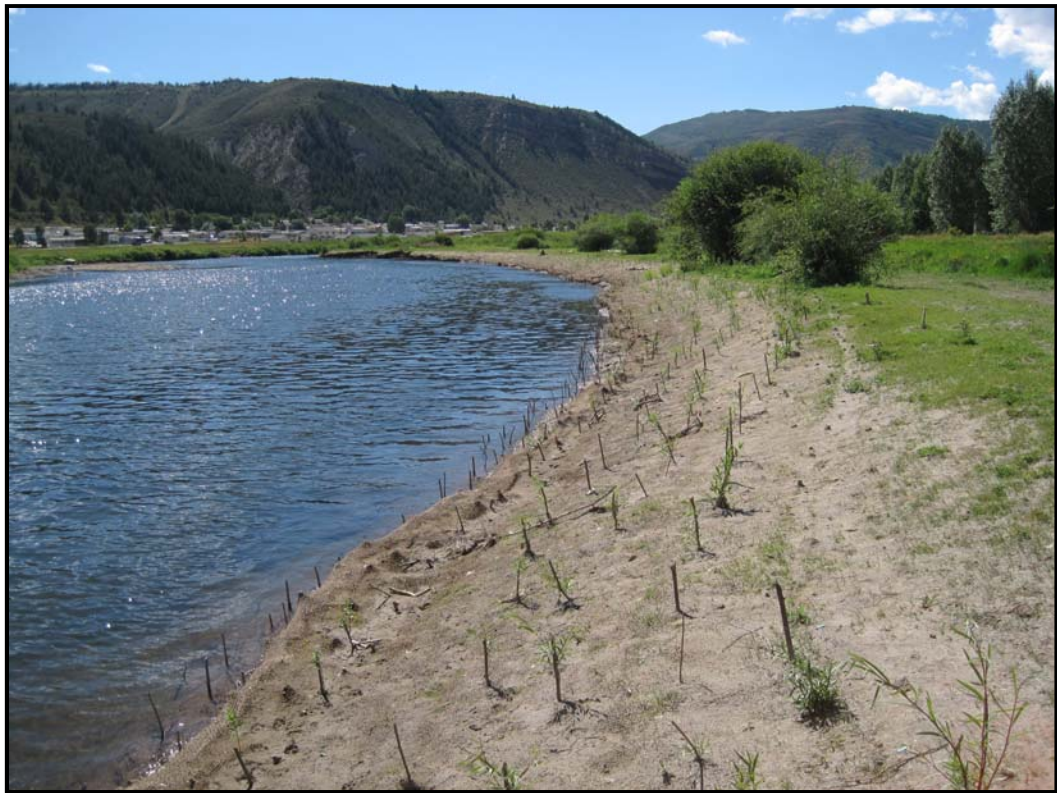
Native grass cover on graded banks is approximately 20% from the establishing streambank seed mix. Native grass cover on areas at the top of the banks that were seeded with an upland seed mix varies, with some areas nearly bare and others showing 100% cover. The average grass cover is estimated to be 60% and in most areas, the newly-seeded areas are holding up well to heavy presence by Canada geese. Canada thistle was sprayed with herbicide in fall of 2011. There is a patch of annual weeds (approximately 100' x 50') at the top of the bank in the downstream portion of the area.

Point 2V1R: 8-15-11 Treatment area 2-13 looking downstream, 1 year after bank layback and willow wattle installation. (Willow wattles are underneath erosion control blanket at toe of slope.)

The bank damaged by high flows was repaired using the smashbank technique, in which river banks are pushed back with a large excavator bucket to a more gradual slope, but no soil is removed. Willow wattles and coir erosion control blanket were replaced, and an extra width of coir erosion control blanket was installed at the top of the bank slope.

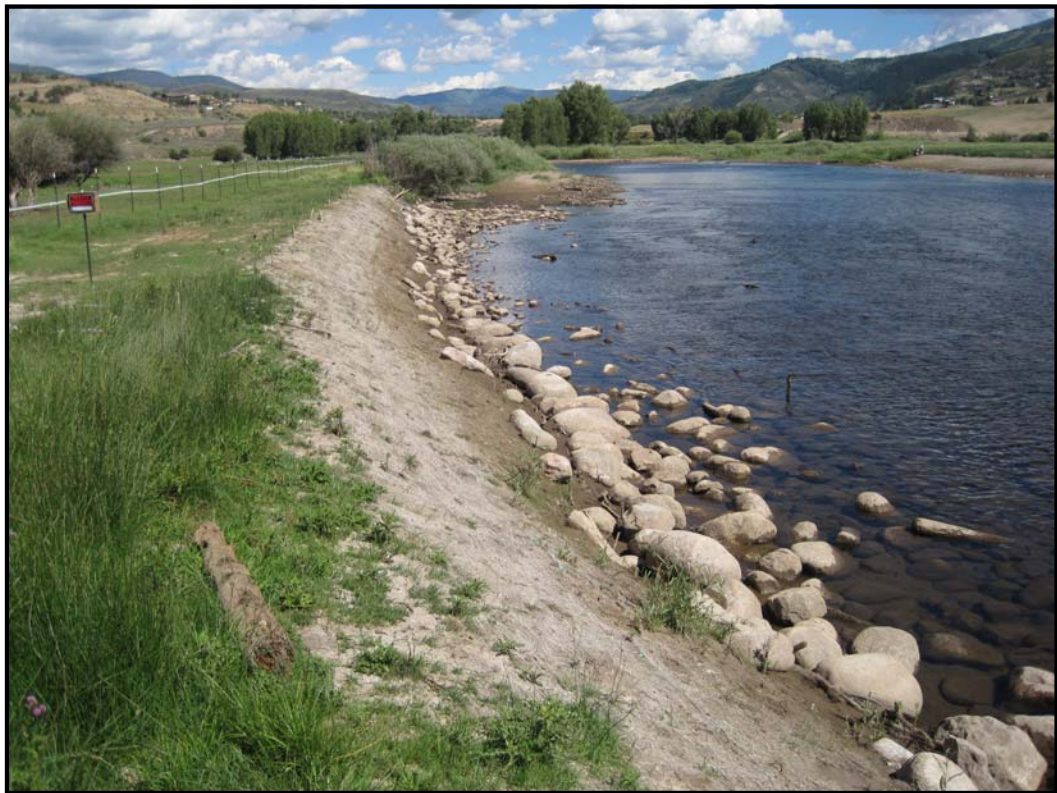
The erosion control blanket is intact, and there is approximately 70% cover from the streambank seed mix. Willow stake survival averages approximately 35%. There is one area of Canada thistle approximately 12' x 30' in size at the downstream end of the treatment area.

Point 2S1R: 8-15-11 Treatment area 2-11 after bank layback, willow wattle installation, and cobble bar enhancement. Fence was moved northward (to the left) to keep cattle off the river bank.

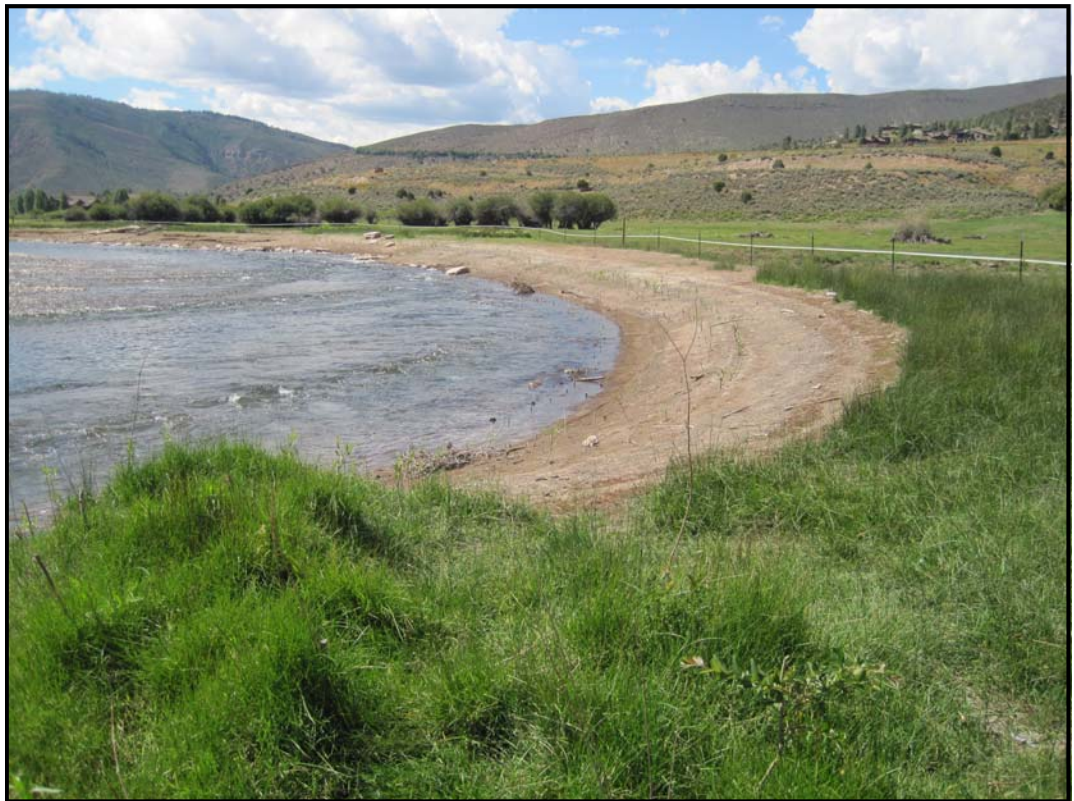
For discussion purposes, this large area is divided into thirds. The downstream-most third exhibits over 90% herbaceous cover and includes primarily Baltic rush (*Juncus balticus*), bottlebrush squirreltail (*Elymus elymoides*), and Canada wildrye (*Elymus canadensis*). Willow stake survival averages 85%. Willow sprouts are emerging from willow wattles at an average rate of one per every one linear foot. In the central third, willow stake survival is approximately 60% and willow sprouts are emerging from

wattles at an average rate of two per linear foot. Native grass cover averages approximately 80%. In the upstream third, willow stake survival is approximately 50% and willow sprouts are emerging from wattles at an average rate of one per linear foot. Native grass cover ranges between 40% and 80% and there is a notable presence of sedge (*Carex spp*) from topsoil that was reserved and replaced on the bank. There are no noxious weeds present in this treatment area. Electric fence that keeps cattle off of the river banks is a major factor in the positive trend of native vegetation establishment.

Point 2V4R: 8-15-101 Treatment area 2-6 after bank layback, willow wattle installation, and cobble toe reinforcement.

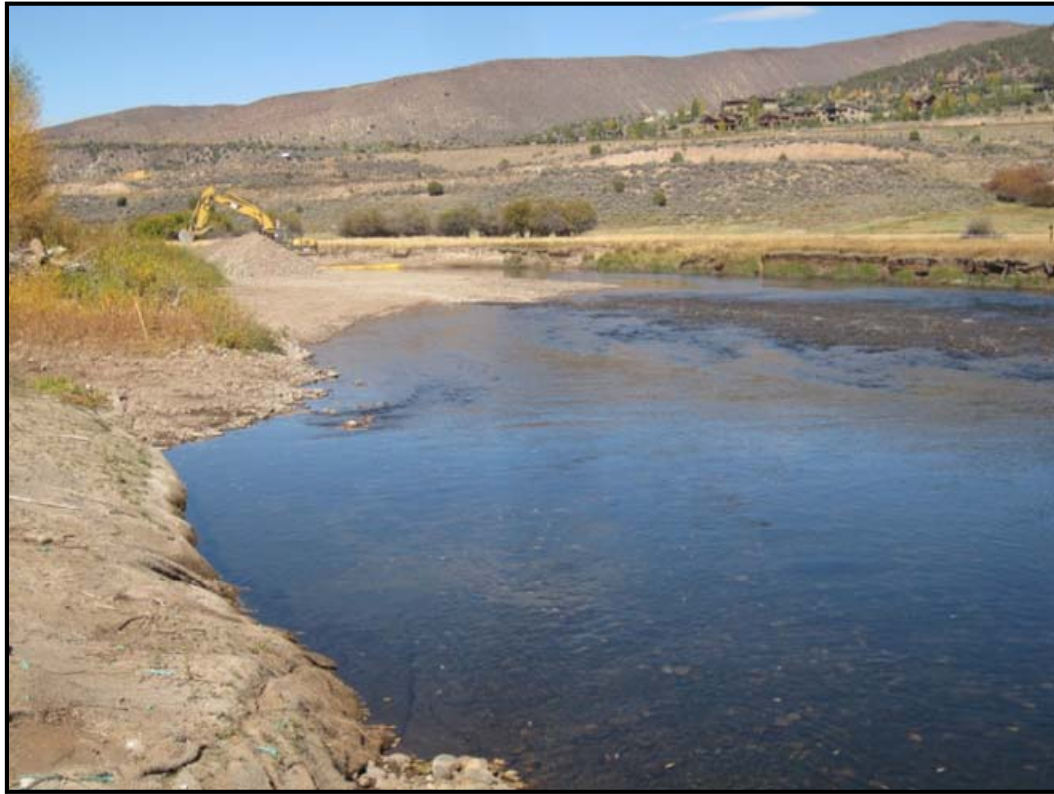
Point 2S1L: 11-18-11 Treatment area 2-8 looking south into side channel, after enhancements.
