December 29, 2010

**Re: 2010 Monitoring Report for the Phase 1 Edwards Eagle River Restoration Project in Eagle County, Colorado, Corps File No. SPK-2008-00608-CW**

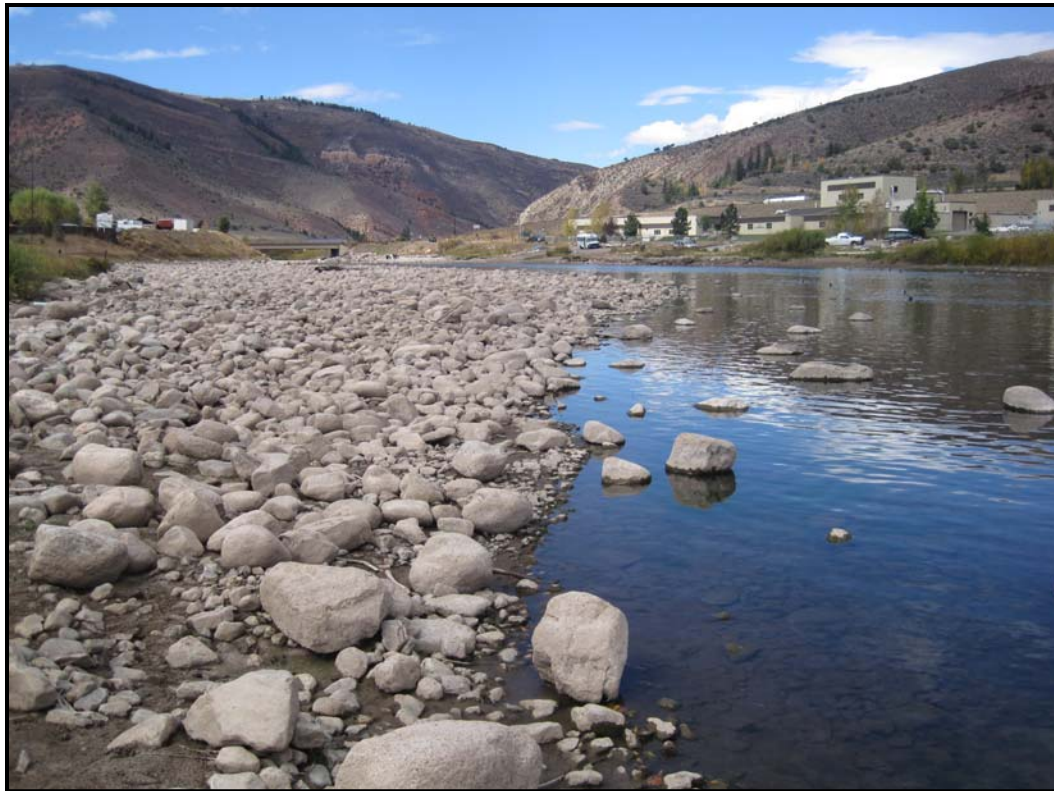
**Point 1S2L:** 10-5-10 Reach 2, left bank, looking downstream to Bar 1-17.

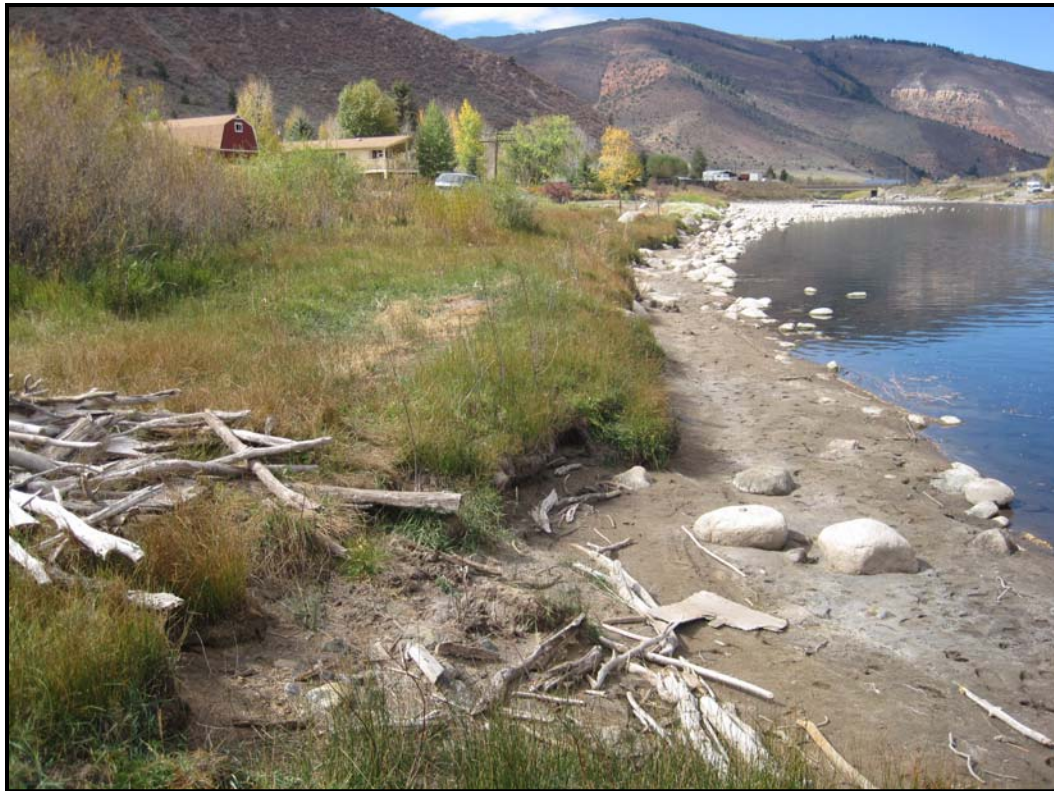
**Point 1S3L:** 10-5-10 Reach 2, looking downstream along Boulder/cobble Toe Treatment 1-16.

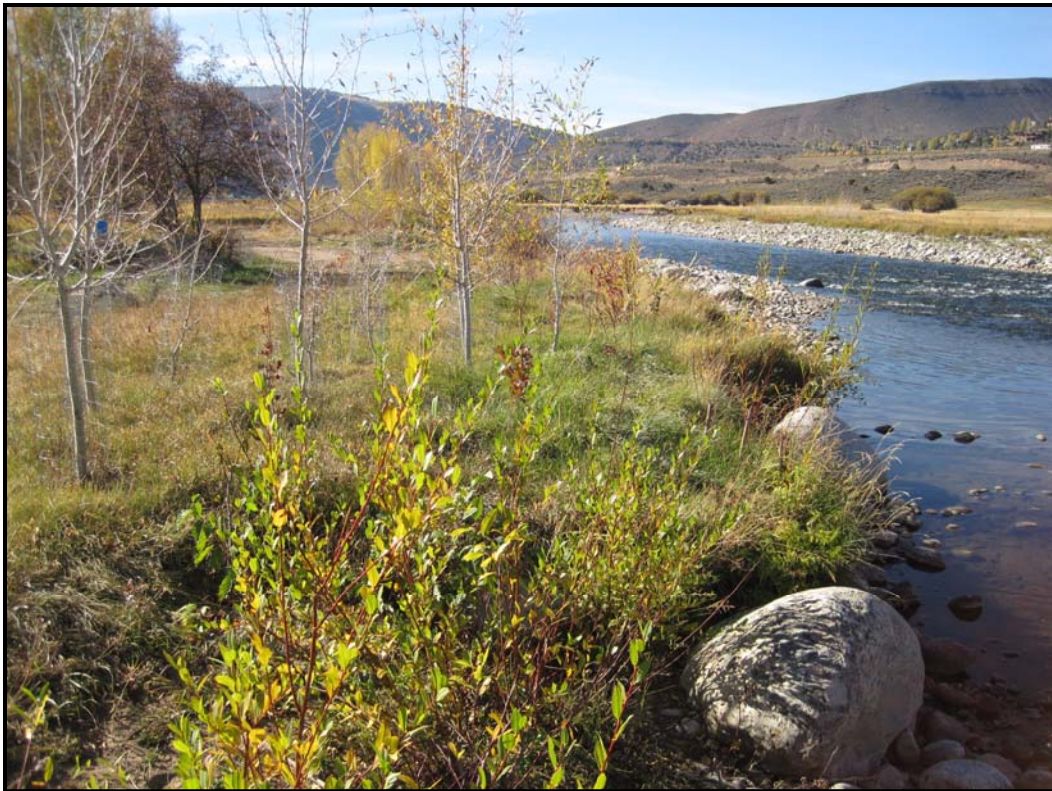
**Point 1S4L:** 10-13-10 Reach 5, left bank, looking downstream to Bar 1-9.

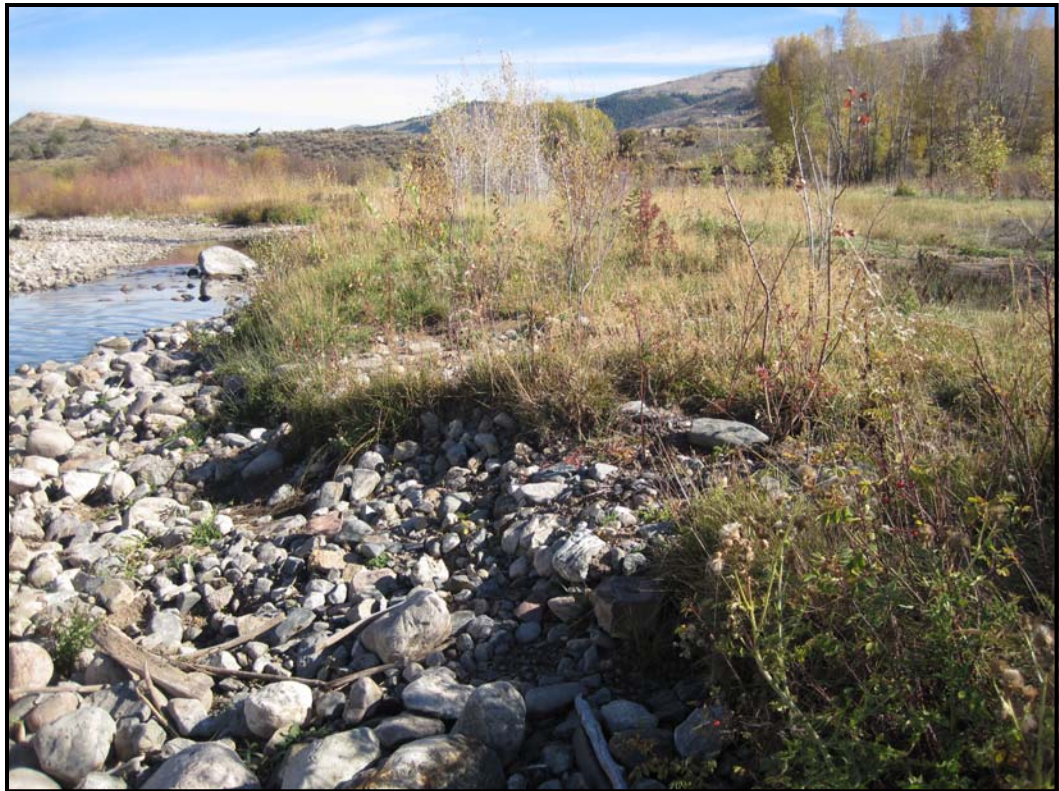
**Point 1S5L:** 10-13-10 Reach 5, left bank, looking upstream to Plug 1-6.

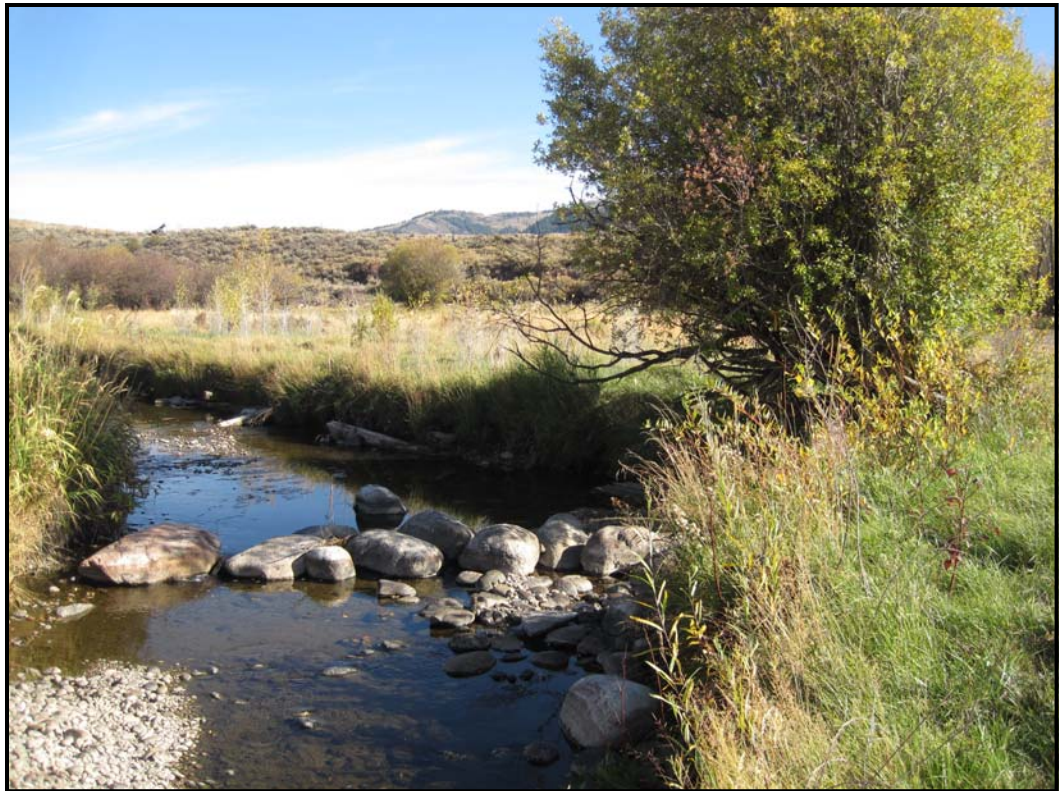
**Point 1S6L:** 10-13-10 Reach 5, left bank, looking upstream to existing grade control augmentation. Habitat logs are also visible.

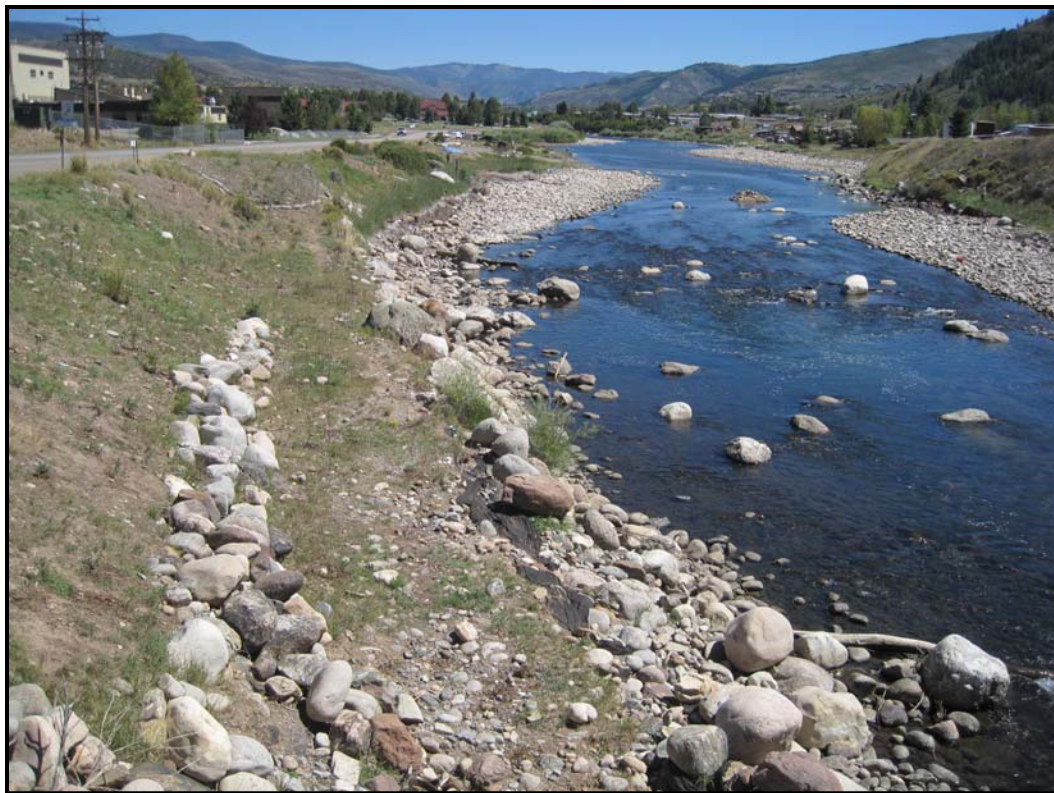
**Point 1S1R:** 9-3-10 Reach 1, right bank, looking upstream from Hillcrest Drive bridge, showing Bars 1-20 and 1-22.

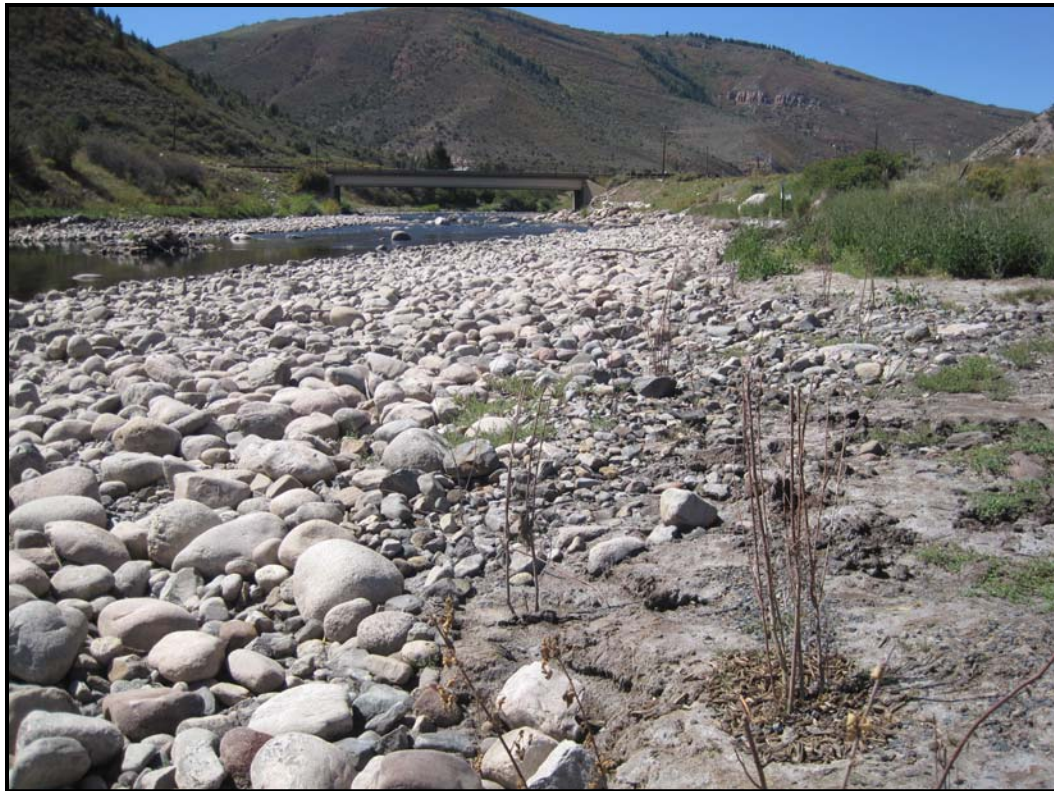
**Point 1S2R:** 9-3-10 Reach 1, right bank, looking downstream to Hillcrest Drive bridge, across Bar 1-20.

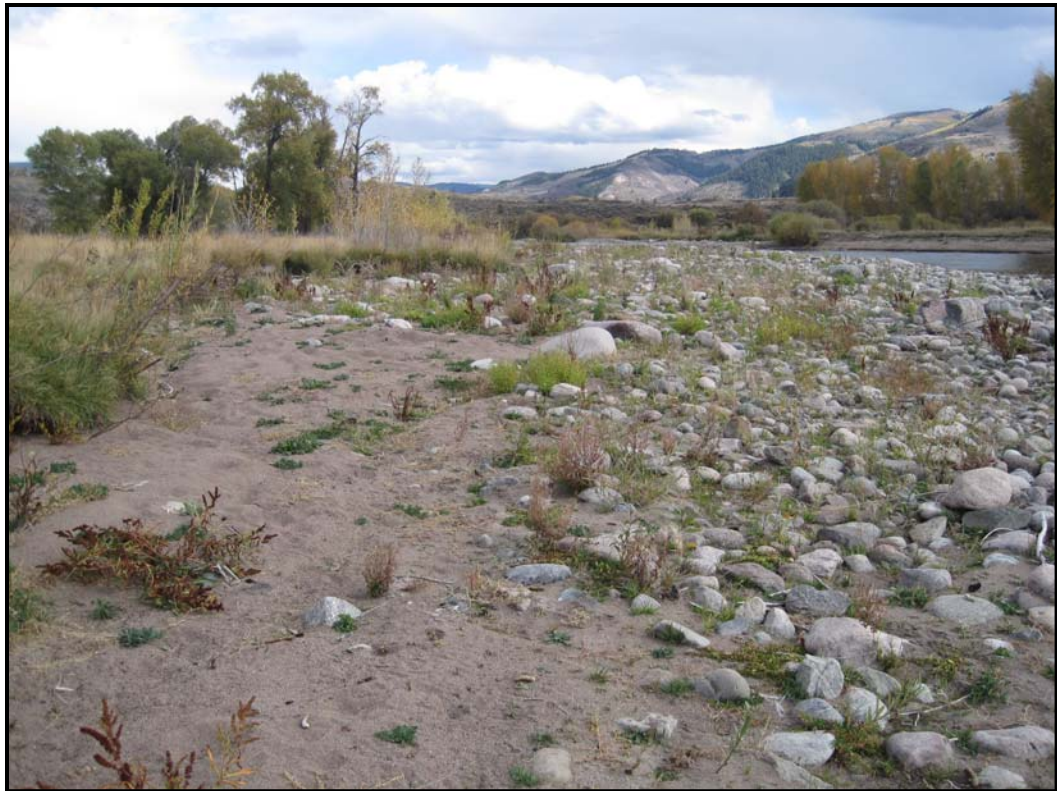
**Point 1S6R:** 10-5-10 Reach 5, right bank, looking upstream at Bar 1-8.

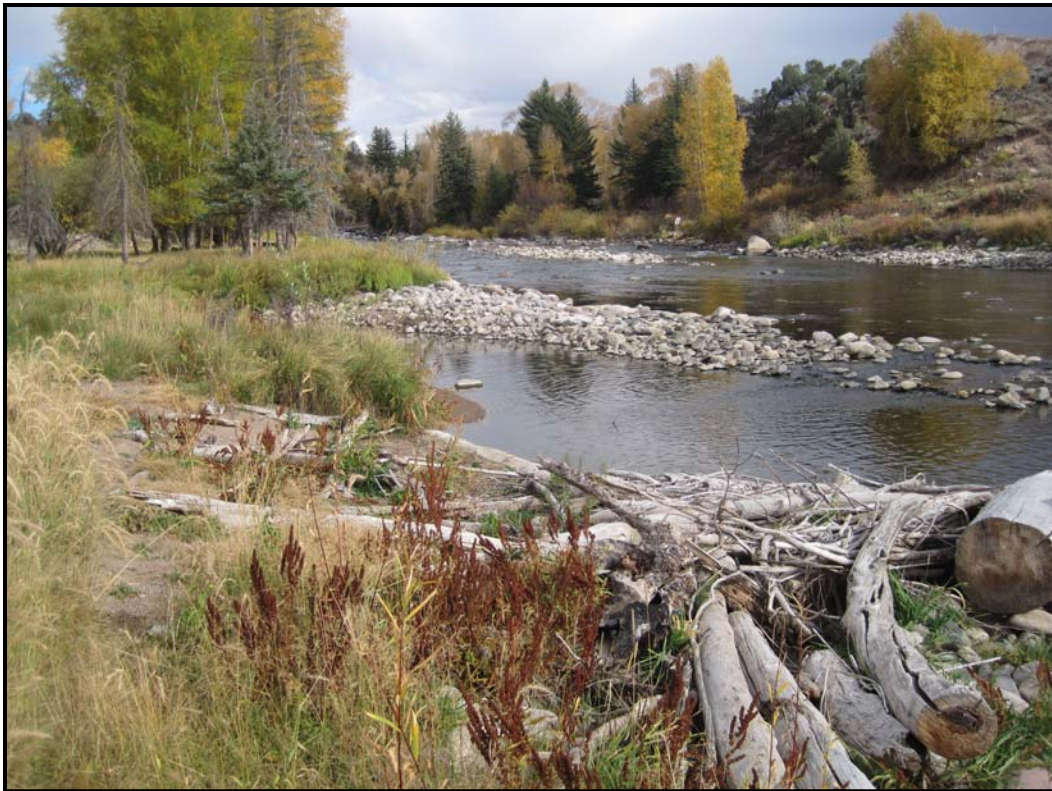
**Point 1S7R:** 10-5-10 Reach 5, right bank, looking upstream at Bar 1-1.

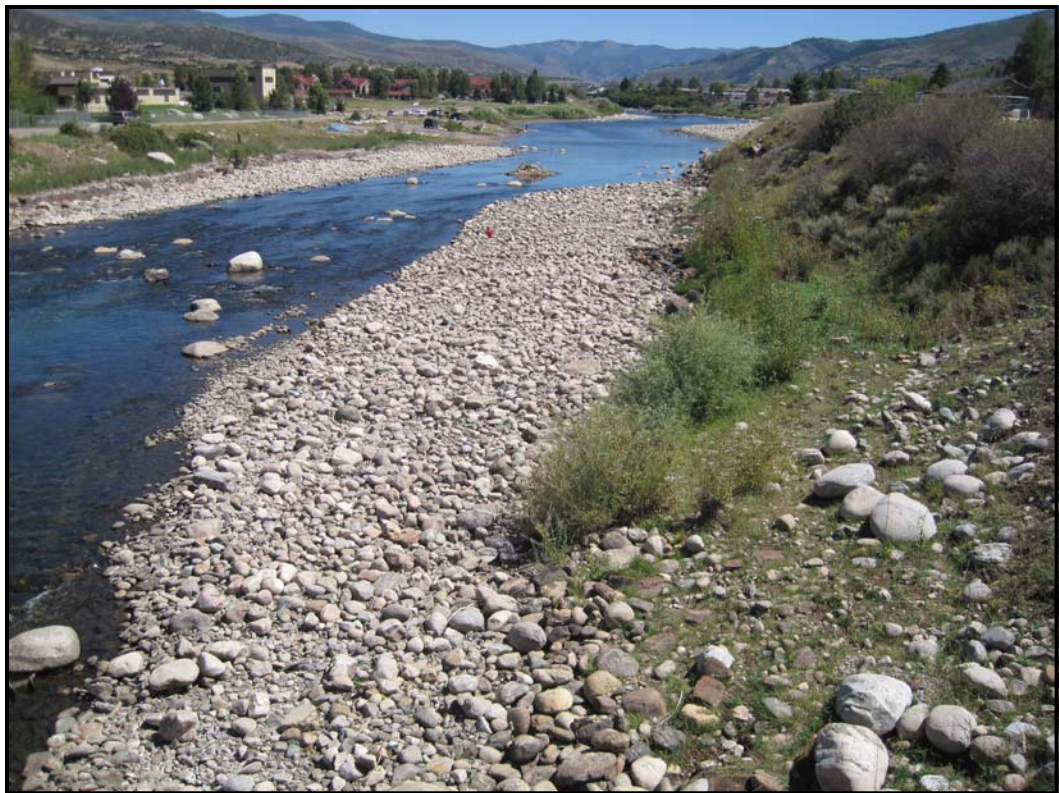
**Point 1V1L:** 9-3-10 Willows planted on the bank; cottonwoods and shrubs on the terrace, and transitional shrubs, spruce, and juniper interplanted into existing shrubs on the slope.

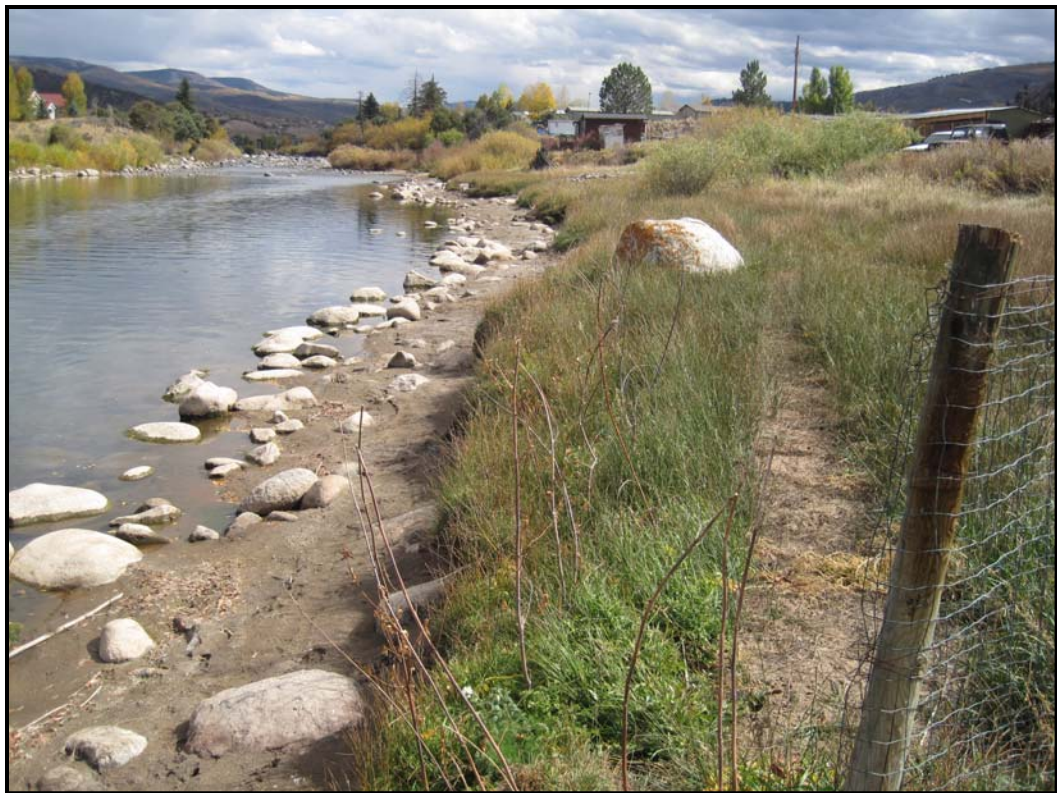
**Point 1V6L:** 10-5-10 Bank planted densely with willows; cottonwoods and mixed shrubs on riparian terrace, and upland shrubs on slope.

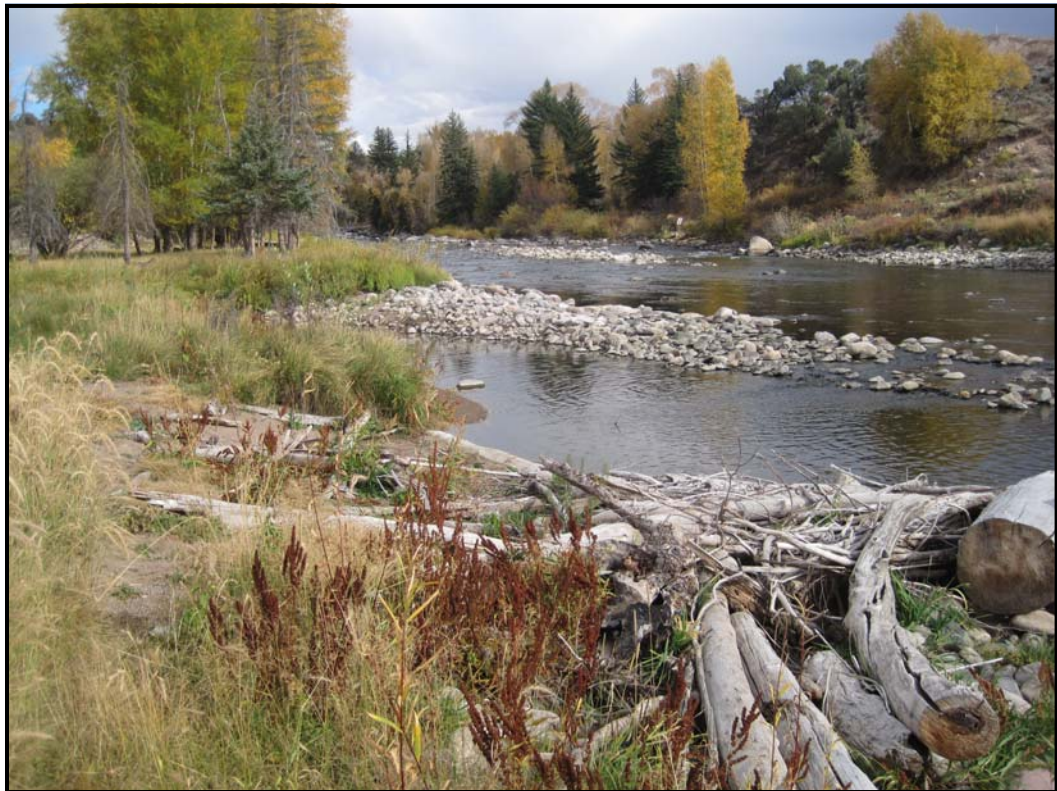
**Point 1V11R:** 10-5-10 Debris from unusually high spring runoff impacted some plantings in this area.
