# Fourmile Creek Stream Channel and Floodplain Enhancement Project Denver Water Property, Park County, CO Channel Repairs Implementation Report

**Mark Beardsley, M.S. and Jessica Doran**  
**EcoMetrics LLC, Fairplay, CO**  
**September 1, 2010**

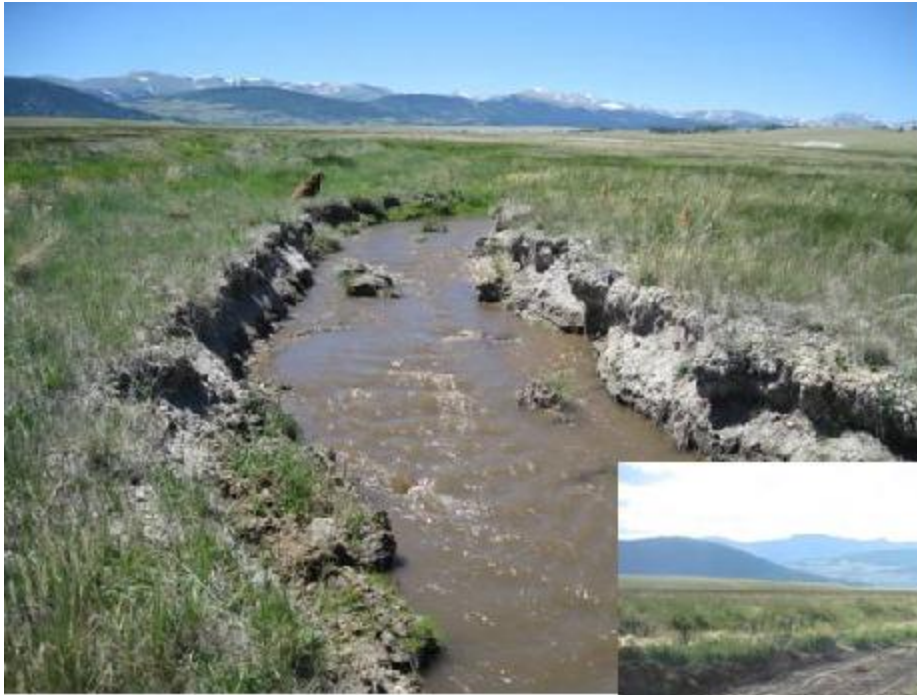
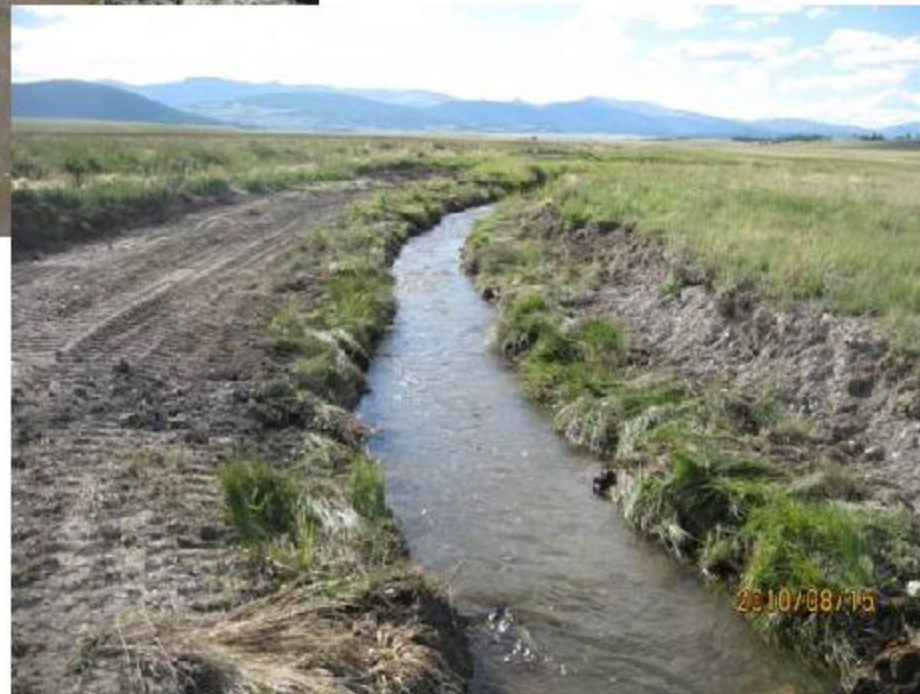
Figure 9 Before-after of bench/floodplain treatment on the upper segment just after construction in August, 2010

On the lower segment (phase 1) we accomplished this by constructing **bank benches** (see figures 8-13) to an appropriate height within the existing wide, deep, enlarged channel. The constructed banks serve to define a much smaller bankfull channel, to provide appropriate growing conditions for streamside riparian plants, and to work as small floodplain areas. Later, the floodplain area was increased by widening the benches on the left side of the channel by excavating terrace material. (Excavated material was used to generate fill needed on an adjacent wetlands restoration project.) Bank benches and floodplain areas are shown in red on the maps in figures 1-7.

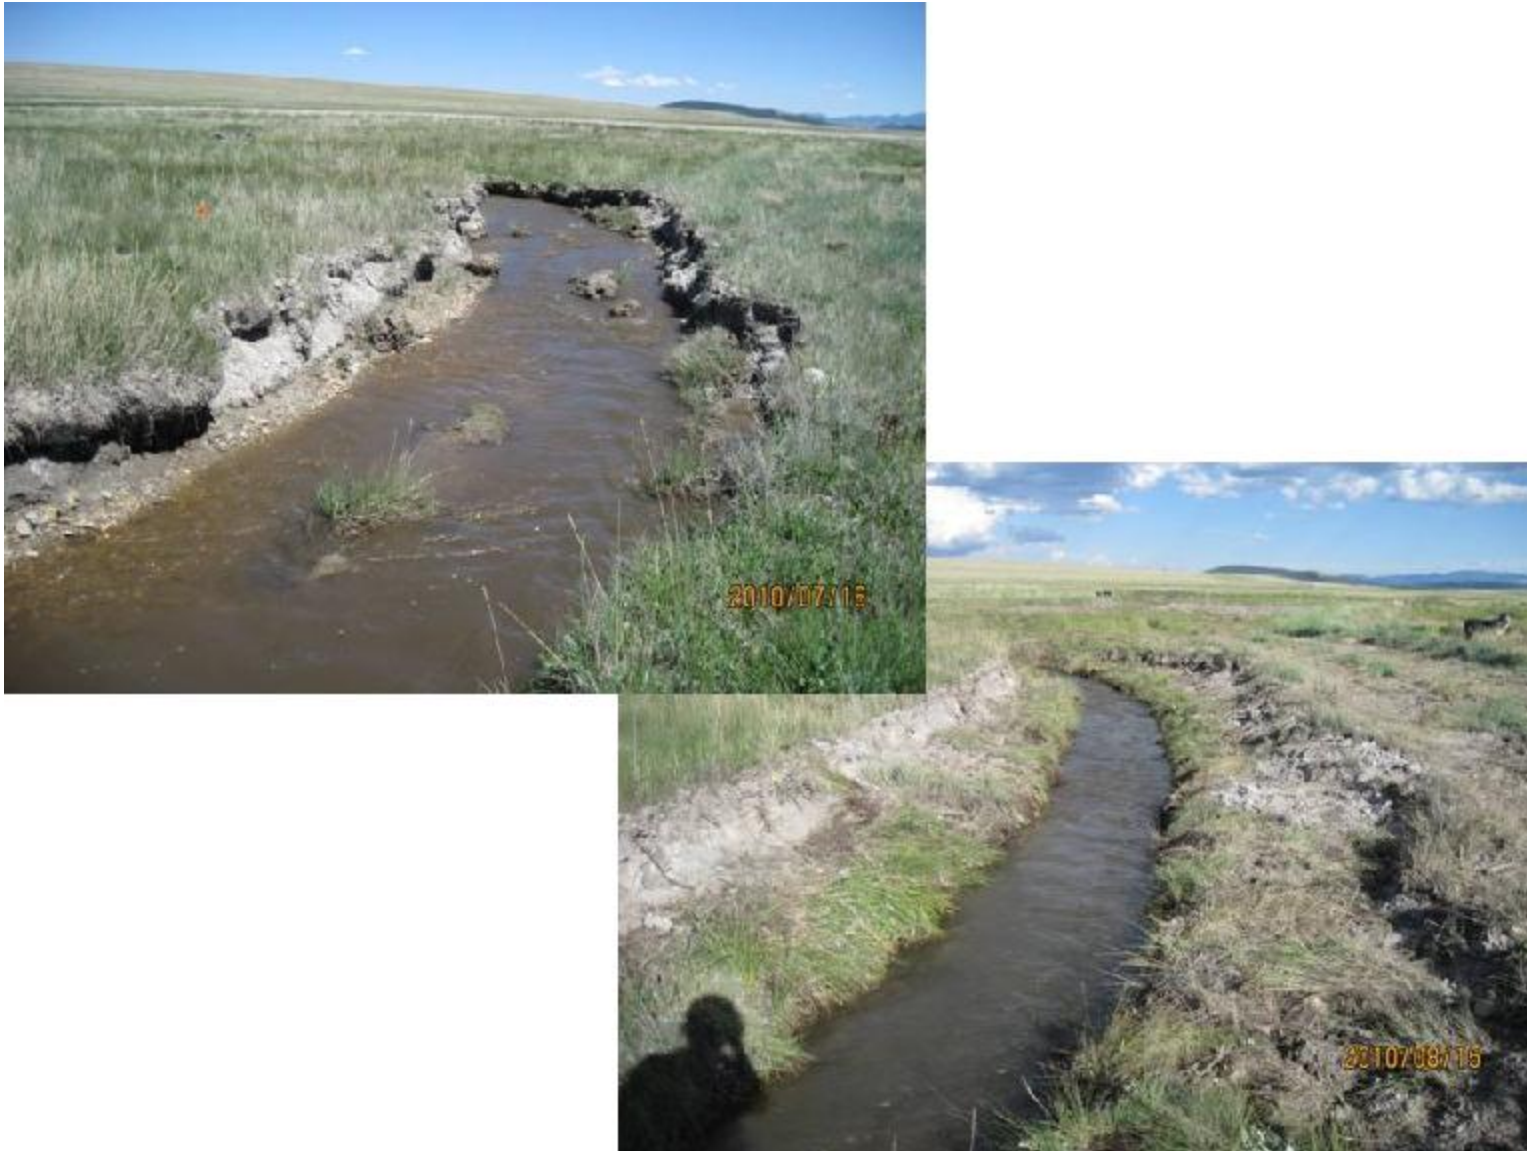
Figure 10 Before-after of bench/floodplain treatment on the upper segment just after construction in August, 2010

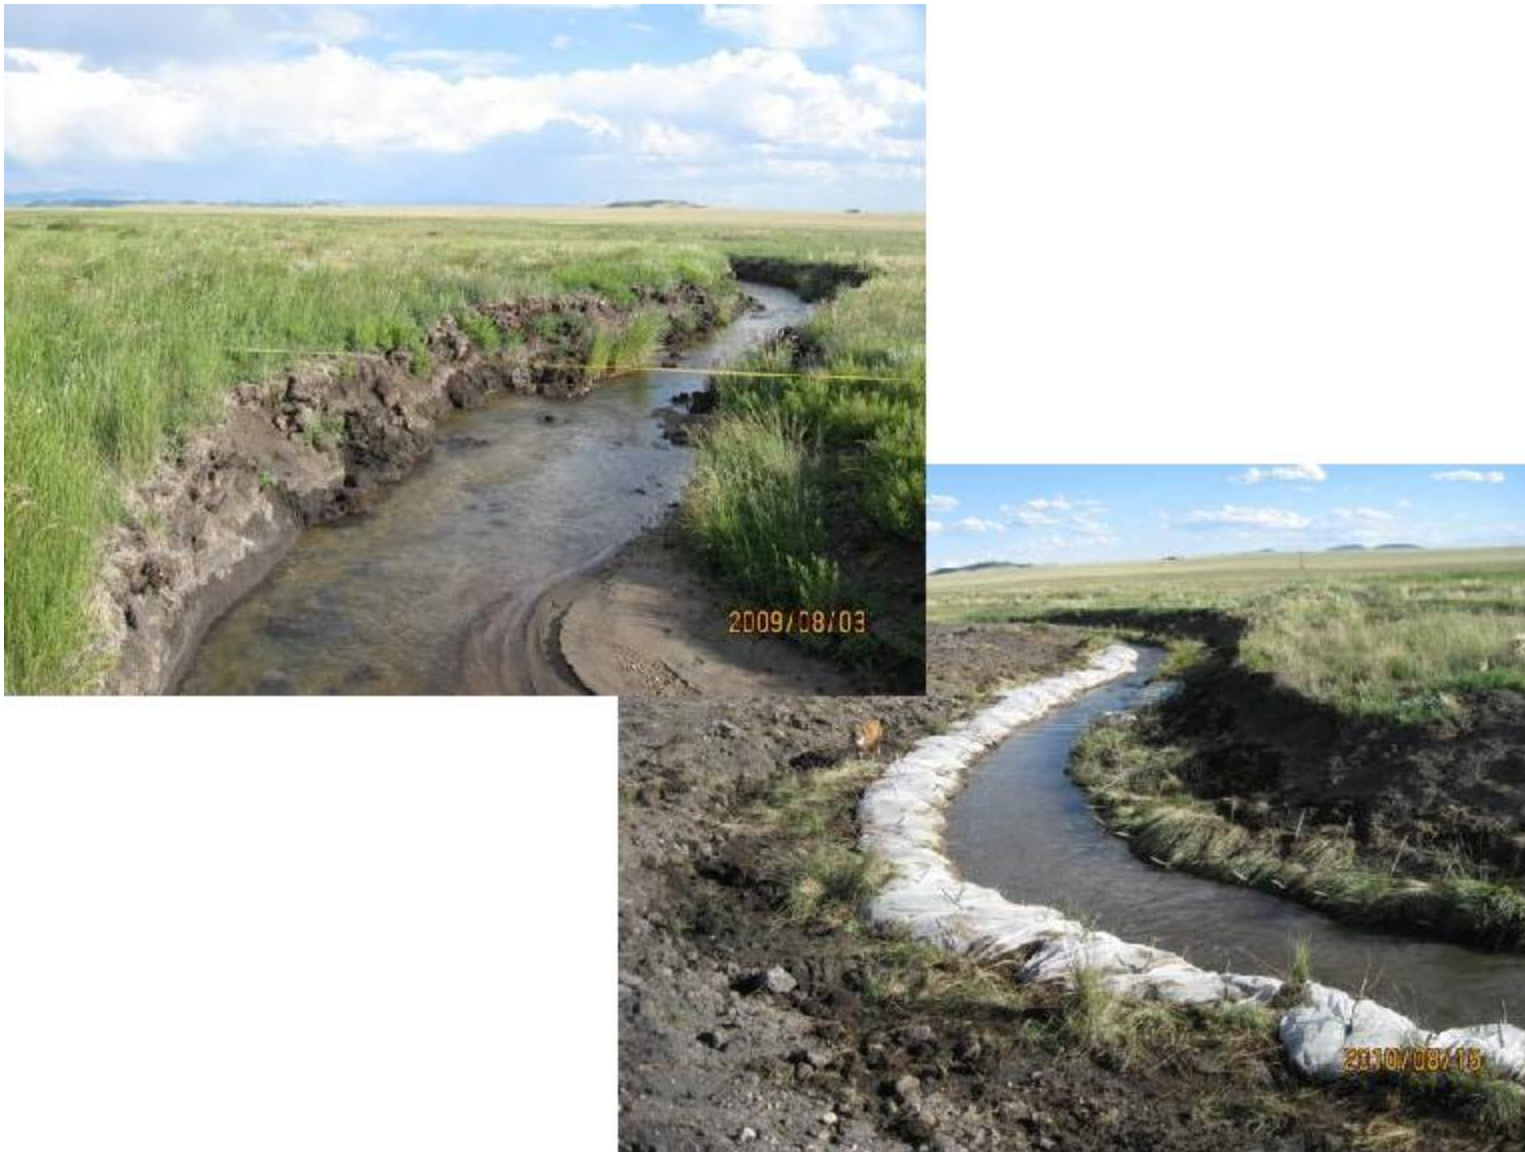
Figure 11 Before-after of bench/floodplain treatment on the upper segment just after construction in August, 2010

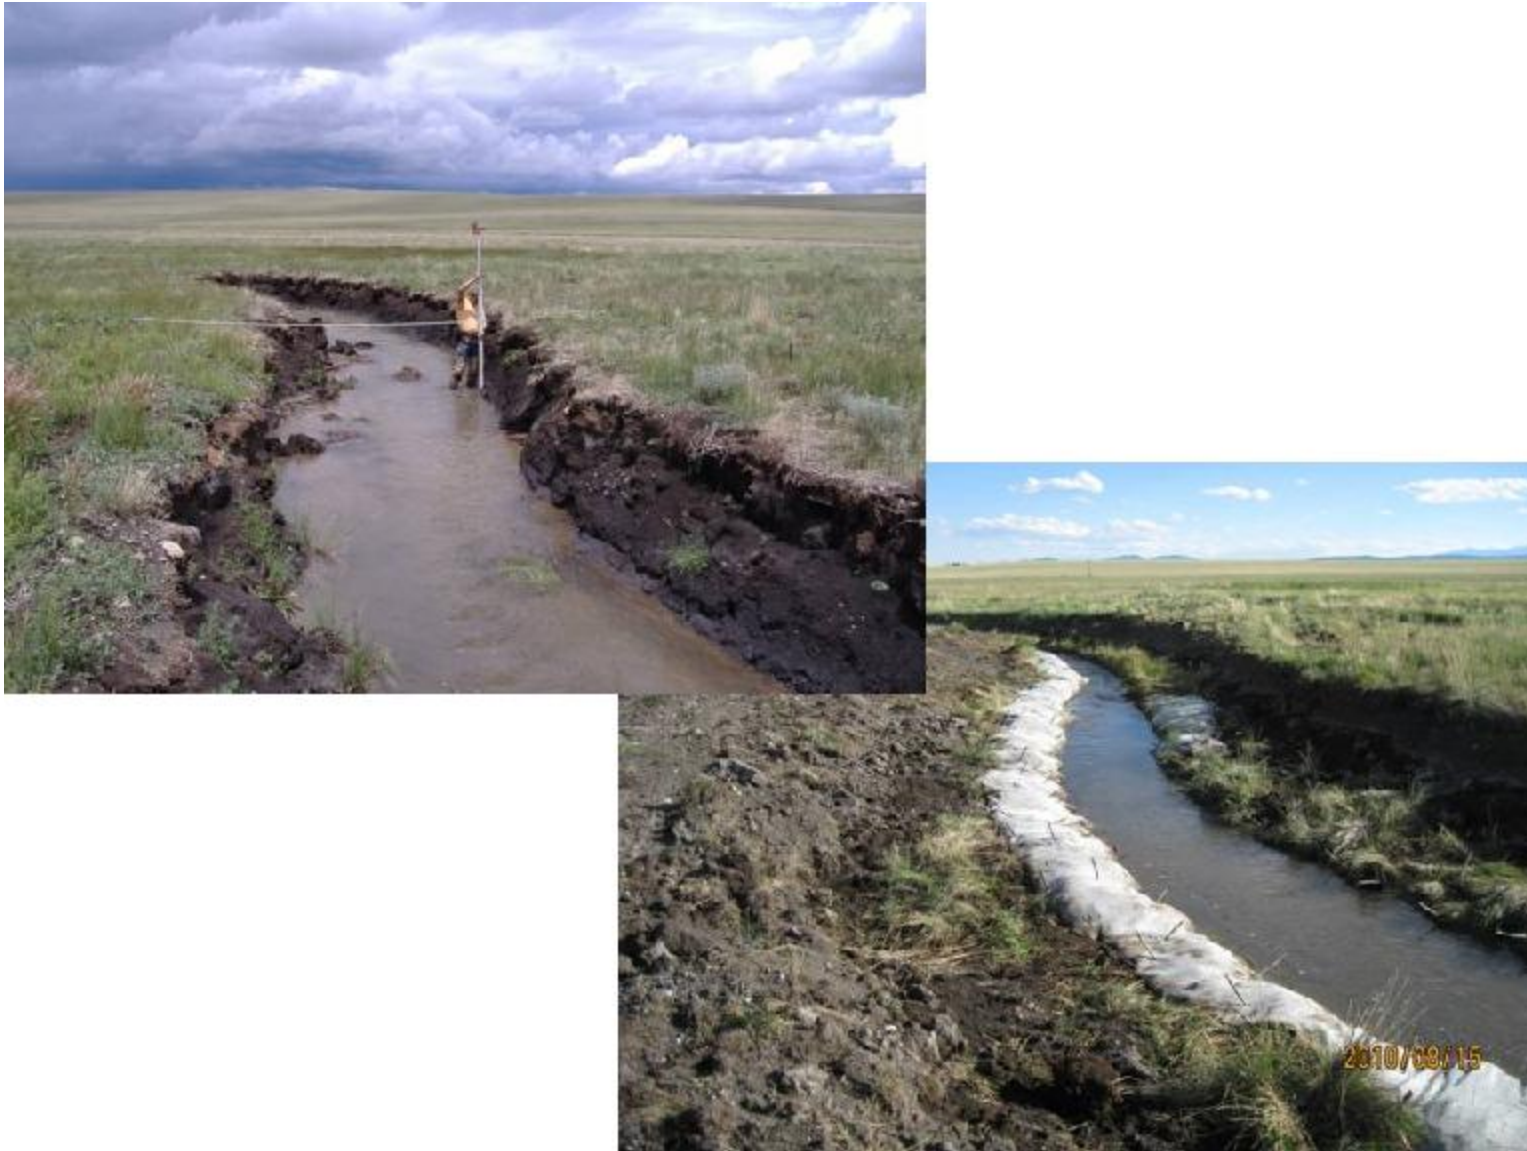
Figure 12 Before-after of bench/floodplain treatment on the upper segment just after construction in August, 2010

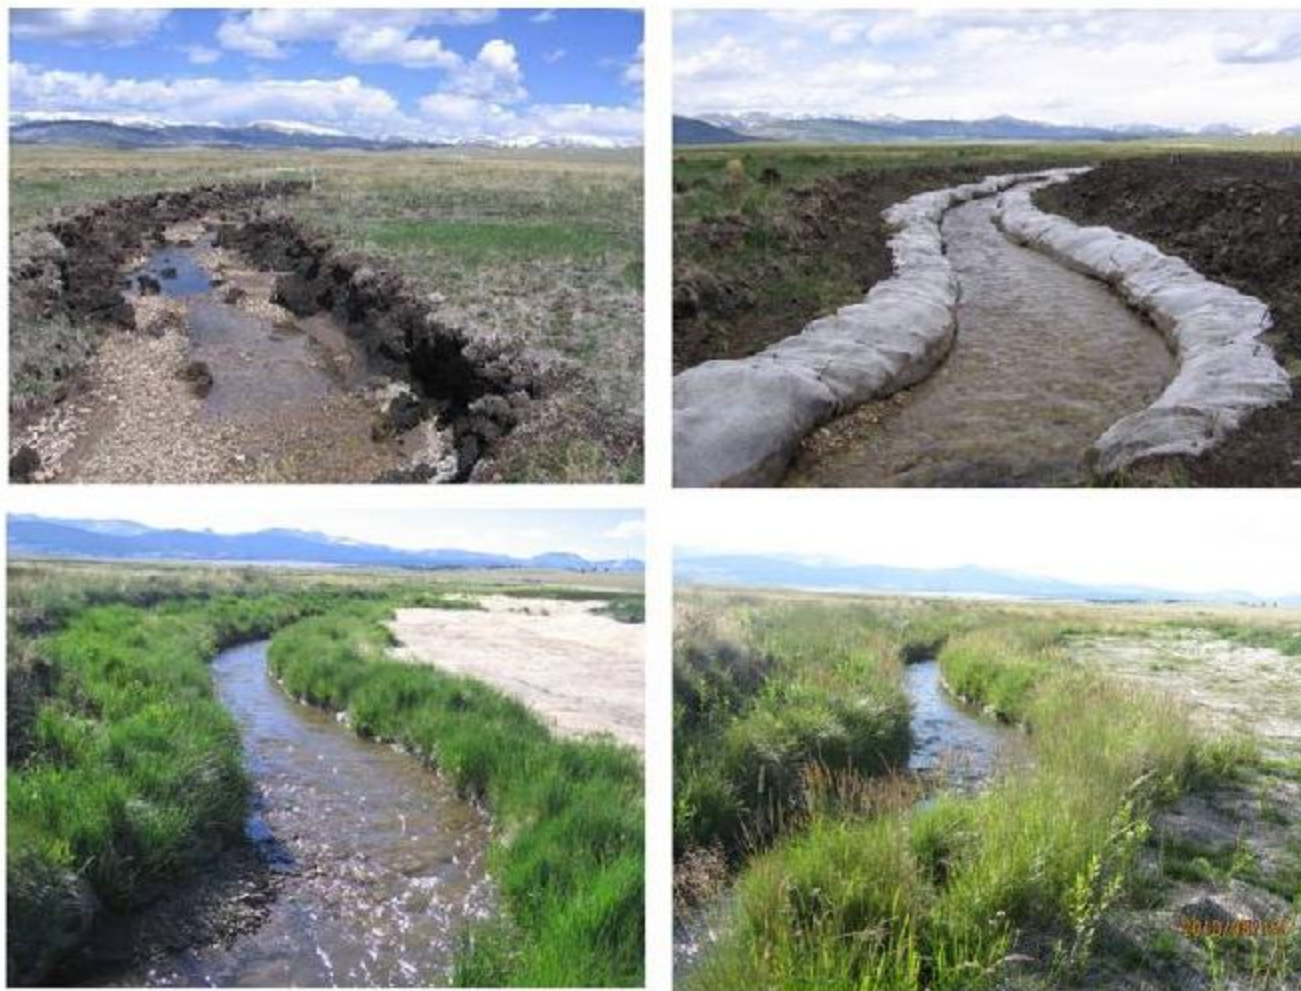
Figure 13 Before-after of bench/floodplain treatment on the lower segment just after construction in June, 2009. The lower photos show the same treatment during the first season after construction in 2010.

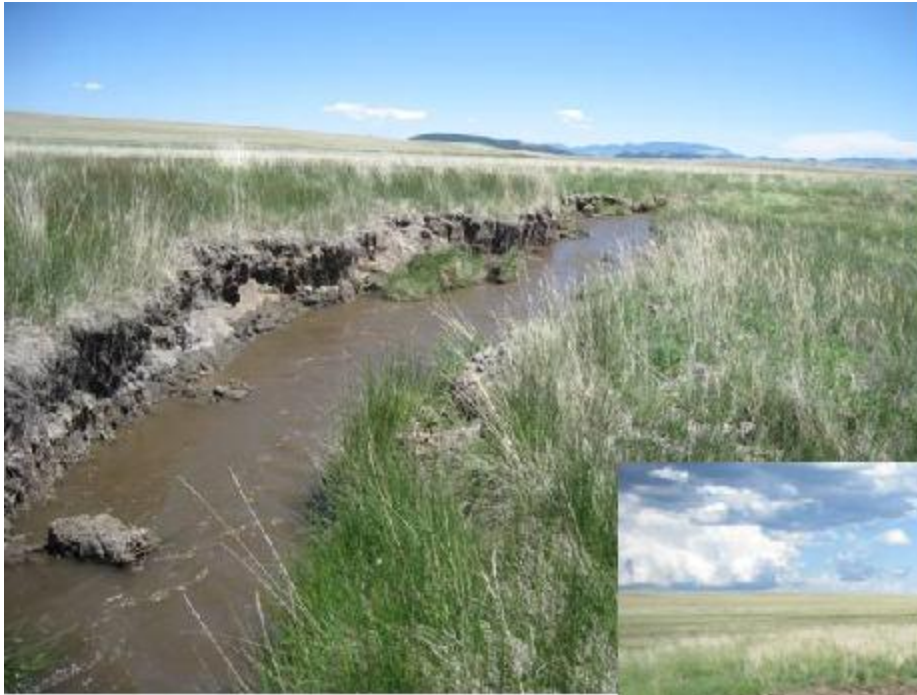
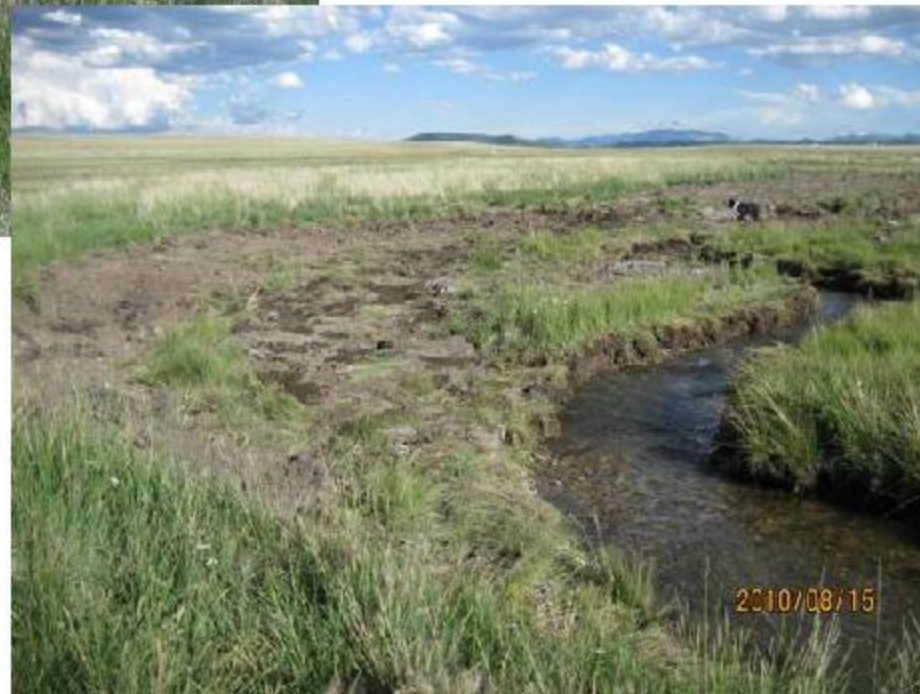
Figure 15 Before-after of channel realignment treatment on the upper segment just after construction in August 2010.

On some sections of the upper segment (phase 3), historic floodplain areas were available within the constrained belt. On these areas (six in total), we simply cut a **new channel** within the floodplain area adjacent to the old channel and filling in the old channel to the floodplain elevation (see figures 14-16). By doing this, we instantly created an appropriately-sized channel dimension with established high-quality bank vegetation and wide floodplain benches. This treatment also resulted in very wide bench widths on outside bends. Areas where the channel location was shifted are depicted with a dotted black line in figures 1-7.

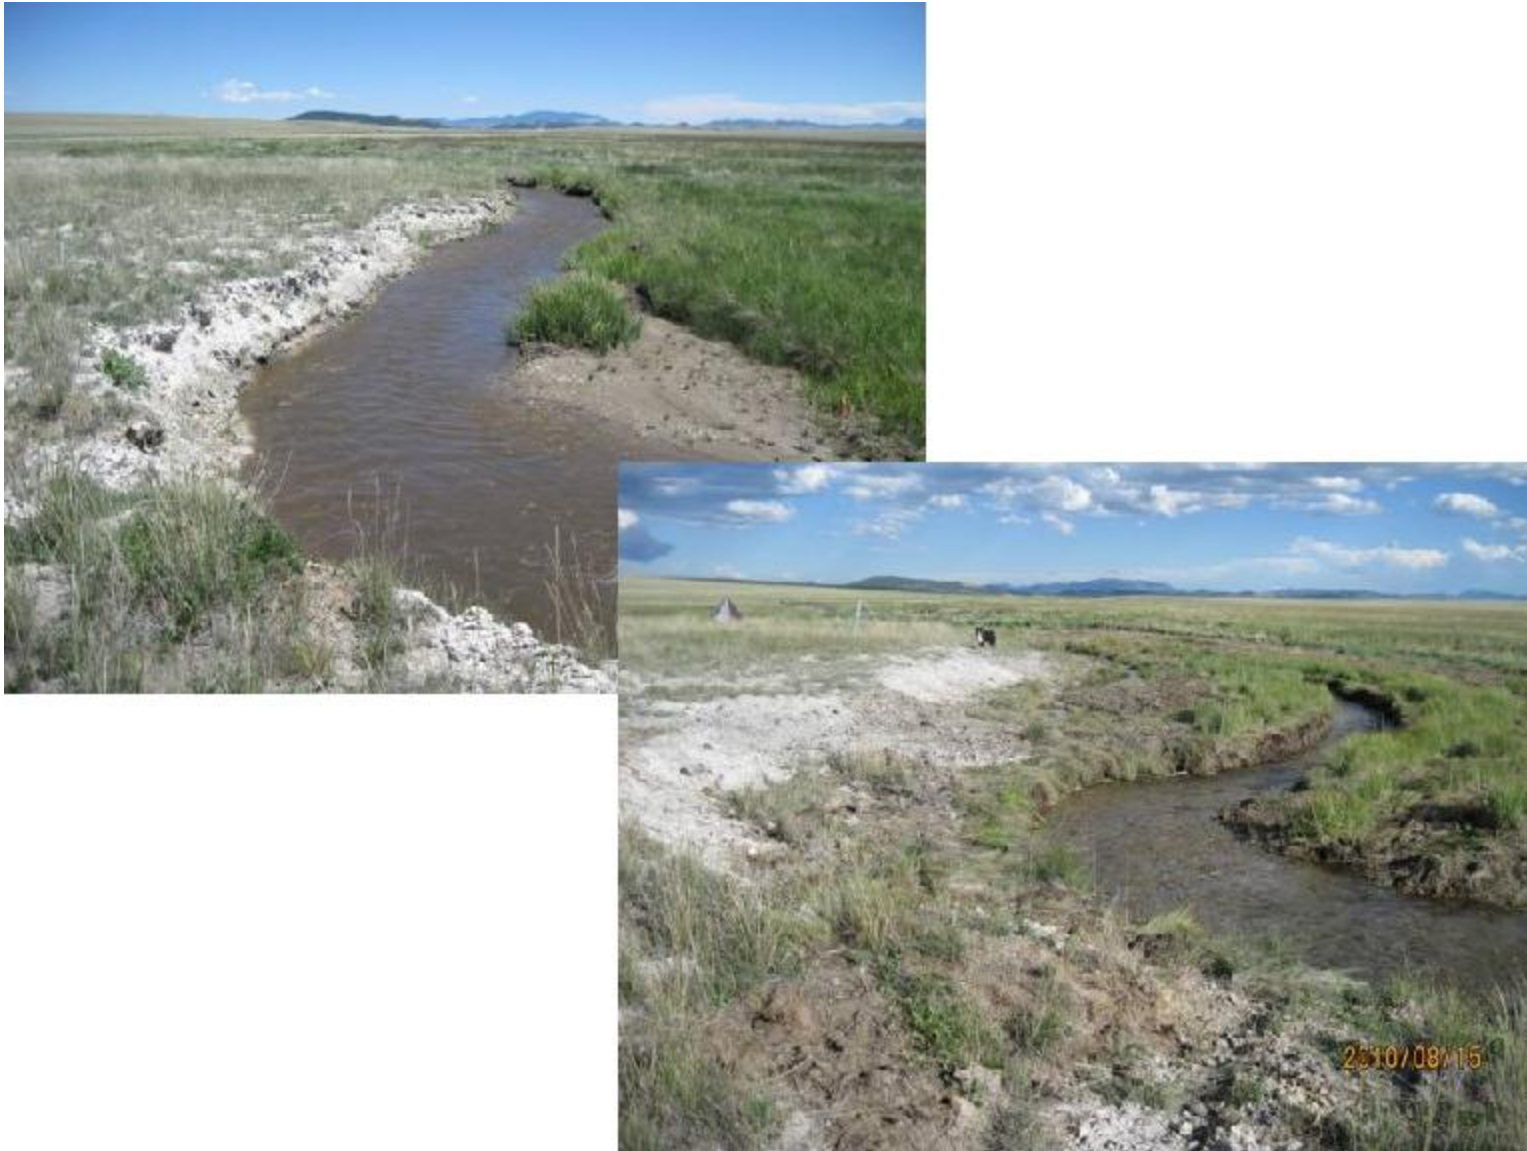
Figure 16 Before-after of channel realignment treatment on the upper segment just after construction in August 2010.

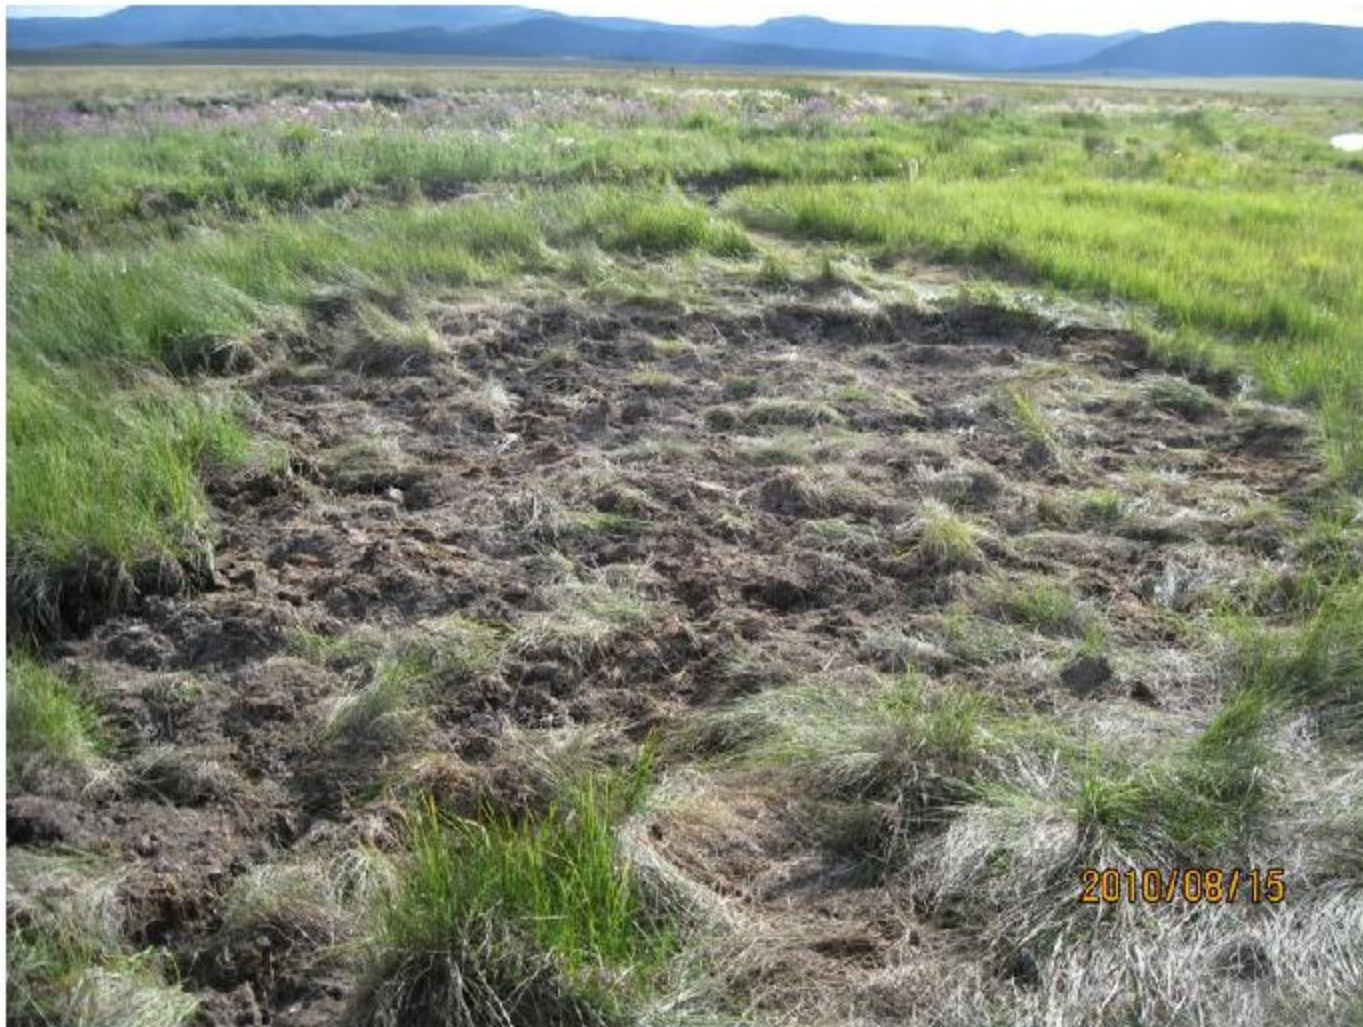
Figure 17 Sod borrow areas were reclaimed by grading and planting sod sprigs and sod mats to for immediate 30-50% cover. They were also heavily seeded.

The streamside portion of benches were revegetated by directly planting sod, but the distal bench and floodplain areas were typically constructed from cut or fill material. In general, these areas were planted with sod sprigs and mats to achieve instant 30-50% cover. All areas with less than 80% initial cover were also heavily seeded using a native high-altitude wet meadow wetlands seed mix combined with an equal proportion of high-altitude native erosion control grass mix. As an exception, the extended floodplain areas that were cut in spring on 2010 on the lower segment were not sprigged with sod. These areas were simply seeded and covered with a layer of mulching fabric. All of the sod borrow sites and fill areas on the upper segment were reclaimed by grading, sprigging with sod to a minimum of 30-50% cover, and heavy seeding using the mix described above (see figure 17).

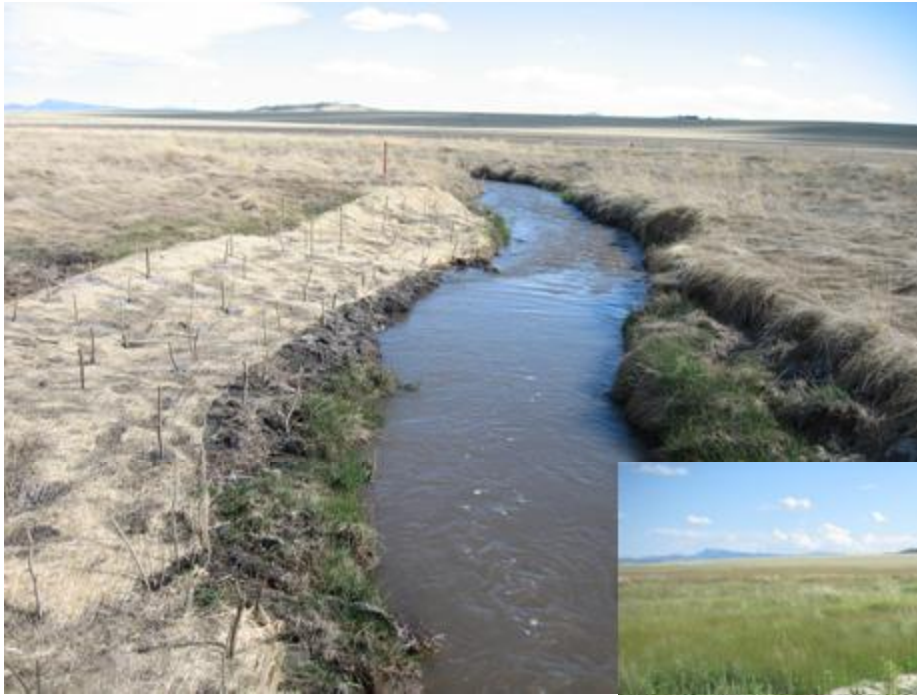
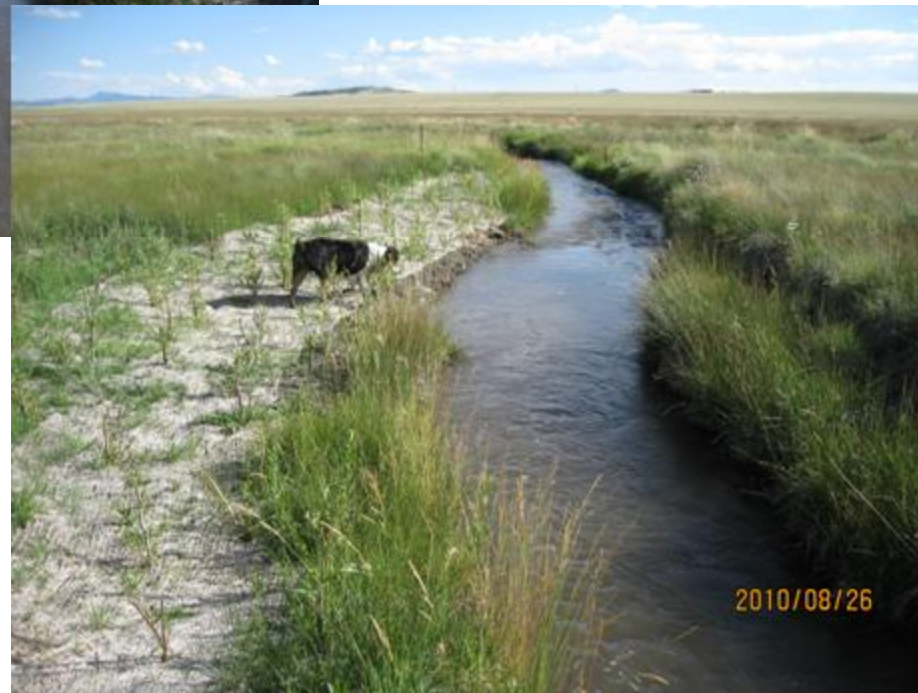
Figure 18 Willow stem plantings on the lower segment

We also planted a large number of willows (see figures 18-19). Approximately 1000 willow stems were planted on the constructed benches in the lower segment during construction in June 2009. An additional 2200 deep-planted dormant willow stem cuttings were planted using a waterjet stinger on the bench and floodplain areas of the lower segment in May, 2010. Finally, 1100 more willow stems were planted on bank benches during construction of the upper segment in August, 2010.

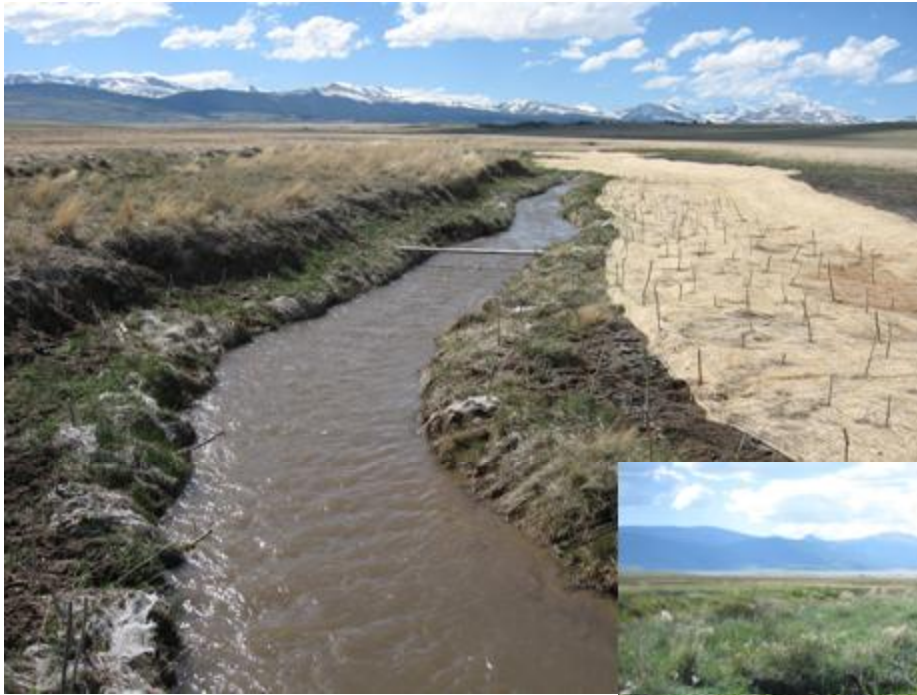
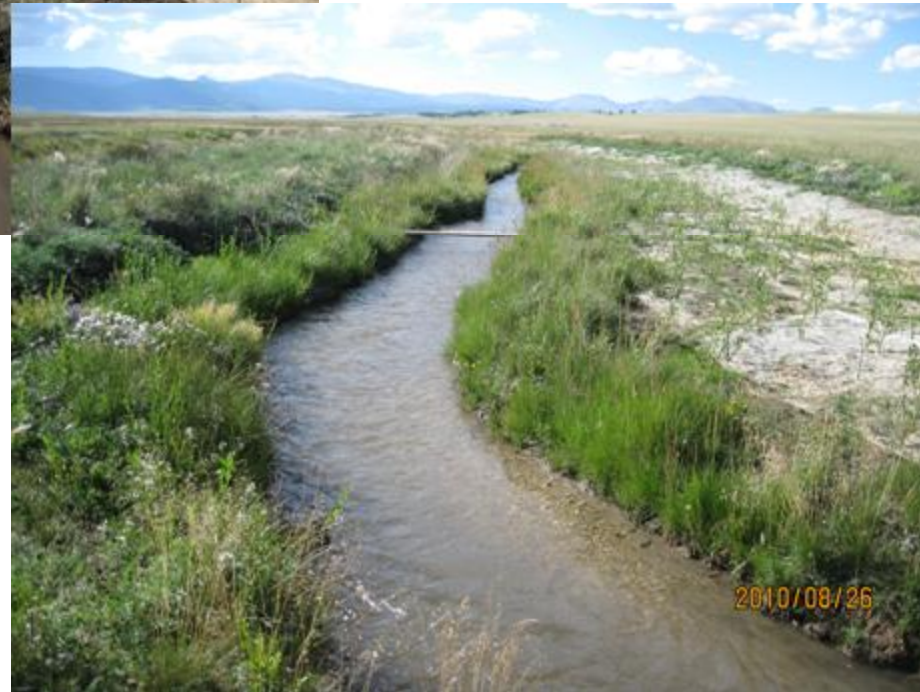
Figure 19 Willow stem plantings on the lower segment
