# Stillwater No. 1 Reservoir Dam Phase I – Feasibility Study

Yampa, Colorado

Tetra Tech

September 29, 2011

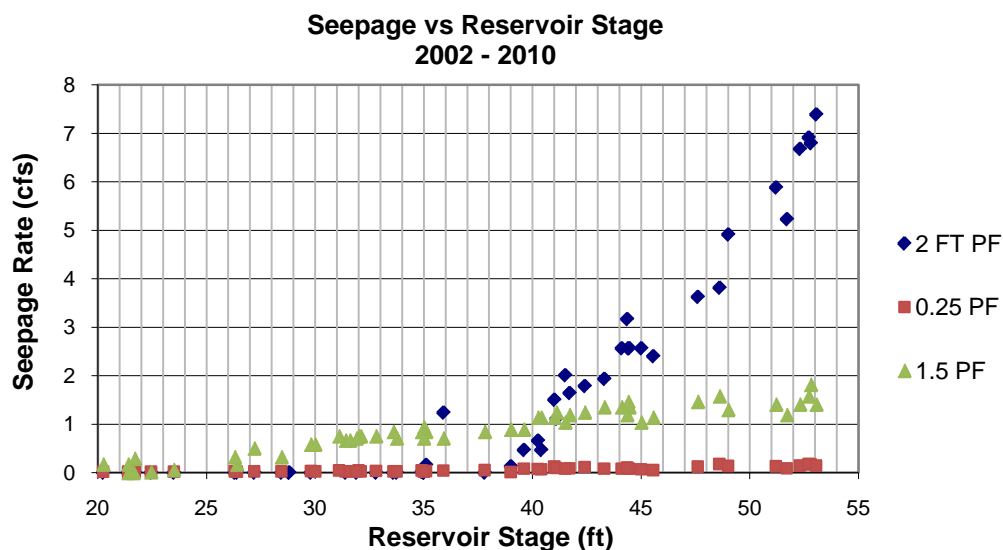
**Figure 3.1 Seepage Rate vs. Reservoir Stage**

The 2-ft Parshall flume is located about 350 feet east of the toe of the dam. The 0.25-ft and 1.5-ft flumes are located to the south and north of the Bear River, near the left abutment.

The seepage data collected from the 1.5-ft and 0.25-ft Parshall flumes below the left abutment show the seepage rates increasing slightly as the reservoir stage increases, showing a correlation to increasing head pressures (Figure 3.1). The seepage rate through the right

abutment increases drastically above the reservoir stage of approximately 37 feet (elevation 10,261 feet). This steep rise in seepage flows possibly indicates the location of an exposed highly conductive gravel layer in the upstream face of the lateral moraine in the right abutment. The lateral and terminal moraine materials adjacent to the dam have surfaces that are hummocky and irregular, and are dotted with numerous depressions, most of which are occupied by ponds or marshes. A seepage pond is located just to east of the right abutment at an elevation of 10,220 feet. The tills downstream of the dam are composed of fragments of basalt embedded in a matrix of unstratified sand and clay. The boulders in general are not large, with not many exceeding three feet in diameter. Several areas downstream from the dam appear to have been reshaped during the dam construction activities based on the distribution and varying ages of vegetation in the area.

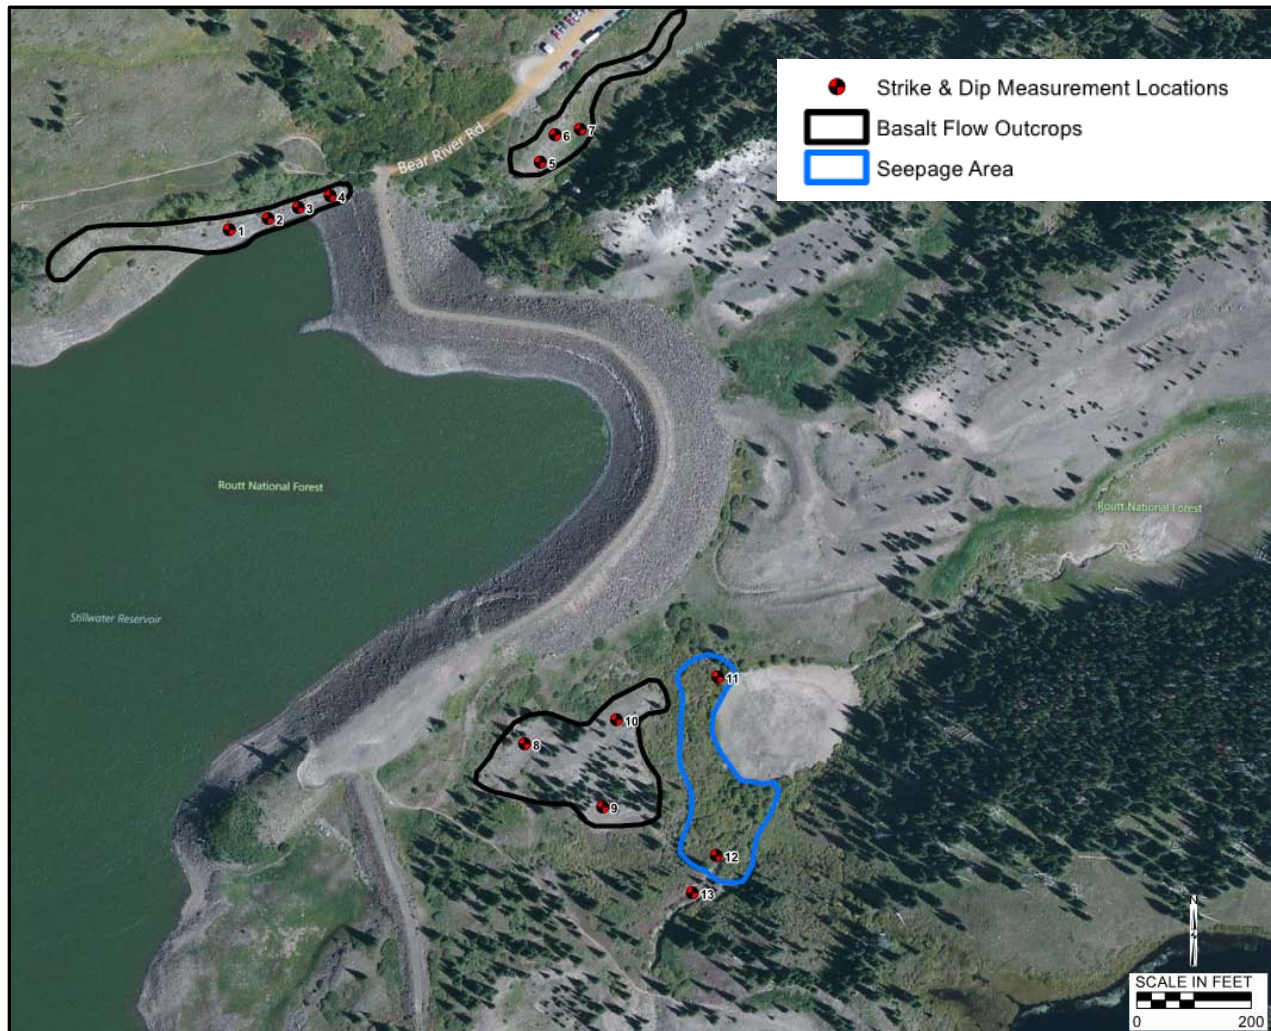
**Figure 3.2 Geologic Evaluation Map**

Given the distribution of seeps above the outlet structure on the left abutment and in the open area below the right abutment, it seems likely that water is flowing through the joint system in one or more of the basalt flows in the area. Glacial outwash deposits, like those observed along the right abutment, typically contain alternating layers of fine and coarse materials. Gravels encountered during the 1983 slurry trench excavation in the right abutment seem to provide a likely flow path through the moraine down to the underlying basalt flows. The highly weathered nature of the some outcrops indicates that flow paths through the basalt flows may be significant.

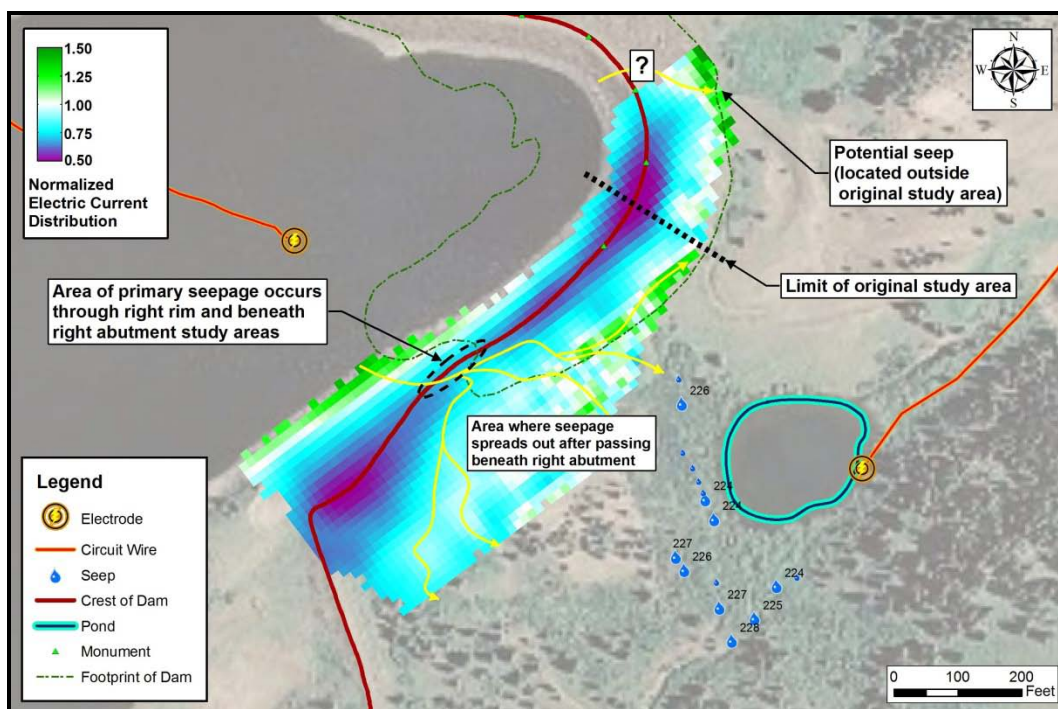
**Figure 3.4 Willowstick investigation results.**

Results of the Willowstick investigation identify the preferential seepage flow beneath the fill material in native soil and/or rock materials directly beneath the southwest end of the dam. Seepage flows through the dam between elevations 10,225 feet and 10,280 feet and then daylights downstream between elevations 10,228 and 10,224 feet. The water drains into a small pond located east of the embankment. The width of seepage is roughly between 250 and 300 feet. Figure 3.4 shows the results of the investigation.

Another possible seep was located on the north end of Survey Area #1, but due to the position of the electrodes at the moment of the survey, the extent of the seepage could not be confirmed. Additional survey would have to be performed north of Survey Area #1 to identify the preferential seepage flow in this area. No additional seepage flow paths were identified through Survey Areas #1 and #2 during this investigation.
