SUBJECT: **Agenda Item 23c, September 27-28, 2012 Board Meeting**
Finance/Water Supply Planning – WSRA Grant & Construction Fund Loan
Sanchez Ditch and Reservoir Company – Sanchez Reservoir Outlet
Rehabilitation Project

**SANCHEZ RESERVOIR PHASE II - OUTLET REHABILITATION
AND GATE TOWER REPLACEMENT**

Exhibit C-1
Excerpts from Feasibility Study
February 28, 2012
Smith Geotechnical Engineering, Inc.
Duane Smith, P.E.

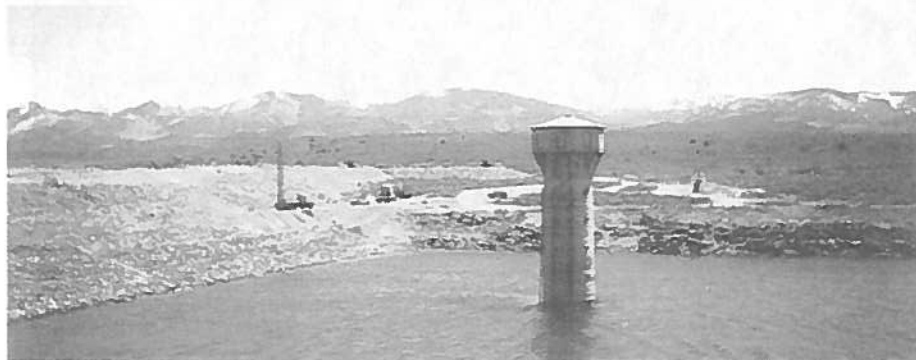
PHOTOGRAPH 1 - TOWER

The two 48-inch diameter valves the cone valve are new valves that were replaced in 1997. The three 30-inch diameter valves and operators located at about elevation 8345 feet were replaced in 1997; the three 30-inch diameter valves and operators located at about elevation 8375 feet were repaired; and the two 30-inch diameter valves and operators located at about elevation 8330 feet are buried under silt and were not repaired. The outlet conduit was not repaired in 1997 when the tower controls, valves, and ladders were rehabilitated.

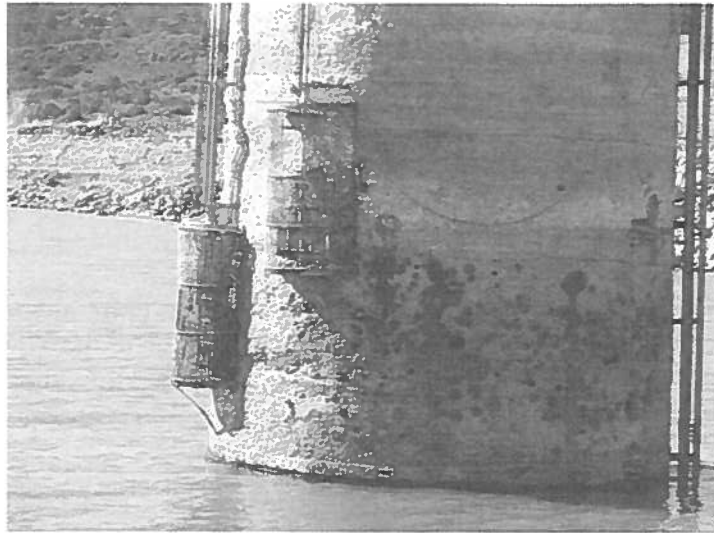
PHOTOGRAPH 2 – OUTLET TOWER DETERIORATION

The exterior of the gate tower was coated by the SDRC in 1993. This coating has generally debonded and peeled off the tower and does not appear to have reduced the deterioration of the concrete. This can be seen in Photograph 2.

The main area of concern is for the deterioration and damage on the exterior of the tower. The tower has experienced light to severe deterioration of the concrete, especially in the zone of water level fluctuations. This can be seen in Photograph 2. Some of the spalling appears to be as deep as several inches and is due to the freezing of water in the concrete. This appears to be combined with the "pop out" of large aggregate in the mix that most likely is not bonded well by the cement.

The concrete surface has spalled due to moisture intrusion and freeze thaw. The concrete in the tower would not be air entrained, based on the date of construction. Concrete without air entrainment is highly susceptible to freeze-thaw action and the deterioration noted would not be unexpected. Also, the quality and quantity of the cement used would not be expected to be high thus the strength would not be expected to be very high. Cores were not removed from the tower itself but cores of the concrete were taken from the outlet conduit as shown in Photograph 4. Based these cores, we have ascertained the strength of the concrete is generally expected to be less than 2,500 psi. The cement to aggregate bond of the concrete in the cores was not good and damage due to freeze-thaw would be expected.

The only way to eliminate or reduce future the spalling and deterioration is to minimize the water penetration into the concrete. Since the concrete does not have air voids that allow for expansion of the moisture as it freezes, the moisture has to be minimized as much as possible. The complete elimination of moisture penetration is not possible and thus future maintenance of the tower can be expected. The goal would be to use a protective system that minimizes the deterioration to an acceptable level and extends the life of the tower.

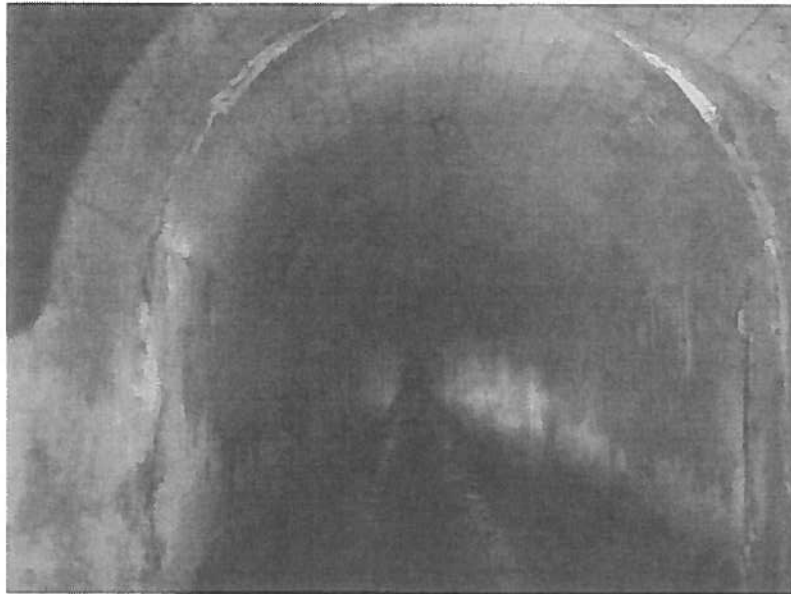
PHOTOGRAPH 3 – OUTLET CONDUIT

The outlet conduit was inspected visually by Duane Smith, P.E. of SGE on November 1, 2011. Photograph 3 show the general condition and shape of the conduit.

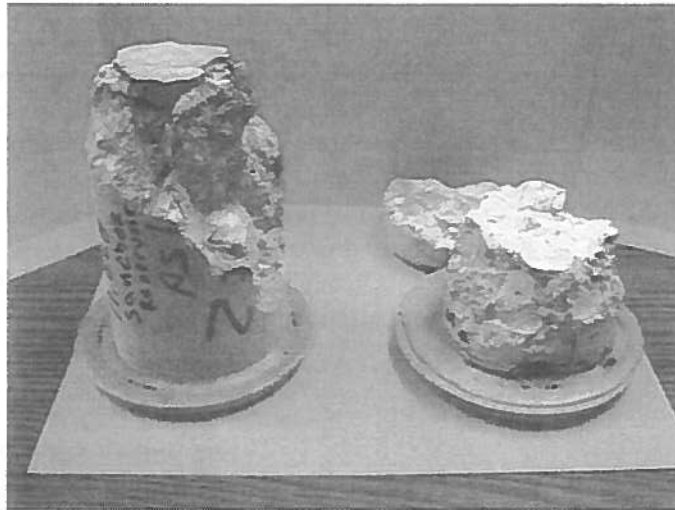
OTOGRAPH 4 – OUTLET CONDUIT CORES

Two 3 inch diameter cores were removed from the conduit and subsequently tested for compressive strength. The strength of the two cores shown in Photograph 4 were 1,244 psi and 2,212 psi. Note the de-bonding of the aggregate in the core on the right, which was the higher strength core.

Based on these cores, we have ascertained the strength of the concrete is generally expected to be less than 2,500 psi. Based on our visual inspection of the cores, we have determined the cementitious portion contained a significant percentage of non-pozzolanic material that did not hydrate. A large amount of loose powdery type non-hydrated residue was found throughout the cores. This material appears to inhibit bonding of the cement-aggregate mixture. There is visual evidence that the aggregate was most likely dirty which inhibits bonding and decreases the strength. The aggregate gradation and distribution was also poor and not uniform and appears to be gap graded.

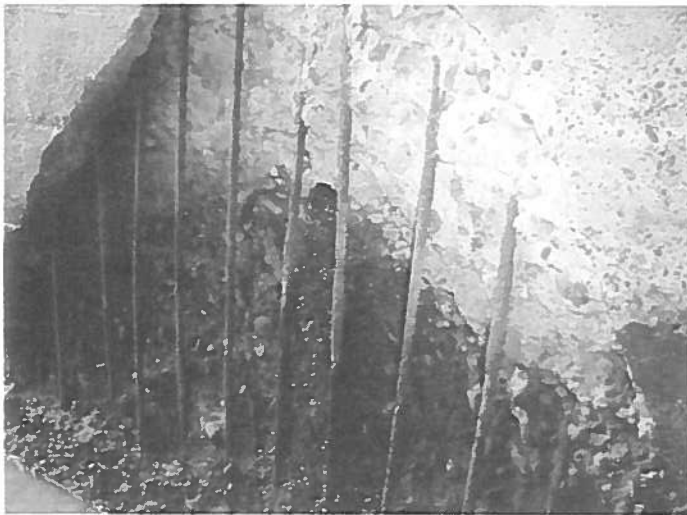
PHOTO #5 – CONCRETE EROSION

The outlet conduit on the downstream end, where freeze thaw has taken place, has deteriorated significantly and eroded. Photograph 5 shows the erosion of the concrete that has resulted. Most of the outlet conduit walls and roof, as can be seen in Photograph 3, are not eroded or significantly cracked. The majority of the outlet appears to be structurally sound as no significant movement or stress cracks were noted in this inspection. This is surprising due to the size and thickness of the walls and roof section, the low strength of the concrete, and the poor reinforcing steel placement.
