Fairmont Drainage District System Inventory

August 17, 2006, rev. 3/14/07 & 4/26/07

The Lower Arkansas Valley Drainage System Rehabilitation Study
Colorado State Univ., Dr. John Wilkins-Wells, Sociology Water Lab
Clark Building B258, Fort Collins, CO 80523 Ph: 970-491-5635

Drainage District Infrastructure notes on the Fairmont Drainage District located in Otero County, Colorado. This district includes all or parts of Section 35 of T23S, R56 W, and Sections 1, 2, 10, 11, and 12 of T24S, R56W in Otero County, Colorado.

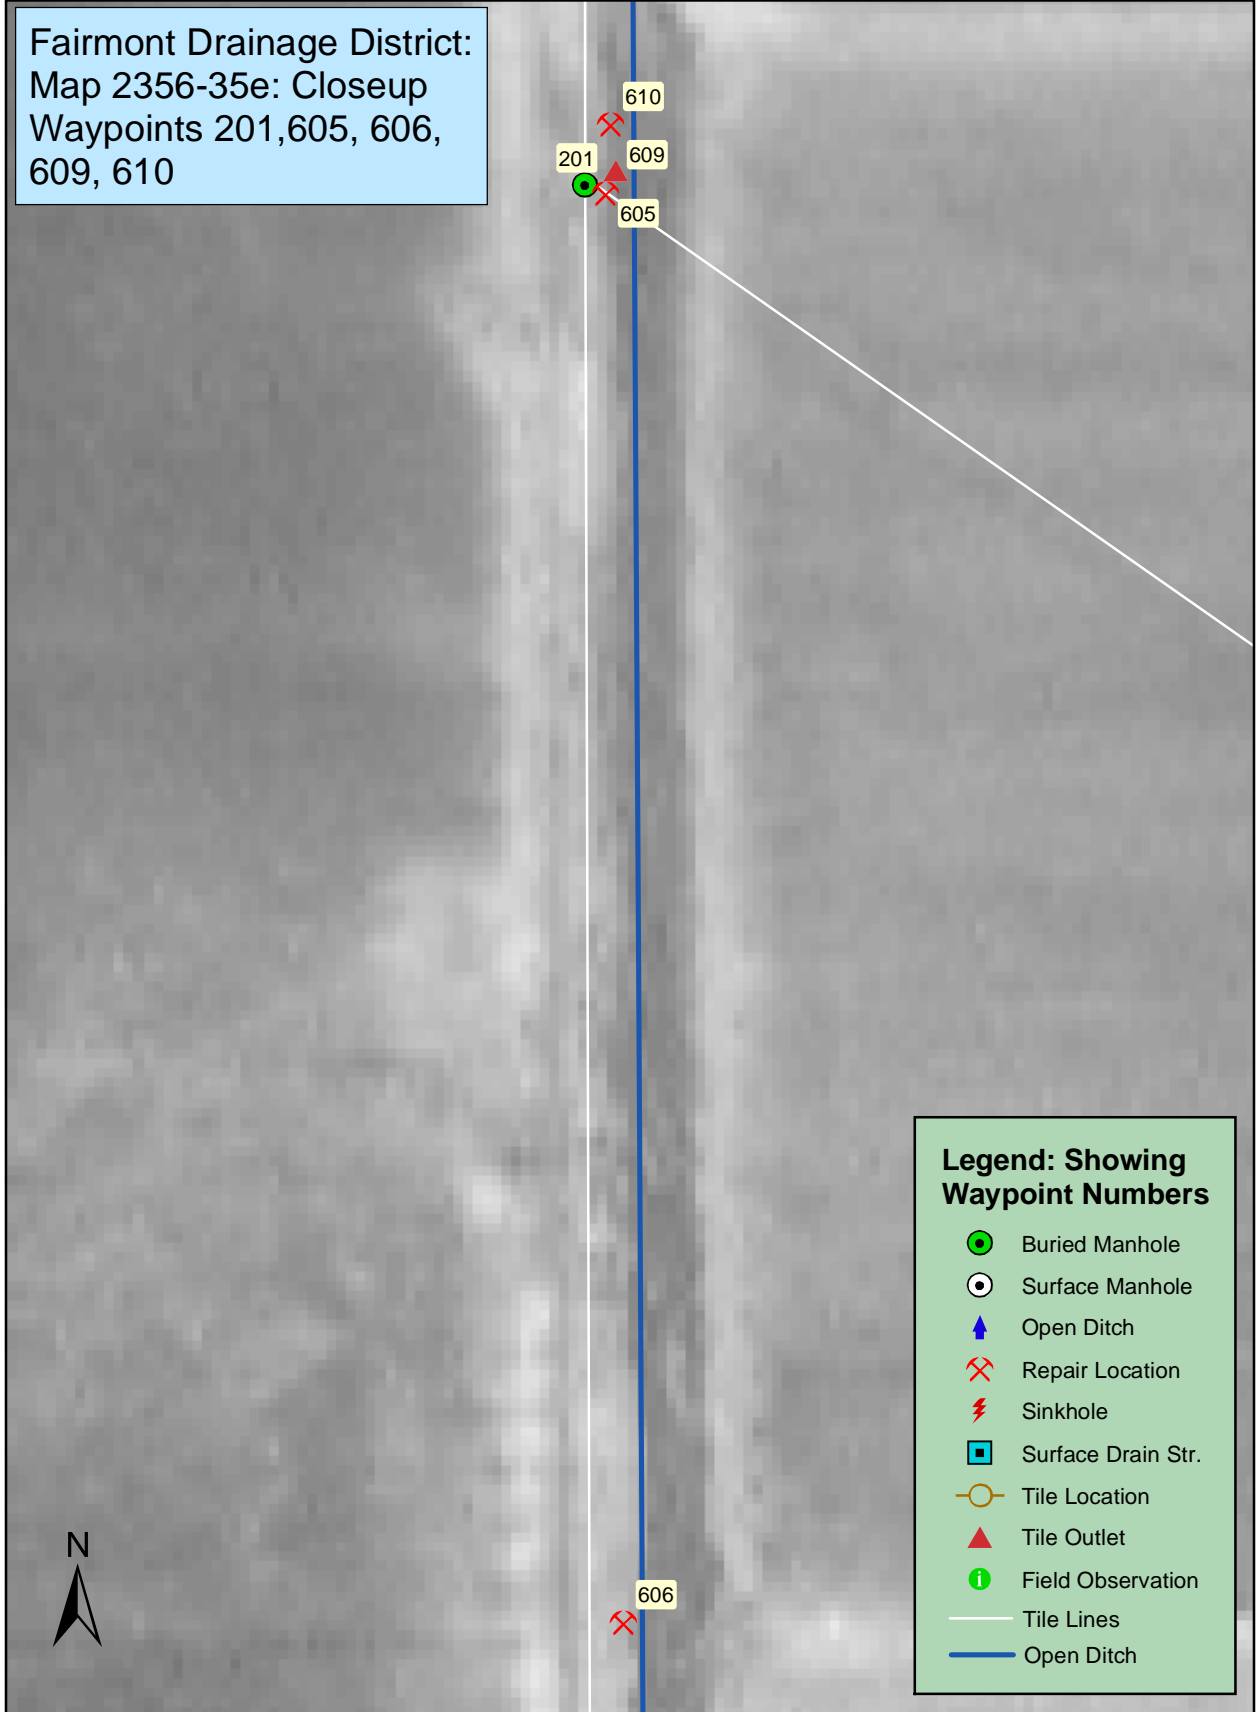
Fairmont Drainage District:
Map 2356-35e: Closeup
Waypoints 201, 605, 606,
609, 610

Manhole along main 15-inch line in the middle of north-south dirt road. This manhole has been repaired and buried. A metal manhole replaced the previous installation. During the repair of the manhole, archive maps showed a line entering from the southeast into this manhole. It could not be found by the construction crew. We have, nevertheless, placed the line on the maps, for the possibility that it is in the vicinity.

Waypoint 609:
Standing on the west bank of open ditch, 6 to 10 feet across at the top, and approximately 6 feet deep, opposite what appears to be a tile outlet. Can see white plastic pipe at the bottom of the ditch, probably 10 inches in size. Line would be coming from the east, westward downhill, dumping into the ditch at this point. (Nov. 13, 2006) Mr. Muth indicates the pipe at the bottom of the ditch is probably not the incoming tile line indicated above. During construction/repair activities on the buried manhole at this location (see Waypoint 201), Mr. Muth indicated that they could not find the tile line entering from the southeast at this location. We have left the line on the maps, however, based on the possibility it is in the vicinity.

1. The open ditch was cleaned from Highway 10 to the outlet in 1985.
2. Line was repaired at Waypoint 133 in 1980.
3. Location of patches in the main line performed by Walter Tucker during the last 10 years include Waypoints 605, 606, 608, 610, 613, 615, 616, 618.
4. Locations where the open ditch has been restructured, and/or rip-rapped on the sides by Walter Tucker during the last 10 years include Waypoints 607, and 608.
5. Repair of 15" line, manhole at waypoint 884, mid-March, 2007.
6. Repair of main line – 14" clay tile at waypoint 620.

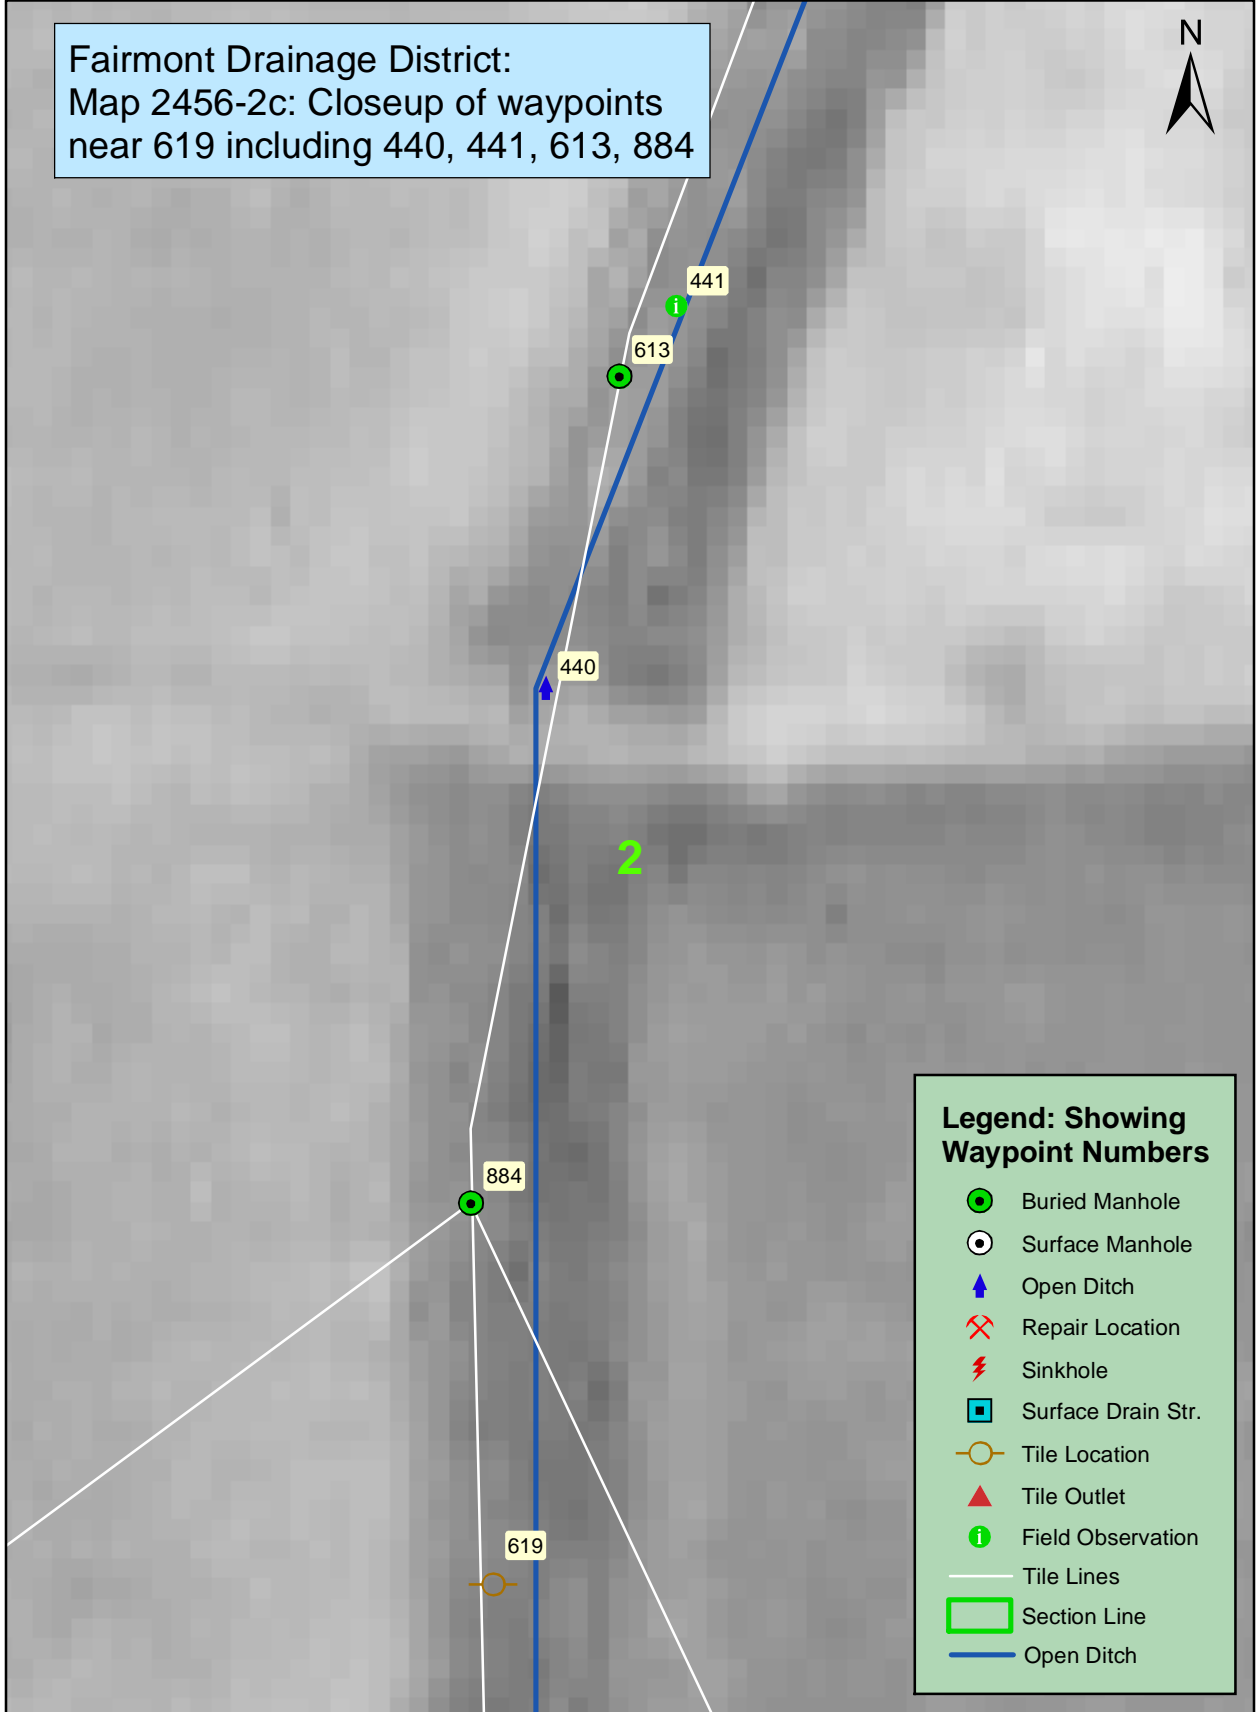
Fairmont Drainage District:
 Map 2456-2c: Closeup of waypoints
 near 619 including 440, 441, 613, 884

Location of manhole buried 3-4 feet deep. Taken on 3/13/07, when a sink was exposed. Walter Tucker excavated the area and discovered the 15" main was broken. There is a manhole here, previously unknown in its location, which contains the junction with a 6" clay tile line going out of the manhole toward the southeast.

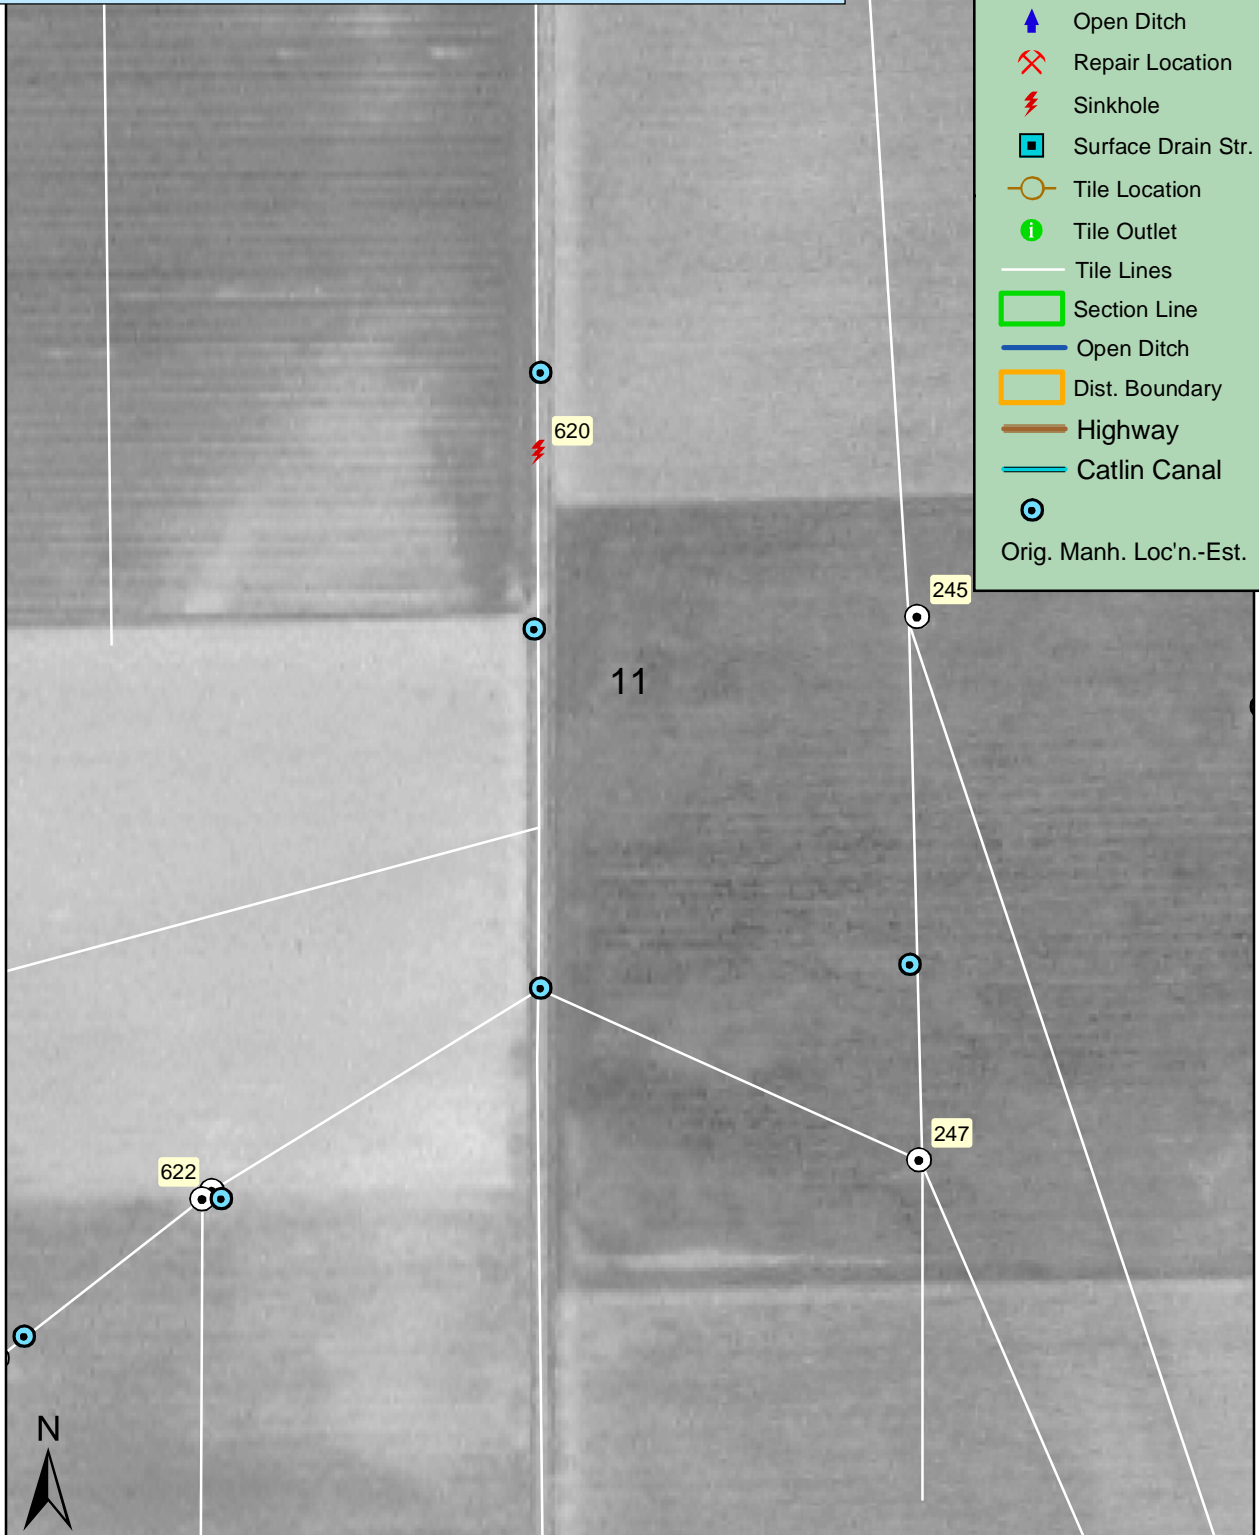
Fairmont Drainage District:
Map 2456-11f: Close-up of
Waypoints 621, 622

Location of brick manhole with wood cover. Through a hole in the cover, wate is observed, and measured approximately 30 inches from the surface of the manhole, which is 2-4" above the surrounding ground level.

Location of brick manhole with wooden cover southwest of Waypoint 622. Through a hole in the cover, water is observed approximately 31" from the surface. It is moving in the manhole, and is clear.
