Holbrook Drainage District System Inventory

May 9, 2007

Prepared with the assistance of Jim Collins, David Froese and Walter Epley
The Lower Arkansas Valley Drainage System Rehabilitation Study
Colorado State Univ., Dr. John Wilkins-Wells, Sociology Water Lab
Clark Building B258, Fort Collins, CO 80523 Ph: 970-491-5635

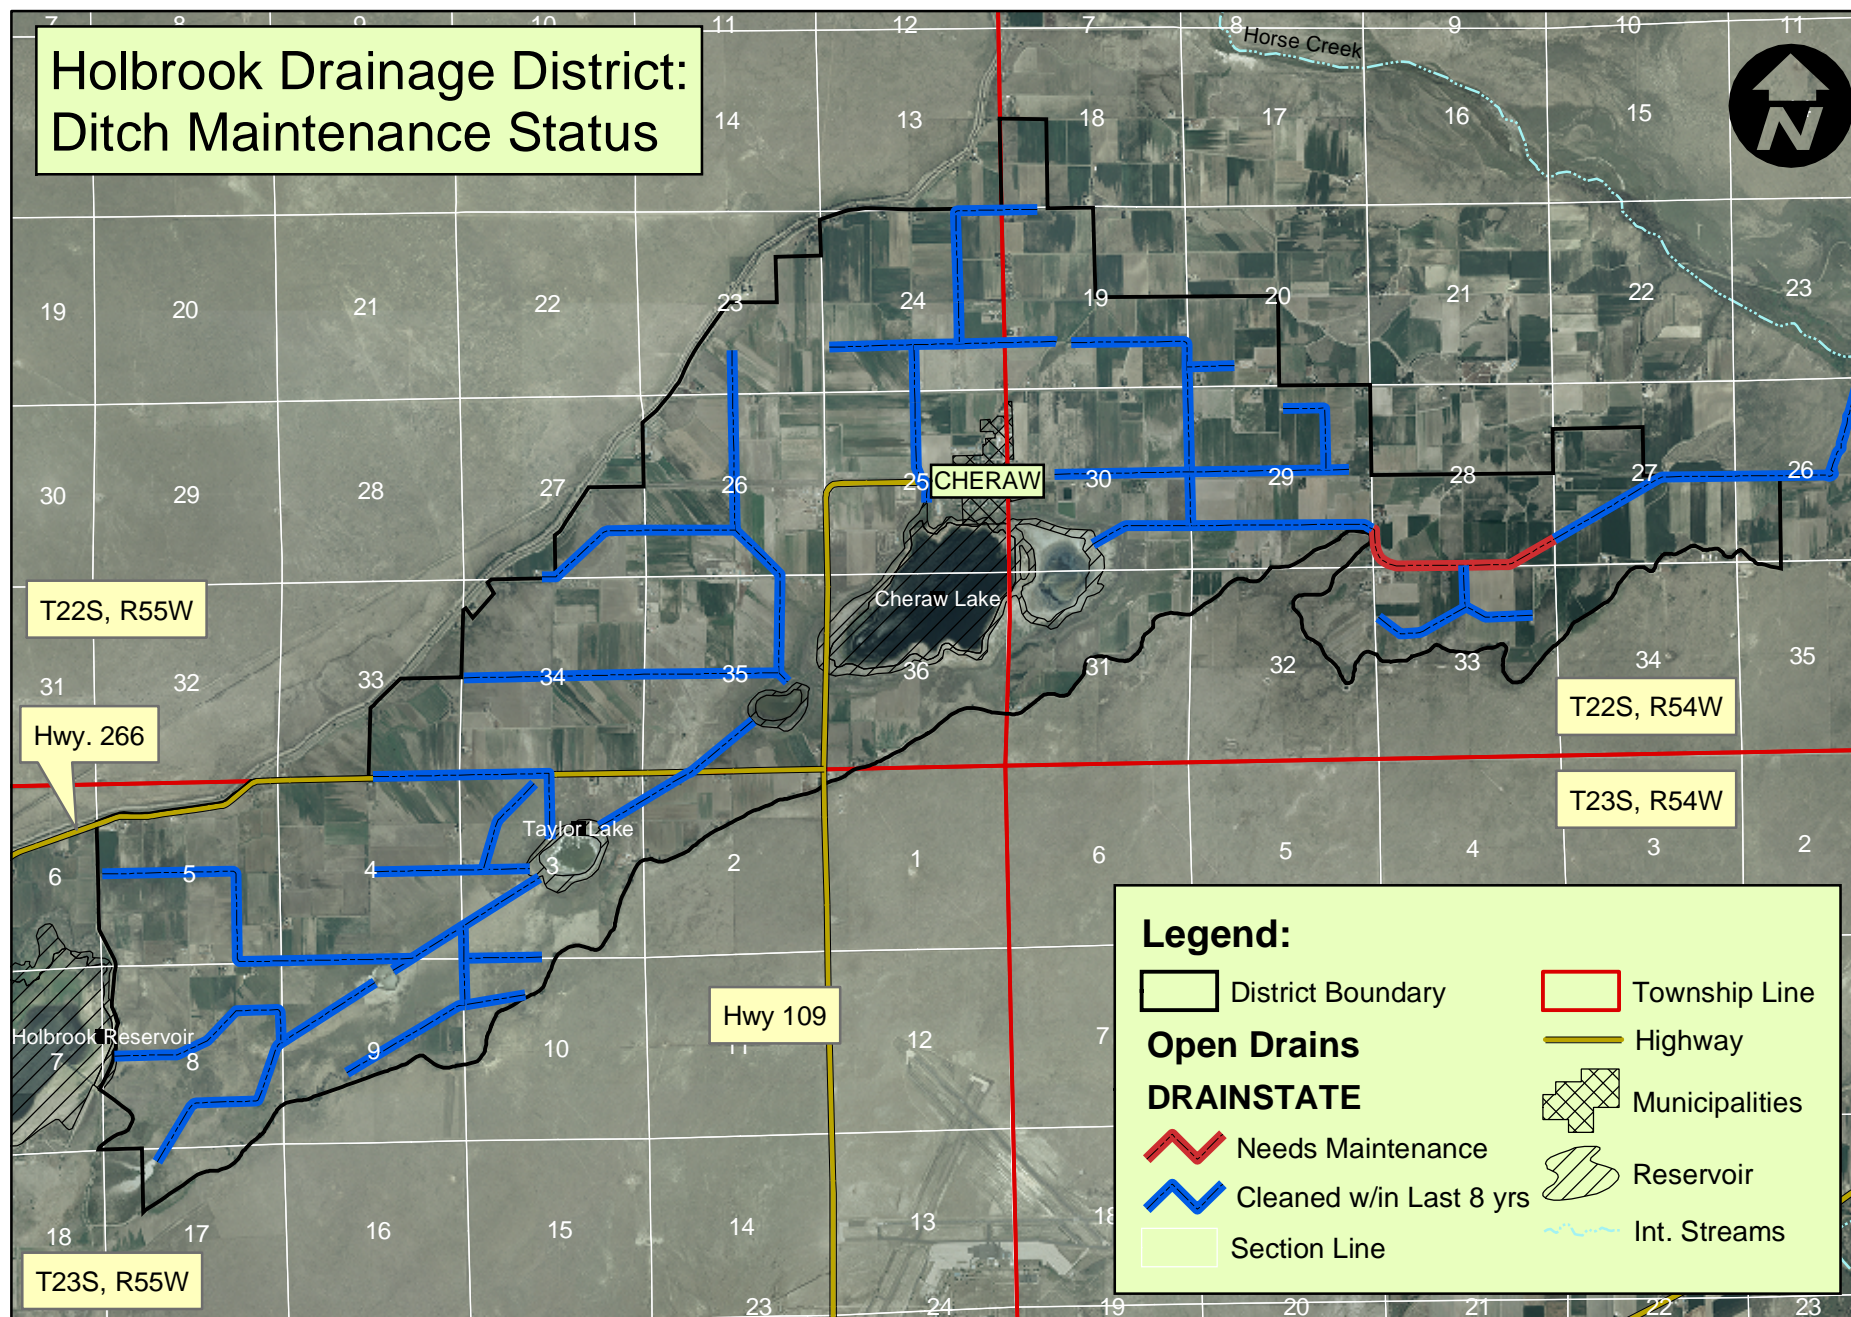
Holbrook Drainage District: Ditch Maintenance Status

Drains have been cleaned on a regular basis over the past years. In the 1980's, drains in Sections 26, 27 and 34 of T22S, R55W were cleaned. During the years 2002 to 2007, Drains in the sections north of Cheraw have been cleaned. During this past year, the main ditch east of Cheraw Lake in Sections 29 and 30 (T22S, R54W) has been cleaned. It was previously cleaned in 1985 and 1986. Cleaning needs to be extended to the east through Section 28.

The main drain has provided draining relief for approximately 10 to 15 years out of the last 50 years. It provides for the long-term relief of high water levels throughout the whole district. Of course, this relief is especially notable during the wet cycles. Overall, the system is in good shape, functioning well, and easily doing the job at the time of this writing.

Length of open drain to be cleaned on a maintenance basis next: 10,208 feet. Note: some of this is open drain which is very deep, which will be a bit more expensive.
