# *Kornman Drainage District System Inventory*

June 15, 2005, Rev. November 20, 2006, January 12, 2007

The Lower Arkansas Valley Drainage System Rehabilitation Study  
Colorado State Univ., Dr. John Wilkins-Wells, Sociology Water Lab  
Clark Building B258, Fort Collins, CO 80523 Ph: 970-491-5635

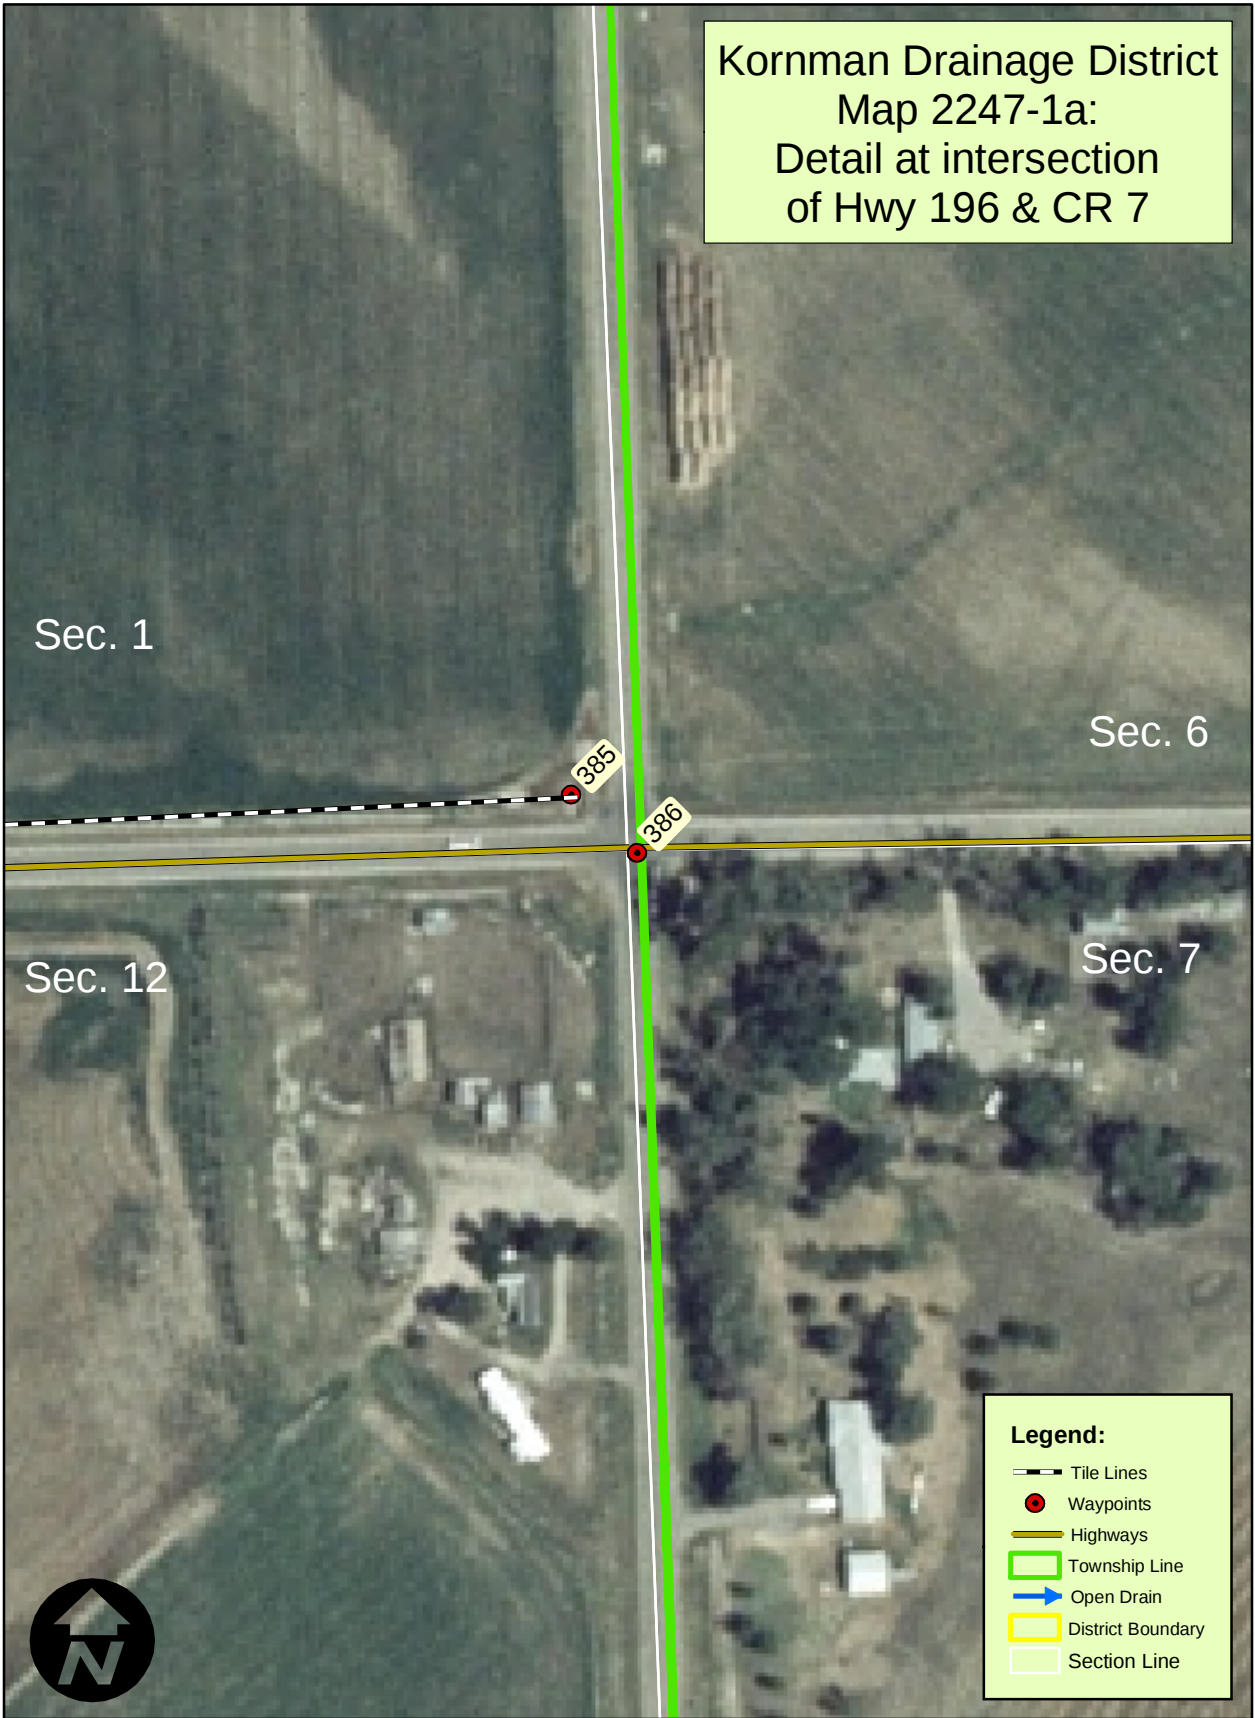
Kornman Drainage District  
Map 2247-1a:  
Detail at intersection  
of Hwy 196 & CR 7

This point is taken standing over the tile outlet in the northwest corner of the intersection of Hwy 196 and CR 7 (Prowers County) of the main east-west line that parallels Hwy 196. It is a 6-inch clay tile. It collects drainage from 3 north-south lines that are 528 feet apart, which are further west from this point. From this outlet, water exits and runs down the east bar ditch of CR 7 for reuse. There are no "rights" to speak of.

This is a test point taken in the middle of the intersection of CR 7 and Hwy 196. Putting the point on the NRCS 1983 composite Mr Sid photo, shows it about 8 ft east-southeast of what appears to be the crossing of the centerlines of both roads.

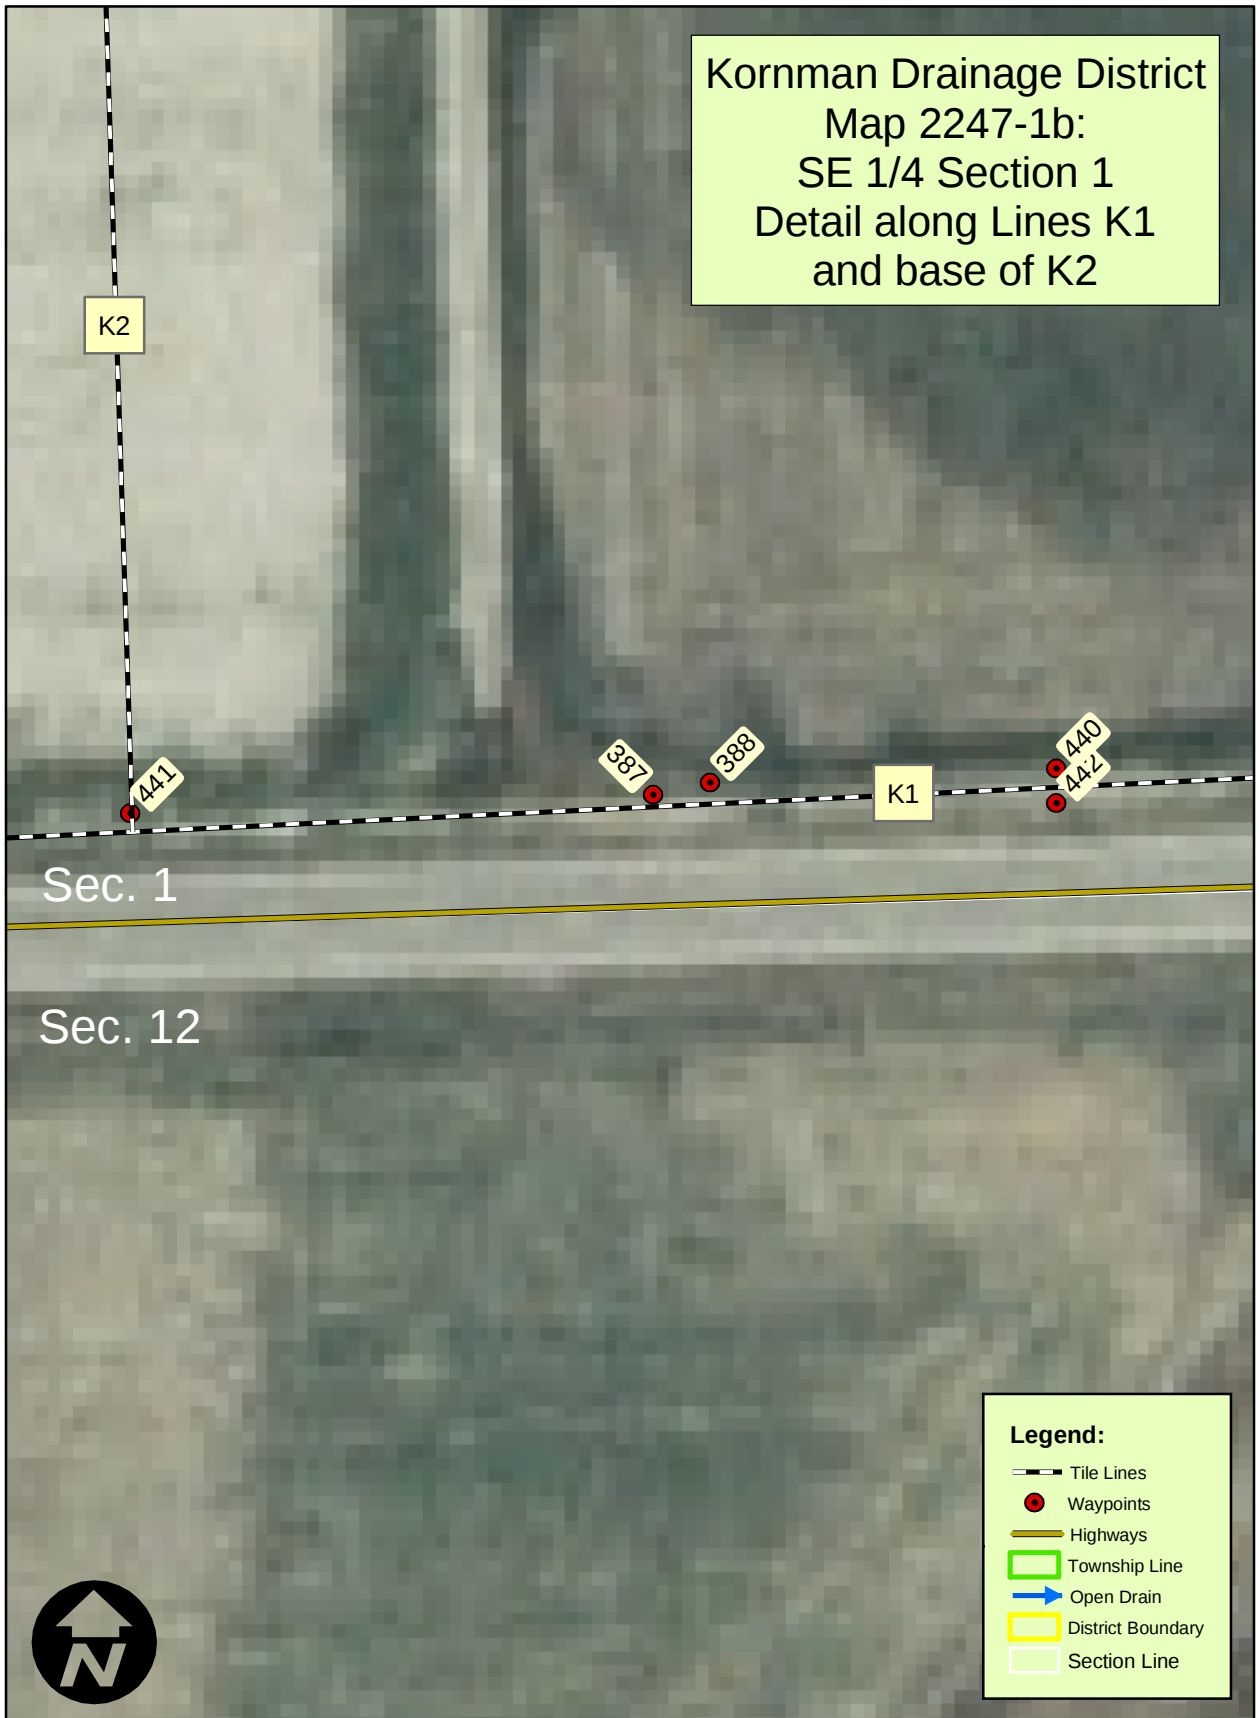
Kornman Drainage District  
Map 2247-1b:  
SE 1/4 Section 1  
Detail along Lines K1  
and base of K2

Taken while standing on top of the east-west main line along Hwy 196.

Taken while standing on top of the east-west main line at a point where the 1<sup>st</sup> north-south line joins the main line from the north. See vegetative differences that may indicate where the tile line is located. The amount of mustard weed is greater along the line, and the alfalfa thinner because there is less seep from the north-south surface field ditch just to the west of this point which would feed the alfalfa.

We think this is the location of the "T" where a north-south line ties into the east-west main line. This line runs straight north to the 4<sup>th</sup> electric pole to the east of Bud's house.

We think this is a "T" where a north-south line enters the east-west main. This runs from this waypoint northward to the 3<sup>rd</sup> electric pole east of Bud Scranton's farm. The Waypoints 439 and 438 are taken on top of this north-south line. At this "T", we see flagstones of sandstone, limestone and limestone chips, and shale chips in the bar ditch on the north side of the road. We think this is detritus from the digging of an old manhole which was put in where the "T" of these lines were placed. They didn't have a manufactured "T", so they used a redwood box to make the junction of the tile lines. Bud Scranton has found these fragments, which come from about 10 ft deep in this area near the old manhole locations.

This waypoint is in line with the first north-south line, which runs toward the 4<sup>th</sup> electric pole eastward from Bud Scranton's house.

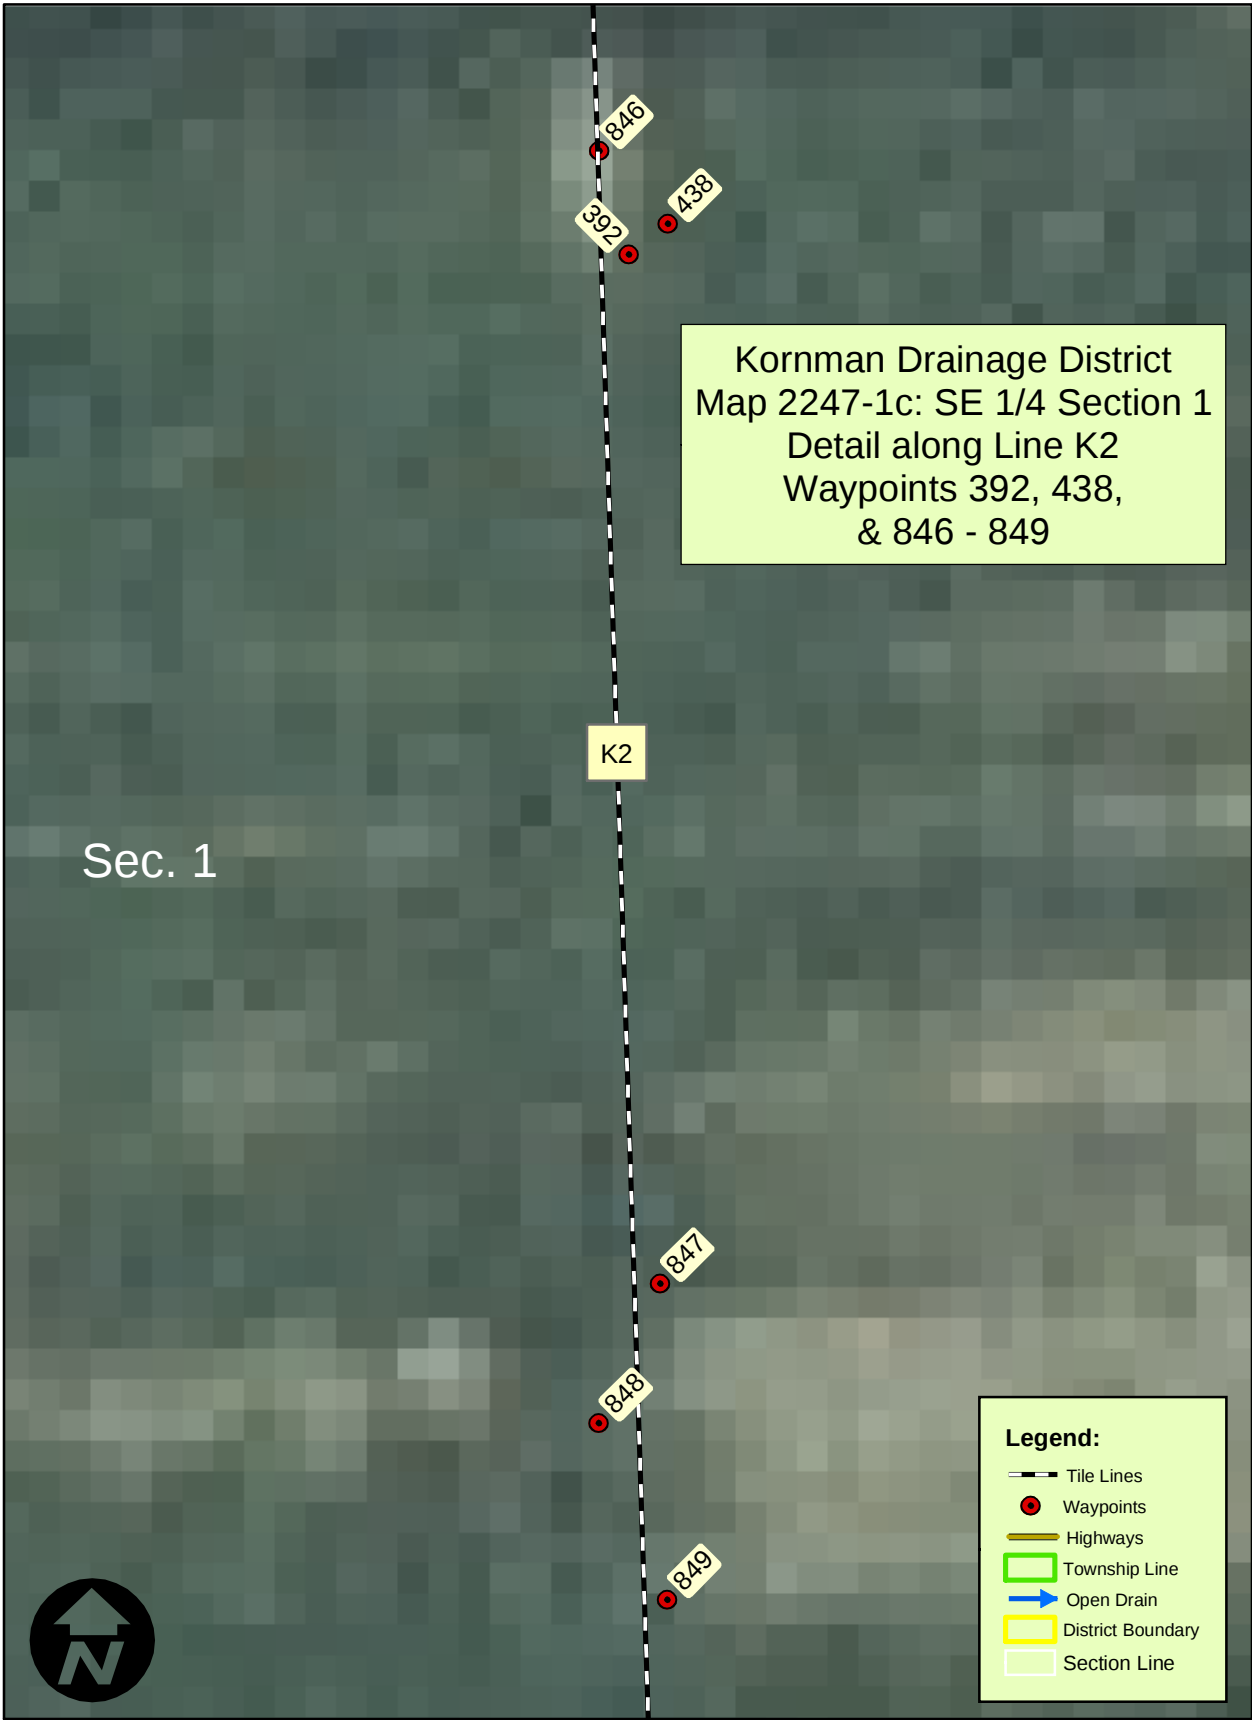
Kornman Drainage District  
Map 2247-1c: SE 1/4 Section 1  
Detail along Line K2  
Waypoints 392, 438,  
& 846 - 849

On top of a repair spot in a north-south line (K2) which should line up and go to Waypoint 388. Note: later we line it up with Waypoint 441, which we think better represents how the tile actually occurs in the field.

This is taken on top of a repair spot in the north-south line (K2). This is a duplication of Waypoint 392 from above, that is, taken at the same location.

Sinkhole 3 feet in diameter and 1 ½ feet deep.

Sinkhole 2 feet in diameter and 1 ½ feet deep.

Sinkhole 1 foot deep and 4 feet in diameter.

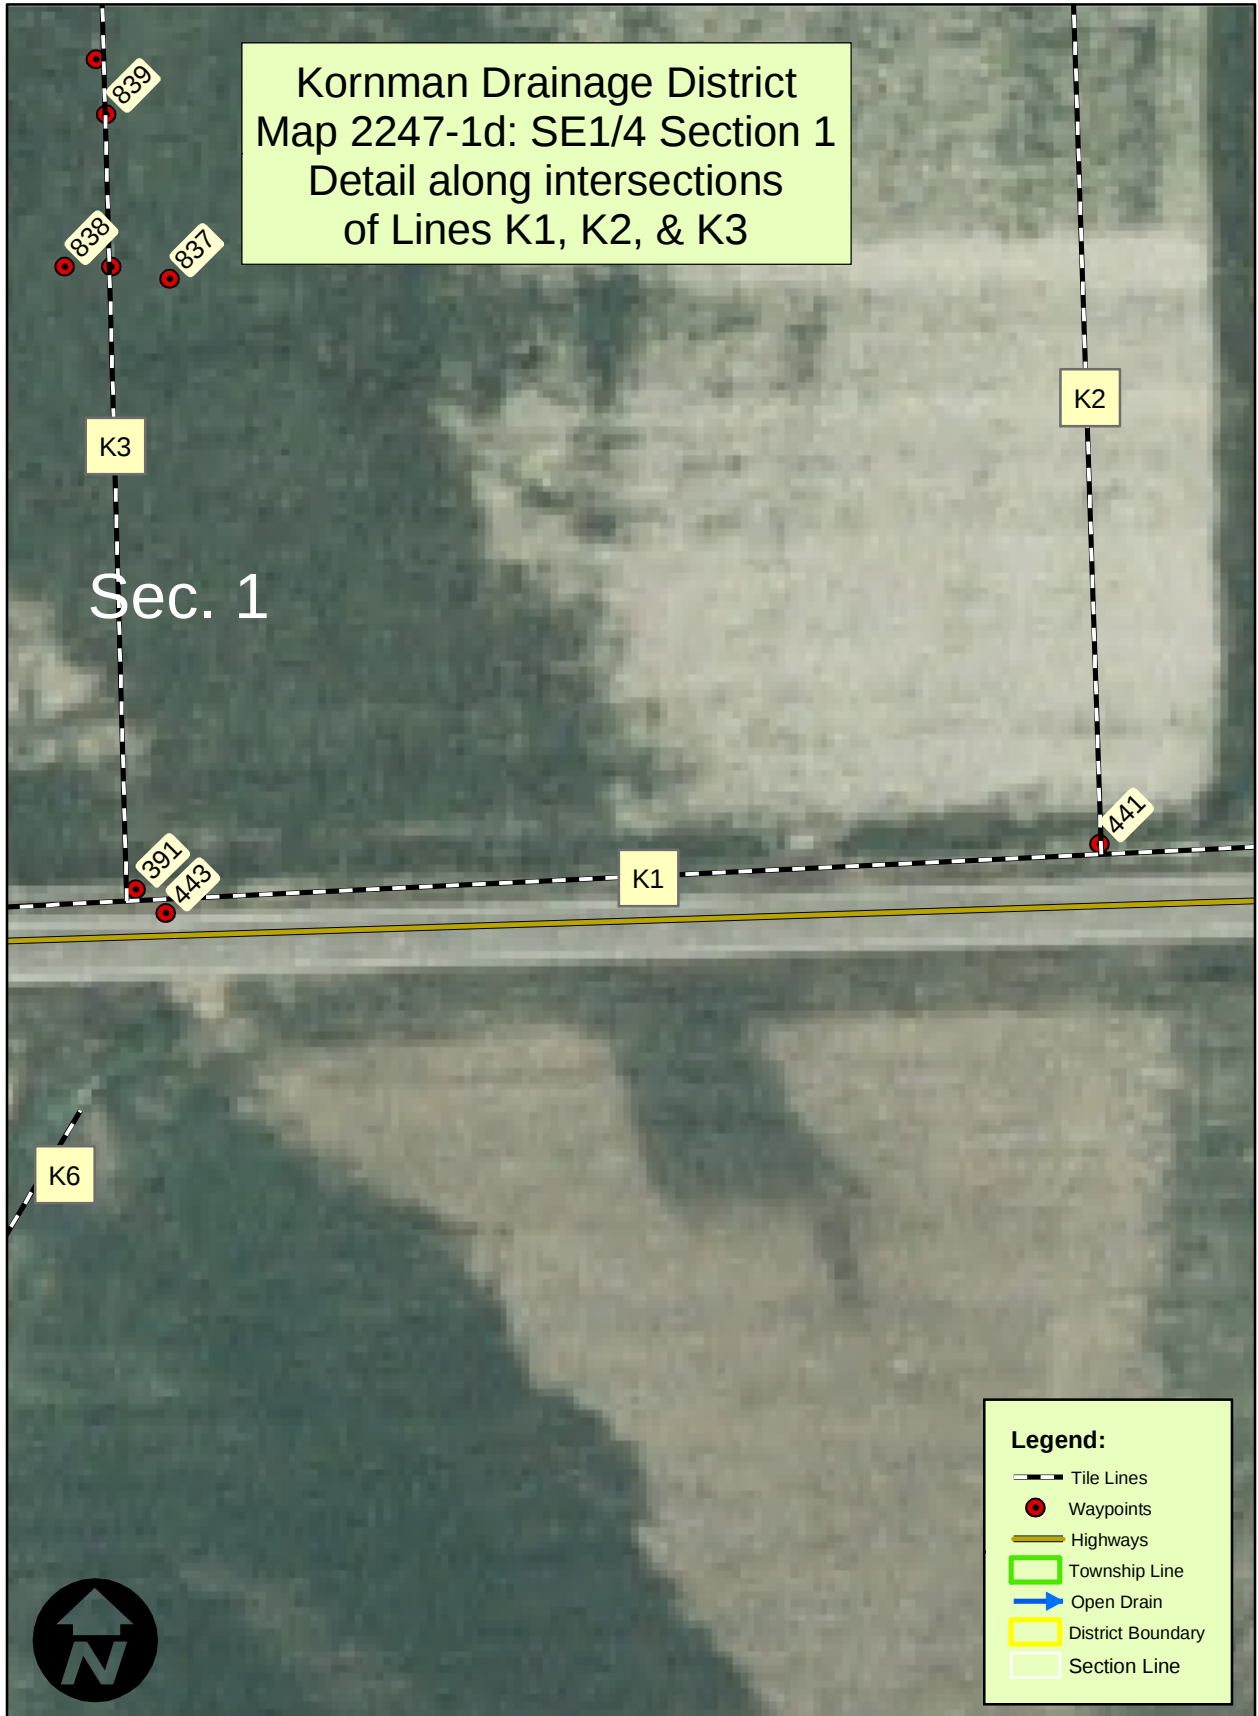
Kornman Drainage District  
Map 2247-1d: SE1/4 Section 1  
Detail along intersections  
of Lines K1, K2, & K3

At the point of the "T" in the main east-west line with the north-south line (K3) coming into it from the north. This is the "T" of the line where the Waypoint 390 is taken. The red tile is the deep one, (the newer one) and the older concrete tile is the shallower one. The red tile is 8-inch tile.

We find a piece of redwood here. We think there was a manhole here. This north-south line runs directly northward to the west edge of a farmhouse. We are on the north edge of Hwy 196, 10 feet north from the white line on the side of the road in the bar ditch.

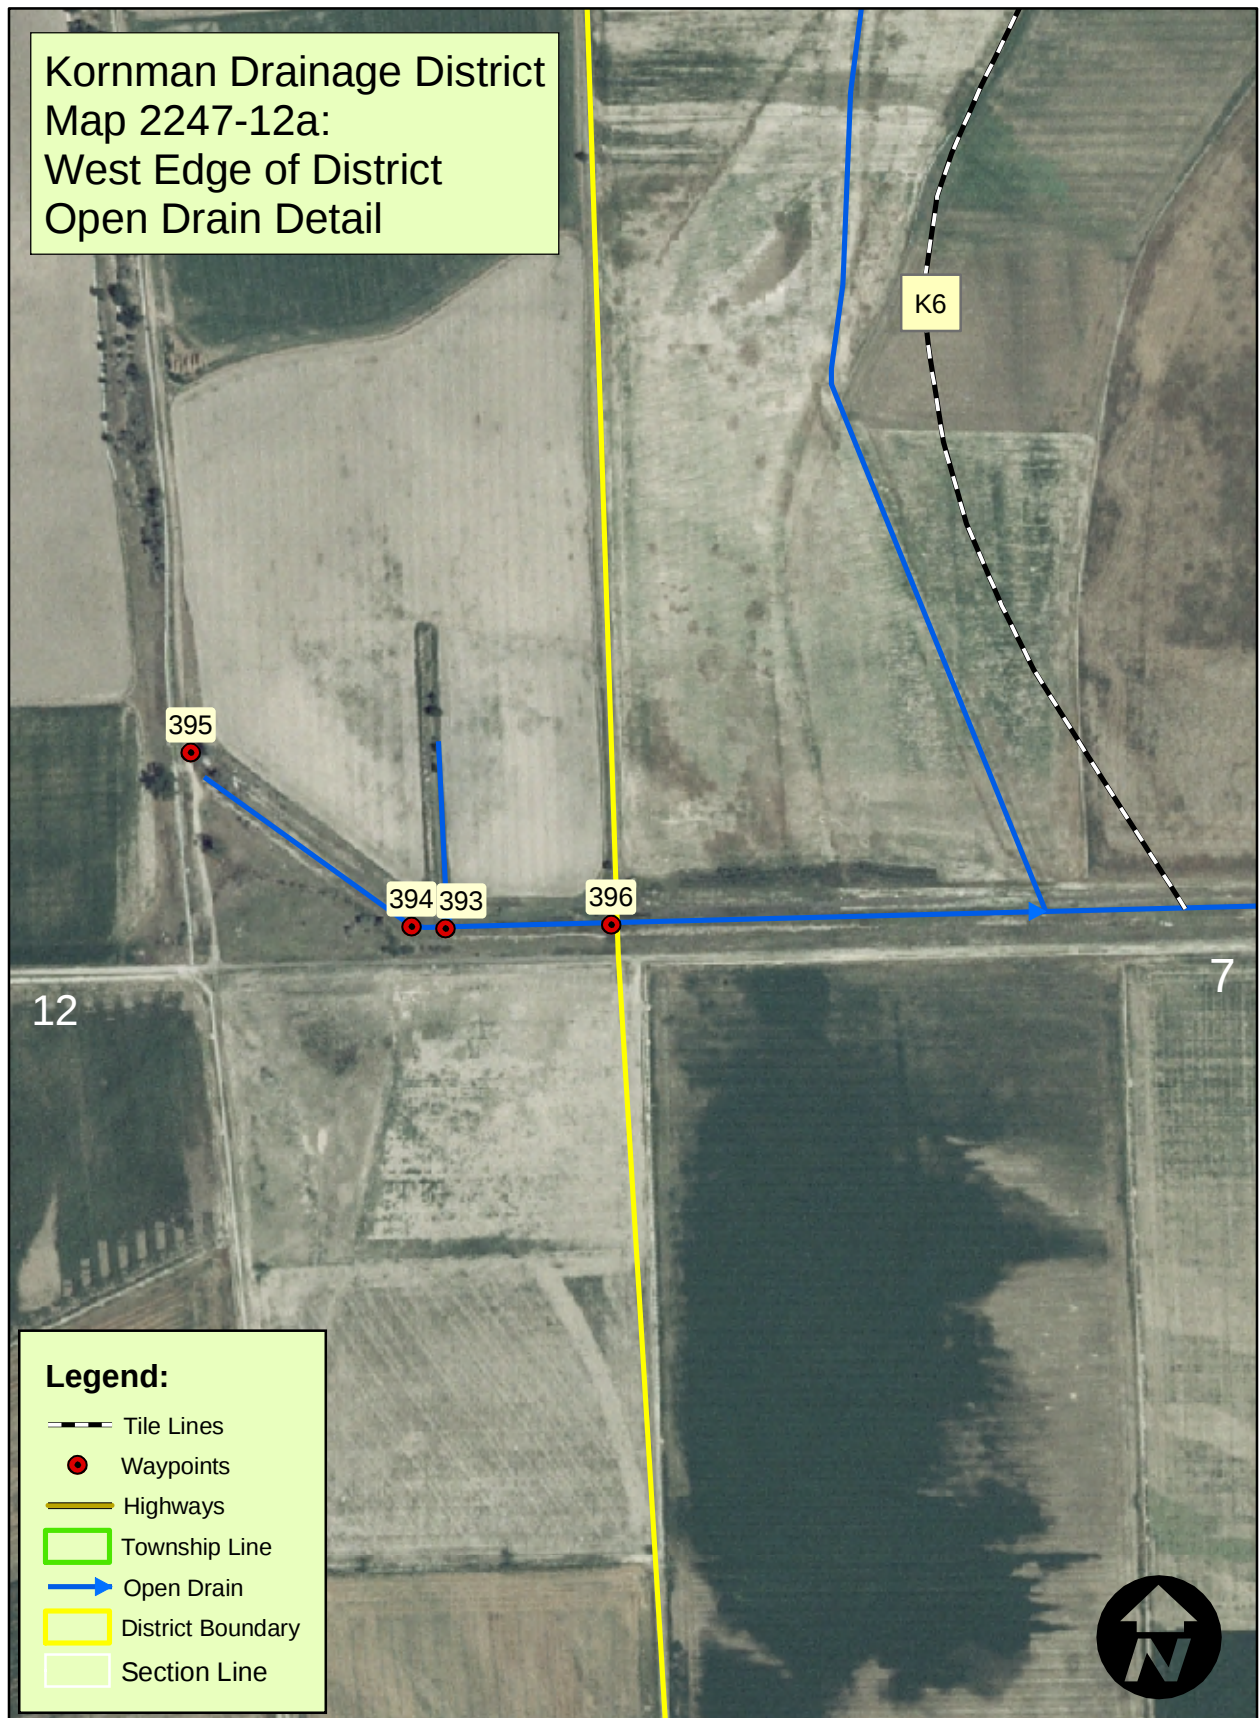
Kornman Drainage District  
Map 2247-12a:  
West Edge of District  
Open Drain Detail

At the junction or elbow of drains as they approach the west edge of the district. There is a short open drain coming from the north, which enters the main open ditch at this point. This waypoint is outside the actual district boundary.

Taken on the south bank of the main open ditch at the point where it bends to the west-northwest. This waypoint is outside the actual district boundary.

Upper end of the main open ditch of the Kornman Drainage District. This waypoint is outside the actual district boundary. We see a dead mole rat in a concrete structure which Bud says is a "mole rat". Olaf Sharp says that, in his experience, they dig down to the tile line and cause the sinks to begin forming.

At this waypoint, there is both a surface drain here, coming from the north into the east-west open drain and a newer tile line to the east of the surface drain. The newer black plastic line was knifed in about 8 years ago, around 1997. We have drawn in the line in an approximate location, not knowing for sure where it is. There is some uncertainty as to whether this line will work because of its shallow placement.

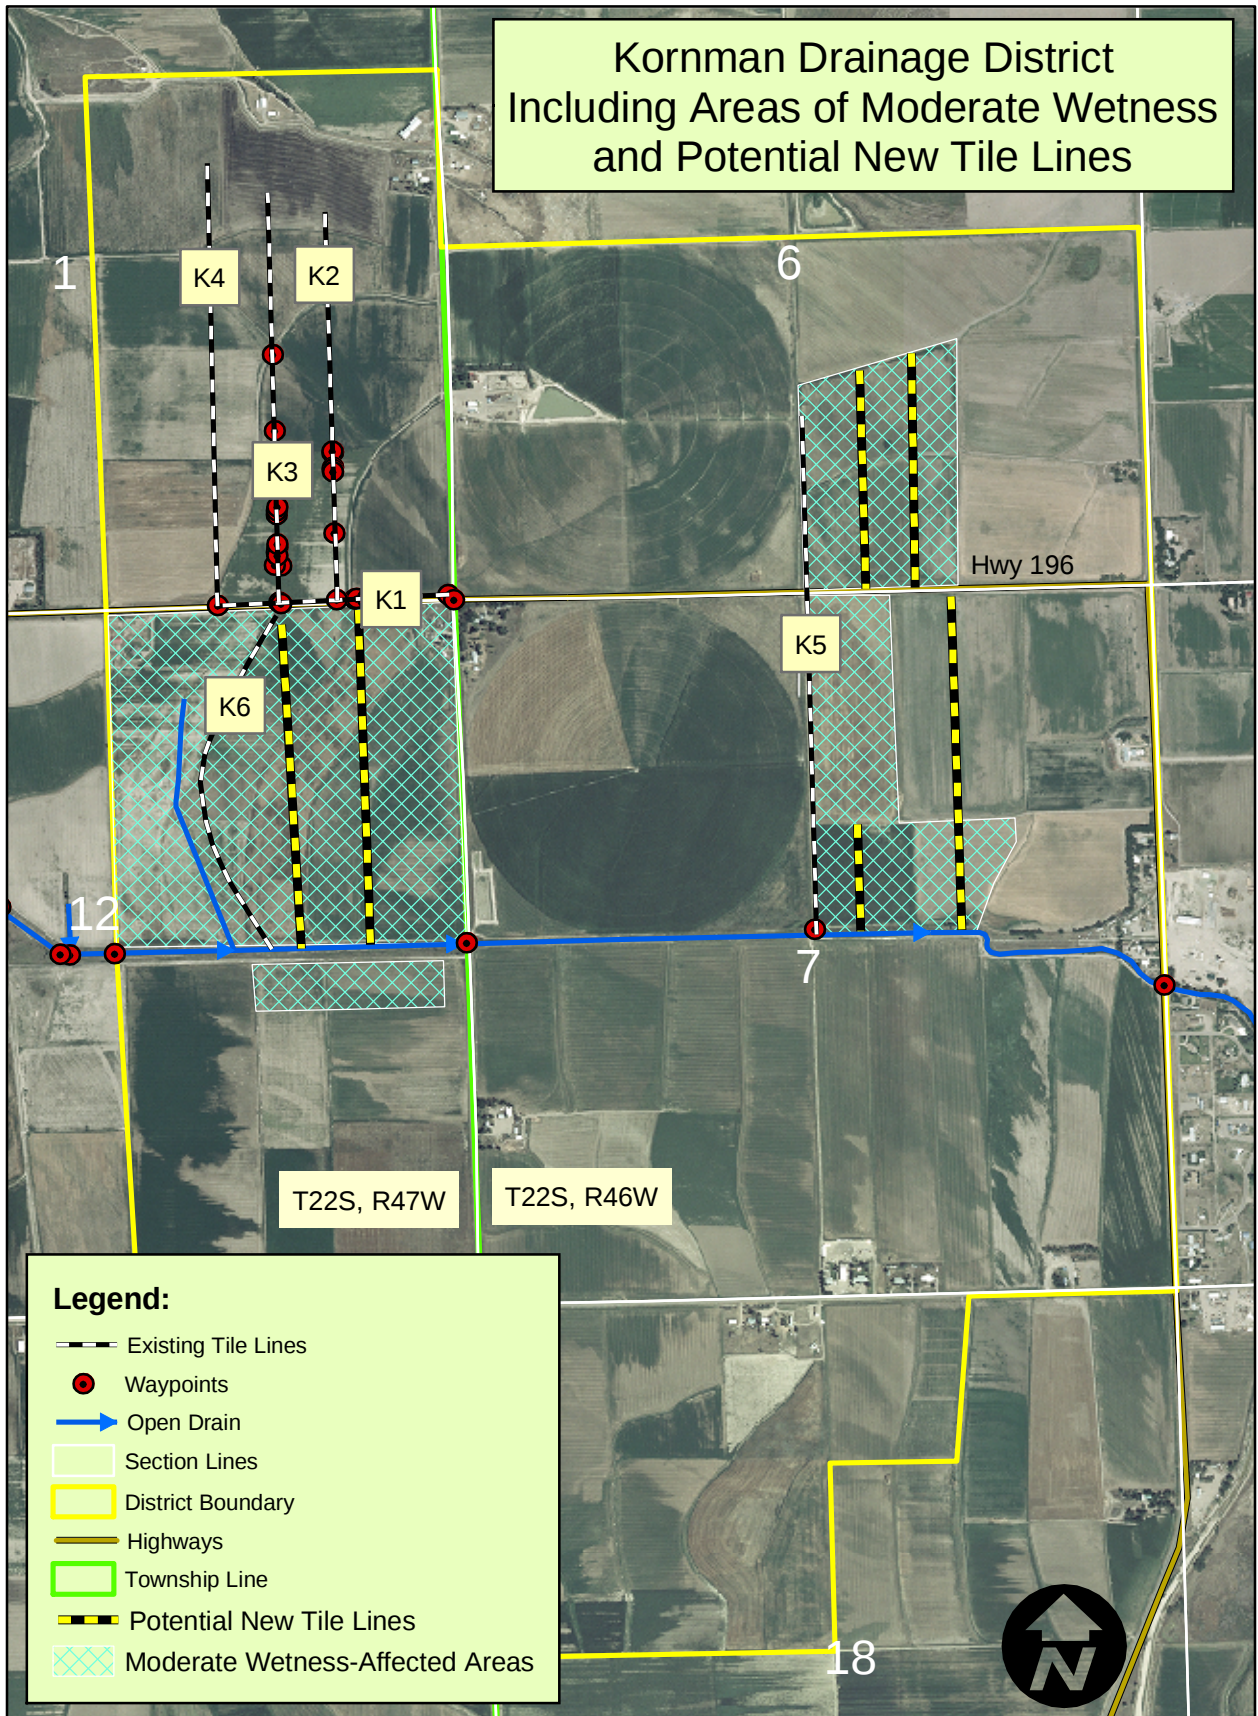
# Kornman Drainage District Including Areas of Moderate Wetness and Potential New Tile Lines

Areas affected by wetness: Moderate affect = 259.53 acres

System has proved adequate except for a limited area in the NE $\frac{1}{4}$  Sec. 12. and in the SE $\frac{1}{4}$  Sec. 1, T. 22S, R 47W. Tile line clogged and broken in NE $\frac{1}{4}$  of Sec. 12, which apparently causes the difficulty. Other tile lines are functioning but outlet canal needs deepening at outlet of tile lines in order to flow free.

Clean the whole open ditch.

3 new lines are needed

Clean all the tile lines.

Potential new tile lines: 11,679 feet
