Las Animas Extension

Drainage District

Drainage System Inventory

March 22, 2005, Rev. 7/24/07

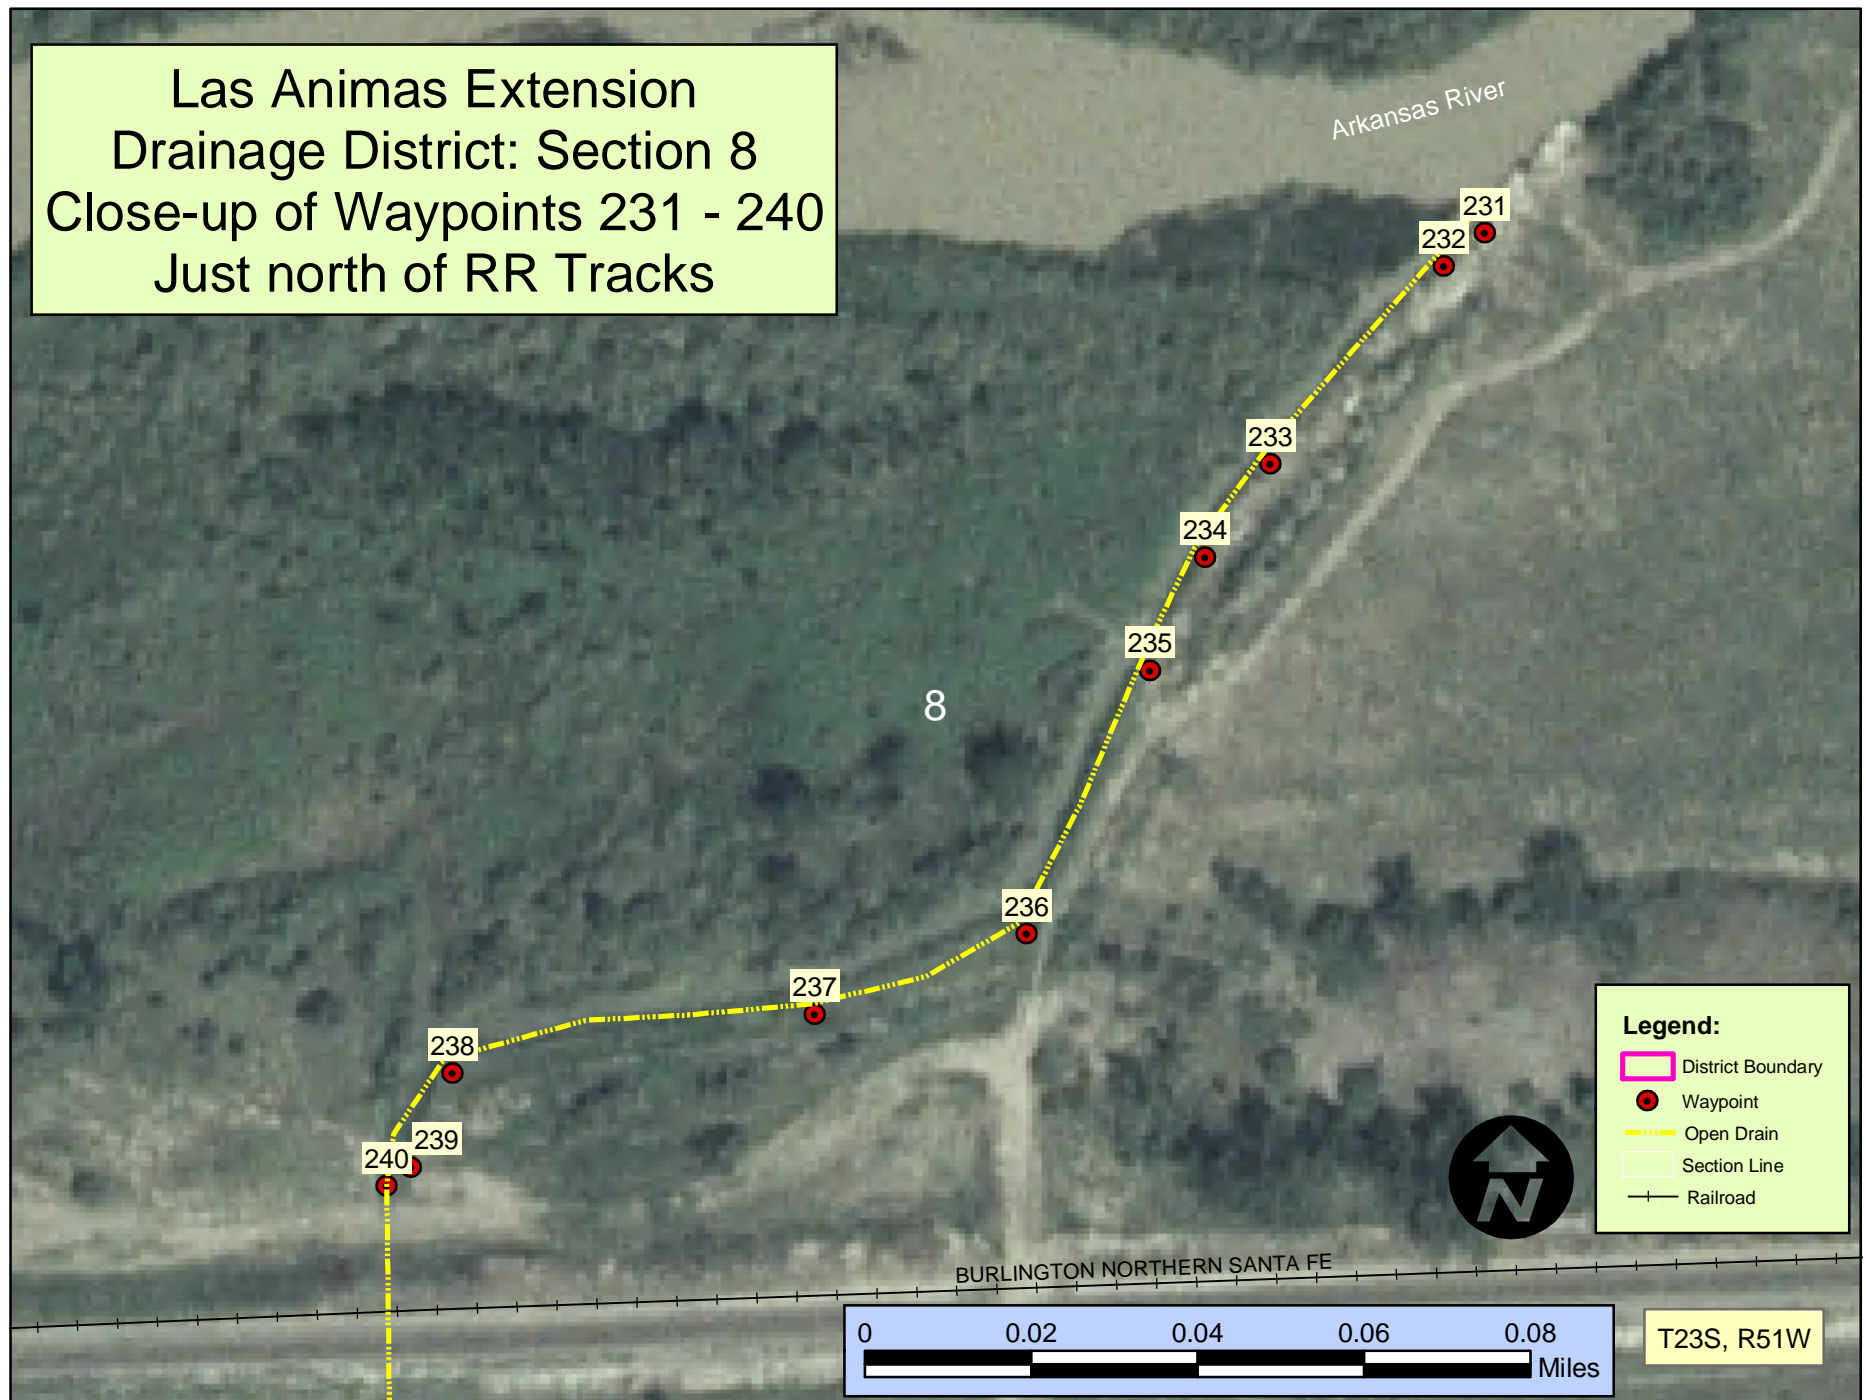
Las Animas Extension
Drainage District: Section 8
Close-up of Waypoints 231 - 240
Just north of RR Tracks

There is constant problem with beavers at this location, and southwestward to the southwest corner of section 8. The stick dams they build block the water and prevent drainage from the district system.

Standing on the southeast bank, this is the point at which the open ditch dumps into the Arkansas River. A beaver dam just above this to the south, holds back water maybe a foot high or so.

This waypoint is taken next to a beaver dam on the southeast side of the river, and on the bank of the open ditch.

Ditch runs from the southwest at this point, toward the northeast. This point is on the east bank of the open ditch, which is 10 to 12 ft. wide at this point, and 1 – 2 foot deep.

The first big beaver dam south of the river with sticks and mud holding back the water. It holds back the water at least 2 ft of height. At this point, the ditch widens considerably, widening back westerly into the “swamp”. Mr. Gardner reports that this beaver dam was dug out with a backhoe on the 15th of March, 2005, and on the 29th of March, the beaver had put back in/replaced a dam that was about 1 foot high.

Bend in the open ditch from the river toward a west-southwesterly orientation. It appears that the water may be deep here, 6 or 7 ft or more, and 18 ft wide at the top.

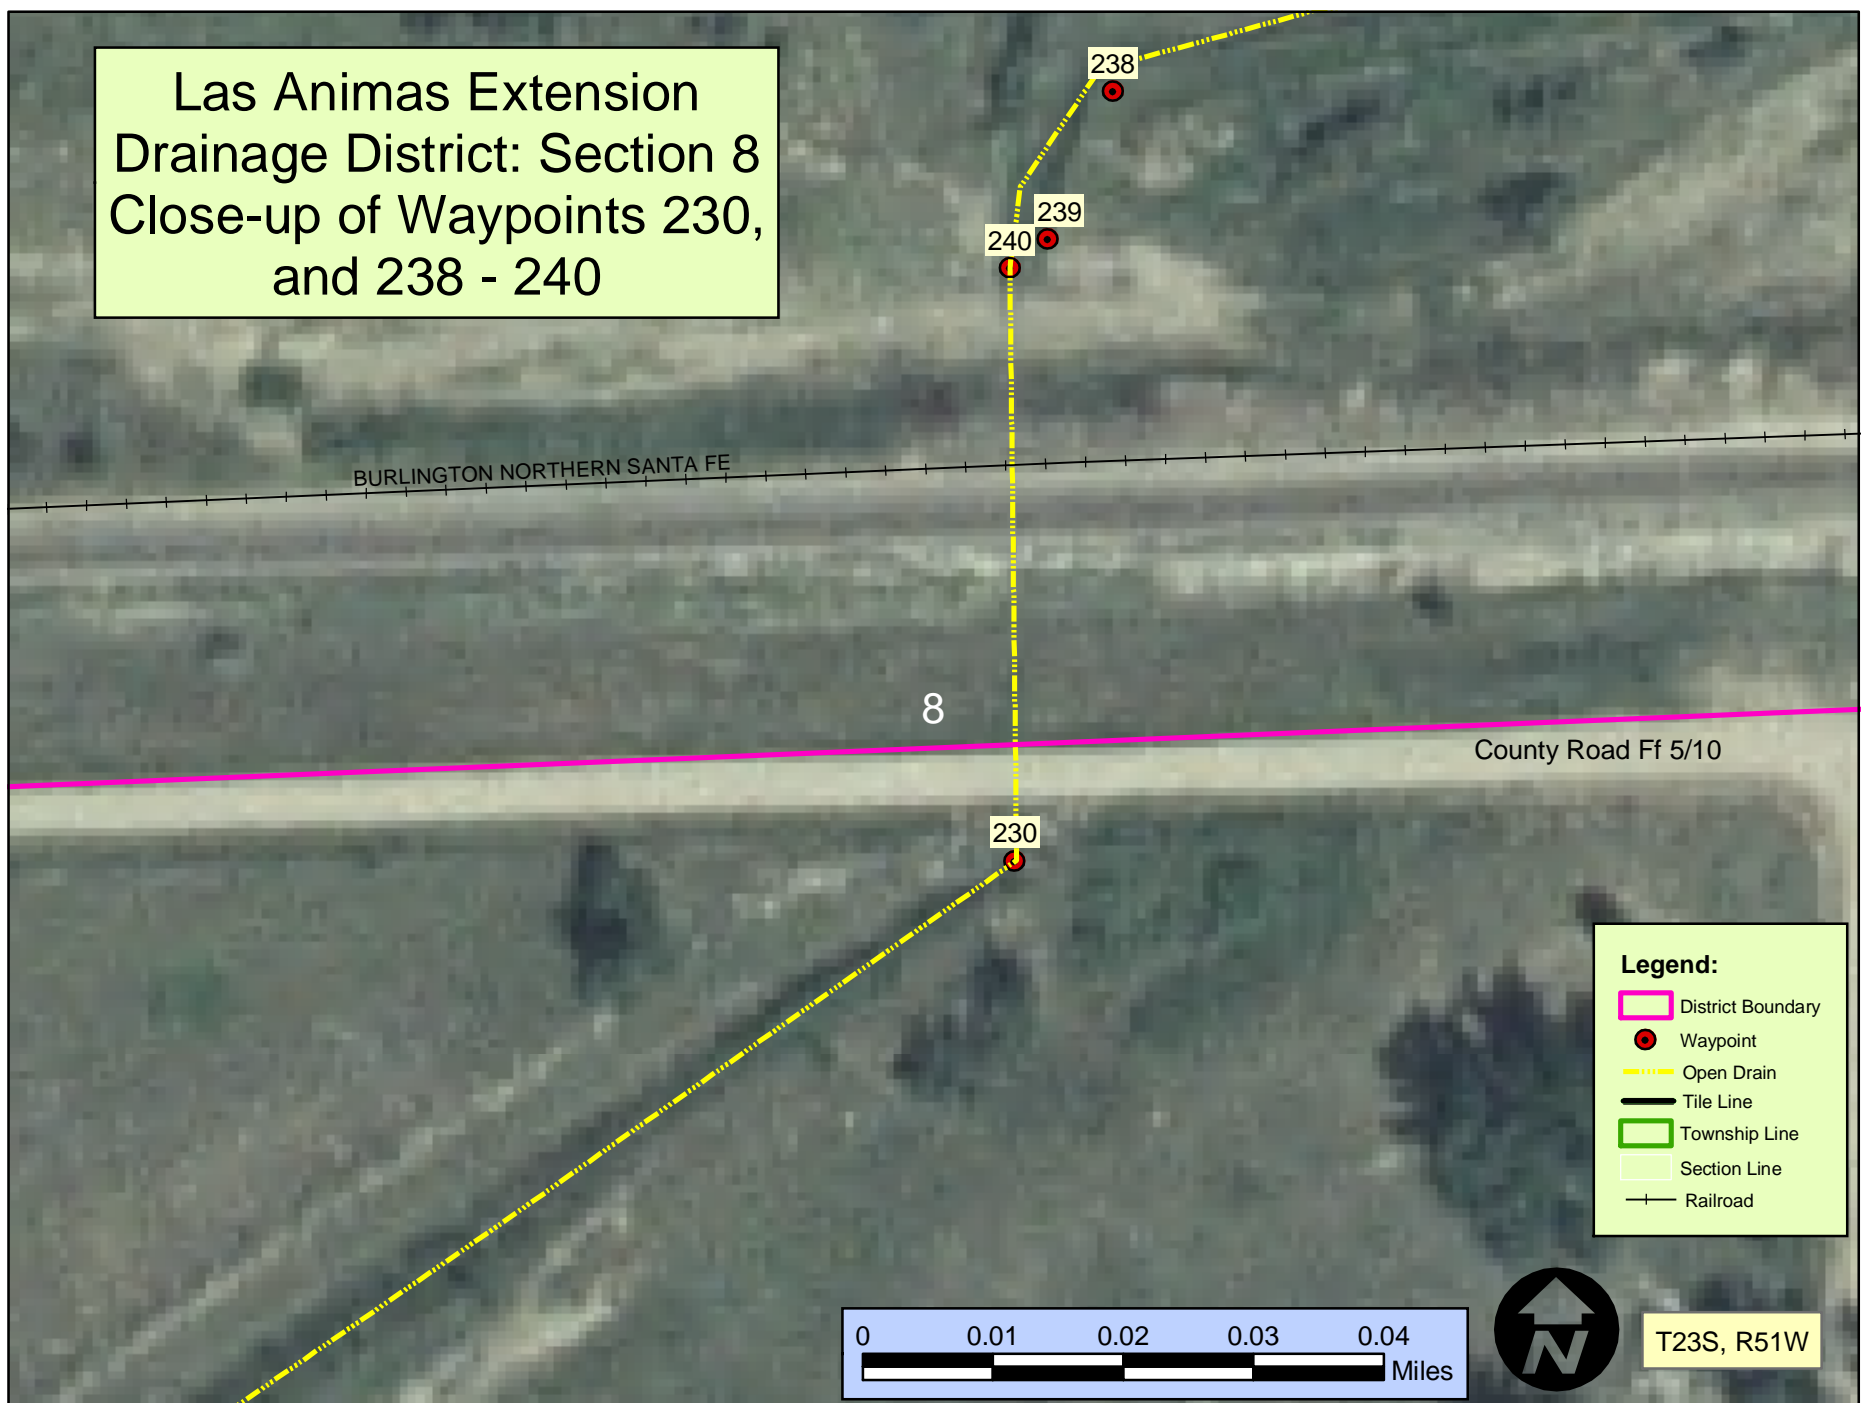
Las Animas Extension
Drainage District: Section 8
Close-up of Waypoints 230,
and 238 - 240

The main ditch temporarily ends at this point, going into a pipe under County Road Ff 5/10, and the RR tracks. Ditch at this waypoint lies in a northeastward – southwestward orientation. It is probably 6-9 ft deep with water at the bottom, maybe 3 feet or more. The ditch is at least 20 ft wide at the top. From this waypoint, it travels in the underground pipe straight north to a point on the north side of the railroad tracks, where the ditch is open again. This point is directly north of the opening under the tracks on the south side. The end of the tile is directly opposite a RR tie which is upright in the bank. The open ditch continues onward in an easterly direction toward the Arkansas River, and angles to the northeast where it dumps into the river.

Location of a bend to a north-south orientation, as open ditch goes under the RR tracks. The tip of the culvert underneath the railroad track bank extends maybe 8 ft. into the open ditch. At this point, it is covered with water – at least 2 ft of water.

On the east bank of the open ditch, “even” with the tip of the culvert in a North-south way.

End of the open ditch just north of the RR track. I’m at the top of the bank (ditch bank) at the centerline of the ditch. It goes from here straight south under the RR track, which runs straight east west. The culvert is at least 18 inches in diameter.

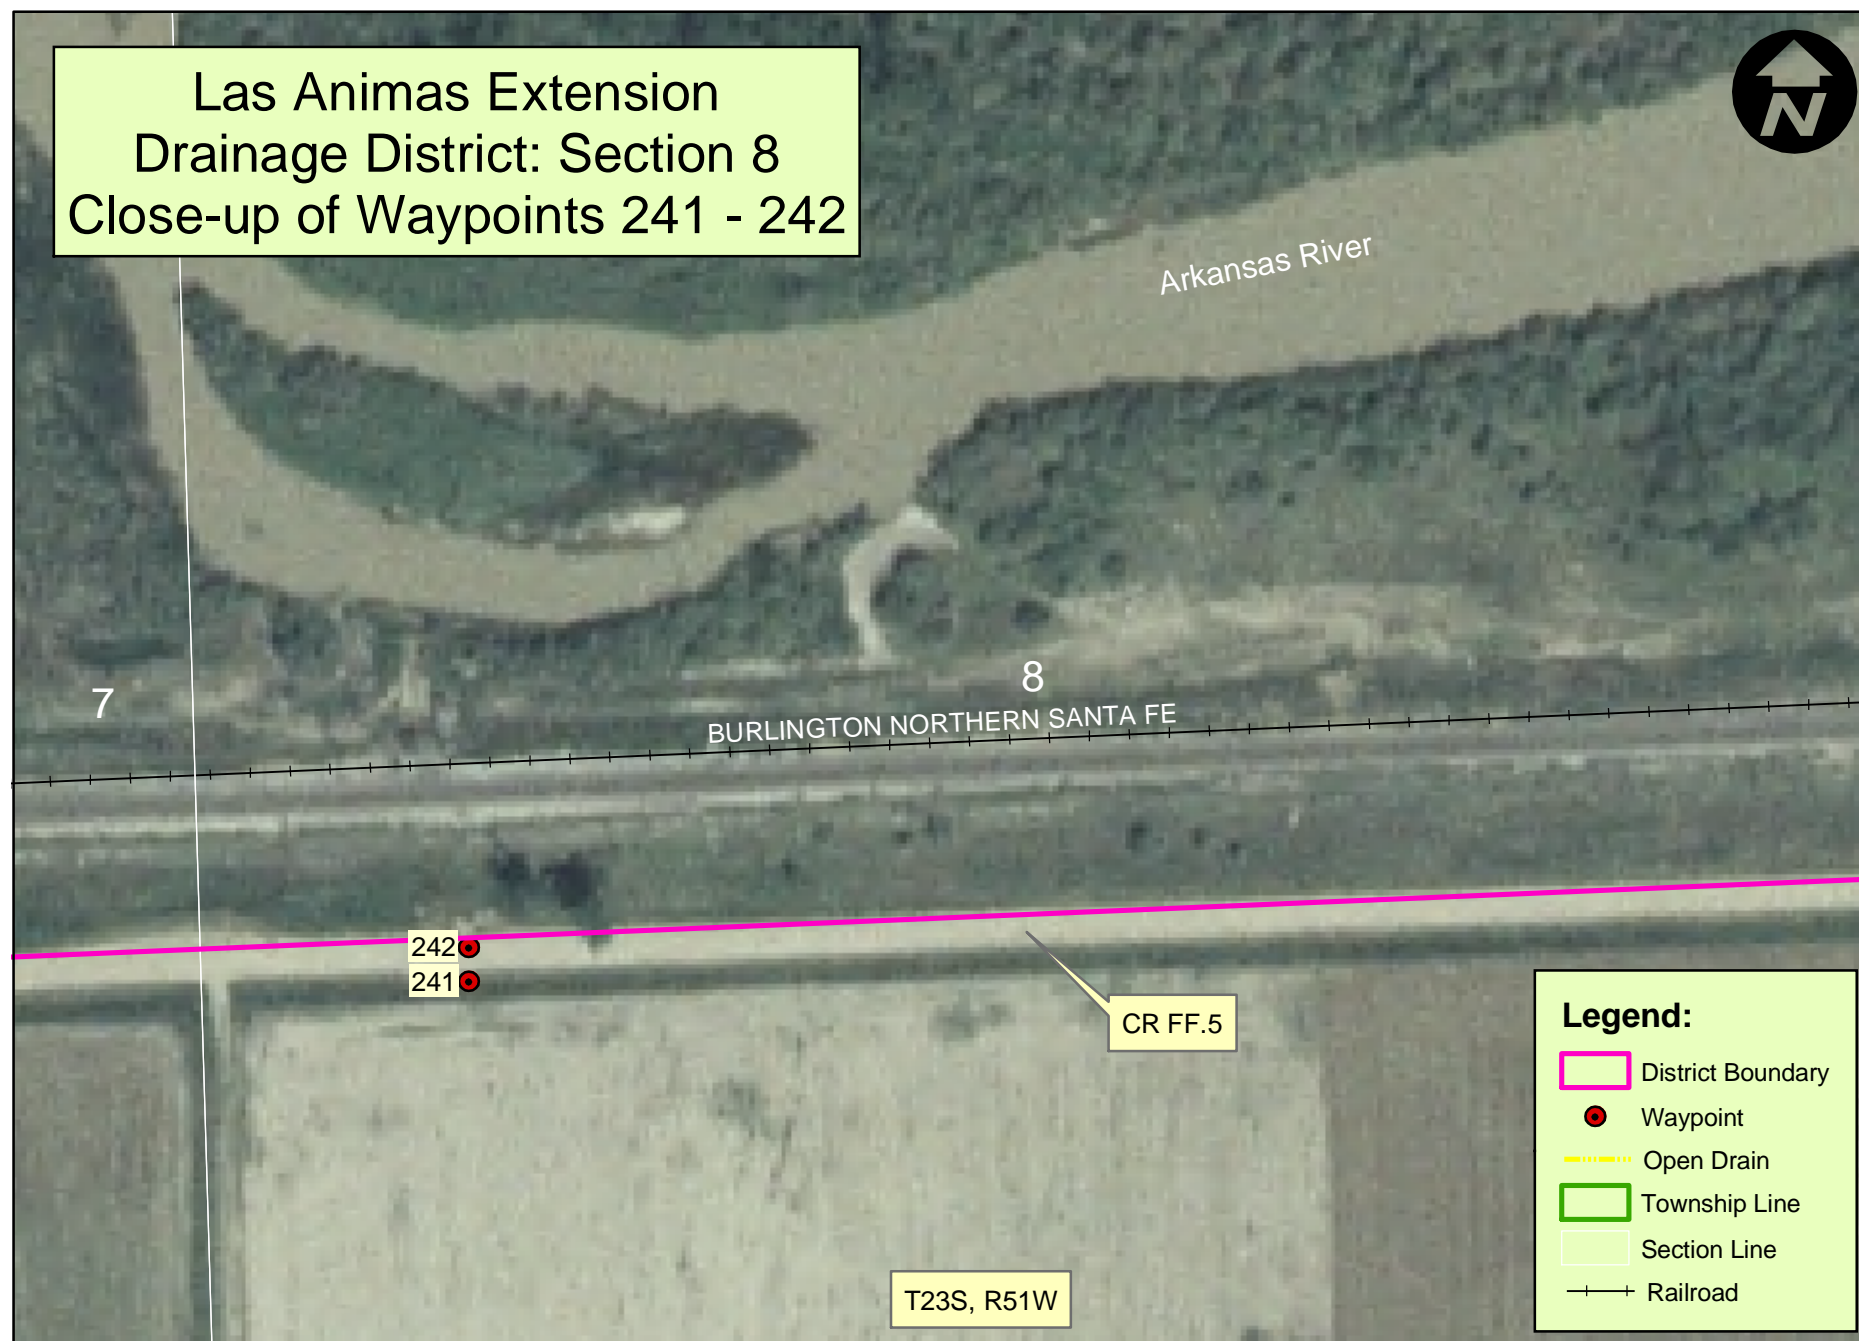
Las Animas Extension
Drainage District: Section 8
Close-up of Waypoints 241 - 242

South side of the east-west county road "FF.5", running parallel with and on the south side of the tracks. This location is at south end of culvert running under the road. Mr. Gardner indicates that the tile originally dumped into this culvert at this point. At this time, there is no water running at this location.

This is at the north edge of the road directly above the culvert, which goes under the road, which used to receive water from the old tile line. There is no evidence of water running through it today. It appears that it has been like this for a long time.

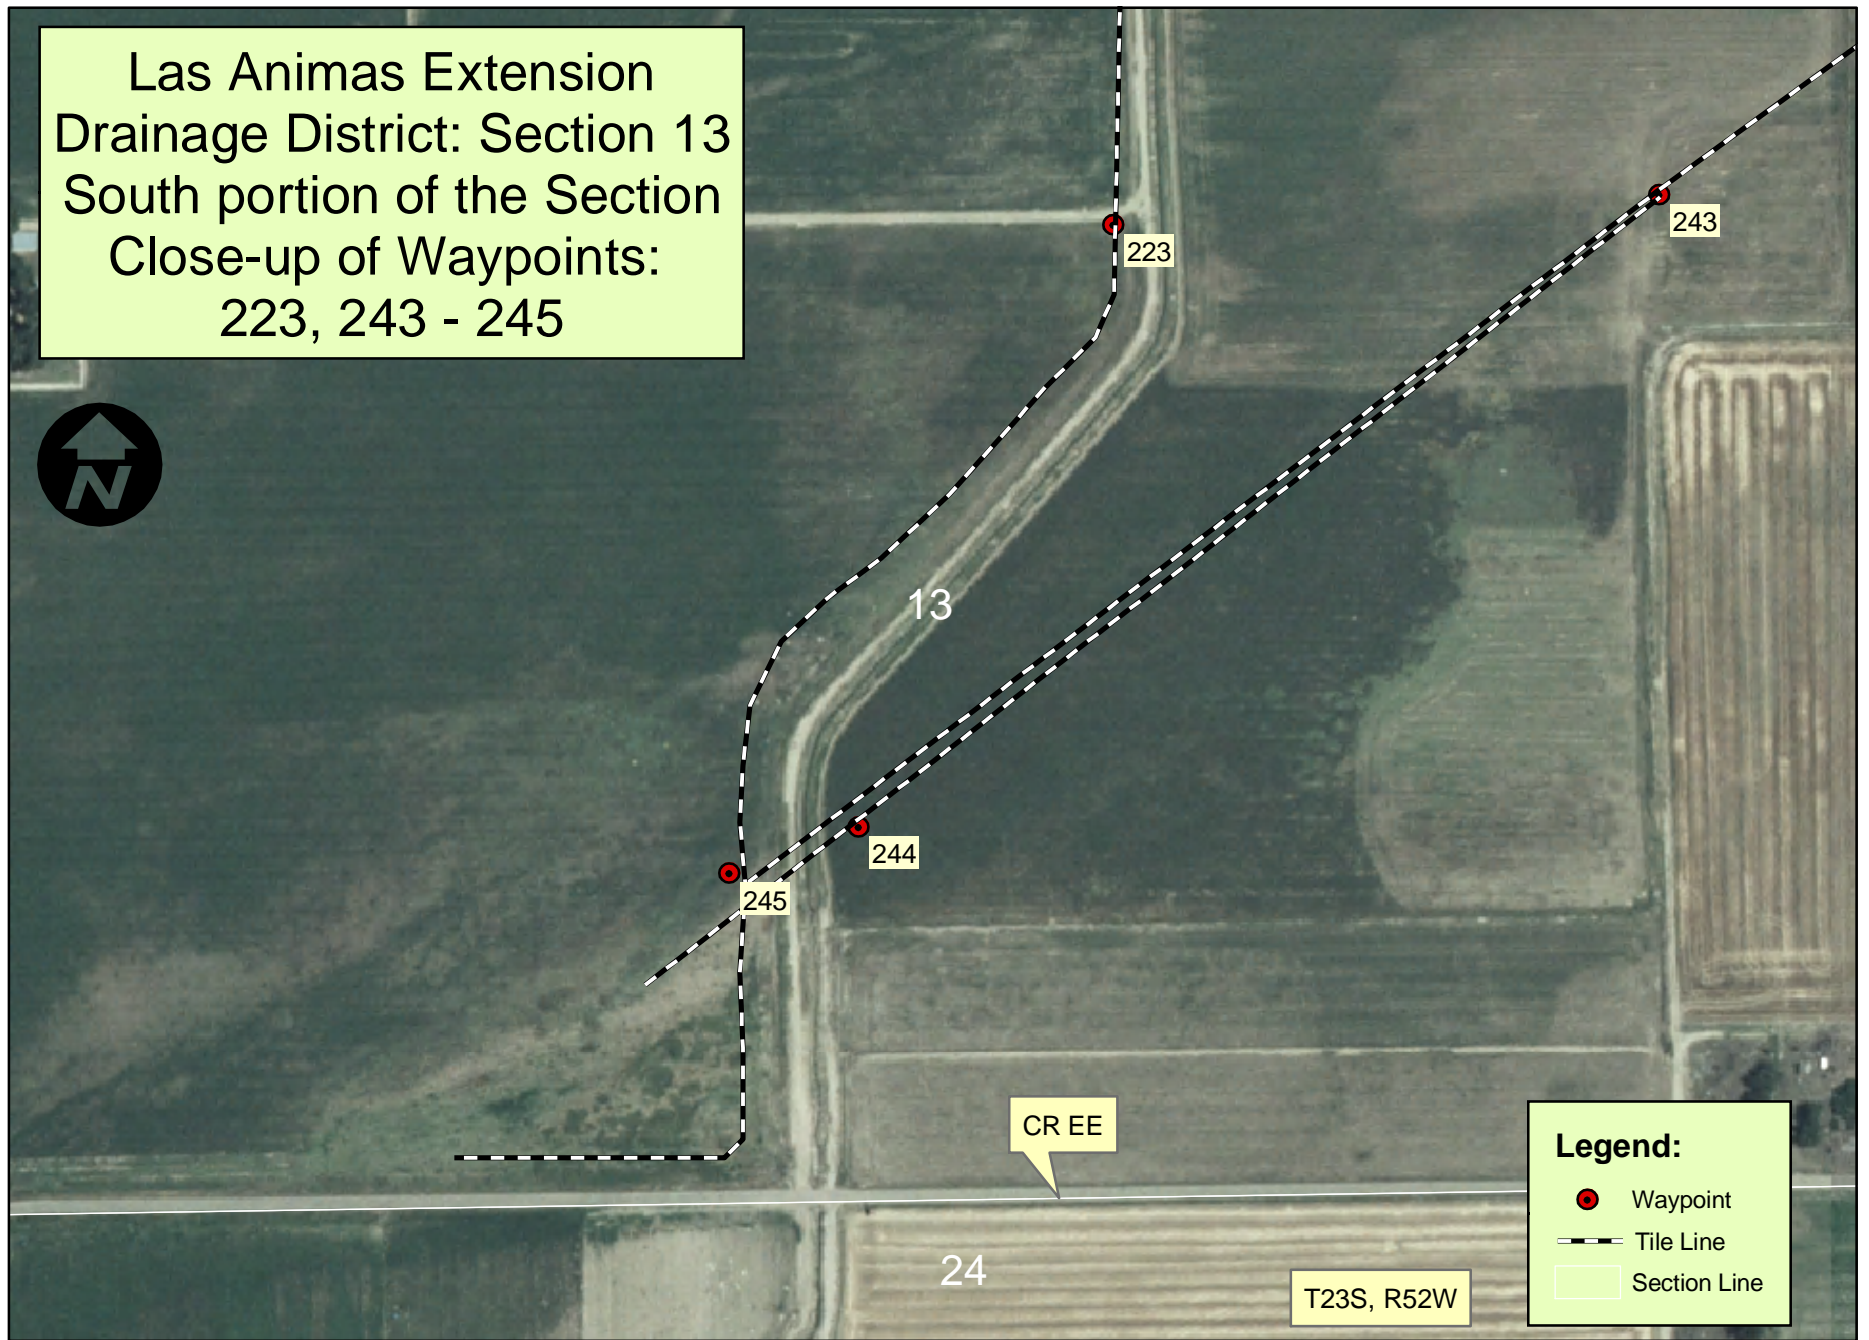
Las Animas Extension
Drainage District: Section 13
South portion of the Section
Close-up of Waypoints:
223, 243 - 245

An 8” black plastic line that was chiseled in. Line goes north-south at this point. Crosses under field road at this point. Point taken at south side of field road. This is in the SE ¼ of Section 13, T23S, R52W.

This waypoint is located directly over an old line going southwest. There are two lines here, side-by-side. Mr. Gardner installed one a while ago, right beside the old one, perhaps 6 ft or so apart. The two lines run parallel to each other, with the newer line being black plastic.

Black plastic drainage tube ends at this location.

This is a rough estimate – within 50 ft or so – of the location of the upper end of the clay tile – the original tile ends here. The area near this point is wet. Mr. Gardner indicates that the old clay tile just “falls apart” sometimes when you dig it up. He says he put in black plastic, but that it plugged up after a year of operation or so. It is not thought that “rooting out”, or attempting to clean out the old tiles will work. He is more inclined to put in new clay tile. In the notes we have outlined several "salty" or wet areas.

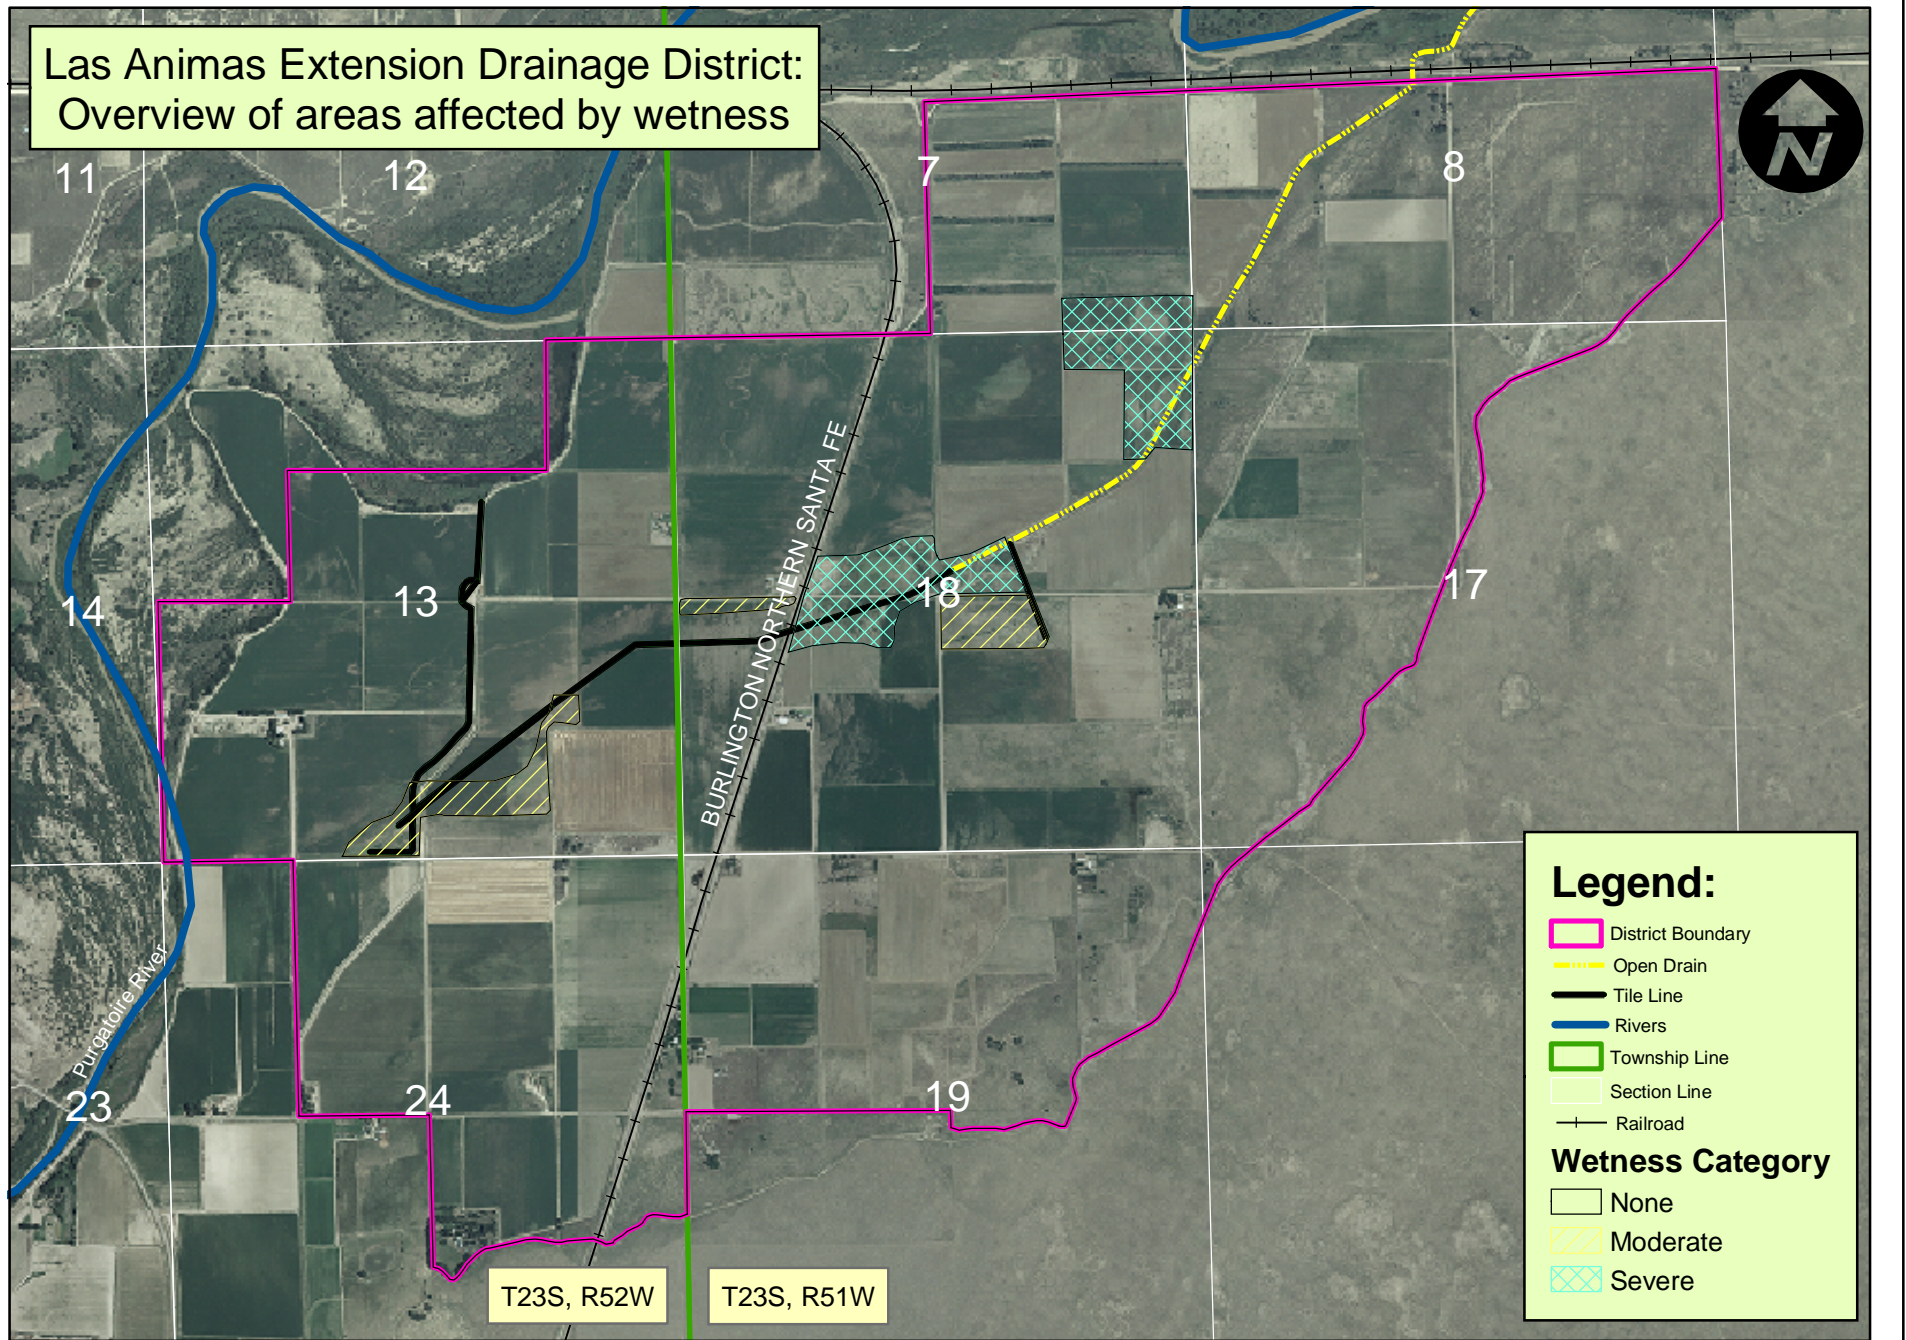
Las Animas Extension Drainage District:
Overview of areas affected by wetness

There are areas that are too wet to farm. See the "wet/salty" areas shapefile, or map. They are put in grass because they are too wet to farm.

Not affected by wetness: 2,367.53 acres

Areas of Moderate effect: 38.37 acres

Areas of Severe effect: 71.20 acres
