*Lubers Drainage District
Drainage System Inventory*

July 14, 2005, Rev.-July 18, 2007

Prepared by: Dean and Doug Smartt, Walter Epley
The Lower Arkansas Valley Drainage System Rehabilitation Study
Colorado State Univ., Dr. John Wilkins-Wells, Sociology Water Lab
Clark Building B258, Fort Collins, CO 80523 Ph: 970-491-5635

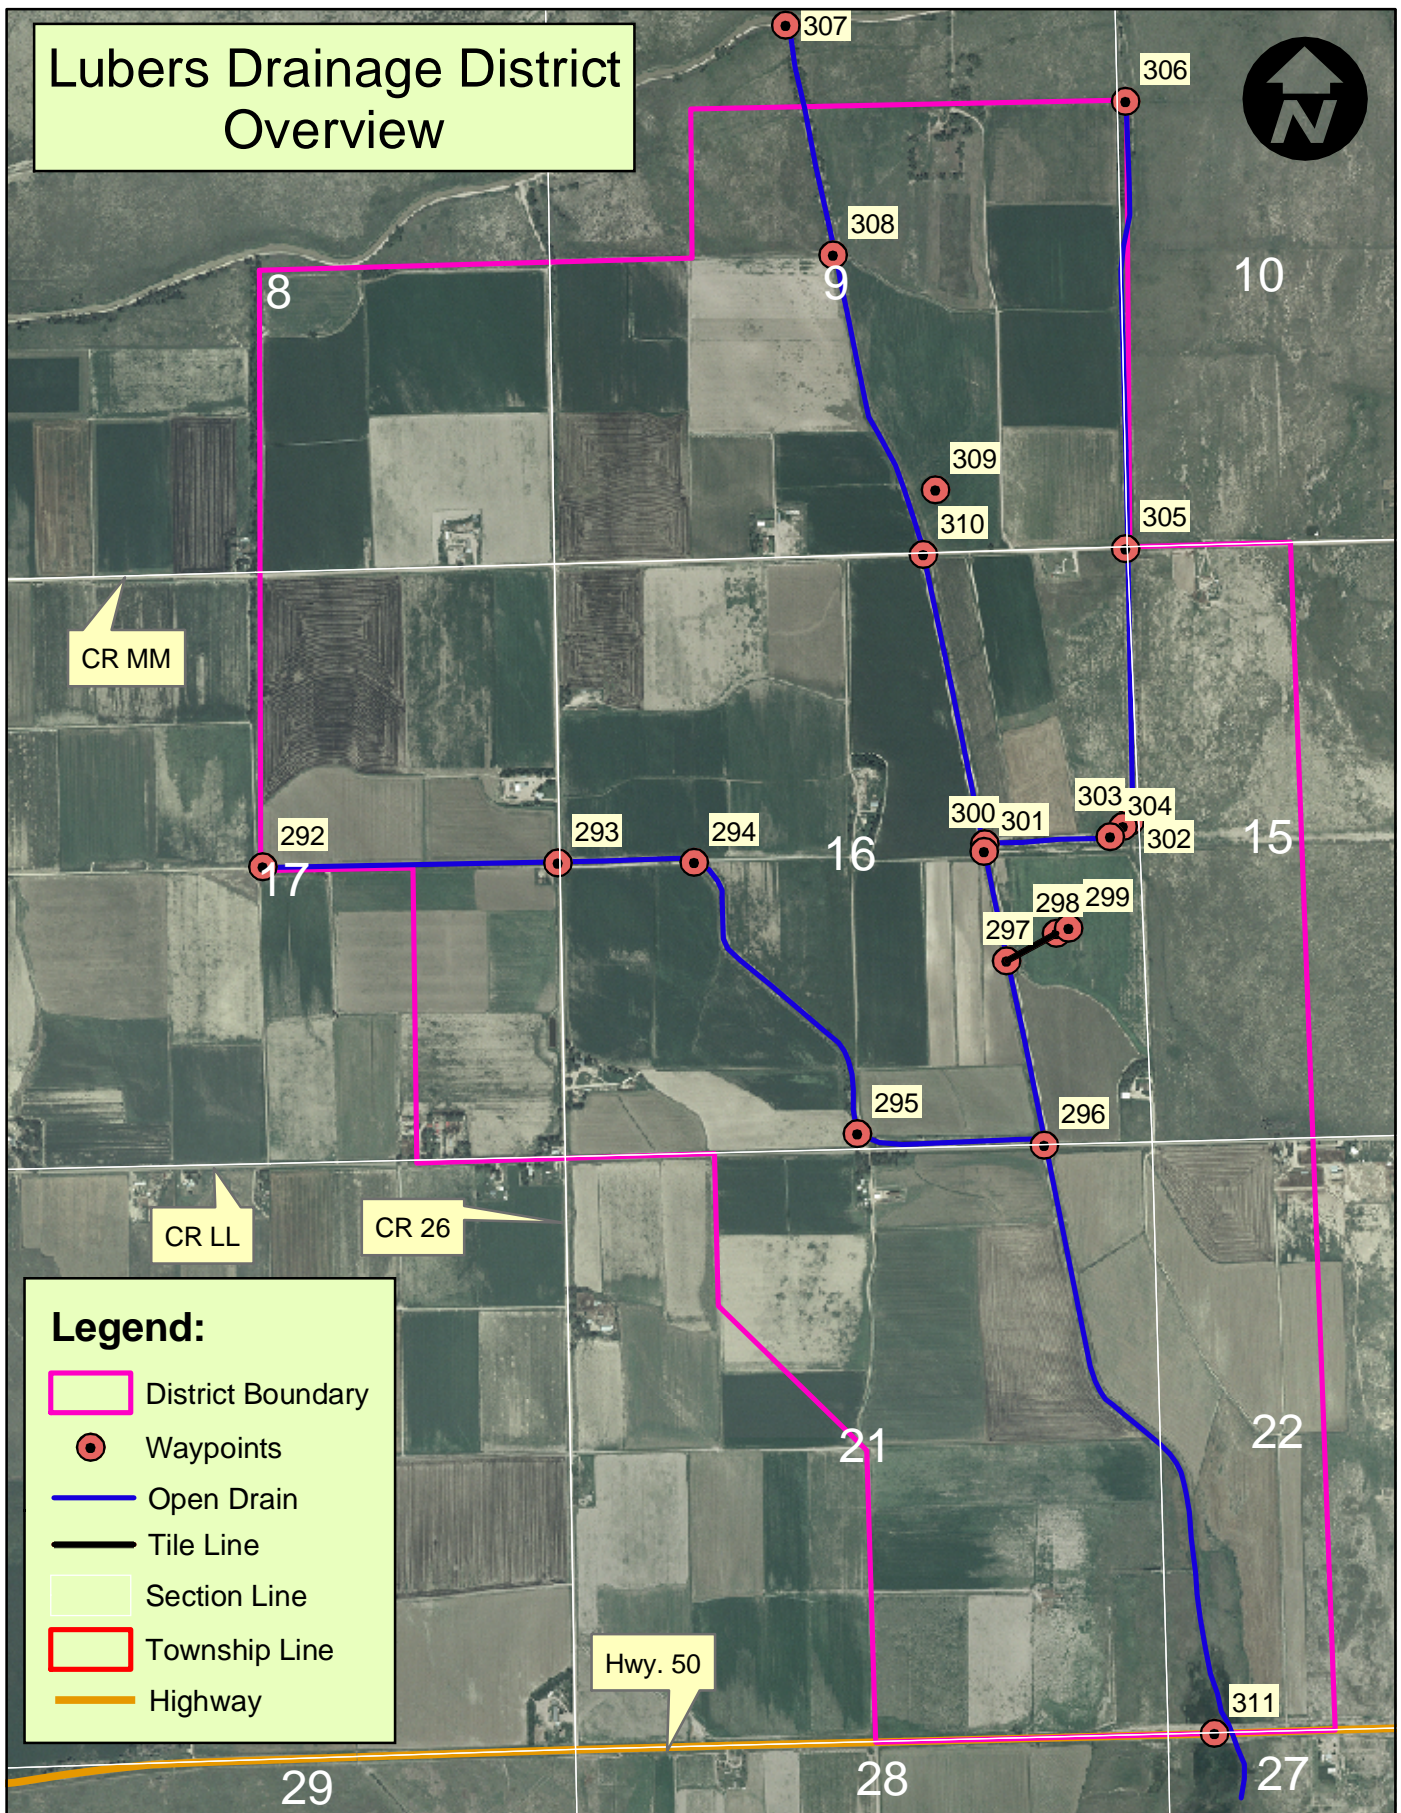
Lubers Drainage District Overview

1. The district maintains the open ditch coming down from the Fort Lyon Canal through its center. There is also a spur that begins in the southeast corner of section 16, and runs to the north and west to the middle of section 17. One tile line is known to be present. It is possible there are other tile lines in the district, but the exact location is not known. The included maps show the known details of that tile line, as well as a separate map showing tile lines indicated in archive files of the NRCS.

2. On the whole the drainage infrastructure is adequate. Maintenance requirements include the frequent cleaning of the open drains. It is thought that the one tile line present is not functioning adequately. Perhaps this needs cleaning. An additional 2000 + feet of tile line draining the area where Section 16 and 15 meet might be helpful if feasible, practical or beneficial to install.

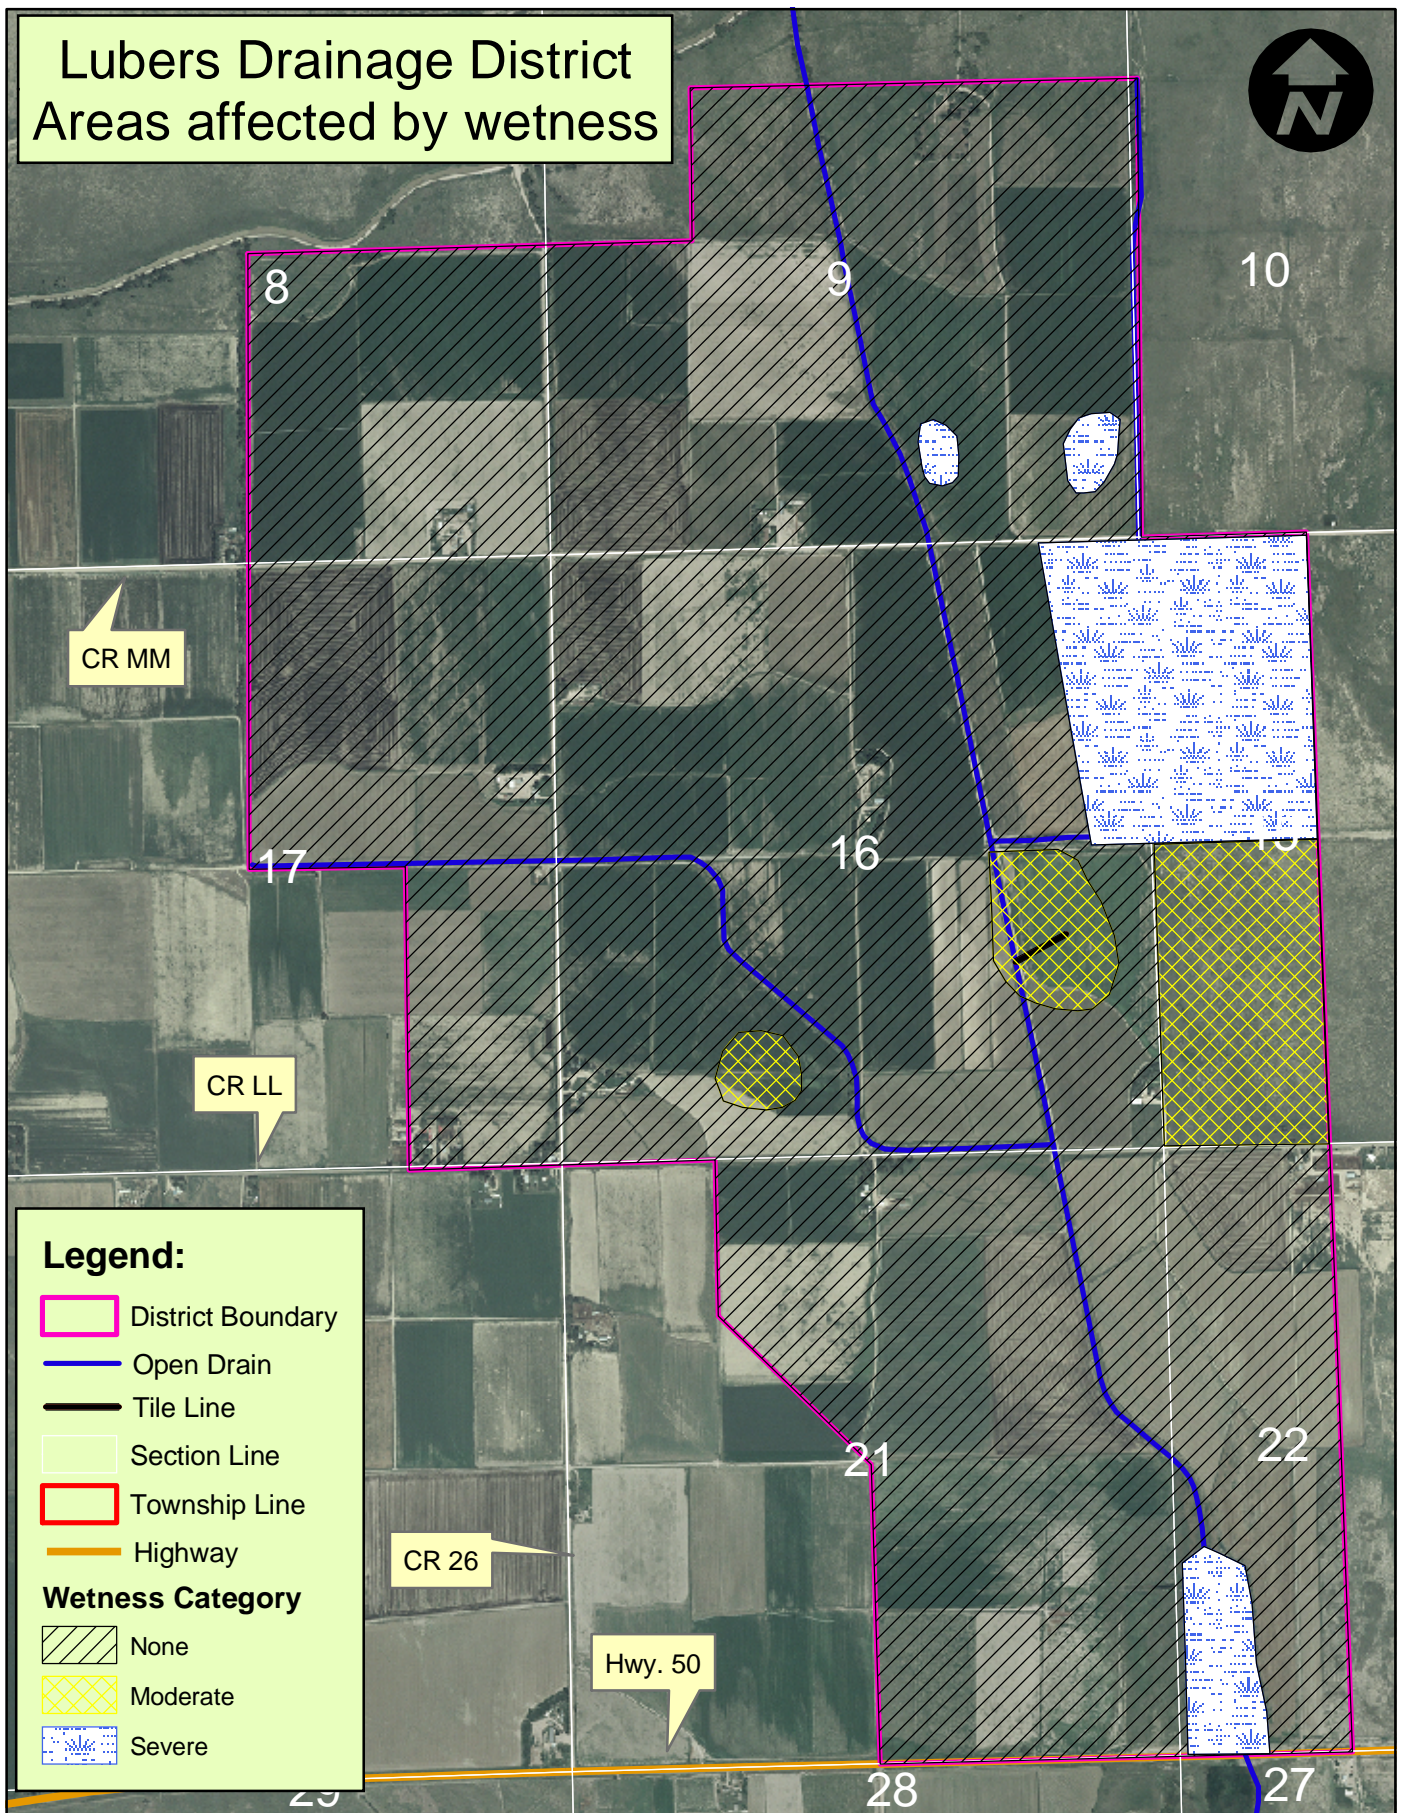
Lubers Drainage District Areas affected by wetness

Areas of no wetness effect:	1909.80 Acres
Areas of moderate wetness effect:	124.56 Acres
Areas of severe wetness effect:	165.07 Acres
