**Final Report**

**Water Supply Reserve Account Grant:**

**Repairing Grand Mesa Reservoir #6 - Lining Outlet Pipe**

**November 13, 2012**

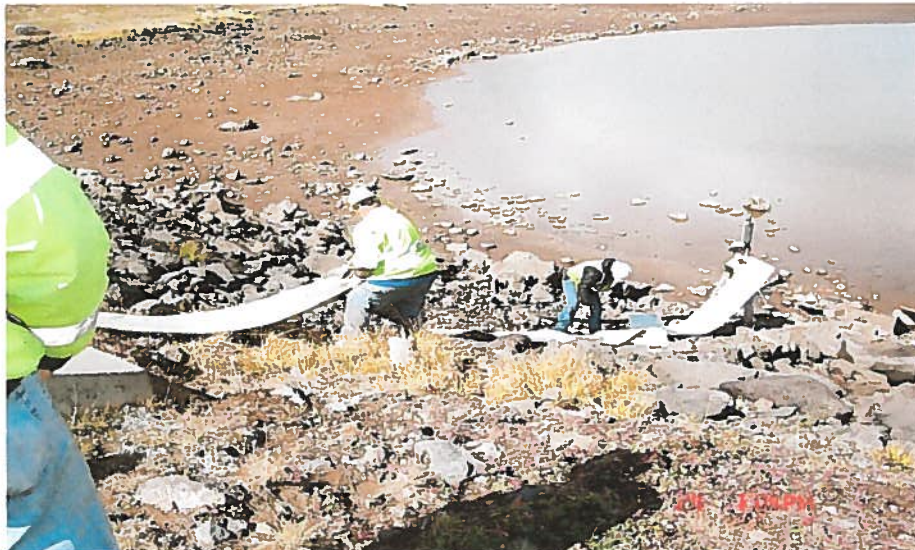
Figure 1 Workers laying out the liner along the inner face of the dam

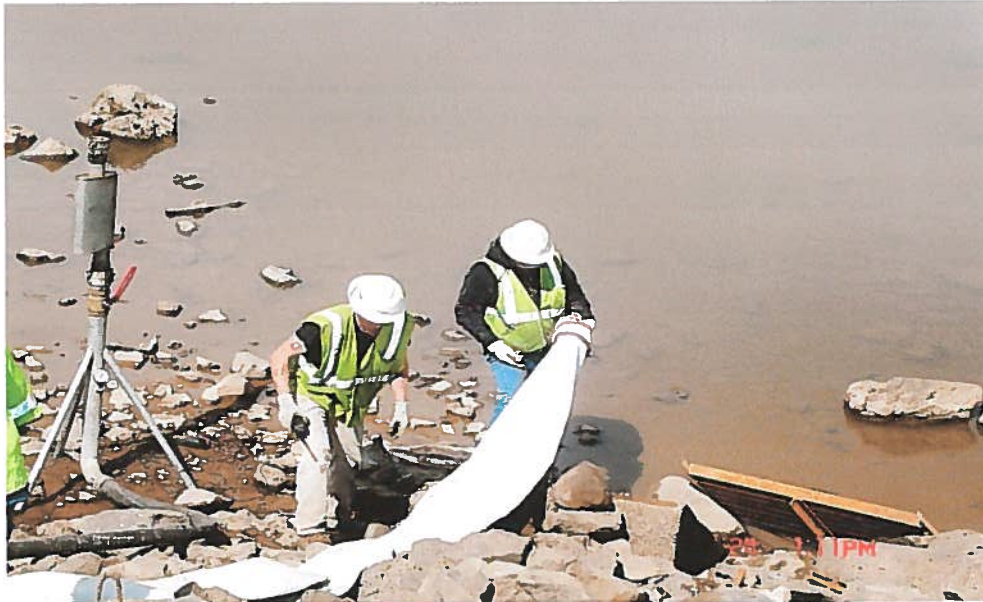
**Figure 2** Wrapping a rope around the end of the heavy liner before using the rope to carefully pull the liner through the steel pipe to the exit on the outside of the dam.

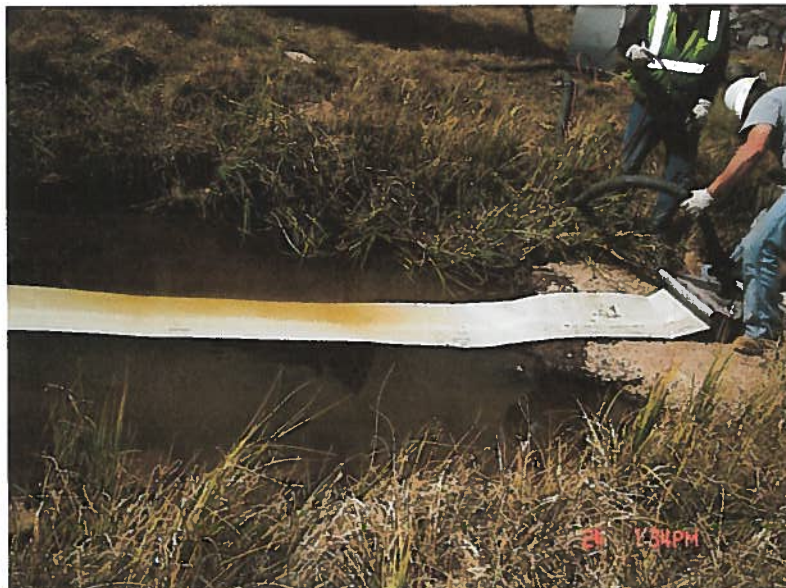
**Figure 3** Inner liner going through the rollers. The 2 ½ inch air hose is visible on the far right in the hand of one of the workmen.

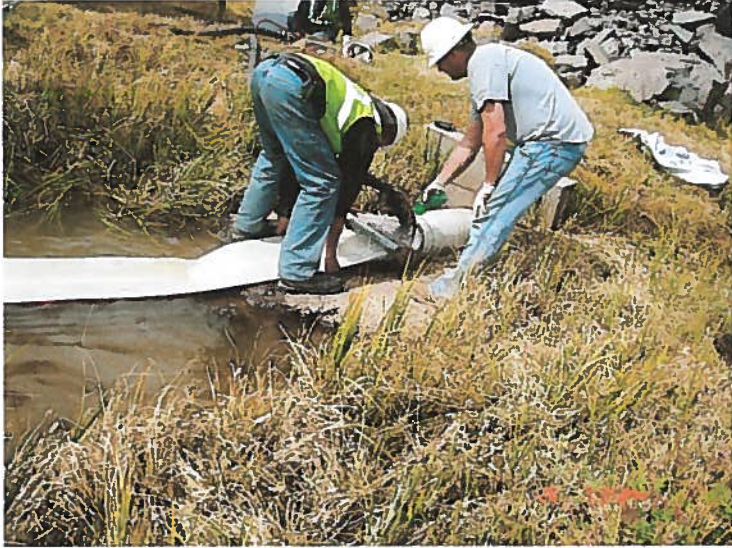
Figure 4 Checking the alignment of the liner feeding through the rollers.

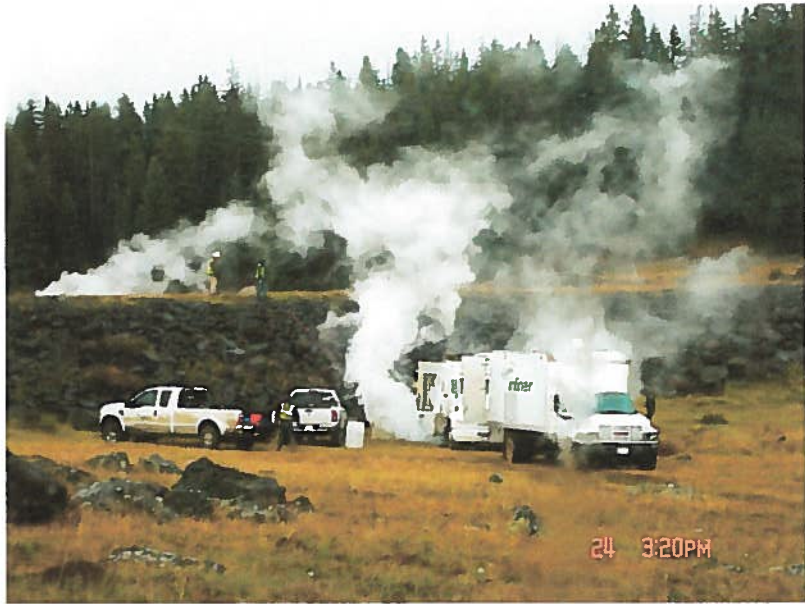
Figure 5 Steam being generated by the trucks.

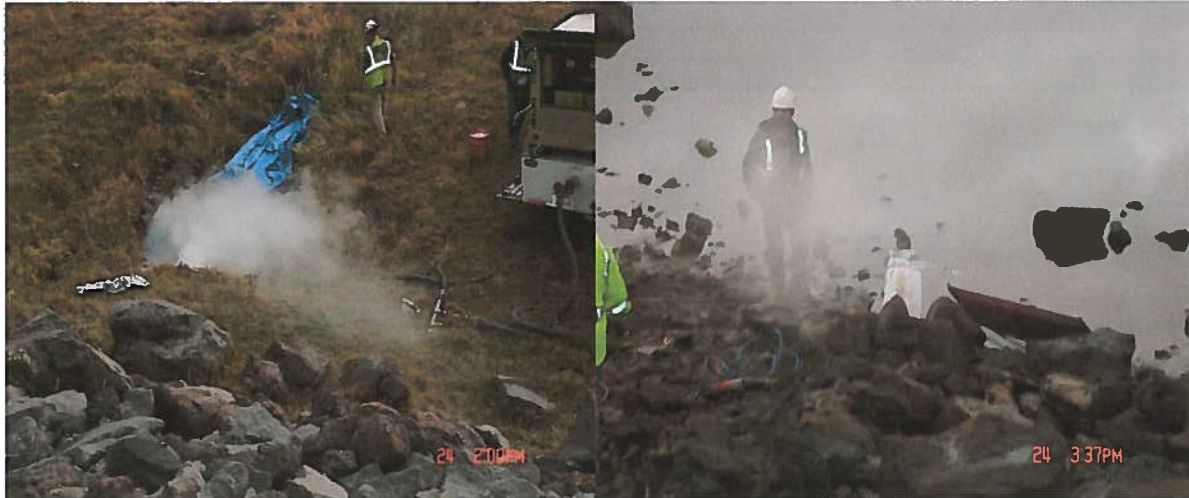
**Figure 6 & 7** Steam showing at both ends of the outlet pipe.

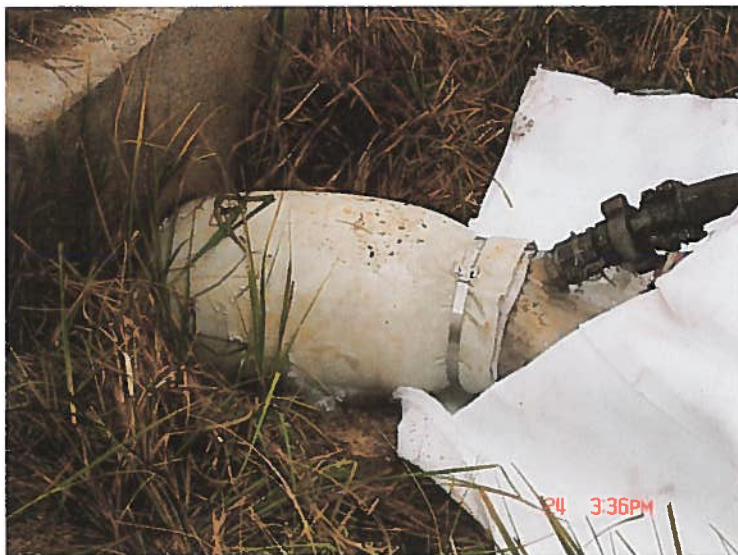
**Figure 8** Close up view of the apparatus used to cure the CIPP. Both the inner and outer liner layers used to make the CIPP are visible.

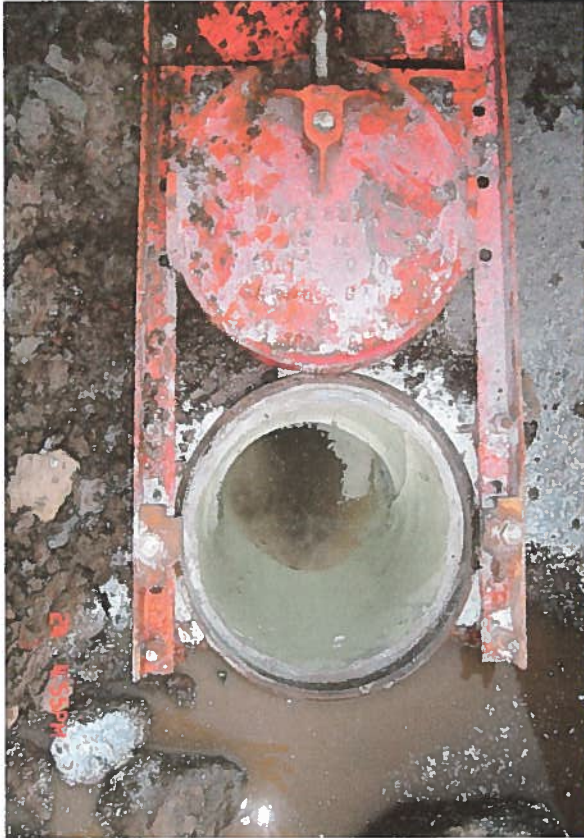
**Figure 9** Water-tight seal at the slide gate.

Once the liner has been treated with steam long enough to form the cured-in-place pipe, the pipe is allowed to cool. It is then cut to finish and both ends of the new CIPP outlet pipe are attached to the old steel one. The exhaust manifold on the inside of the dam is removed close to the slide gate with a grinder. The CIPP is glued to the old pipe with epoxy to form a water-tight seal, Figure 9. The excess CIPP at the exit end of the outlet is removed with a saws all and clamped to the metal pipe, Figure 10.

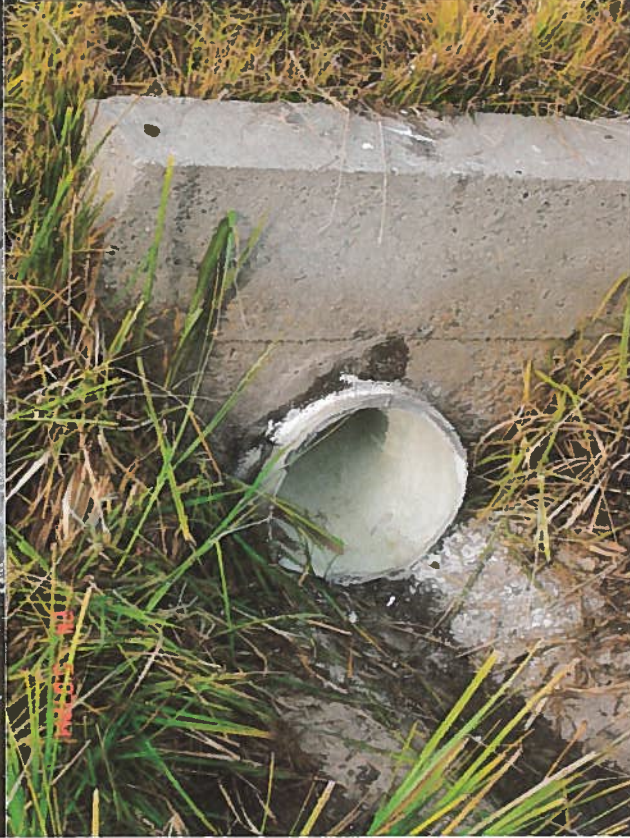
**Figure 10** Finished CIPP at the outlet of the reservoir.
