## BEAVER PARK DAM DAM ID: 200102 ALTERNATIVES REPORT

RIO GRANDE COUNTY, COLORADO  
WATER DIVISION 3  
WATER DISTRICT 10

March 5, 2012

### ALTERNATIVES REPORT

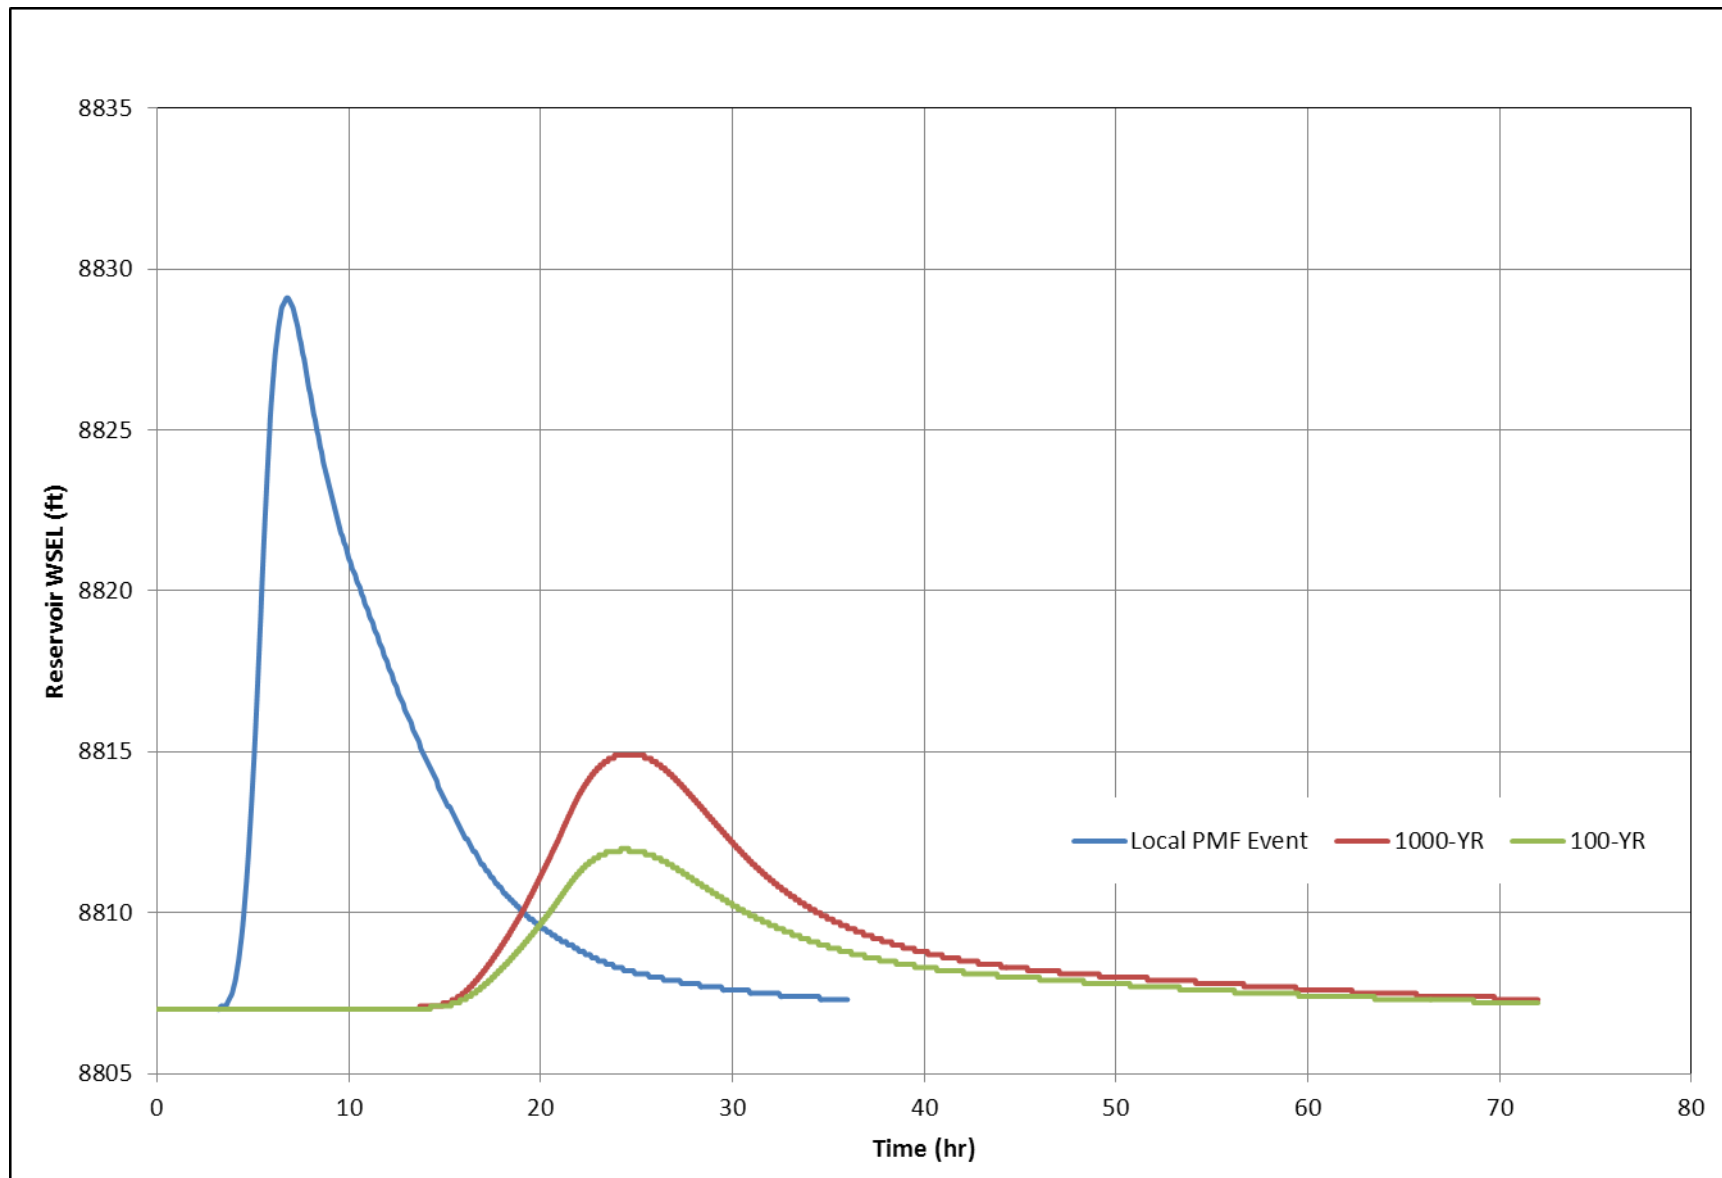
**Figure 3-1 Reservoir Water Surface versus Time for the 100-year, 1,000-year and Local PMF Events**

The results of the routing of the various storm events, it was determined that the dam would not be overtopped during the controlling PMF (local) event. The resulting reservoir water surface versus time relationships for the 100 year, 1,000 year and local PMF events are shown on Figure 3-1.

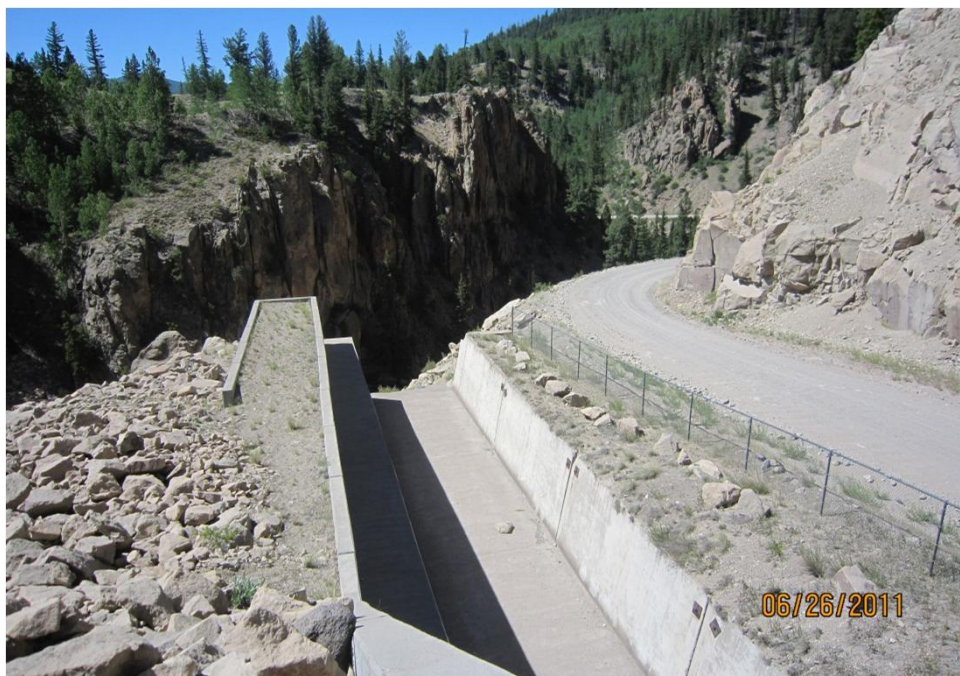
Photograph No. 2 View from the right abutment looking downstream along the primary spillway chute.

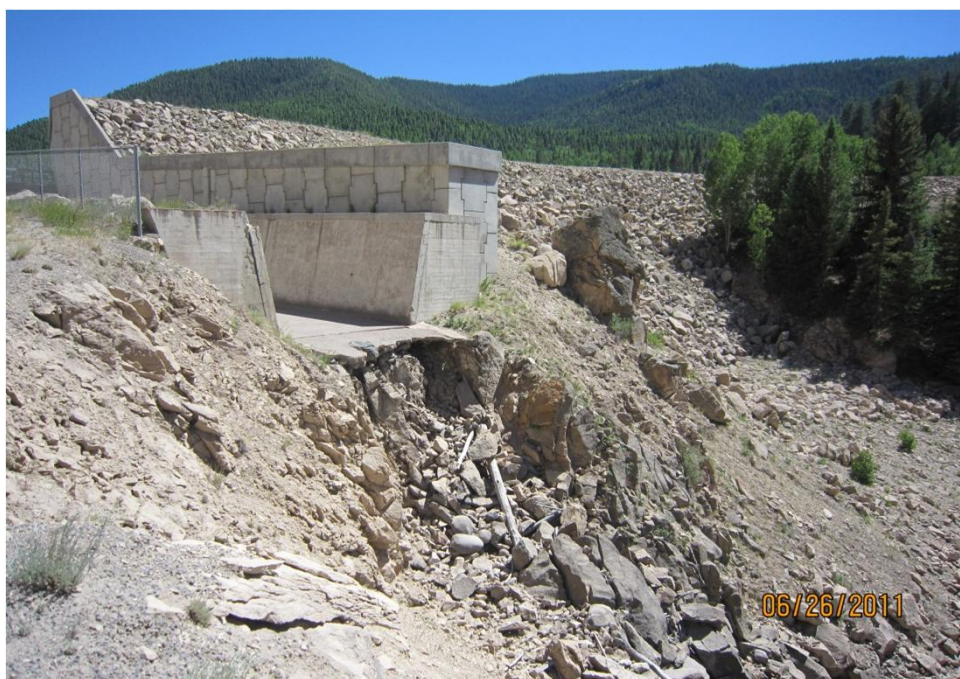
Photograph No. 3 View from the access road looking upstream at the downstream end of the primary spillway chute.

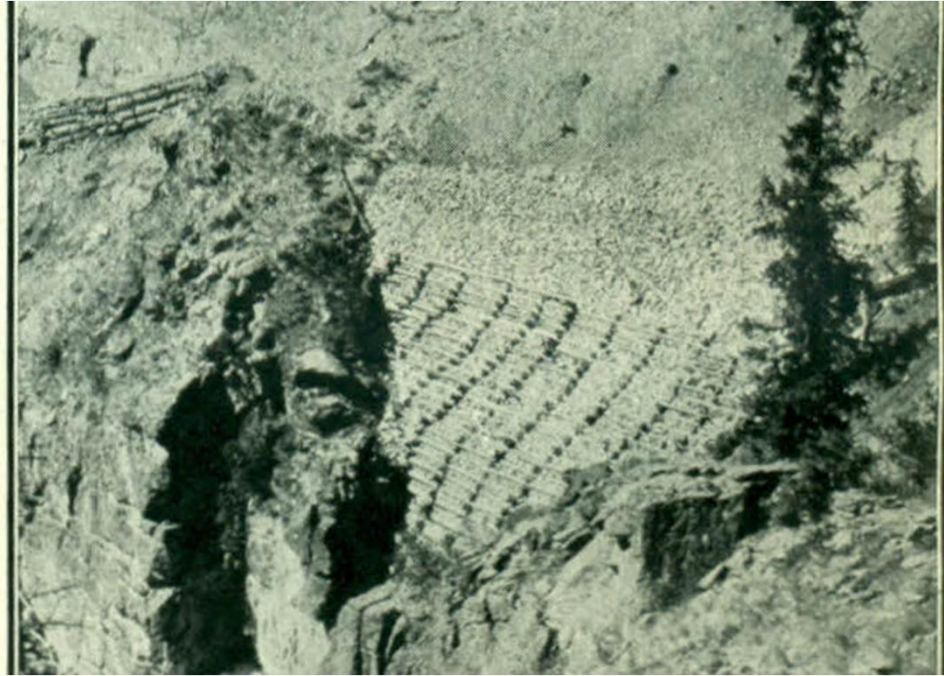
Photograph No. 6 View of downstream slope cribbing. Cribbing was constructed between 1915 and 1916. Cribbing is not visible today.

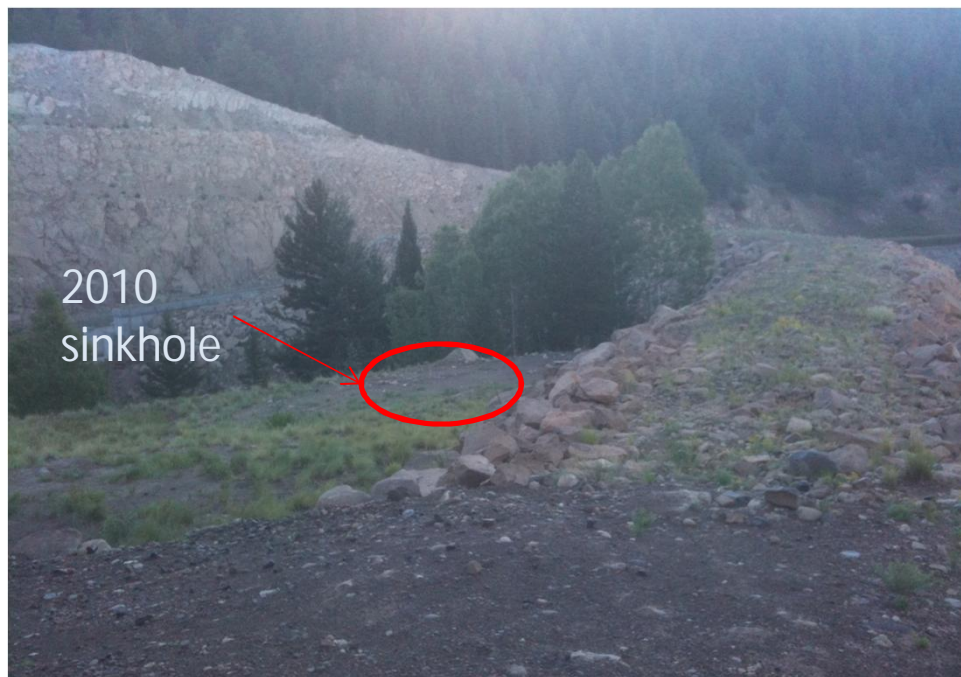
Photograph No. 7 View from the left abutment looking right toward the right abutment and primary spillway along the crest dike. Note approximate location of 2010 sinkhole.

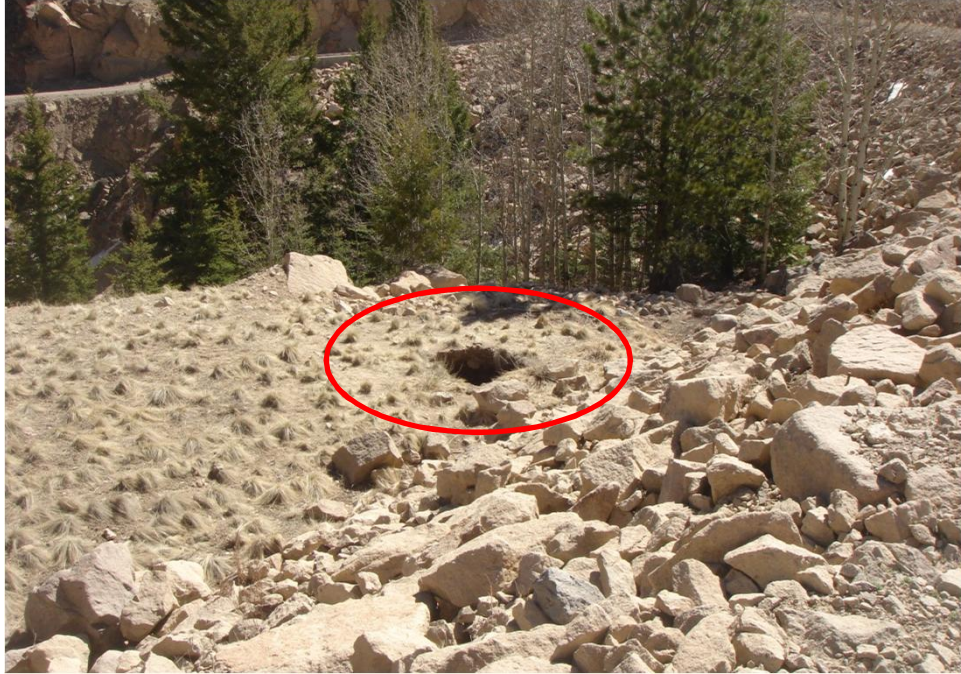
In 2010, the SEO observed a sinkhole in the downstream left abutment area and imposed a 20-foot restriction on the reservoir elevation, as noted earlier in this report.

Photograph No. 8 View from crest dike looking downstream at the 2010 sinkhole.
