FEASIBILITY STUDY

SANCHEZ RESERVOIR  
OUTLET REHABILITATION PLAN

PROJECT NO. 11.028  
JULY 2012

**FEASIBILITY STUDY**  
**FOR**  
**OUTLET REHABILITATION PLAN**  
**AT**  
**SANCHEZ RESERVOIR**

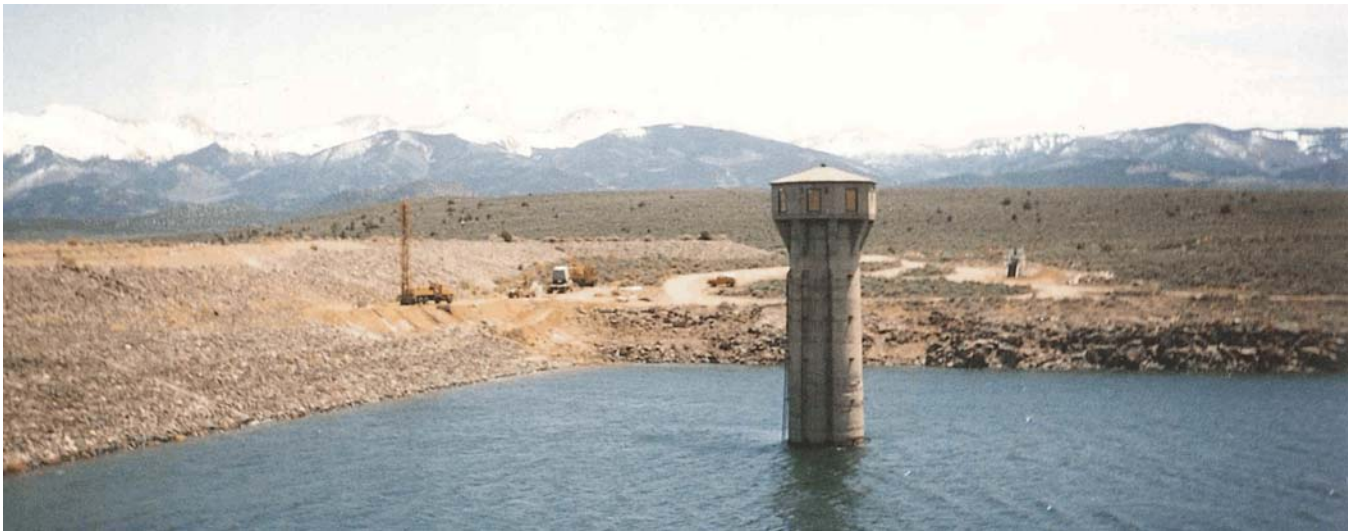
PHOTOGRAPH 1 - TOWER

The exterior of the gate tower was coated by the SDRC in 1993. This coating has generally debonded and peeled off the tower and does not appear to have reduced the deterioration of the concrete. This can be seen in Photographs 2. The tower deterioration needs to be addressed to ensure the structural integrity of the tower is maintained over the next 75 years.

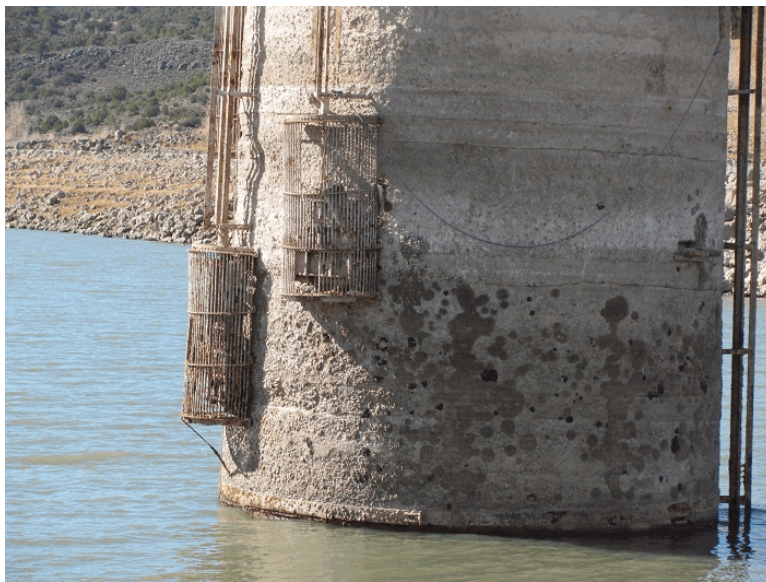
**PHOTOGRAPH 2 - OUTLET TOWER DETERIORATION**

The main area of concern is for the deterioration and damage on the exterior of the tower. The tower has experienced light to severe deterioration of the concrete, especially in the zone of water level fluctuations. This can be seen in Photograph 2. Some of the spalling appears to as deep as several inches and is due to the freezing of water in the concrete. This appears to be combined with the "pop out" of large aggregate in the mix that most likely is not bonded well by the cement.

The concrete surface has spalled due to moisture intrusion and freeze thaw. The concrete in the tower would not be air entrained, based on the date of construction. Concrete without air entrainment is highly susceptible to freeze-thaw action and the deterioration noted would not be unexpected. Also, the quality and quantity of the cement used would not be expected to be high thus the strength would not be expected to be very high. Cores were not removed from the tower itself but cores of the concrete were taken from the outlet conduit as shown in Photograph 4. Based on these cores, we have ascertained the strength of the concrete is generally expected to be less than 2,500 psi. The cement to aggregate bond of the concrete in the cores was not good and damage due to freeze-thaw would be expected.

The design of concrete mixtures today to withstand the level of freeze-thaw action the tower experiences is still a challenge. The use of air entraining agents and the minimum strength requirement of 4,500 psi is the norm today. The low quality of the concrete mix on the tower can not be expected to adequately resist deterioration under the conditions to which it is subjected.

The only way to eliminate or reduce future the spalling and deterioration is to minimize the water penetration into the concrete. Since the concrete does not have air voids that allow for expansion of the moisture as it freezes, the moisture has to be minimized as much as possible. The complete elimination of moisture penetration is not possible and thus future maintenance of the tower can be expected. The goal would be to use a protective system that minimizes the deterioration to an acceptable level and extends to life of the tower.

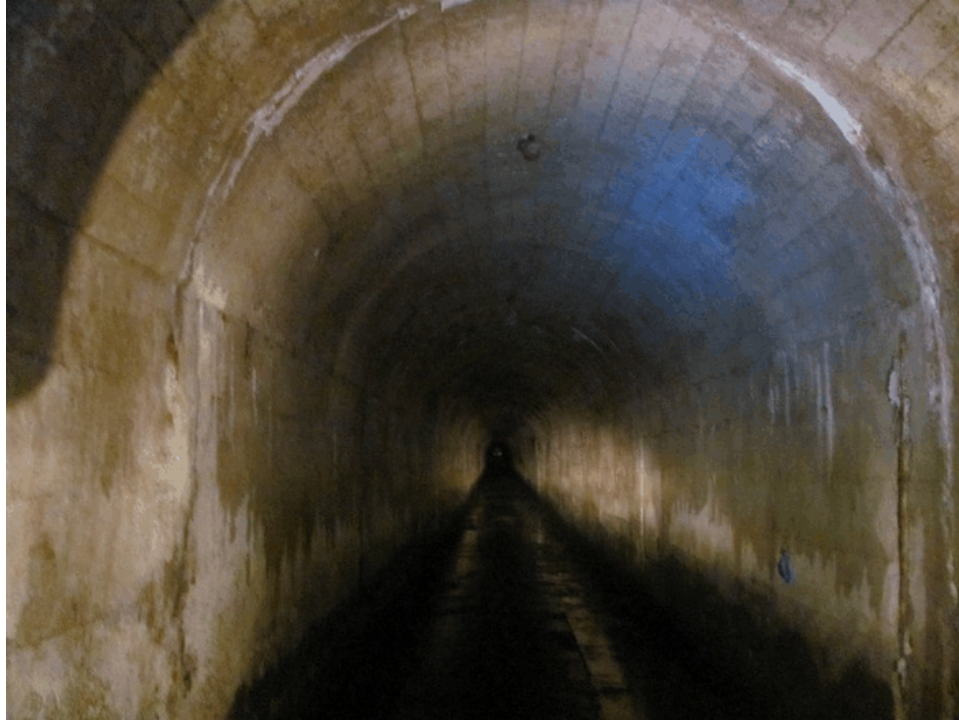
PHOTOGRAPH 3 - OUTLET CONDUIT

The outlet conduit was inspected visually by Duane Smith, P.E. of SGE on November 1, 2011. Photograph 3 shows the general condition and shape of the conduit.

This is believed to be due to the poor quality of the concrete and also due to the unbonded cementitious material in the concrete.

Based these cores, we have ascertained the strength of the concrete is generally expected to be less than 2,500 psi. Based on our visual inspection of the cores, we have determined the cementitious portion contained a significant percentage of non-pozzolanic material that did not hydrate. A large amount of loose powdery type non-hydrated residue was found throughout the cores. This material appears to inhibit bonding of the cement-aggregate mixture. There is visual evidence that the aggregate was most likely dirty which inhibits bonding and decreases the strength. The aggregate gradation and distribution was also poor and not uniform and appears to be gap graded.

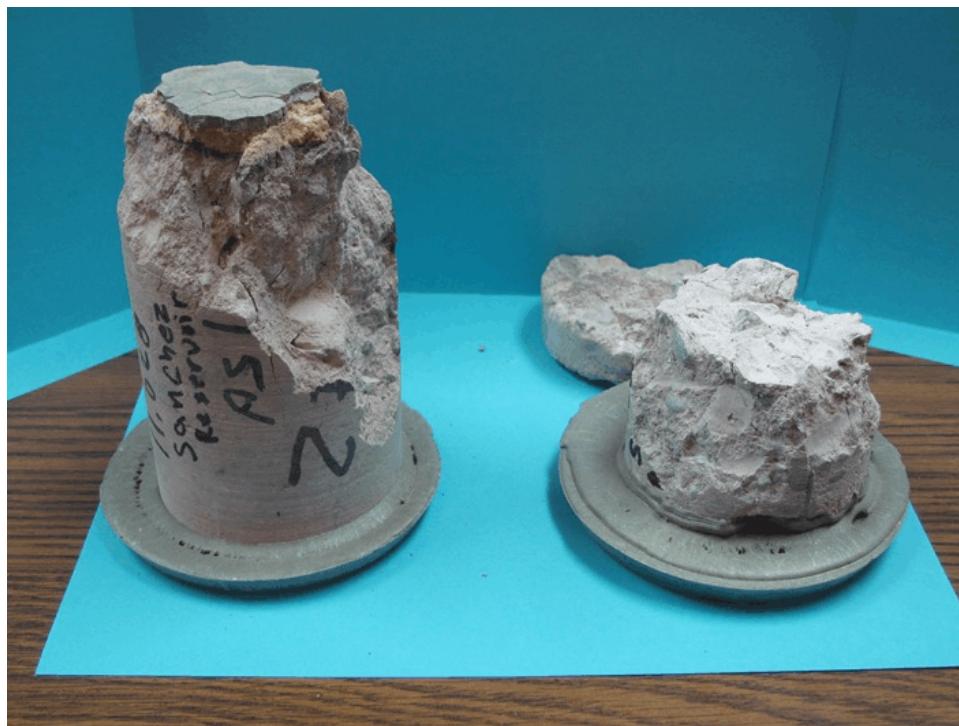
PHOTOGRAPH 4 - OUTLET CONDUIT CORES

Two 3 inch diameter cores were removed from the conduit and subsequently tested for compressive strength. The strength of the two core shown in Photograph 4 were 1,244 psi and 2,212 psi. Note the debonding of the aggregate in the core on the right, which was the higher strength core.

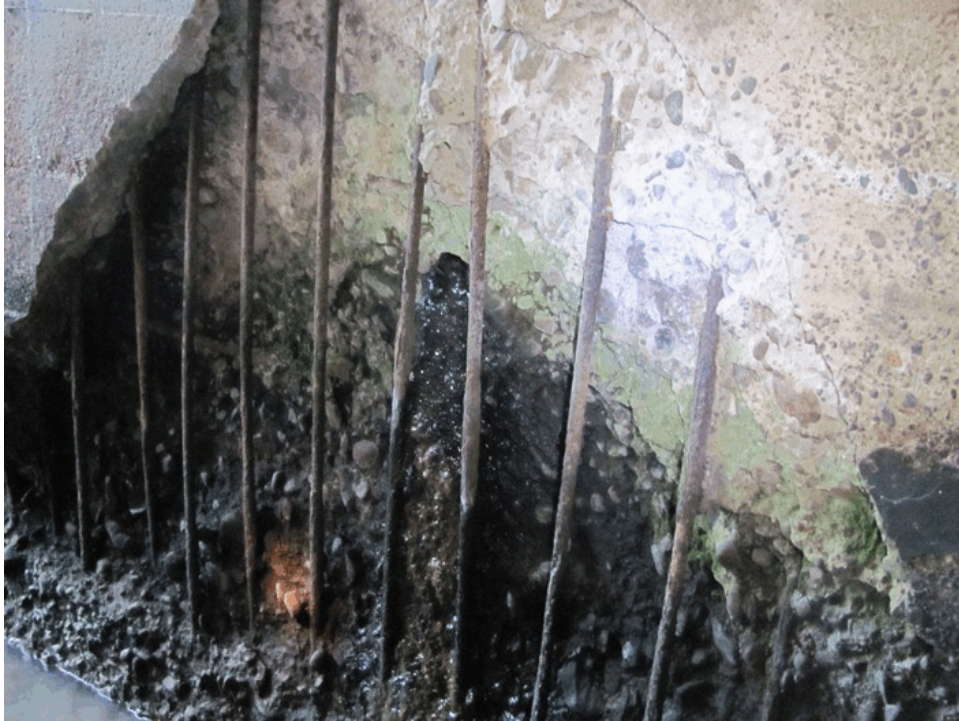
PHOTOGRAPH 5 - CONCRETE EROSION

The outlet conduit on the downstream end, where freeze thaw has taken place, has deteriorated significantly and eroded. Photograph 5 shows the erosion of the concrete that has resulted. Most of the outlet conduit walls and roof, as can be seen in Photograph 3, are not eroded significantly or cracked. The majority of the outlet appears to be structurally sound as no significant movement or stress cracks were noted in this inspection. This is surprising due to the size and thickness of the walls and roof section, the low strength of the concrete, and the poor reinforcing steel placement.

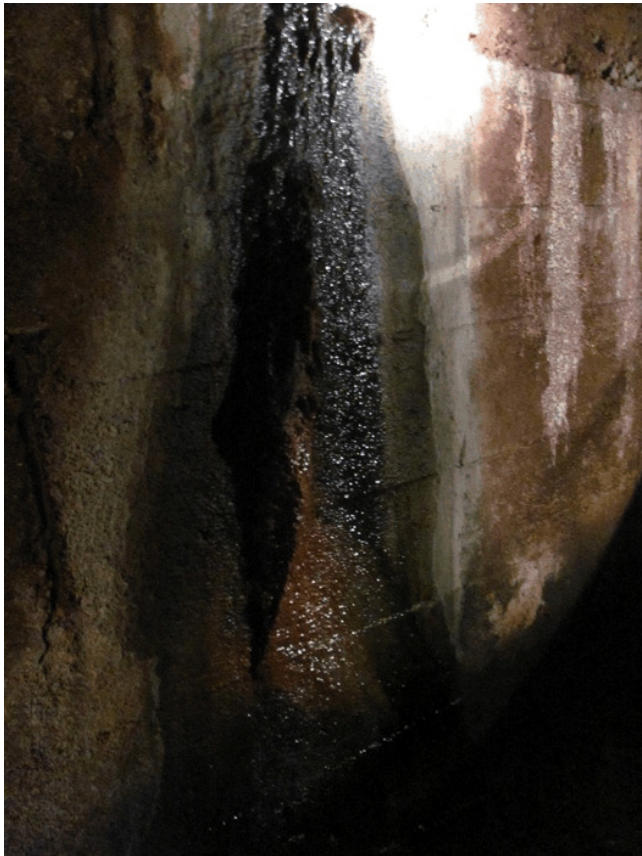
PHOTOGRAPH 6 - LEAKAGE  
AT CONSTRUCTION JOINT

Other problems noted by our inspection includes leakage at several of the construction joints, especially on the sidewalls, and reinforcing steel placement problems. Photograph 6 shows leakage at a sidewall joint and Photograph 7 shows minor staining from leakage at an overhead joint. There

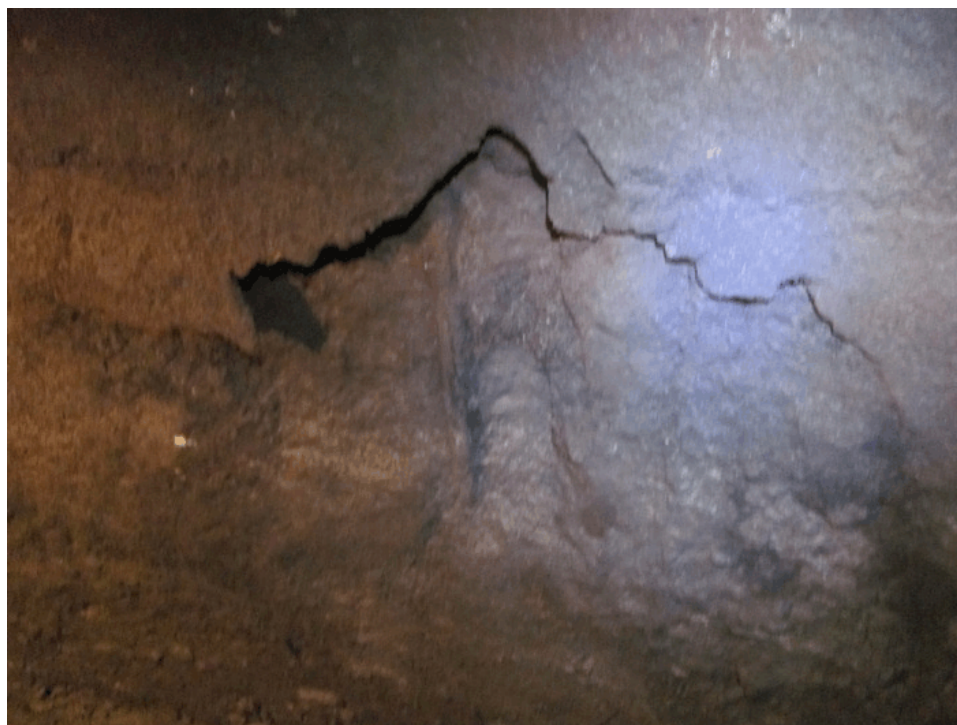
PHOTOGRAPH 8 - CONCRETE SURFACE PATCH

are several areas where the reinforcing steel does not have proper cover and is at the face of the concrete or actually exposed as in Photograph 9. Photograph 8 shows a patch which appears to have been applied during the original construction, most likely to cover the reinforcing steel where it was exposed on the face. There are many areas, especially on the lower end of the conduit, that have a surface patch that appears to have been applied to cover the reinforcing steel. It would appear shifting of the reinforcing steel during concrete placement was a major problem, at least for a portion of the project. We do not see the same type of problems on the tower.

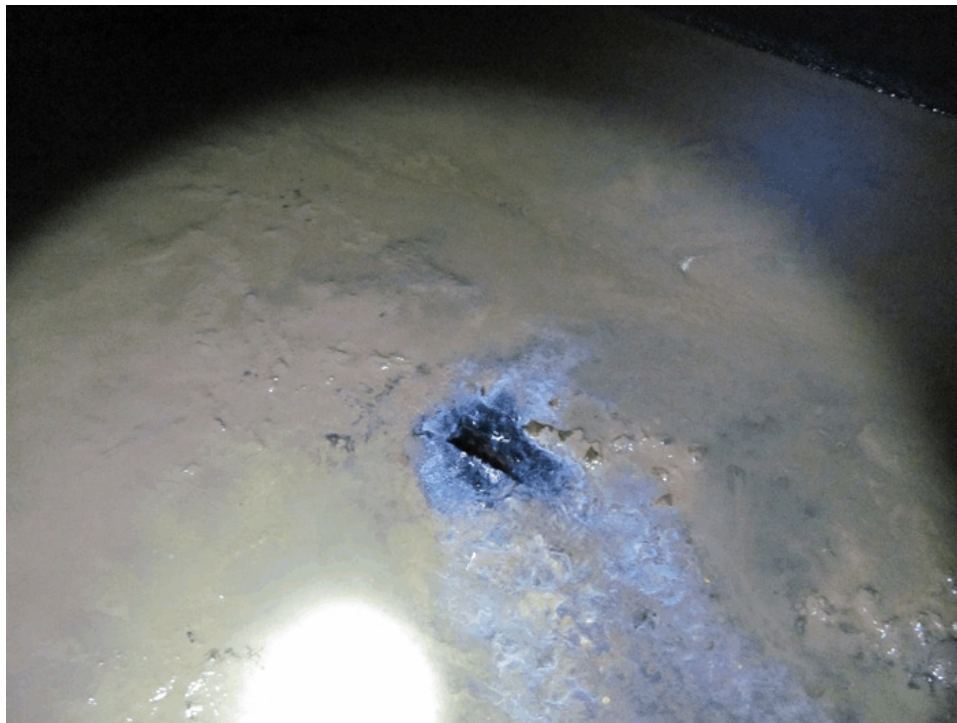
PHOTOGRAPH 10 - HOLE IN FLOOR SLAB

The floor slab is deteriorated from erosion due to discharge flows. The erosion appears to have removed from 1-inch to as much as 3-inches from the floor slab. This erosion would be expected with the low strength of the concrete and poor bonding noted in the cement-aggregate matrix. The floor does not appear to be cracked significantly and the only seepage noted in the floor is near the upstream end of the conduit as shown in Photograph 10. Clear water is discharging from the hole at an estimated rate of approximately 3 to 5 gallons per minute. We attempted to fill the hole with water plug grout and also with a polyurethane foam and were unable to plug hole long enough for it to set. There is enough pressure that we were unable to jamb the hole with rags without them being blown out.

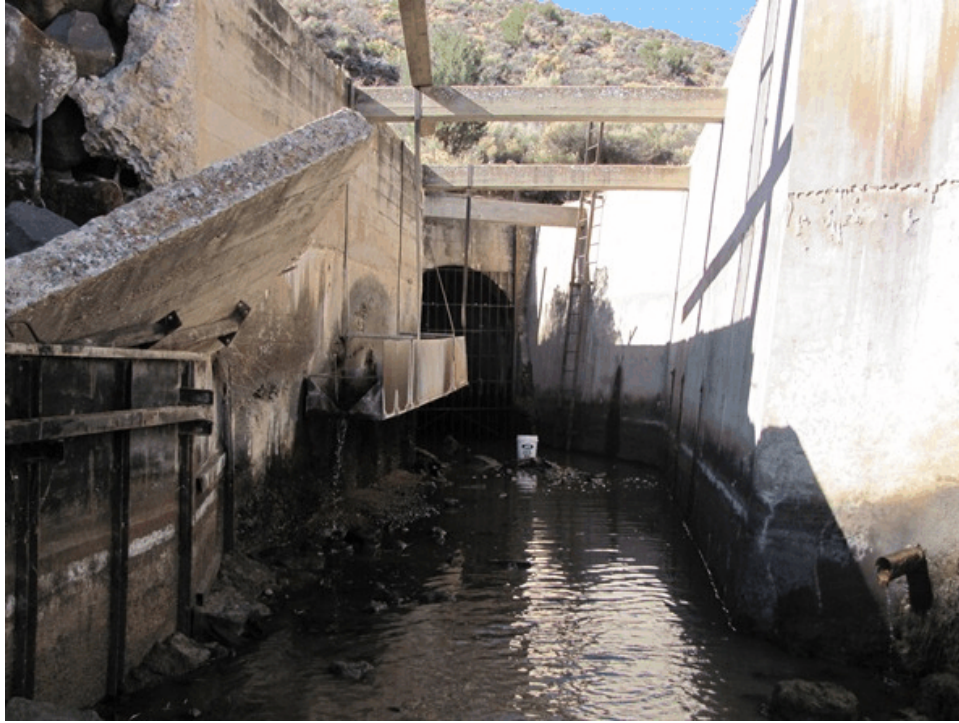
**PHOTOGRAPH 11 - OUTLET DISCHARGE STRUCTURE**

The discharge structure at the downstream end of the outlet is deteriorated and in disrepair. As can be seen on Photograph 11, a portion of the walls on the right side have major structural damage that needs to be repaired. The right side is also where seepage builds up and is collected in steel troughs from holes drilled through the walls. The floor of the structure is also eroded and needs repair.

Included in the repair option would be the removal and replacement of the deteriorated portions of the downstream outlet works structure. The right side of this structure is in disrepair and portions of the concrete walls have failed. This will increase the long term stability of the dam as measures can be added to properly collect and filter the seepage that exits into this structure as seen in Photograph 11. The repair on the structure includes excavating the area adjacent to the right side wall for the installation of a drain and filter system. The new wall will be backfilled with granular materials to intercept the seepage, collect it in the drain, and discharge

it downstream through a measuring weir for seepage monitoring. The right side wall will be demolished and replaced. Riprap, made from the rock that will be excavated, will be placed in the downstream channel to control erosion of the ditch.
