Colorado Water Conservation Board
Emergency Funding for Damaged River Diversions/Dams
from the September 2013 Flood Event

Emergency Loan Application and Feasibility Study

As-Constructed Report Louden Irrigation Canal 2013 Flood Repair

January 2014

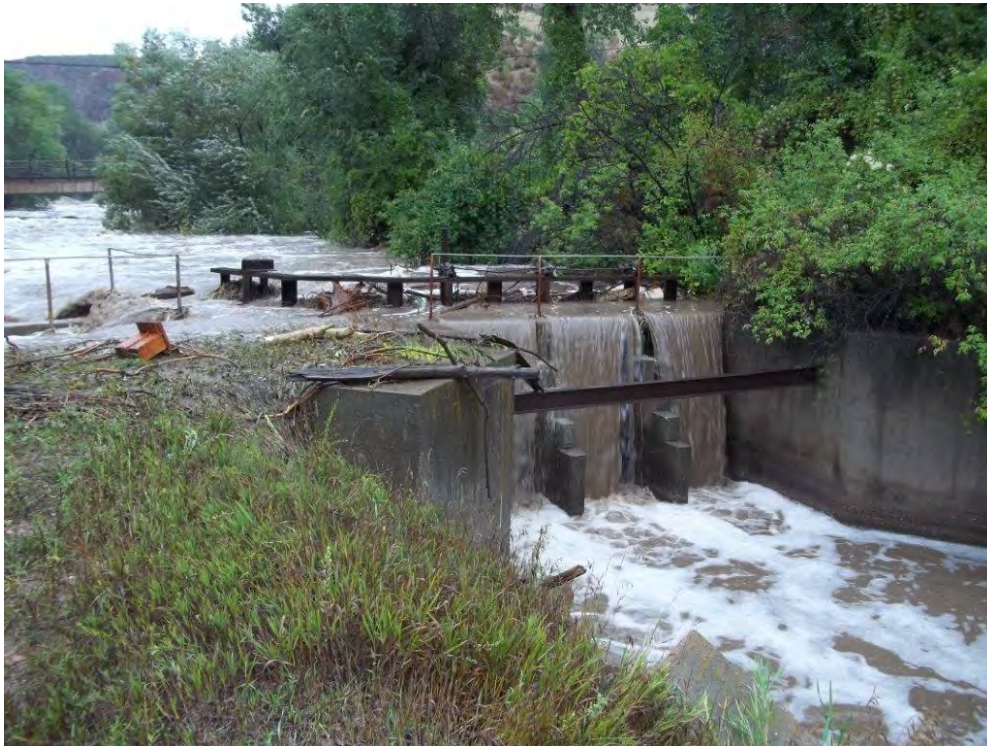
Photo 2 Headgate Start of the Flood September 12, 2013

Appendix A Photo 1 shows the pre-flood headgate, diversion, and surrounding fill. Appendix A Photo 2 was taken as the flood started when the surrounding fill was still intact. Appendix A Photo 3 was taken September 16, 2013 just after the flood water receded. Based on the inspections of the Ditch's headgate the following major damages were observed:

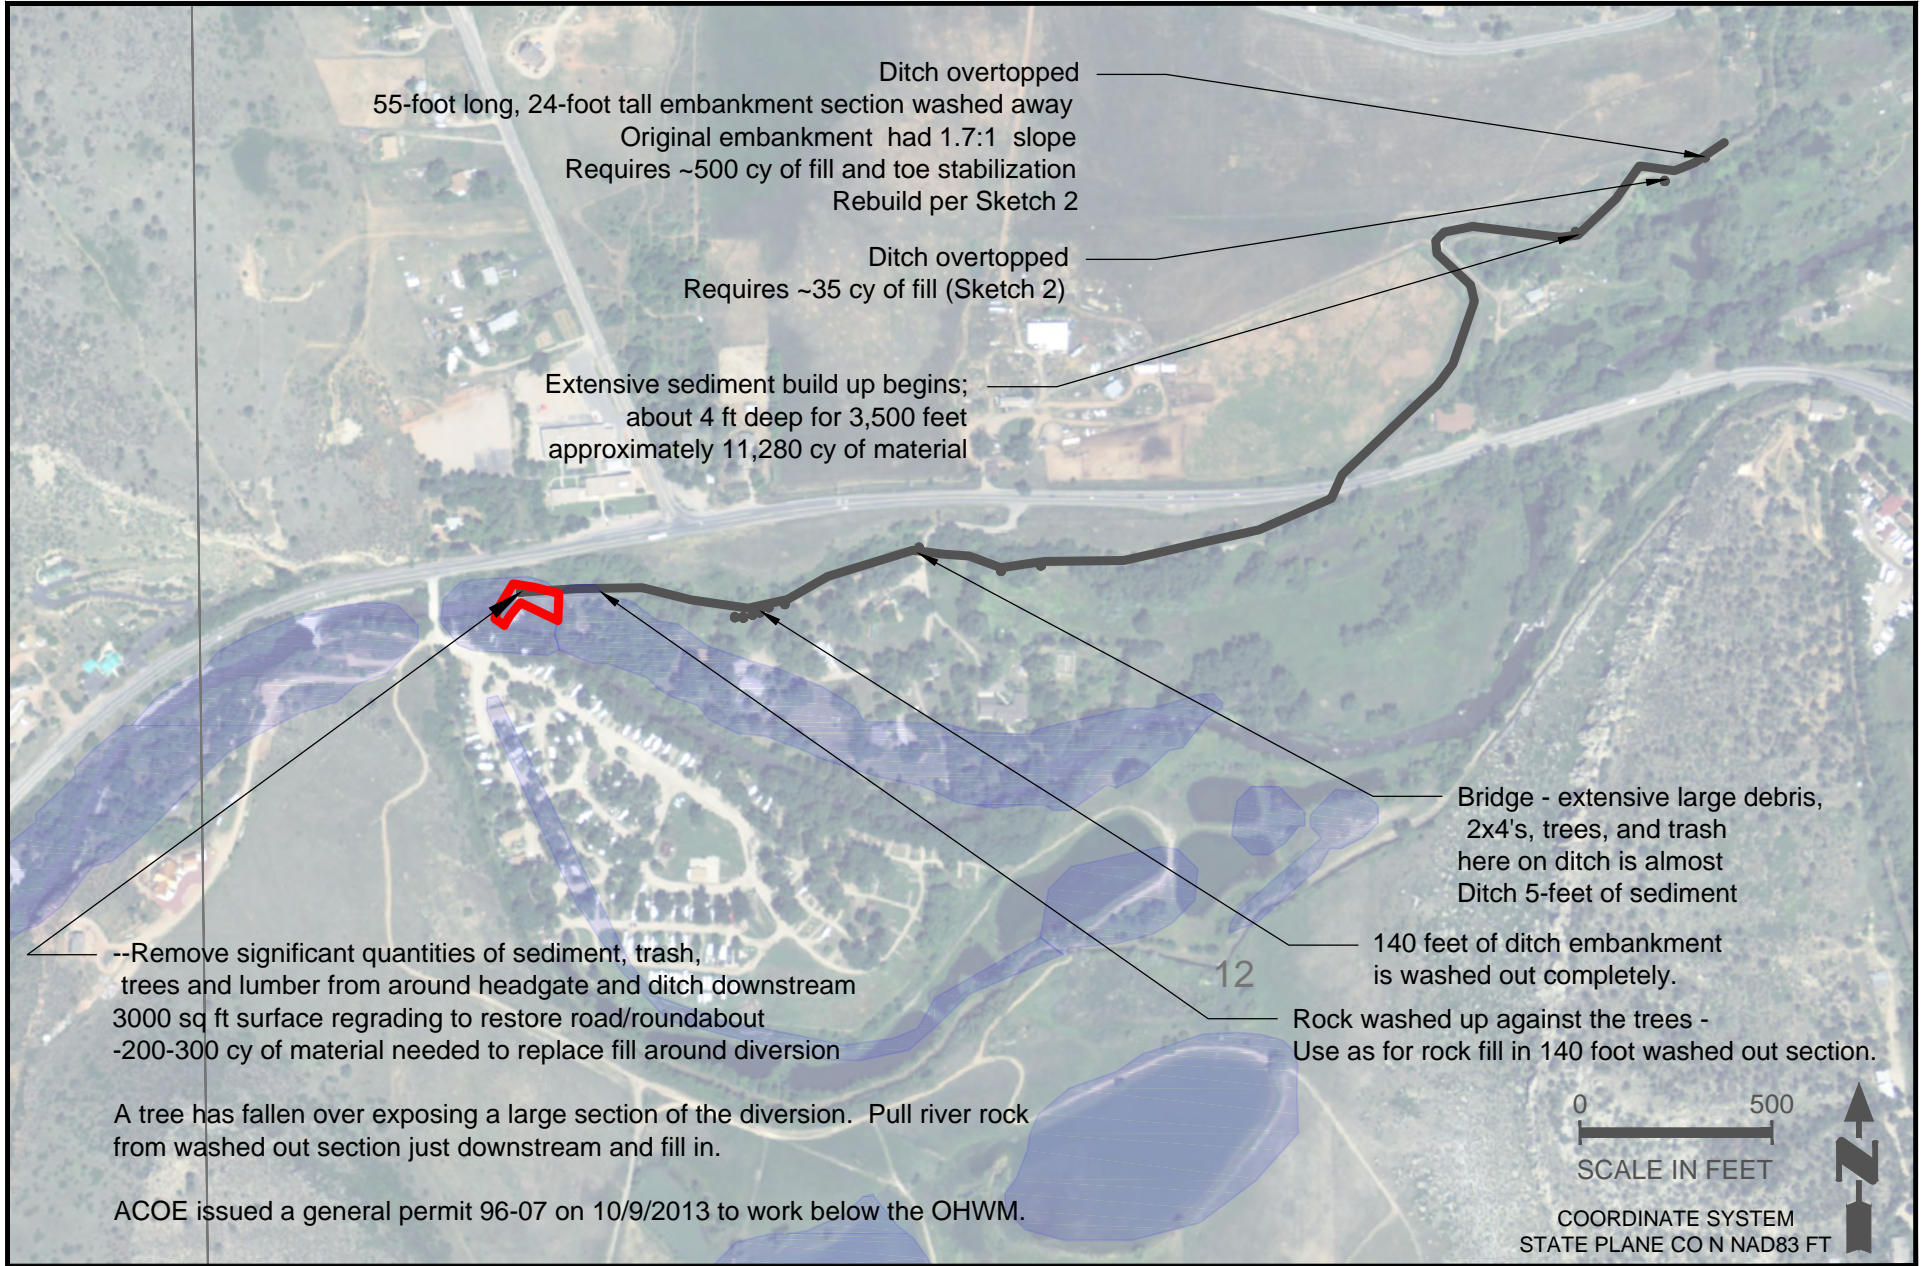
FIGURE 1
Louden Ditch 2013 Flood Overview

Based upon a field investigation on September 16, 2013 and on October 3, 2013 the following areas require repair. Quantities are estimated and were not measured in the field unless otherwise noted. Figure 1 describes the damage locations.

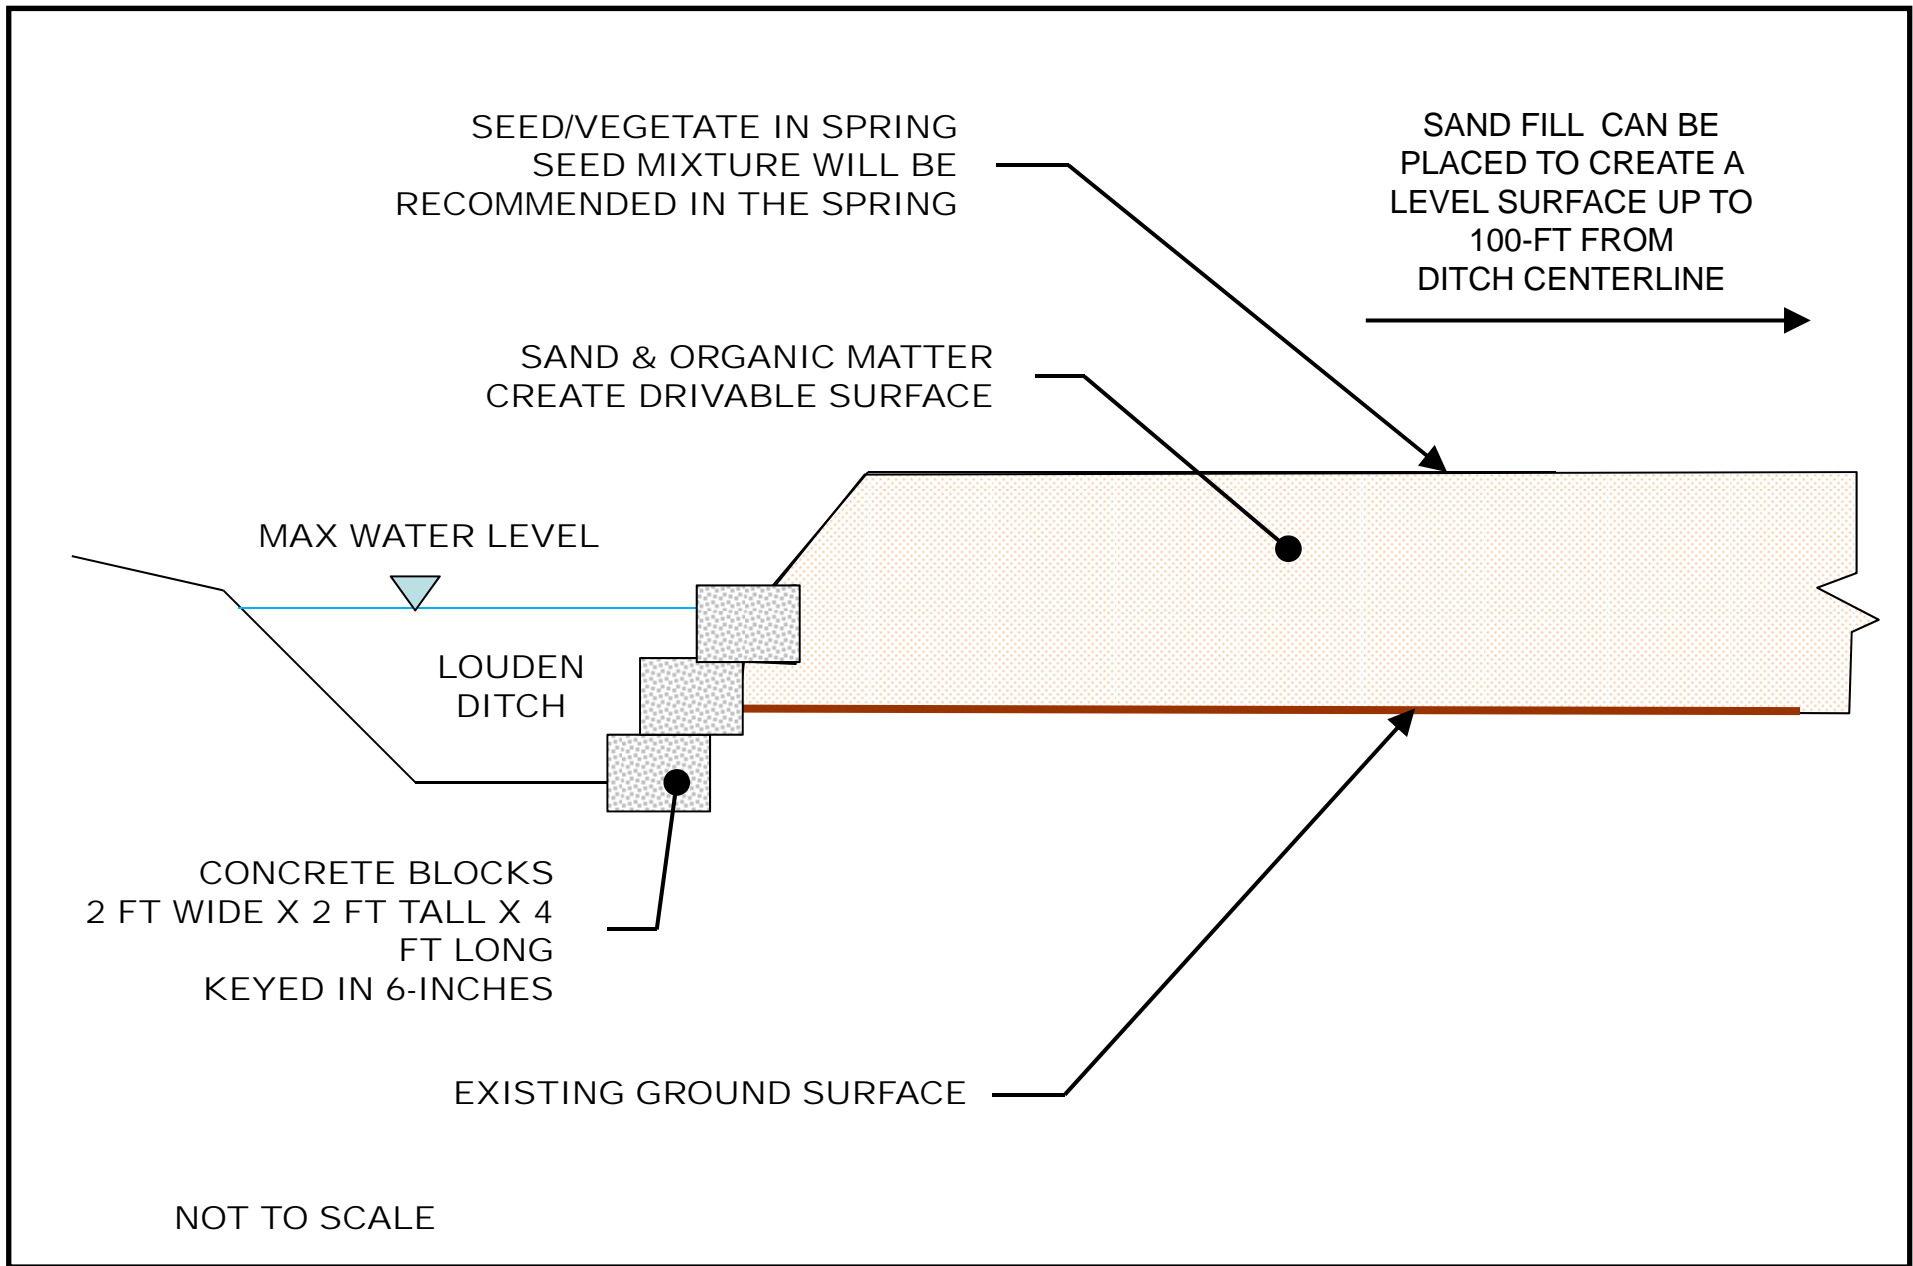
SKETCH 1
WASHED OUT DITCH EMBANKMENT DOWNSTREAM OF HEADGATE
APPROXIMATELY 230-FT LONG

Three major breaches occurred along the Ditch. The first occurred approximately 600 ft down ditch from the headgate and approximately 500 ft up ditch from the subdivision bridge. This washout eroded the right ditch bank and part of the road. Although the subdivision experienced major flooding from the Big Thompson River, it appears that water running into the subdivision from the washed out Ditch saved several residences by pushing river debris away from homes. As part of the repair, large concrete blocks (2-ft by 2-ft by 6-ft) were placed along the Ditch wall to stabilize the banks and add structure to the ditch access road. Excavated sediment from the Ditch was used as fill material behind the blocks (Appendix A Sketch 1; Appendix D Photo Set 11).

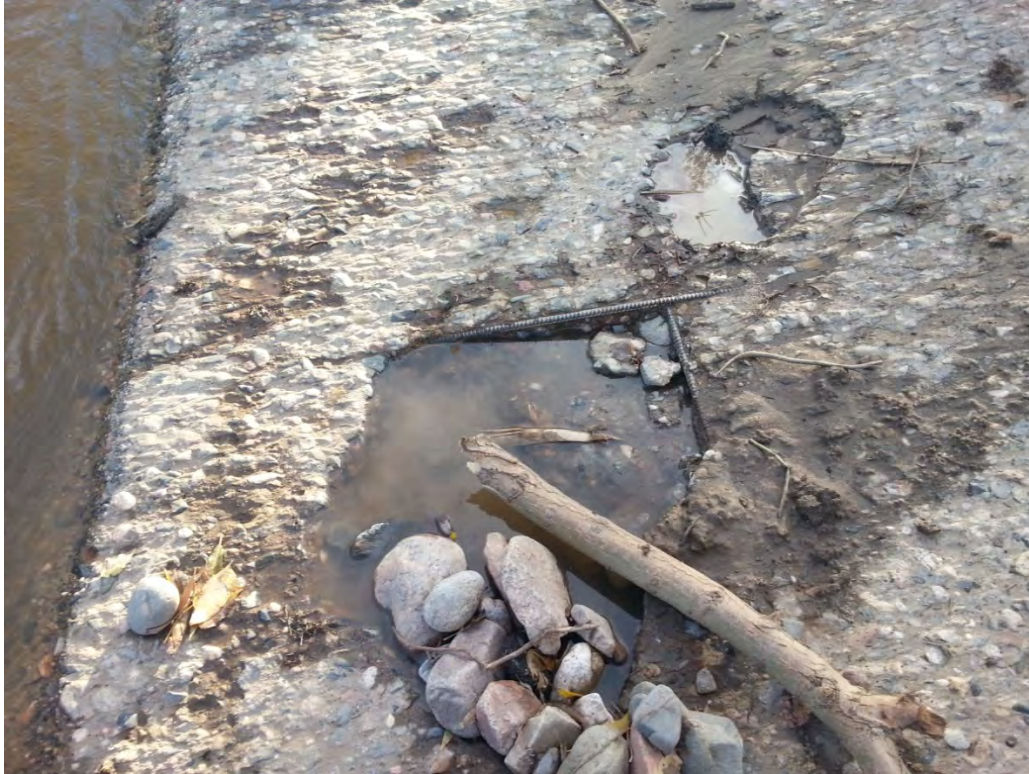
Photo 1 Diversion Dam damage on eastern/downstream face

Using methods similar to the roundabout on the north side of the river, the void at the south side of the diversion structure and the undercut diversion toe was filled with large boulders, cobble and gravel. The fill material was taken from accumulated flood deposits located along the bank of the river in the general vicinity of the diversion structure. Appendix D Photo Sets 6 and 7 show the diversion structure before and after the completed repairs.

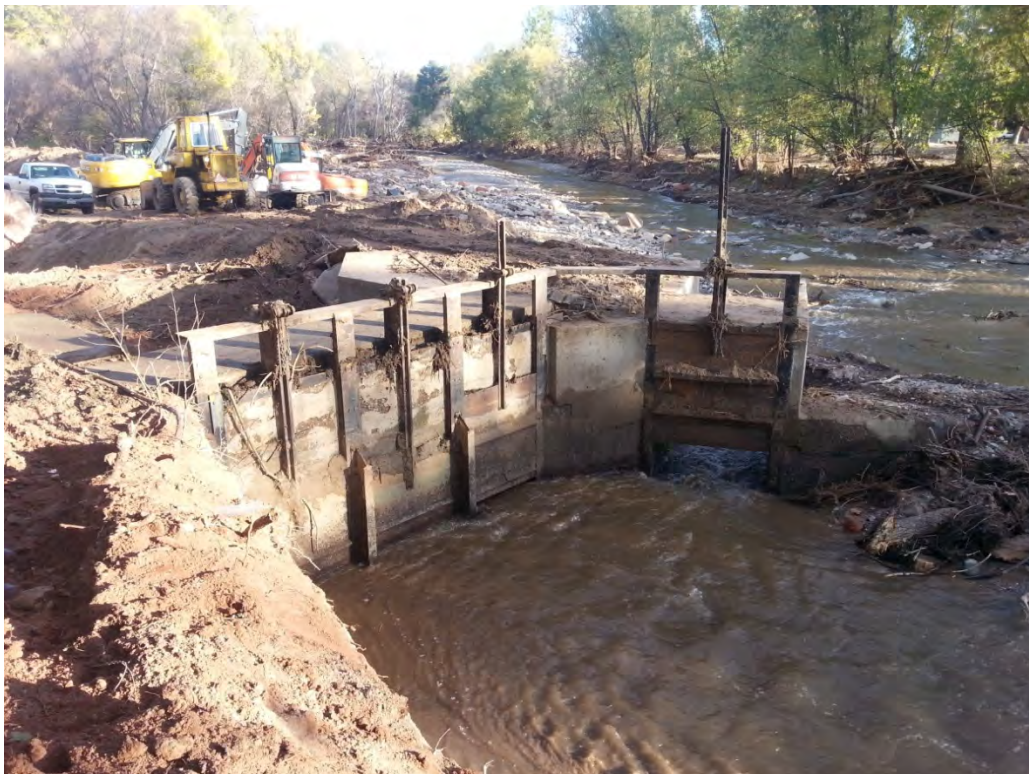
Appendix C Photos 2 and 3 show the headgate after debris had been cleared. Appendix D Photo Sets 1 through 4 show the headgate, diversion structure and surrounding area before and after the completed repairs. Louden also cleared the debris piles from beneath the trailer park bridge west of the headgate (Appendix D Photo Set 5).

Photo 2 Headgate October 21, 2013

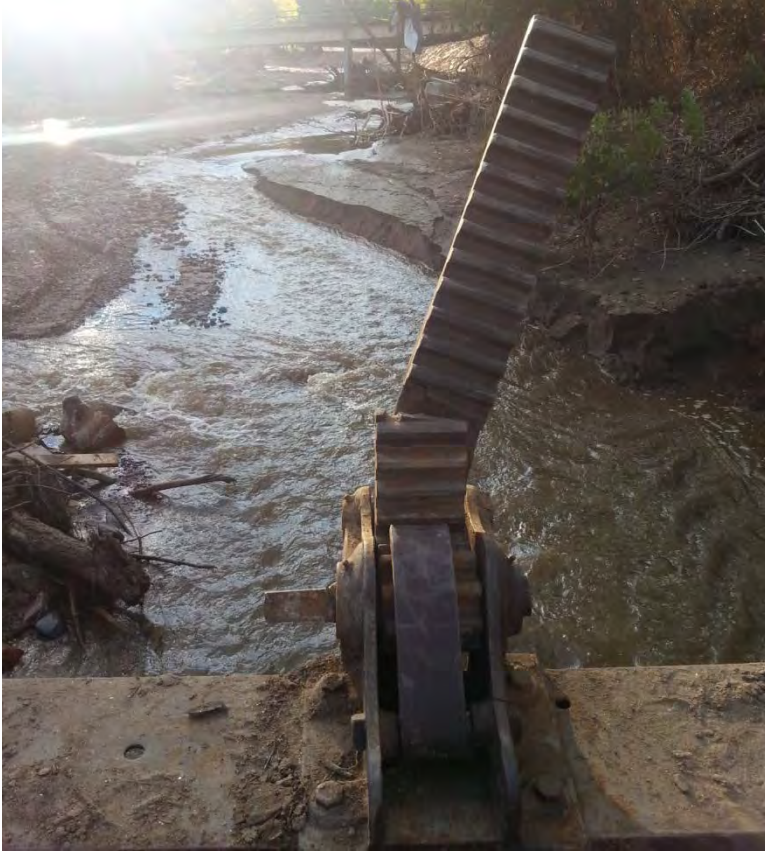
- Dirt road 3,000-square-foot roundabout was washed out
- Steel safety rails embedded in the concrete along the top of the headgate were washed away or significantly bent
- One gate mechanism was cracked from the force of the flood (Appendix C Photo 3)

Photo 3 Broken headgate hoist mechanism

The headgate showed no major damage once the large debris pile was removed. The major washout directly below the headgate and the roundabout was backfilled with approximately 300 cubic yards (cy) of material from the flood outwash located in the general vicinity of the headgate. Large concrete blocks (2-ft by 2-ft by 6-ft) were placed as erosion control along the bank of the river just downstream of the diversion structure. Small boulders, cobble, and gravel from the general vicinity of the headgate was used to backfill behind the blocks. The sediment that was cleaned out of the Ditch was used for the remainder of the roundabout fill, creating an interlocking matrix capable of sustaining vegetation. Louden welded the cracked gate mechanism.

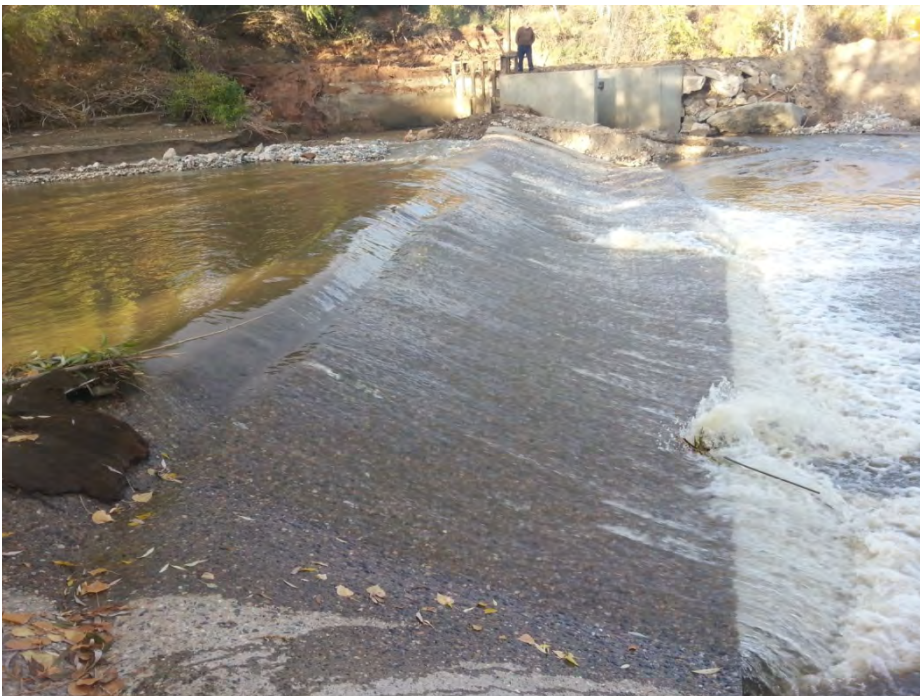
Photo 4 Diversion Dam Damage and Undercut Toe

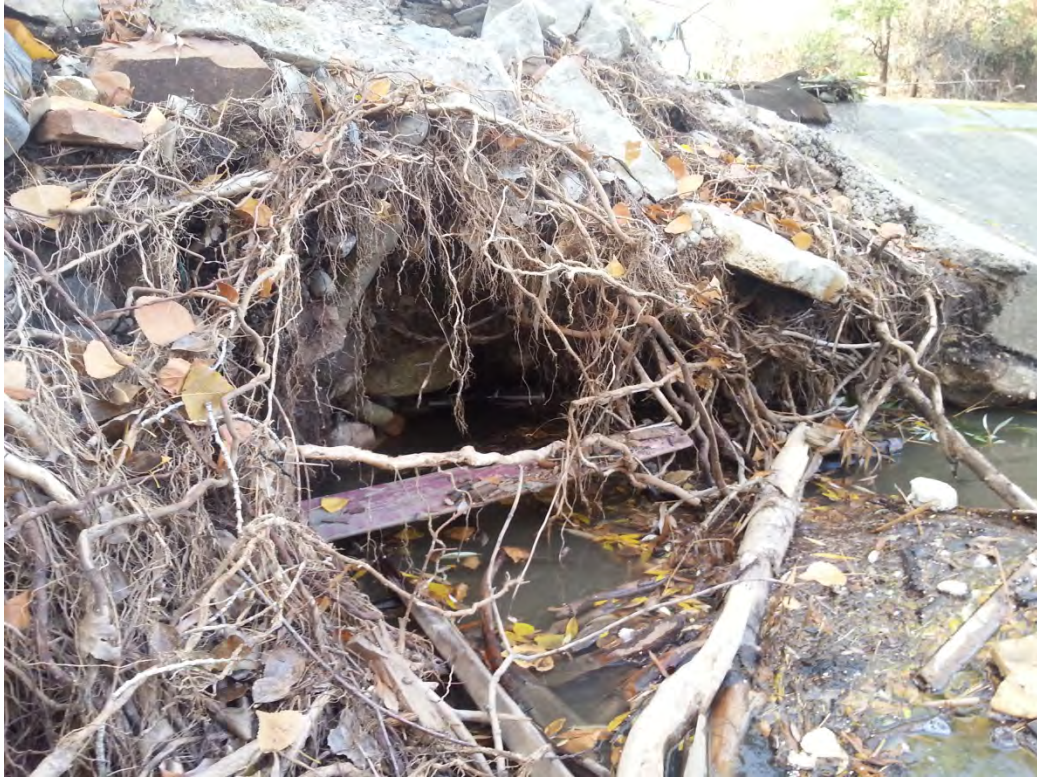
Photo 5 Scour hole to the south side of the Diversion Dam

- Periodically inspecting the embankment on the south side of the diversion structure, where the scour hole was repaired, to ensure eddies do not form that would erode into and around the diversion structure. Telesto advises planting one or two tree saplings in this area to replace the trees lost in the flood.
- The river immediately downstream of the diversion structure should remain free of turbulence/churning that would erode beneath the structure. Water

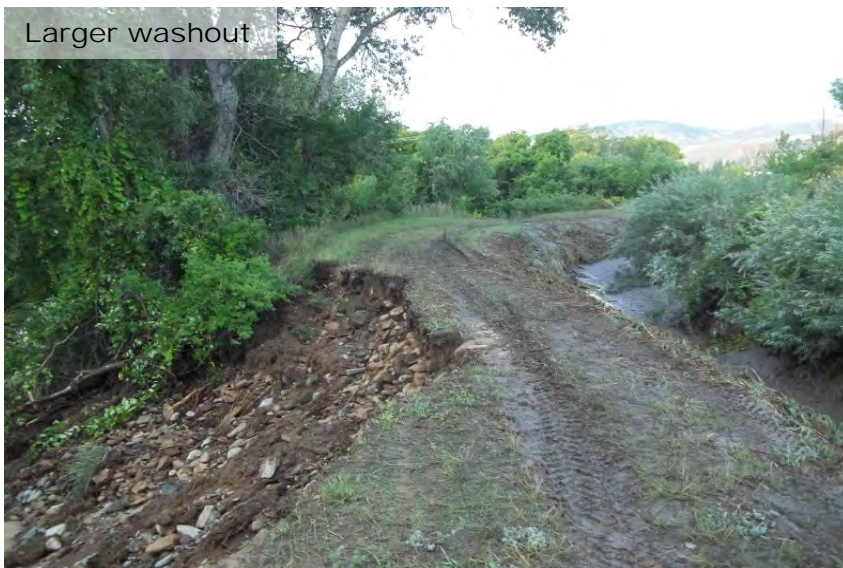
Larger washout

Two other major washouts occurred, approximately 3,500 ft down ditch from the headgate. The original design was to buttress and fill in these sections; the larger of the two washouts would have required about 500 cy of fill and the smaller about 35 cy of fill. Two major issues were encountered during the planning of the repair: 1) limited access and space for required equipment and 2) the large quantity of material required. Considering the condition of the road and the location of the washouts, the original repair plan (as shown in Appendix A Sketch 3) was not feasible in terms of time and cost. Telesto, the contractor, and Loudon discussed other options to repair the ditch access road and the washouts. Utilizing a field engineering and design approach, a plan was developed to realign the Ditch to the north of the washed-out region (Appendix C Sketch 1 and Figure 2). The completed realignment of the Ditch allowed for a straighter flow path and improved maneuverability. Furthermore, the realignment of the Ditch provided the appropriate material necessary to repair the washout areas. The completed repairs and realignment are shown in Appendix D Photo Sets 12 through 14.

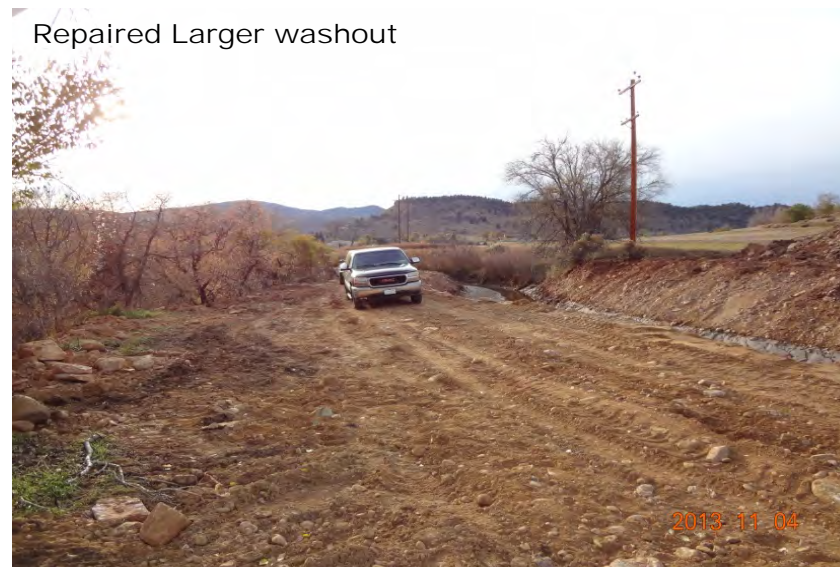
Repaired Larger washout

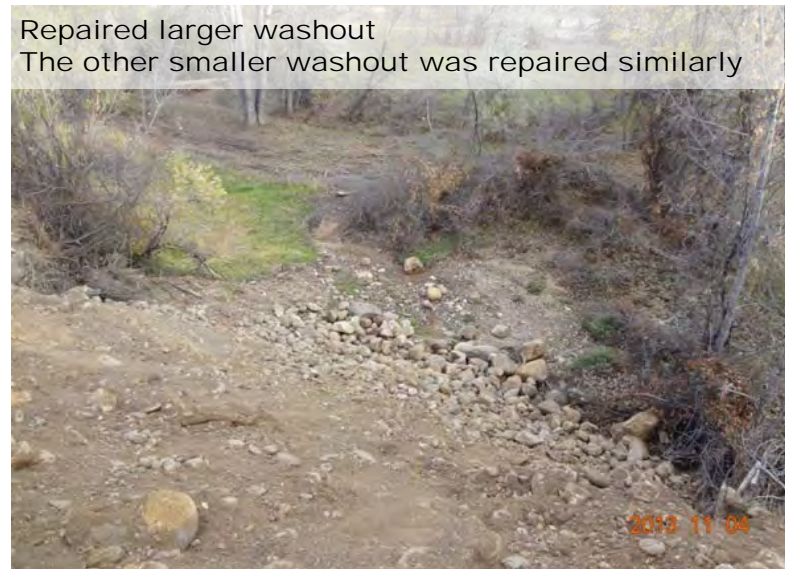
Repaired larger washout
The other smaller washout was repaired similarly
