# **Riparian and Aquatic Habitat Assessment of Lower Tomichi Creek, Gunnison County, Colorado.**

Bio-Environs,  
114 N Boulevard, Suite 206  
Gunnison, Co. 81230  
970.641.8749

**December, 2012**

## Lower Tomichi Creek Riparian Assessment, 2011

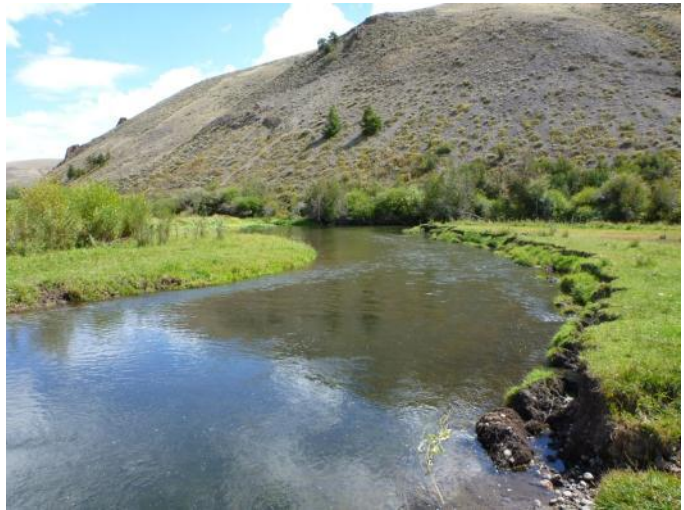
**Photograph 1.** Photograph taken September 16, 2011 looking downstream near the northern boundary of Segment 1. Note the absence of riparian vegetation along the northern bank (right) and resulting collapse of the eroded streambank into the stream channel. The more robust and intact riparian zone that exists along the south bank can be seen in along the toe of Tenderfoot Mountain in the background of photograph (Tomichi Creek Riparian Assessment, Gunnison County, CO)

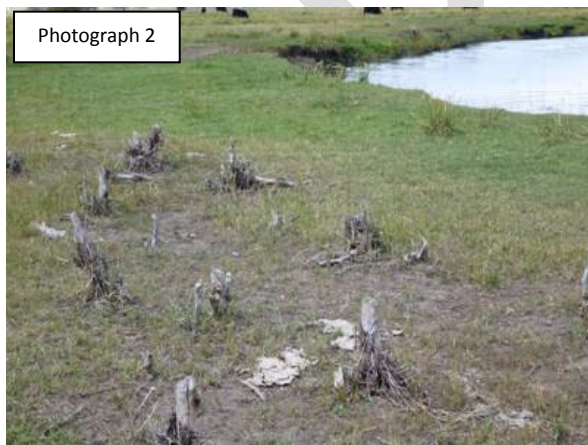
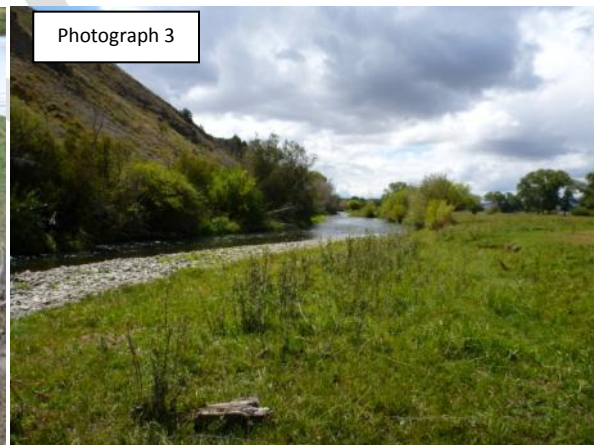
The north bank is subject to active grazing and continuous entrance to the stream channel by domestic livestock. The compromised function along the north bank is the result of narrow, fragmented riparian zones that lacks varying age class and higher species diversity that is characteristic of healthy riparian zones. The lack of diversity appears to be due to the removal and hedging of vegetation by historical practices and domestic ungulates (Photographs 2 and 3).

The loss of this vegetation results in heavily eroded and failing streambanks. The segment includes several isolated cottonwood stands that appear to be remnants of riparian area that was historically associated with this stream segment (Overview 1). An abandoned stream meander that is located mid segment is identified as FAR riparian because the channel appears to be saturated and supports wetland/riparian characteristics (Overview 1). Although the feature is not part of the main channel riparian system, this swale is identified as part of the

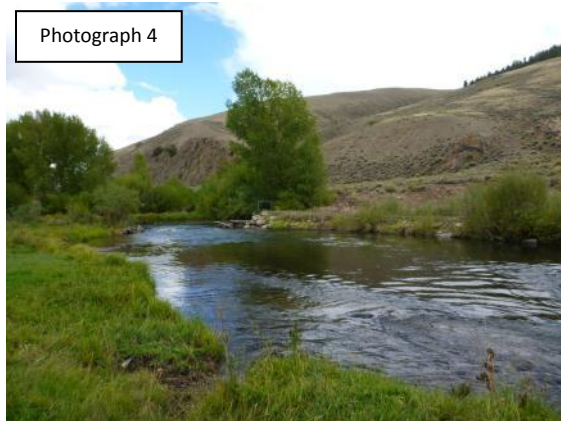
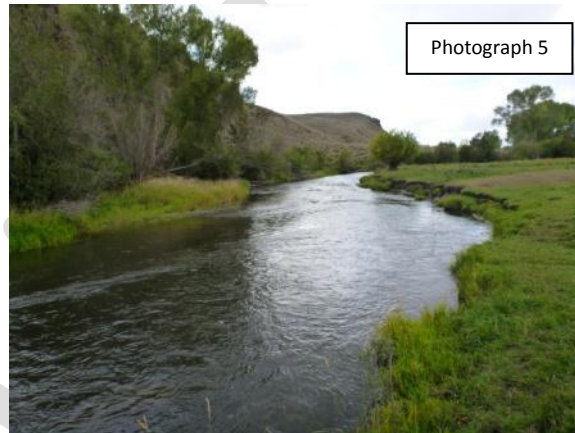
with varying age class and species diversity. The lack of diversity appears to be due to the removal and hedging of vegetation by livestock and wildlife. The loss of vegetative diversity and coverage results in heavily eroded and failing streambank conditions (Photograph 7). The south bank in Segment 2 includes the Adams #2 irrigation diversion and a small stretch of streambank that is identified as Nonfunctional due to a lack of vegetation in association with the Adams #2 diversion structure (Photograph 4).

The above Photographs were taken September 16, 2011 looking southeast towards the Adams #2 diversion structure and southwest from just below the Adams # 2 diversion structure, respectively. Note the absence of riparian vegetation along the northern bank (left Photograph 4, right Photograph 5) and the presence of more robust properly functioning riparian vegetation along the southern bank at this location (left, Photograph 5) (Tomichi Creek Riparian Assessment, Gunnison County, CO).

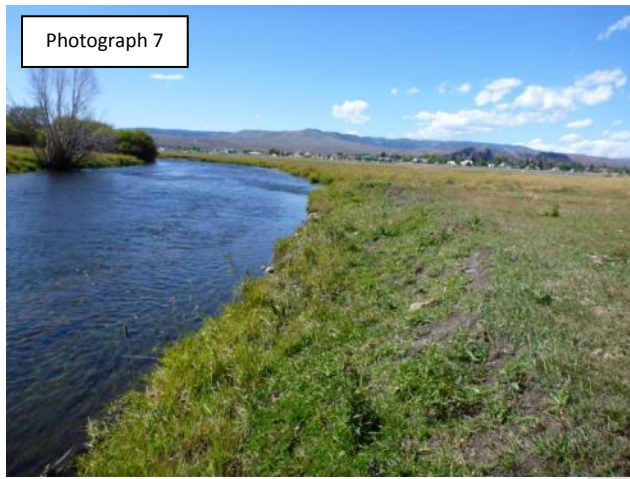
compromised to Functioning at Risk with extensive damage to streambanks in the eastern portion of Segment 2 (Overview 2).

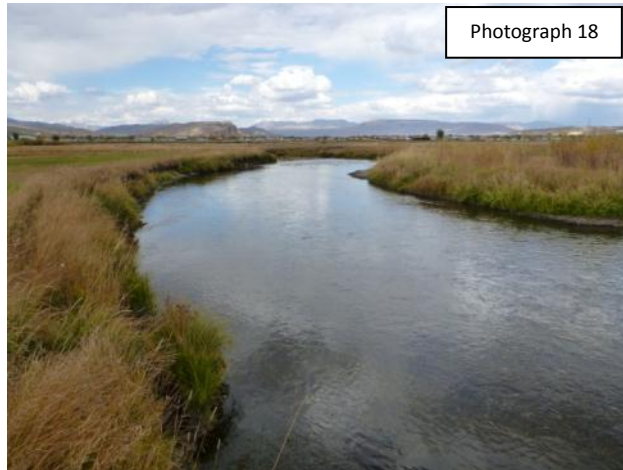
Photograph 18

often protected from grazing with fence alignment which excludes grazing for a period of time during the growing season to allow hay production to reach potential. Similar to Segments 4 and 5, the seasonal exclusion of livestock from the streambank permits grasses and vegetation to reach growing season potential. The increased production has enabled pasture grasses to grow down to the stream edge thus providing some vegetative cover and slight increase in ability to withstand higher flows where these grasses are established. These areas exhibit sloughing but to a lesser extent than those without the cover of the grasses (Photograph 18). In many cases, the pastures that are adjacent to the stream in these segments are harvested right to the edge of the stream leaving very little protective buffer between the pasture and streambank (left bank Photograph 18). This mowing

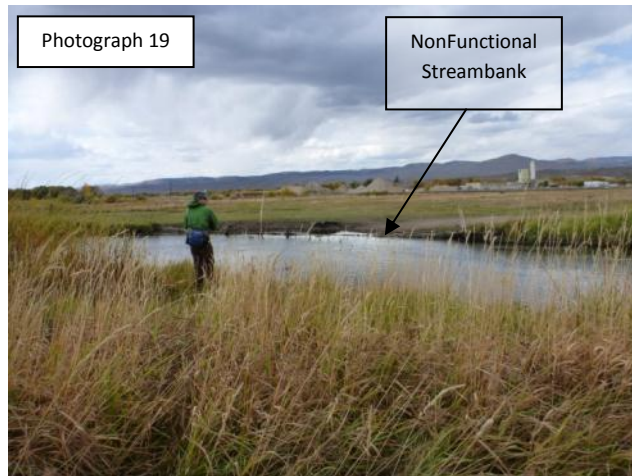
riparian impact resulting from grazing pressure and streamside access of livestock with a departure from the hay production back to a grazing influence. This section of Segment 8 includes numerous NonFunctional riparian and sloughing streambanks resulting from streamside access to livestock (Photograph 19).

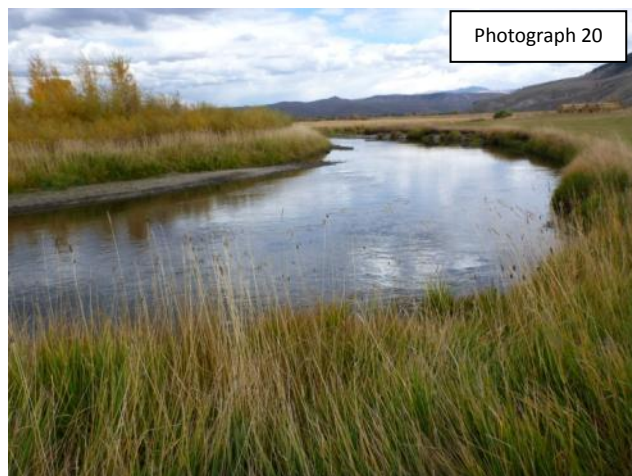
slow deep, slow shallow, fast deep and fast shallow. Due to persistent channel widening, the flow regimes in these segments are generally limited to three or less of the regime types necessary to provide a balanced Velocity/Depth ratio (Photograph 20).
