# **Kerber Creek Restoration Project Final Report**

Trout Unlimited/Bureau of Land Management (BLM)

January – December 2011

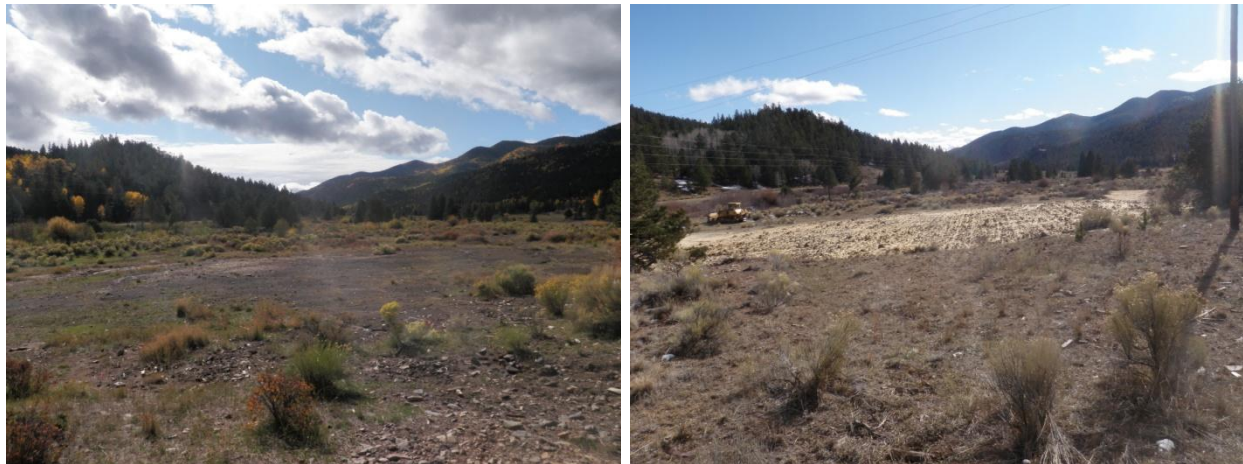
The northernmost and largest mine waste area was 0.56323 acres (Figure 5.1) and was immediately below the specified staging area. This area was one of the last to be completed since the contractor performed in-situ treatment from downstream to upstream.

**Figure 5.1: KC 20 looking south from staging area at first large mine waste area before restoration (left) and after (right)**

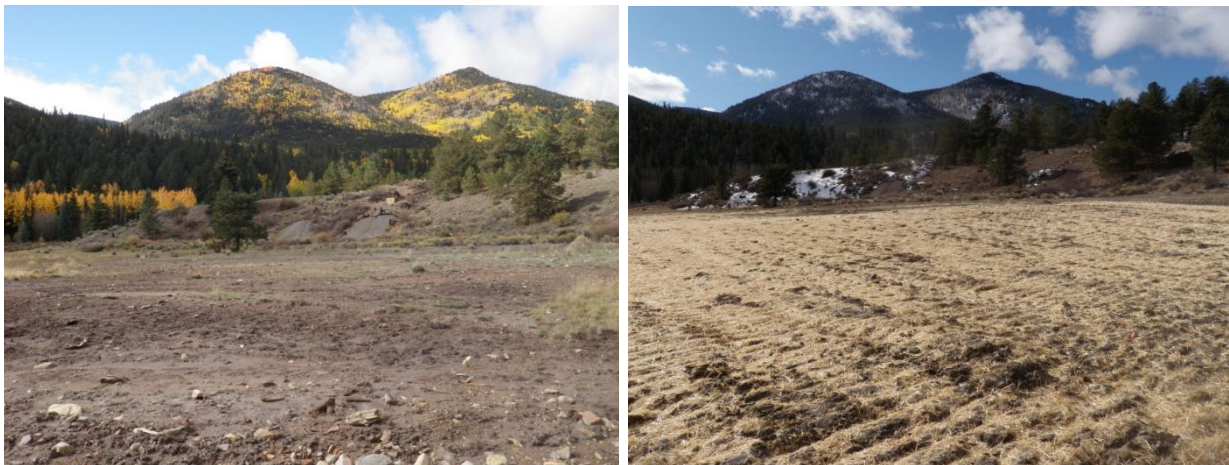
The largest mine waste areas in the southern portion of the property totalled 0.8223 acres (Figure 5.2). These two areas were divided by a small vegetated area, and were in a heavy cattle grazing and traffic section.

**Figure 5.2: KC 20 lower mine waste area facing twin mountains before restoration (left) and after (right)**

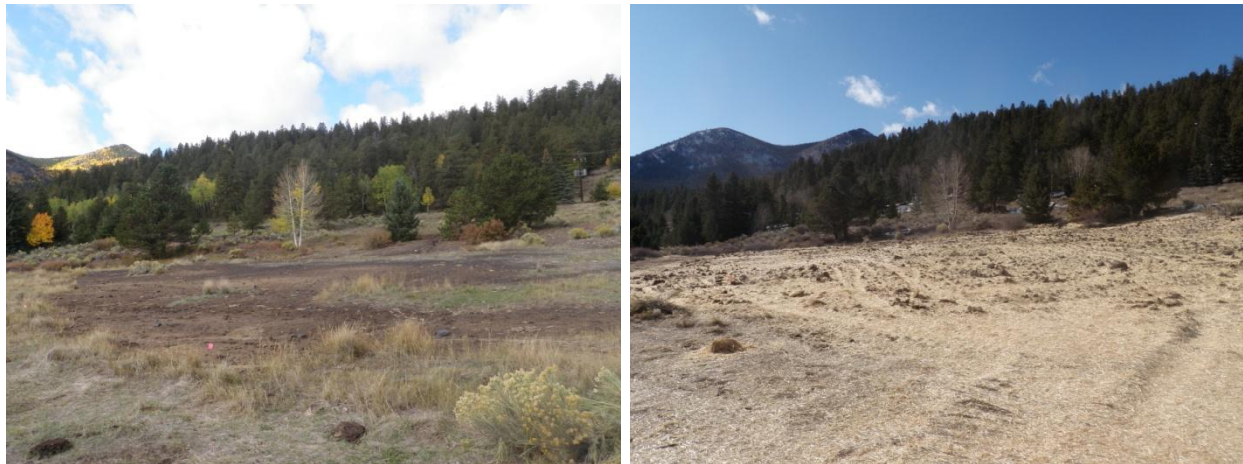
The largest mine waste area was a priority due to its size, and visual deficiencies that could be viewed from the LL56, Brewery Creek roads, and landowners access road (Figures 5.3 and 5.4).

**Figure 5.3: KC 20 first mine waste area facing west toward aspen tree before restoration (left) and after (right)**

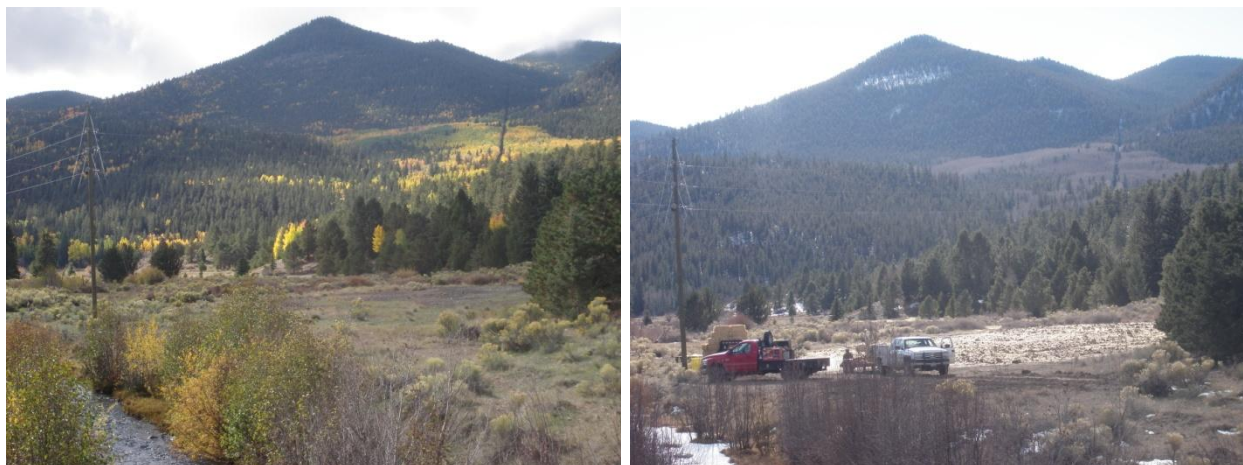
**Figure 5.4: KC 20 on Brewery Creek Bridge looking southwest before restoration (left) and after (right)**

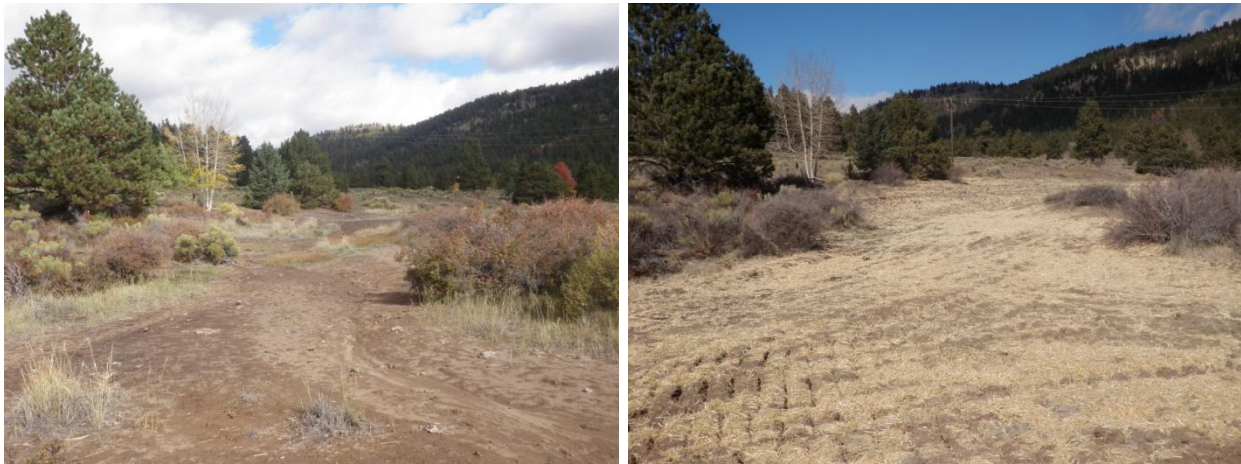
A skinny section of mine waste connected two larger areas and was used as an access road by the contractor during construction (Figure 5.5). Since this area was toward the north of the site, it was one of the last to be restored. Significant improvement is can be observed, with no trace of the access road.

**Figure 5.5: KC 20 2<sup>nd</sup> mine waste area (long and narrow) facing north before restoration (left) and after (right)**

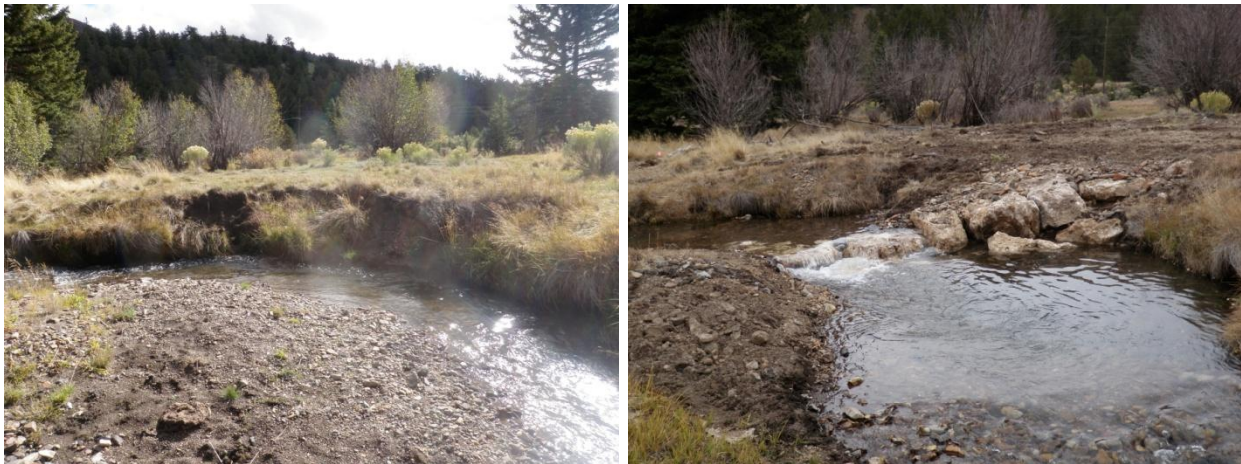
There were several areas along Kerber Creek that had steep banks, large width-depth ratios, and poor trout habitats. Banks were pulled back to a 3:1 slope and J-hooks were installed on appropriate meander bends (Figures 5.6 and 5.7) to reposition the thalweg and stream energy toward the center of the channel and away from the banks.

**Figure 5.6: KC 20 Kerber Creek cutbank before restoration (left) and after J-hook installation and reshaping (right)**

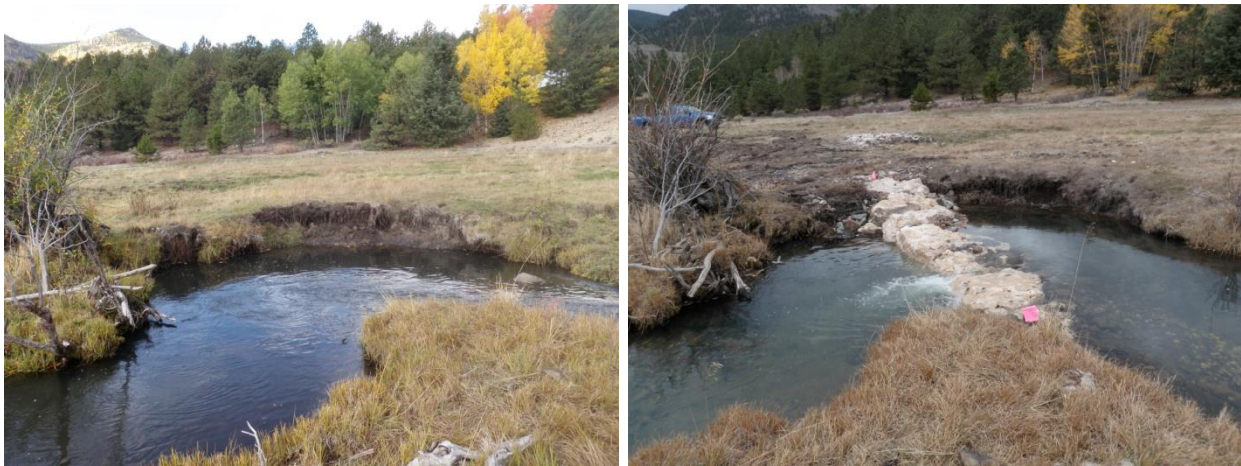
**Figure 5.7: KC 20 Kerber Creek meander bend before restoration (left) and after installation of J-hook (right)**
