# Coal Creek Confluence Reach Assessment

Gunnison County, Colorado

*Prepared for: Coal Creek Watershed Coalition and the Upper  
Slate River Steering Committee*

*November 18, 2012*

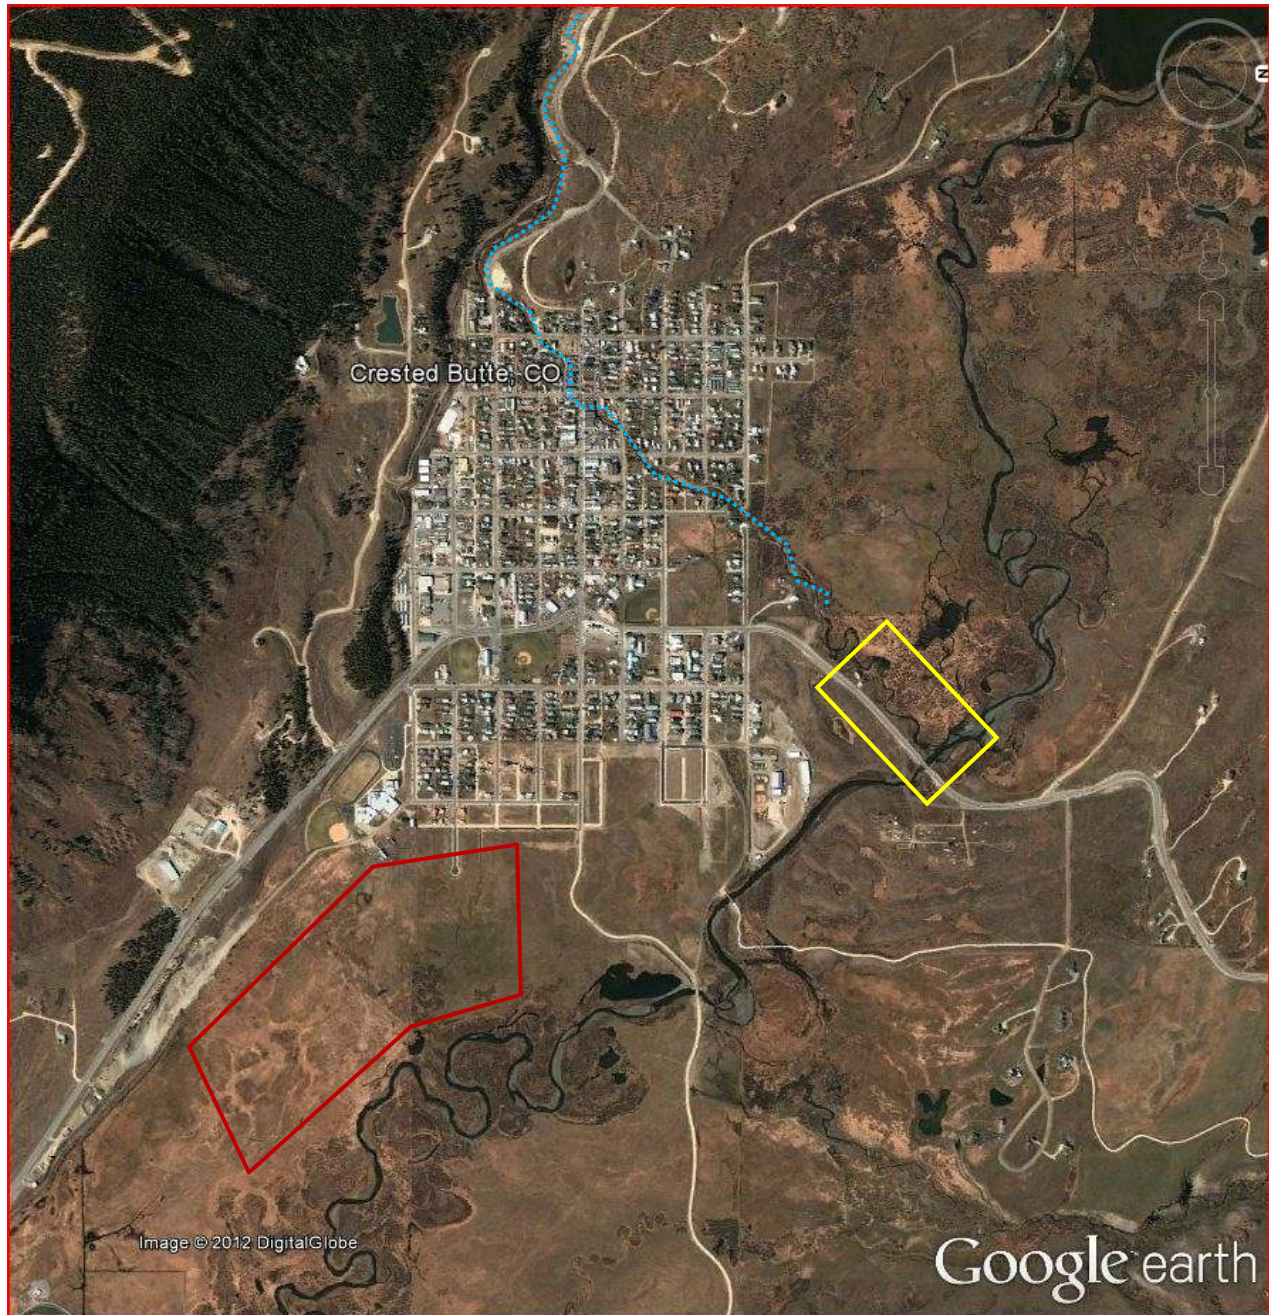
**Figure 4: Current Aerial of Crested Butte Area**

*This current image of the Crested Butte area shows the Confluence Parcel in the yellow box and evidence of historic river features in the red box.*

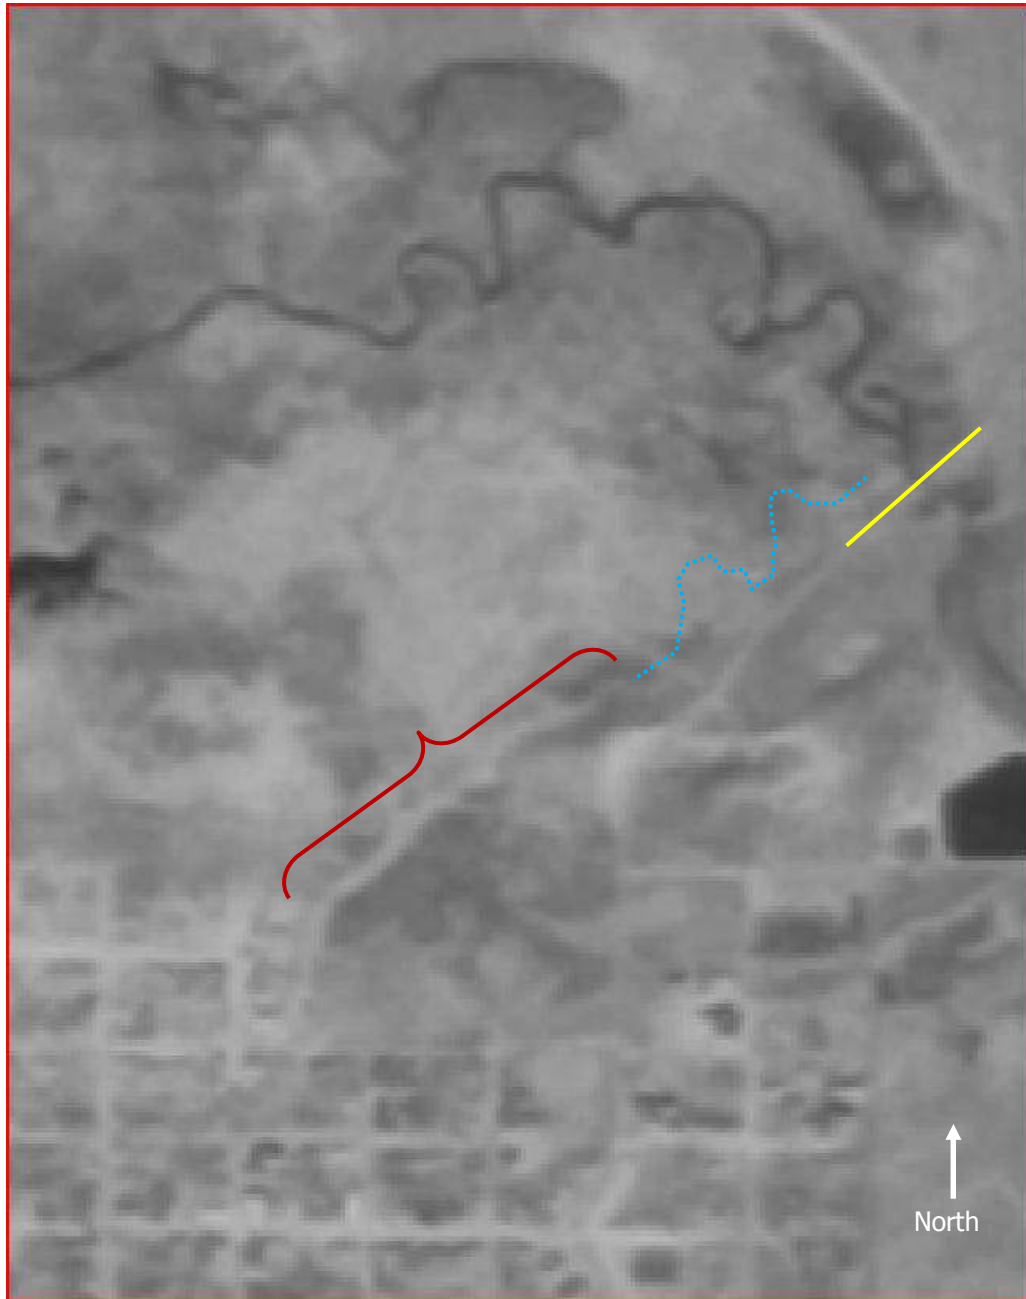
**Figure 5: Historic Aerial Photo of the Confluence Reach**

*This cropped image from a 1978 historic aerial photo shows evidence that Coal Creek may have been artificially straightened and/or channelized at that time (identified by the red bracket). The approximate alignment of Coal Creek through the Confluence Reach is shown by the blue dashed line. The lower portion of this alignment may have been altered to accommodate the realignment of the Gothic Road and construction of the Gothic Bridge prior to 1978 (yellow line).*

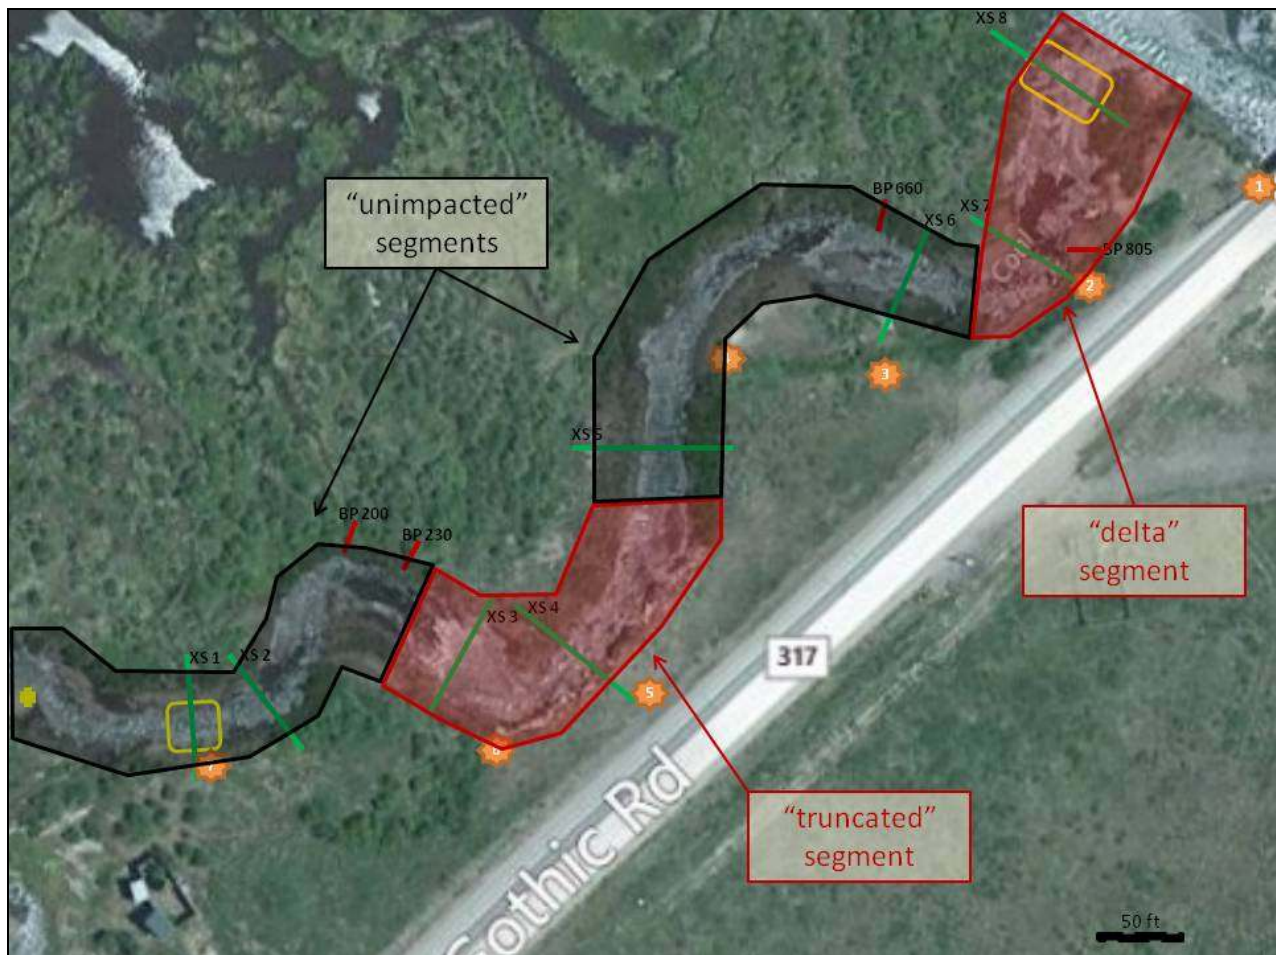
**Figure 6: Segments of the Confluence Reach**

The segment from about station 230 to 480 we named the "truncated segment" since its meander pattern is abruptly truncated by fill at the Gothic Road. The "delta segment" runs from about station 700 to the bottom of the reach at the Slate River near station 945. This segment shows signs that it is probably a backwater when the Slate River becomes impounded during high flows behind the Gothic Road Bridge. The delta segment is also truncated by road fill, and it actually appears this whole segment was relocated to its present position when the Gothic Road was realigned in the 1960s or 70s.

Finally, the “unimpacted segments” run from the top of the reach down to about station 230 and from about station 480 to 700. These are stream segments that are not directly impacted by the road or the bridge, and they may serve as a reference of the potentially stable condition. An analysis of the data and stability assessments throughout the rest of the report provide a compelling case that the “unimpacted segments” on this reach are a good reference for stable channel morphology. Based on this assumption, a set of reference data for stable channel morphology was derived from these segments and summarized in **Table 7**.

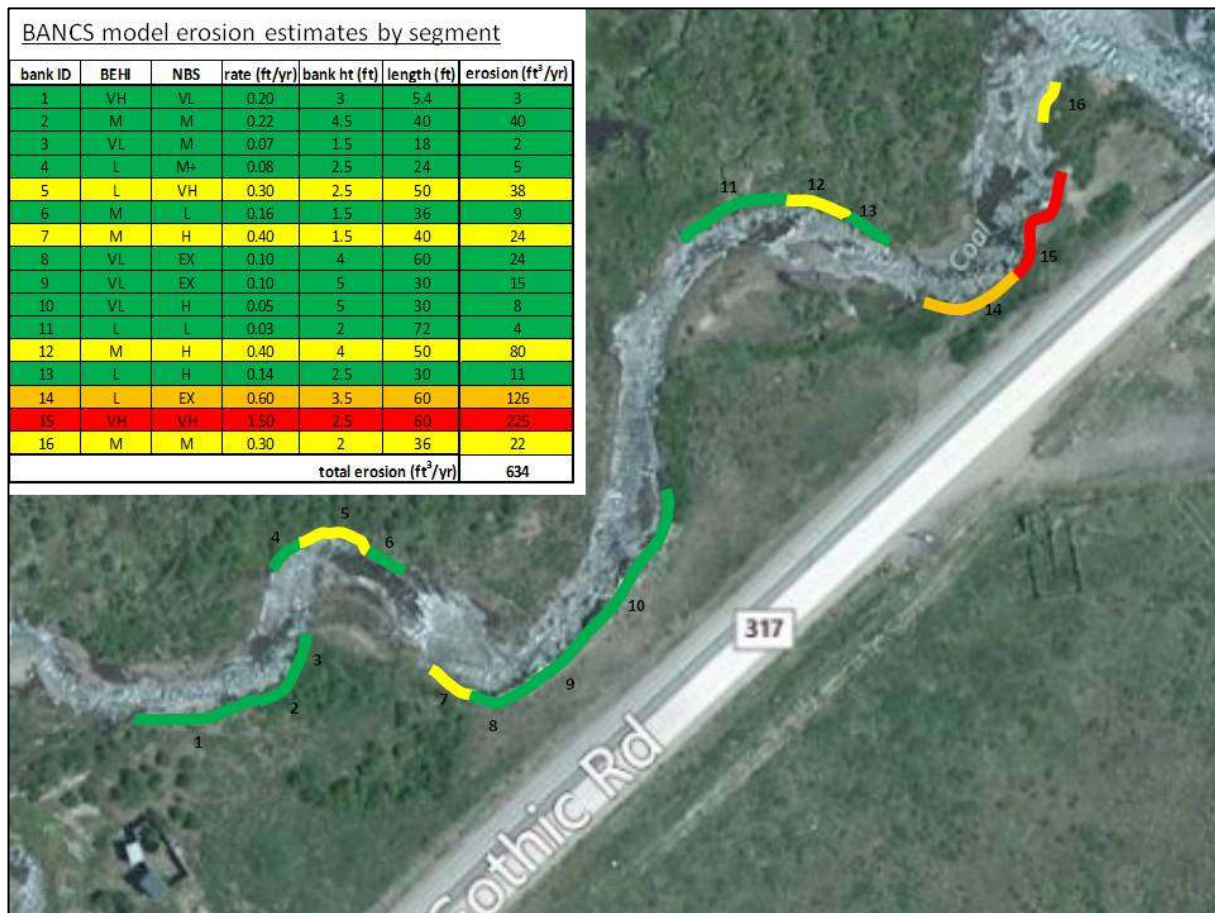
**Figure 7: Results from Streambank Erosion Estimates Using the BANCS Model**

Over the entire reach, an estimated 634 cubic feet (ft<sup>3</sup>) or about 30 tons of sediment is produced annually from bank erosion. Roughly two-thirds of this total, 373 ft<sup>3</sup> (about 20 tons) comes from the short delta segment. The other presumably unstable truncated segment shows relatively little predicted bank erosion because the primary susceptible bank is extensively armored with concrete and boulders.. In contrast, only a portion of the eroding bank on the delta segment is armored, and the armoring on this bank is simply a layer of loosely stacked rock and concrete pieces that may fail.

*The location of individual bank segments is identifies on the site map and color coded to indicate the relative magnitude of erosion. The table summarizes all of the BANCS model data.*
