# Union Creek Stream Stabilization Project Final Report

Submitted to: Colorado Water Conservation Board

Submitted by: Colorado Mountain College Natural Resource Management Program

March 7, 2014

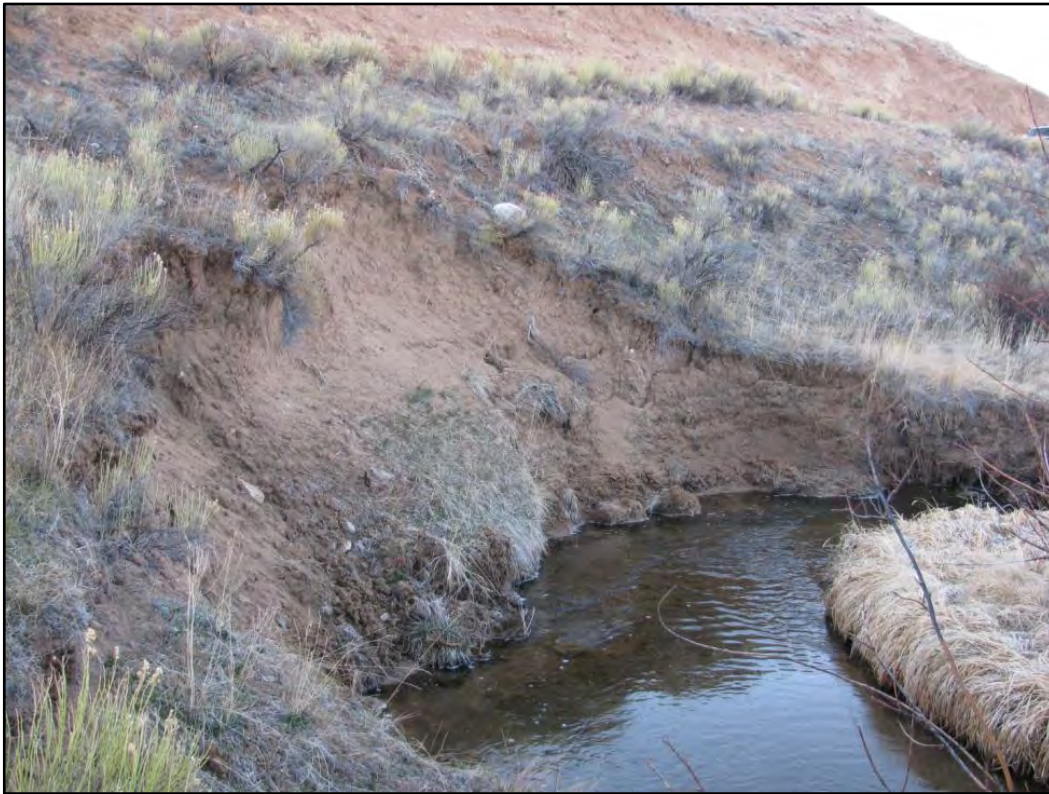
**Figure 5. Pre-construction photo of Meader 1.**

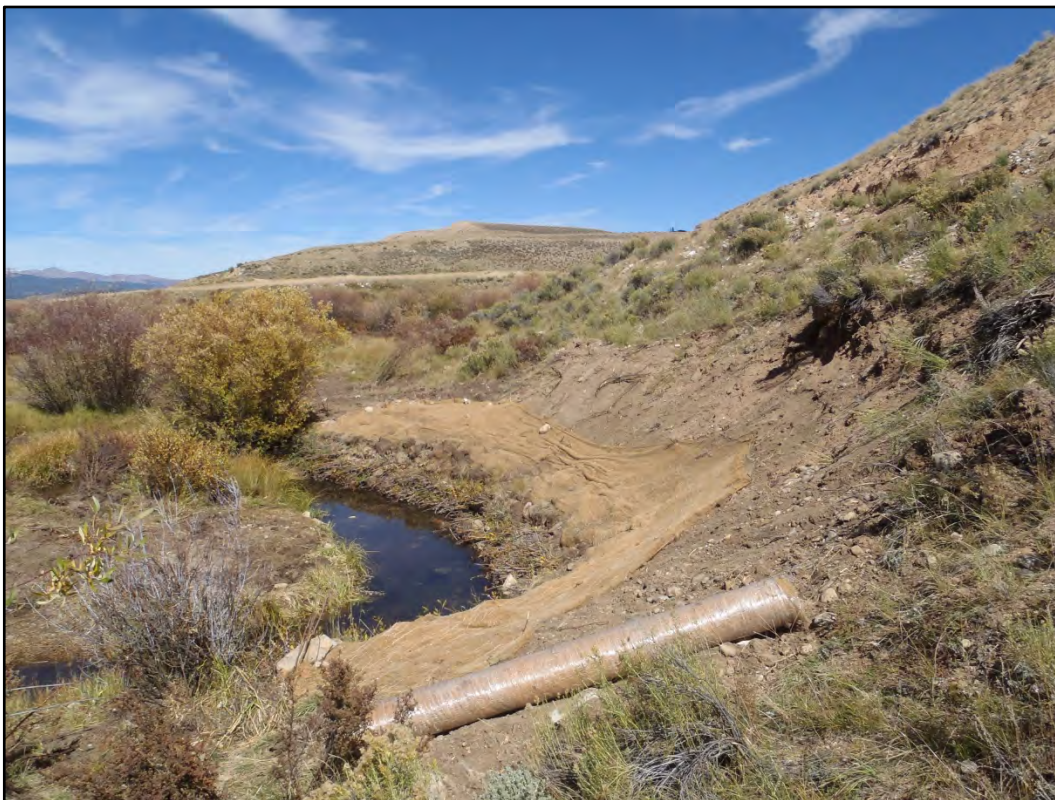
**Figure 6. Post-construction of Meander 1.**

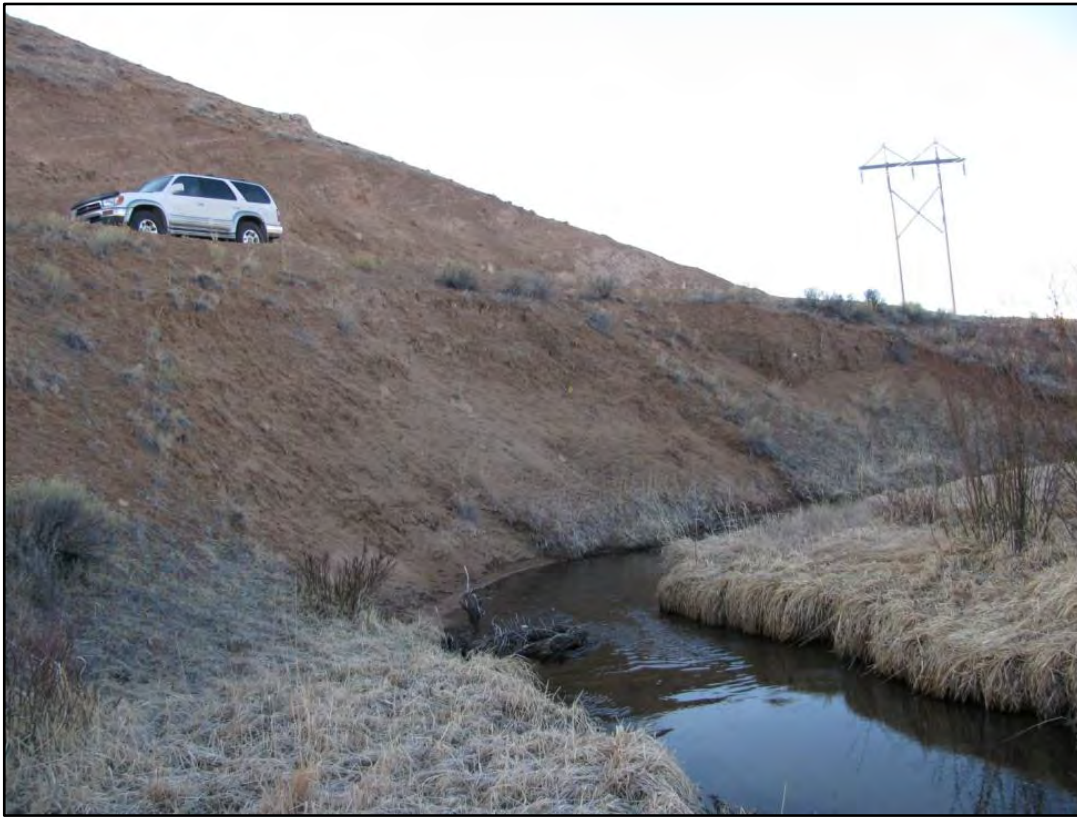
Figure 7. Pre-construction photo of Meander 2.

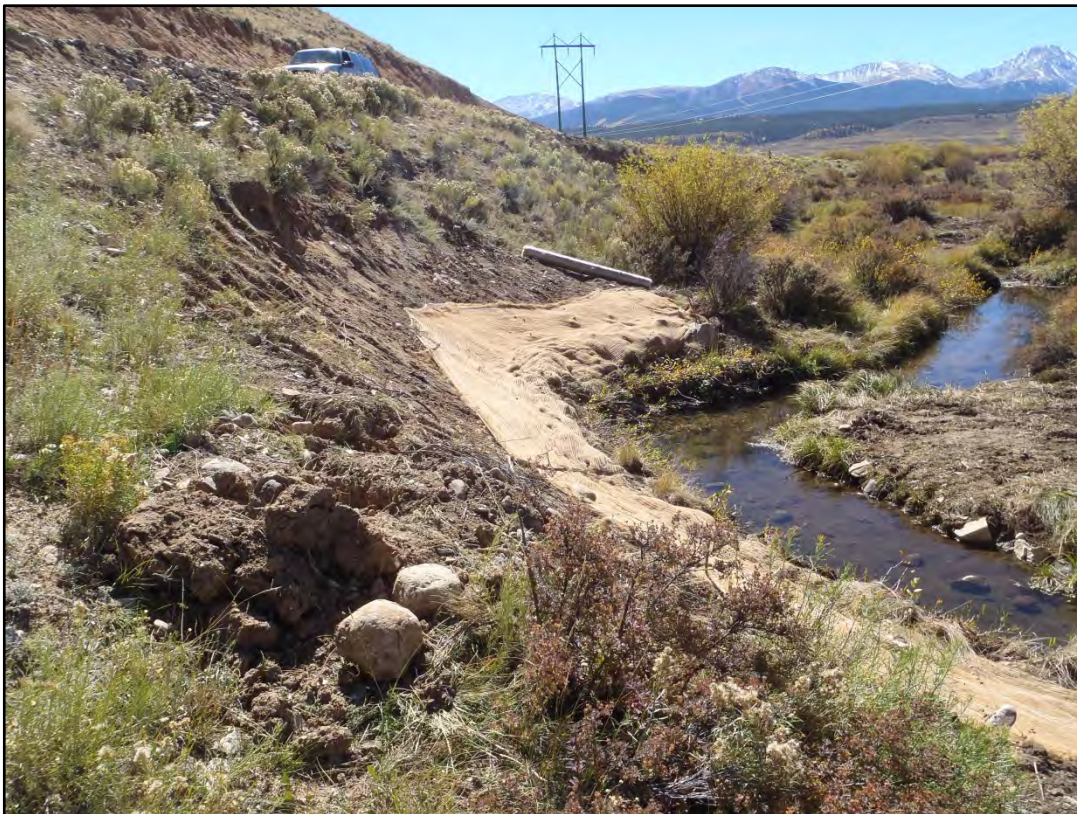
Figure 8. Post-construction photo of Meander 2.

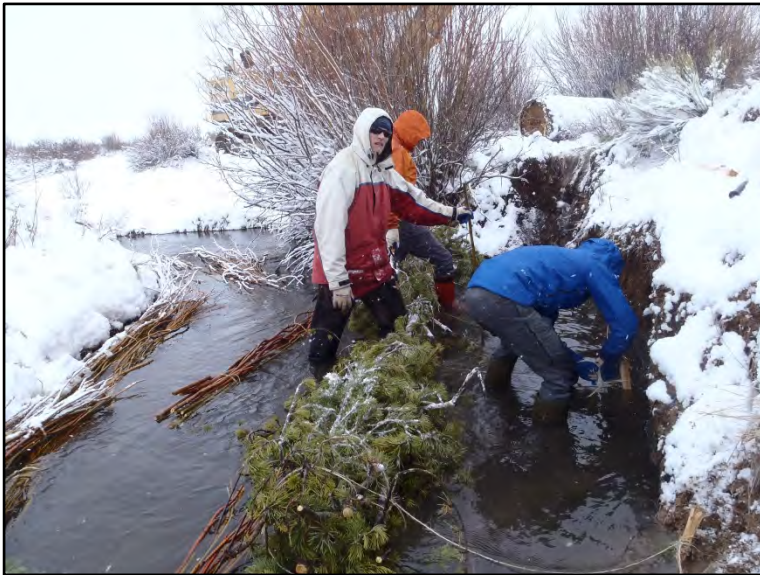
Figure 18. Staking pine bough fascines to the back of the bank.

After CPW surveying was complete, an excavator cut the bench for the soil lift in the bend at Meander 1. Pine bough fascines were placed on the bench and staked into the back of the bank using guidelines (Figure 18).

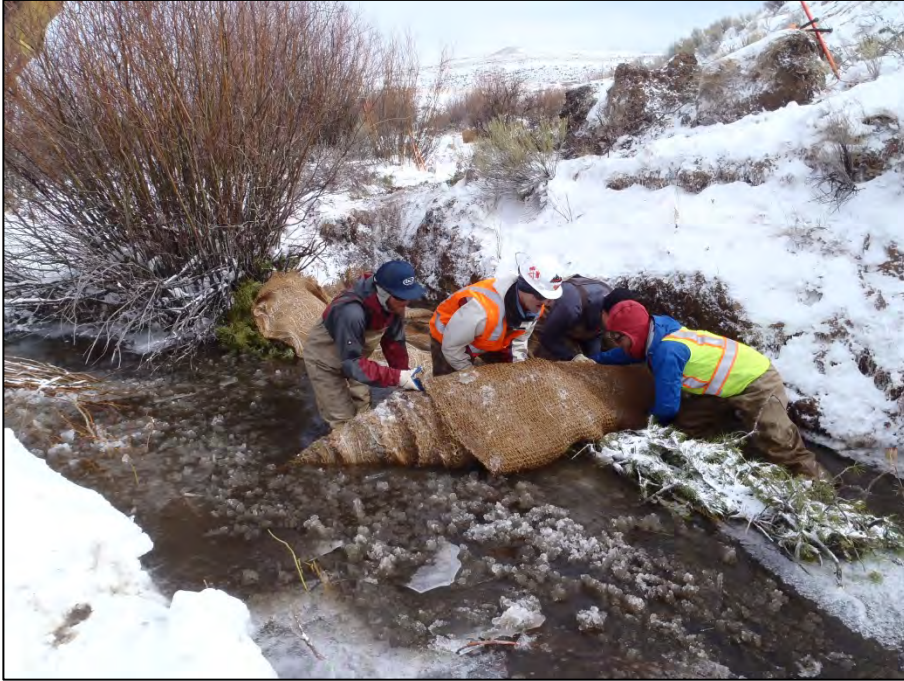
Figure 19. Rolling out Coir fabric on top of fascine.

The Coir fabric, which is double layered, was unrolled on top of the pine bough fascine, filled with one foot of locally available sediment, folded back over the soil and staked to the back of the bank (Figure 19 and 20).

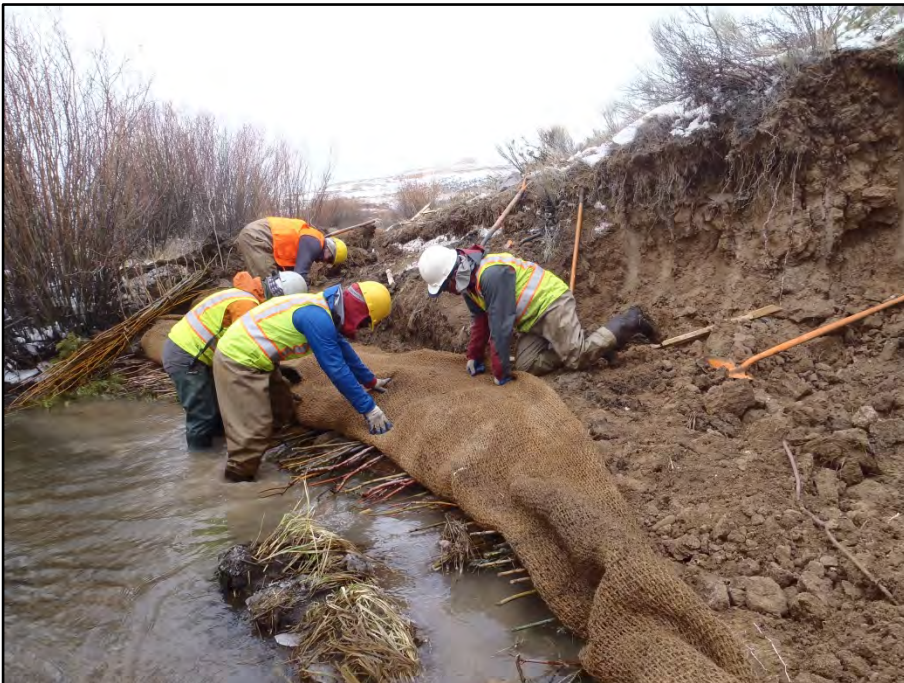
Figure 20. Folding Coir fabric over soil.

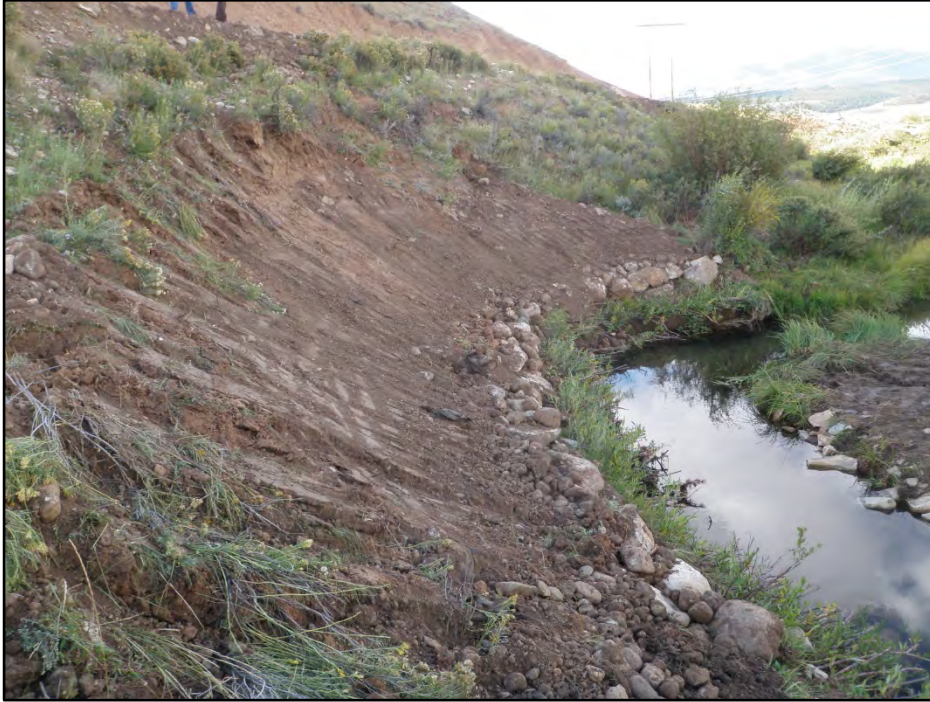
Figure 21. Completed soil lift.

Live willows were placed on top of the fabric at a frequency of one willow per inch. Three inches of soil were spread out on top of the willows. A second soil lift was installed following the same steps. In August 2013, rocks with a diameter of two to three feet were placed at the front of the soil lift and gaps

were chinked with smaller rocks and the entire slope was backfilled (Figure 21). In November 2013, the slope was dressed with straw, seed and erosion blankets (Figure 22).

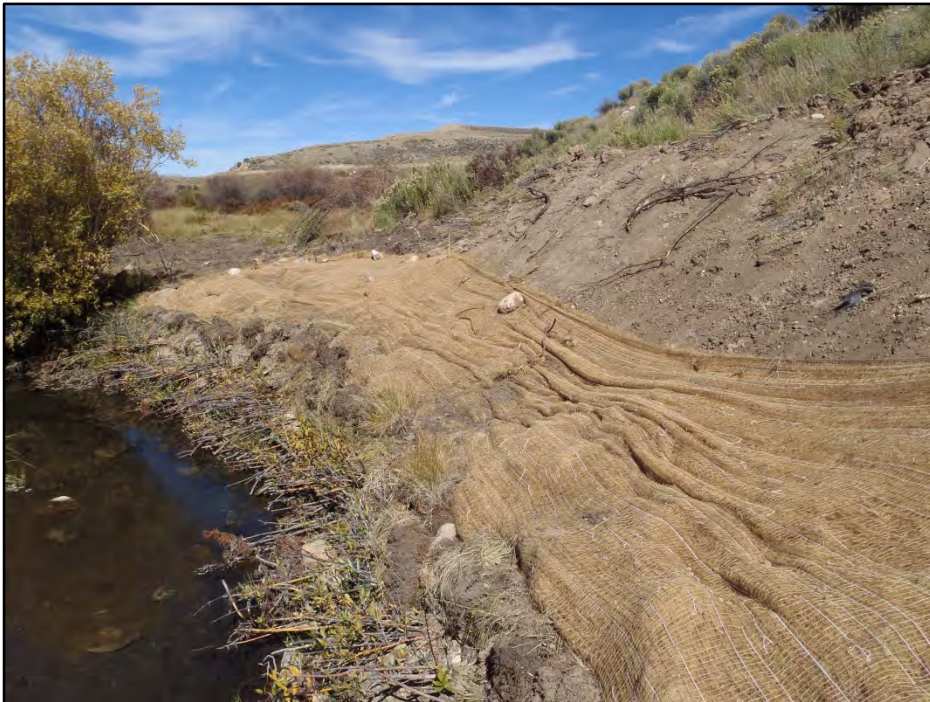
Figure 22. Soil lift with erosion mats at Meander 1.

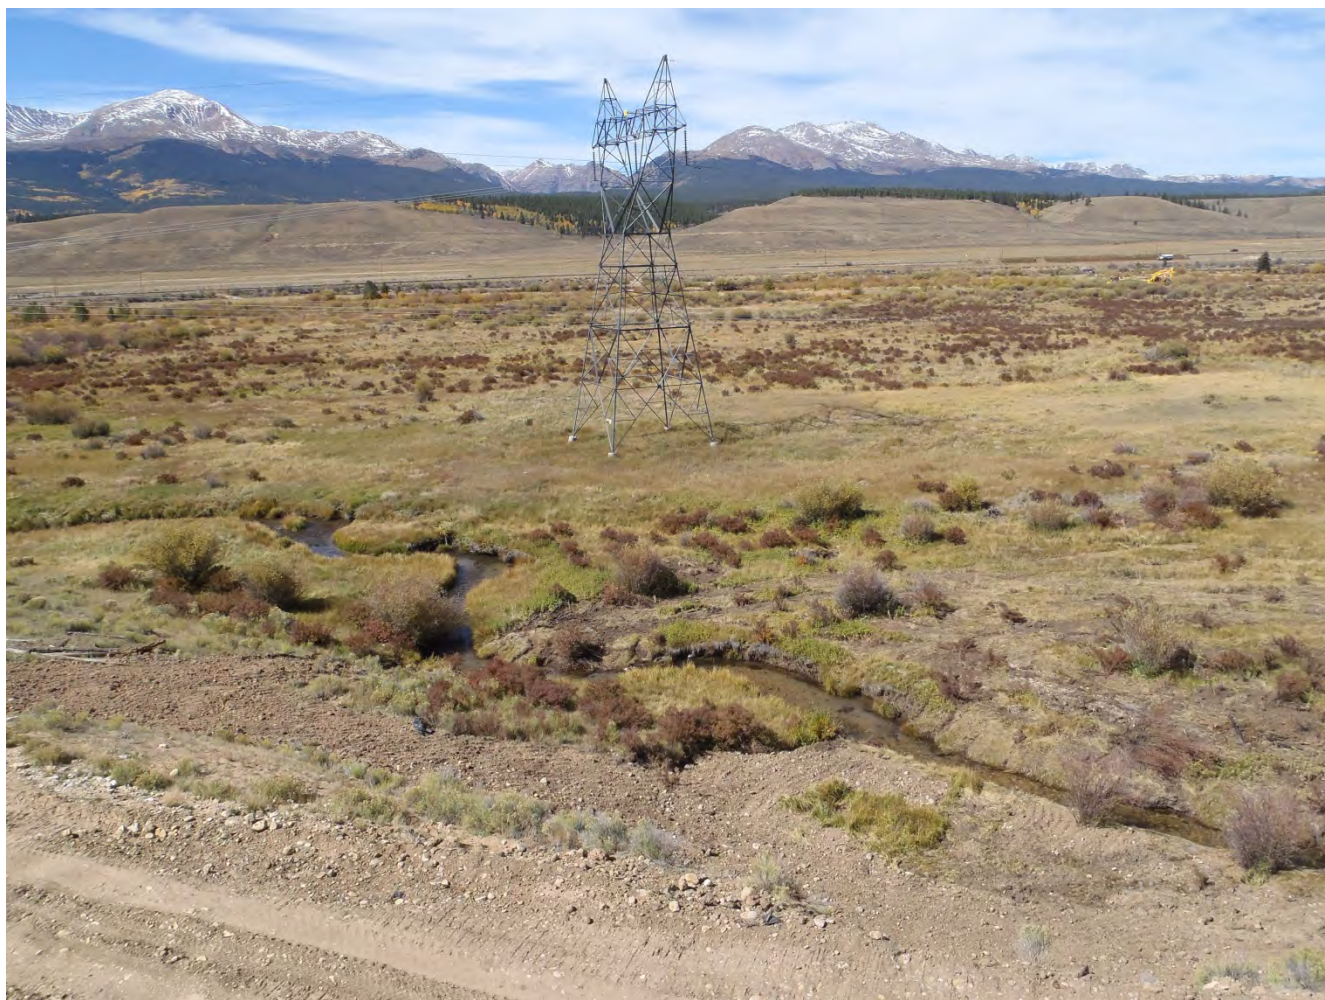
**Figure 23. Completed channel realignment at Meander 2.**

Construction of the modifications around the Meander 1 area and all construction in the Meander 2 area were completed by North State Environmental on September 14 and 15, 2013. Near Meander 1, new channels were created by removing an oxbow and controlling elevations which will enhance trout habitat. A new channel was cut for Meander 2 and the abandoned channel was backfilled with large cobble. Additional topsoil was side cast from the road above to fill the channel and improve the slope of the hill. Sod mats were also placed on top of the topsoil. At the top of the abandoned channel, large mature willows and sod mats were transplanted to prevent water from flowing down the closed channel. The new channel was cut and rocks were placed on the bottom of the channel. In order to stabilize the channel, sod mats were placed on the banks. CMC NRM students and staff completed backfilling of the banks and revegetated the area by tilling in straw, spreading native upland seed mix and installing erosion mats (Figure 23).

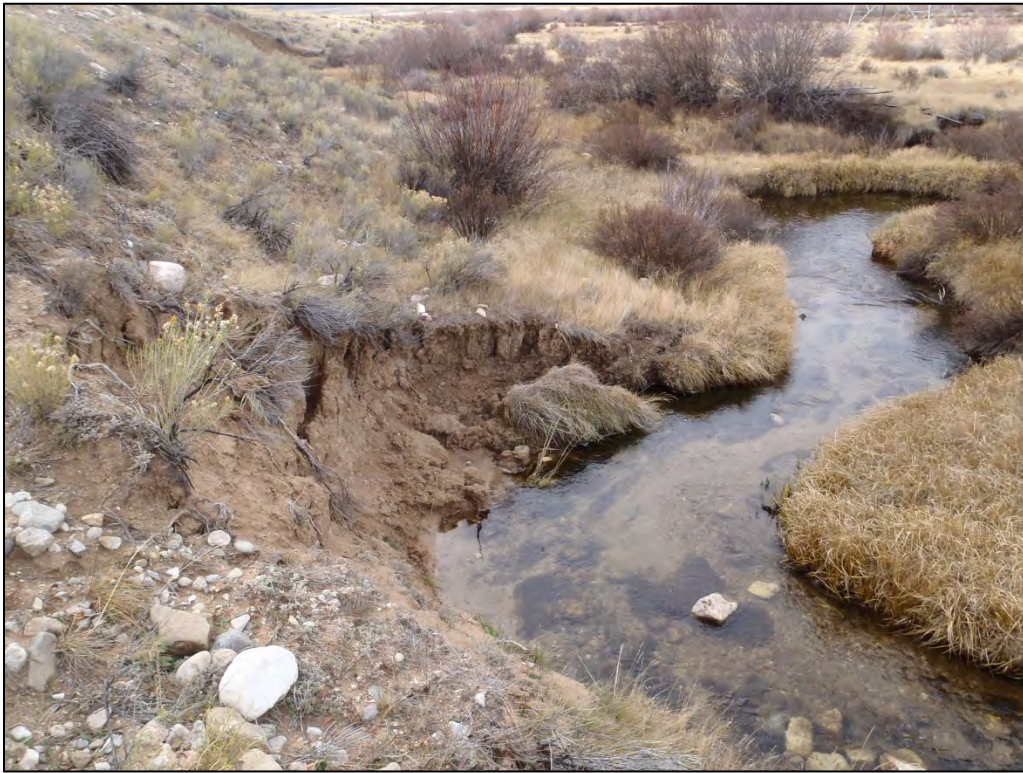
**Figure 1. Photo Point 1 - Meander 1 Pre Construction**

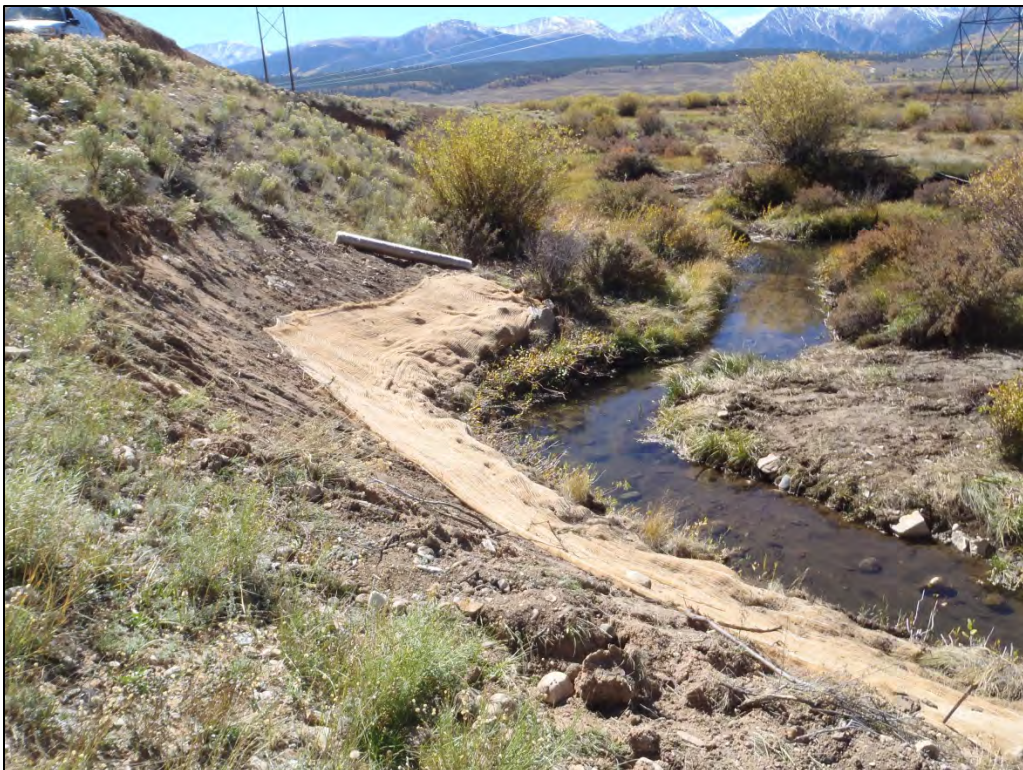
**Figure 2. Photo Point 1 – Meander 1 Post-Construction**

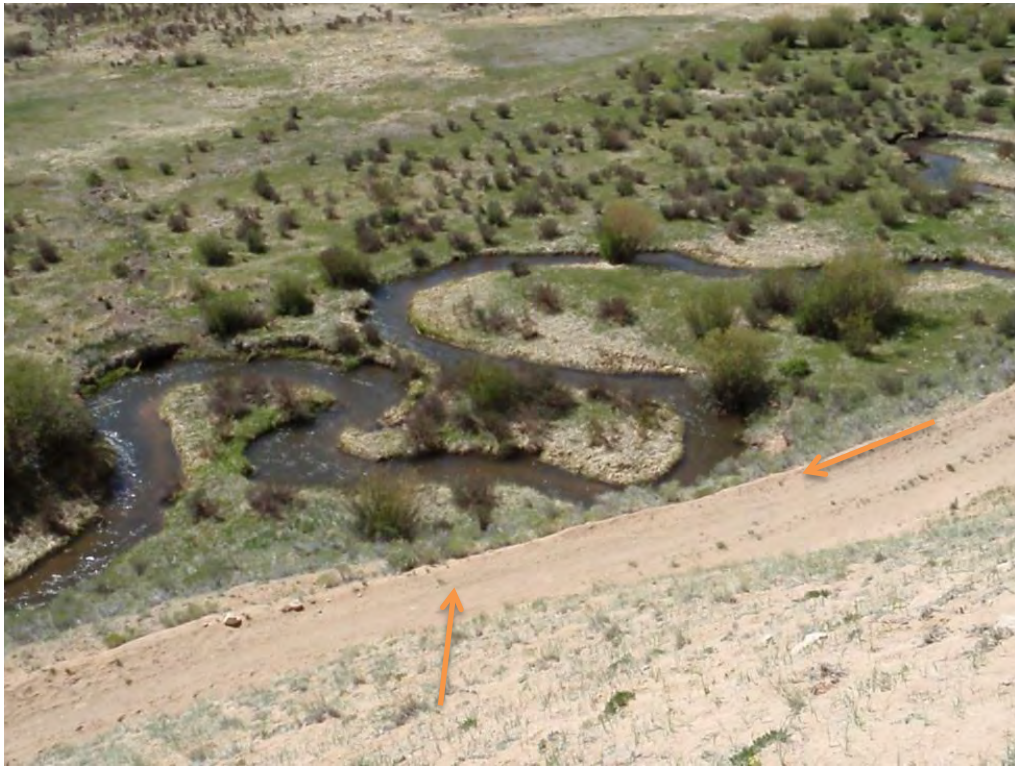
**Figure 3. Photo Point 1a- Meander 1, location of soil lift installation seen between arrow points.**

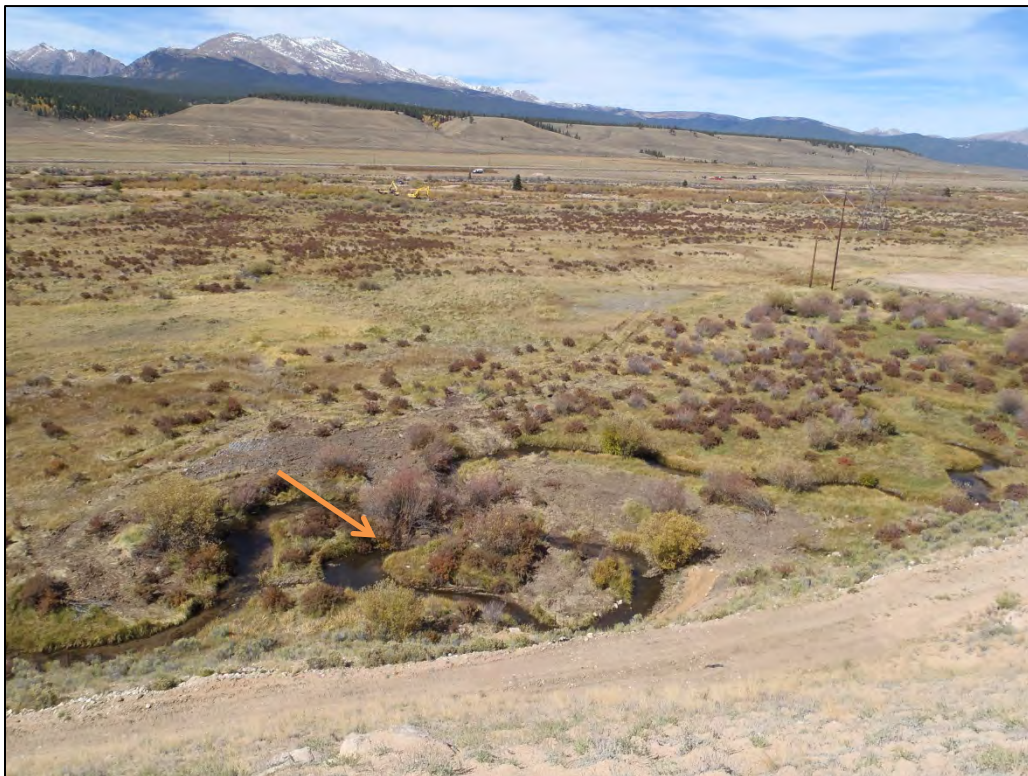
**Figure 4. Photo Point 1a – Meander 1, Post Construction.**  
Note closer of oxbow at orange arrow, new elevation control ripple is behind large transplant willow.

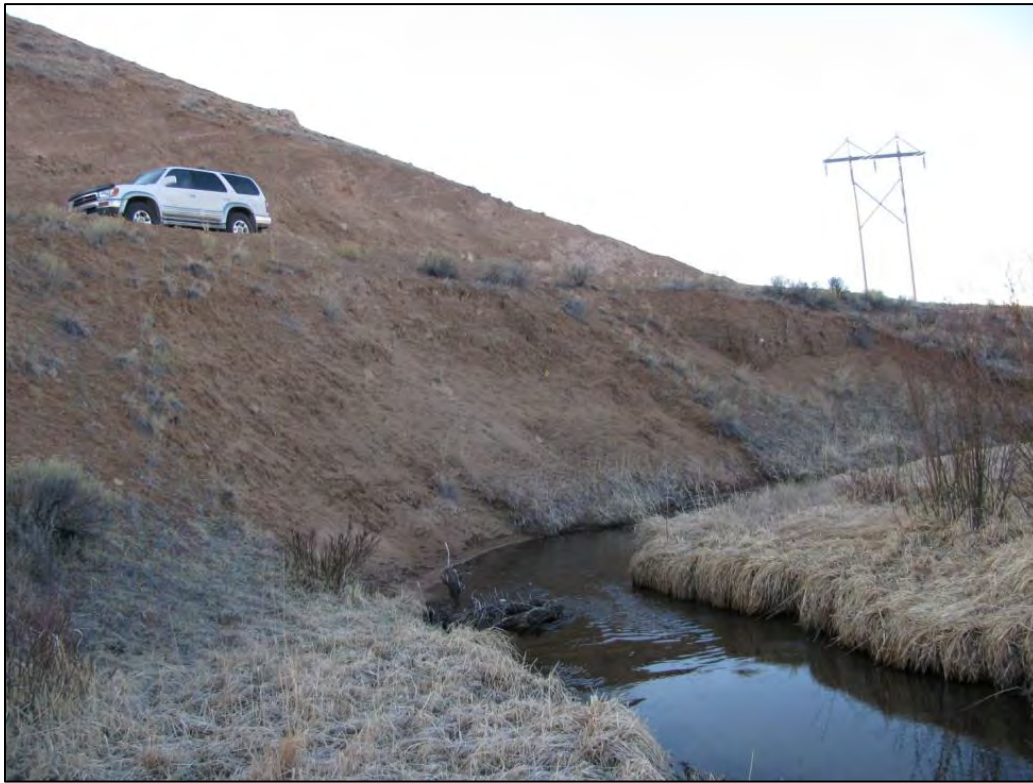
**Figure 5. Photo Point 2 - Meander 2, pre-construction**

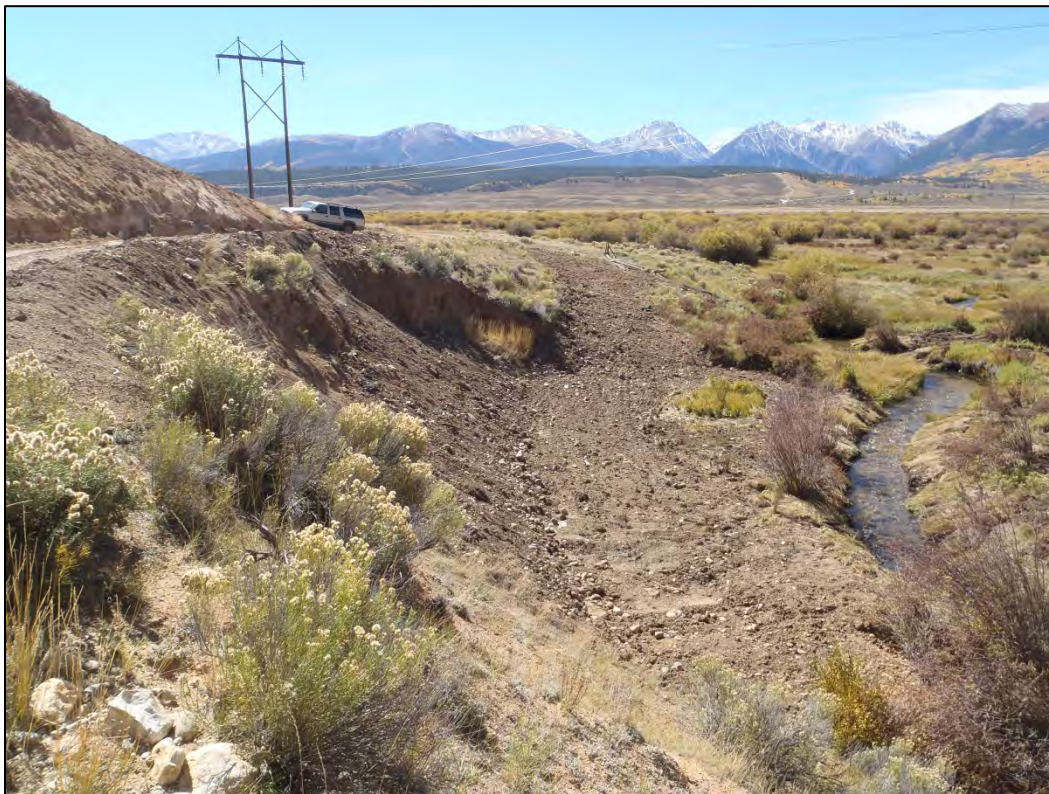
**Figure 6. Photo Point 2 – Meander 2, post construction.  
Backfill is approximately 60% complete in this picture**

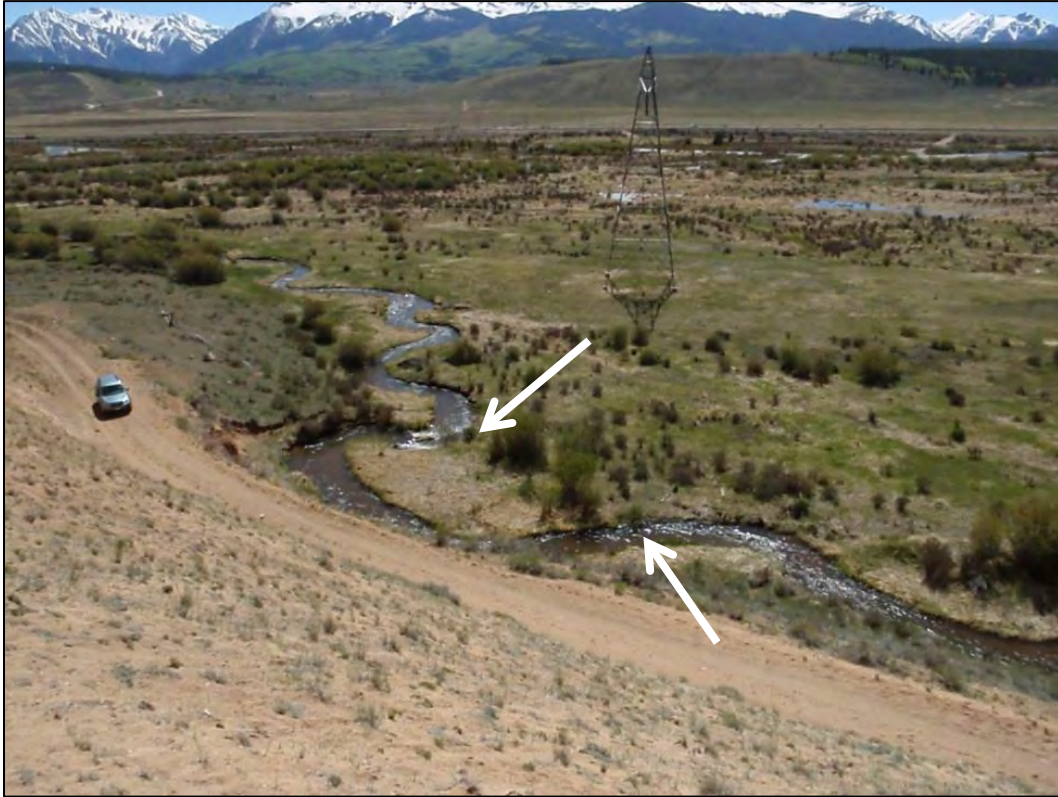
**Figure 7. Location of channel realignment point of exit and re-entry. Pre-construction**

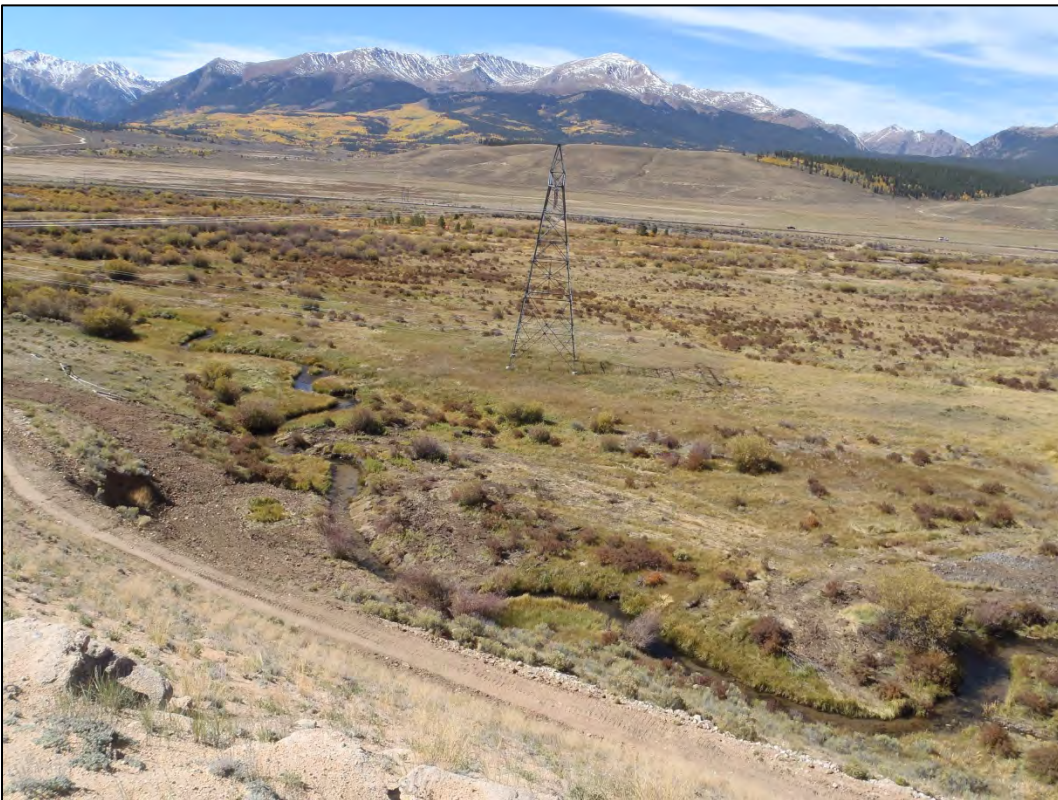
**Figure 8. Photo 2b- Channel realignment post-construction.**

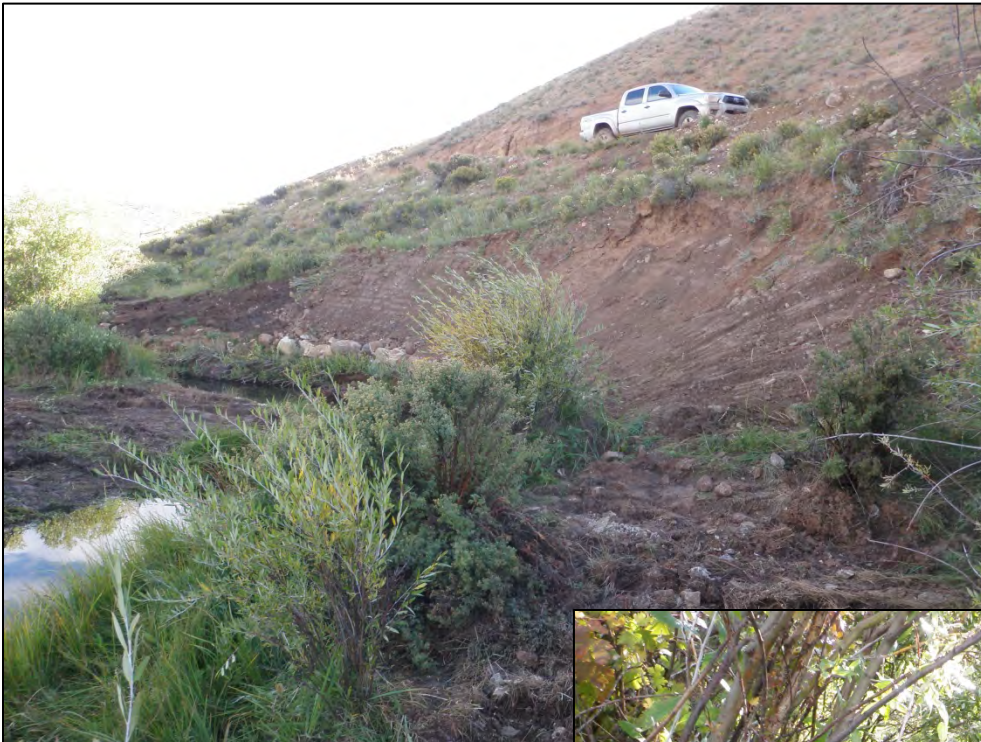
**Figure 32. Re-graded Meander 1 Soil Lift area.**

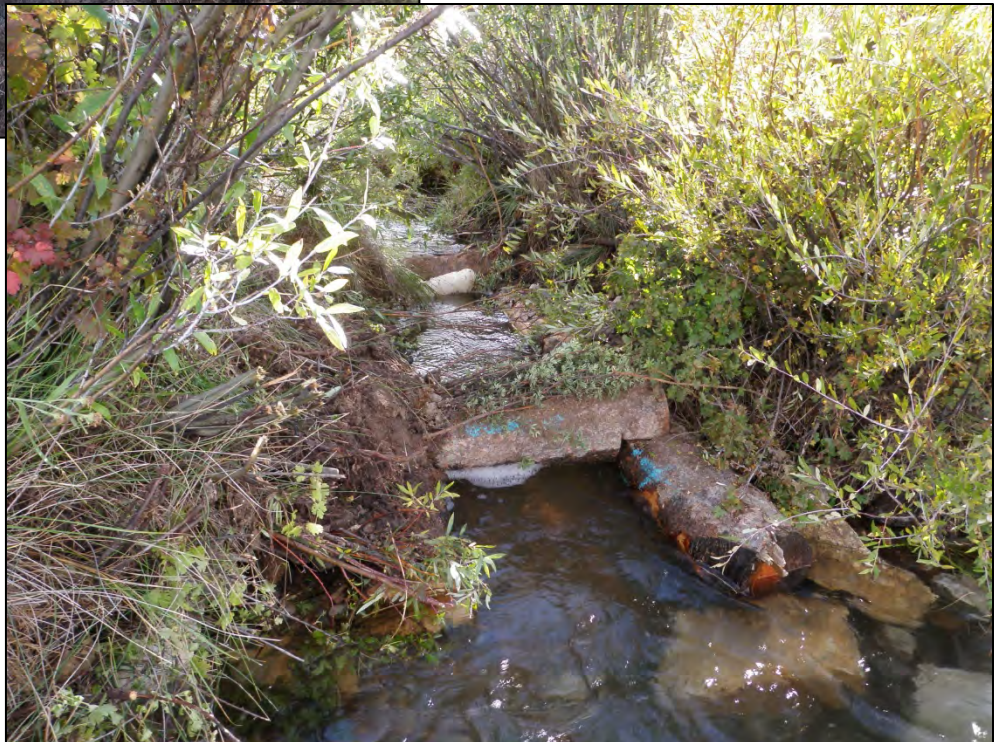
**Figure 33. Log diversion structure used to divide flow into two separate channels creating better fish habitat.**
