North Fork Gunnison River-Midway Stabilization and Riparian Improvements Project

Final Report December 14, 2011

MIDWAY BANK STABILIZATION
DEMONSTRATION PROJECT
NORTH FORK GUNNISON RIVER
DELTA COUNTY, COLORADO
OVERALL PLAN VIEW

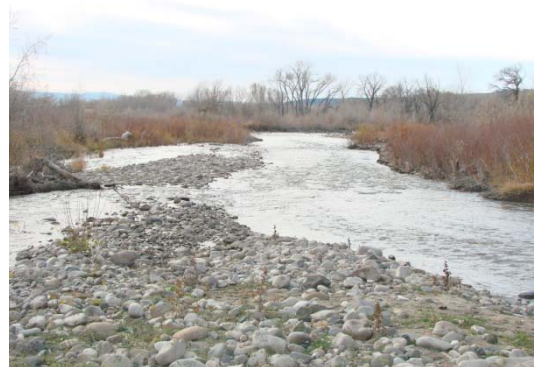
Avulsion channel 2010

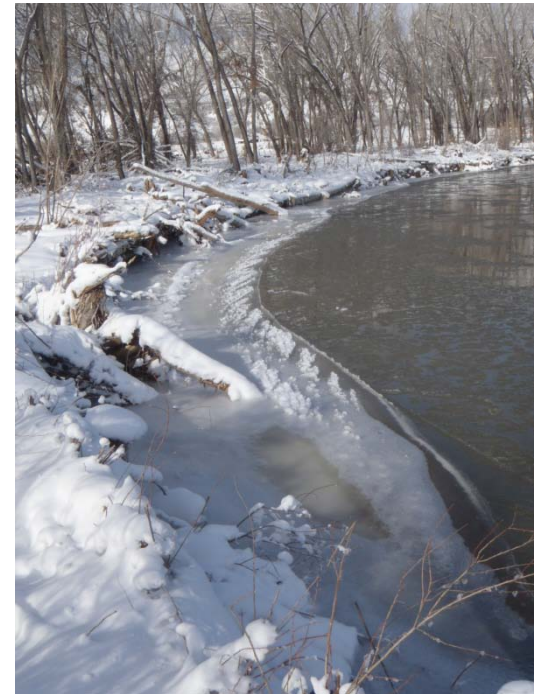
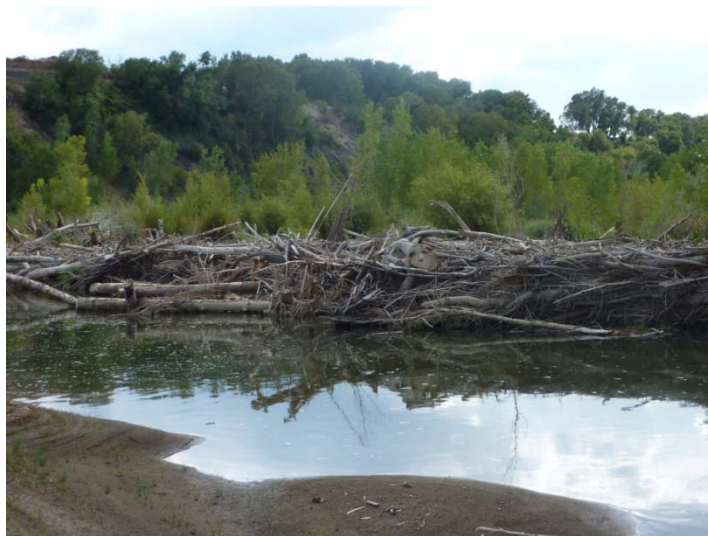
Avulsion channel blocked by woody debris caught in log structures

The structures held up well throughout the above-average spring runoff and actually strengthened itself throughout the process. Tons of woody debris was caught in these structures and created a beaver dam type of structure that allowed small amounts of water through but diverted the flow of the river back into its original meander. Much of the live willow silt fence became buried under mounds of woody debris but 2 months after the runoff subsided willow starts began to sprout up throughout the structure. The avulsion channel began to receive deposition of silt and native riparian seeds and cottonwoods starts sprouted up all across the previous active channel.

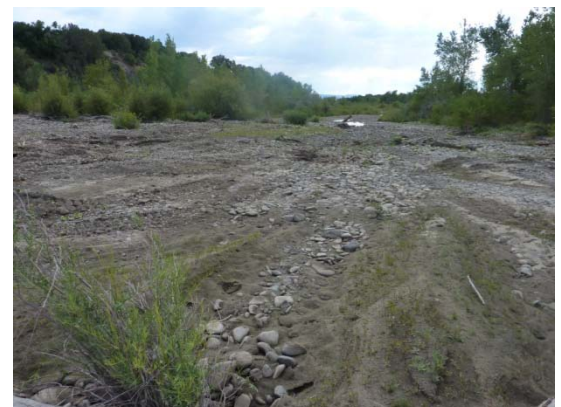
The avulsion channel that was created when the river cut through the meander bend can now act as a part of the active floodplain. Floodwaters are still allowed to overtop the structure during the runoff events which will help dissipate erosive fluvial energy, allow for deposition of sediment and the regeneration of riparian vegetation to absorb nutrients. *(Photo at right shows avulsion channel in Sept 2011 with sprouts in recent silt deposition)*

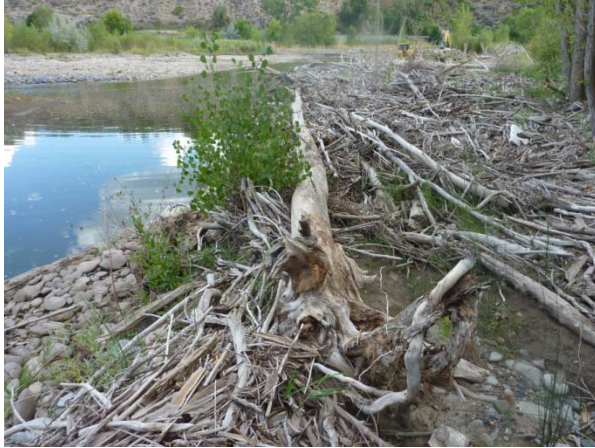
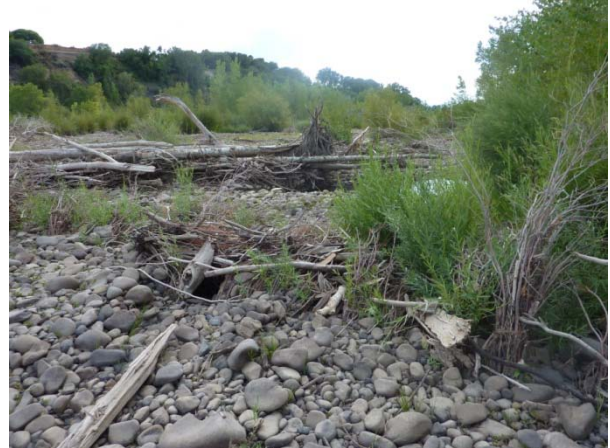
Regeneration of native cottonwoods and willows following the high runoff event of 2011

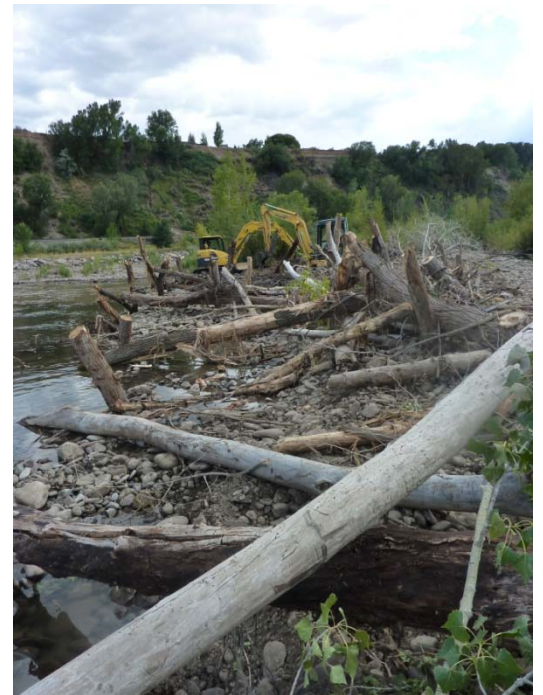
As with most stream restoration projects there are usually some unanticipated results. This project was no exception. Following the runoff the thalweg of the channel moved toward river left and developed a more direct line toward the avulsion channel (*see the plan view drawing-sheet 1 of 7 in the appendix*). The structures held well but the river skirted around the downstream terminus of the structures and began to develop another active channel. An adaptive management plan was implemented in September 2011 and as a result the length of the structure was extended another 150 feet and the secondary channel was then abandoned. The entire river is in the original meander and expected to remain that way (*Photo on right shows construction of the extension*). The new floodplain on river right received large quantities of sediment and has already begun sprouting sedges, rushes, cottonwoods and willows (*shown below*).

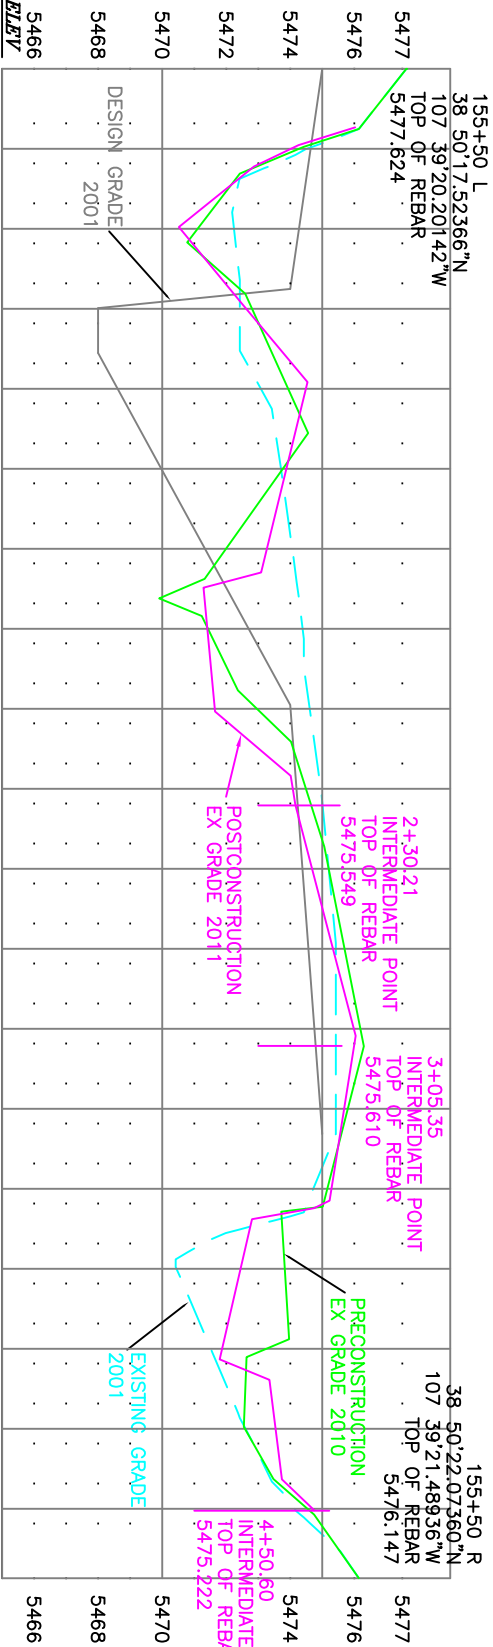
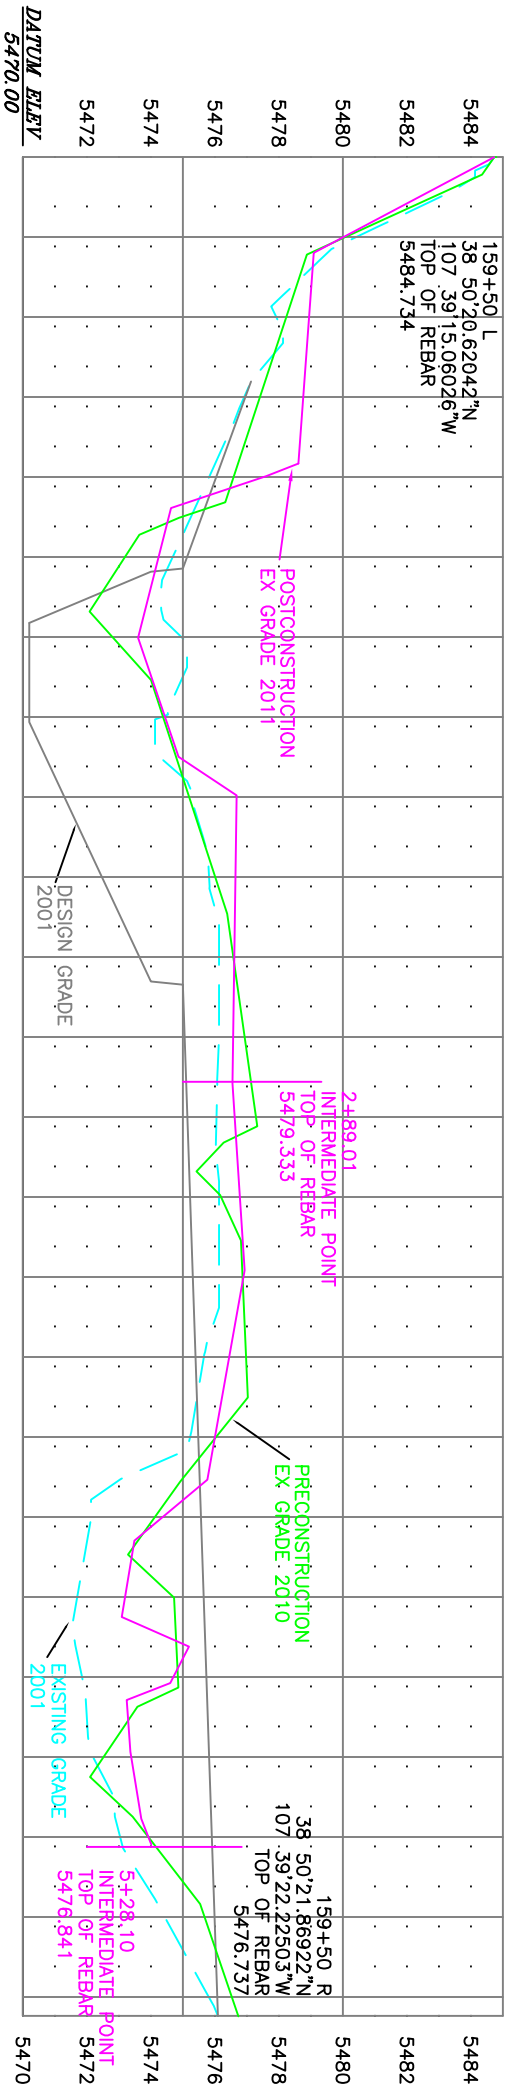
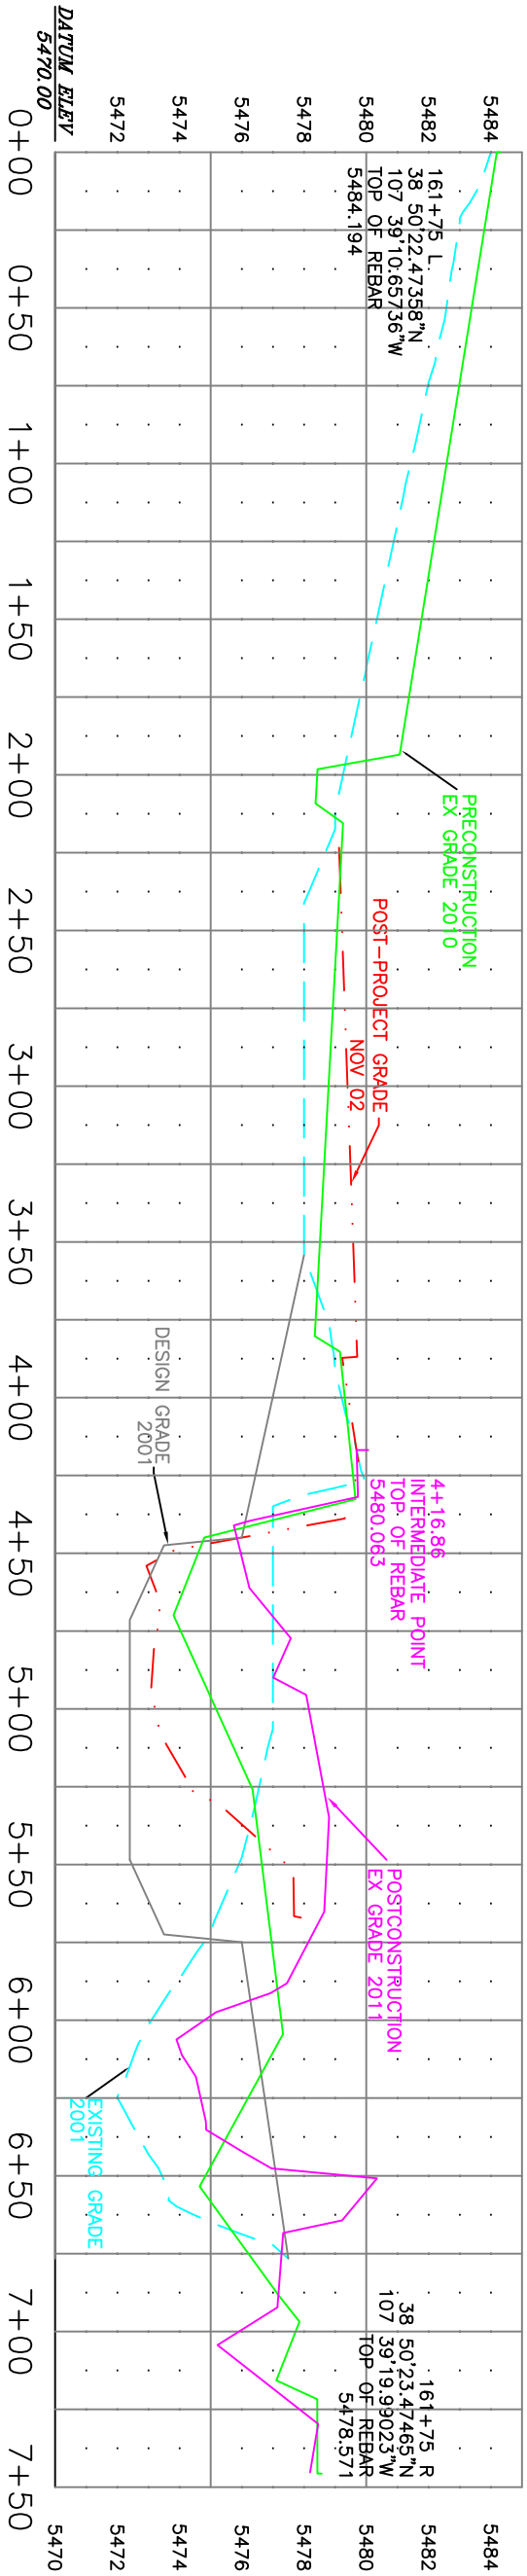
Sheet 4 of 7

The 390 linear feet of streambank that lost nearly 10,000 tons of sediment in two years showed no loss in the high water runoff of 2011. The avulsion channel began a regeneration process with the deposition of fine sediments on the new floodplain and the establishment of new riparian vegetation. The wetlands previously destroyed by the active channel also began to rehabilitate itself with new wetland plants.

A 400 foot reach of the river shifted from left to right but did not contribute to any new floodplain erosion. It was an unanticipated but natural adjustment in the active river channel. The erosion of the new channel was compensated by increased deposition in the old channel and resulted in a balanced relocation of bedload.
