RE: Emergency Consolidated Home Supply Ditch and Reservoir Company ("CHSDRC"), Loan Contract #C150375 - Additional Loan Amount for Big Dam Flood Repairs and Mitigation.

**Re: Big Dam Diversion Structure, Examination and Proposed Repair;
D&A Job No. CG-0122.019.00**

This letter report presents our observations and recommendations for the proposed repair of Big Dam on the Big Thompson River. The top five feet of the dam was washed out during the flooding of September 11 through 15, 2013. Peak flows may have been of the order of 15,000 to 20,000 cfs with maximum overtopping of the structure of the order of 10 feet.

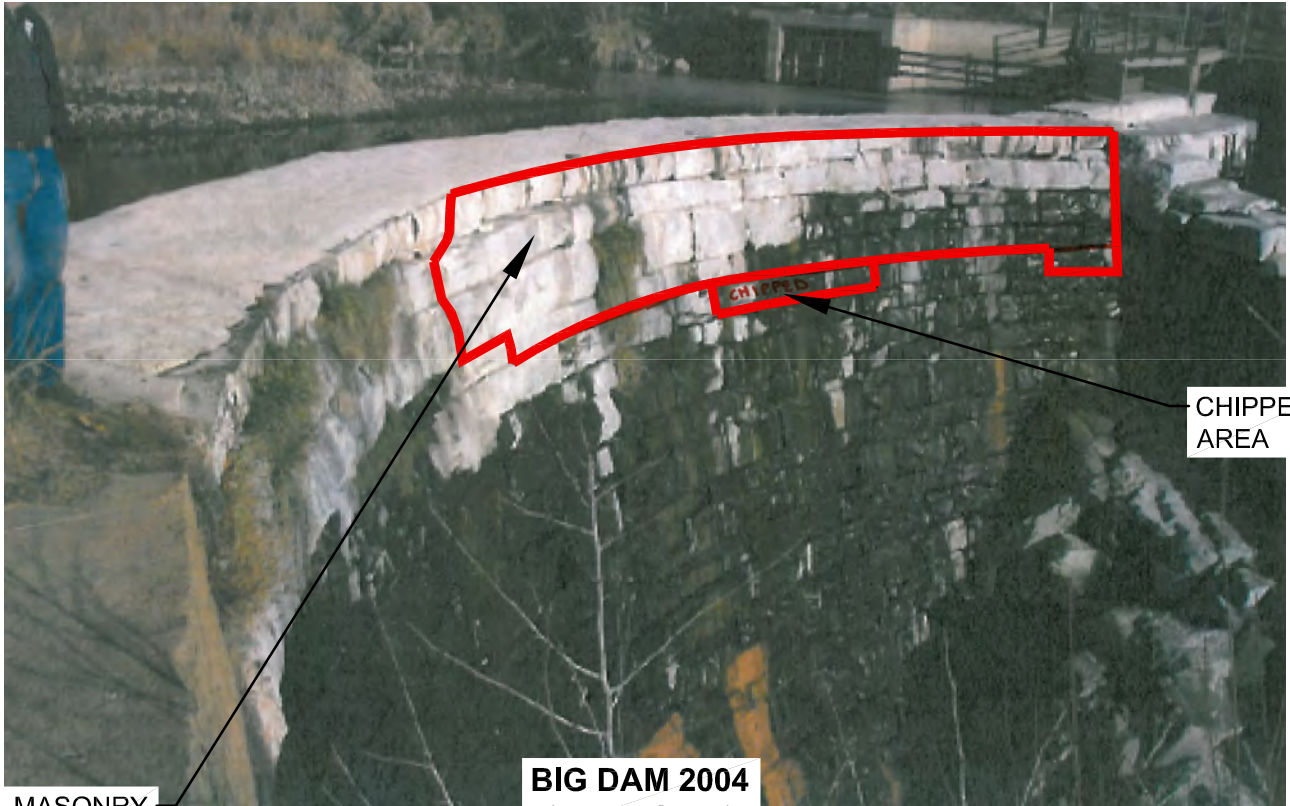
BIG DAM 2004
(VIEW NORTH)

Figures 2 and 3 compare 2004 and October 2013 photographs of the dam's downstream face near the crest. As shown on the figures, four vertical courses of masonry were lost. A fifth course was damaged and chipped locally.

As can be seen on **Figures 2 and 3**, the failed section corresponds closely with an apparent seep line seen in the 2004 photographs. Remnants of the upstream gunite face (sprayed concrete with fine aggregate) can be seen on **Figure 2**. It appears the one to two-inch thick gunite facing, that is believed was installed in the 1960s, only extends about five feet below the original crest. During the flooding, the courses of masonry blocks below the gunite probably experienced uplift forces, which contributed to failure.

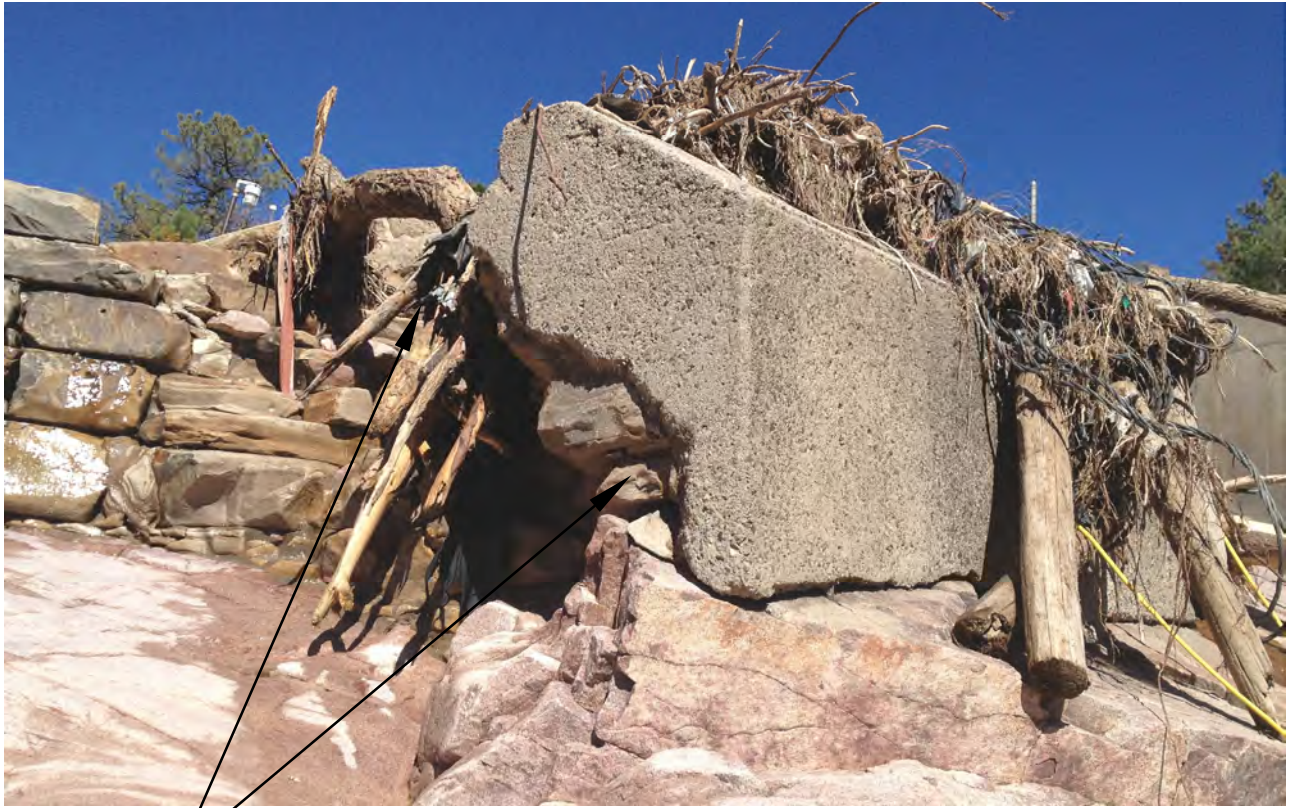
The damage to the arch dam's left abutment buttress is shown on the upper photograph of **Figure 4**. This area may be where failure initiated in the upper dam masonry courses. Most of the arch dam is confined within the narrow slot canyon in very good quality Colorado Red Granite. A coherent arch in compression is formed throughout most of the dam structure, making it a strong and robust structure. The exception to this is the top few feet of the dam, which because of the topography, relies on this artificial buttress thrust block to engage full arching action in the upper dam courses.

Review of flood videos revealed very turbulent flow in the area of the flow restriction caused by the buttress. Masonry blocks in the buttress and adjoining arch dam were probably the first blocks to fail and resulted in loss of arching action for remaining blocks in the upper dam masonry courses. This loss of arching action, combined with hydrostatic uplift, flow velocity and depth, cavitation, and debris impact all contributed to the failure.

DAMAGED LEFT
ABUTMENT
BUTTRESS

The left abutment buttress thrust block needs to be reconstructed. Additional inspection is required once all trash is removed. It could require demolition of some or all of the existing concrete buttress and rebuilding with reinforced concrete. Alternatively, it may be repaired utilizing shotcrete, placement of rock anchors, and grouting.

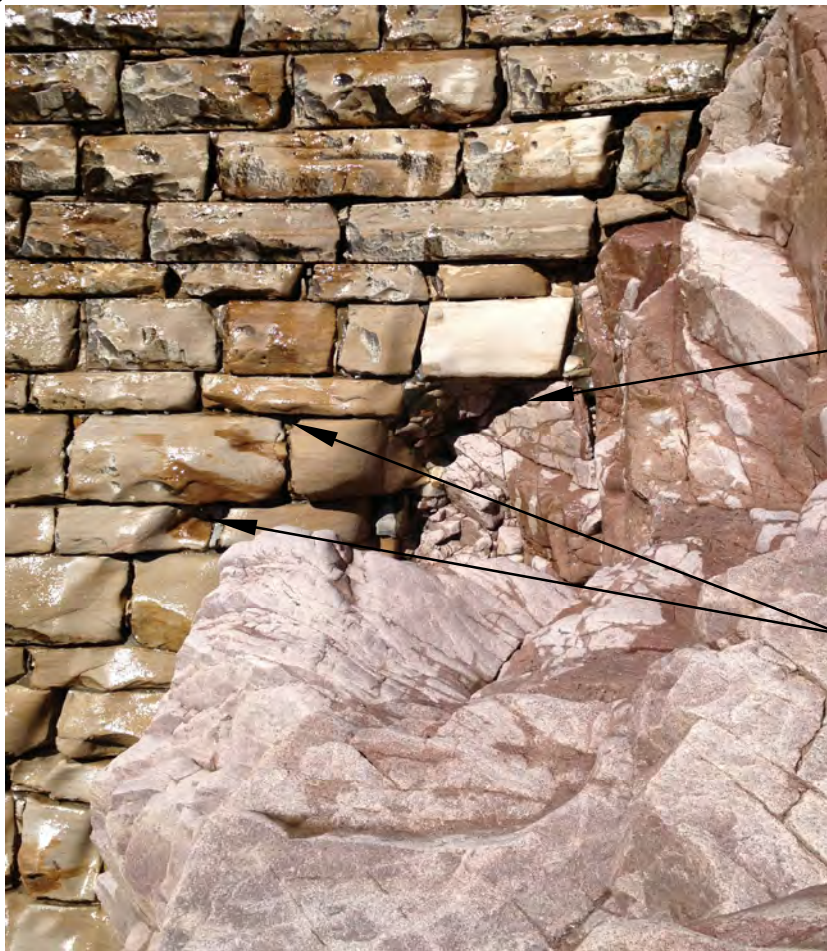
HOLE ON
DOWNSTREAM
LEFT ABUTMENT
CONTACT
APPROXIMATE
20FT BELOW
CREST

DOWNSTREAM
MASONRY
BLOCKS IN NEED
OF MORTAR
REPOINTING

The hole in the downstream left rock abutment contact should be filled with reinforced shotcrete and then grouted. Further inspection will allow us to evaluate if this repair is critical for operation or can be moved into next year's Phase 2 work.

We recommend repointing of masonry blocks on the downstream dam face. Small drain pipes will be installed in the mortar joints to continue to allow drainage to occur. Special care is needed along the rock/masonry contact.

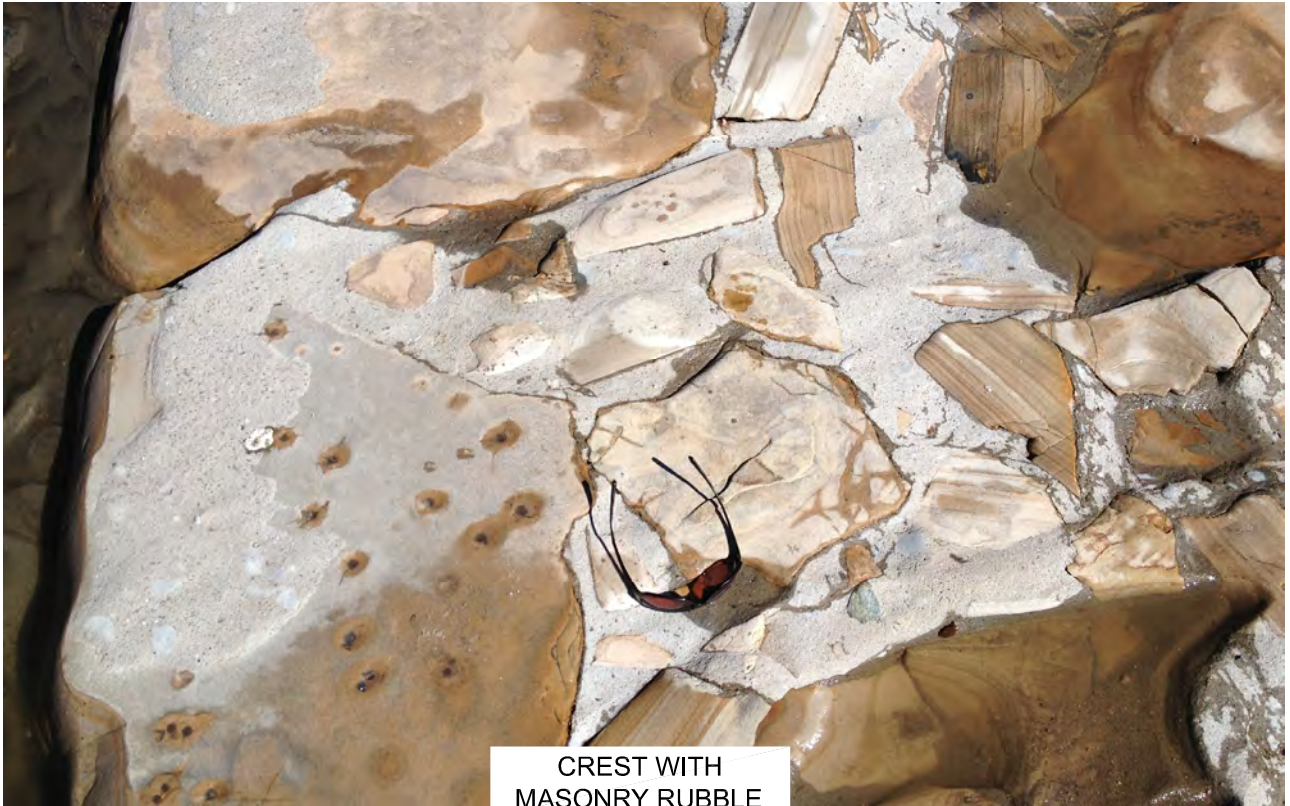
CREST WITH
MASONRY RUBBLE

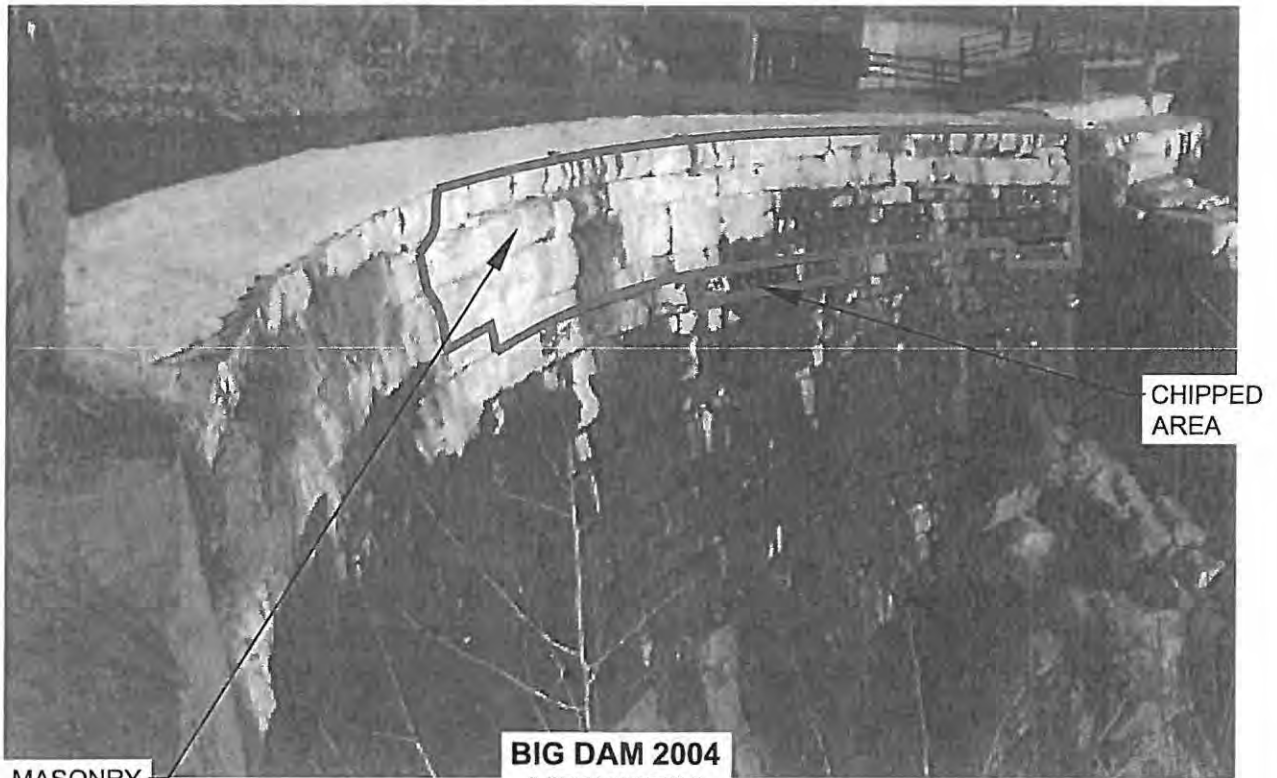
MASONRY
REMOVED
BY FLOOD

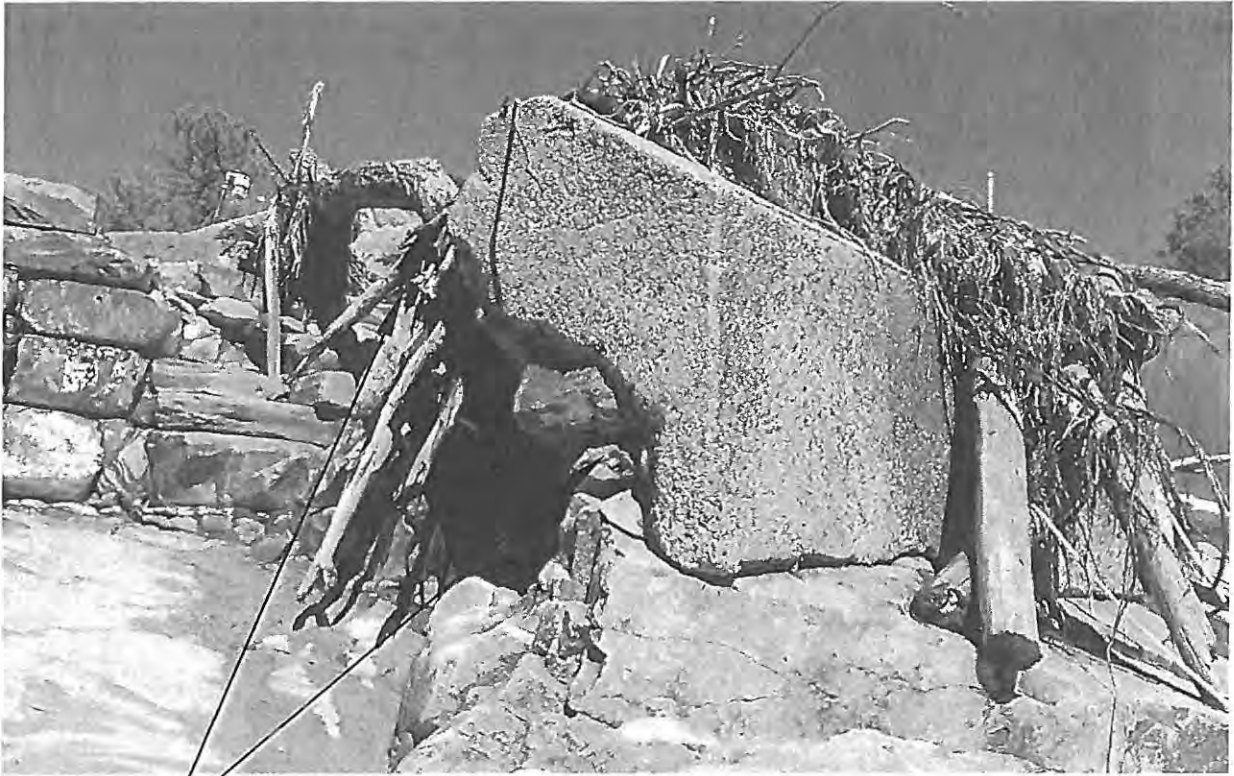
DAMAGED LEFT
ABUTMENT
BUTTRESS

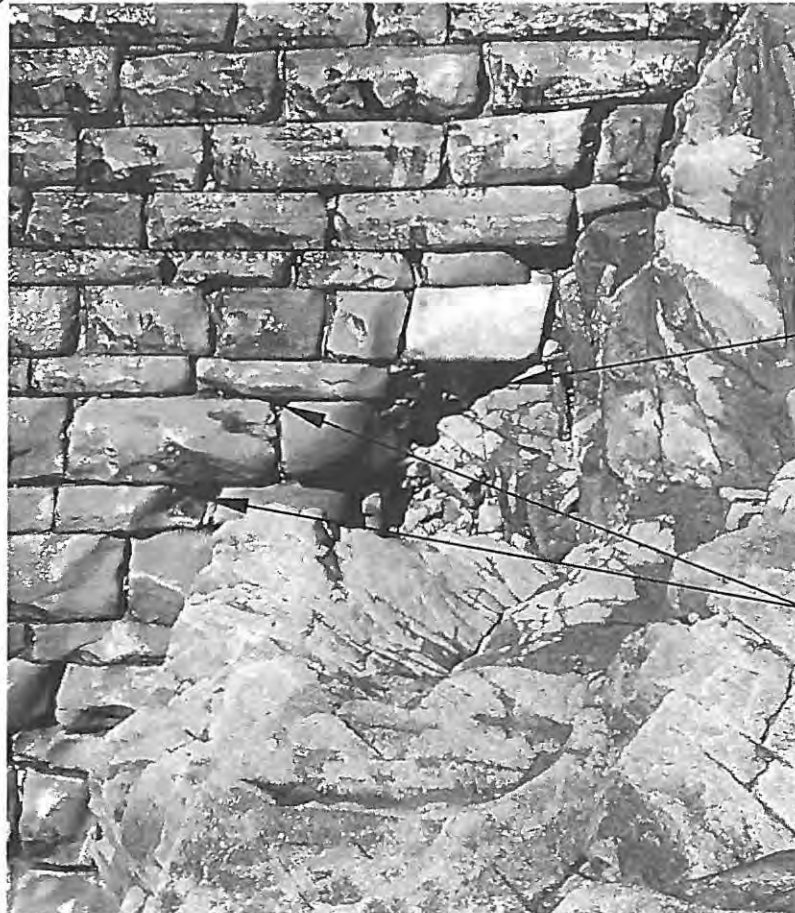
HOLE ON
DOWNSTREAM
LEFT ABUTMENT
CONTACT
APPROXIMATE
20FT BELOW
CREST

DOWNSTREAM
MASONRY
BLOCKS IN NEED
OF MORTAR
REPOINTING

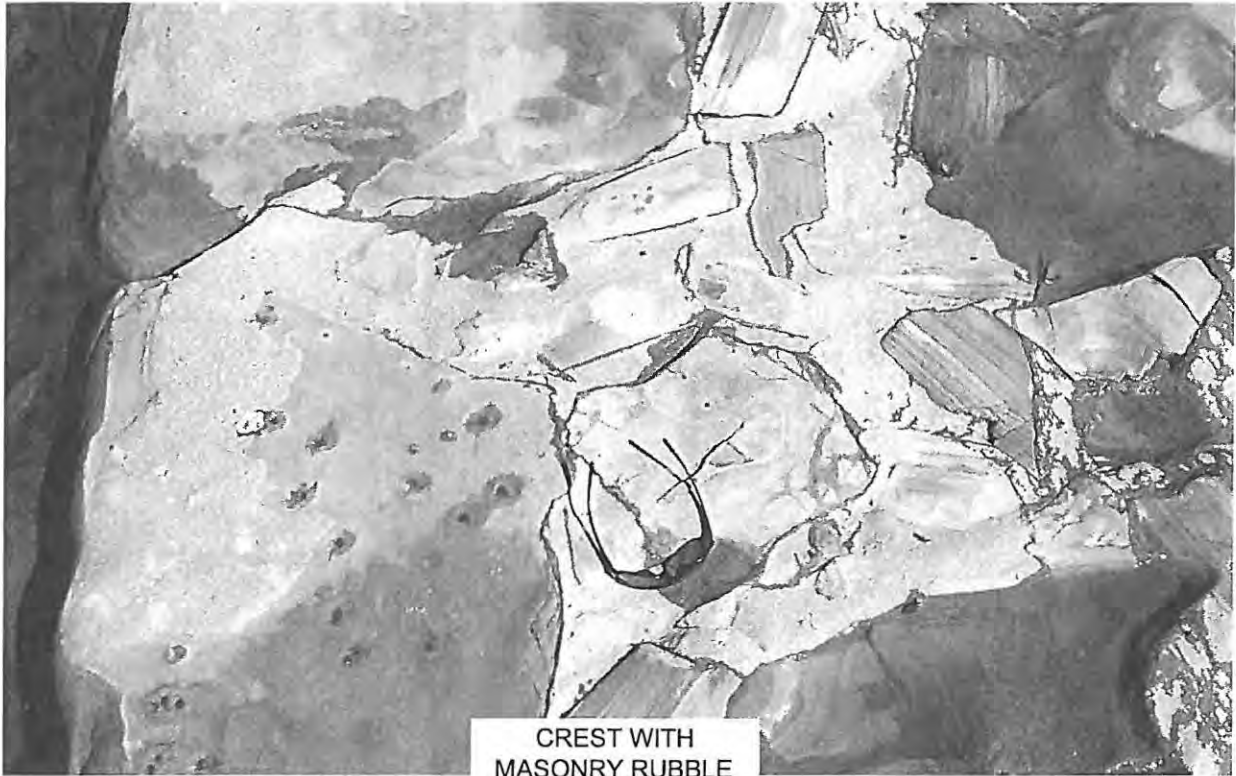
CREST WITH
MASONRY RUBBLE

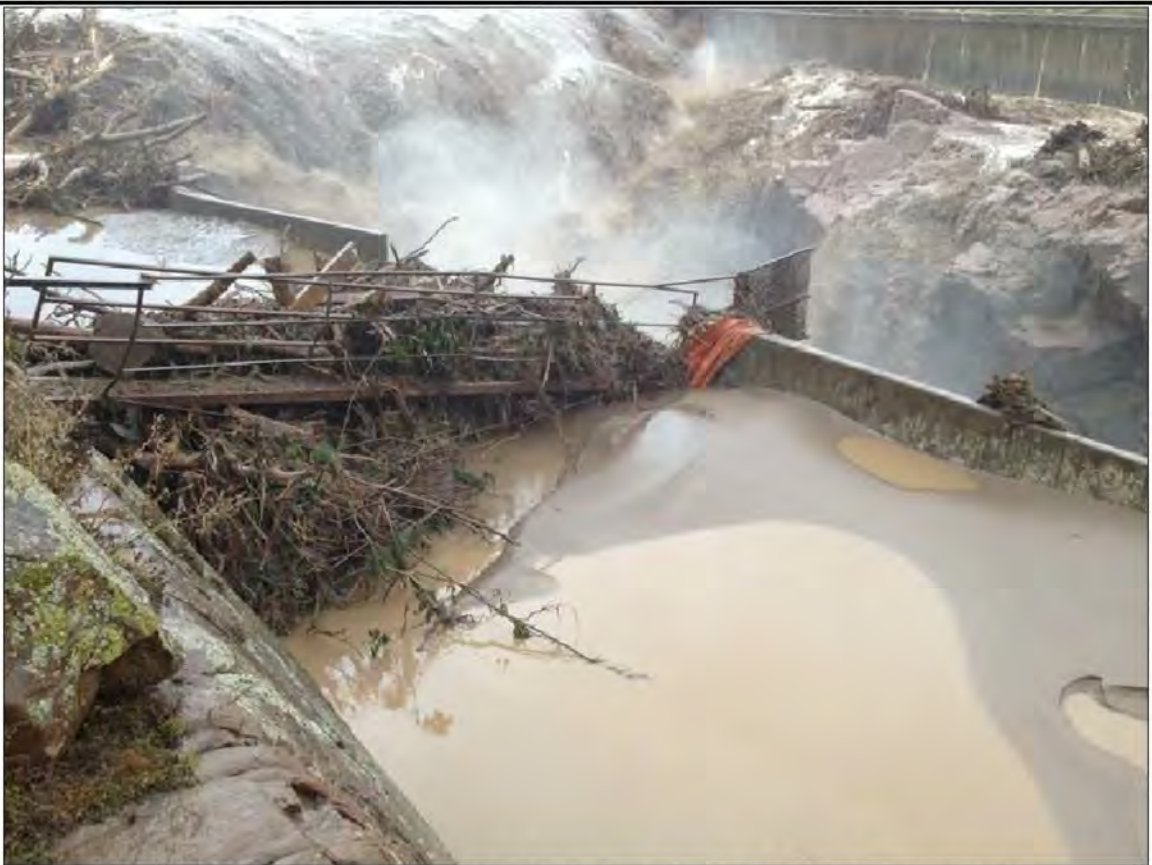
PHOTO 1 - DEBRIS AGAINST SAND OUT GATES ACCESS WALKWAY

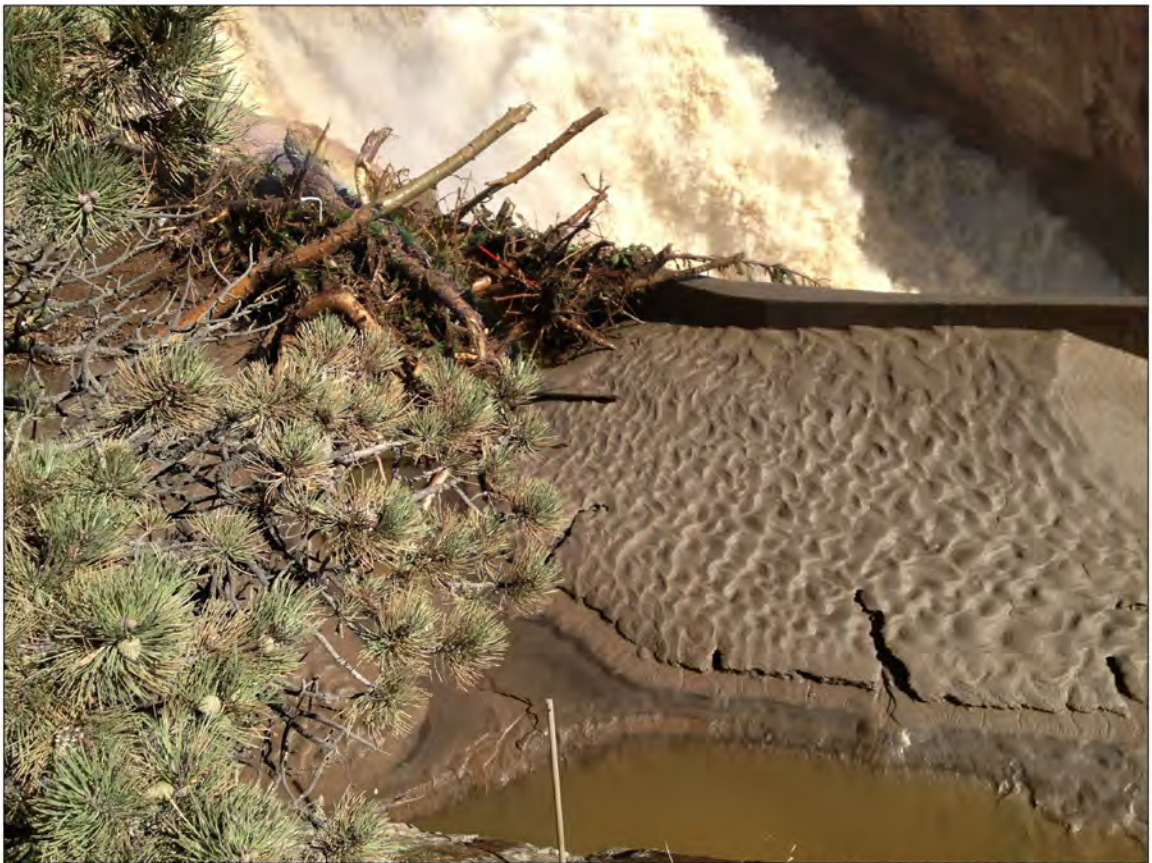
PHOTO 2 - SEDIMENT FILLED IRRIGATION CHANNEL UPSTREAM OF THE SAND OUT GATES

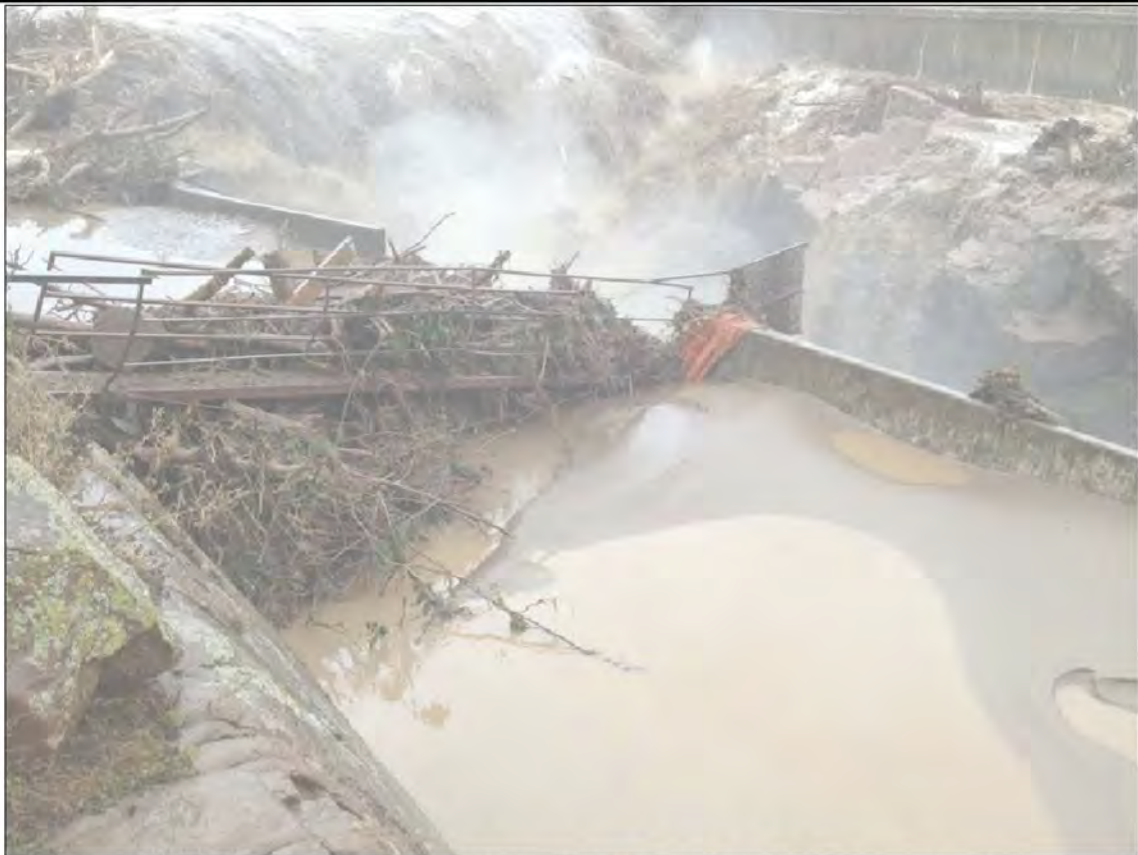
PHOTO 1 - DEBRIS AGAINST SAND OUT GATES ACCESS WALKWAY

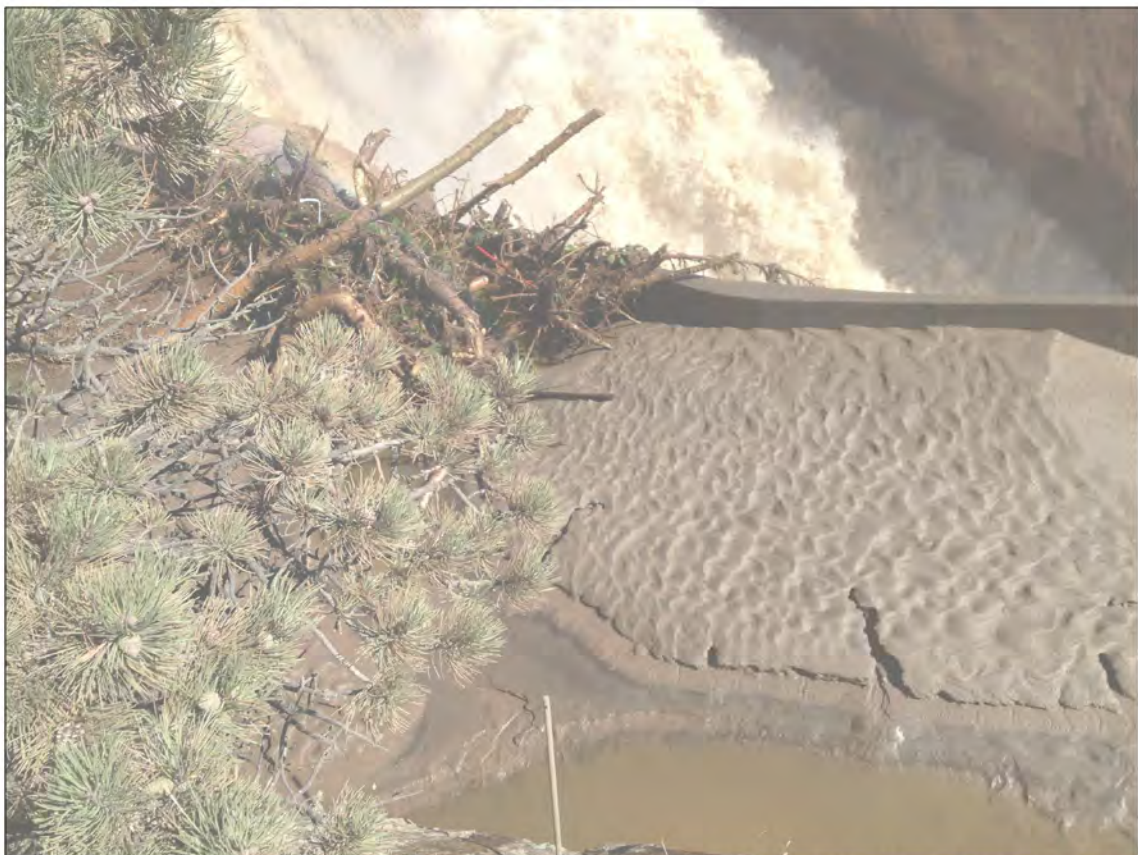
PHOTO 2 - SEDIMENT FILLED IRRIGATION CHANNEL UPSTREAM OF THE SAND OUT GATES

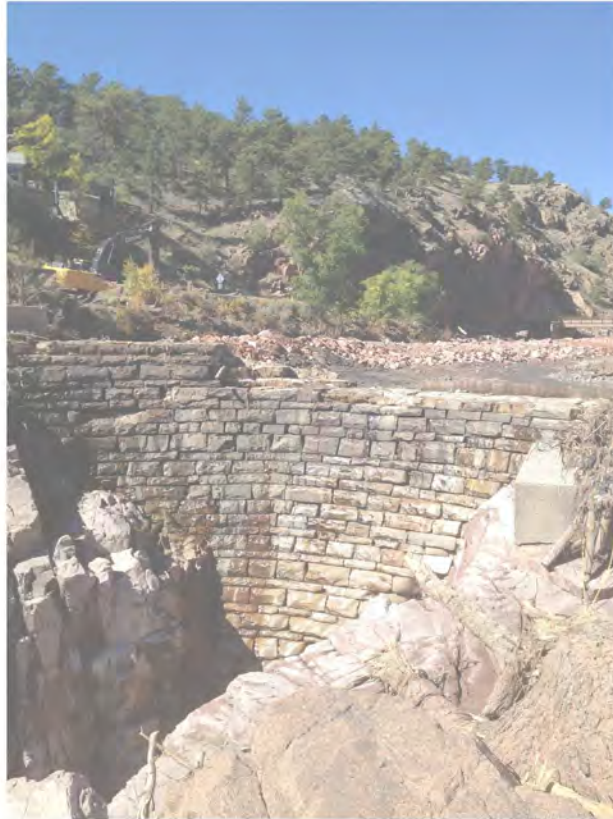
PHOTO 1 - DAMAGE TO BIG DAM (LOOKING UPSTREAM)

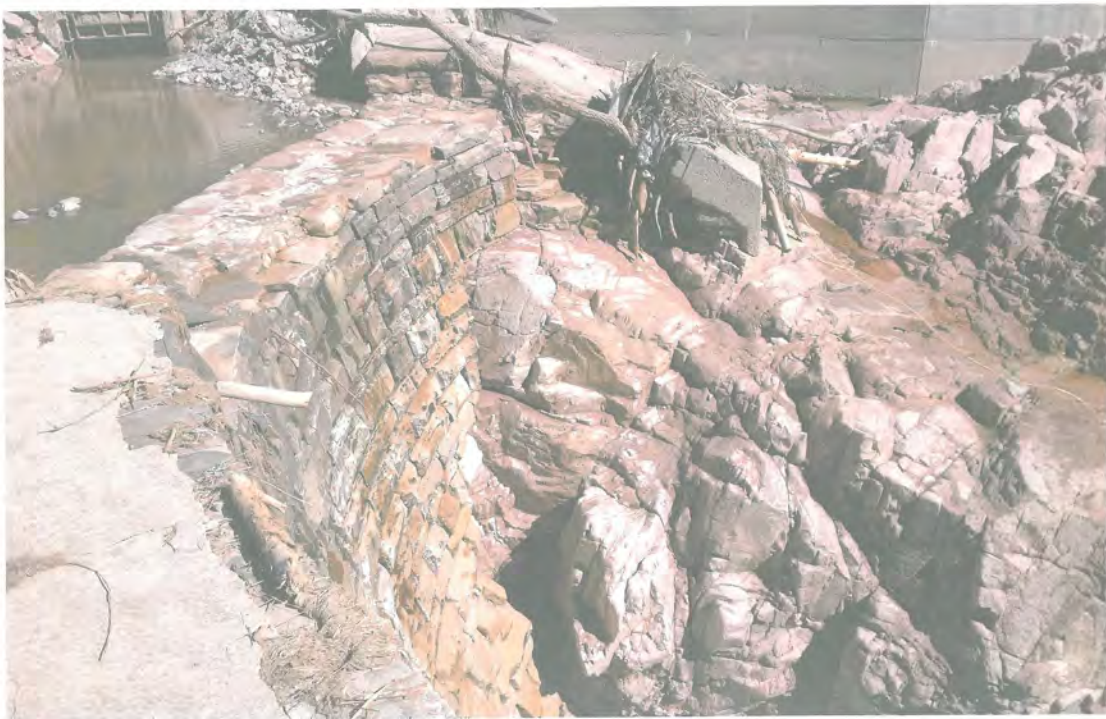
PHOTO 2 - DAMAGE TO BIG DAM (LOOKING AT NORTH ABUTMENT)
