Lone Cabin Ditch and Reservoir Company

DAMID: 400404

Final Construction Report for Dam Repair, Lone Cabin Reservoir

September 11, 2014

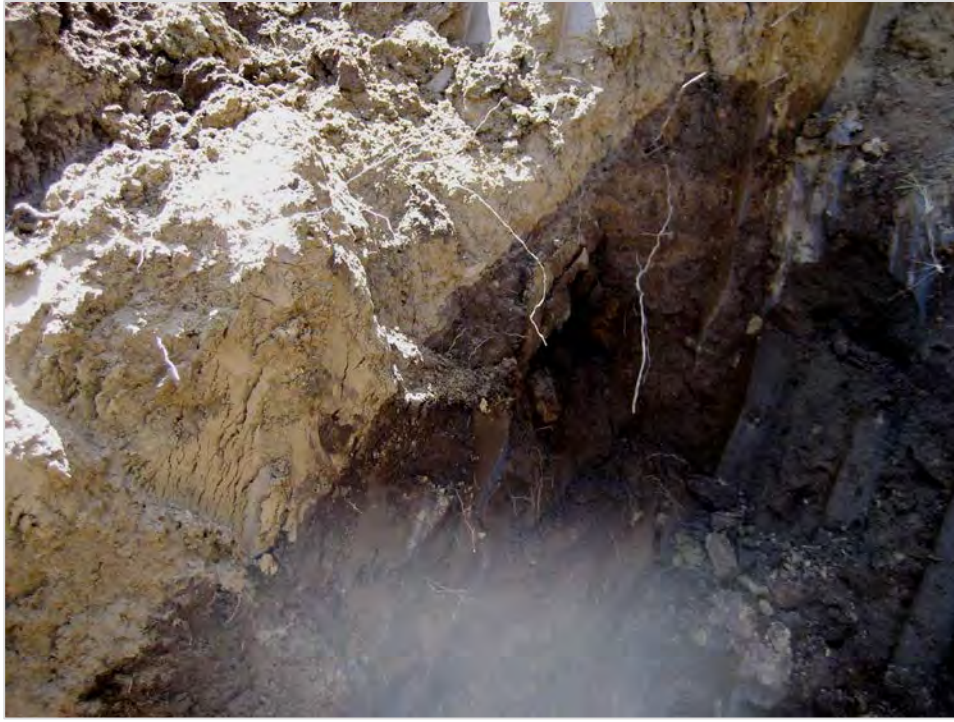
Met Lacy Superintendent, Jason Pietsch and excavator to dig a test trench perpendicular to the slope in the central area of the slump failure. Test trench revealed thick deposits of organic material below the slumped area. The organics extended vertically up to about 10 feet below the surface, were soft and uncompacted, were irregular and extended from above the slump scarp to about 25 feet downslope (as measured along the cut face. Below 25 feet, the organics appeared to taper off and became sparse. Representative photographs are presented as Photographs 1 and 2 attached. Based on this observation, it is our opinion that the organics compressed and caused the slumping noted. This also explains why there was not a "toe" to the slump area as there was not sliding or flow of the slump materials but primarily compression.

Photograph 1: Shows obvious contrast between clay embankment and organics at scarp slump area near top of test trench

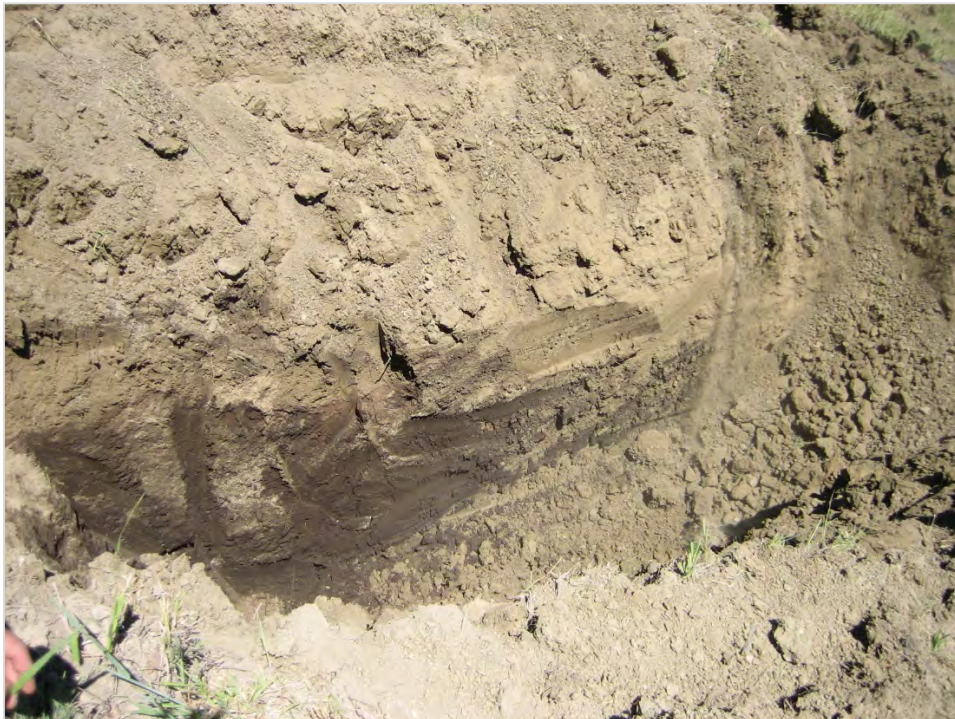
Photograph 2: Organic laden soils below surface clays

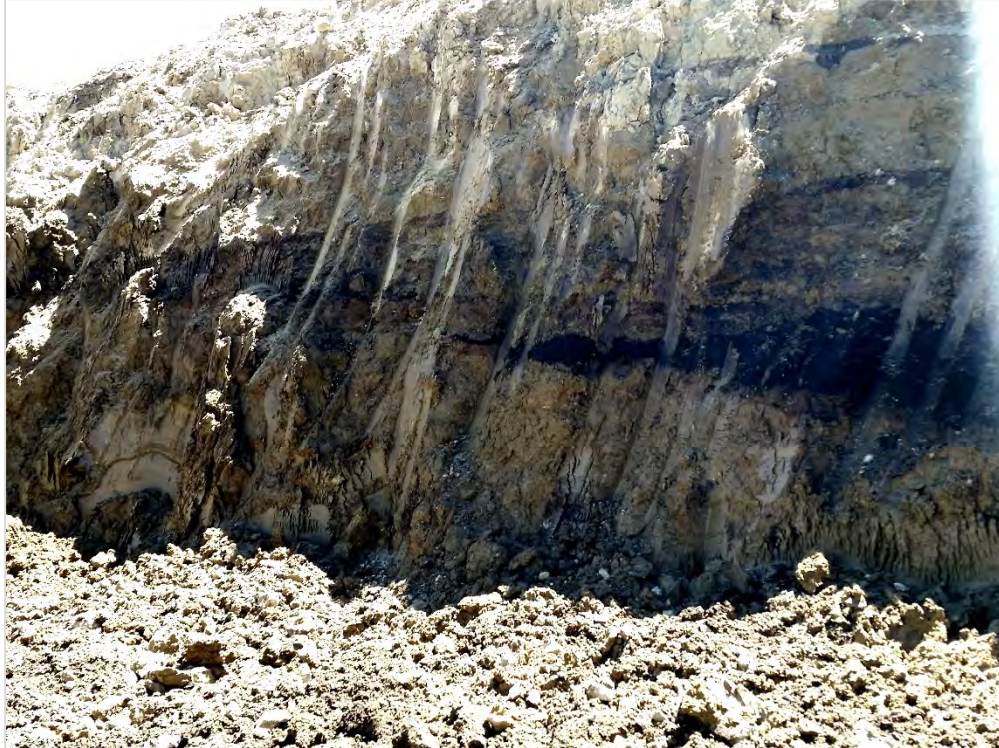
Activities included excavating the slump failure area and segregating re-usable material from unusable organic material and stockpiling in the relatively level area of the north of the dam. A third pile of possibly re-usable material was also created and apparently has slight organic contamination. Hauling of filter sand began today and it was placed on geotextile fabric to separate it from the stockpile area subgrade. Photographs 3-5 represent the day's activities.

Photograph 3: Shows layered nature of the organic material in the side slopes of the excavated area

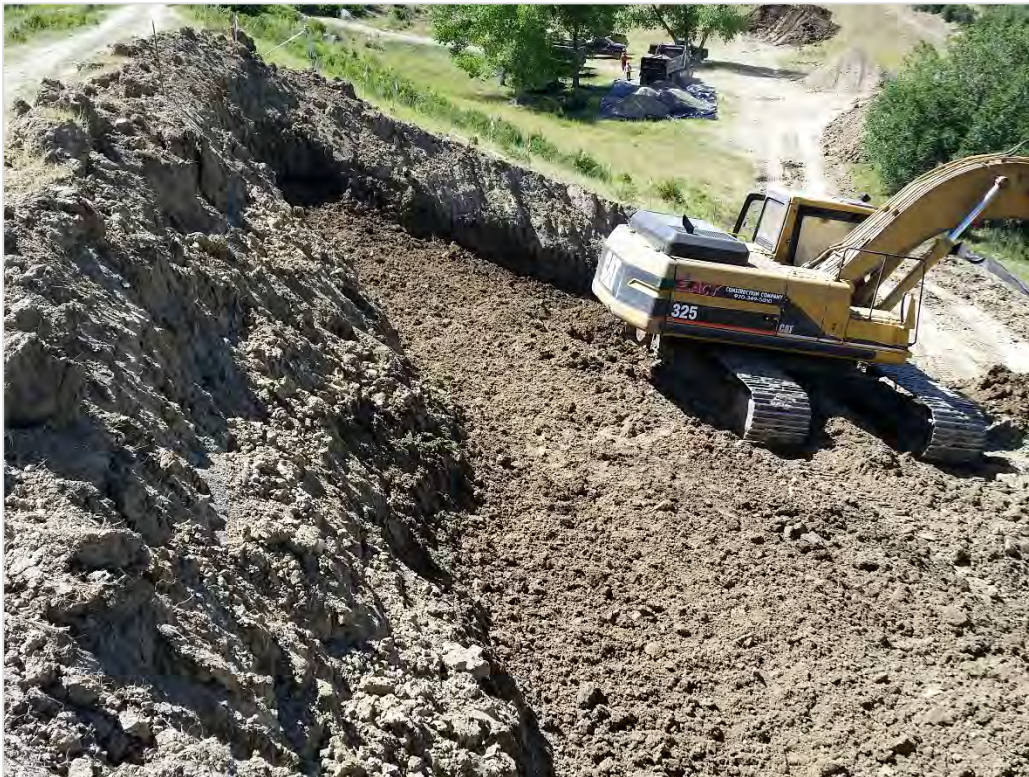
Photograph 4: Shows general methodology and progress of the excavation area

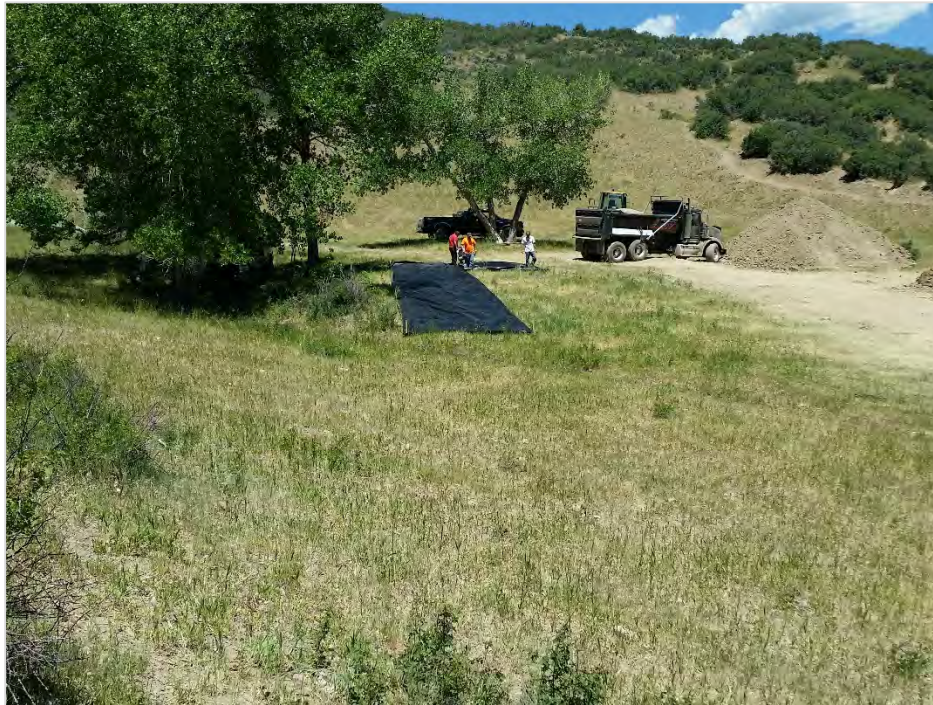
Photograph 5: Shows geotextile fabric being placed in area where filter sand will be stockpiled

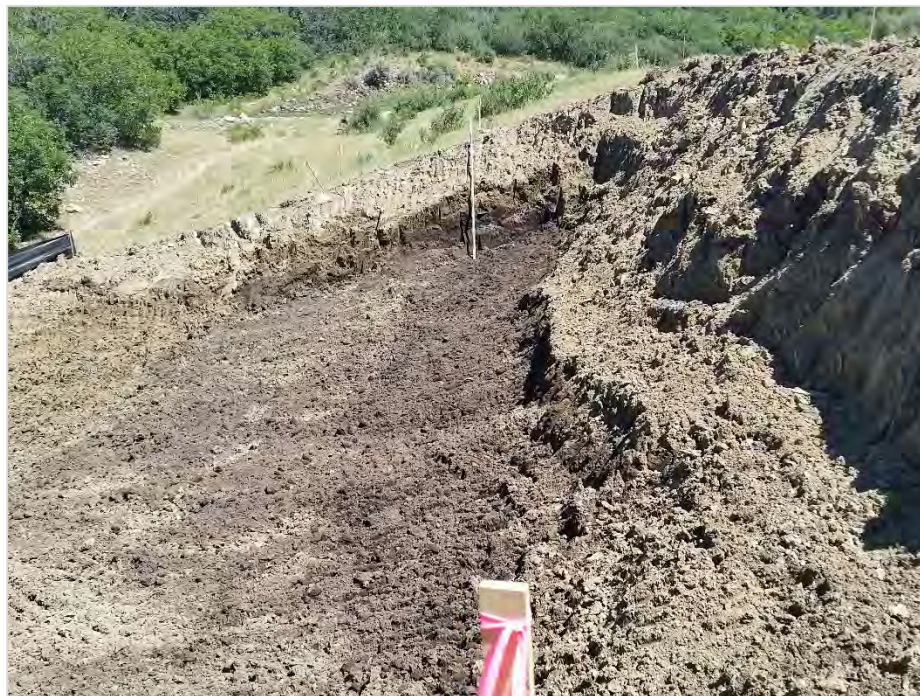
Photograph 6: Shows excavation looking south and the organic material at the base of the cut and the large organic mass extending beyond the planned excavation limits.

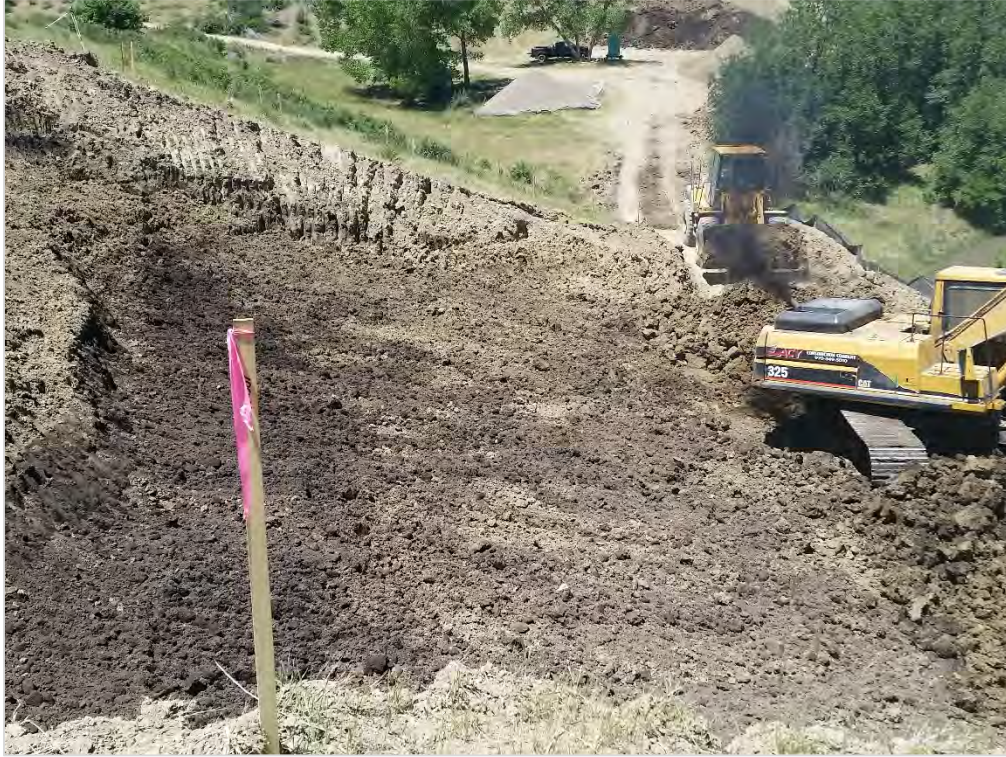
Photograph 7: Shows excavation progress looking north

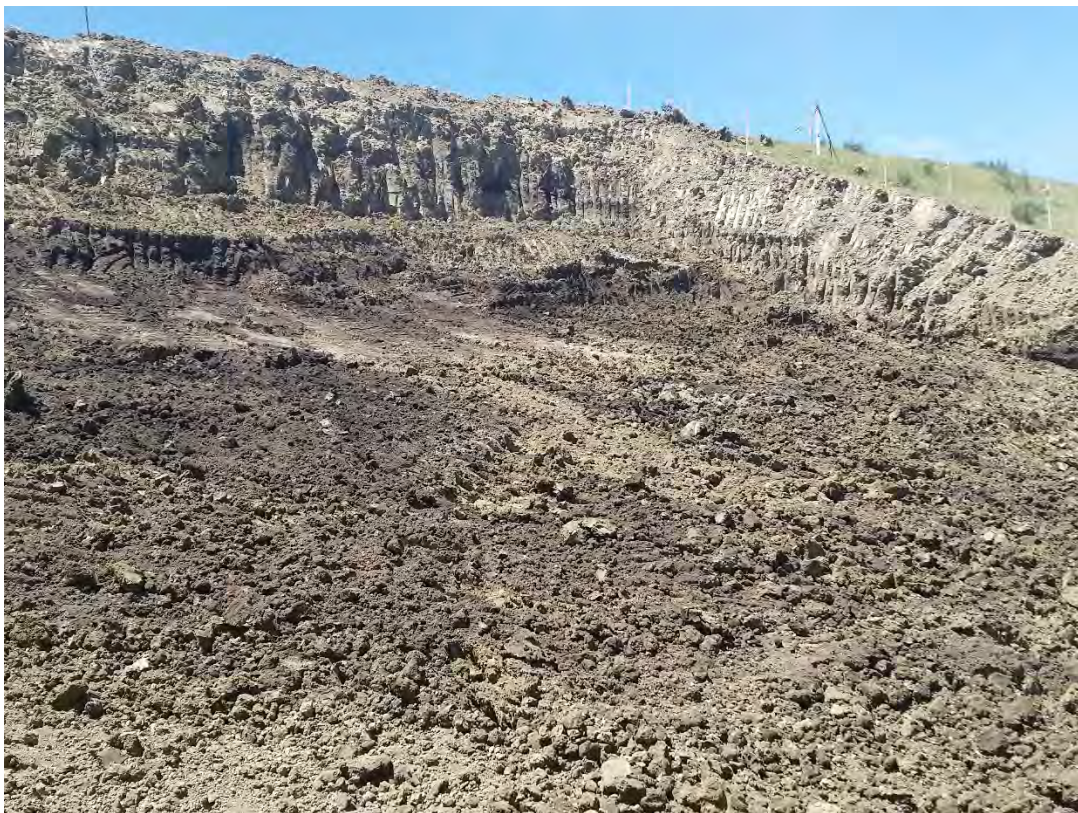
Photograph 8: shows excavated area looking northwest

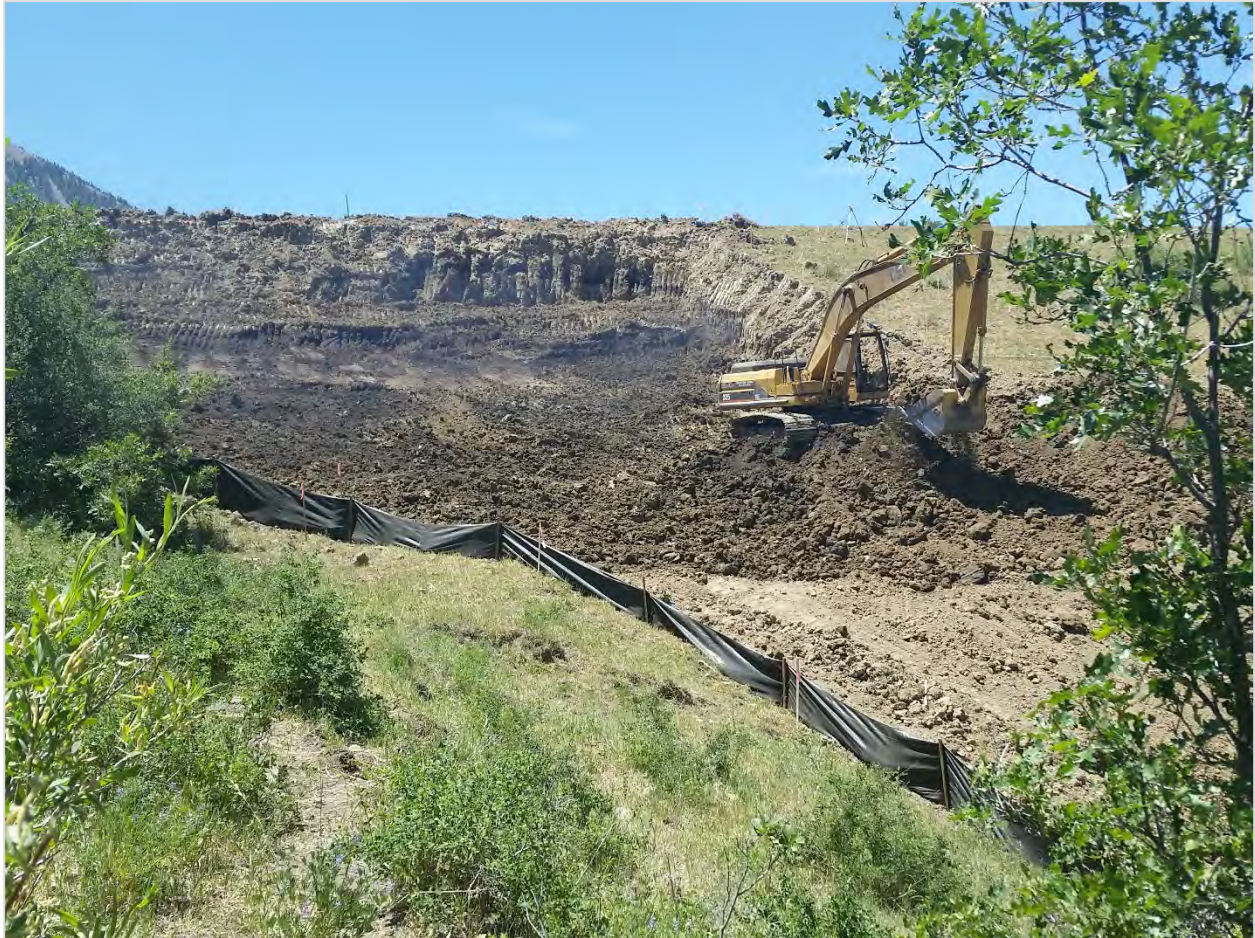
Photograph 9: excavated area at end of day July 2, showing silt fence and general progress of the excavation

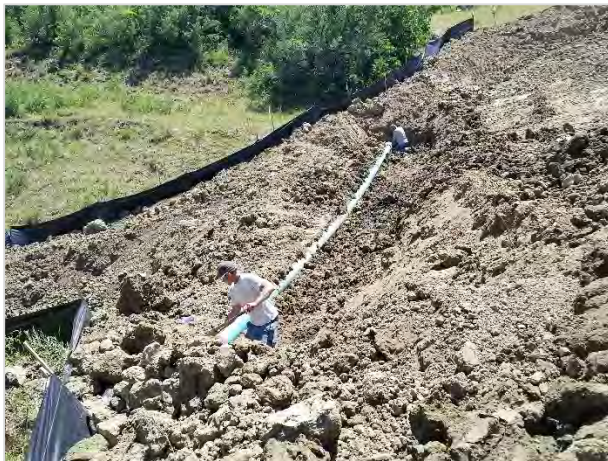
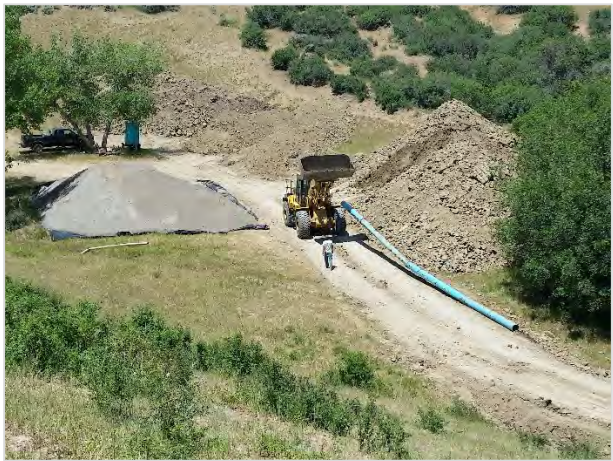
Photograph 10 (left): shows diversion pipe being exposed and Photograph 11 (right): show removal. Note the filter sand stockpile in the background.

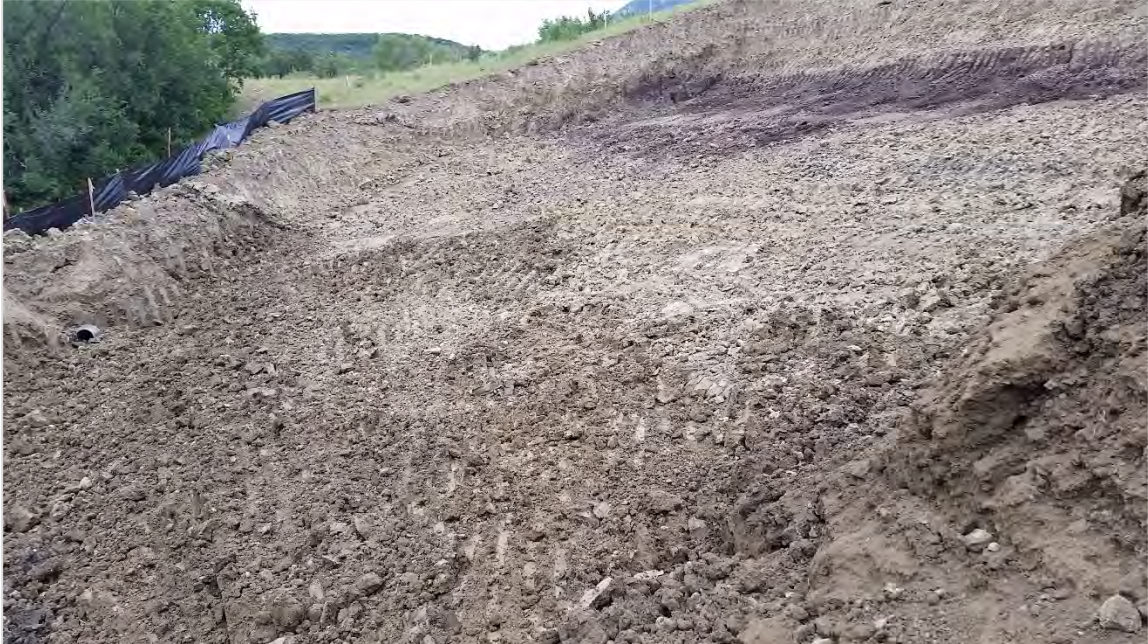
Photograph 12 looking east across the excavated area near the end of the work day

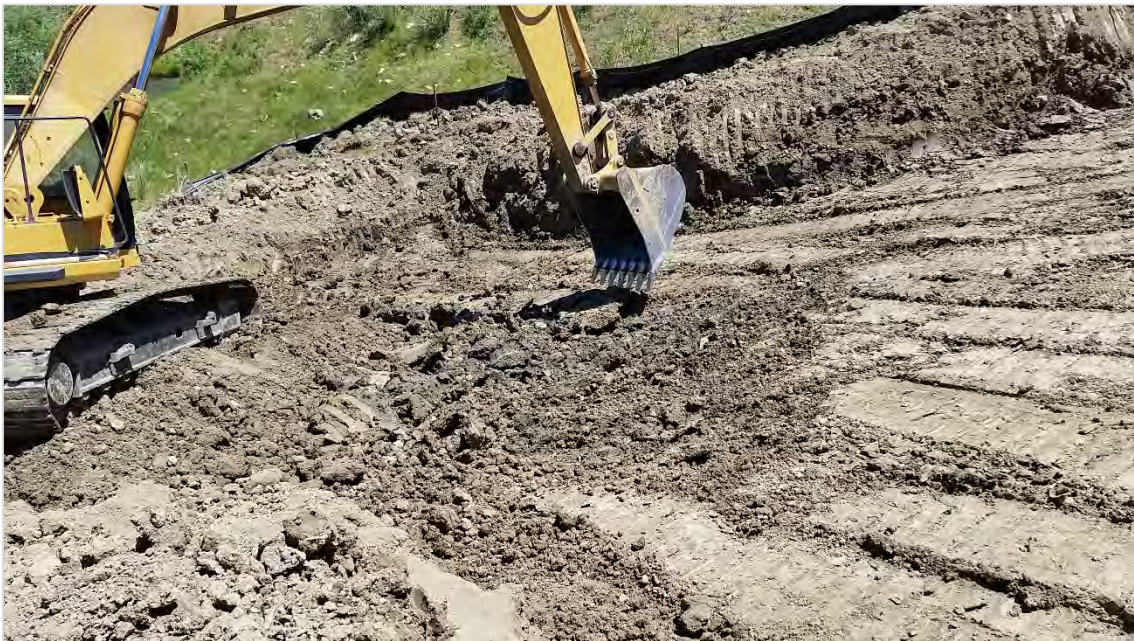
Photograph 13 showing excavation nearly complete at the toe of the dam

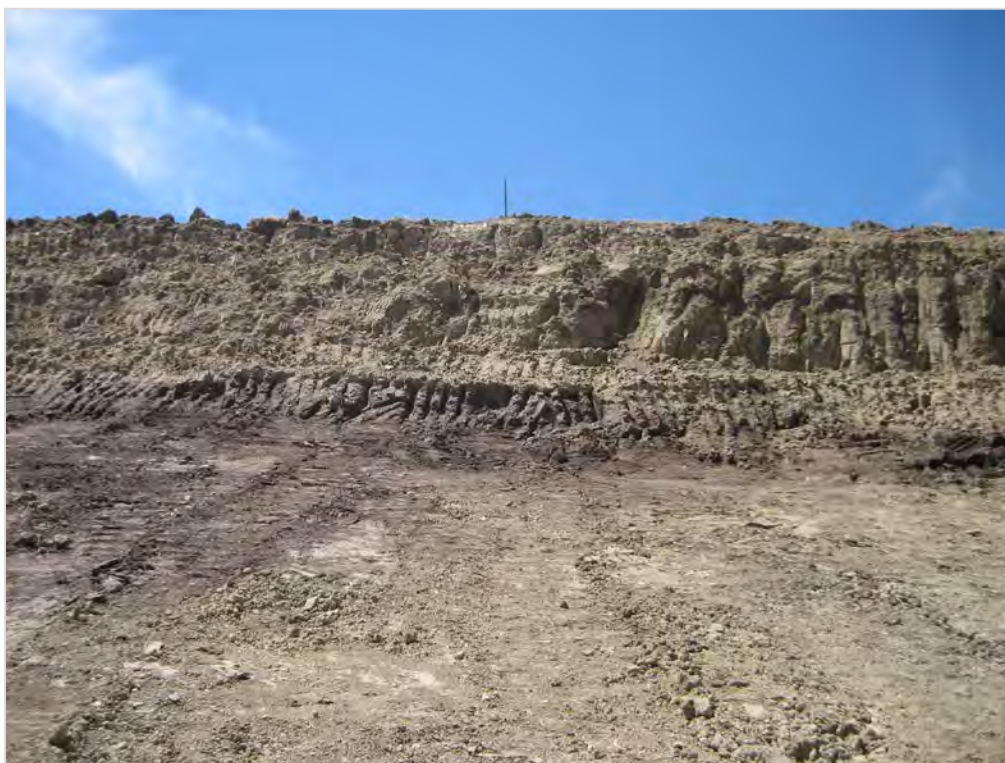
Photograph 14 showing the condition of the north cut face on Wednesday July 9

1. The north cut face would be cleaned of loose material to expose the organic material and the cut face and top of the organics surveyed for an as-built condition. Filter sand would be spread up onto the cut face sufficiently to intercept seepage through the organics. A minimum of 2-3 feet of filter sand above the organic line was discussed (about 5 feet below crest level). Photograph 14 shows the condition of the north cut face this day. An as-built of the finished configuration to be included in the as-built drawings was requested by Jason Ward (CDWR).

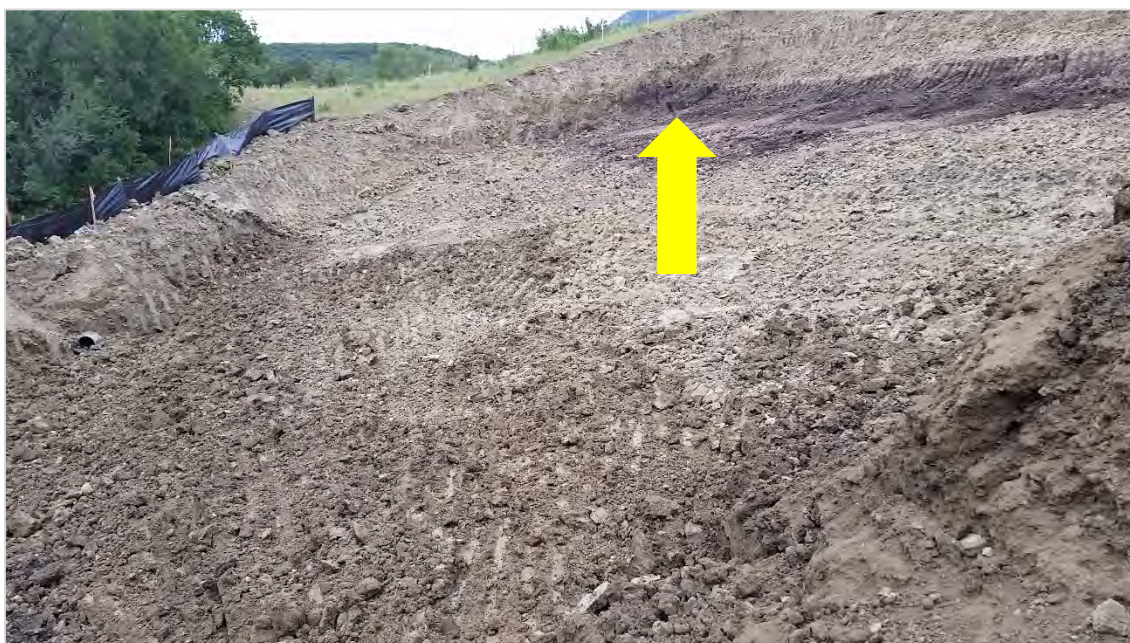
Photograph 15 showing the pocket of organics that extends west of the upper portion of the excavation (see arrow)

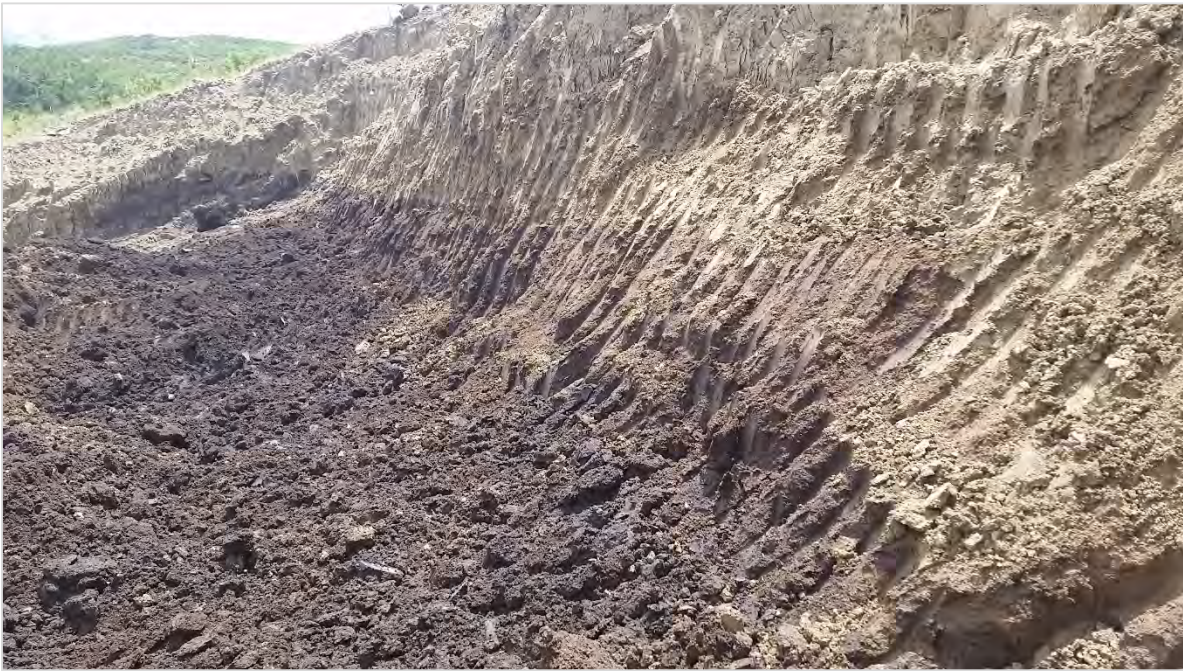
Photograph 16 showing the nearly constant elevation of the organic material in the north cut face which seems to indicate that the organics are along a former dam crest elevation.

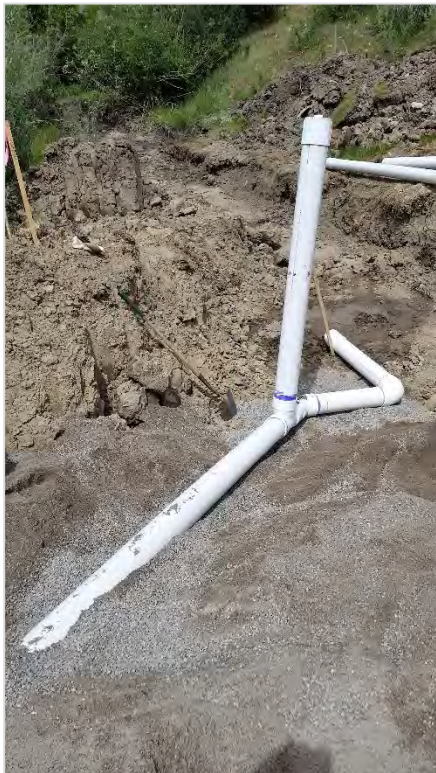
Photograph 17, left, showing the placement of the toe drain pipe at the northeast corner, note aggregate media under pipe.

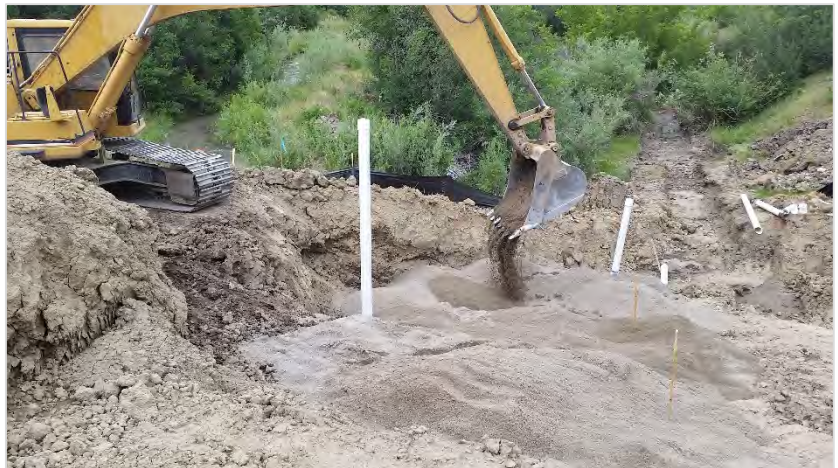
Photograph 18, below, showing placement of filter sand over the toe drain area.

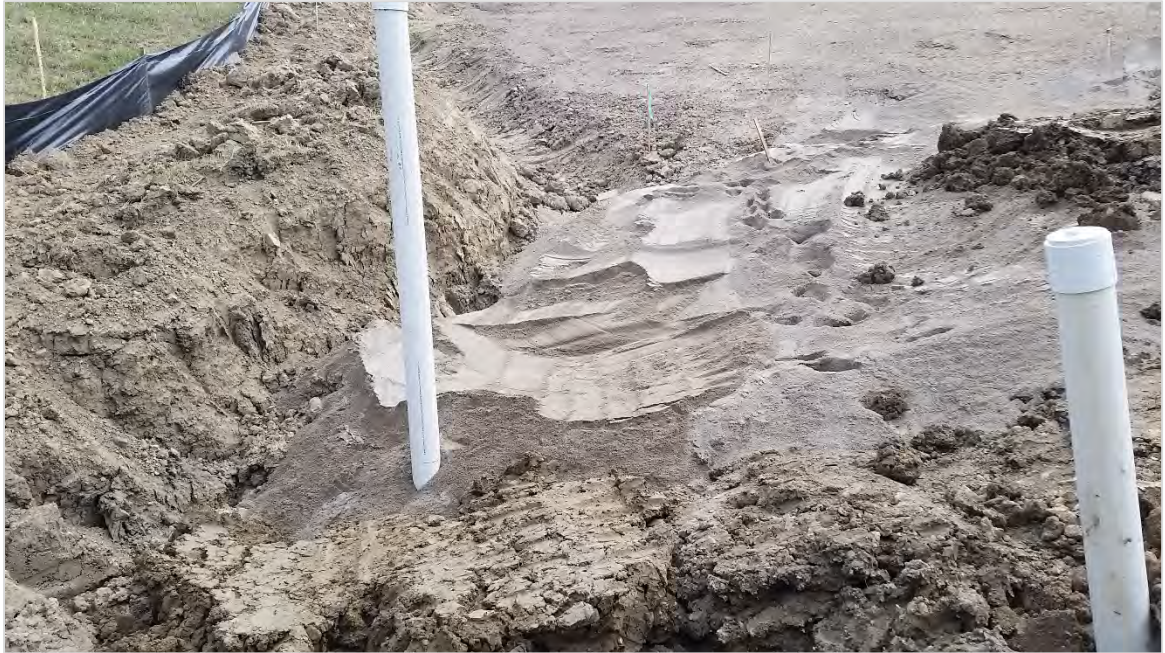
Photograph 19 showing the placement of the filter sand above the toe drain.

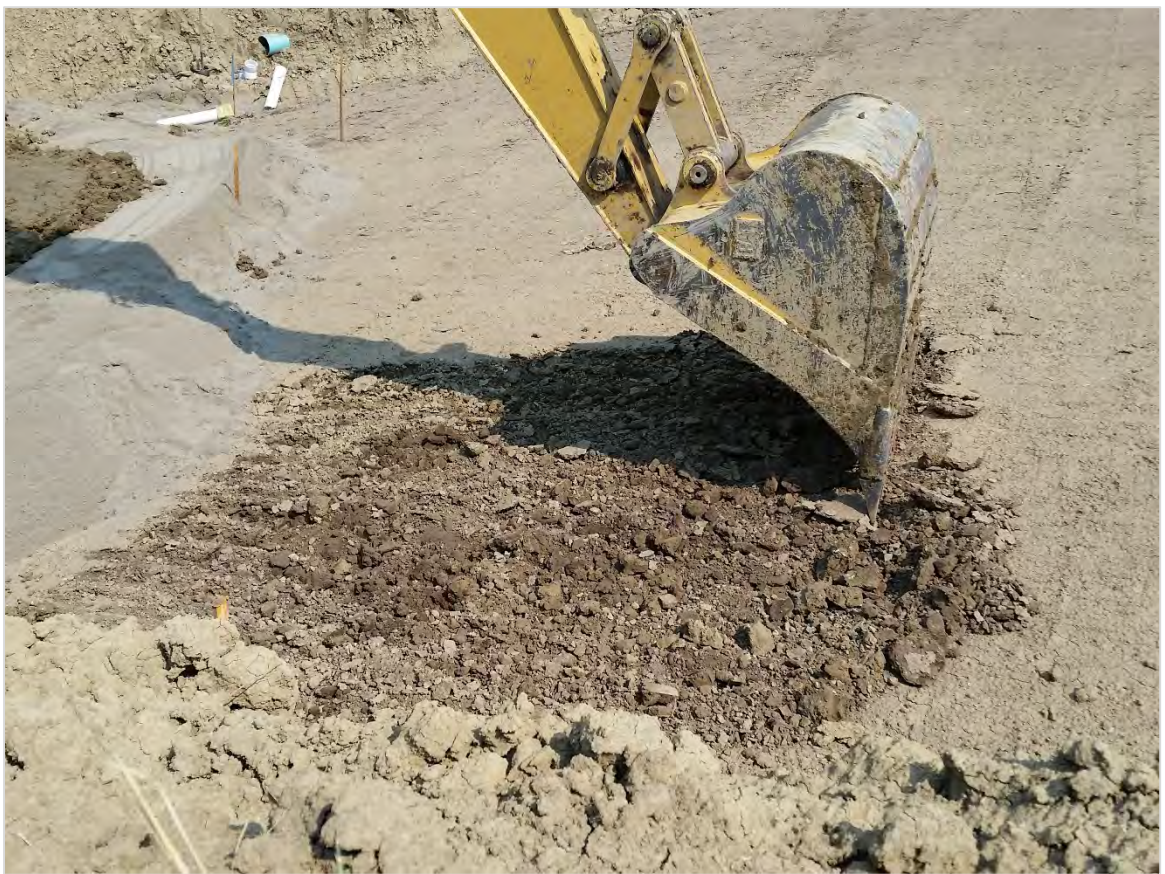
Photograph 20 shows scarification of the embankment with the bucket of the backhoe.

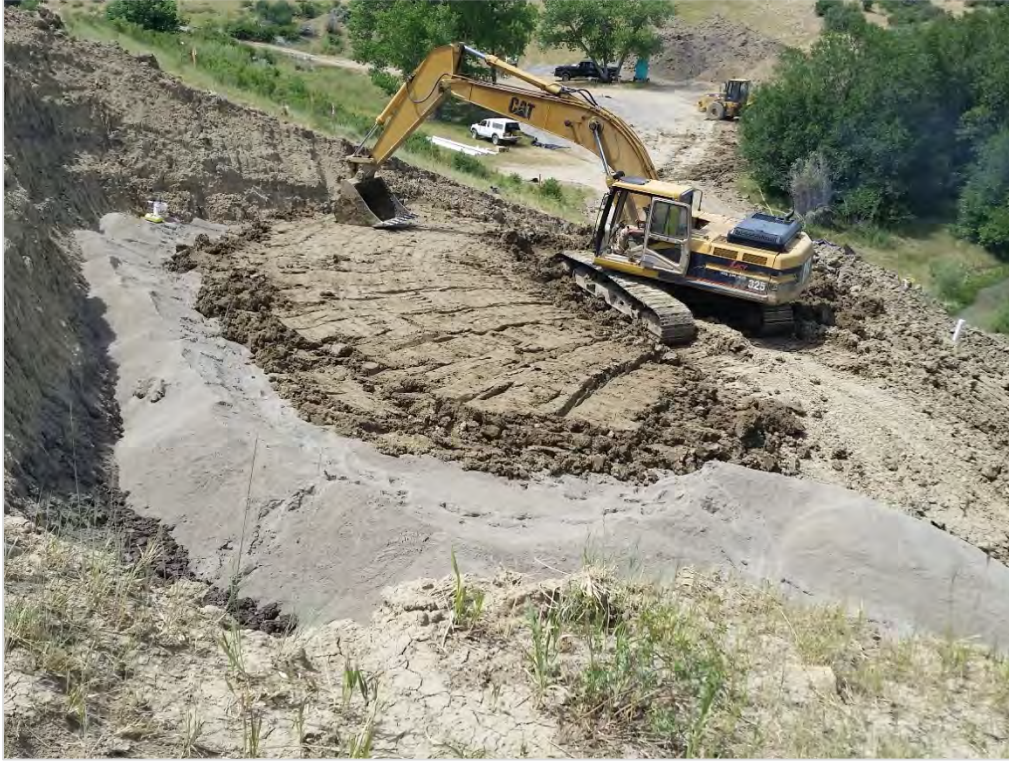
Photograph 21 showing the general methodology of filter sand placement and embankment soil.

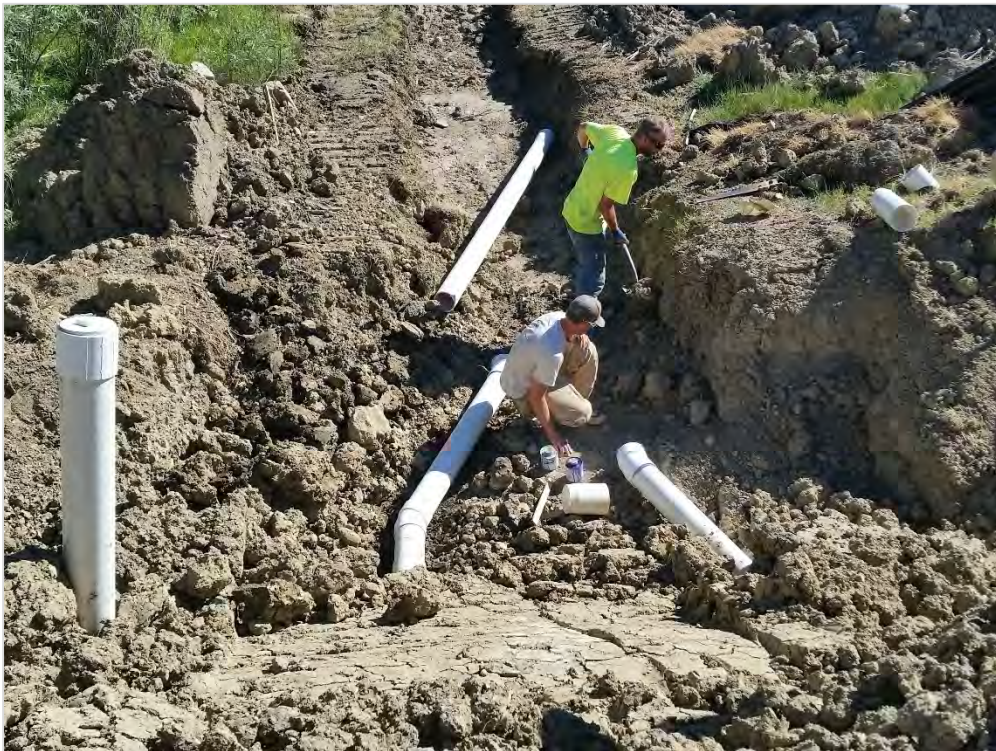
Placement of sand blanket and embankment material halted due to a broken hydraulic line on excavator. A replacement line was ordered. The solid sections of the outfall portion of the toe drain were plumbed. Photograph 22 shows a portion of the installment of the outfall portion of the toe drain.

Photograph 22 shows the installment of the outfall portion of the toe drain.

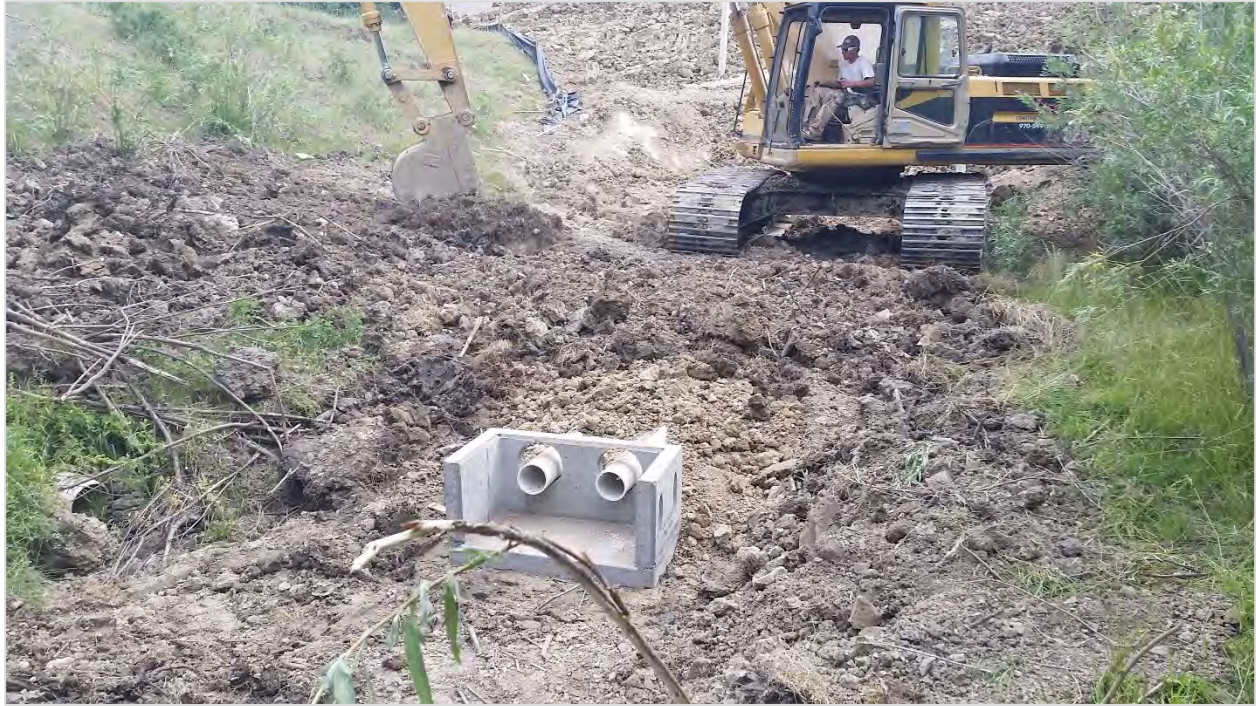
Photograph 23 shows the placement of the concrete outfall structure.

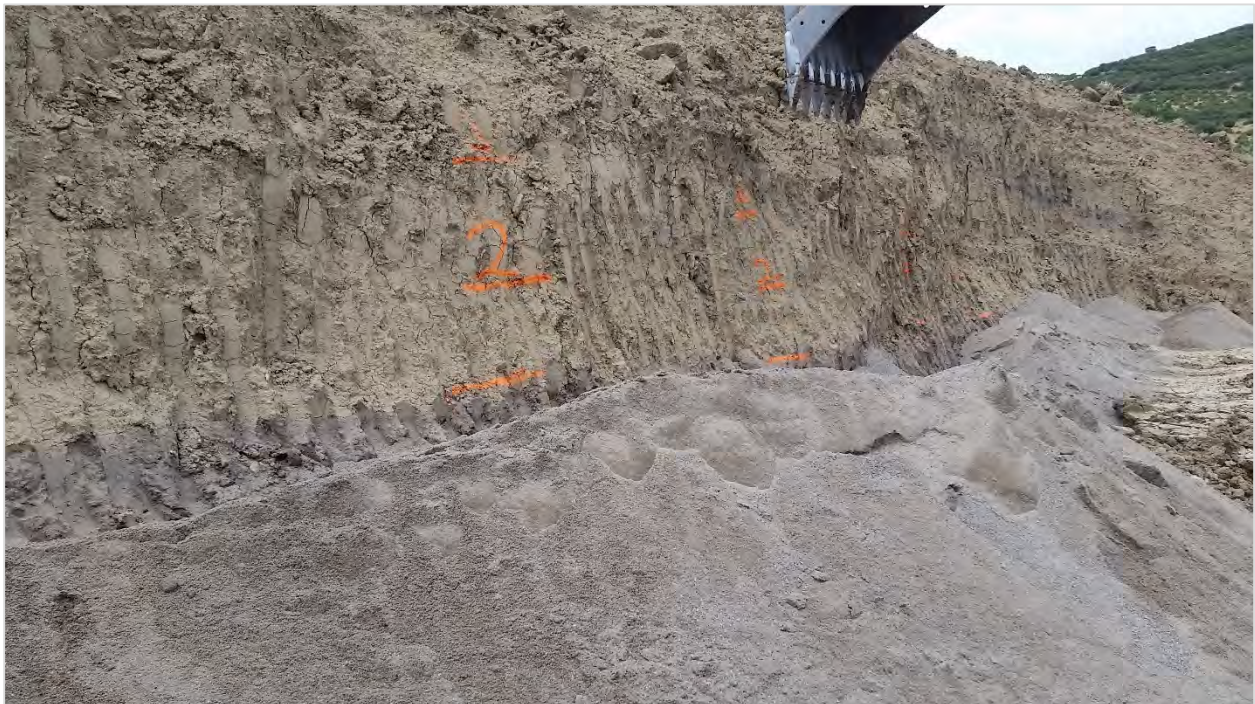
Photograph 24 showing the placement of the sand blanket which will extend to a height of two feet above the organic horizon. The desired height is marked with paint on the excavation wall.

Jason Ward of the Colorado Division of Water Resources was on-site and expressed satisfaction with condition of work. Discussion ensued regarding the sand filter at the interface of the dark, organic material. The proposed approach is to start back approximately 8 feet from the wall and increase the sand depth, creating a wedge that will extend a minimum of 2 feet above the dark, organic material. The key in the stair steps will start at this 2'+ elevation.

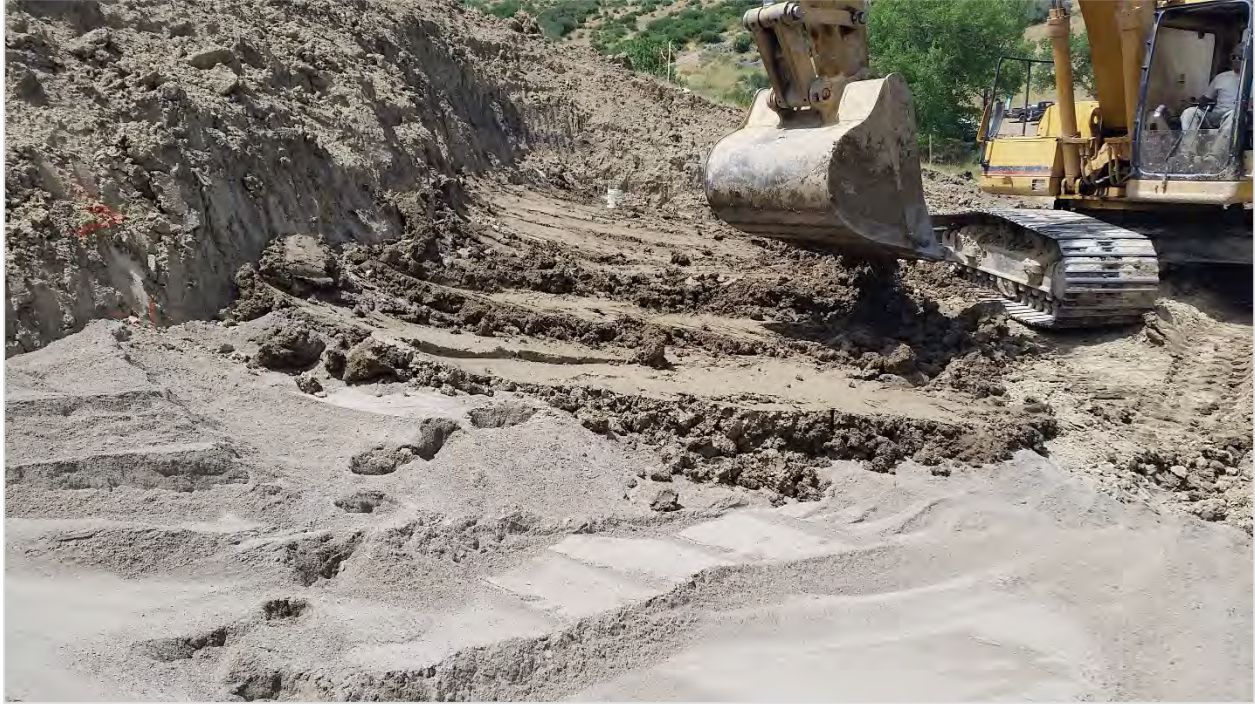
Photograph 25 showing the placement of a clay cap over the sand blanket.

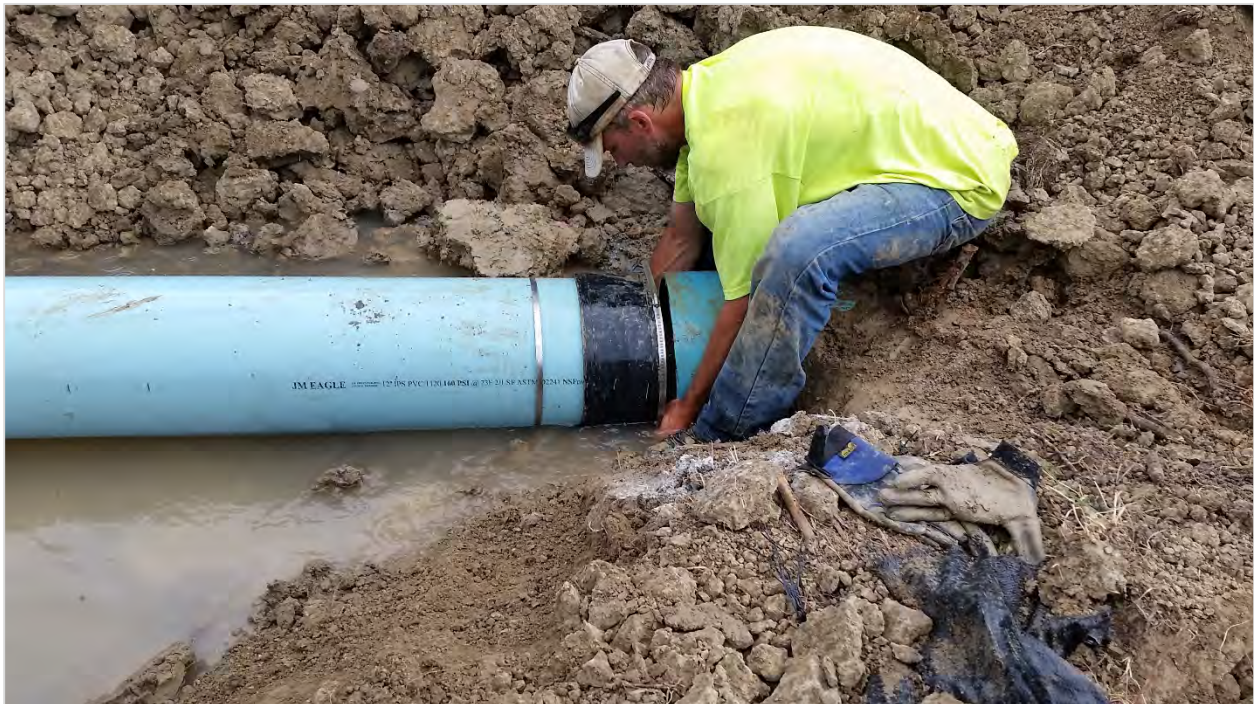
Photograph 26 showing the connection of the bypass line (left) to the existing pipe (right).

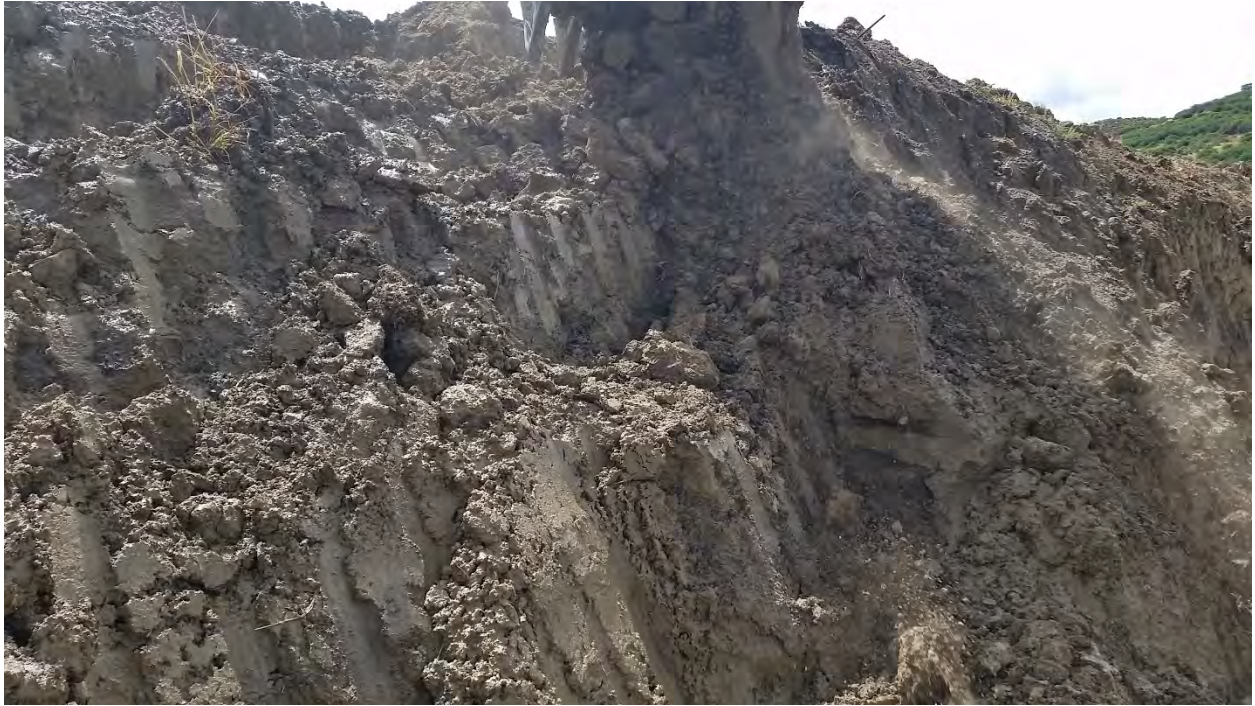
Photograph 27 showing excavation of 1 foot benches in the western face of the excavation.

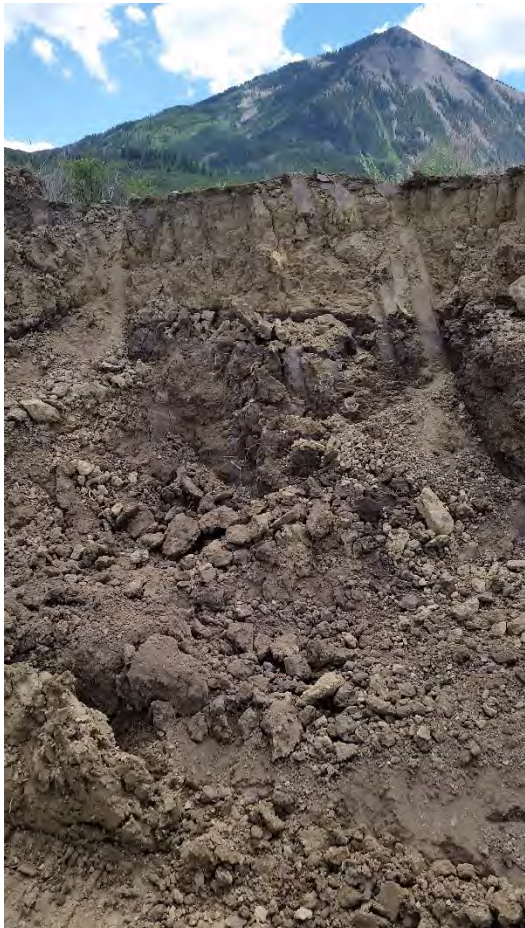
Continued placement of embankment soil. Benching was constructed with a 1 foot by 1 foot dimension. At a location 3 to 5 feet below the ground surface, a blended layer of organic material was encountered. This organic horizon was lighter in color than previous organic horizons and appeared to be blended with on-site soils that are brown in color. The organic horizon was observed to be intermittent in occurrence. The small amount of organic material,

Photograph 28 showing the presence of an additional layer of organic material. This layer was lighter in color than previous organic horizons.

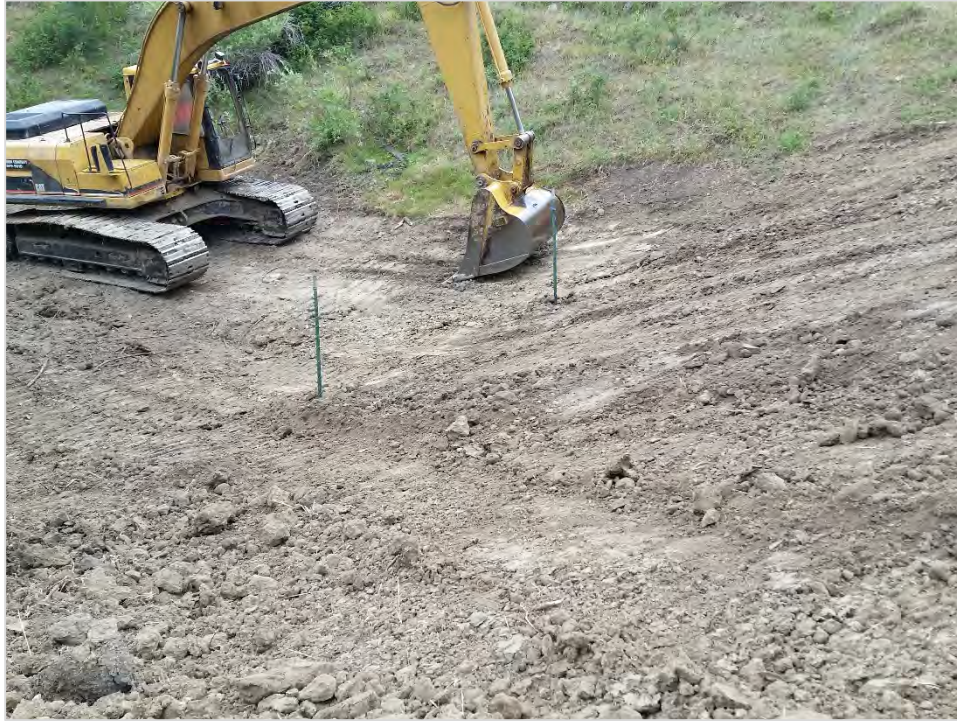
Photograph 29 showing the tracer wire attached to T-posts at each toe drain clean out/inspection port.
