Lone Cabin Ditch and Reservoir Company

DAMID: 400404

Final Construction Report for Dam Repair, Lone Cabin Reservoir

September 11, 2014

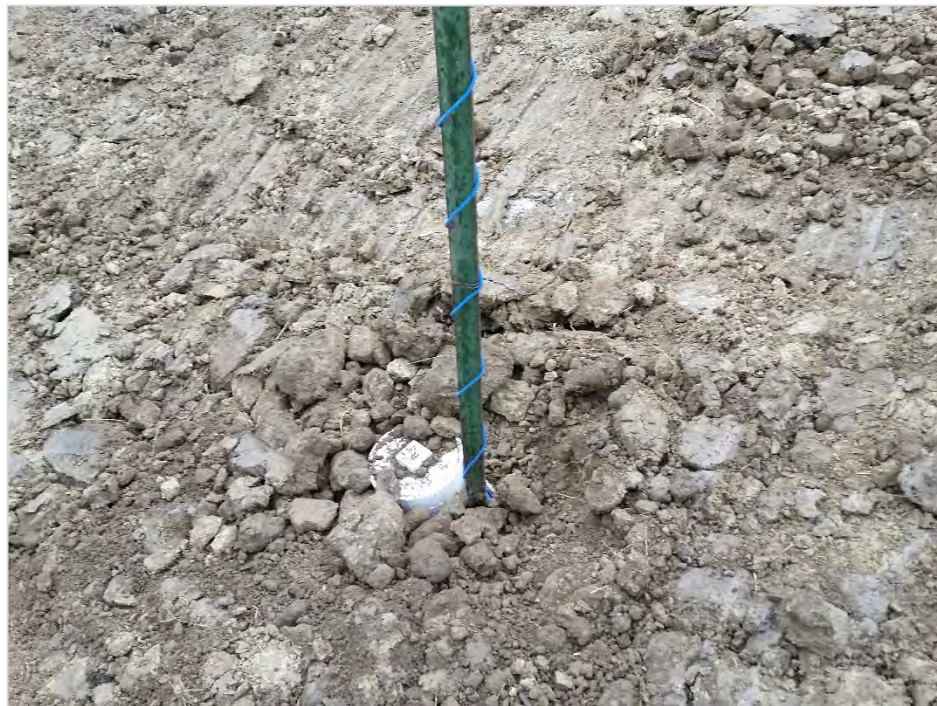
Photograph 30, detail of tracer wire secured to T-post at toe drain pipe clean out/inspection port.
