Blue River Watershed Group
P.O. Box 1626
Frisco, CO 80443
September 10, 2014

Attached is the final report from the Blue River Watershed Group for the Tenmile Creek restoration project (grant CMS # 59794, contract #C150523).

Executive Summary

This is the final report from the Blue River Watershed Group (BRWG) for the Tenmile Creek restoration project (CMS number 59794). The project included stream and floodplain restoration, soil amendment, wetlands creation and revegetation in a heavily impacted reach of Tenmile Creek near the Copper Mountain ski area. This area had been impacted by historic mining, timber harvest, ski area development, and railroad and highway construction. Field construction occurred in the fall of 2013. Revegetation work was conducted in the summer of 2014. The project resulted in approximately 1,600 linear feet of restored stream channel and the creation of 5 new meander bends, 5 new riffle-pool-glide sequences, and 5 new oxbow wetland features. A total of 3.15 acres of riparian, wetland and floodplain habitat was restored. This project enhanced floodplain connectivity, fish habitat quality, scenery, and wetlands function by re-creating the stream morphology

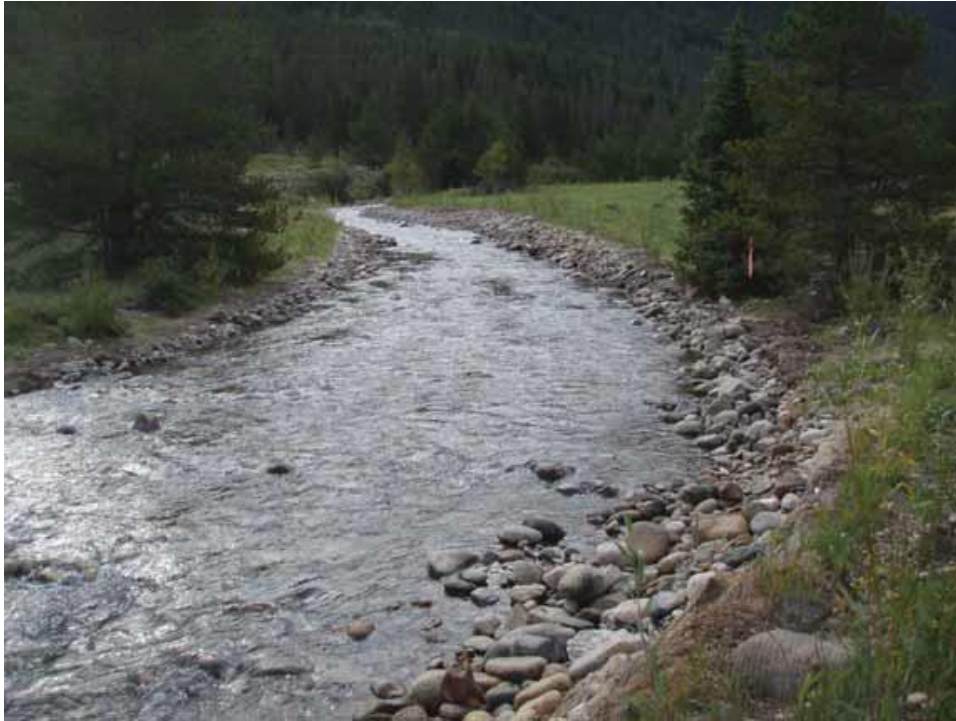
Figure 1: Example of the new channel at Tenmile Creek

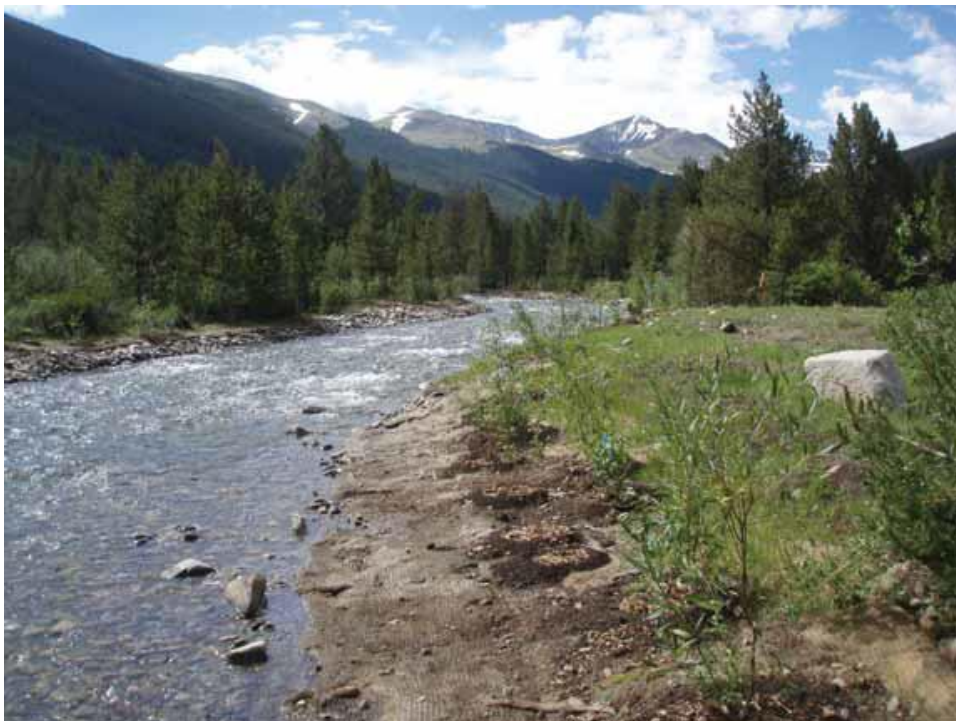
Figure 2: Another example of the new channel at Tenmile Creek showing excellent channel shape

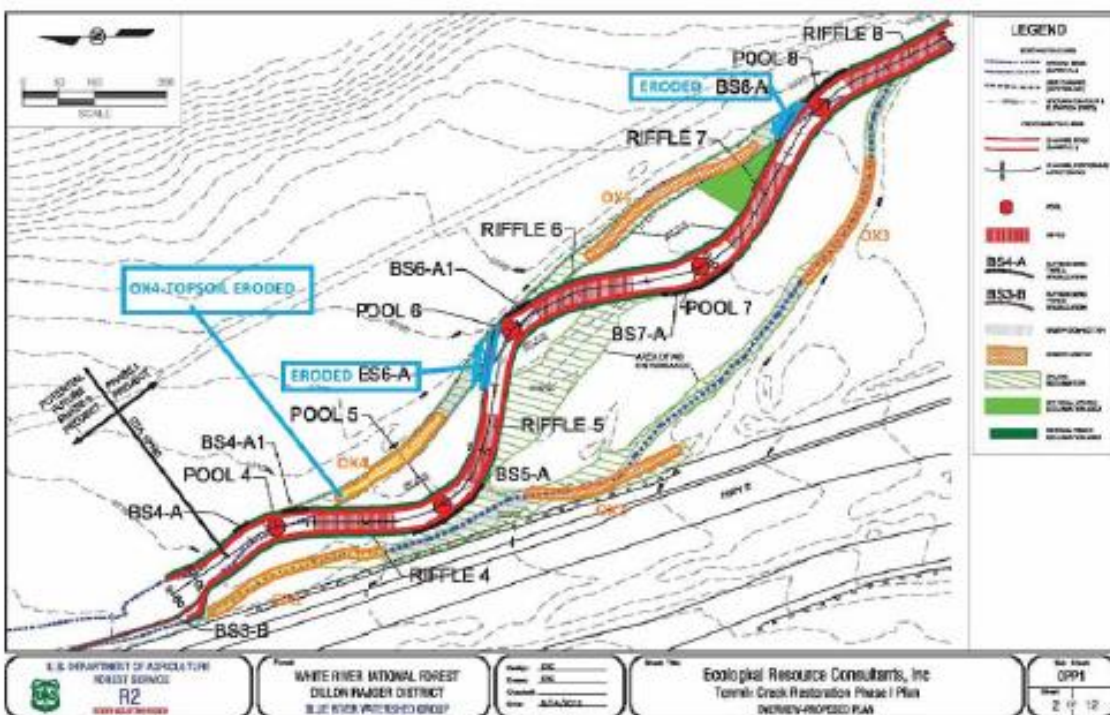
Figure 3: Overview of the construction plans, with notes identifying areas of bank erosion

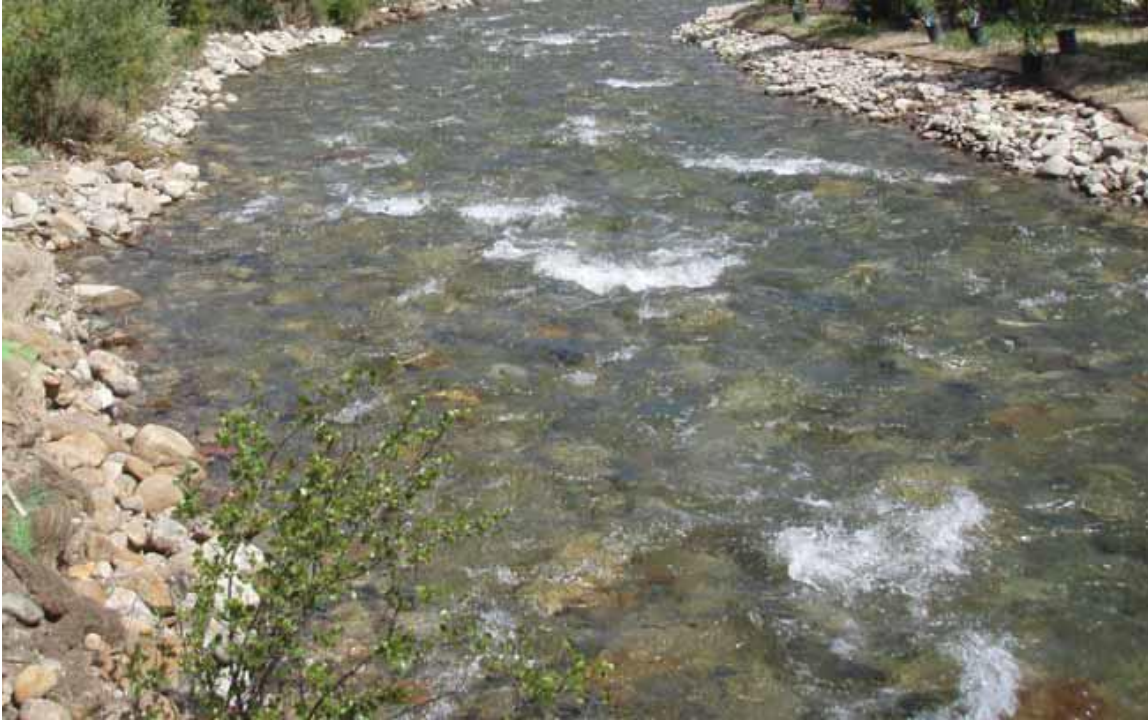
An evaluation of the channel behavior and performance has been possible after the 2014 runoff season. An analysis of stream flow observations from 2014 and historical flows recorded by the USGS at the gauging site for Tenmile Creek at Frisco indicate that the project site experienced a flood in 2014 with a magnitude that can be expected approximately once every 10 to 15 years. The magnitude of this event, which was much higher than the average annual flood, tested the channel design; the results were mixed. The design approach included a natural channel design that relies in part upon riparian vegetation as an important component of channel stability. Ideally, the riparian vegetation would have had at least one year of growth before experiencing a flood of the magnitude seen in 2014. In 2014 most of the new vegetation had not been planted and this affected the stability. In general we saw a stream channel that functioned well however, the channel experienced adjusted in both width and depth. There were two areas where the bank stability was insufficient to prevent bank erosion (Figure 3). One of those is in need of some repair (identified as BS8-A in Figure 3) and that is expected to occur in 2014. The other (identified as BS6-A in Figure 3) is being reevaluated and may be left alone. One result of the channel adjustments was that Tenmile Creek overtopped its bank and flowed into OX-4 during spring runoff carrying away much of the amended topsoil that was applied for the purpose of creating an off-channel wetland in that location. That flow helped protect the next downstream bank and it may be desirable for to maintain an overflow channel here, however created wetlands are still desired in this location. Riparian plantings conducted this year after runoff peak have been largely successful and consequently bank stability will be improved in 2015 compared to 2014.

Figure 4: An example of an area where a pool was constructed but had filled in after erosion and deposition occurred during the 2014 flood

from seeing the reaction of the channel to a flood. Discussions between ERC, BRWG, and the USFS are ongoing about how to improve channel performance, pool characteristics and bank stability. It is clear that there is room for improvement in the constructed channel, but the improvements would be minor compared to the large effort undertaken in 2013. It is anticipated that if Phase 2 of the project receives funding, lessons learned from the flood will be incorporated into final design for the Phase 2 channel. If Phase 2 is implemented there will be an opportunity to make some minor improvements to the Phase 1 channel at a reasonable cost when equipment will be on-site.

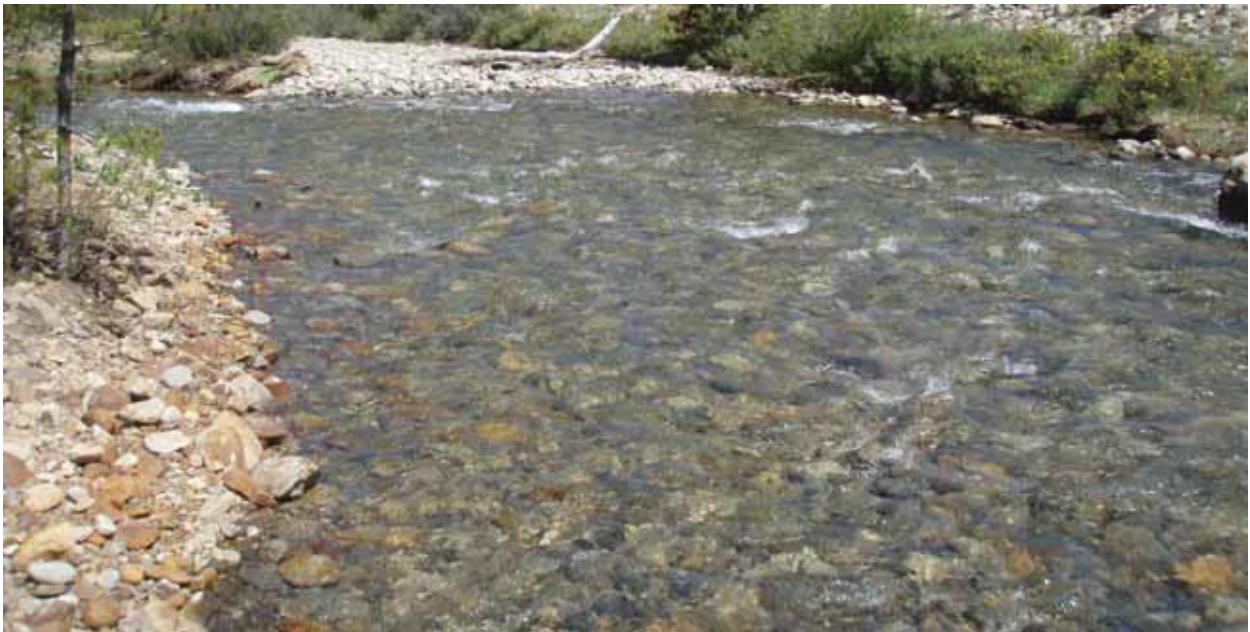
Figure 5: Another example of an area where a pool was constructed but had filled in after erosion and deposition occurred during the 2014 flood

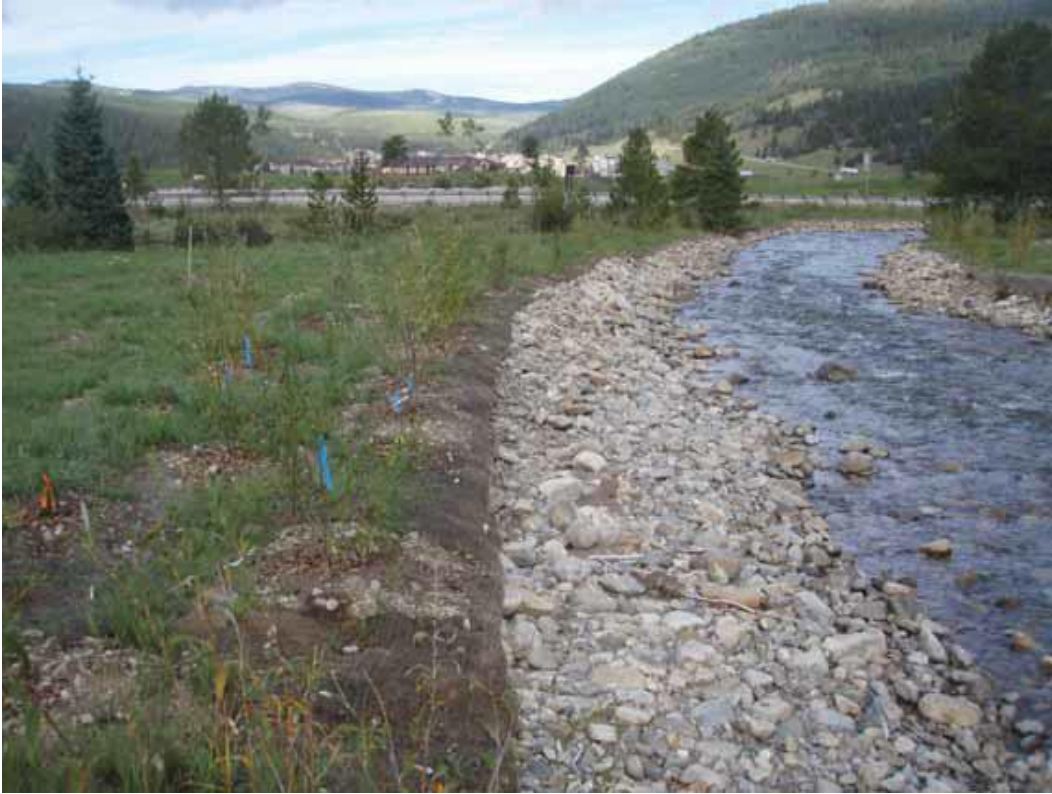
Figure 6: An example of an area where channel function and bank stability were very good

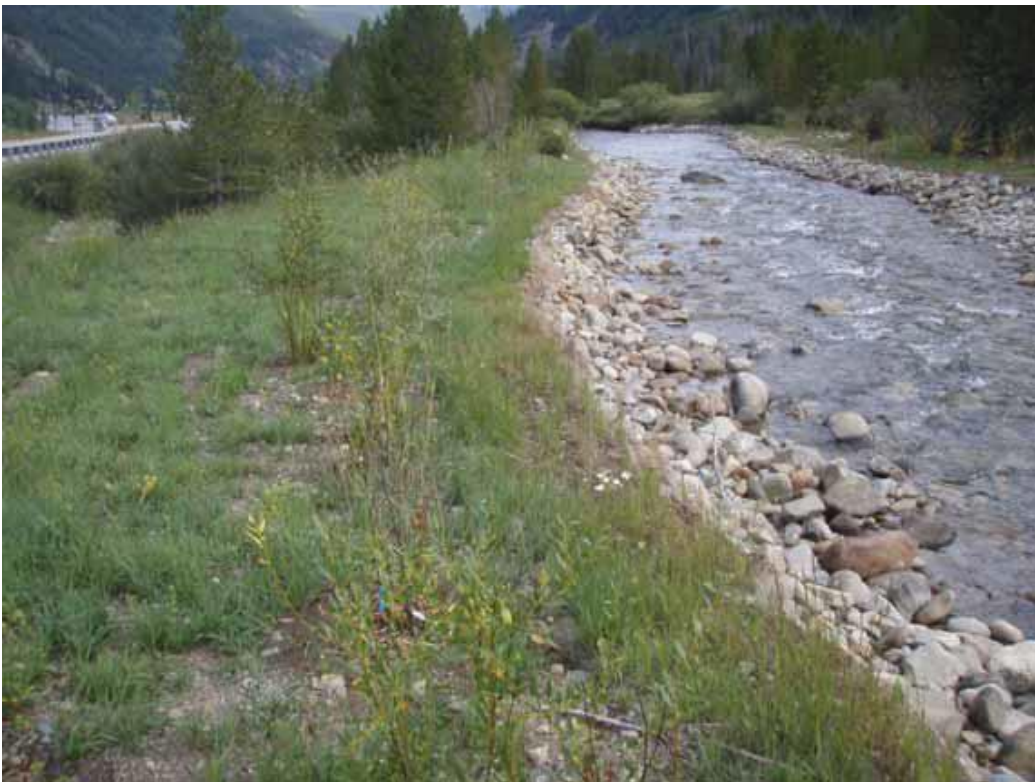
Figure 7: Another example of an area where channel function and bank stability were very good

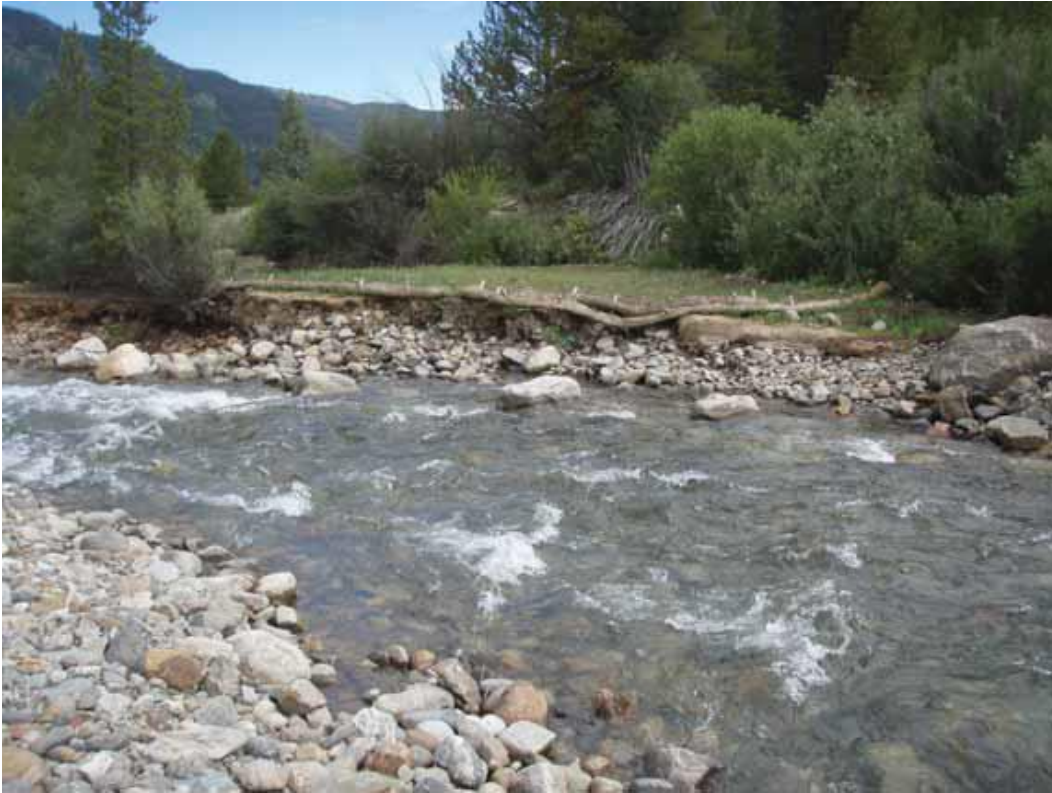
Figure 8: An example of an area where bank erosion occurred

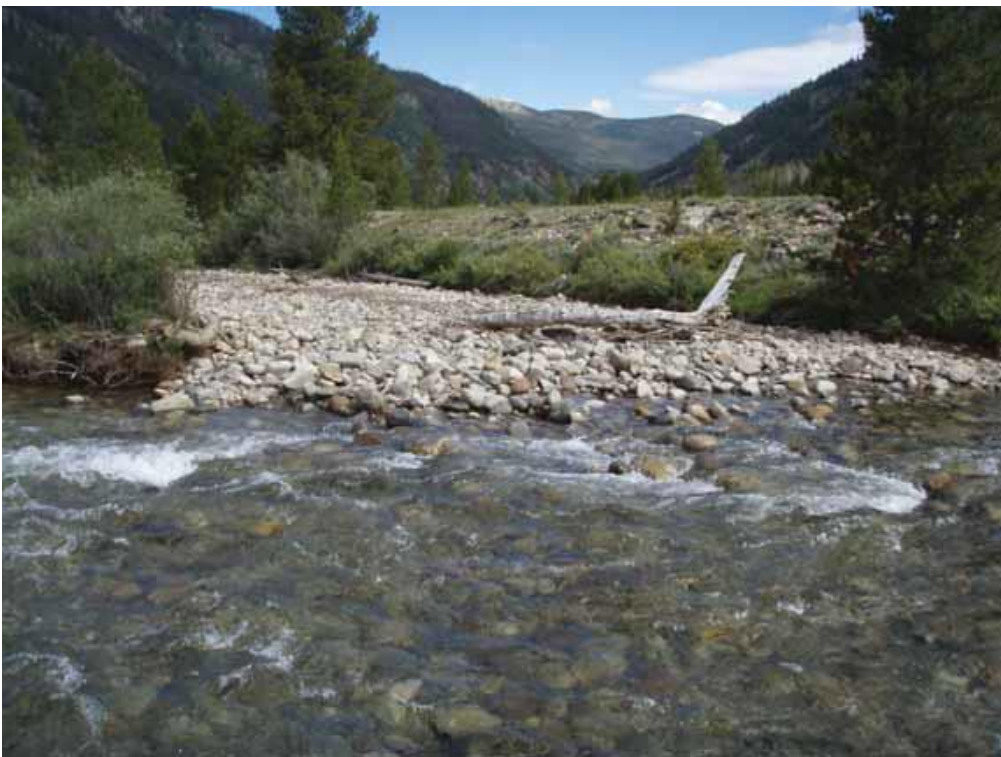
Figure 9: Another example of an area where bank erosion occurred

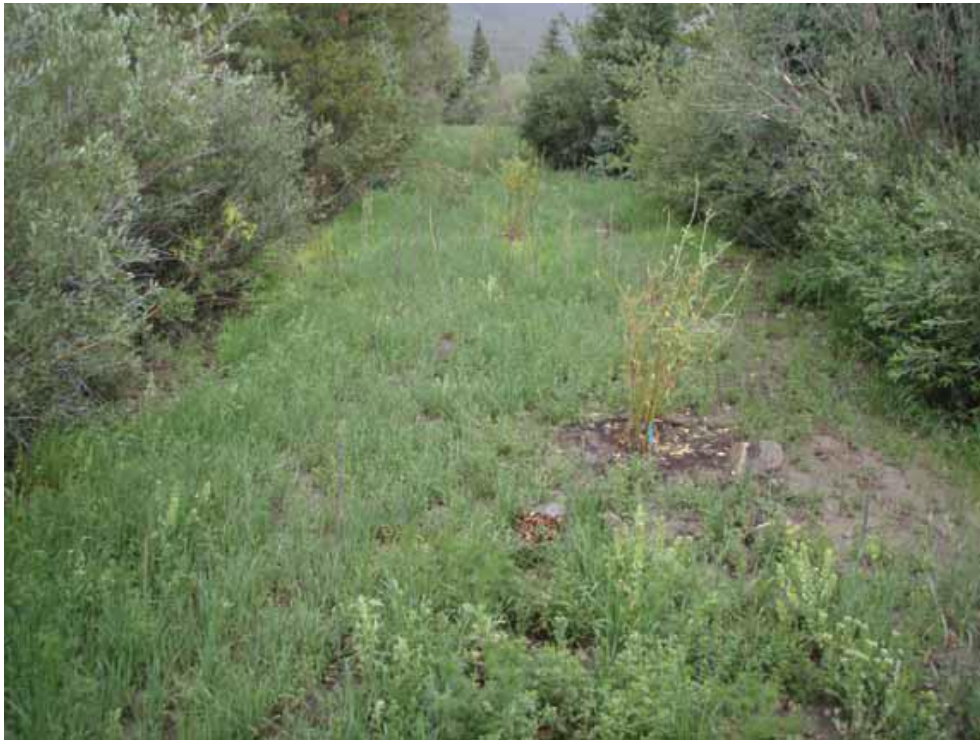
Figure 10: An example of successful revegetation in a created oxbow

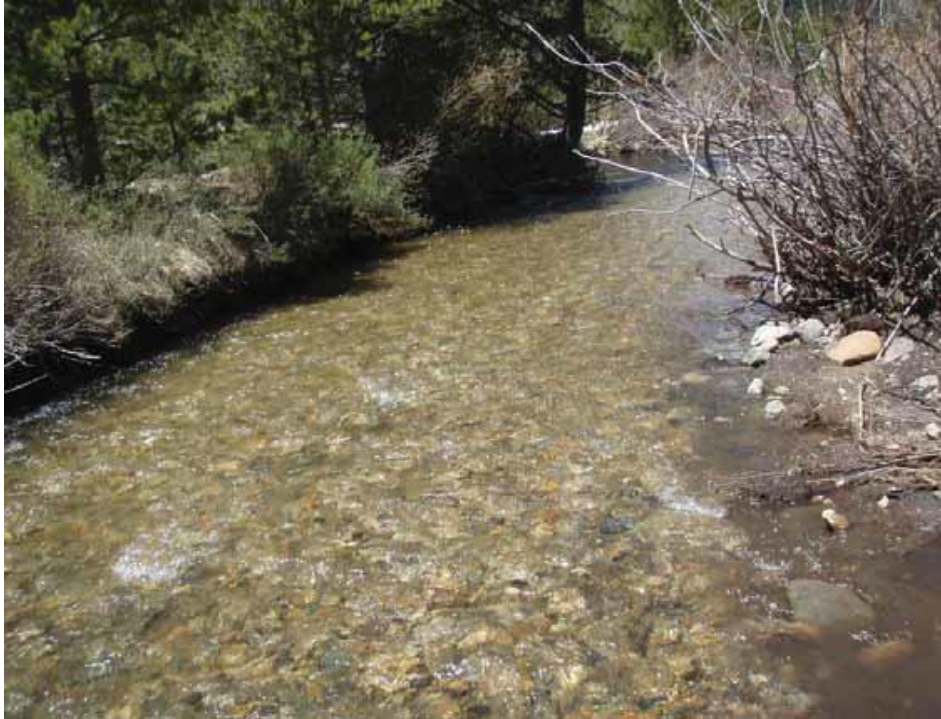
Figure 11: An example of flooding and topsoil loss in what was intended to be a created wetland characterized by saturated soils rather than running water

| Number | Unit & Description |
|---|--|
| 5 | Oxbow wetland features created (one failure in spring runoff at OX-4) |

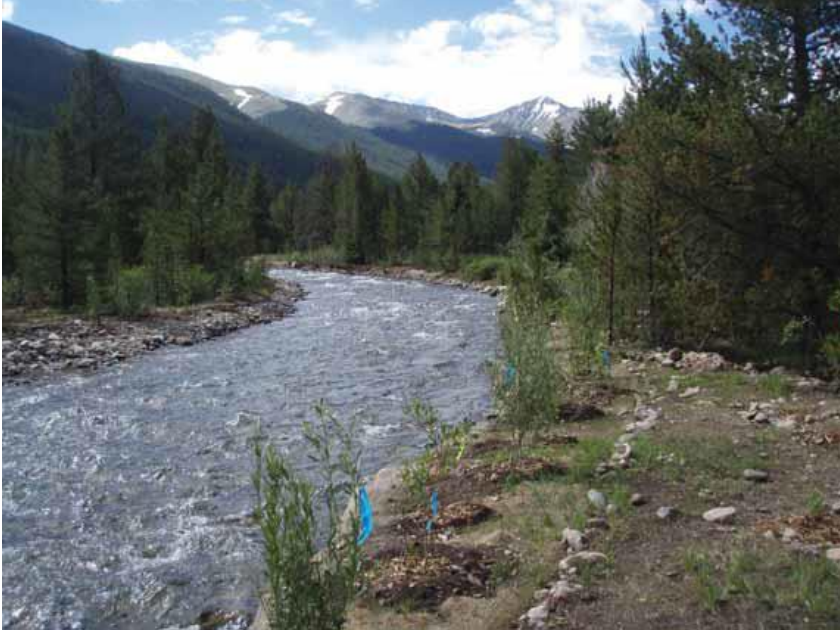
Figure 12: An example of riparian plantings

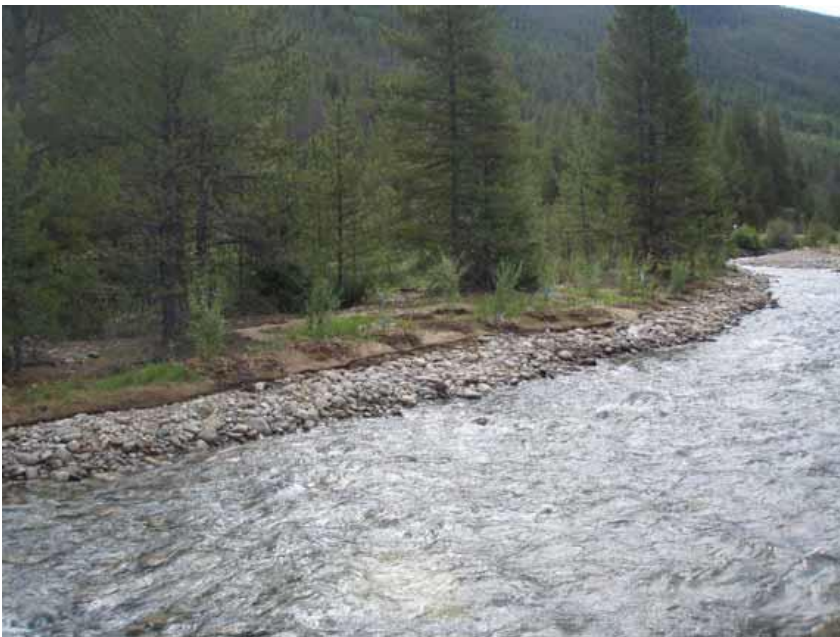
Figure 13: Another example of riparian plantings

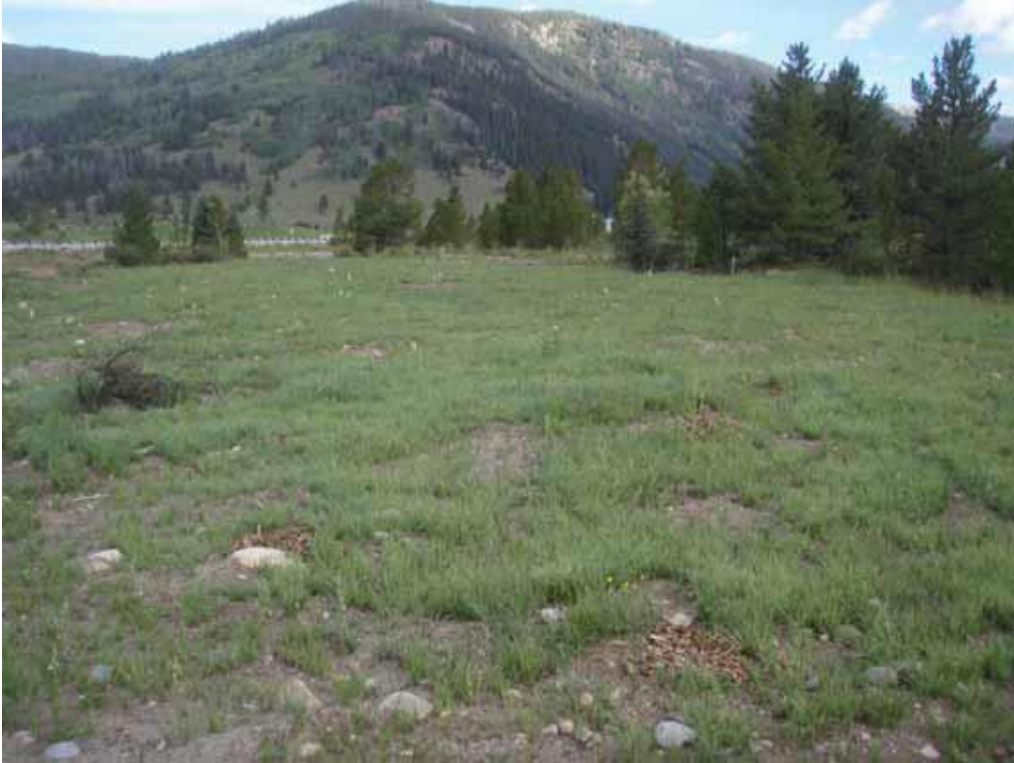
Figure 14: An example of successful floodplain revegetation

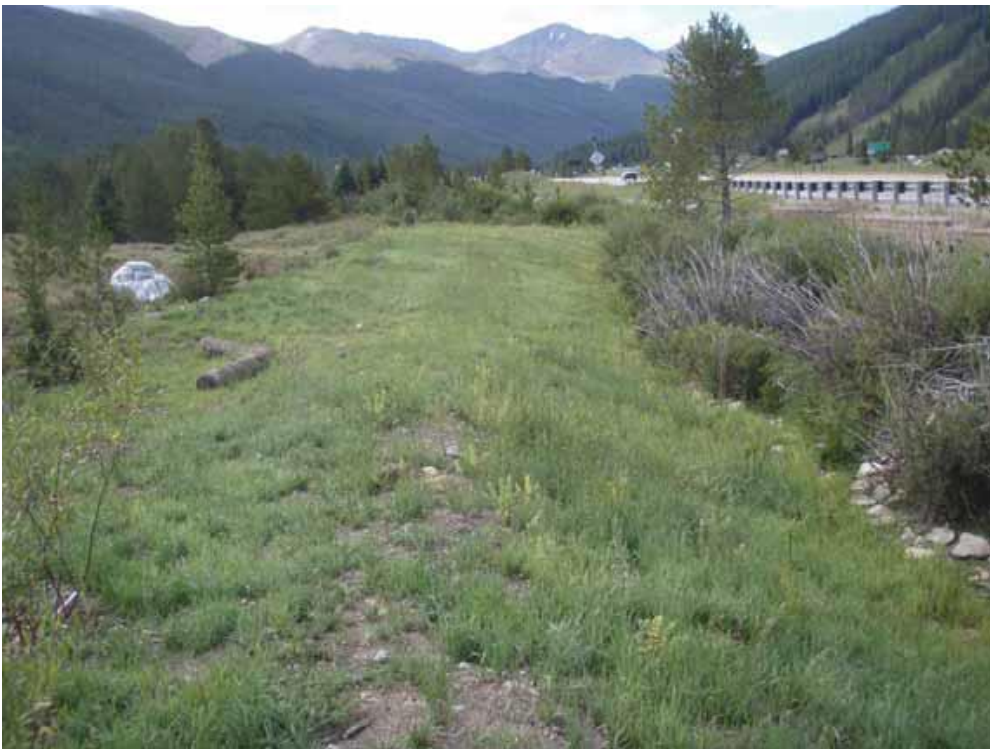
Figure 15: Another example of successful floodplain revegetation
