Steward Mesa Water Company Improvement Project Final Report

Submitted to Colorado Water Conservation Board 1580 Logan, Suite 200 Denver, CO 80203

March 25, 2015

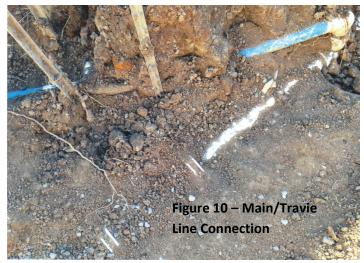
Figure 10 shows the main line (white pipe) running diagonally from the top right corner toward the bottom left corner. Above the main line is a blue service line pipe. This service line not only provided service for the Travie line, but also included the service to the Todd house. Between the tee posts and to the left is the partially uncovered white tee joint in the service line that leads to the Todd house meter pit adjacent to the line. To the right of the tee joint and left of the right hand tee post there is a corroded gate valve, which was the old shutoff valve from the main line. Above the white tee joint there is the red plastic covered handle of a quarter turn ball valve, which was the old shutoff valve for the Todd house. The condition of the valves seen in Figure 10 indicates neither valve was operable.

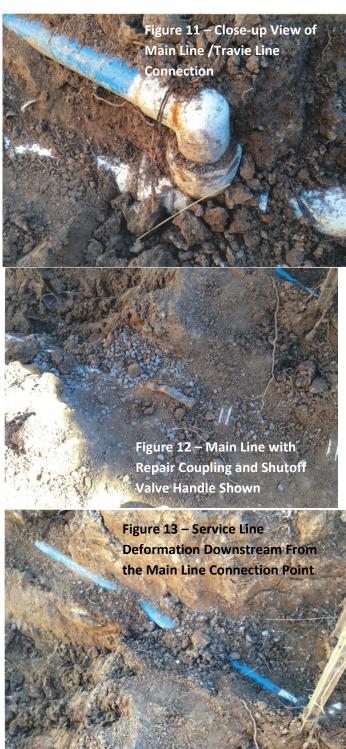
Figure 11is an up close view of the service line/main line connection. The corroded nine wire is probably from original installation.

Just upstream from the connection point, Figure 12 shows a main line shutoff valve just above the flanges of an old main line repair coupling. This valve also was inoperable with the valve handle frozen in the open position.

Figure 13 shows the Travie service line running to the east. The blue service line in center of photo is deformed from improper bedding when originally installed.

The entire service line/main line connection area was improved through this project. The damaged service pipe section, tee to the Todd house and all the valves on the service line were replaced. The main line section from above the old service line connection past the inoperable valve was replaced. Figure 14 shows all of the service/main connection replacements.

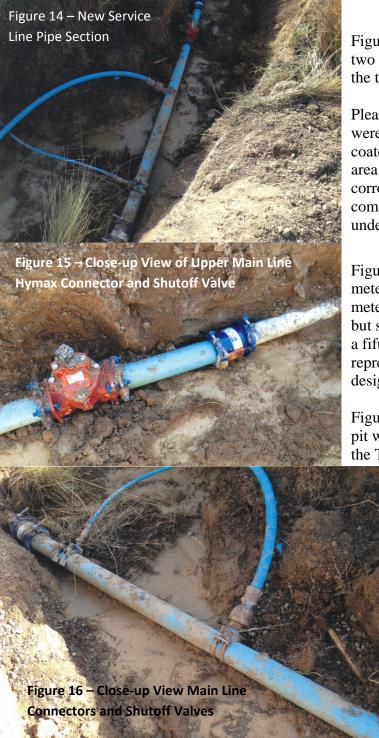
Figure 15 provides a close-up view of both the Hymax connector and the shutoff valve on the main line.

Figure 16 provides a close-up view of the two saddle connections used to connect the two service lines to the main line.

Please note that all new components used were either glass, stainless steel, or epoxy coated. The highly corrosive soils in our area require the use of these highly corrosive resistant coatings on all components place on the ground or underground.

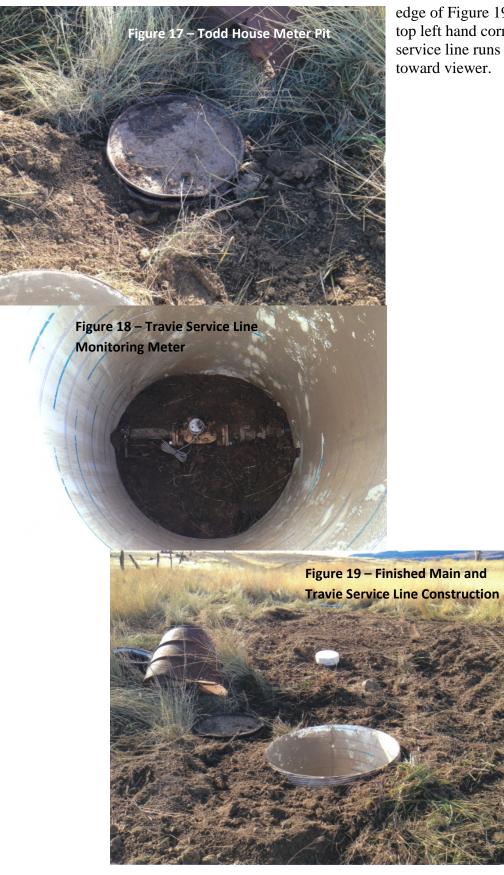
Figure 19 shows the completed main/Travie line installation. The Travie monitor meter pit can be seen without a cover. The existing Todd house meter pit is to the left of the Travie pit. The White 12-inch disk in the center of the figure is the riser for the main line shutoff. The main line runs from middle of right hand

edge of Figure 19 diagonally to top left hand corner. The service line runs directly toward viewer.
