Slate River, Gunsight Reach

Prediction Level Assessment of River Stability and Recommendations for Alleviating Instability Consequences

**Mark Beardsley, M.S.
February 19, 2014**

Prepared for: The Crested Butte Land Trust

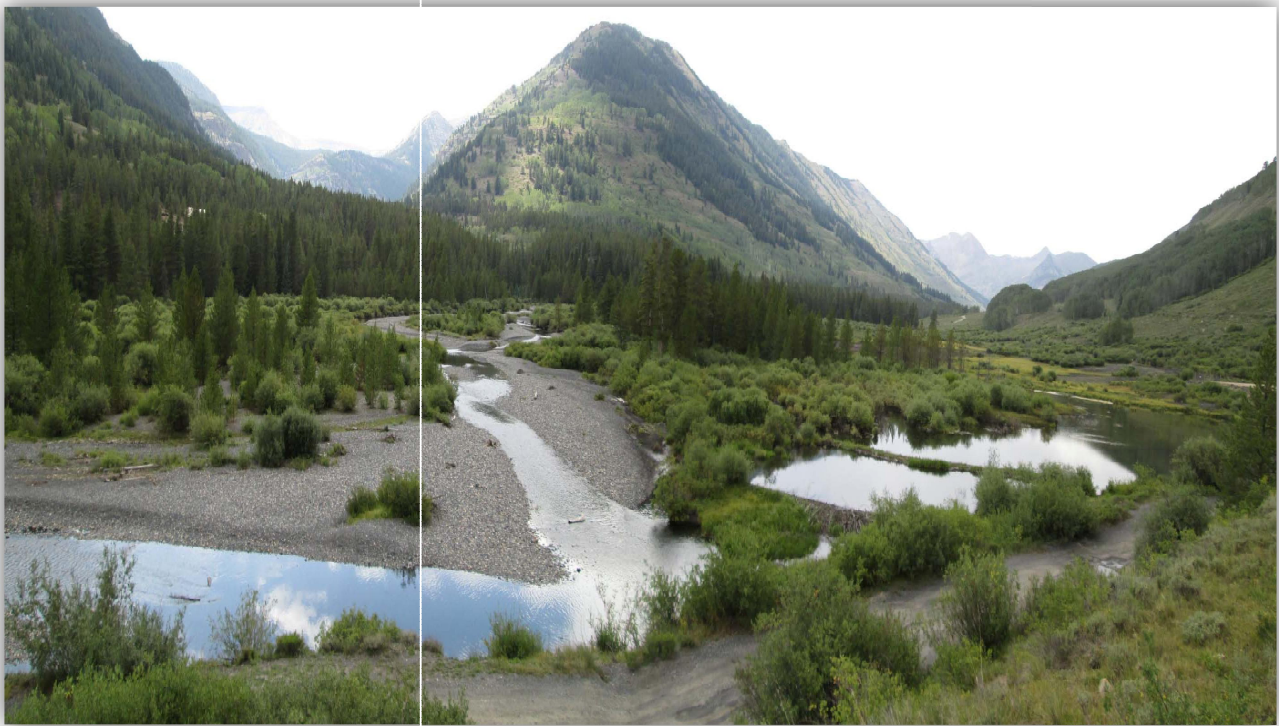
Figure 5: Slate River at the Top of the Gunsight reach

The Slate River flows diagonally across the valley (directly towards the viewer) making a sharp 90-degree right turn where it hits the valley edge and the Gunsight Pass Road in the foreground. The oxbow is seen on the right.

This point is also the site of a relatively recent (geologically speaking) meander avulsion. The abandoned meander sits north of the channel and is now an oxbow pond that impounds groundwater and overbank flows behind beaver dams (**Figure 5**).

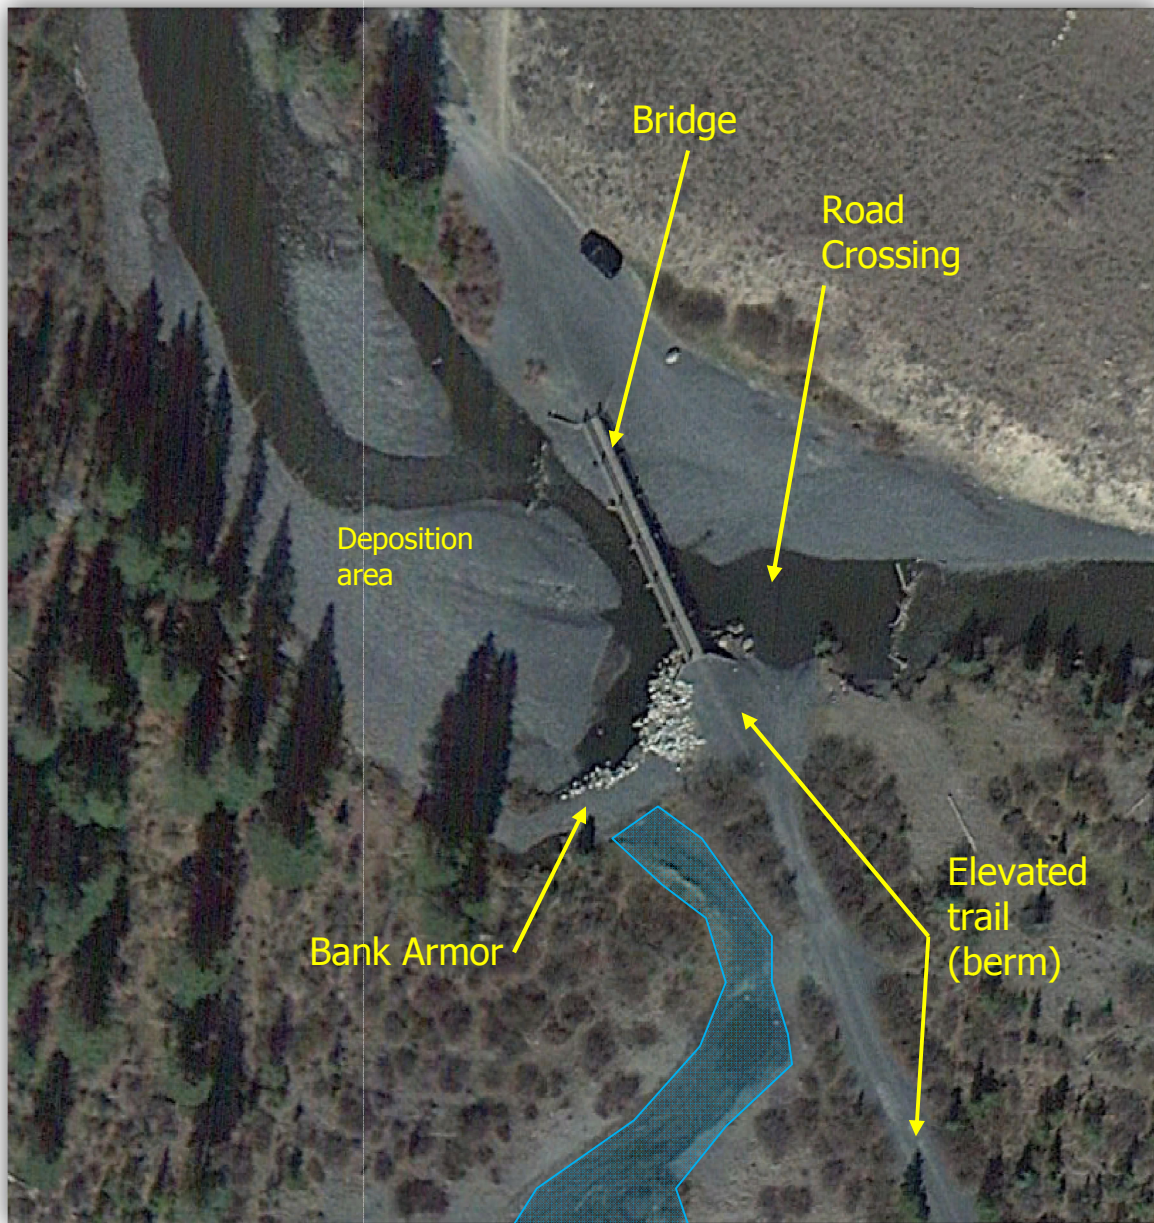
Figure 6: Aerial View of the Gunsight Bridge

into the bridge from upstream was recently armored with boulder rip-rap several times between 2004 and 2010. The object of this hardening effort was surely to protect the bridge, but it also limits low flow connectivity between the river and a large backwater area upstream of the bridge. Interestingly, most of the hardened bank was mostly buried under deposited sediment in 2013.

The Gunsight Bridge is aligned diagonally across the Slate River. Bank armor, road crossing, and the berm are identified, as is the deposition area upstream of the bridge. The blue shaded area is backwater habitat. The floodplain area right of the channel (below it on the photo) is wetland upstream of the berm, but much drier upland where it is cut off from overbank flows downstream of the berm.

We begin with some simple solutions. First, we recommend creating openings in the berm so that flood flows can have access to a wider floodplain and not be as drastically impounded behind the bridge. This should be done whether the bridge is replaced or not. It would be a simple task to survey the berm to determine the degree to which it does function as a barrier and then to alleviate this by designing openings of a proper size to provide adequate flow-through. The openings could either be portions of the berm that are removed to the floodplain elevation or culverted drains that are bored through the base of the berm, depending on the desires of stakeholders. This activity may also provide an opportunity for wetlands restoration by allowing flows to reach the apparently dewatered wetland areas downstream of the berm.

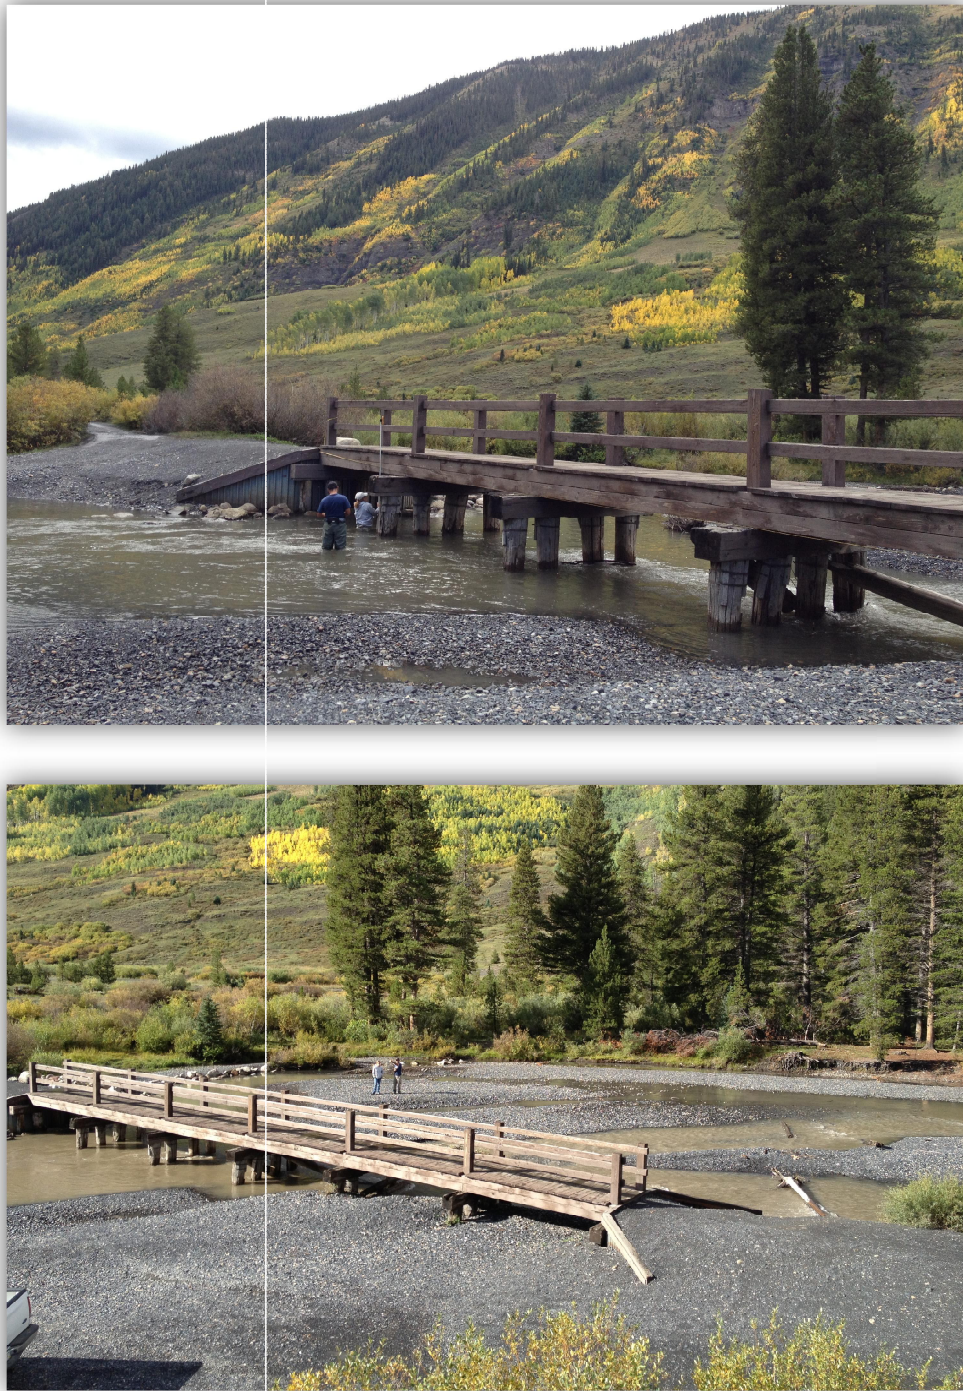
Figure 7: The Gunsight Bridge

The narrow opening, diagonal alignment, and flow interference of the piers are evident on these photos of the Gunsight Bridge

An ideal solution for the bridge would be to rebuild it with a design that has a more appropriately sized opening, better alignment with the channel, and floodplain drains. At the same time the bridge is replaced, the aggraded channel should be restored to form a multi-stage channel dimension that can effectively transport sediment through the site. A full span bridge rather than one supported by piers would alleviate the clogging issue if large woody debris is able to pass through unobstructed; a full-span design would also be much safer for boaters. A suspension bridge might be the best

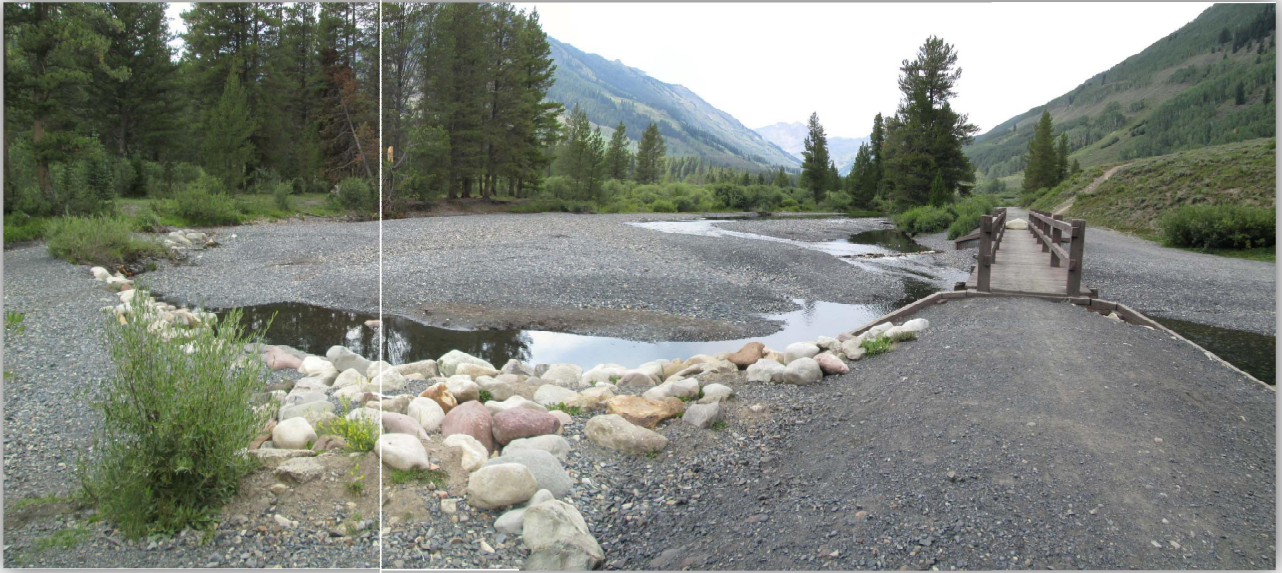
Figure 8: Deposition Area Upstream of the Gunsight Bridge

The river upstream of the bridge is a deposition area. The hard armored right bank and elevated berm are visible in the foreground.

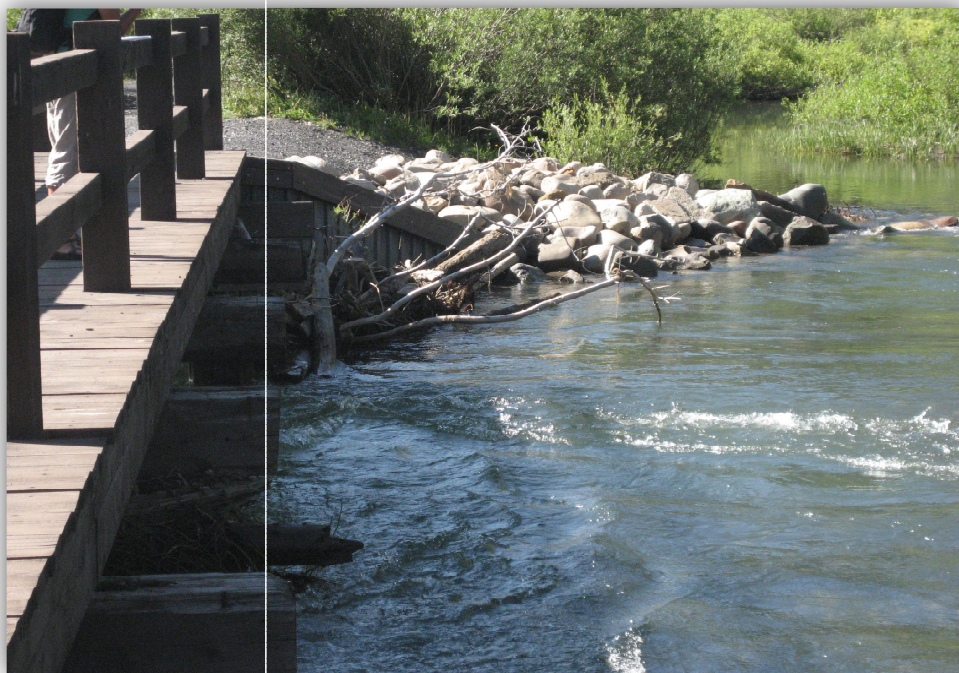
Figure 9: Debris Jams are Common at the Gunsight Bridge

Large woody debris like this dead tree are common in the Upper Slate Watershed, but this bridge does not accommodate transport of this material. Debris jams that clog the bridge during high flows cause impoundment, flooding, and sediment deposition.

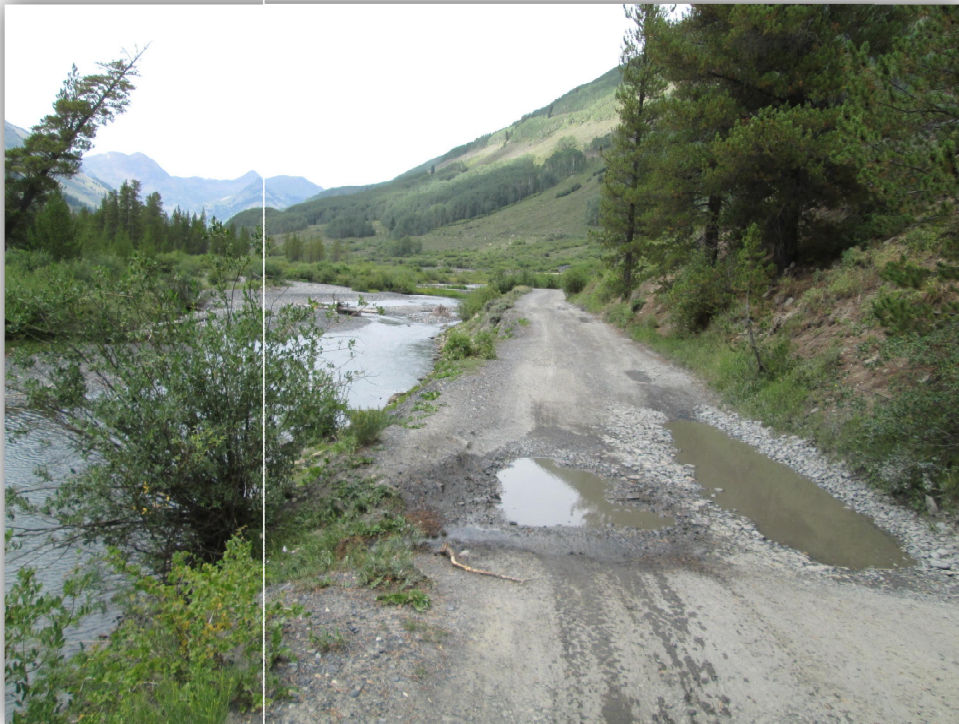
Figure 10: Gunsight Pass Road on the Bank of the River

The Road: The Gunsight Pass Road (**Figures 10-11**) is another stressor with direct impact on the river. The road is a hard compacted dirt surface that obviously prohibits the growth of normal bank side riparian vegetation. This would be a much greater stress on the system were it not for the position of the road cut into a steep valley side slope. Vegetation is less important in this condition than it would be on a floodplain setting, though it is still an issue. The most significant impact from the road is probably the need to maintain it. Rivers like the Slate on this reach are mobile. Migration and bank erosion are natural processes that can either be accommodated or artificially arrested. The position of the road adjacent to the active river means that active management is probably necessary to prevent the road from being washed out. It is inevitable that fill or engineered stabilization will have to be added or installed to protect the road at this location if erosion is actively occurring.

The road is also a point source of fine sediment to the river. Every time it rains, the bare dirt surface creates fine sediment that goes directly into the river with no opportunity for buffering. The actual volume of sediment introduced by this mechanism is not known, but it is at least enough to affect water quality, if not geomorphology. Below the road, the river becomes very turbid during and after each significant rain or runoff event.

The road is on the left bank of the river. Active maintenance is probably necessary to combat erosion and to maintain it in this position. Fine sediment from the road and traffic enters the river directly, making the water turbid during and after each significant rain event.

Solutions for the road are more difficult. Ideally the road would be moved away from the river, but there does not appear to be an alternative road alignment that is practical. Given these constraints, our best recommendation at this time is to live with the road in its present alignment but to seek management strategies that minimize its negative effects. Stakeholders should investigate alternative road surfaces or maintenance strategies for the riverside portions of the road to reduce sediment runoff. Regarding road stability in the face of bank erosion, it would be worthwhile for stakeholders to evaluate what is presently being done to maintain the road. Maintenance records or interviews with staff may be enough to determine how much effort is required to keep the road protected and what types of treatments have been made in the past. It is especially important to determine if fill is ever placed on the bank to rebuild washed-out sections of road. If this is the case, then it may be more cost efficient and less environmentally damaging to consider engineered stabilization of banks along the road. Another benefit of this approach would be that these could be designed to create a strip of native riparian vegetation along the river in addition to stabilizing the road.

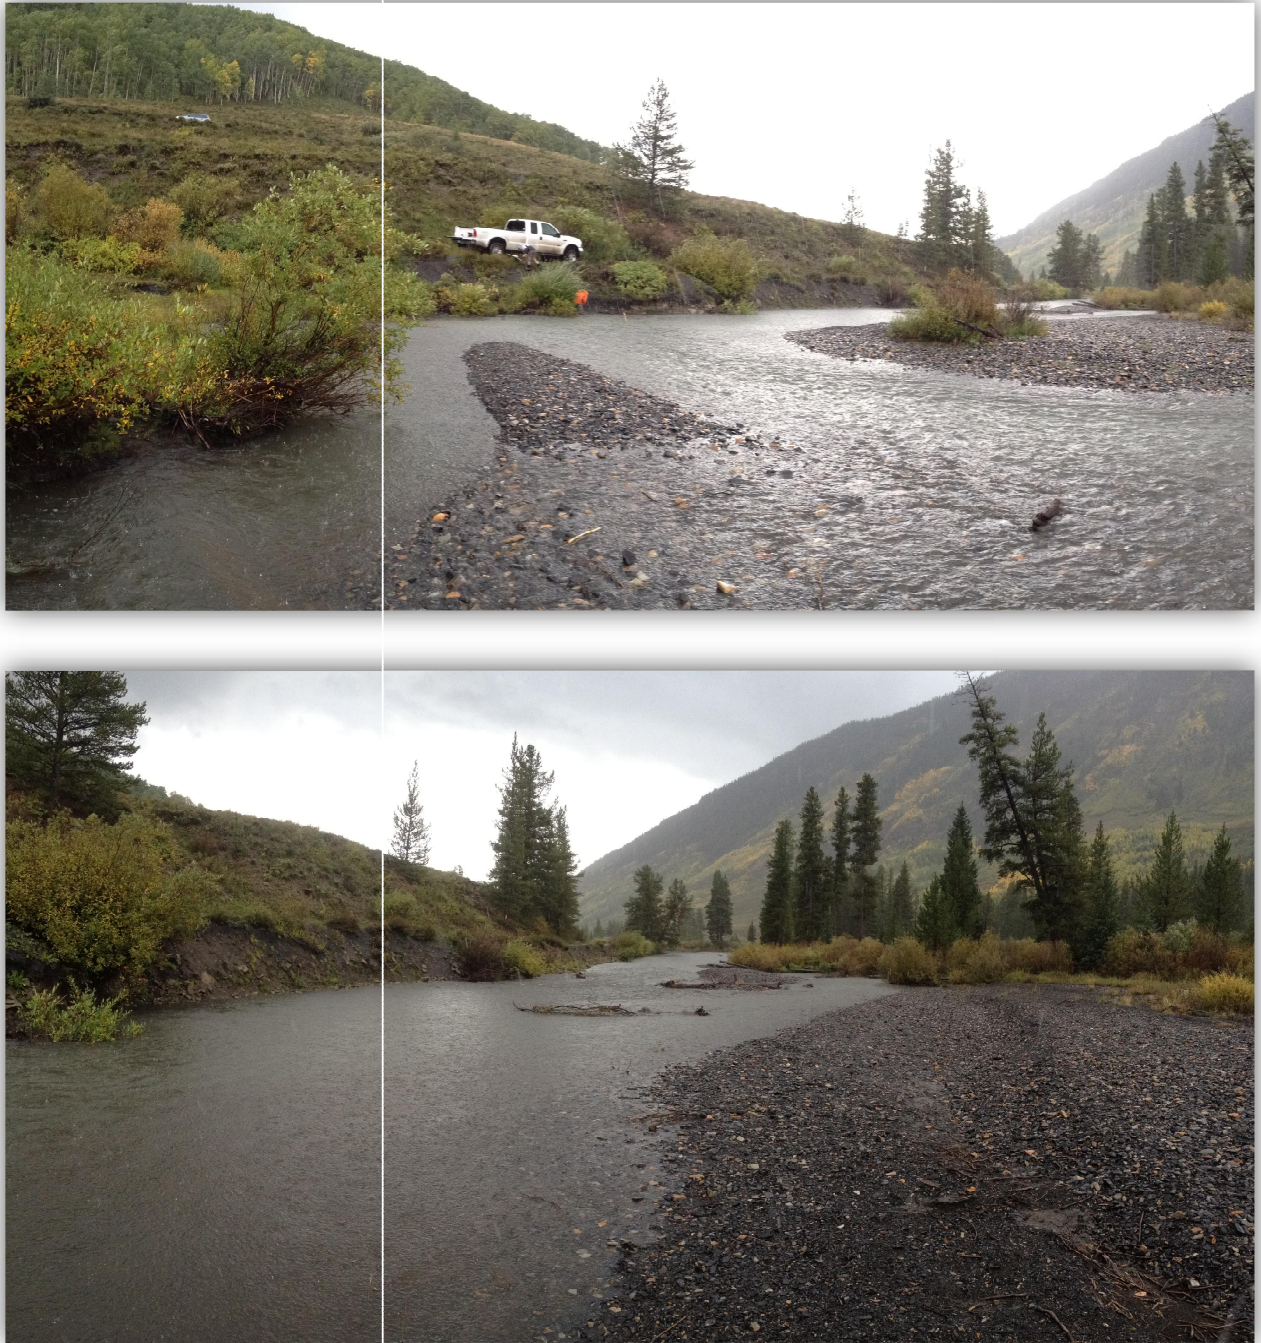
Figure 11: Gunsight Pass Road on the Bank of the River

The eroding left bank of the river is adjacent to the road.

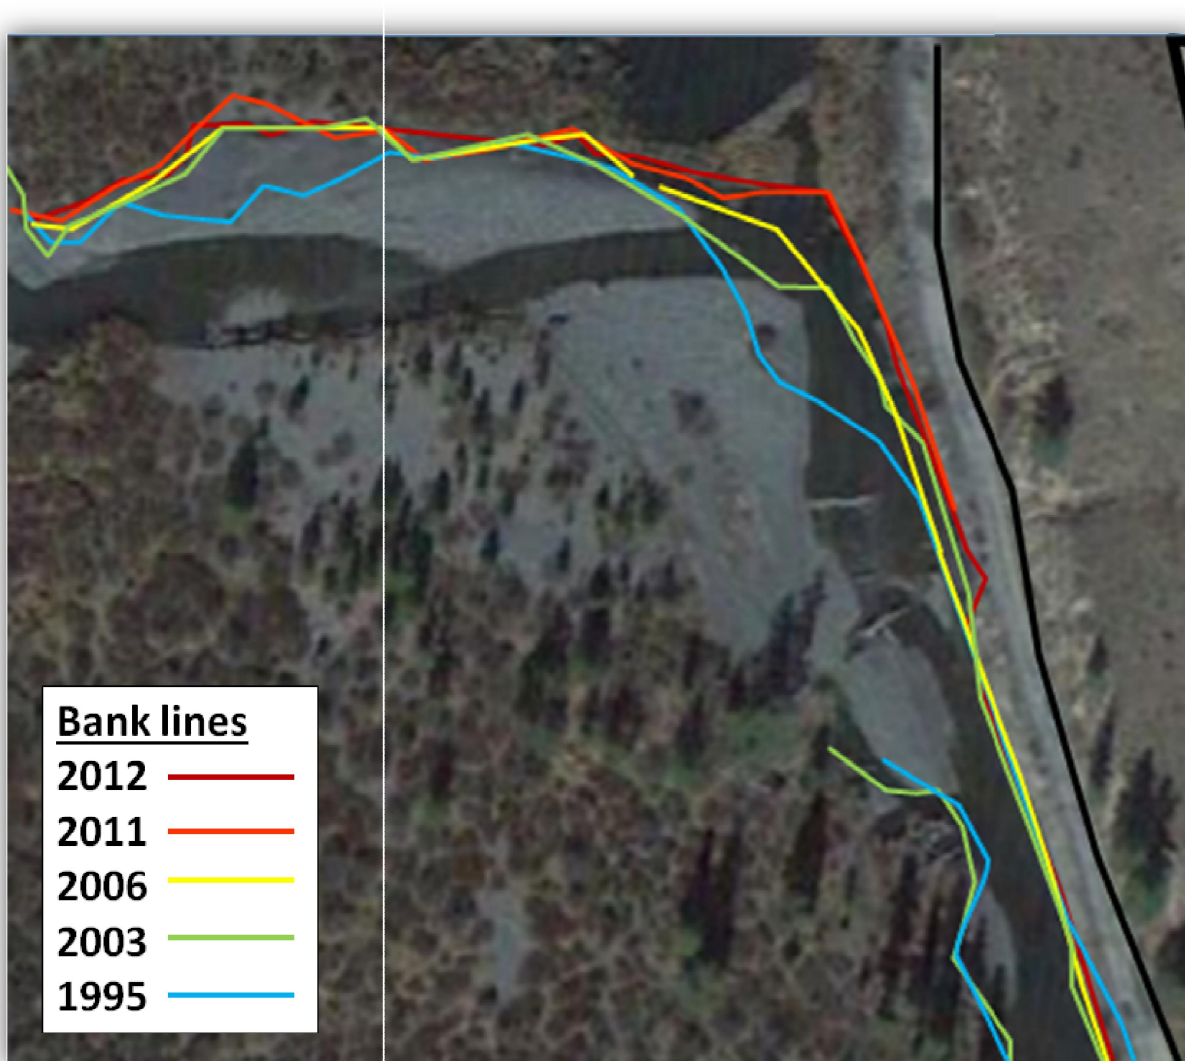
Figure 15: Historic Bank Lines on for the Gunsight Reach (Upper)

Historic bank lines indicate channel migration towards the road at a rate of approximately 2.3 ft/yr from 1995 to 2012.

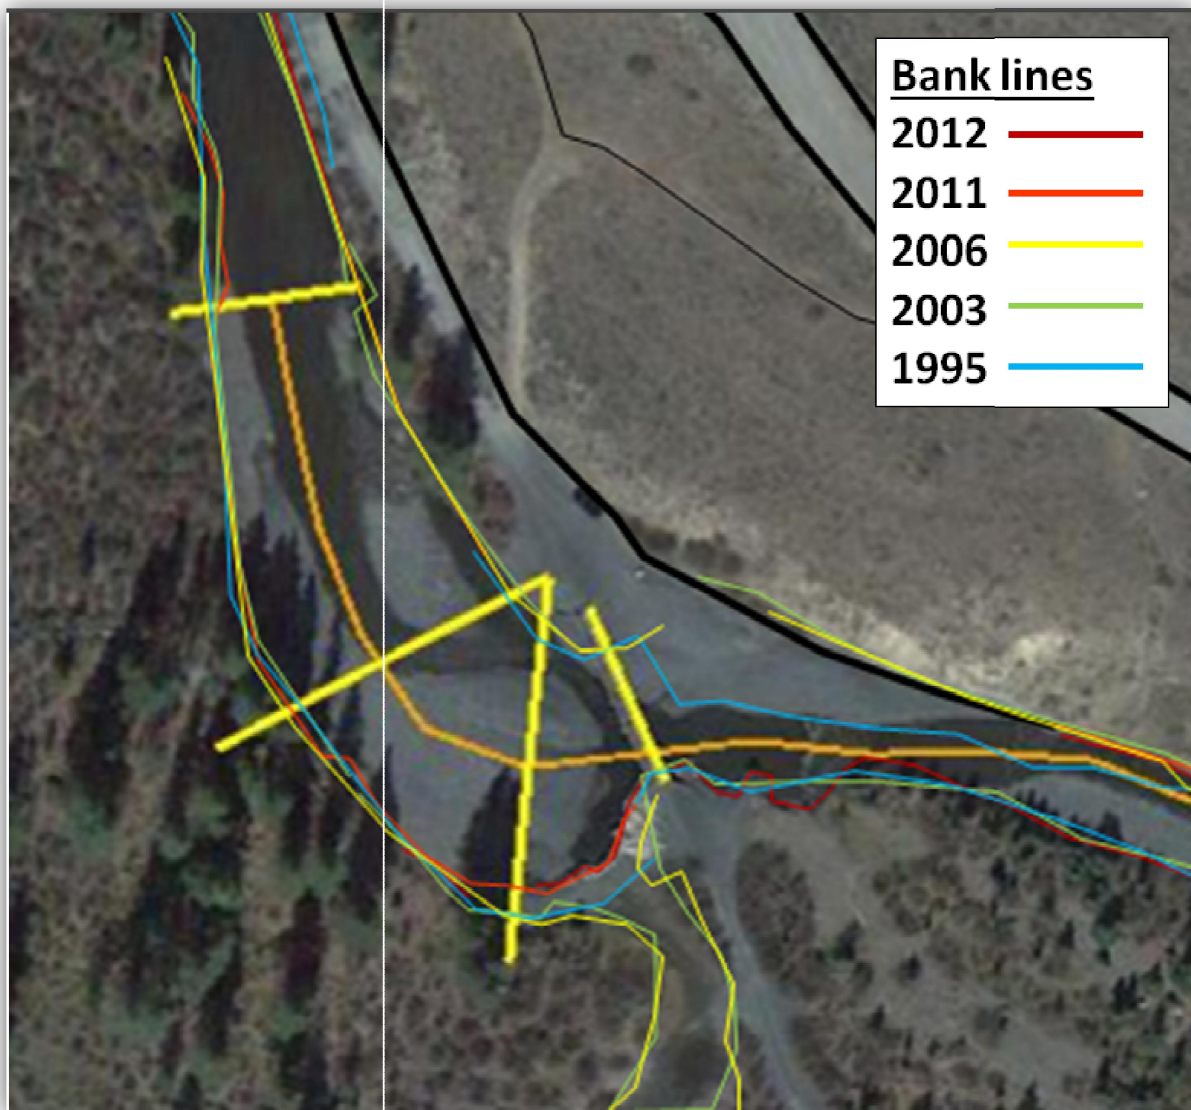
Figure 16: Historic Bank Lines for the Gunsight Reach (Bridge Area)

Historic bank lines show channel changes near the bridge from 1995 to 2012. Most notable is the construction of a right bank and armoring that occurred in 2010 just upstream of the bridge.

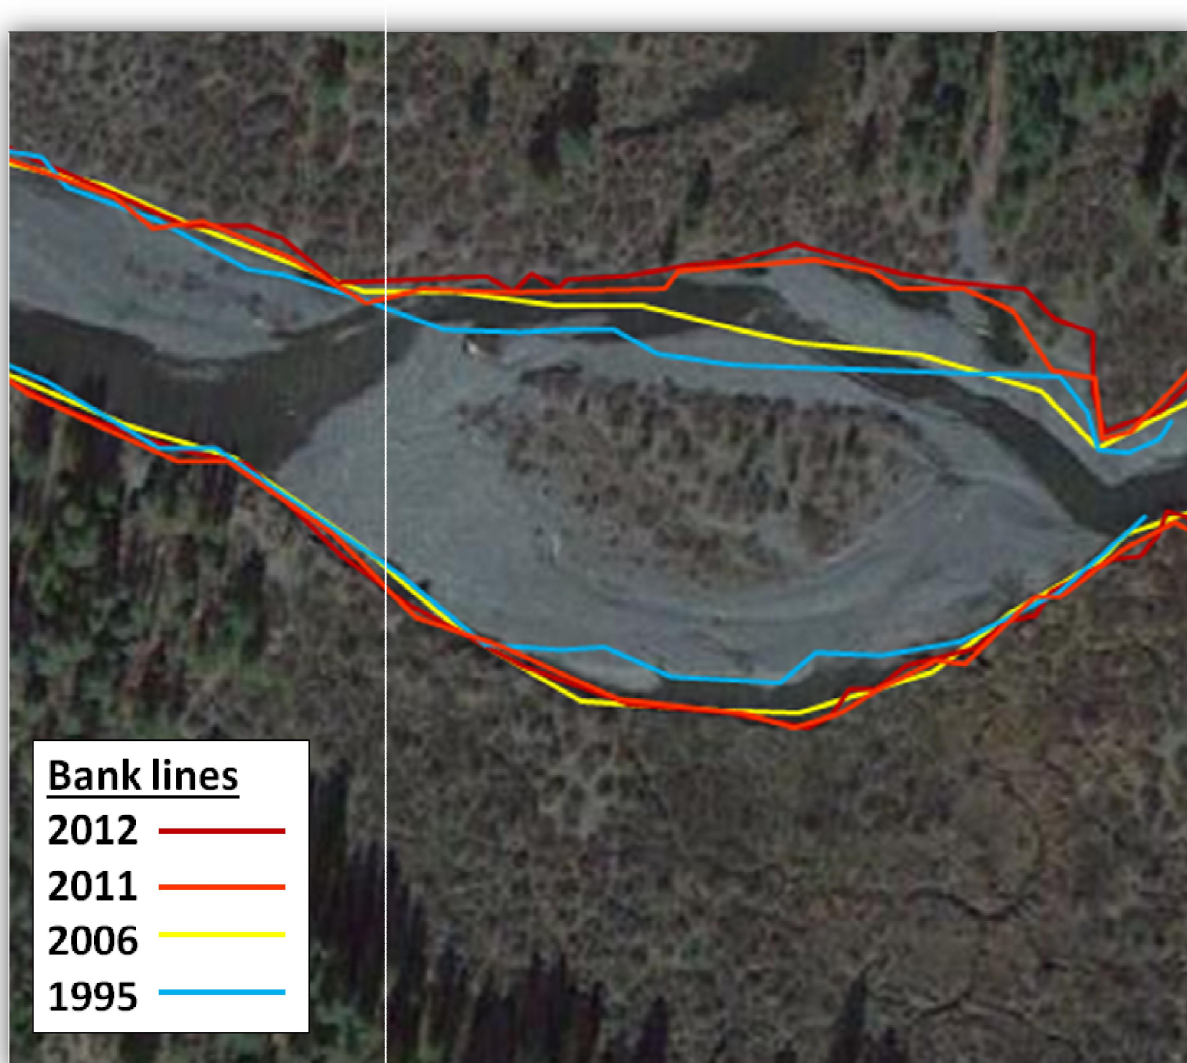
Figure 17: Historic Bank Lines for the Reach Above Gunsight

Channel migration and bank erosion is common on wide braided rivers like the Slate. On the reach upstream from the Gunsight, migration rates of 20-50 feet over 18 years (1.1-2.8 ft/yr) were observed (**Figure 17**).

Historic bank lines on the braided reach upstream of Gunsight show rates of bank erosion on the order of 1-3 ft/yr.

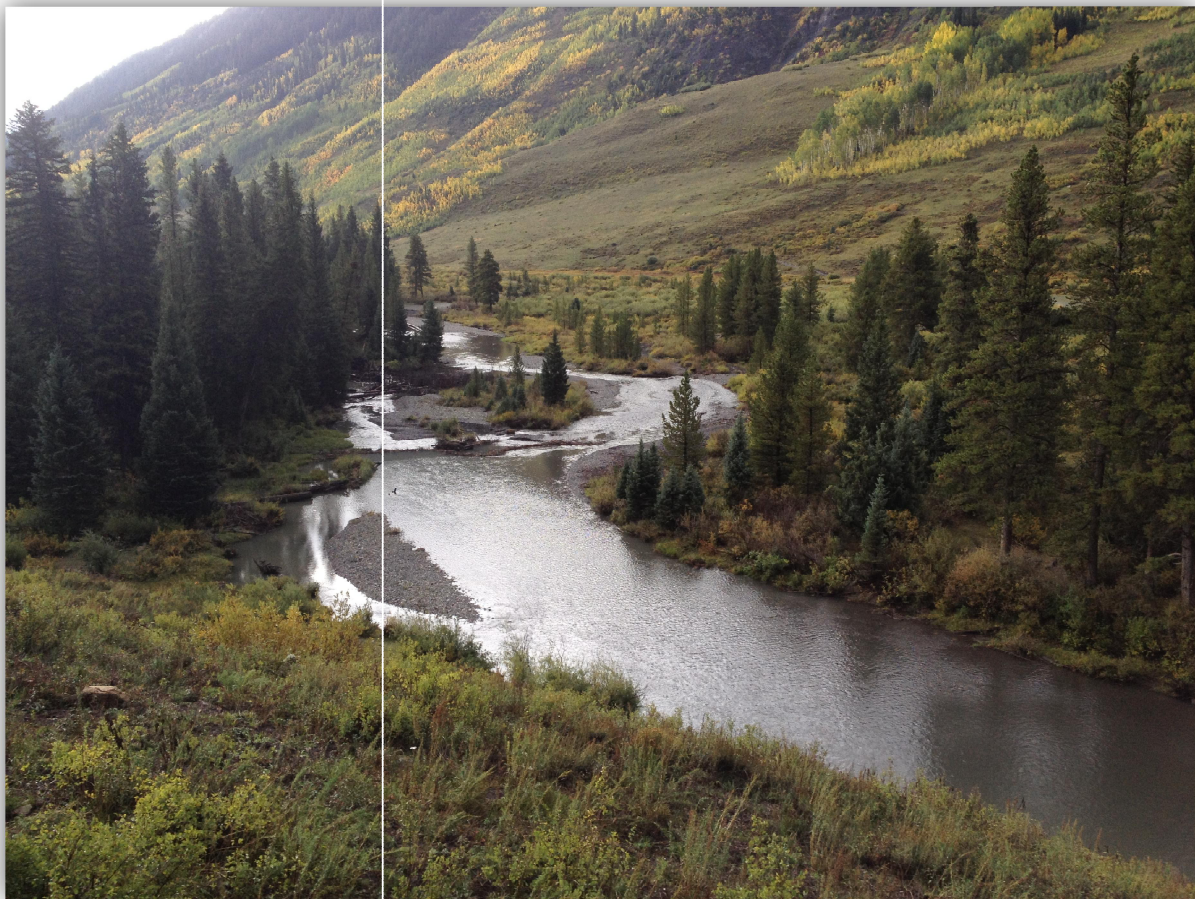
The Slate River at the downstream end of the Gunsight Reach where it transforms back to a braided channel form.

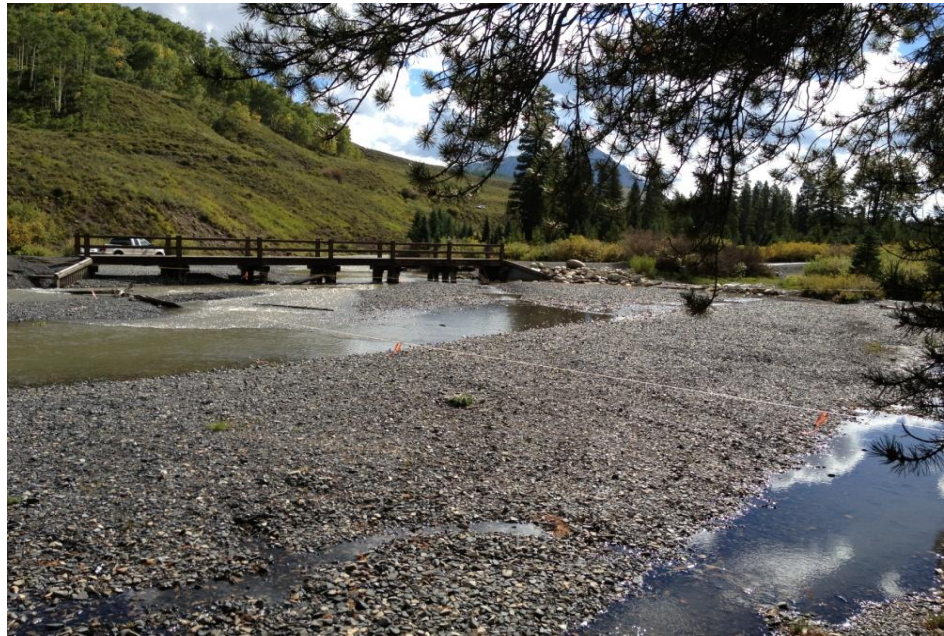
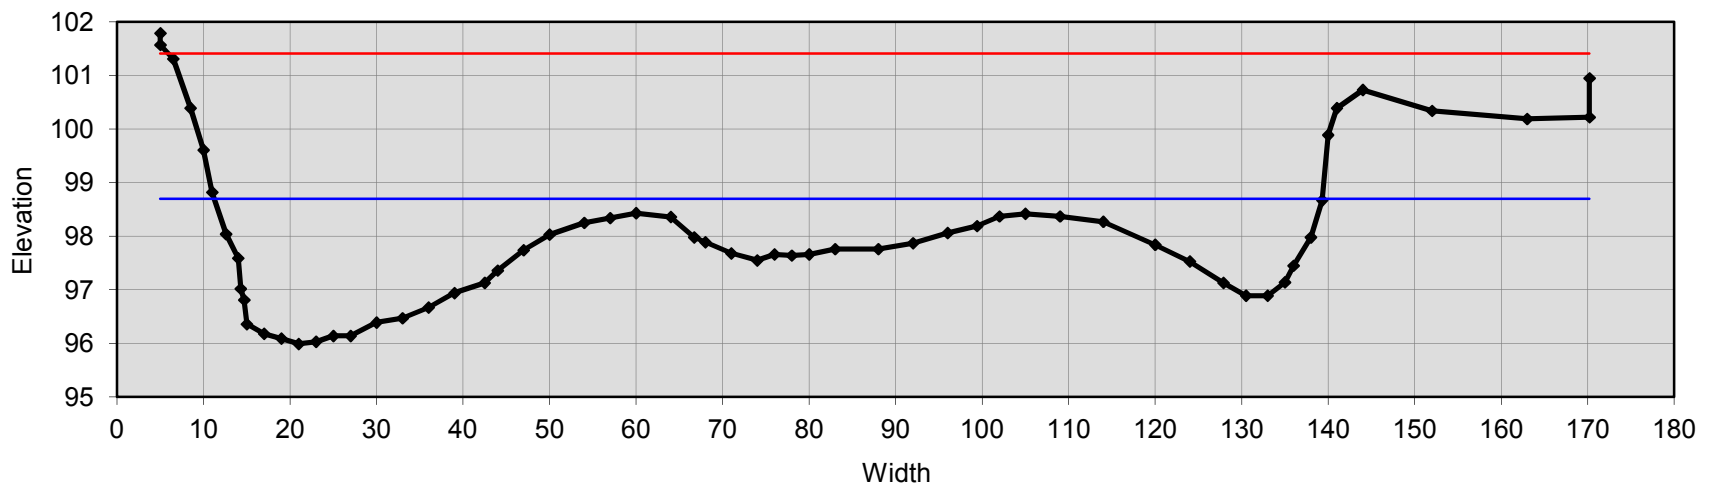
Figure A-2: XS-192

Note: This XS is across the upper end of the deposition area upstream of the bridge.

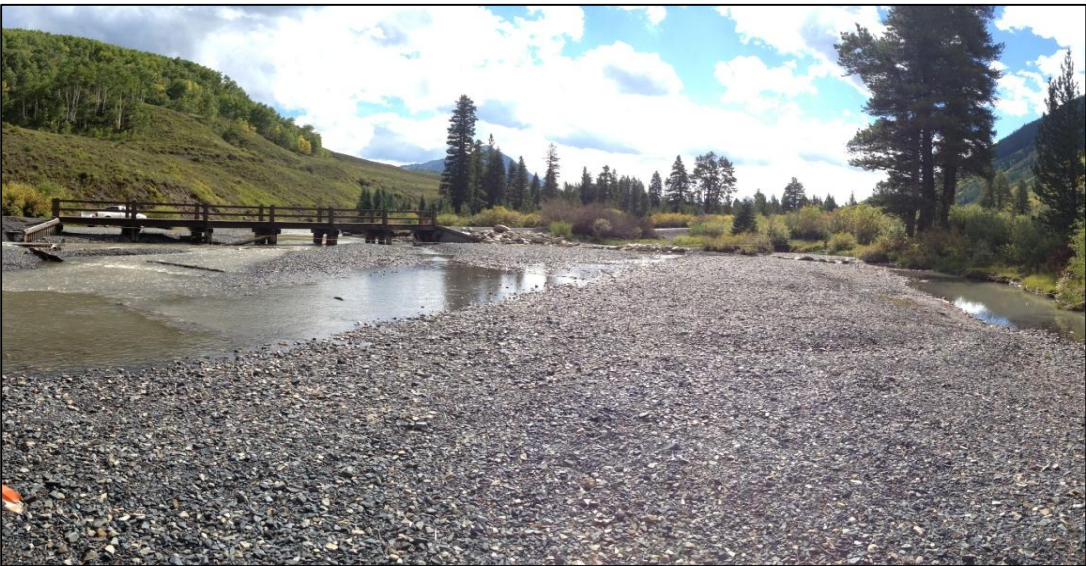
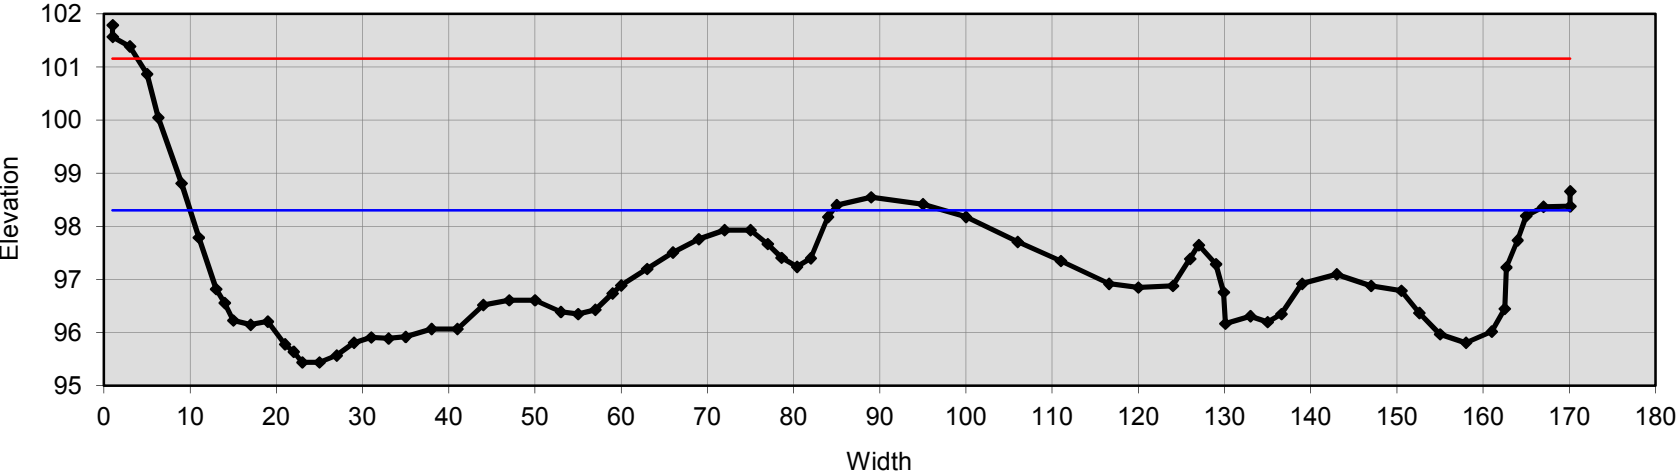
Figure A-3: XS-253

Note: This XS is across the main deposition area upstream of the bridge where the channel is turning to the left to go through the bridge .

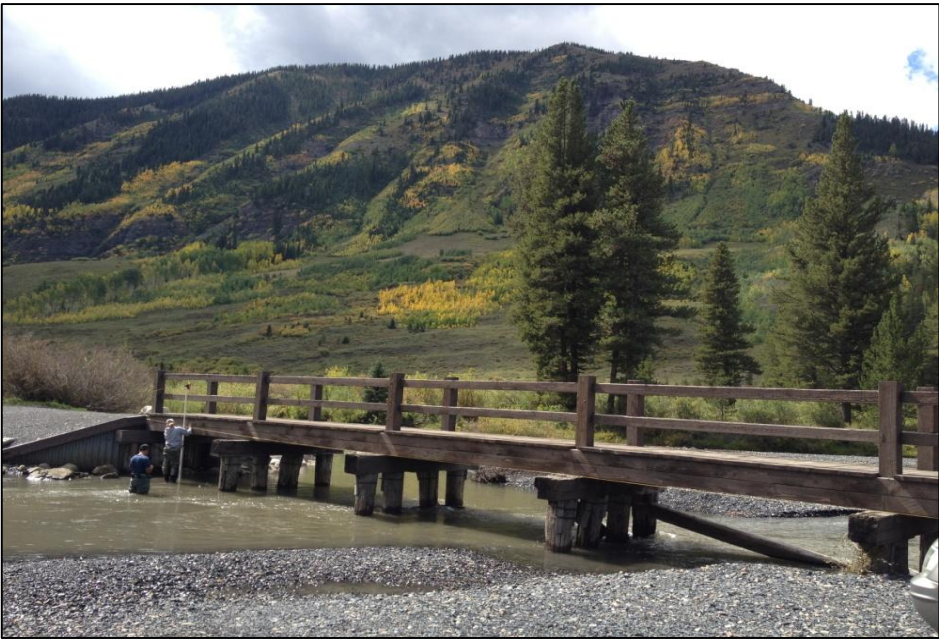
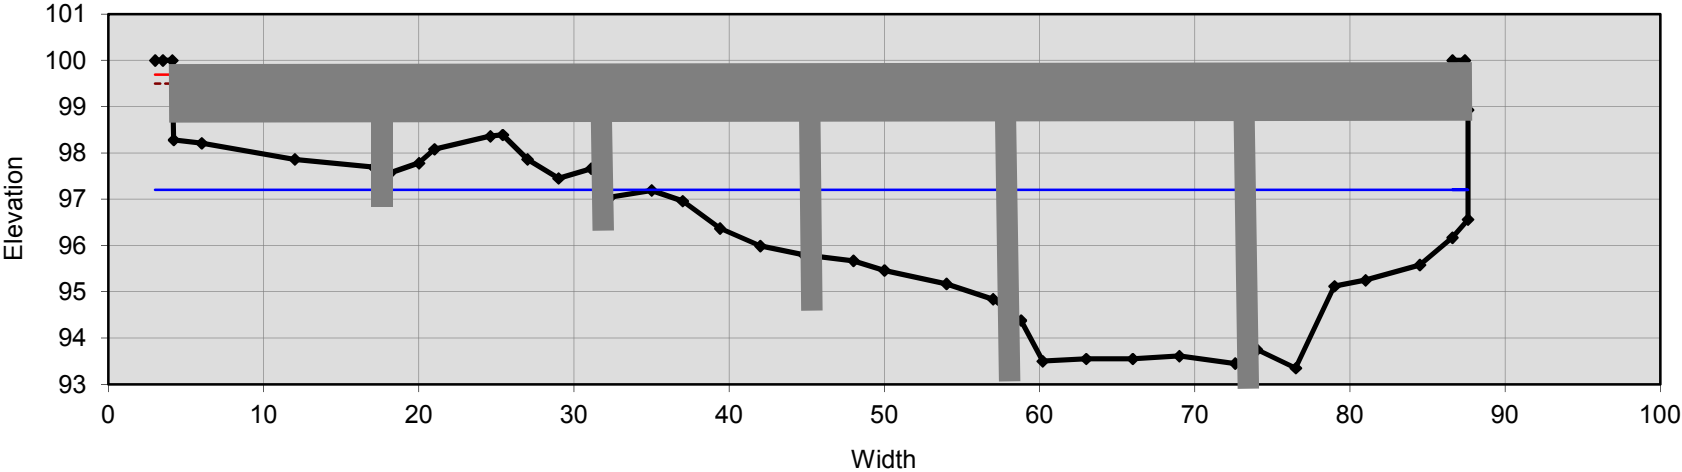
Figure A-4: XS-302

Note: This XS is along the downstream edge of the bridge. Bridge structure is depicted in the plot below. The road on the left bank and a berm on the right bank confine flood flows to the bridge span.

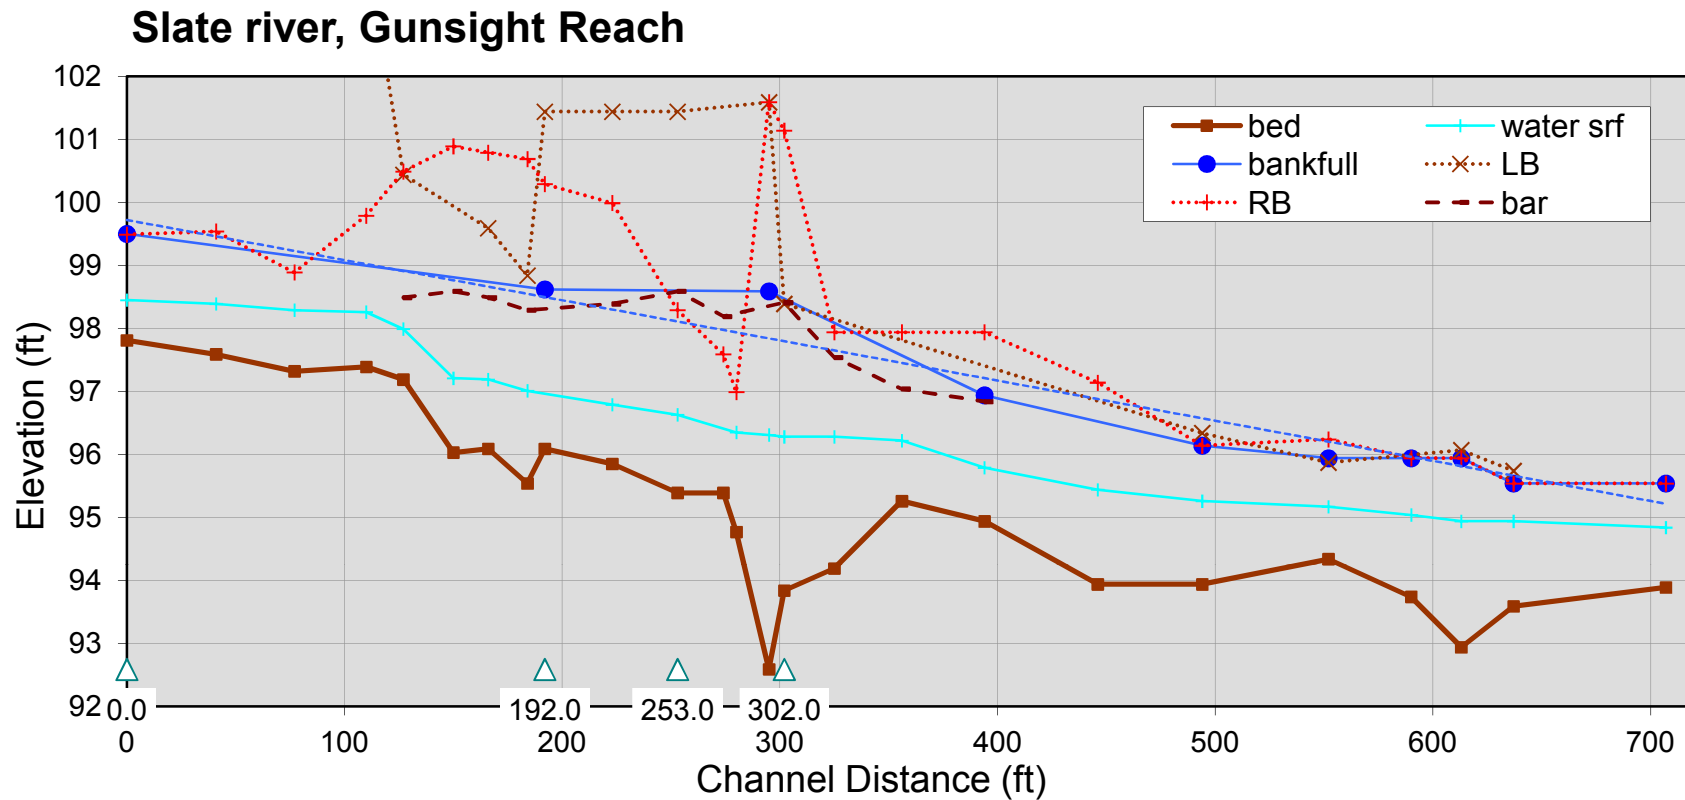
Figure A-5: Longitudinal Profile

Results of the longitudinal profile survey are displayed in **Appendix 1, Figure A5**. Channel slope, a measure of stream gradient, averaged over the length of the reach is 0.51 percent, meaning that water elevation at bankfull stage drops an average of 0.51 ft per 100 ft of stream length. However, the Bridge constriction restricts flow to the point that effective bankfull slope is diminished to an estimated 0.14% gradient upstream. The flattened slope caused by bridge constriction has significant consequences for sediment transport and deposition.
