Bergen Ditch and Reservoir Company Loan Feasibility Study

**Colorado Water Conservation Board
Water Project Loan Program
August 2012**

**Rehabilitation of Bergen Reservoir No. 2
and Minor Improvements to Other Bergen Facilities
Located near C-470 and Bellevue
Jefferson County, Colorado**

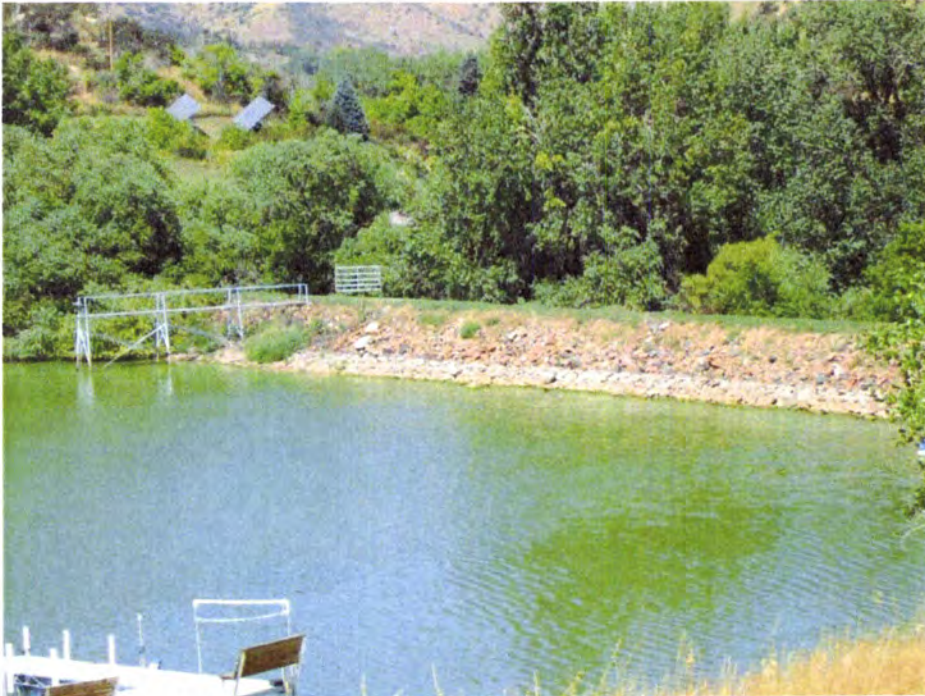
PHOTO A1 – View of upstream slope of the embankment and access walkway for the outlet works. The upstream slope and riprap protection are in good conditions.

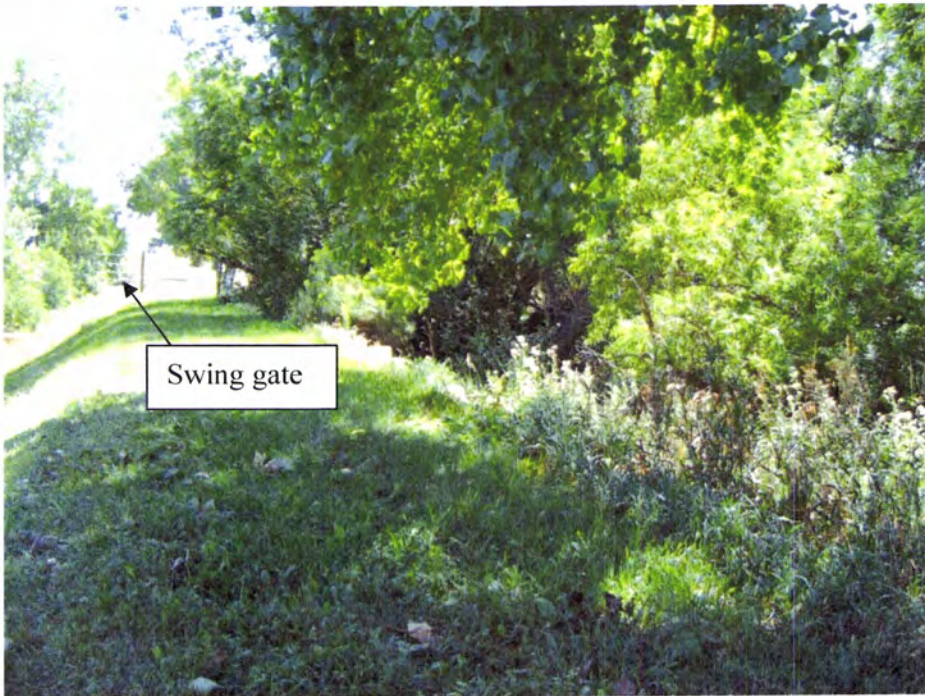
PHOTO A2 – View of upstream slope west of the swing gate, looking toward the right abutment. Note heavy vegetation on the embankment slope.

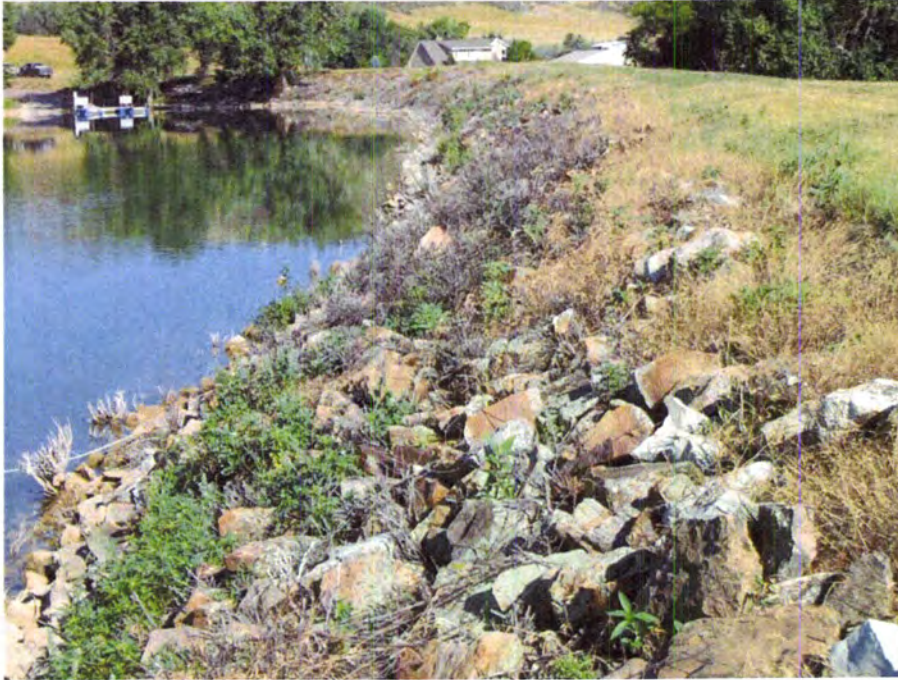
PHOTO B1 – View of upstream slope, looking toward the left abutment. The slope is too steep, and riprap erosion protection is inadequate.

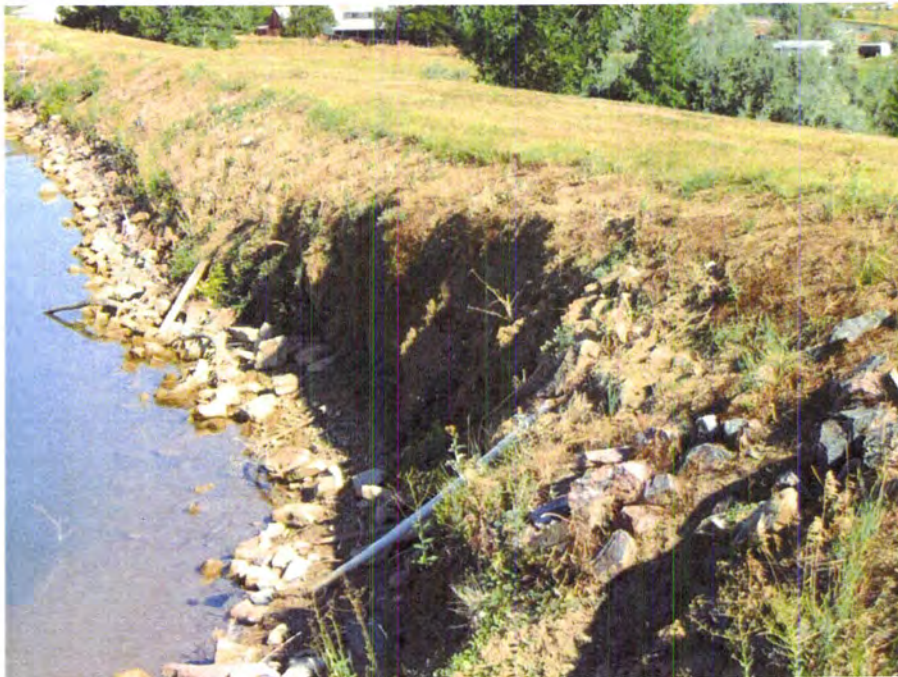
PHOTO B2 – View of upstream slope near the right abutment, looking toward the left abutment (west). Note near-vertical erosion scarp at the top 8 to 10 feet of the slope.

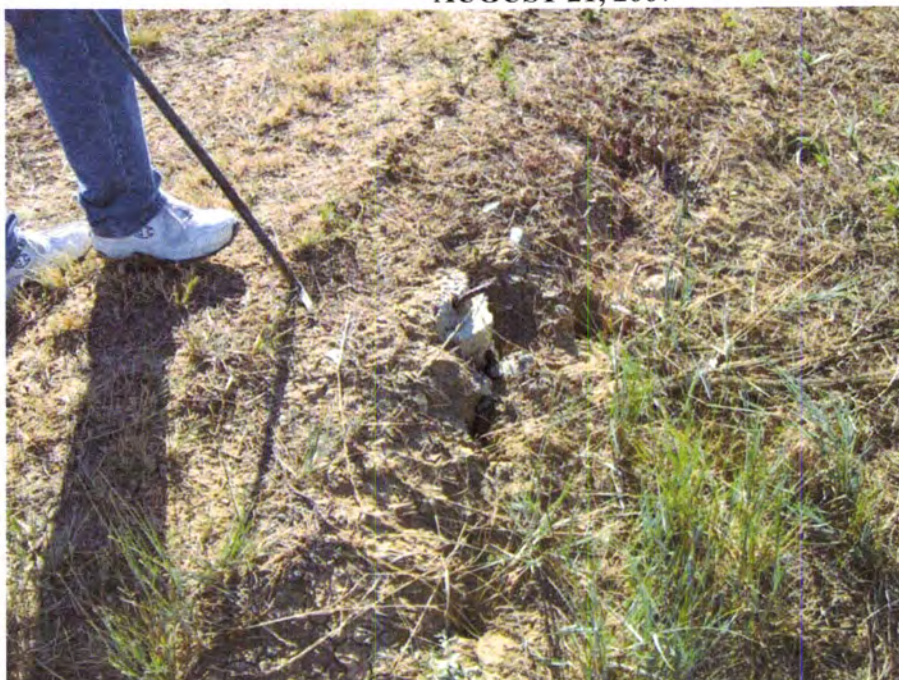
PHOTO B3 – Closeup of longitudinal crack at the top of the upstream slope near the right end of the embankment.

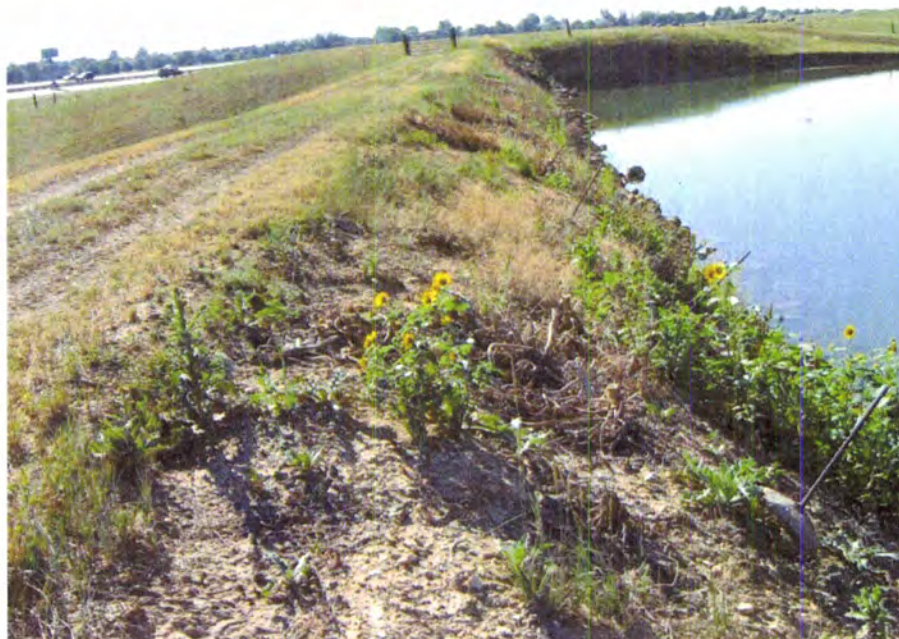
PHOTO B4 – View of the upstream slope near the right abutment. This area of the slope has no riprap protection and showed evidence of slumping and cracking.

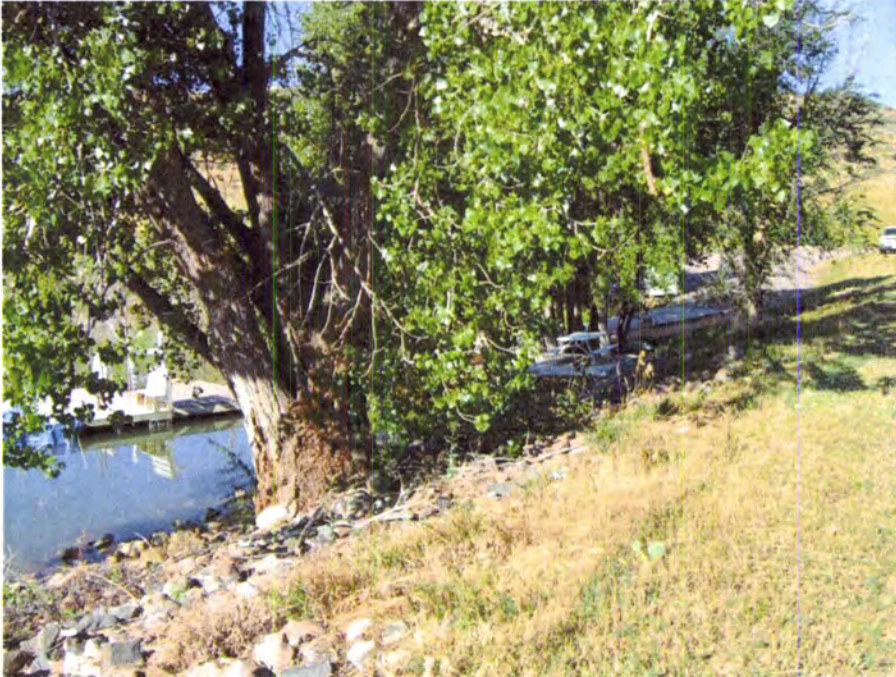
PHOTO B5 – Upstream slope near the left abutment. Note several trees growing on the slope in this area.

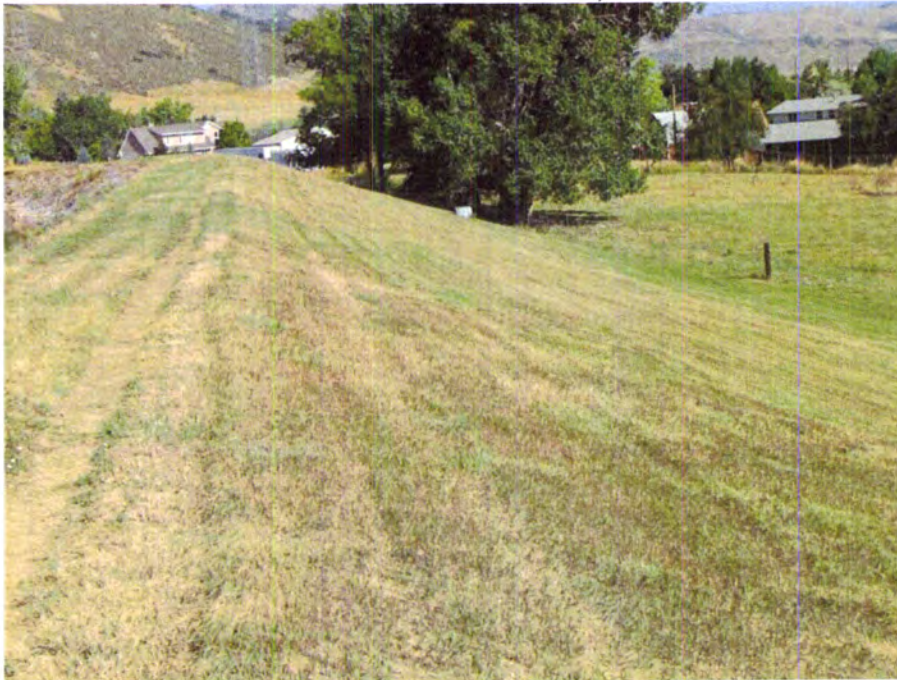
PHOTO B7 – View of the downstream slope, looking west toward the left abutment. The downstream slope is well maintained and in good condition.

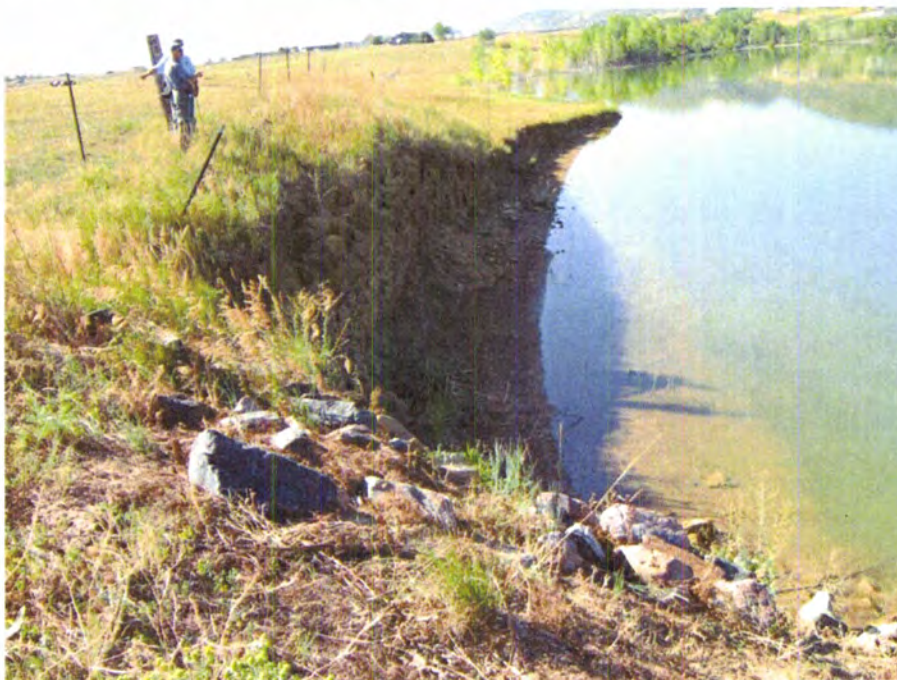
PHOTO B8 – Vertical scarp in the upstream right abutment just upstream of the dam.

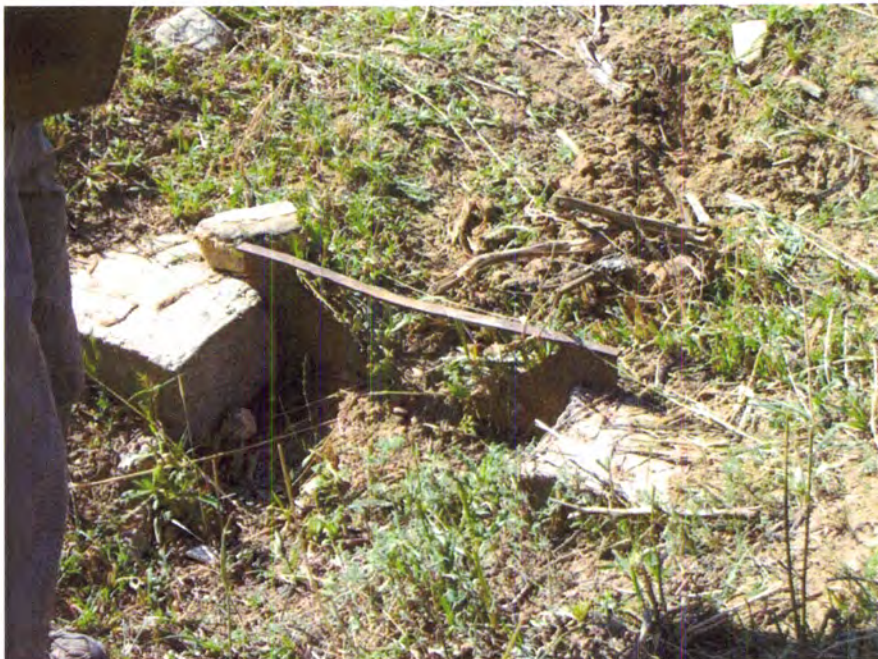
PHOTO B10 – Weir No. 1 just west of outlet works. No flow was observed.

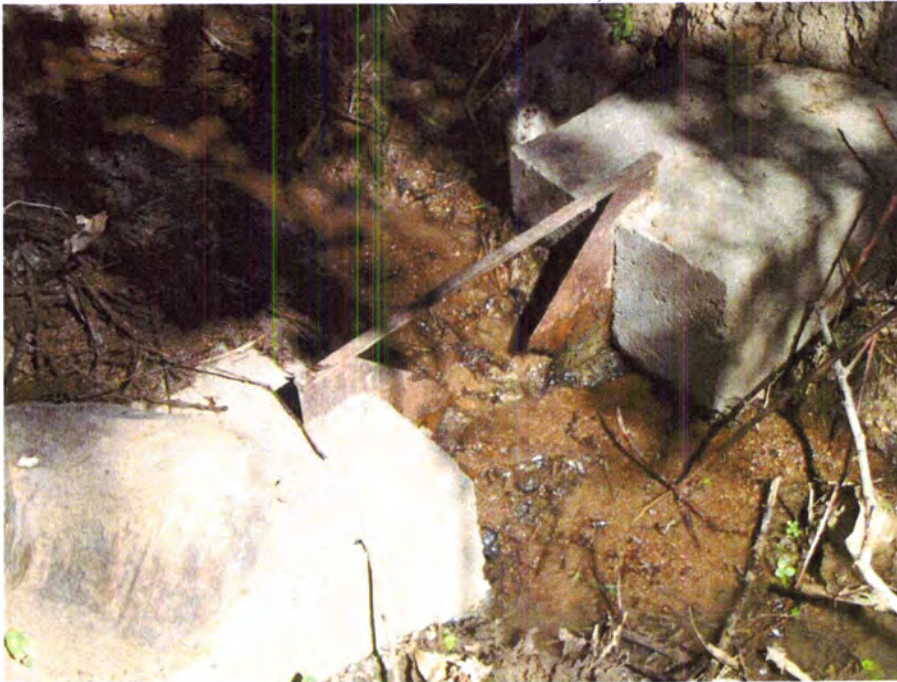
PHOTO B11 – Weir No. 2 just downstream of a 6-inch tile drain. Significant Sediments were accumulated between the weir and the tile drain.

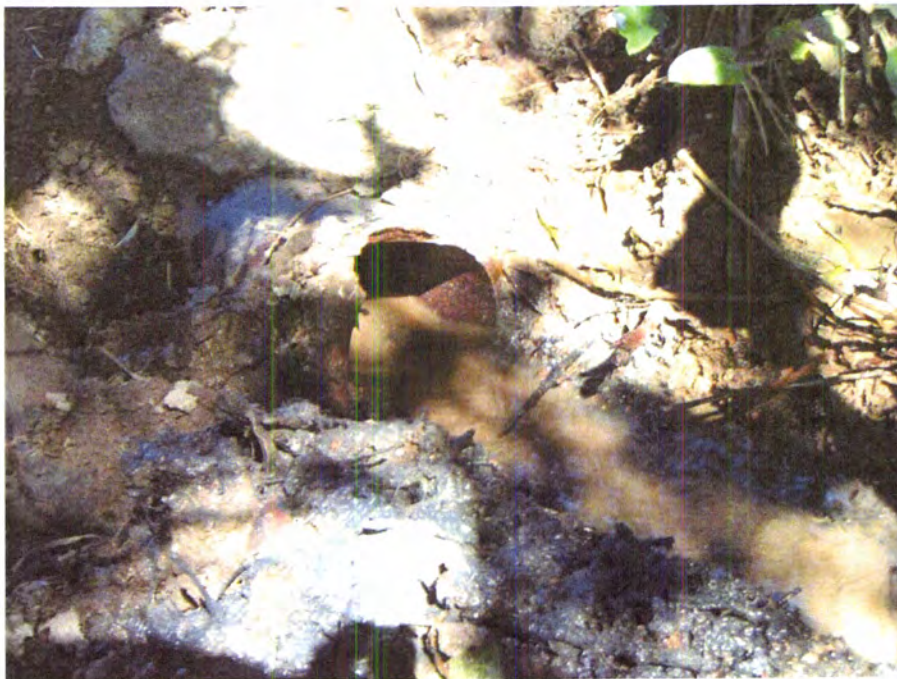
PHOTO B12 – Exposed 6-inch tile drain flowing about several gallons per minute. Sediments were observed at the bottom one-third of the drain. Cloudy water was caused by attempt to remove the sediments, and water became clear shortly thereafter.

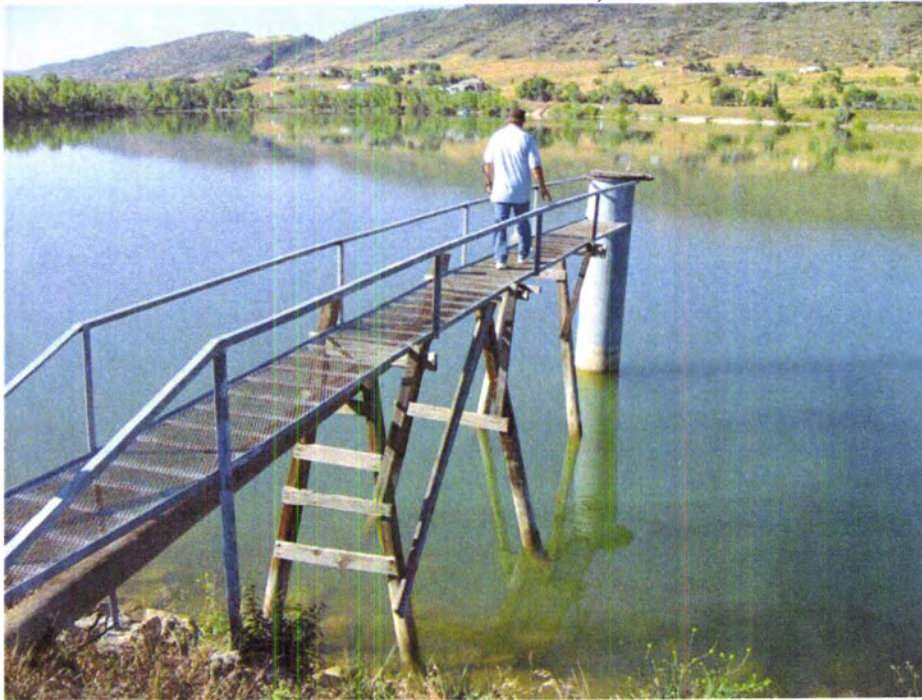
PHOTO B13 – Outlet works walkway and riser structure. Note the tilting of the riser structure.

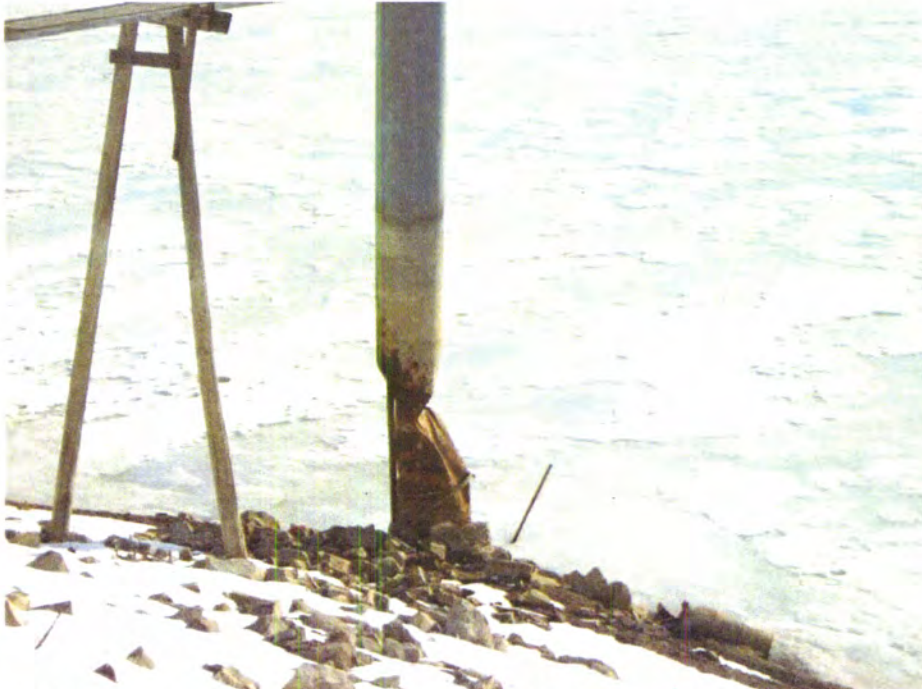
PHOTO B14 – Condition of the damaged riser structure of the outlet works. (Photo was taken on January 11, 2007 during low reservoir level, courtesy of W. W. Wheeler & Associates).

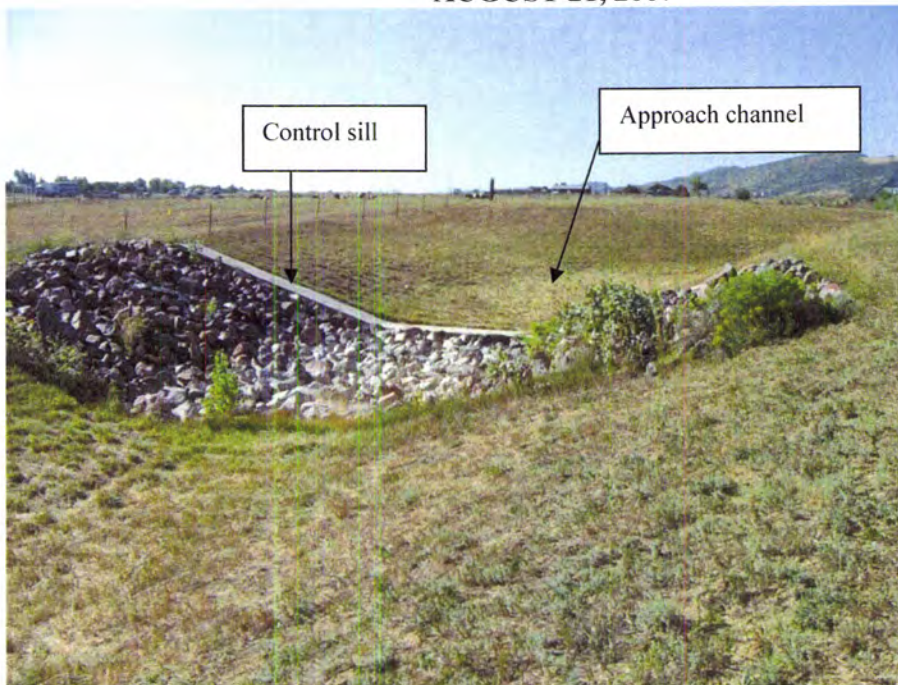
PHOTO B15 – General view of spillway channel, looking upstream. Approach channel, control sill and riprap are in good condition.

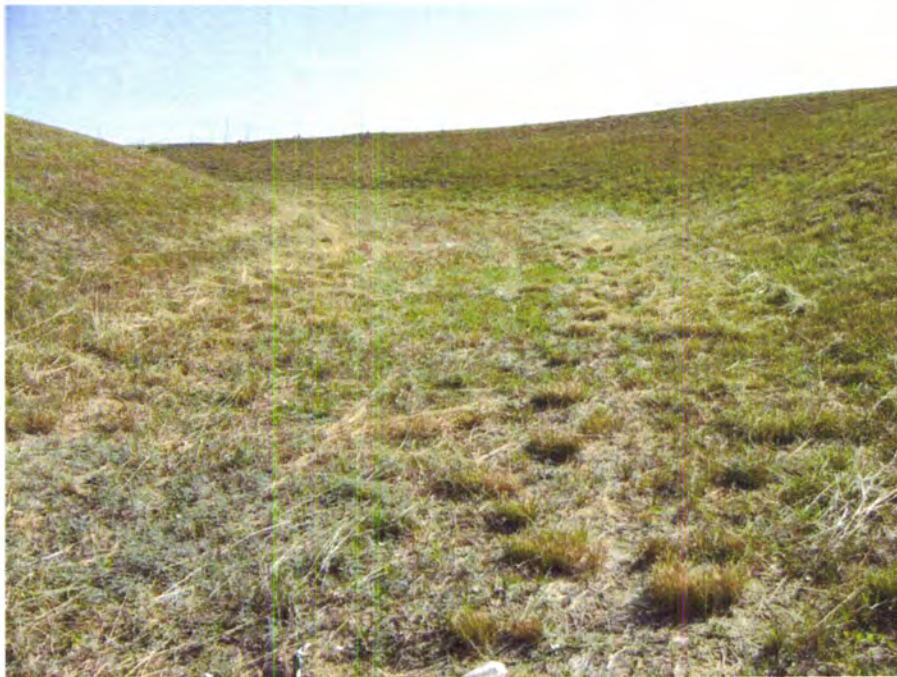
PHOTO B16 – Spillway discharge channel downstream of control sill, looking downstream. Low areas were reported in this channel. Otherwise channel is in good condition.

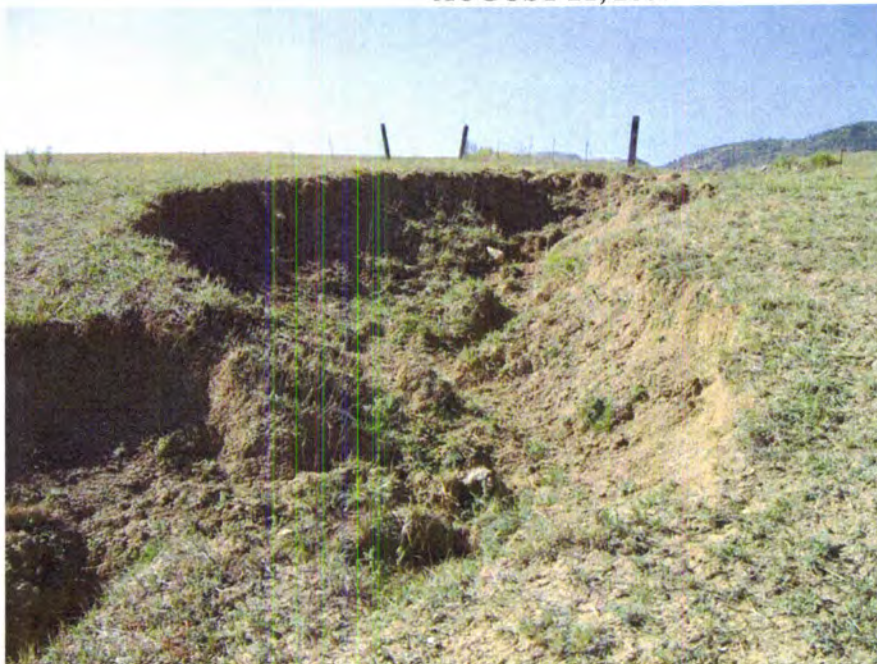
PHOTO B17 – Erosion in spillway discharge area, downstream of the downstream cutoff wall. This erosion area is at least 200 feet from the dam, and is not a dam-safety problem.

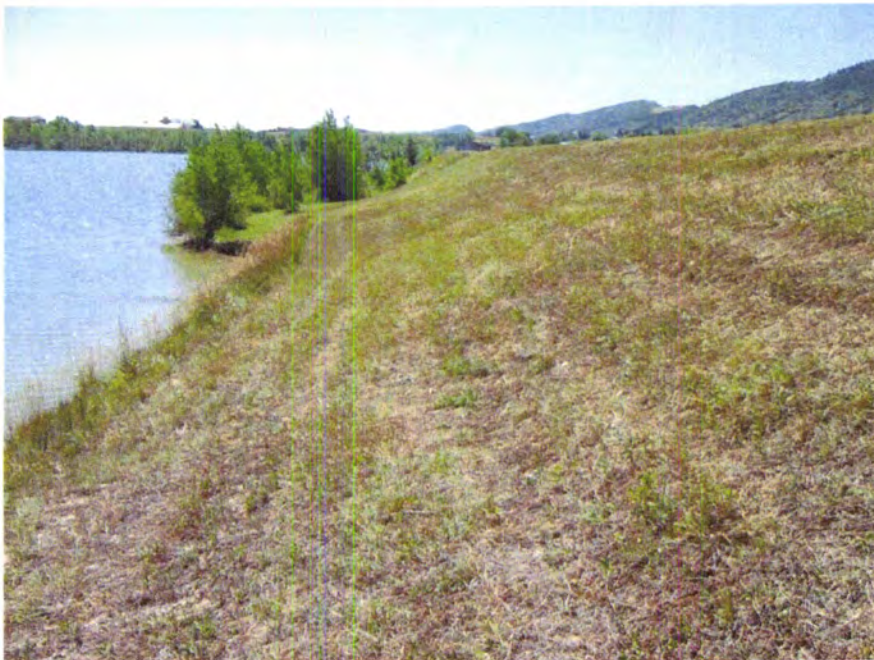
PHOTO C2 – Downstream slope of the dike, looking south. Overall condition of the slope is acceptable. Bergen Reservoir No. 2 is at left side.

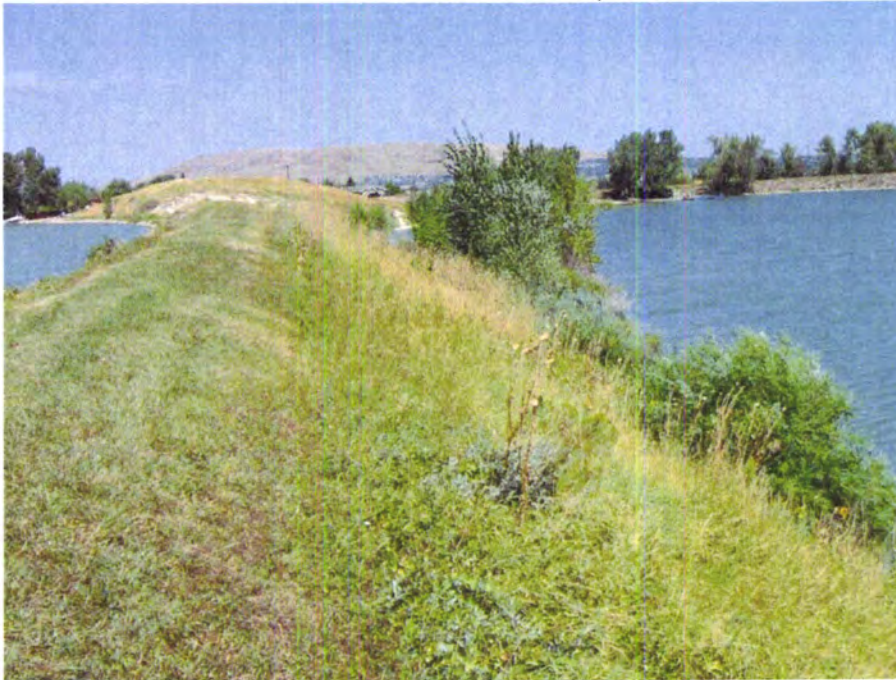
PHOTO C3 – Downstream slope of the dike looking south. This area of the slope is locally steep and includes some woody vegetation.

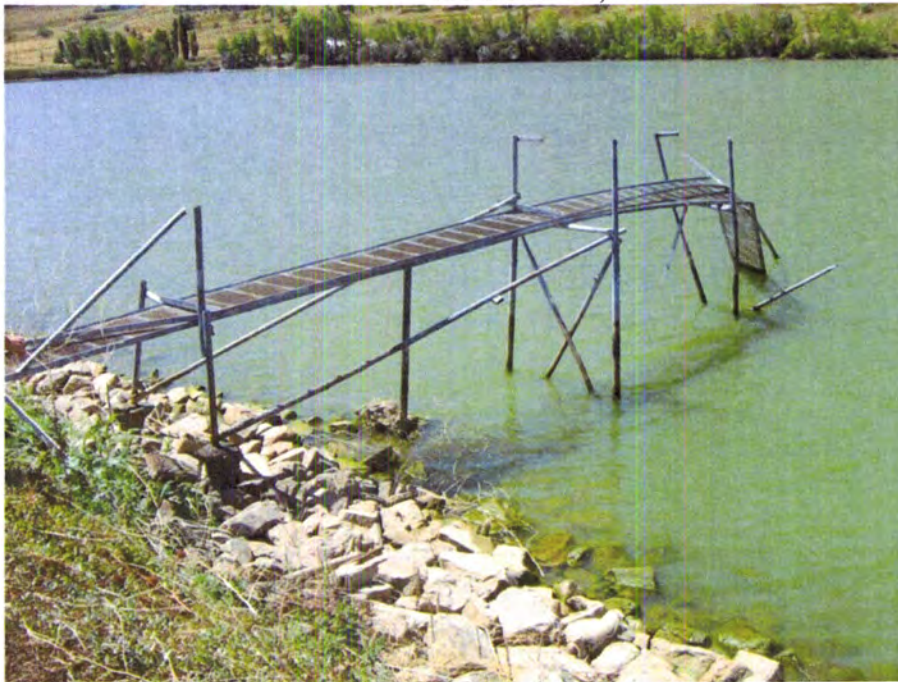
PHOTO C5 – Damaged walkway of the outlet works. The riser structure cannot be observed.

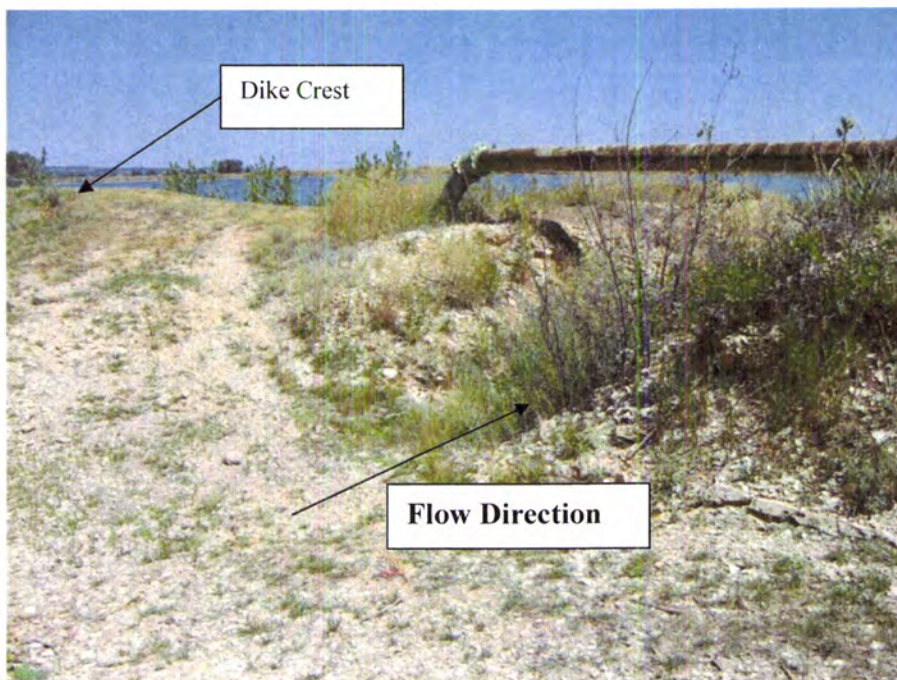
PHOTO C6 – Service spillway crest of Bergen Dam No. 1 on the north abutment of the dike. Flow is from left to right. There control crest is in acceptable condition.

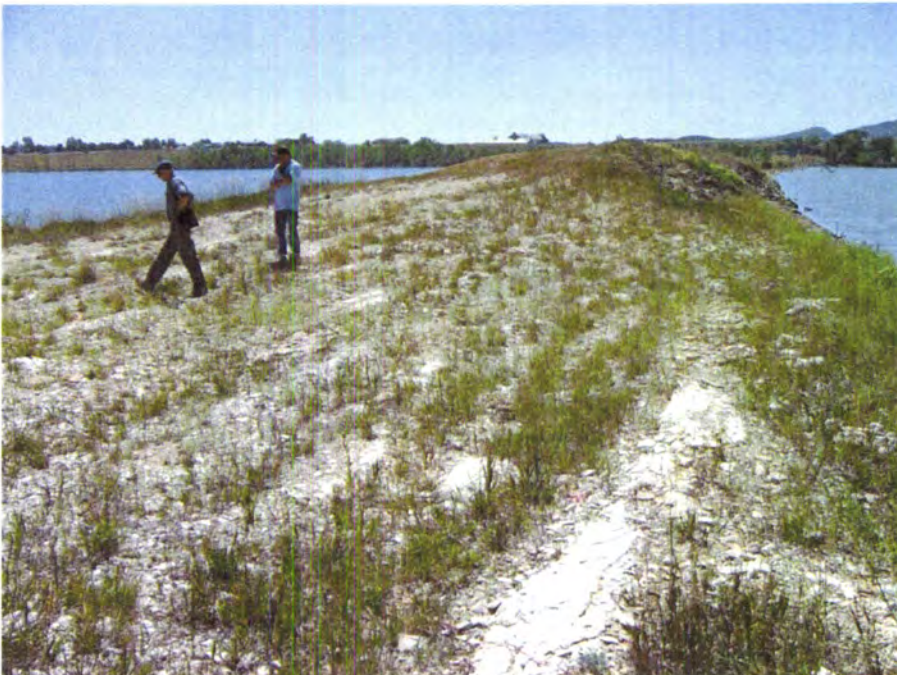
PHOTO C8 – Emergency spillway for Bergen Dam No. 1 at the south abutment of the dike, looking south. The condition of the rock spillway (limestone) is good.

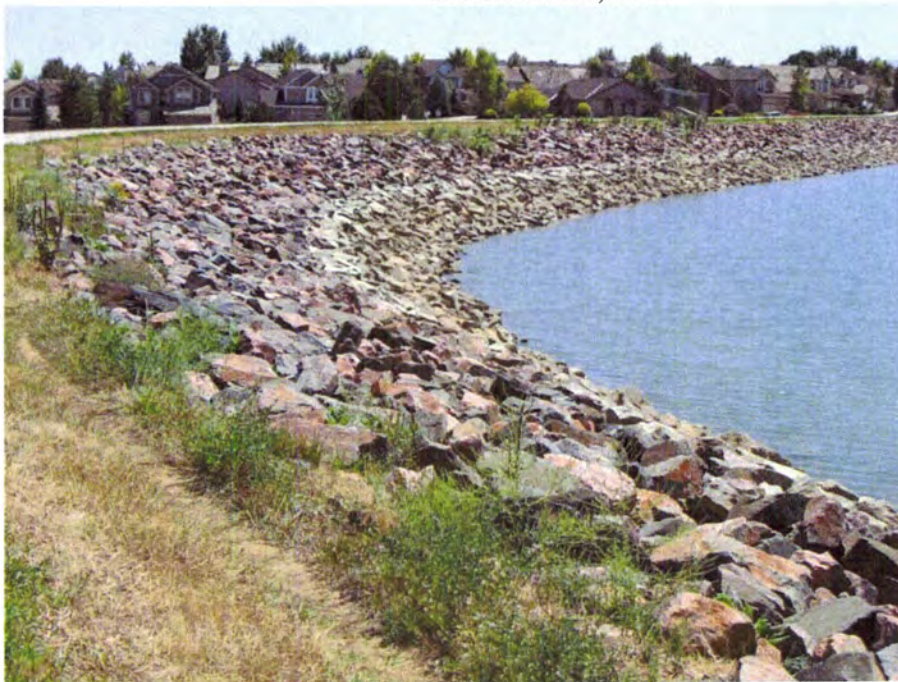
PHOTO D1 – General view of the upstream slope, looking toward the right abutment. The slope and riprap protection are in good conditions.

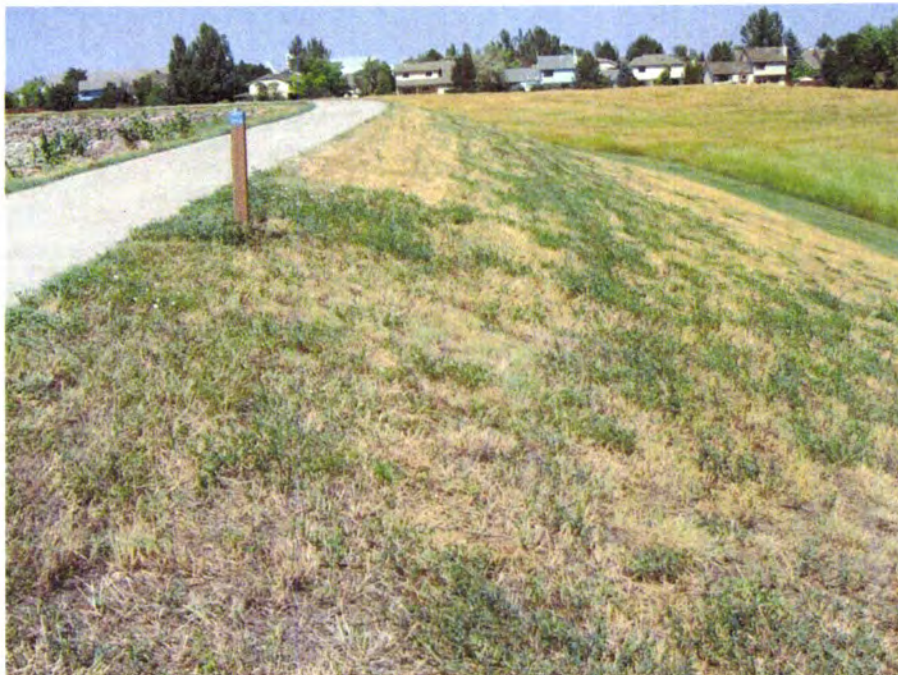
PHOTO D2 – General view of the dam crest and downstream slope. Both the dam crest and downstream slope conditions are good.

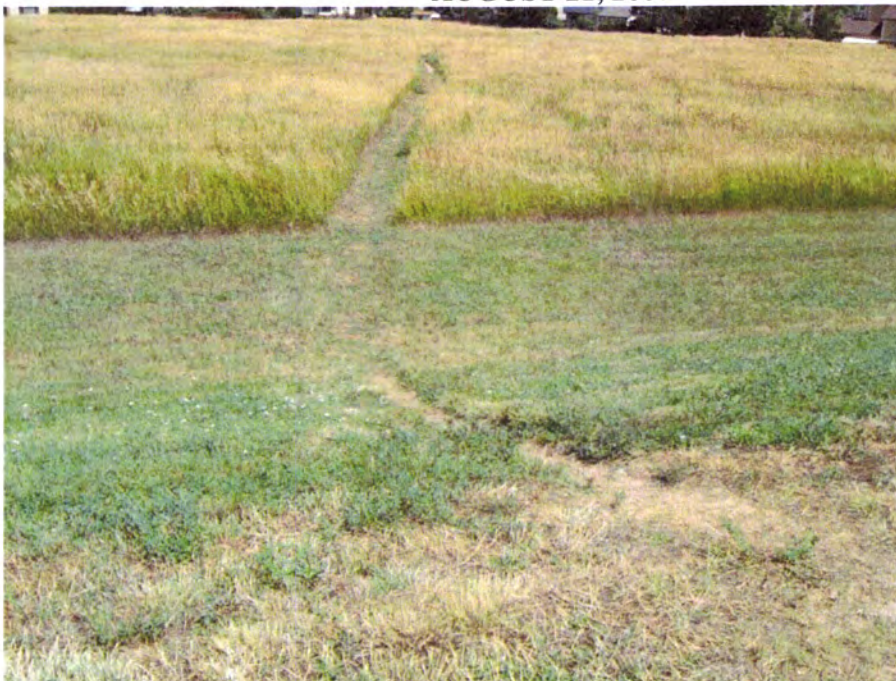
PHOTO D3 – View of the downstream slope of the dam, looking downstream, showing minor erosion of the slope face from pedestrian foot traffic.

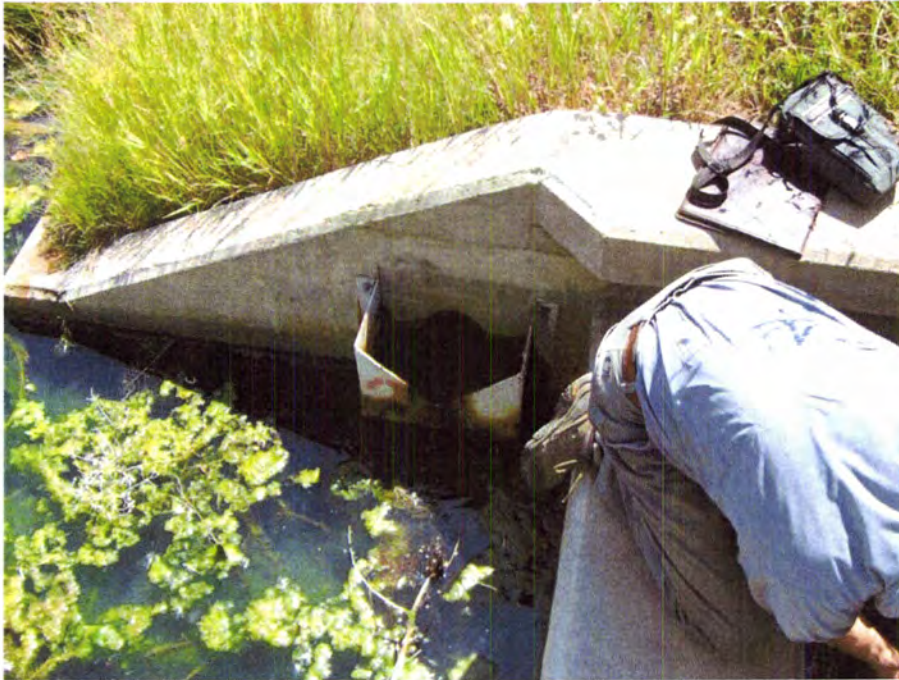
PHOTO D7 – Typical seepage weir mounted on the outlet basin. Note rusting of the weir coating. Also note the backwater in the outlet channel has submerged the entire outlet pipe.

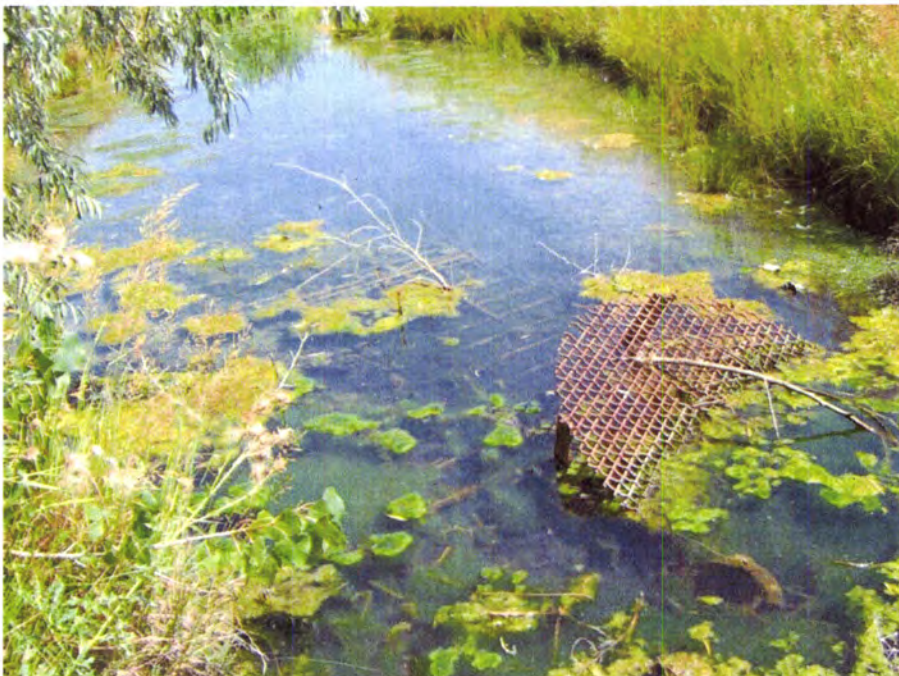
PHOTO D8 – View of the outlet channel just downstream of the basin. Note metal debris exposed and submerged in the channel.

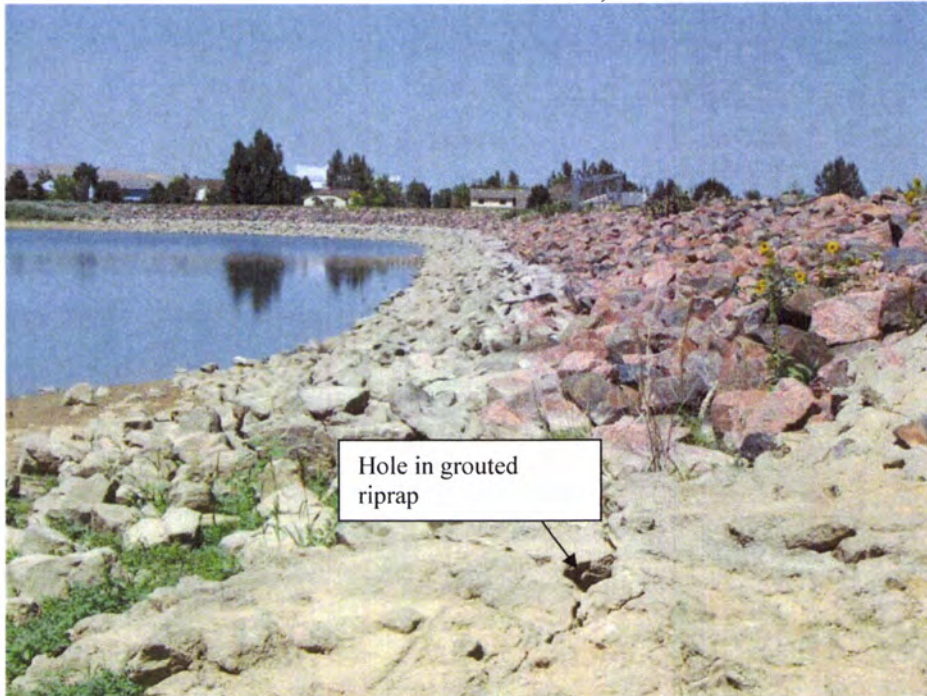
PHOTO D11 – Damaged grouted riprap on the left side of the spillway approach channel.

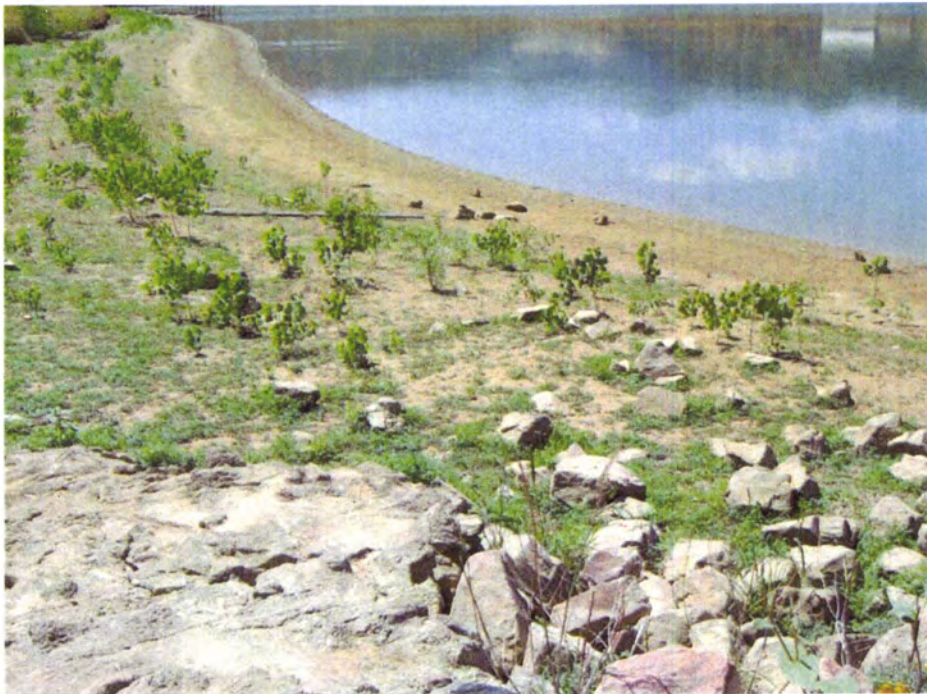
PHOTO D12 – Spillway approach channel, looking upstream. Note numerous tree saplings in the channel.
