## City of Lamar Transmission Line

## **Final Report**

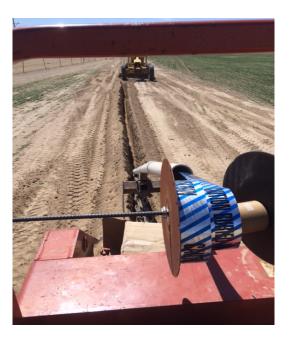
All Compaction tests have met the design specifications. Before any compaction tests were performed, tracer tape was trench in above the pipeline. Carrigan Excavating properly coordinated with a geological surveyor throughout the installation to insure we keep accurate GPS coordinates of the pipeline.

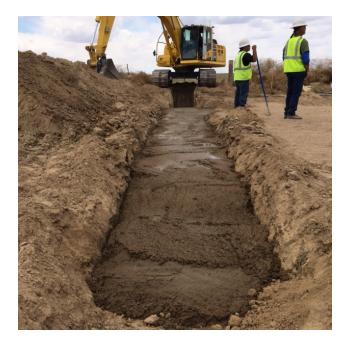
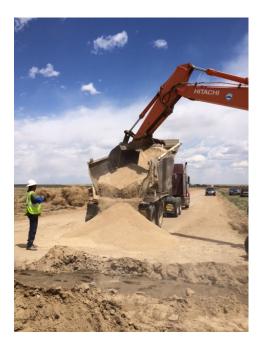
All road crossings that Carrigan Excavating has crossed has been secured with flow fill, per CDOT standards. Once the flow fill had time to set and cure, CDOT road base was installed and compact tests were performed.
