END OF PROJECT REPORT

Project #2014-02-022

**Repair and Rehabilitation of Montezuma Valley Irrigation
Company Flume No.6- McElmo Creek Flume –Flume #6**

Grant Recipient: Montezuma County Colorado.

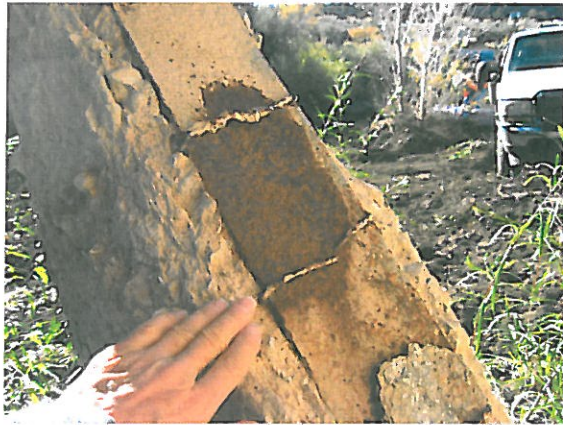
Deteriorated concrete and corroded steel

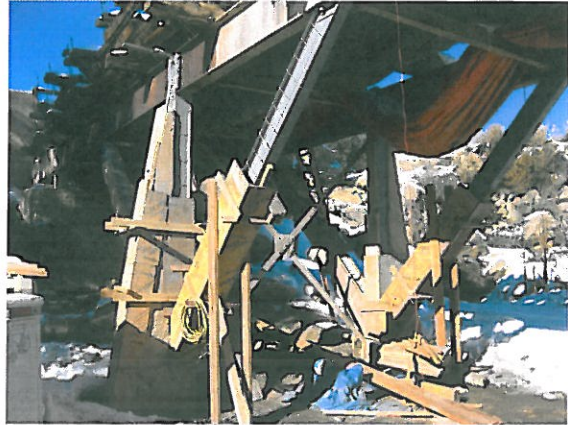
Formwork and steel preparation for new concrete

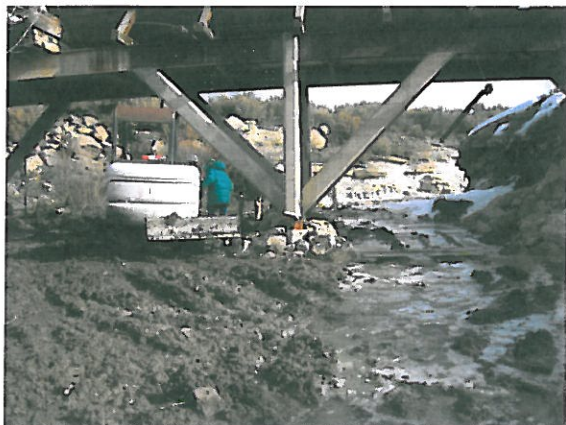
Final Construction before spring thaw

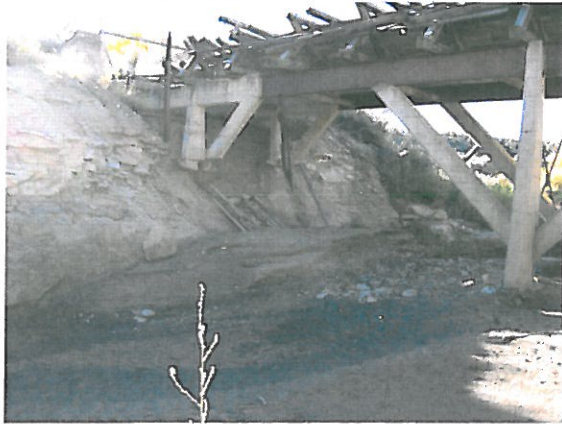
Before: Severely eroded foundation

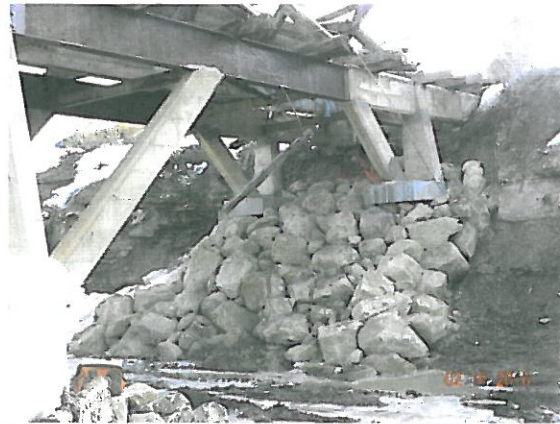
After: New Footers and protective rip rap.

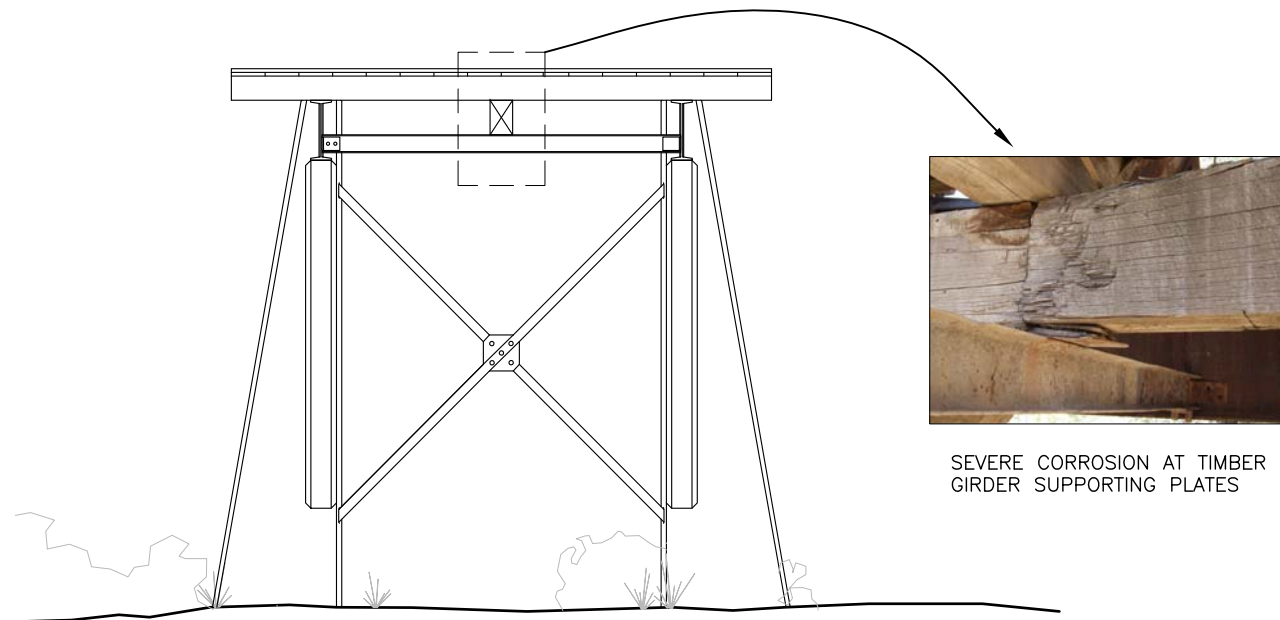
1 BEARING PLATE AT TIMBER GIRDER
S3 CURRENT CONDITION 3/16" = 1'-0"

SEVERE CORROSION AT TIMBER GIRDER SUPPORTING PLATES

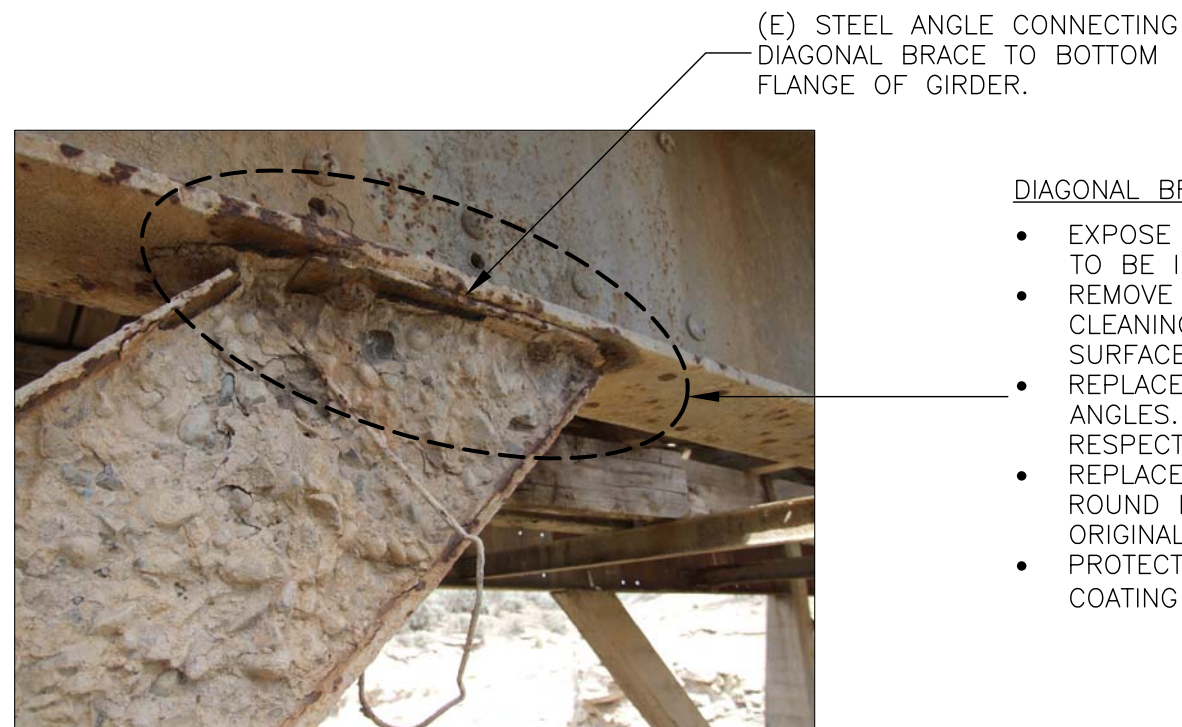
3 DIAGONAL BRACE-GIRDER CONNECTION
S3 REPAIR 1" = 1'-0"

(E) STEEL ANGLE CONNECTING DIAGONAL BRACE TO BOTTOM FLANGE OF GIRDER.

- EXPOSE ALL DIAGONAL BRACE-GIRDER CONNECTIONS TO BE INSPECTED BY THE STRUCTURAL ENGINEER.
- REMOVE EXISTING STEEL ANGLES TO ALLOW CLEANING AND PROTECTION OF THE CORRODED SURFACES.
- REPLACE EXISTING ANGLES WITH NEW ASTM A36 ANGLES. NEW ANGLES TO MATCH ORIGINALS WITH RESPECT TO SIZE AND NUMBER.
- REPLACE EXISTING RIVETS WITH ASTM A307 Gr. A ROUND HEAD BOLTS. NEW BOLTS TO MATCH ORIGINALS WITH RESPECT TO SIZE AND NUMBER.
- PROTECT ALL STEEL SURFACES WITH APPROPRIATE COATING (SEE GENERAL NOTES).

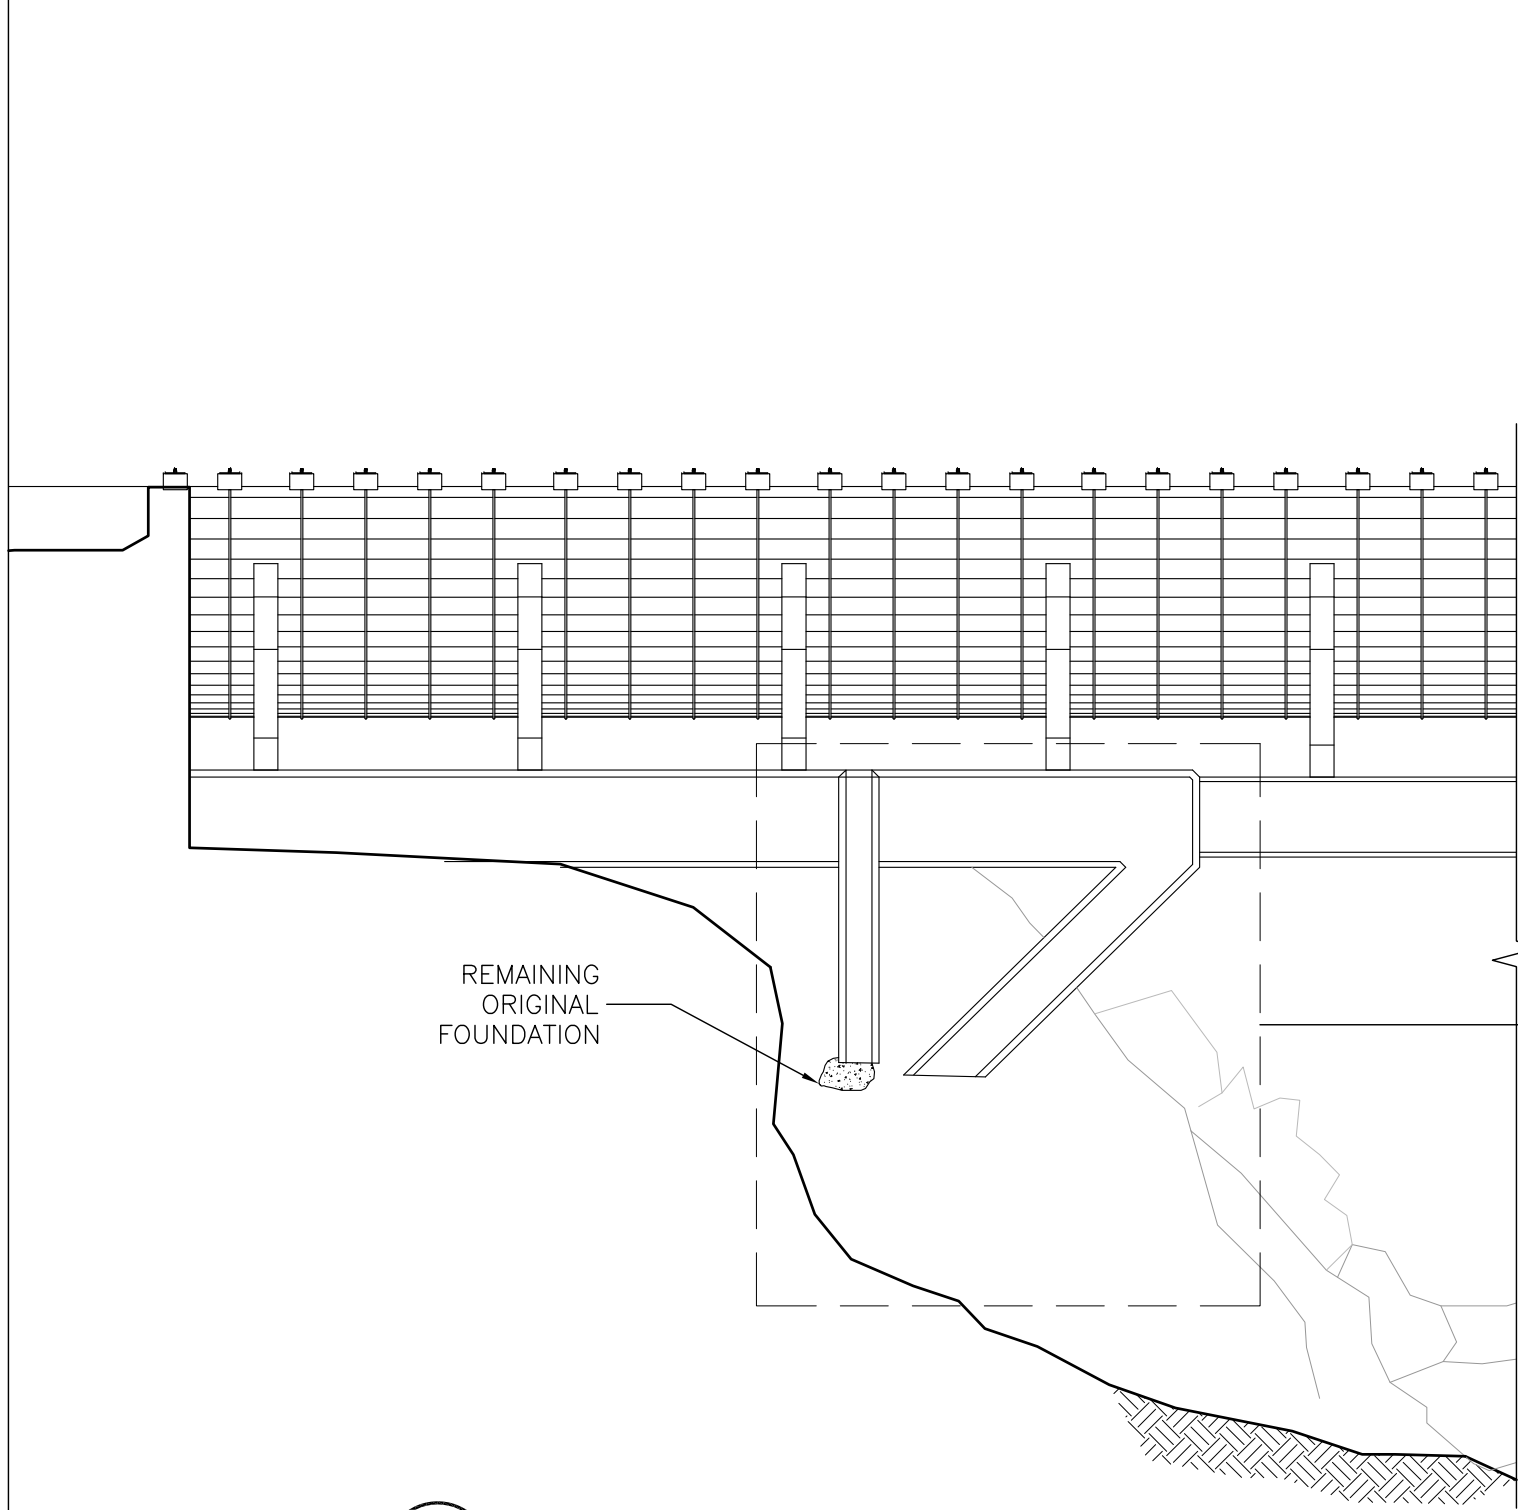
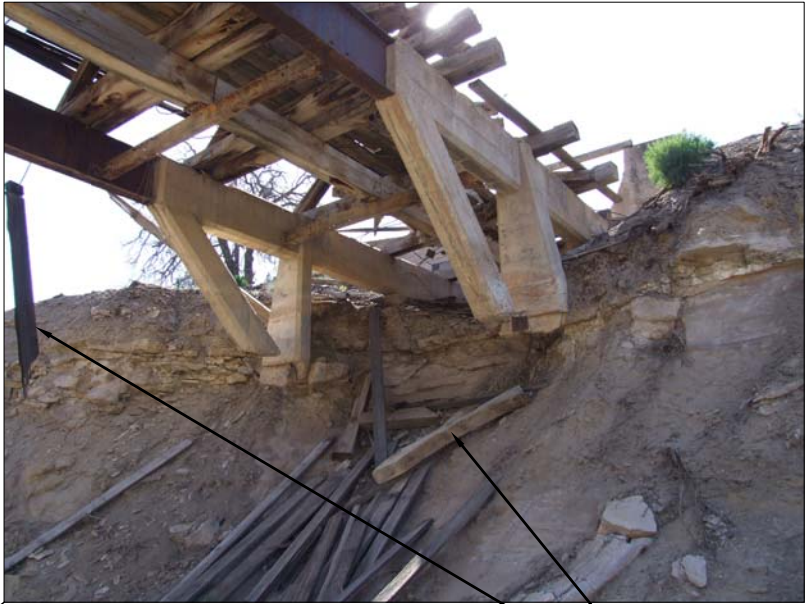
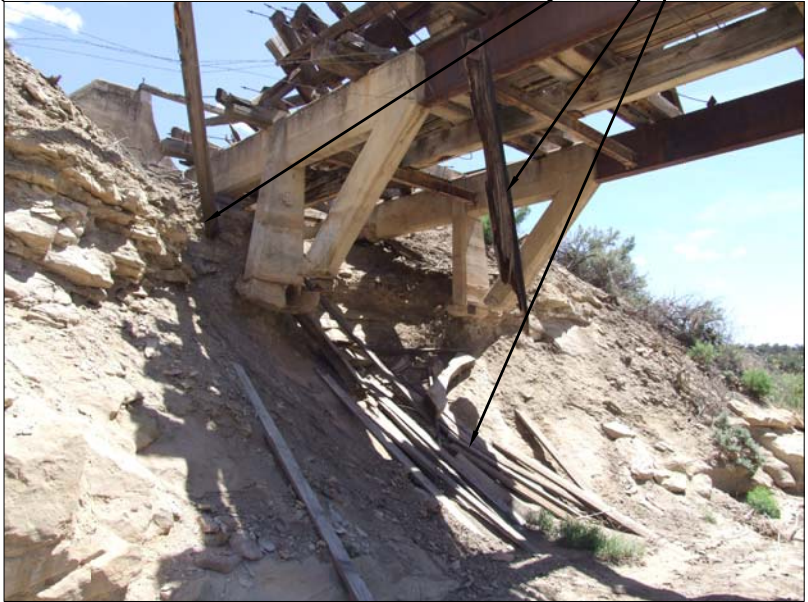
SOUTH PIER FOUNDATION
CURRENT CONDITIONS

UNSUPPORTED PIERS AND DIAGONAL
BRACES AT SOUTH END OF FLUME
DUE TO SCOUR.

COLLECT AND SAFELY
STORE ALL LOOSE AND
DISPLACED ELEMENTS
OF THE EXISTING
FLUME AROUND
CONSTRUCTION AREA

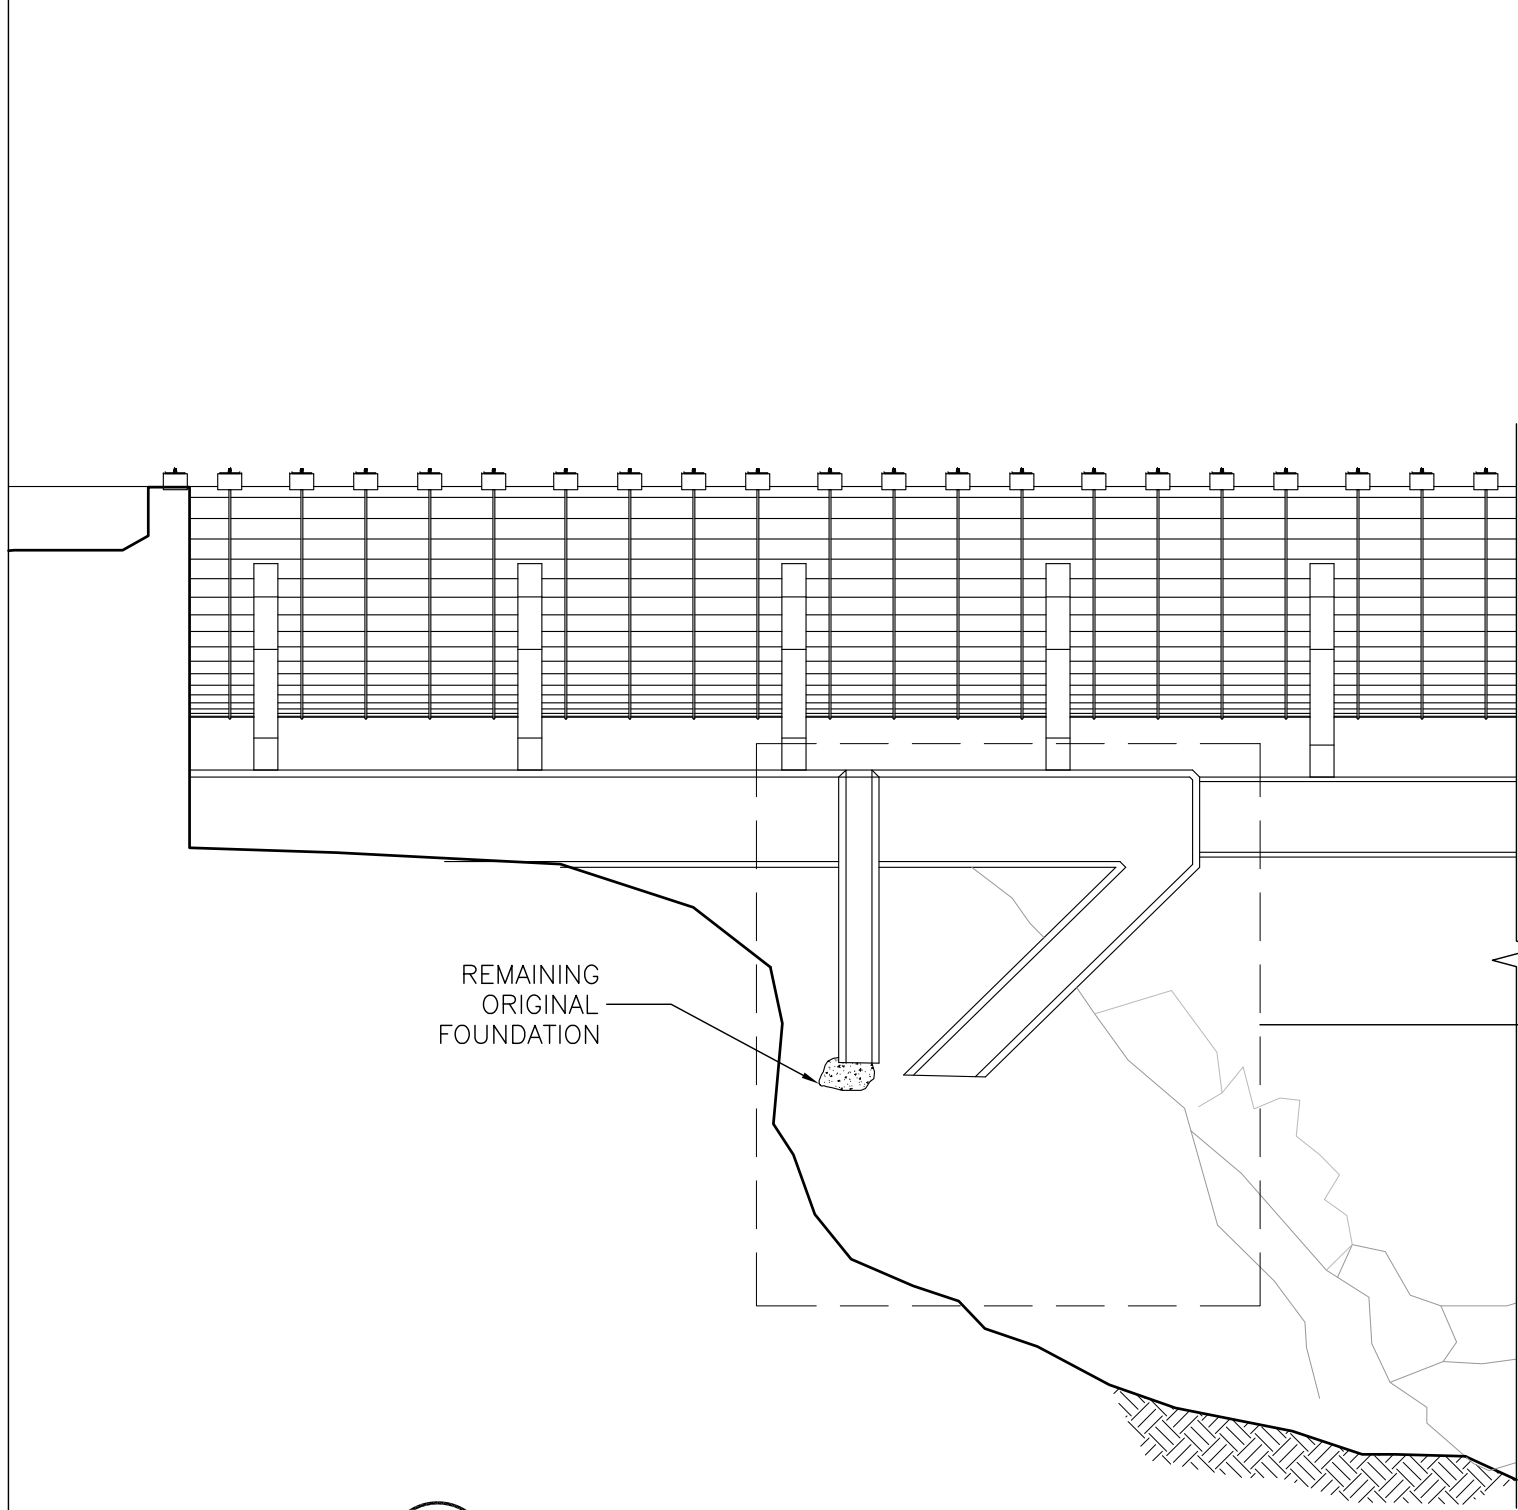
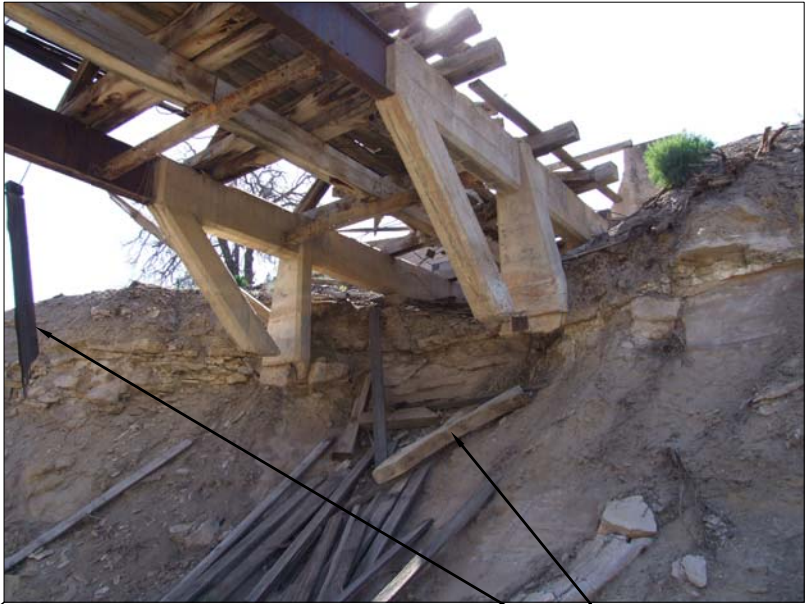
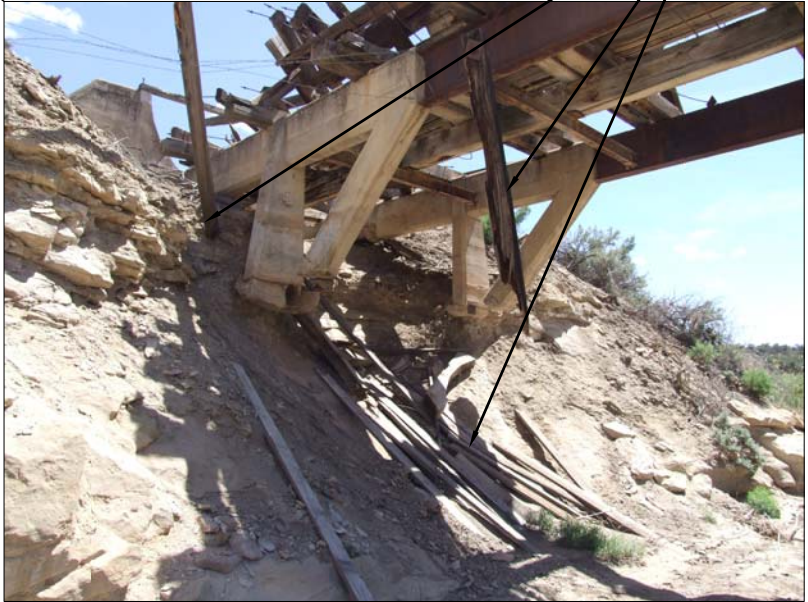
SOUTH PIER FOUNDATION
CURRENT CONDITIONS

UNSUPPORTED PIERS AND DIAGONAL
BRACES AT SOUTH END OF FLUME
DUE TO SCOUR.

COLLECT AND SAFELY
STORE ALL LOOSE AND
DISPLACED ELEMENTS
OF THE EXISTING
FLUME AROUND
CONSTRUCTION AREA

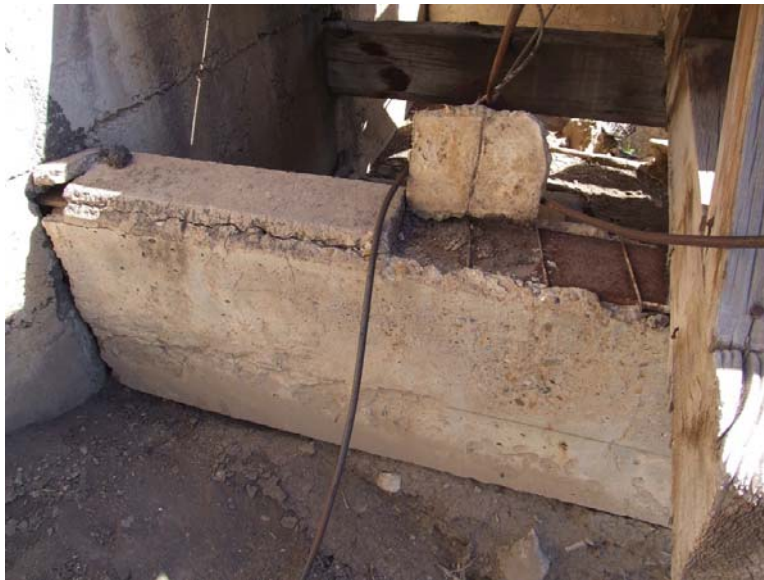
Figure 3. North end of western girder showing typical concrete cracking and spalling at top flange of encased steel beam.

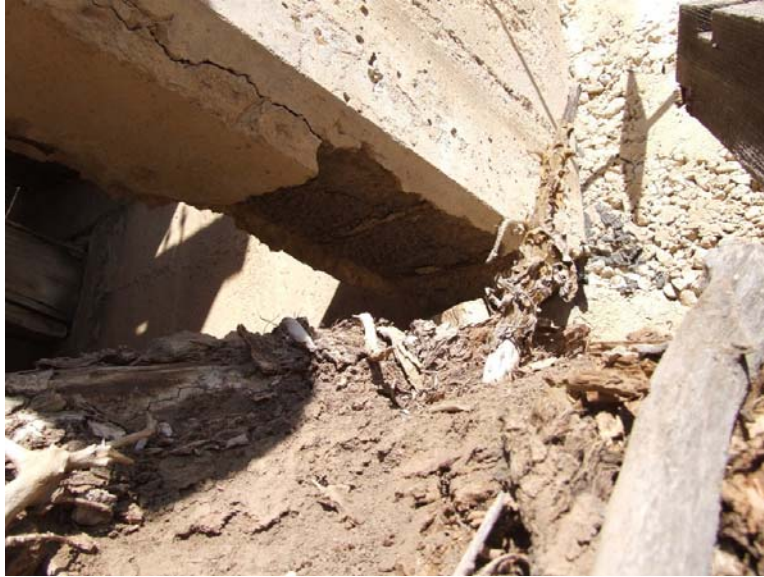
Figure 4. North end of eastern girder showing typical concrete cracking and spalling at bottom flange of encased steel beam.

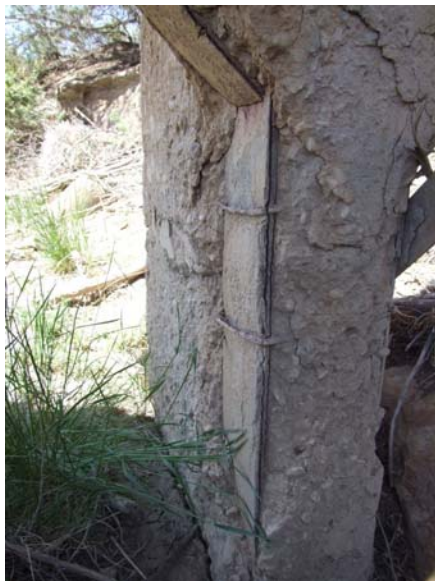
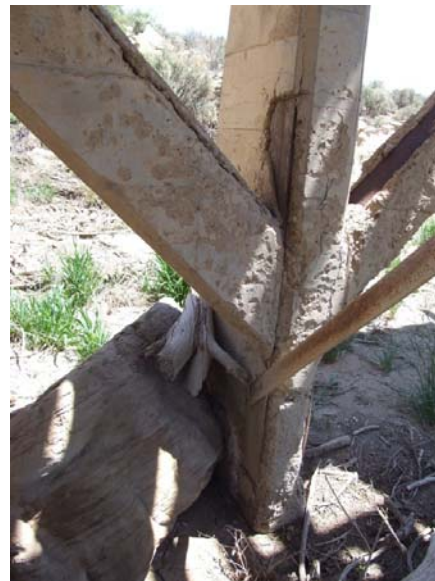
Figure 5. Spalling and concrete deterioration at base of columns. At left: northwestern column. At right: northeastern column. Severe distress conditions were observed at these locations.

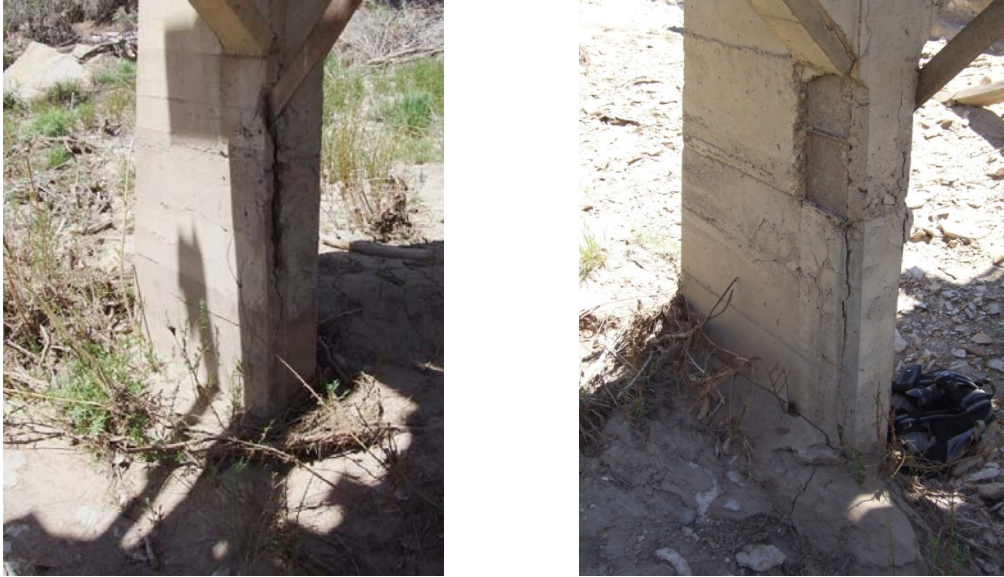
Figure 6. Spalling and concrete deterioration at base of columns. At left: southwestern column. At right: southeastern column.

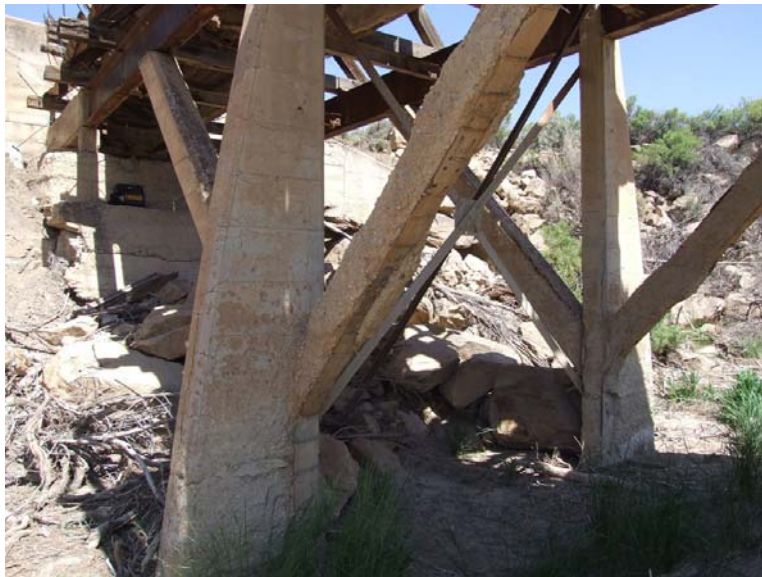
Figure 7. South diagonal brace of northwestern frame showing severe concrete spalling. Both top and bottom flanges are fully exposed.

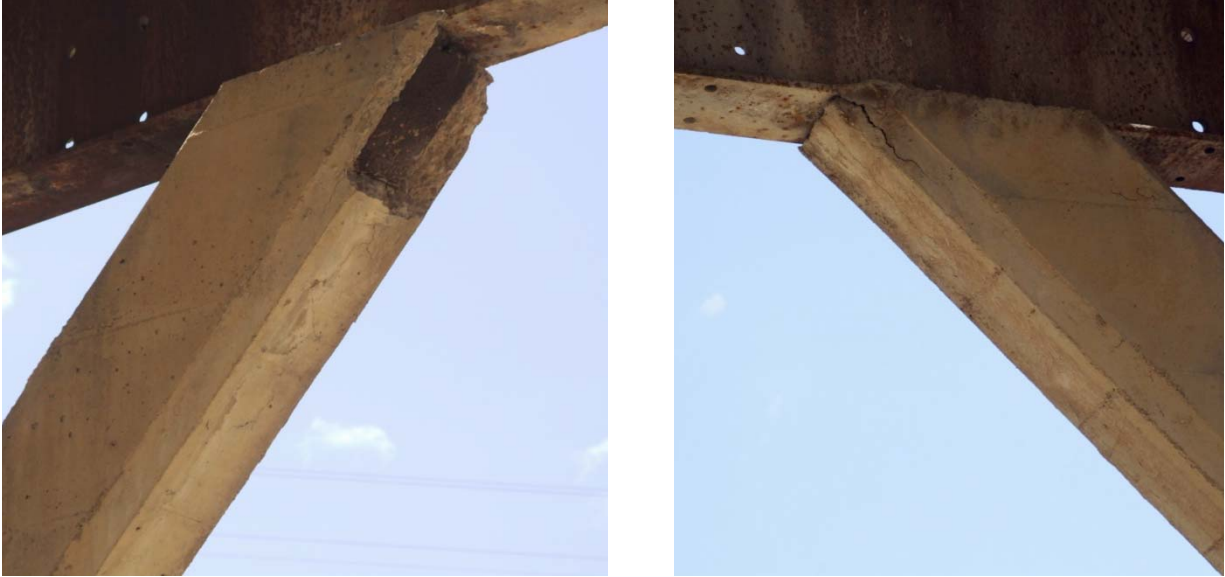
Figure 8. Typical spalling and concrete cracking at top of diagonal braces of southern frames.

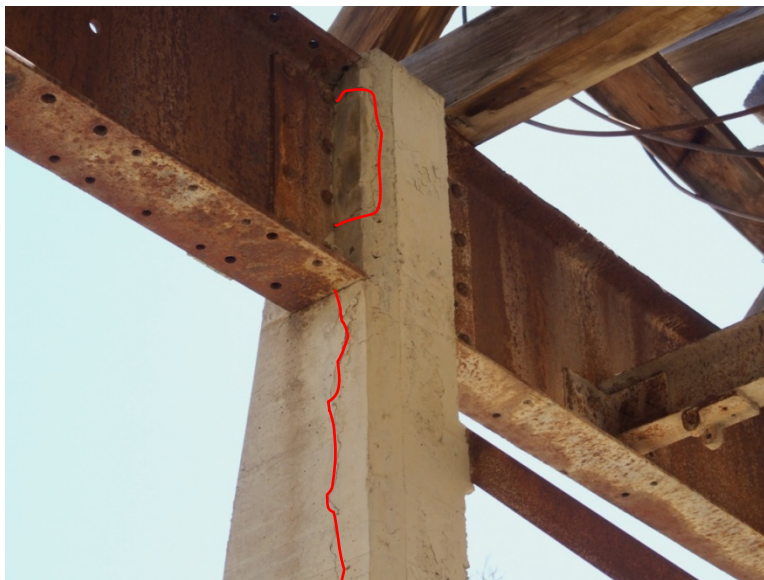
Figure 9. Typical concrete cracking (marked with red lines) at column-girder connection.

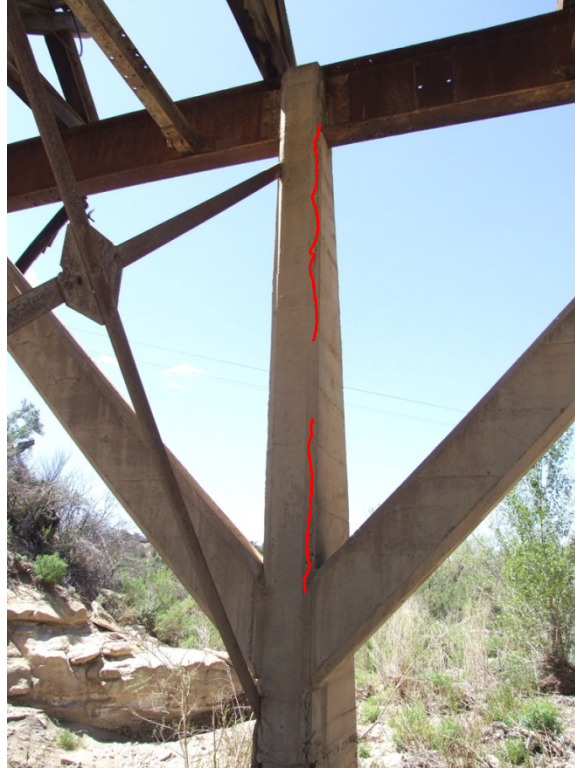
Figure 10. Typical vertical cracks (marked with red lines) at concrete columns. This photo shows the southwest frame, looking west.

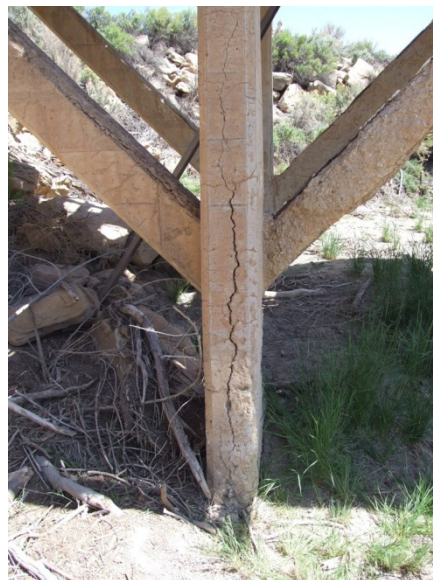
Figure 11. Large vertical crack at west side of northwestern column. The crack is likely due to corrosion of the vertical steel reinforcement that was located by Pachometer scanning.

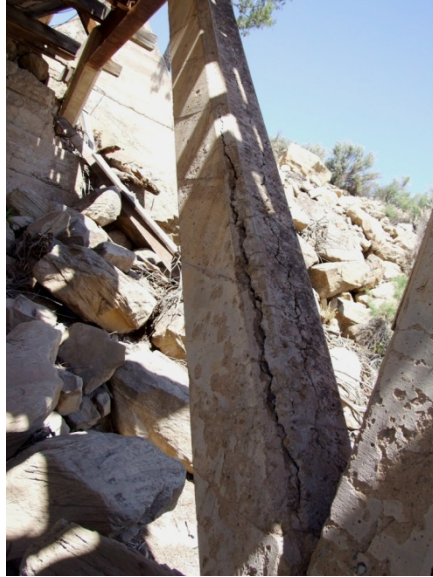
Figure 12. Concrete crack near top flange of encased steel element at north brace of northeastern frame. The crack extends for approximately 6 ft. Similar crack was observed at the north brace of the northwestern frame.

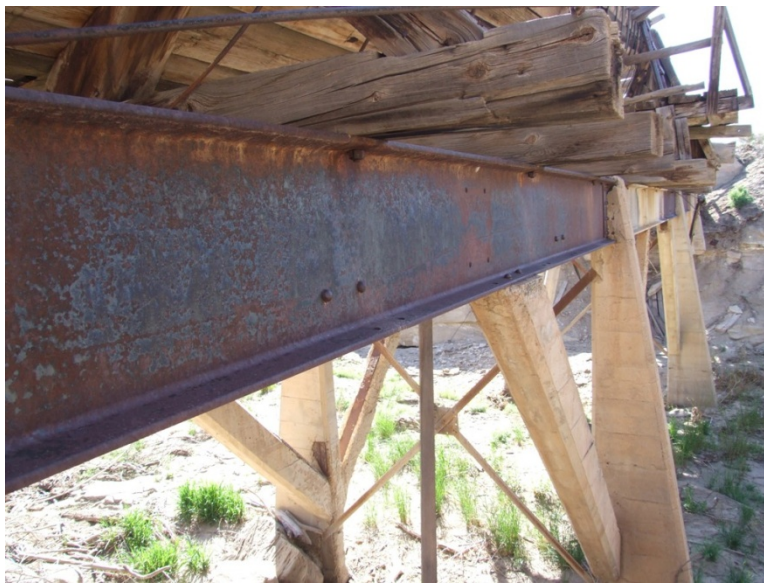
Figure 13. Minor surface corrosion affecting the majority of the steel girders exposed surface.

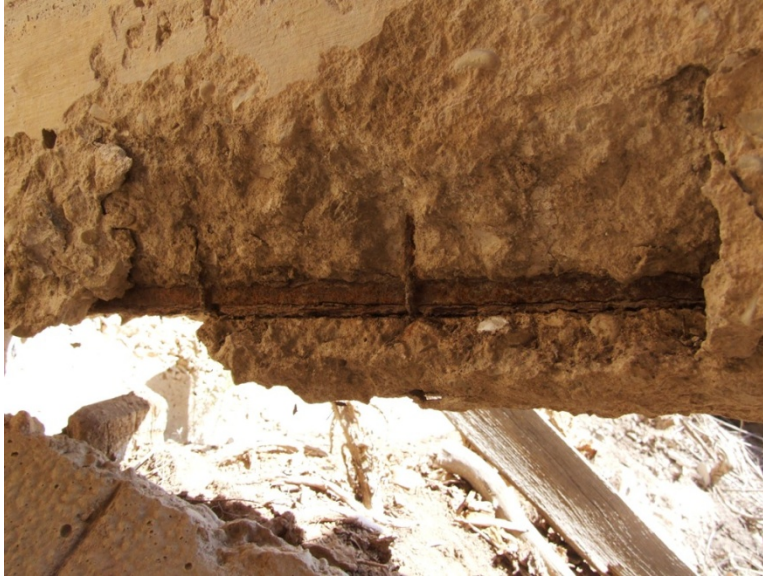
Figure 14. Moderate corrosion was observed at the portions of girders encased in concrete. This photo shows corrosion at the bottom flange of the east girder, near the north abutment. Note severe corrosion of metal ties.

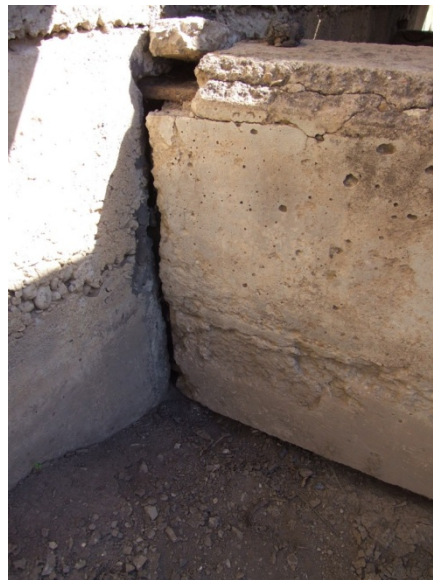
Figure 15. Corrosion at the girder inside the bearing pocket was observed. The empty cavity is likely to trap water and moisture, which will accelerate the corrosion process.

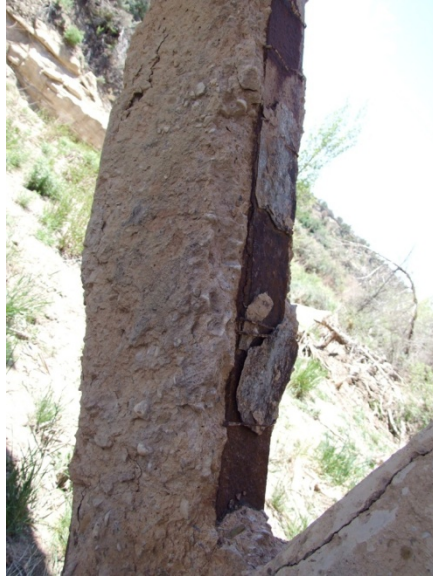
Figure 16. Severe corrosion at the south diagonal brace of the northeastern frame. 25% loss of original top flange thickness was measured at this location.

South brace of northeastern frame, bottom flange near column	0.25	0.402	0.300	25
* Indicates the location of the measured point from the edge of the flange

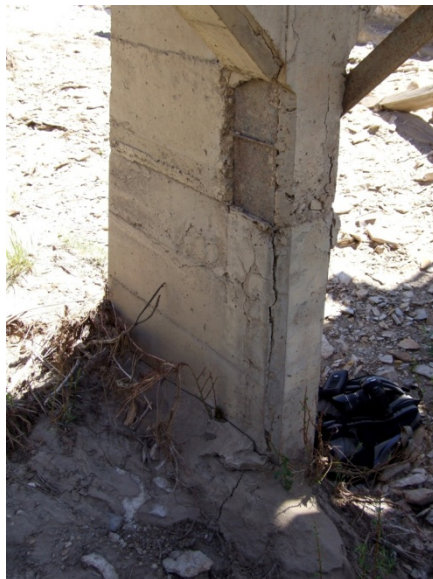
Figure 17. Typical minor corrosion at base of southern columns. At these locations, extensive concrete cracking with some spalling was observed.

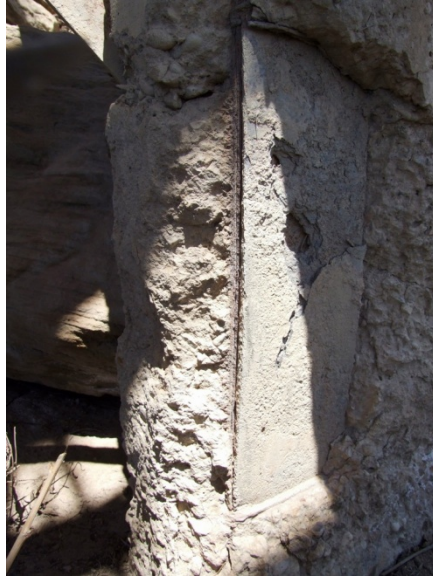
Figure 18. Severe corrosion at the flange of the encased column at the northeastern frame. 55% loss of original thickness was measured at this location.

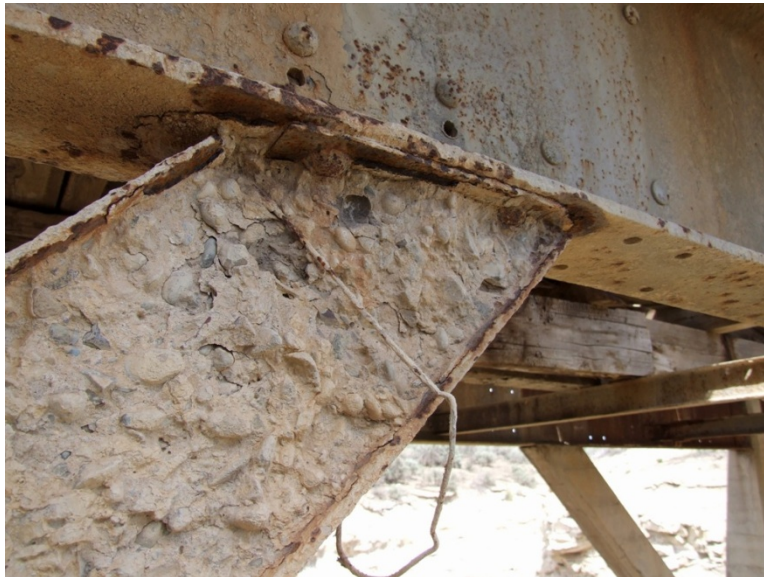
between the diagonal brace and the girder. This condition was observed at the two north braces of the northern frames and is shown in Figure 19. The corrosion is particularly severe at the bottom surface of the girder's flange and at the angle used to connect the two structural elements. The corrosion reduced the thickness of the angle to approximately 0.15". However, it was not possible to estimate the original thickness at the time of this investigation. It is common for these types of connection to have an angle with thickness of 1/4" or greater. This would result in a loss of original thickness of 40%. Furthermore, corrosion was observed between the angle and the bottom flange. Considering that corrosion produces volumetric expansion of the metal, this condition has the potential of introducing additional tension in the rivets used in the connection.

Figure 19. Typical corrosion at the diagonal brace-girder connection. The corrosion is particularly severe at the bottom surface of the girder's flange and the angle used to connect the two structural elements.

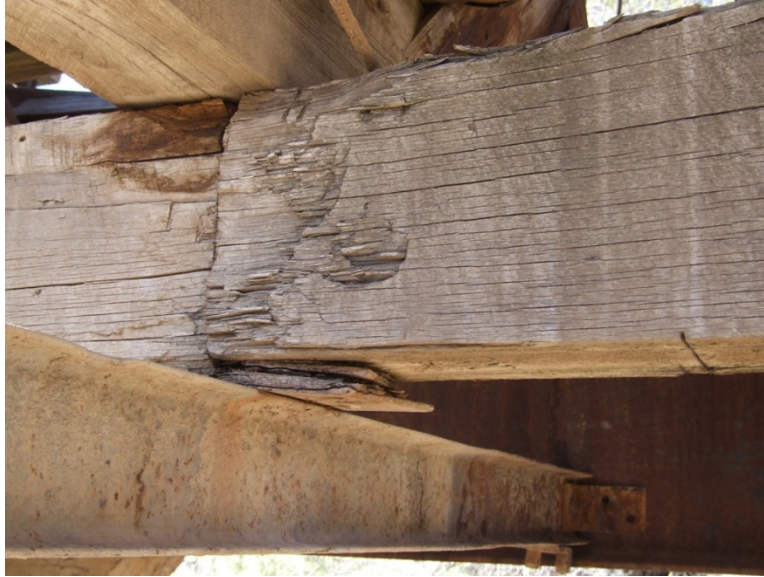
Figure 20. Typical severe corrosion affecting the stringers supporting plates. Note the amount of uplift experienced by the stringer due to the increase in steel volume.

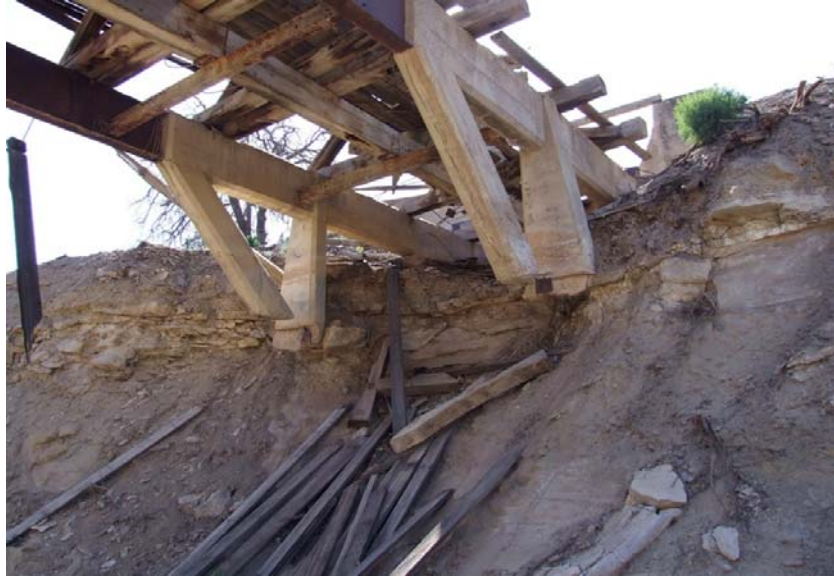
Figure 22. Unsupported piers and diagonal braces at south end of flume due to soil erosion.

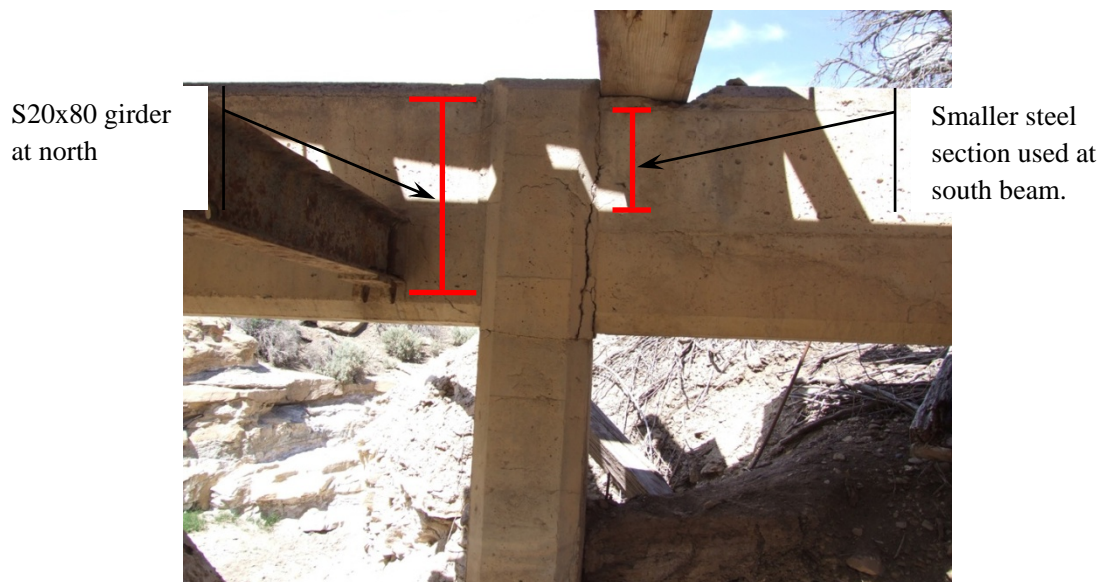
Figure 23. Flexural cracks at pier-girder connection at the south end of the flume. A smaller steel beam was used in the construction of the south beam that spans from the pier to the abutment (steel sections shown in red). The connection between the encased steel beams and column is likely a shear connection. Similar cracks were observed at the opposite pier.

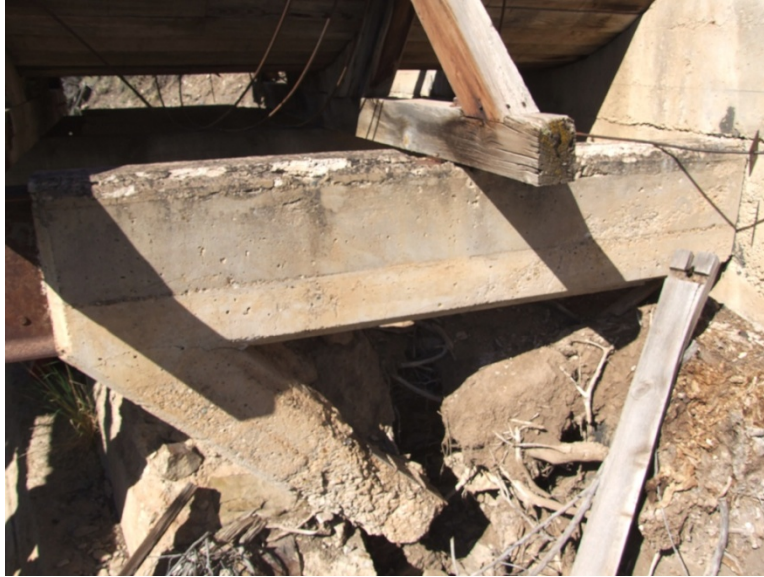
A different configuration was observed at the north end of the flume, where concrete piers were not used to provide additional support to the girders near the abutment. A diagonal brace was only used at the east girder and the bottom support is compromised (Figure 24). However, the steel beams are continuous at this location and don't show any signs of distress directly related to the missing support.

Figure 24. Diagonal brace without support at north end of east girder.
