Re: Final report for the Surface Creek Ditch & Reservoir Piping Project.

Eggleston Dam
W. Div. 4, W. Dist.40
October 6,2016

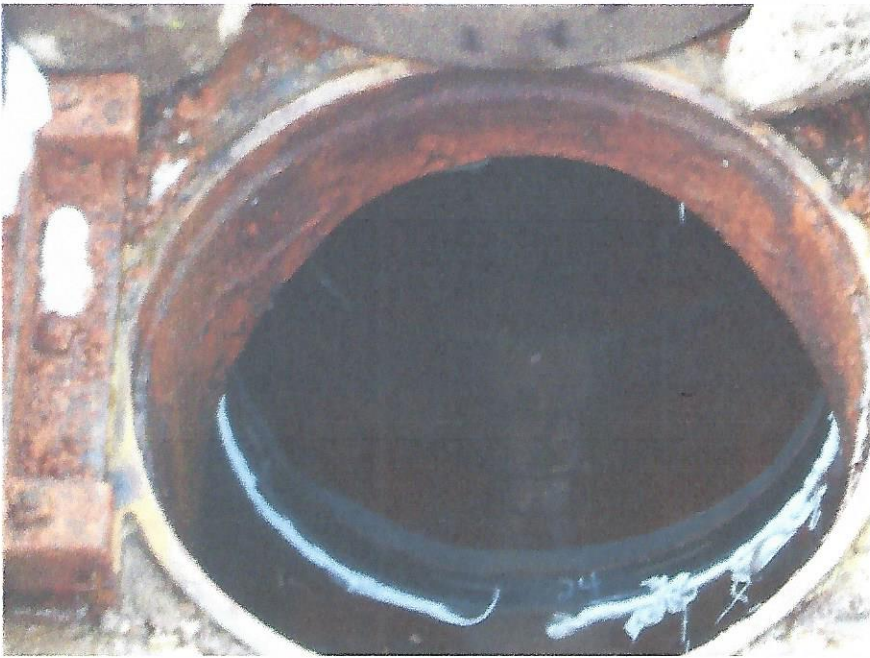
Hydrophilic seal in position at the upstream end of the existing outlet pipe.

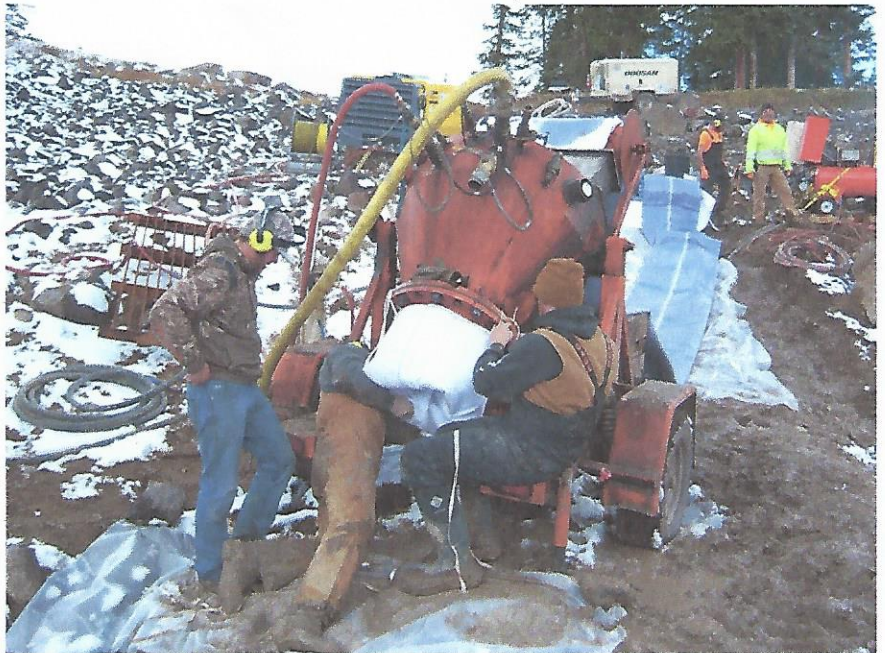
Liner being deployed from a pallette through the shooter and being inverted.

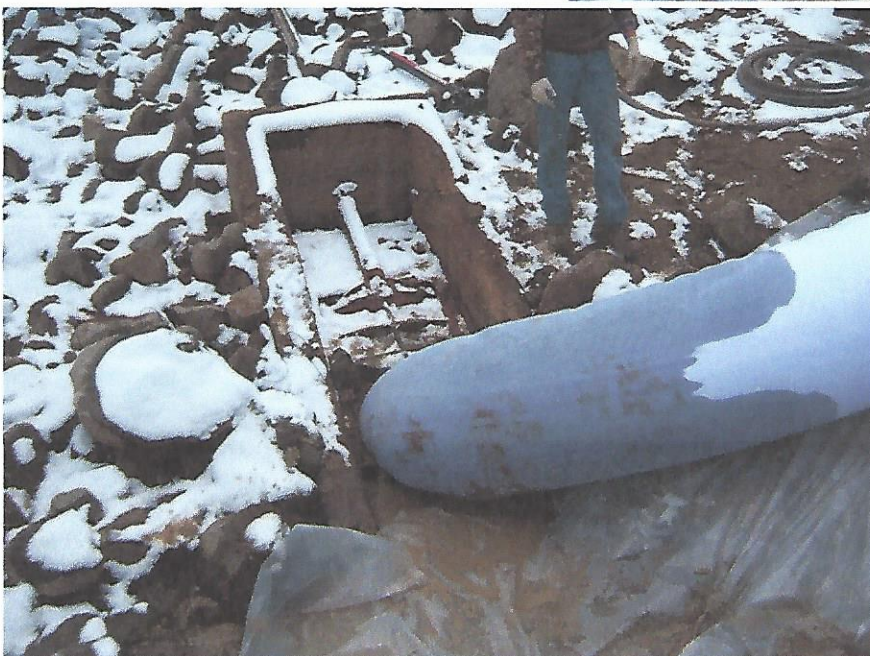
Liner inserted and inverted from upstream end using compressed air.

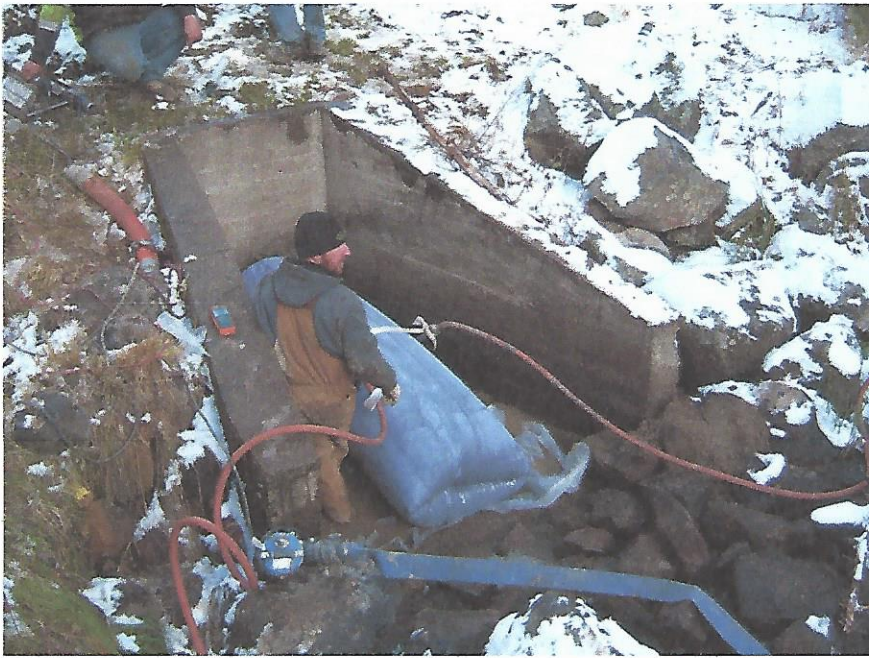
Downstream end of liner. Hoses are provided for steam venting allowing transmission through the entire length of the liner.

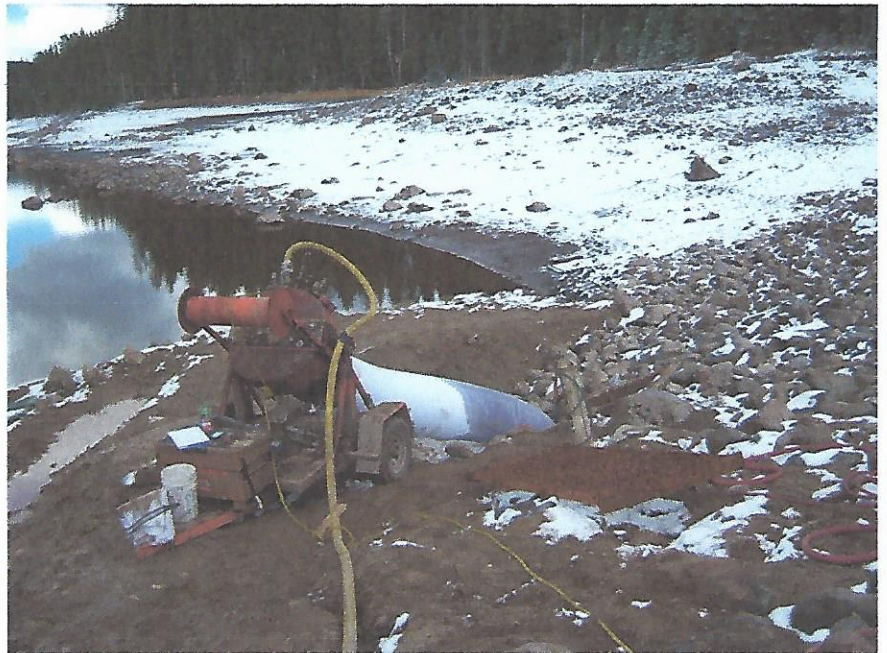
Installation complete and curing begins

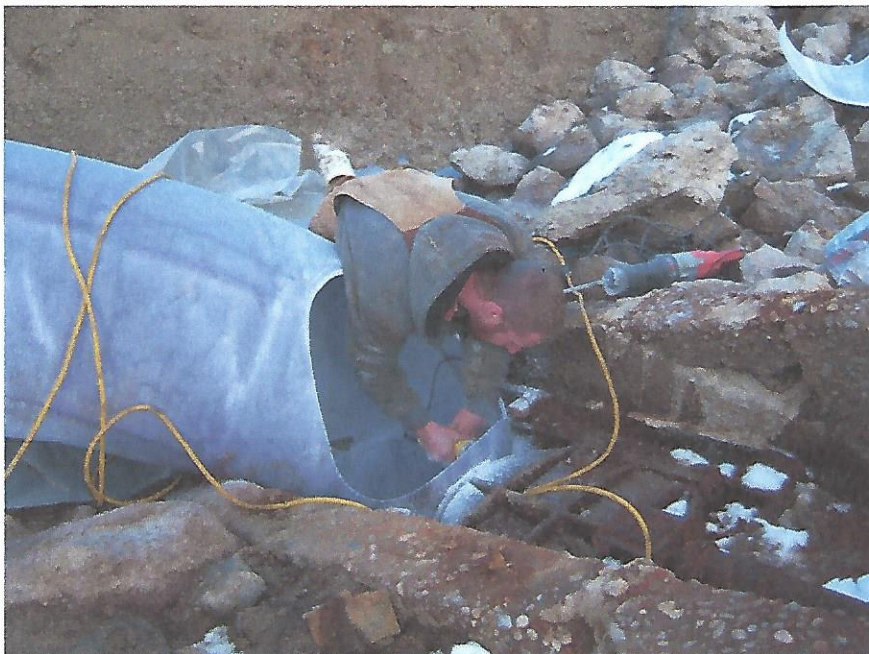
Trimming begins at the upstream end.

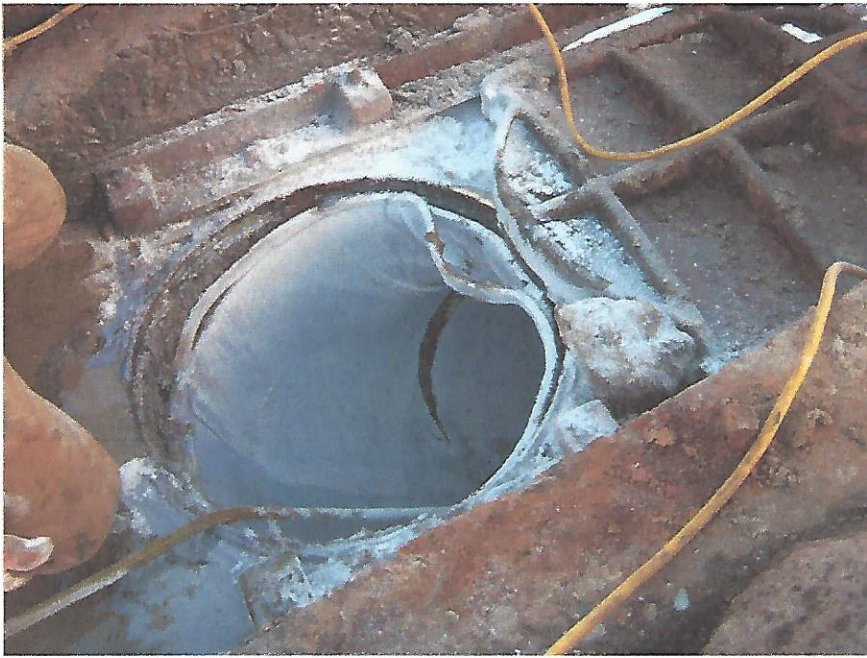
Once the cool down temperature was met the excess liner was trimmed off. There was a small fracture but it was located in front of the hydrophilic seal so it did not appear to jeopardize the integrity of the project.

Fracture of liner occurred around the circumference at the transition with the elbow in front of the hydrophilic seal.

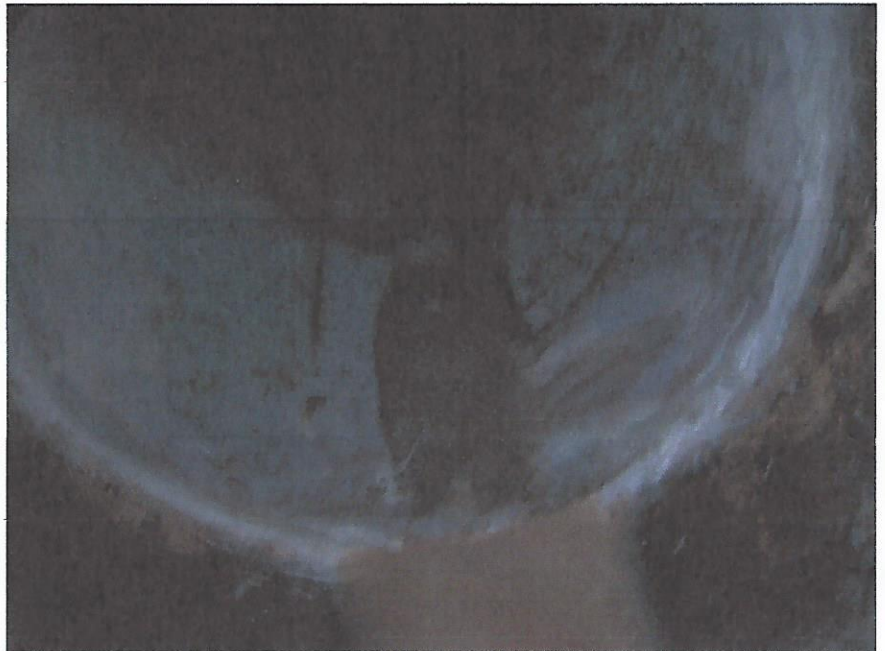
Trimming and sealing complete at upstream end.

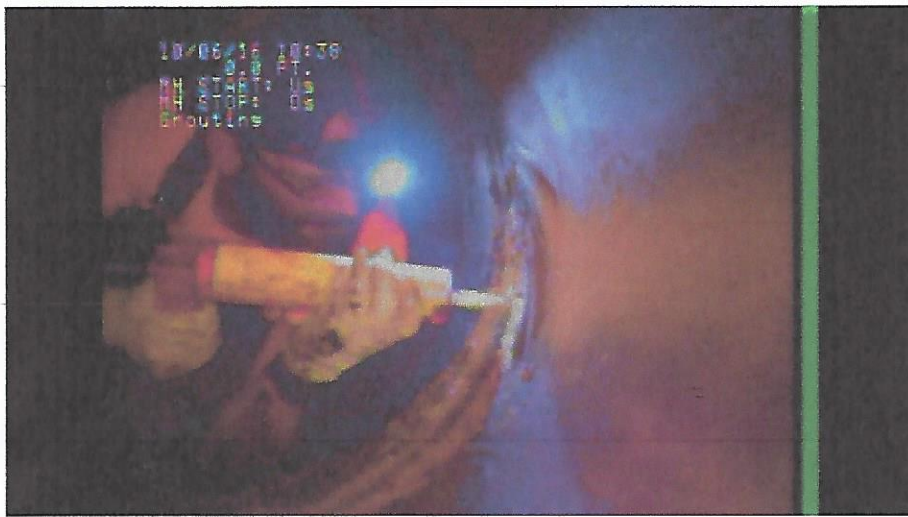
Contractor sealing and cleaning joint at location of observed infiltration. No infiltration was present at this time.

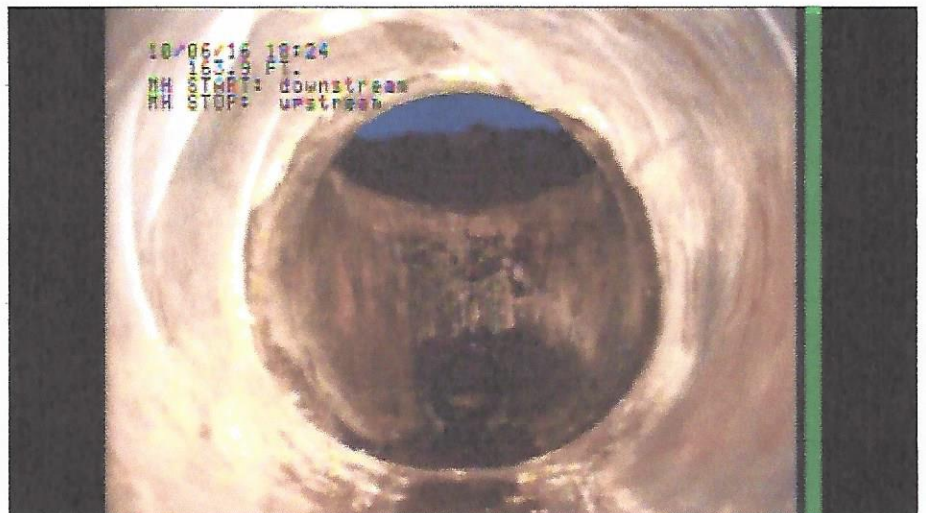
Interior view of the liner terminus and the elbow at the upstream end.

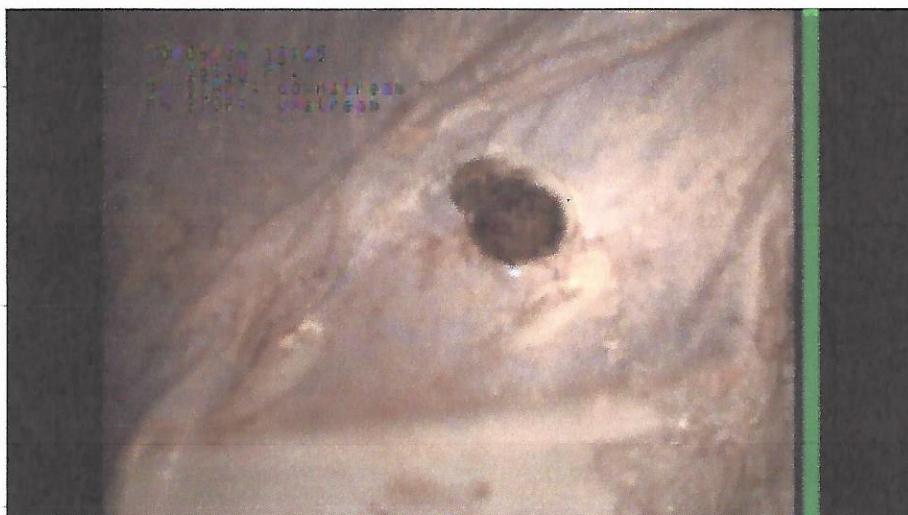
View of open airvent near crown of pipe.

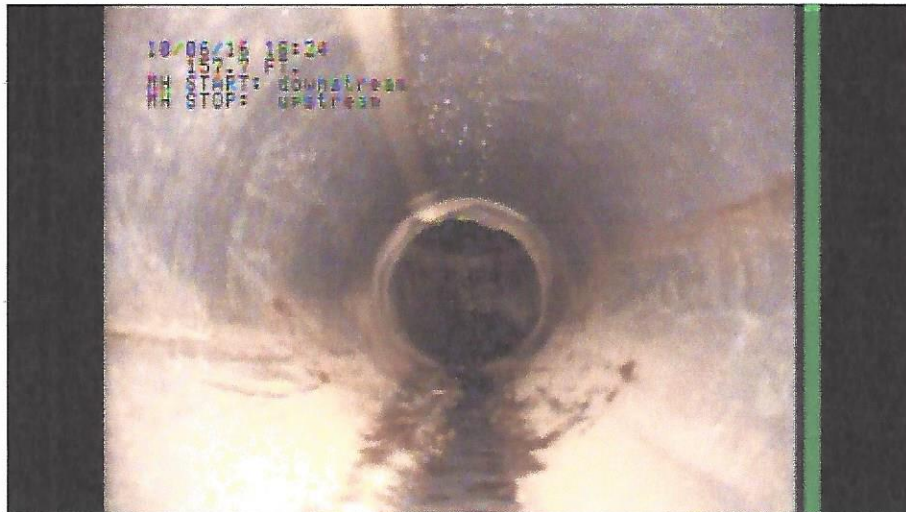
A video inspection of the interior of the liner was done. There were a few wrinkles near the upstream end but otherwise it was smooth and had no flaws. All tests done by the engineer have good results.

Interior view of upstream liner terminus shows small wrinkles in crown of pipe

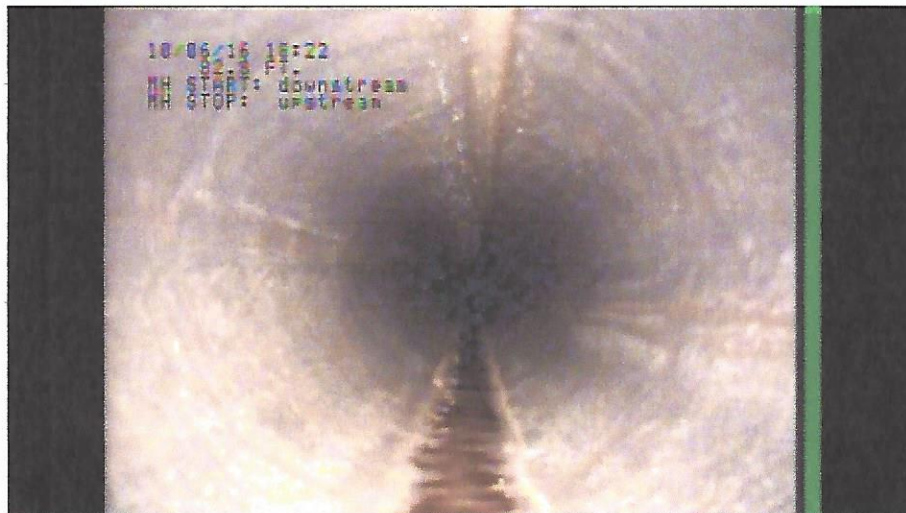
General overview of the liner interior after installation
