**Subject: Adobe Creek Dam Outlet Conduit and Seepage Evaluation,  
Water Division 2, Water District 17, Dam ID 170101,  
Wheeler Project No. 1830.04**

**Attachment A**  
**Adobe Creek Dam Outlet Conduit Inspection**  
**Photo Log**

**Attachment B**  
**Adobe Creek Dam Outlet Conduit Inspection**  
**Video Inspection**

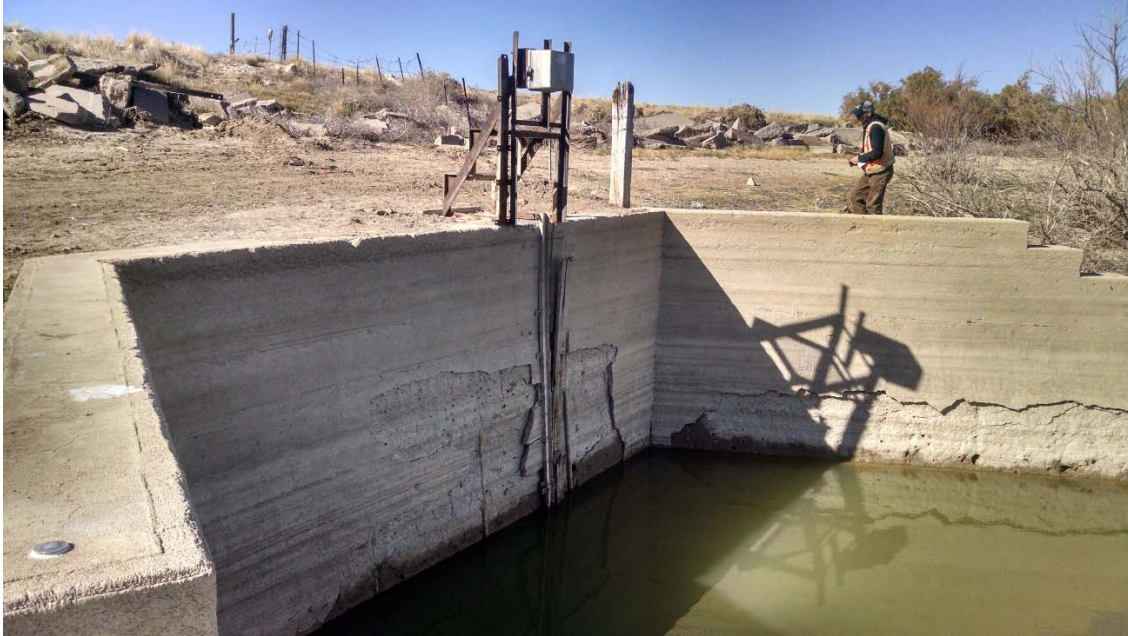
Photo 1: View of the outlet works intake structure from the left wing wall, looking downstream towards the dam. The reservoir elevation was 19.40 feet on the staff gauge on date of inspection. Note the concrete deterioration. November 9, 2016.

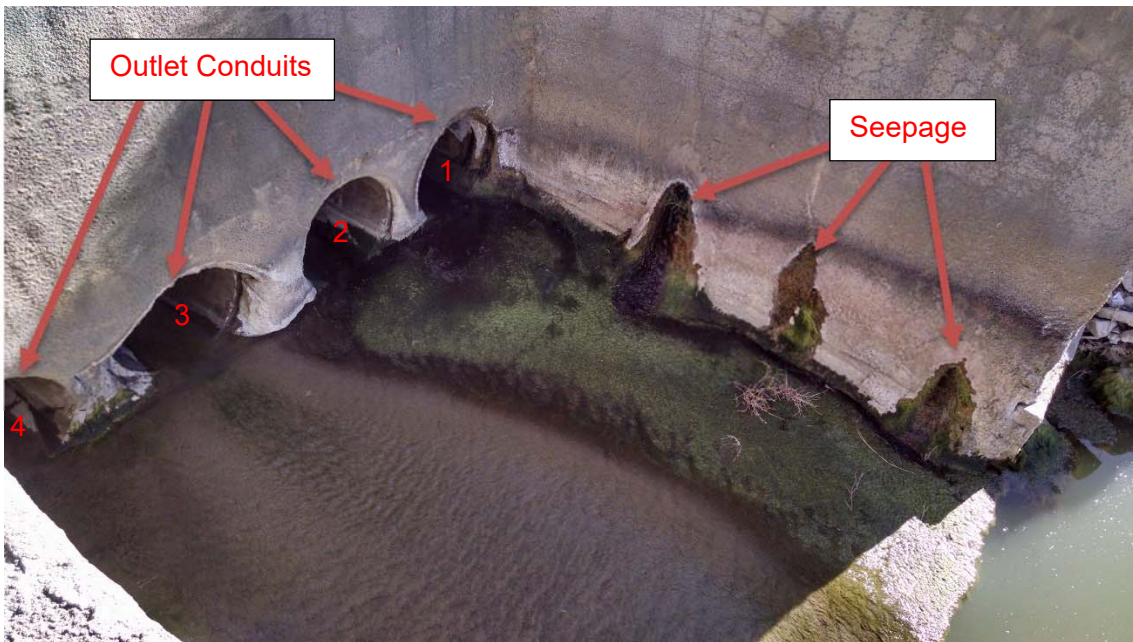
Photo 2: View of the outlet works terminal structure and outlet conduit outfalls from the right wing wall, looking upstream. Note seepage from the weep holes in the left wing wall and gate leakage and seepage flows exiting from the outlet works conduits. November 9, 2016.

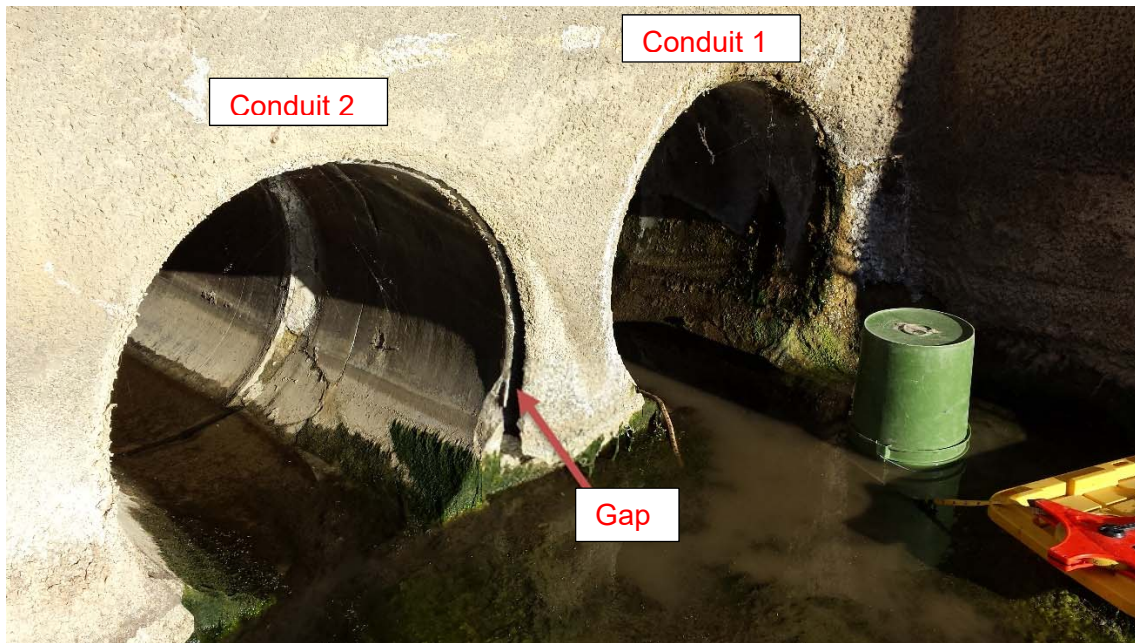
Photo 3: View of discharge from Conduit Nos. 1 & 2, looking upstream. Note gap between facing concrete and terminal structure. November 9, 2016.

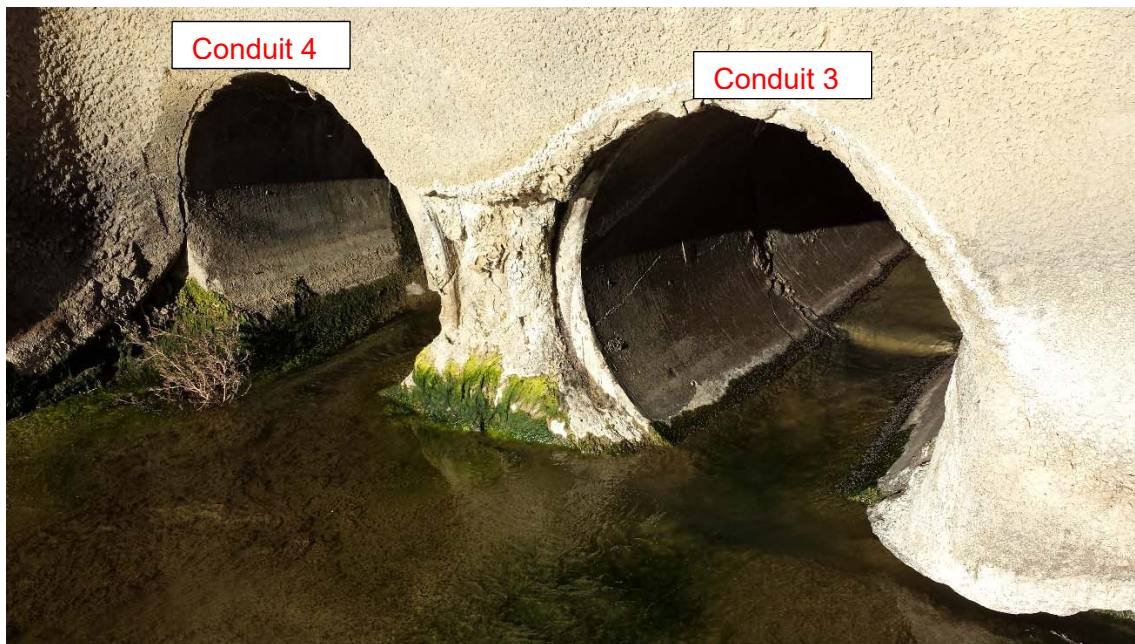
Photo 4: View of discharge from Conduit Nos. 3 & 4, looking upstream. November 9, 2016.

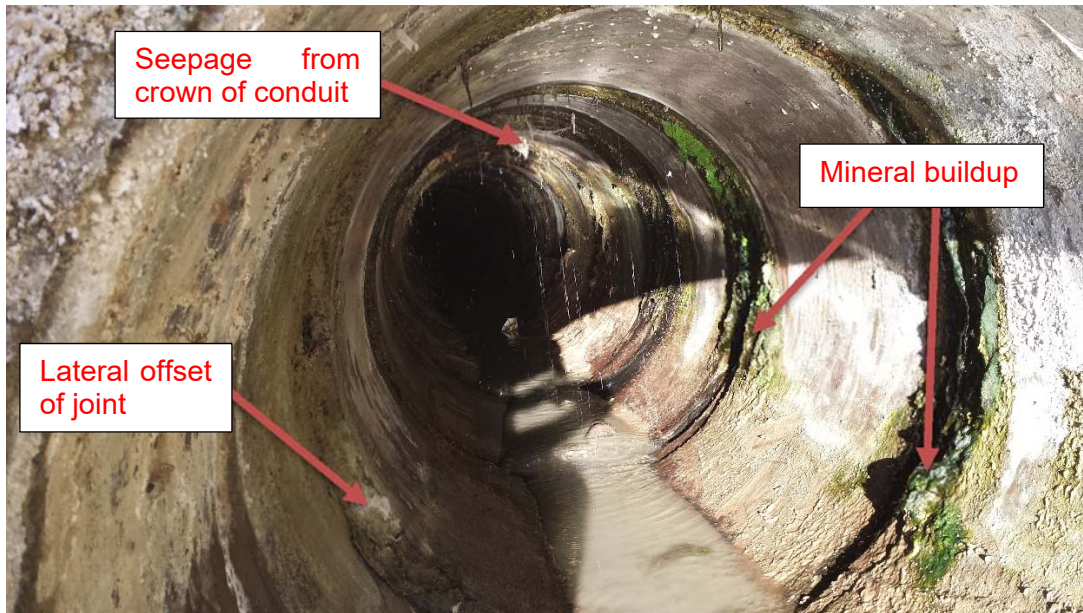
Photo 5: View of Conduit No. 1, taken from the discharge end looking upstream. Note seepage from conduit crest, lateral offset of joints and mineral buildup around joints. November 9, 2016.

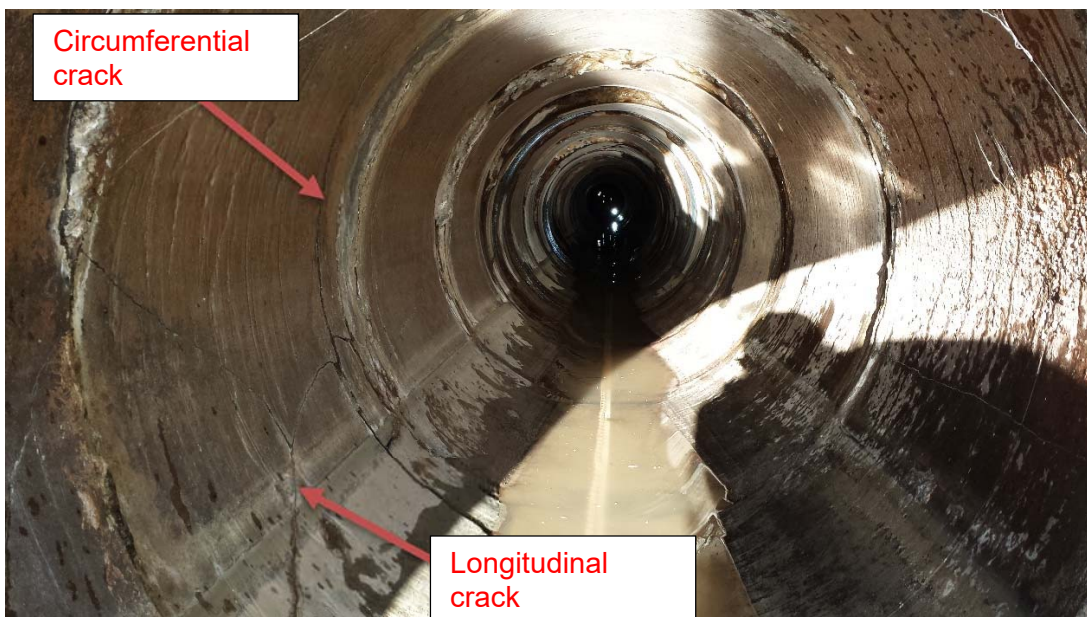
Photo 6: View of Conduit No. 2 taken from the discharge end looking upstream. Note lateral offset of joints and cracking in pipe. November 9, 2016.

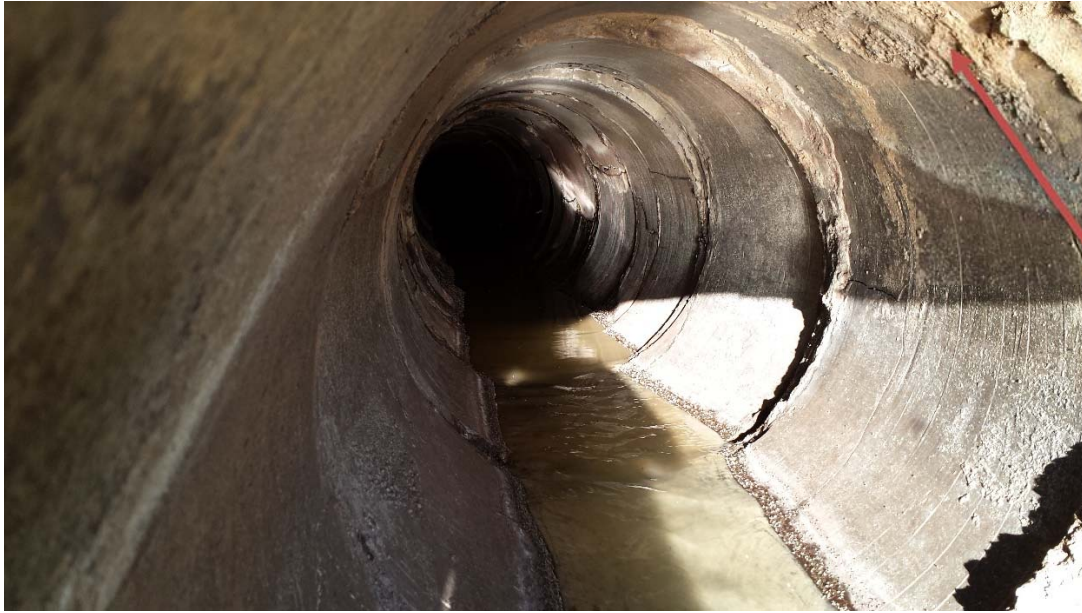
Pipe Crown  
Repair

Photo 7: View of Conduit No. 3 taken from the discharge end looking upstream. Note lateral offset of joints and cracking in pipe. November 9, 2016.

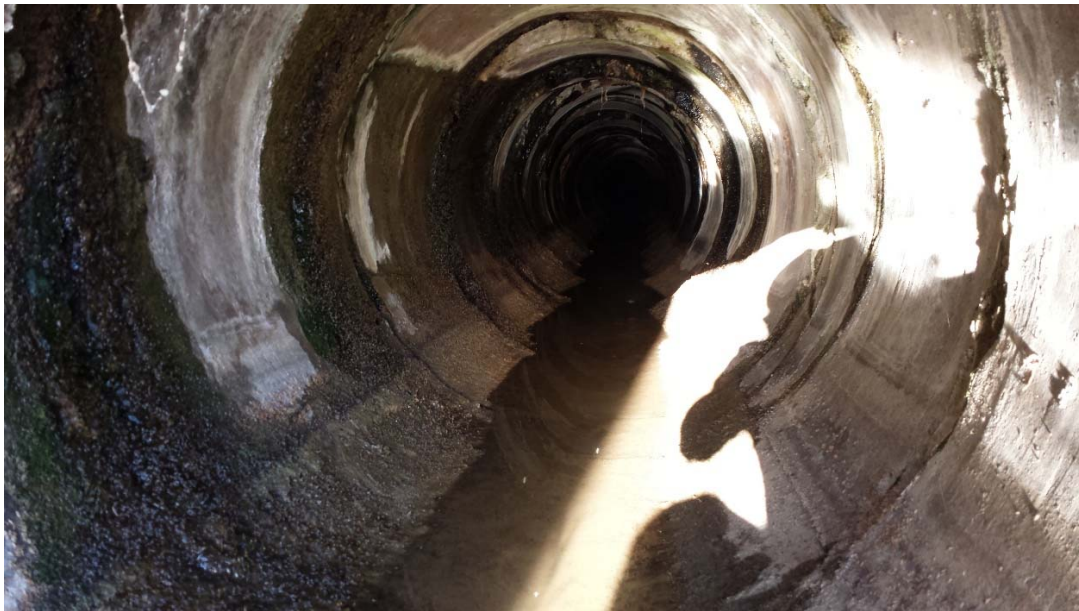
Photo 8: View of Conduit No. 4 taken from the discharge end looking upstream. Note lateral offset of joints and seepage from joints and cracks in pipe. November 9, 2016.

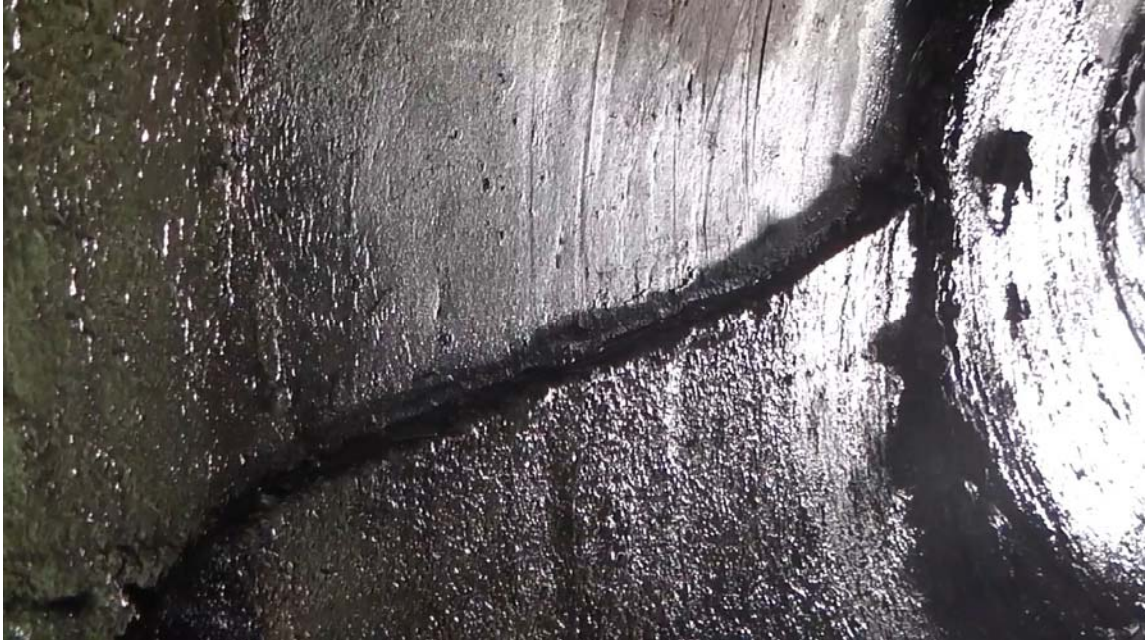
Screenshot 1: View of longitudinal crack running length of pipe section with 1/4" lateral displacement, in Conduit No. 1 Station 0+89 feet downstream of gate, looking downstream. November 9, 2016.

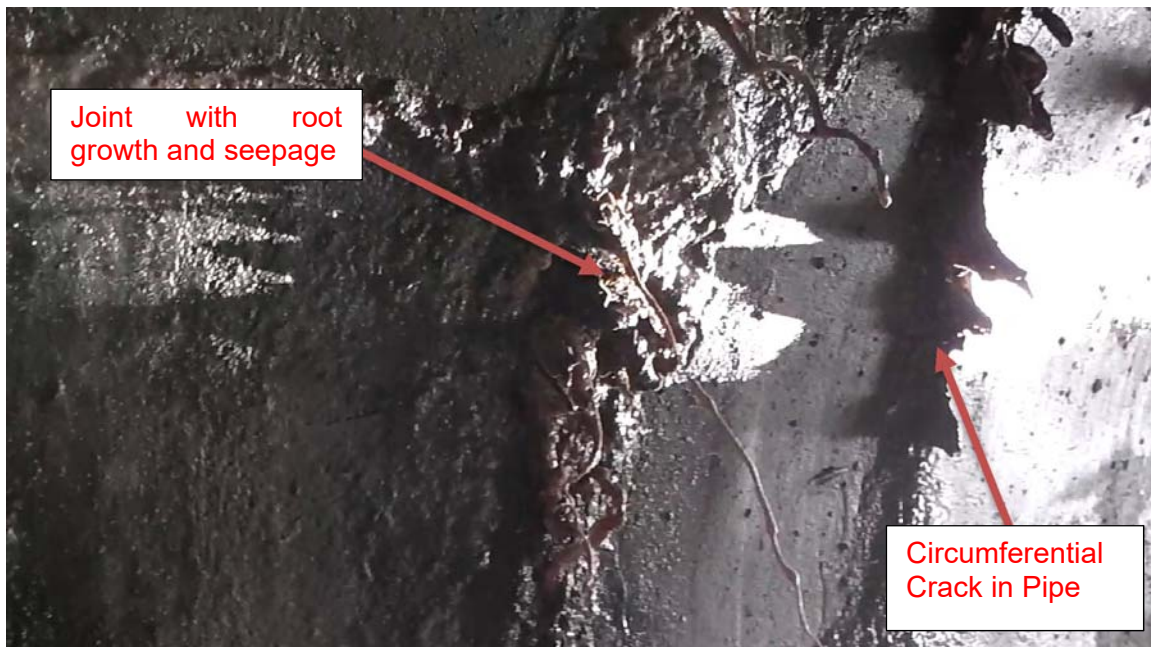
Screenshot 2: View of root growth and seepage through joint, with circumferential crack immediately downstream of joint. View is looking left in Conduit No. 1 at Station 0+95 feet downstream of gate. November 9, 2016.

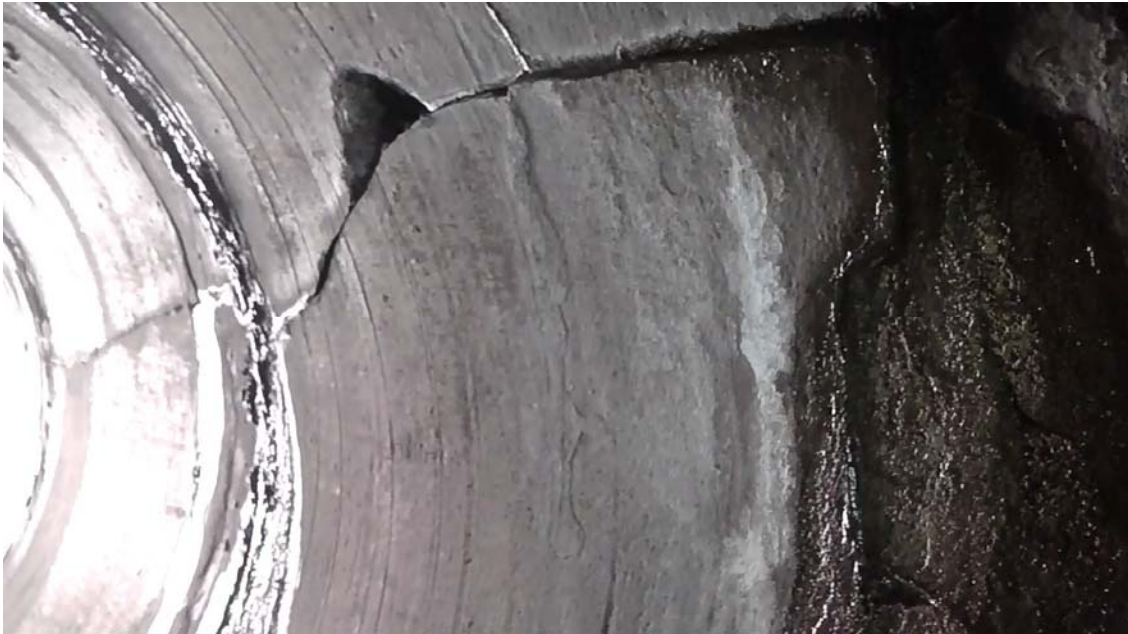
Screenshot 3: View of circumferential crack with seepage and longitudinal crack running length of pipe, in Conduit No. 2 at Station 0+82 feet downstream of gate, looking downstream. Note piece of pipe missing above longitudinal crack. November 9, 2016.

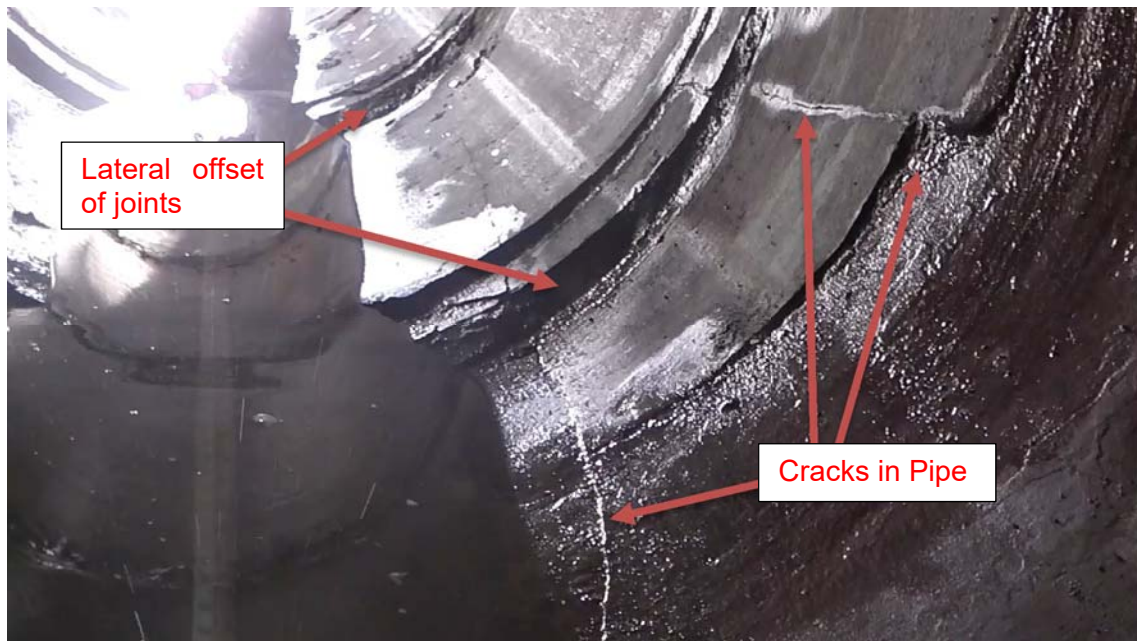
Screenshot 4: View looking downstream in Conduit No. 2 at Station 0+92 feet downstream of gate. Note significant circumferential and longitudinal cracking and lateral offset of joints. November 9, 2016.

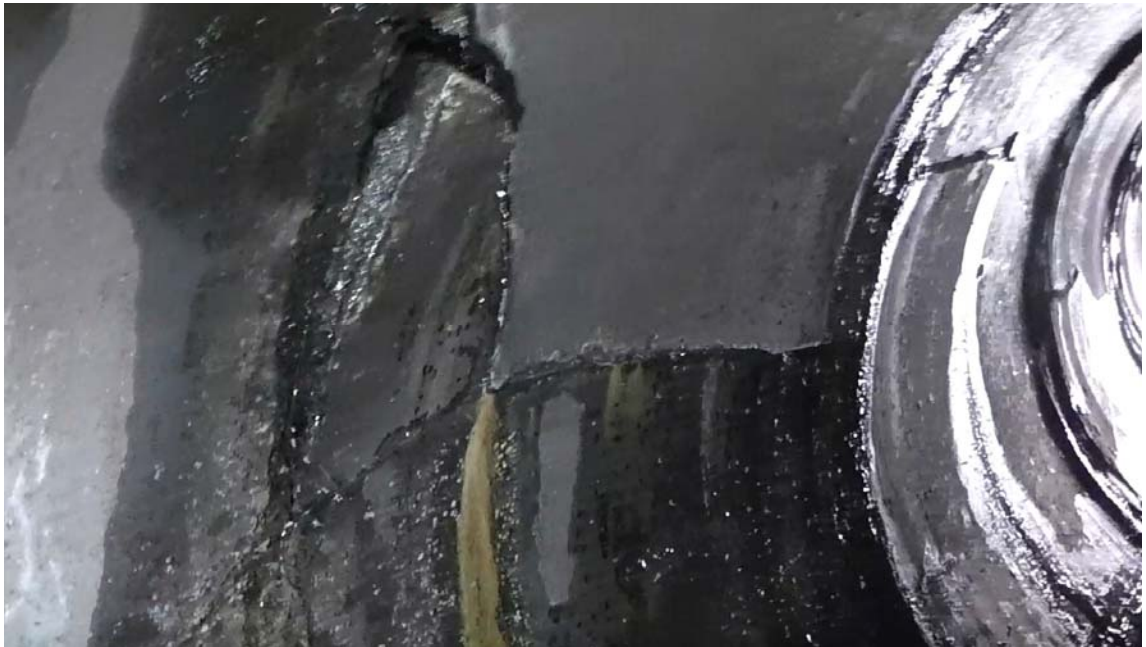
Screenshot 5: View looking downstream in Conduit No. 3 at Station 0+81 feet downstream of gate. Note cracking and movement of a piece of the pipe wall. November 9, 2016.

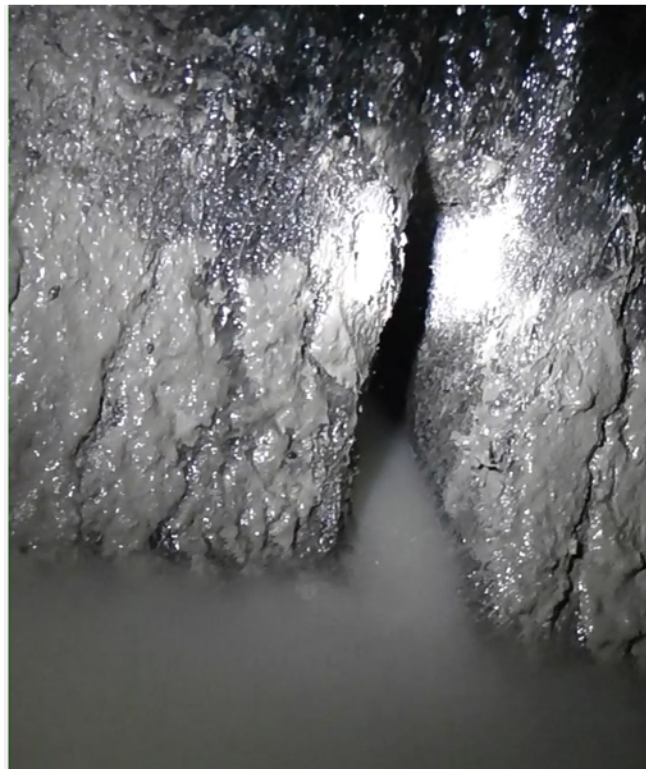
Screenshot 6: Gap in previously repaired pipe joint at bottom. Located in Conduit 4 at Station 0+81 feet downstream of gate. November 9, 2016.

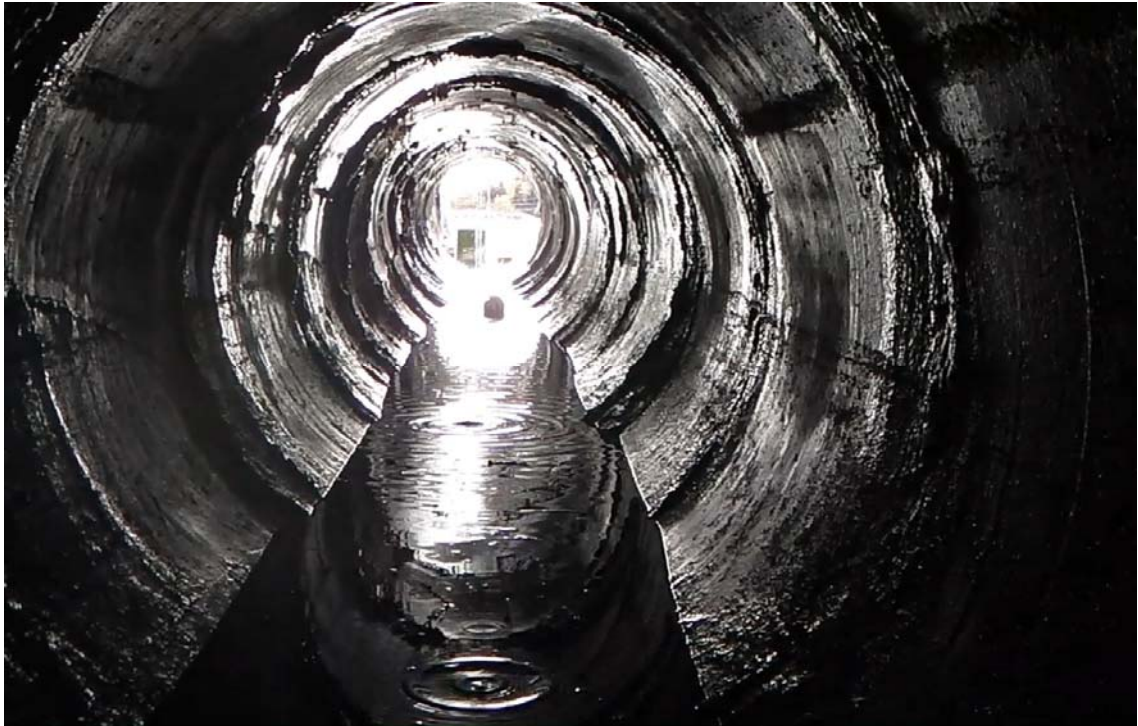
Screenshot 7: View looking downstream in Conduit No. 1 at Station 0+69 feet downstream of gate. Significant seepage, disjointedness and cracking in the pipe was observed from this point to the conduit discharge end. November 9, 2016.

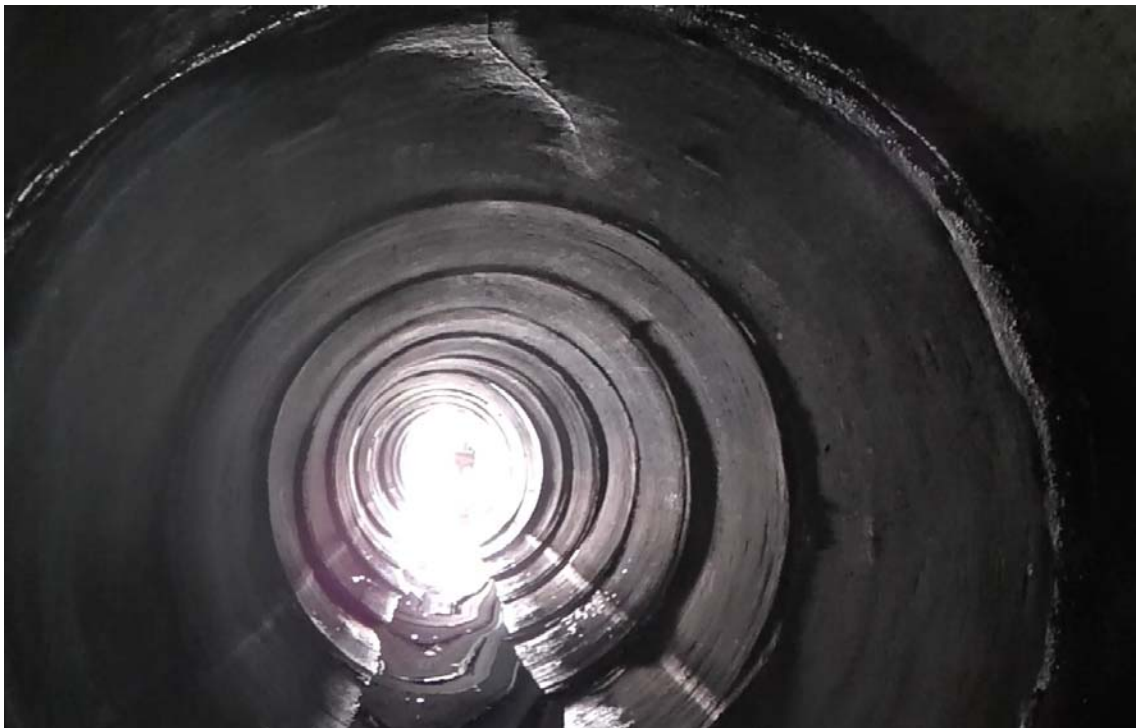
Screenshot 8: View looking downstream in Conduit No. 2 at Station 0+39 feet downstream of gate. View shows cracking in the pipe crown, disjointedness, and movement of pipe sections. November 9, 2016.

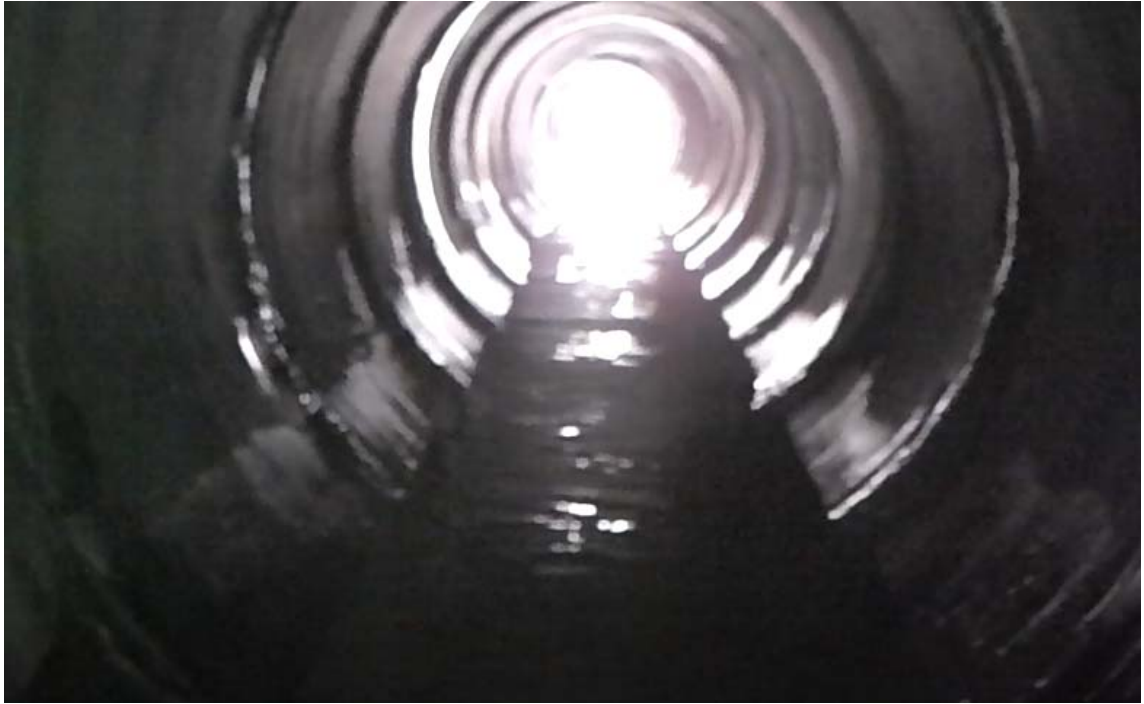
Screenshot 9: View looking downstream in Conduit No. 4 at Station 0+23 feet downstream of gate. View shows disjointedness and movement of pipe sections. November 9, 2016.

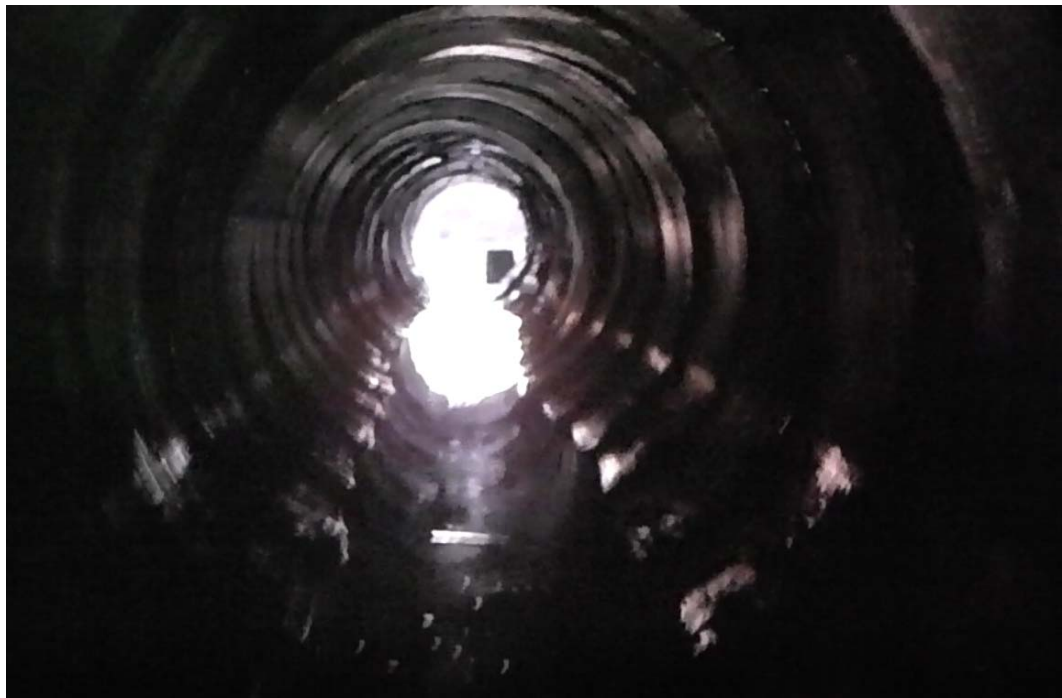
Screenshot 10: View looking downstream in Conduit No. 4 at Station 0+35 downstream of gate. View shows disjointedness and movement of pipe sections. November 9, 2016.

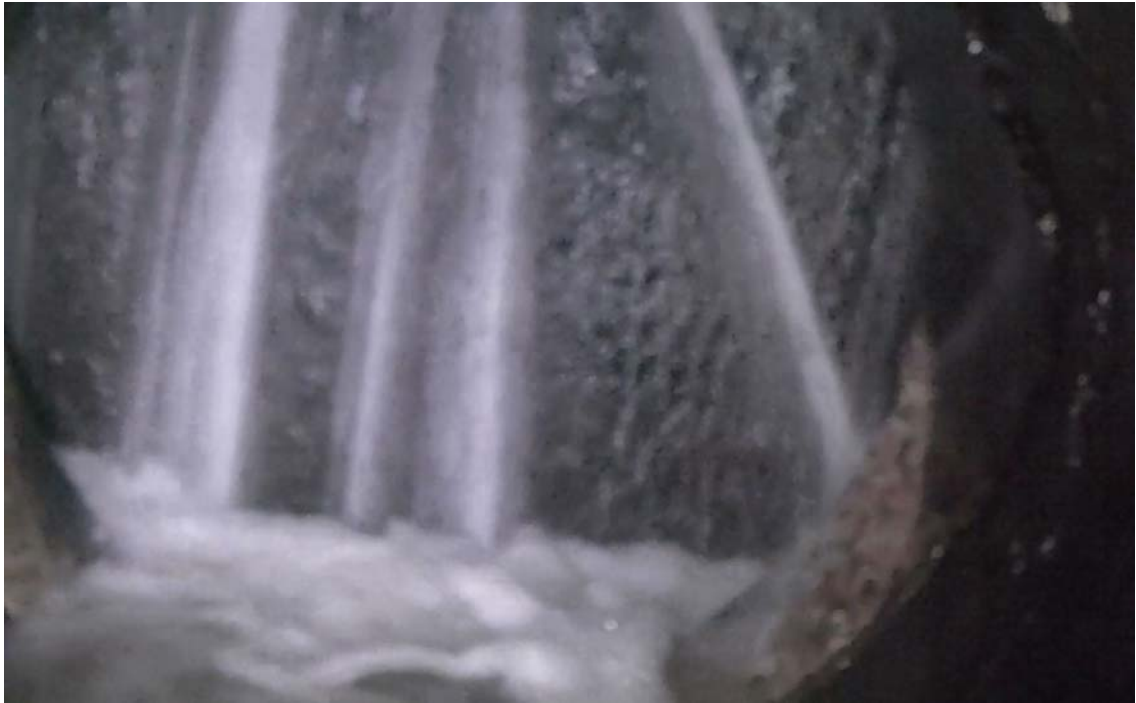
Screenshot 11: View looking upstream at control gate in Conduit No. 3. Note significant leakage around control gate and scour to bottom and sides of pipe. November 9, 2016.

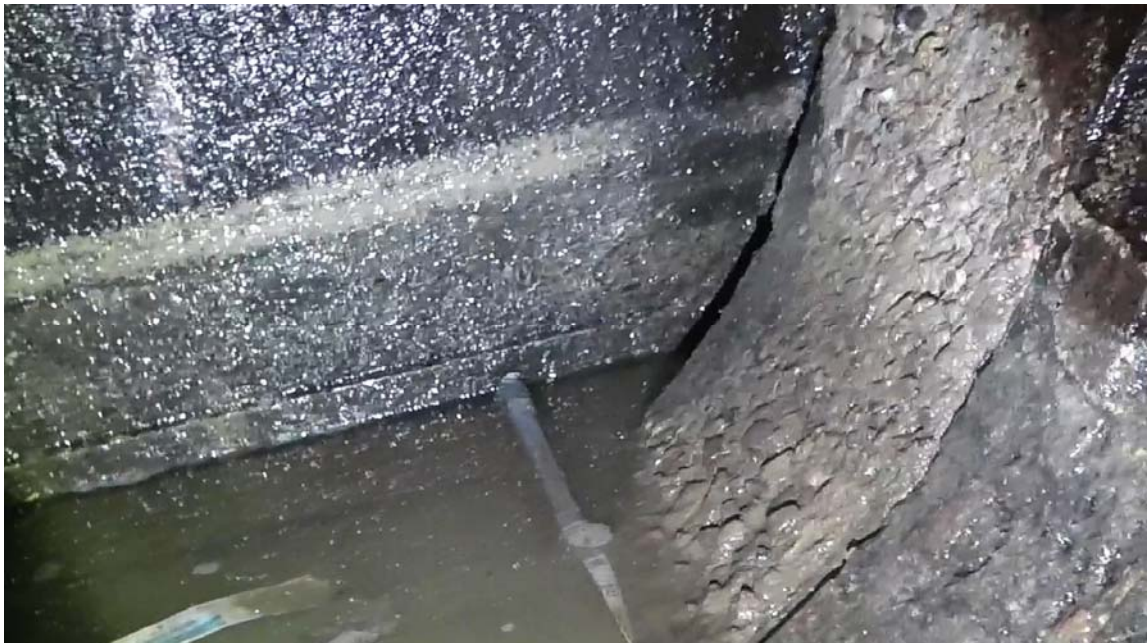
Screenshot 12: View looking upstream at control gate in Conduit No. 2. Note significant scour to pipe immediately downstream of control gate. November 9, 2016.
