**CONSTRUCTION COMPLETION REPORT**  
**WEST RESERVOIR NO. 1 OUTLET WORKS**  
**REHABILITATION PROJECT**  
**DELTA COUNTY, COLORADO**

Submitted to  
**West Reservoir & Ditch Company**  
708 1250 Road  
Delta, CO 81416

Submitted by  
**RJH Consultants, Inc.**  
9800 Mt. Pyramid Court, Suite 330  
Englewood, Colorado 80112  
303-225-4611  
[www.rjh-consultants.com](http://www.rjh-consultants.com)

December 2016  
Project 13129

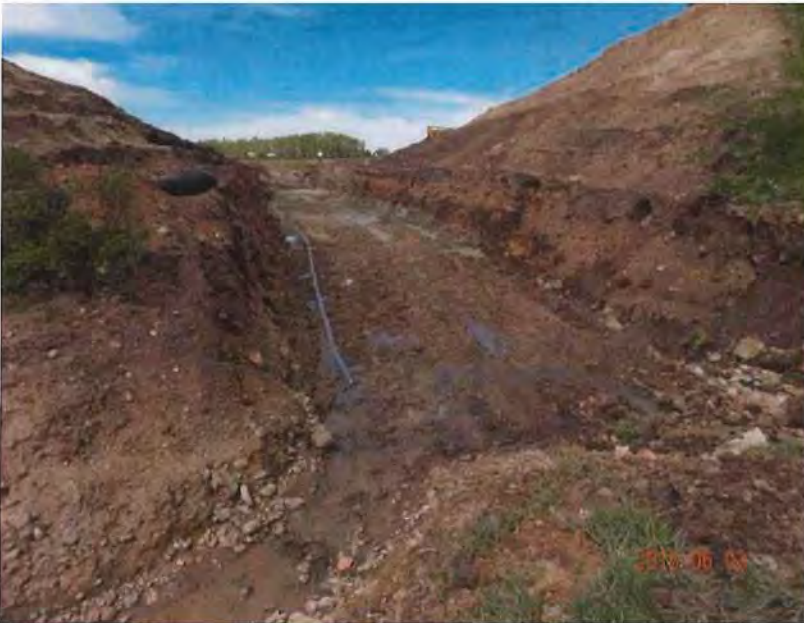
Photo 2 – Condition of the outlet works subgrade, looking upstream.

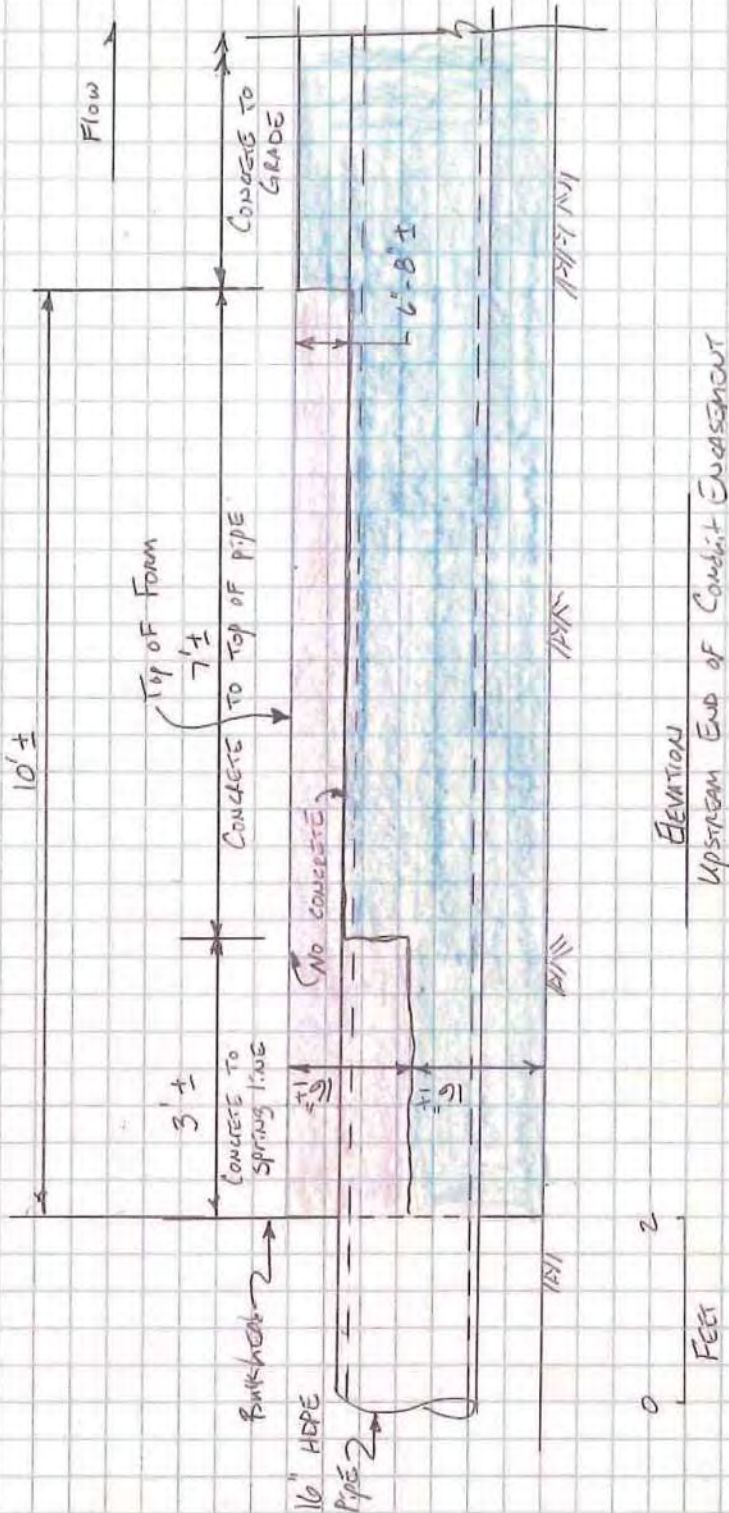
Portion of the conduit encasement that was left un-finished. This area will be completed during a subsequent placement.

Photo 8 – Placing concrete for the outlet works conduit encasement.

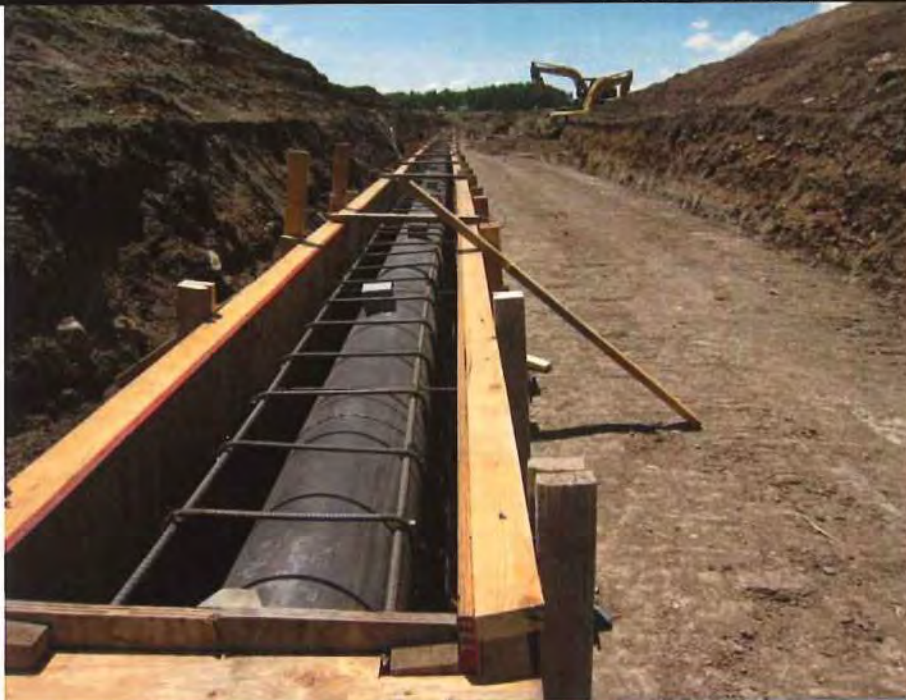
HDPE outlet pipe placed on prepared foundation with encasement reinforcement and concrete forms.

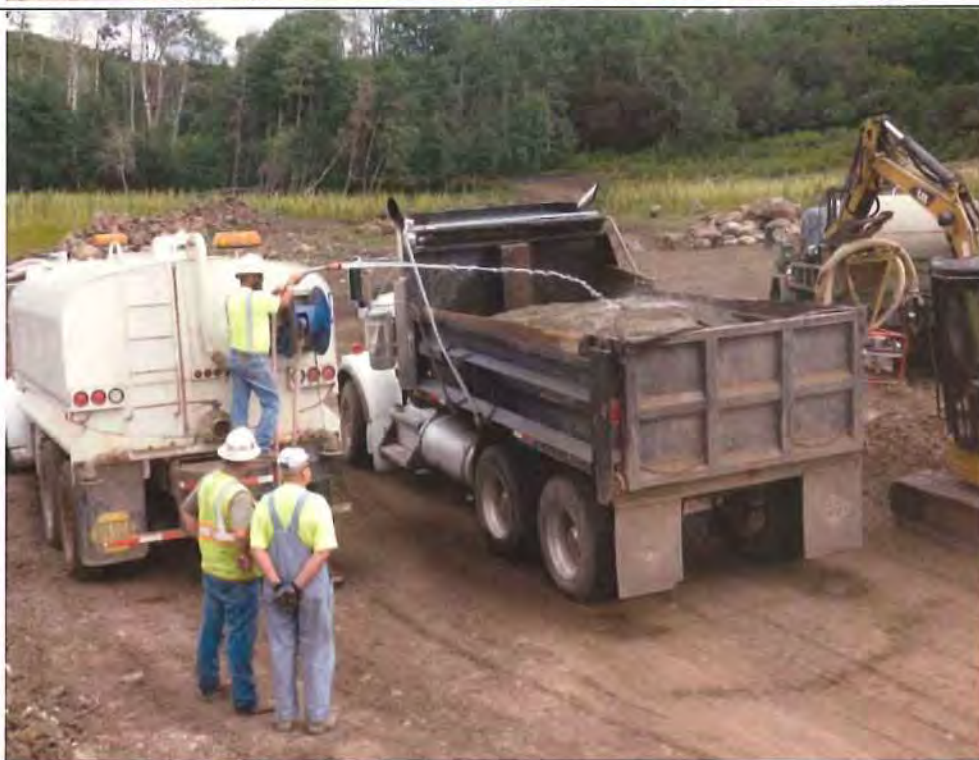
Moisture conditioning the new sand in the delivery truck.

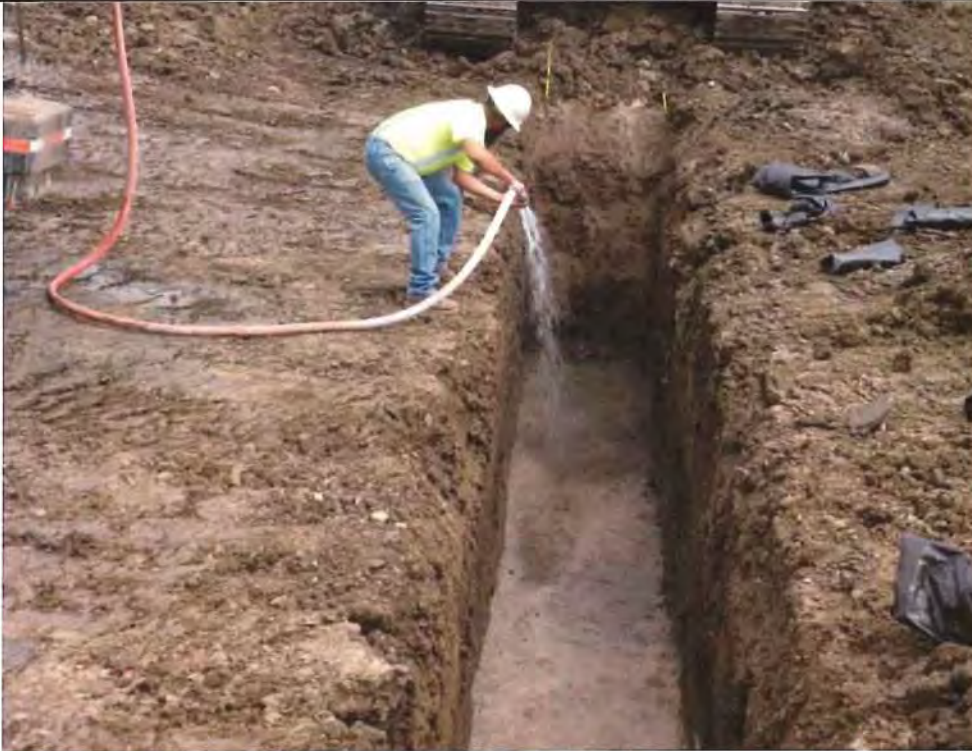
Moisture conditioning the previously-placed sand prior to placing new sand.

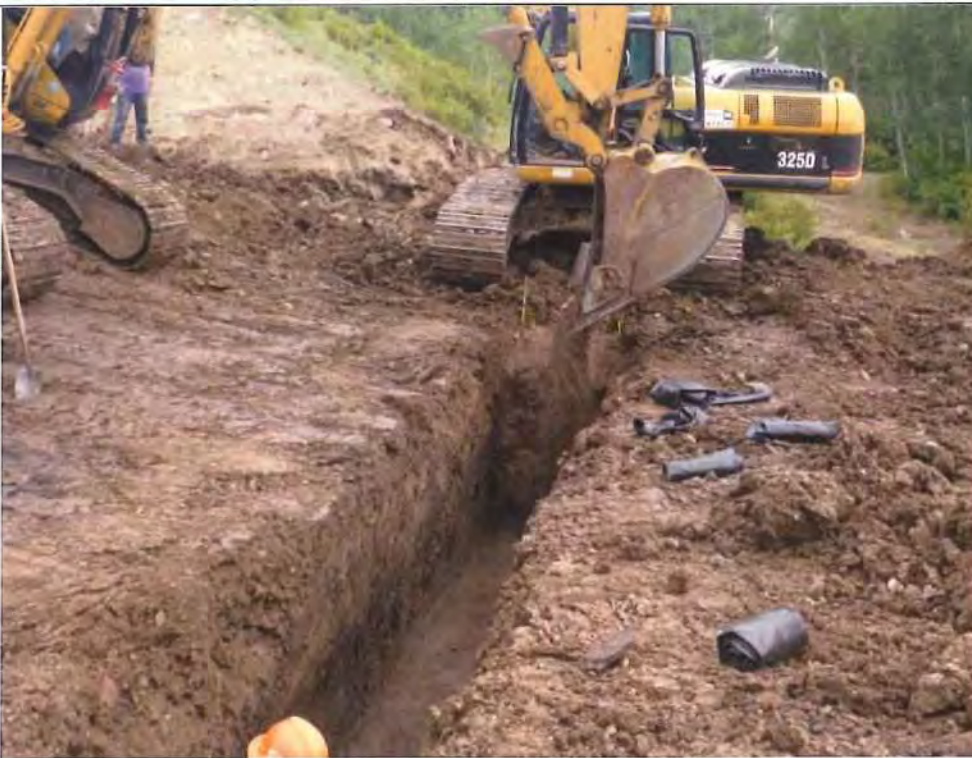
New sand was placed in 16" lifts. 325D excavator bucket was used to gently pack the lift.

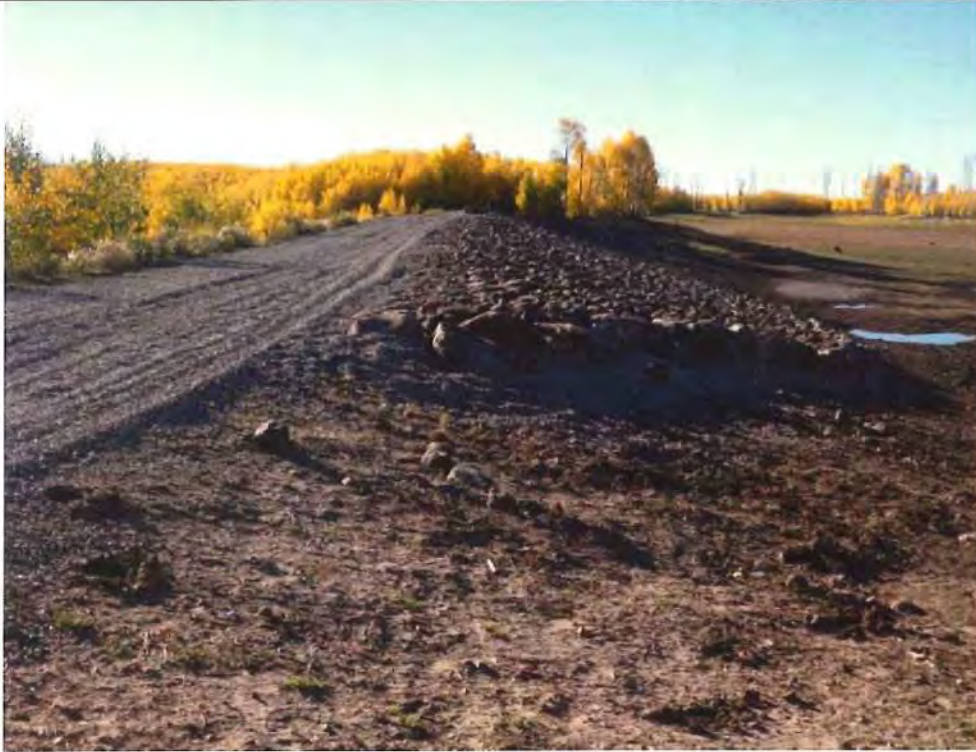
Dam crest has been surfaced with a thick layer of loose gravel, some rutting is occurring.

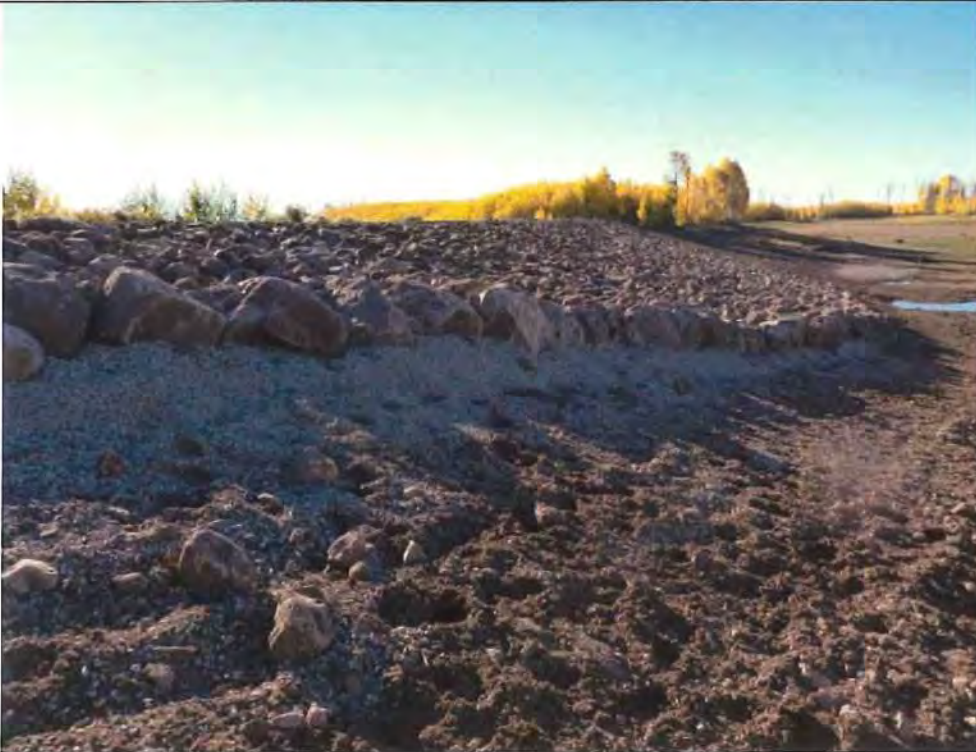
Upstream slope with new riprap and bedding. Large rocks have been lined up along the bottom of the slope to prevent riprap movement downslope.

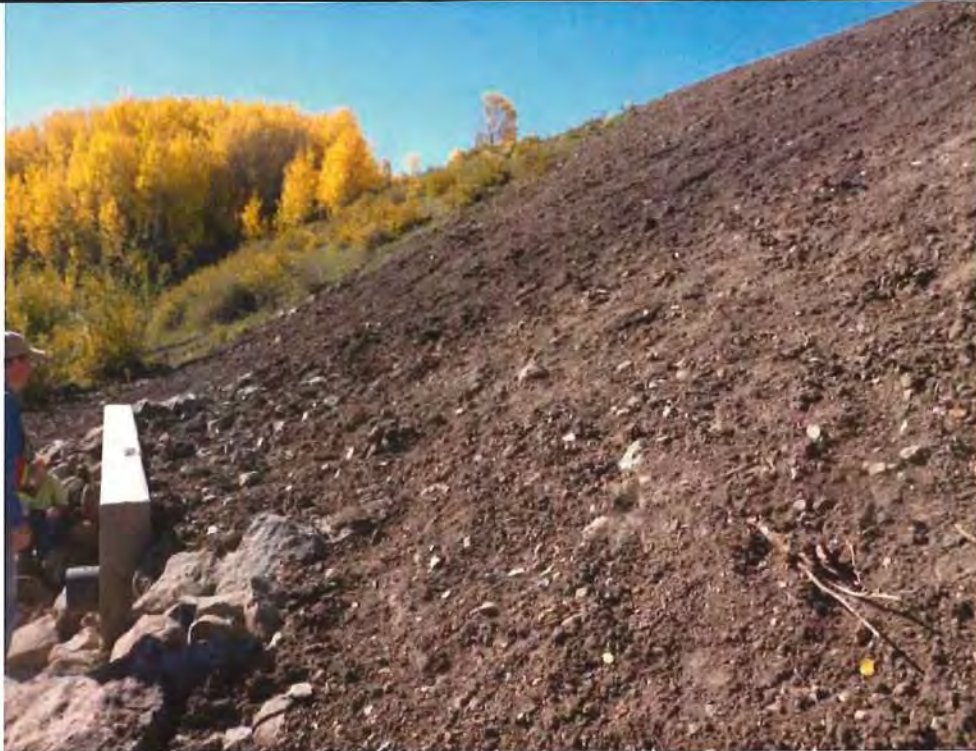
Downstream slope of dam in repaired breach area.

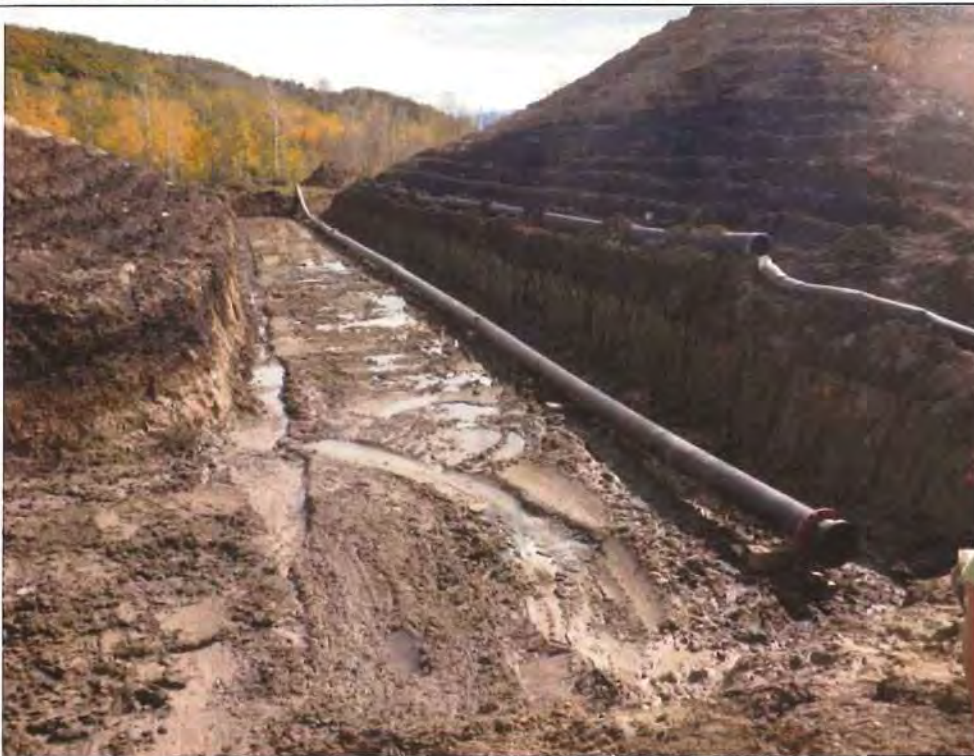
Seepage into the foundation excavation will need to be controlled to permit construction in the dry.

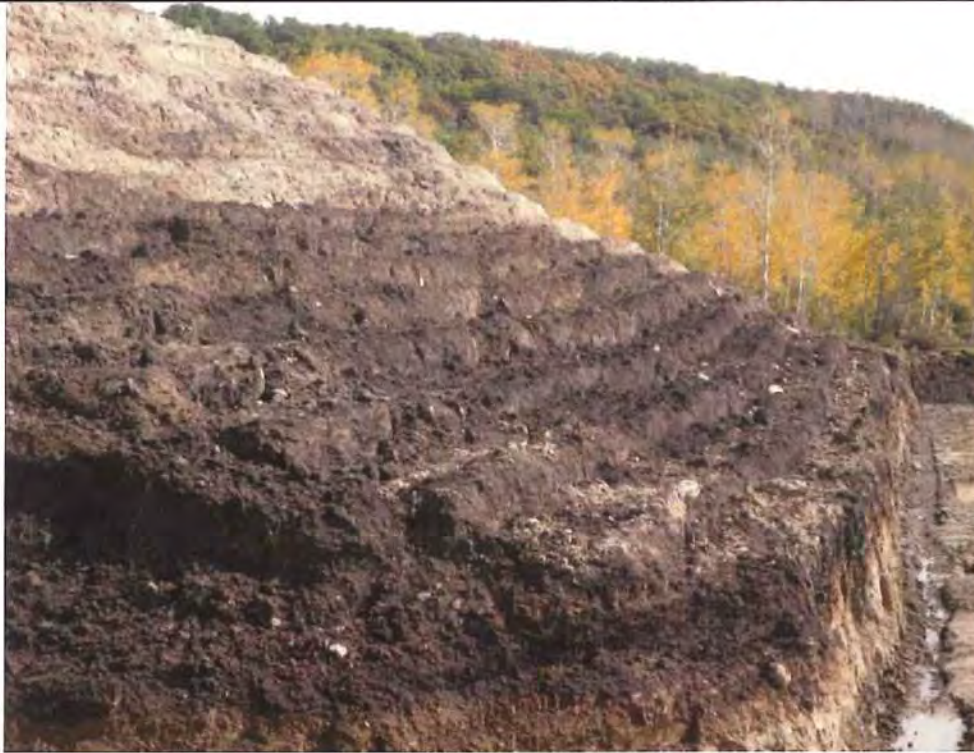
The breach sideslopes have been laid back and benched for stability and to prevent erosion. New embankment fill to repair the breach must be placed with care to key the new fill into undisturbed existing embankment fill to prevent seepage paths along the contact between the new and old materials.

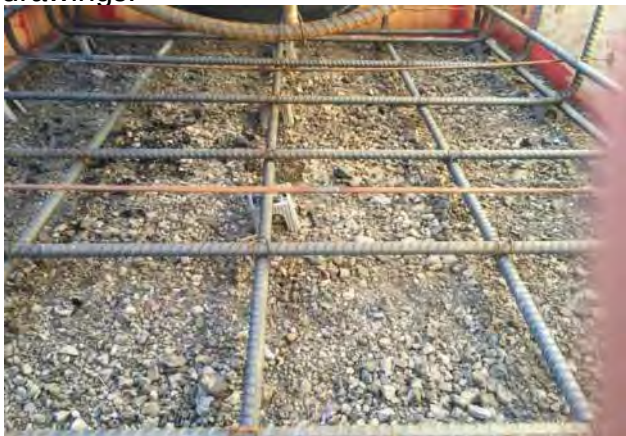
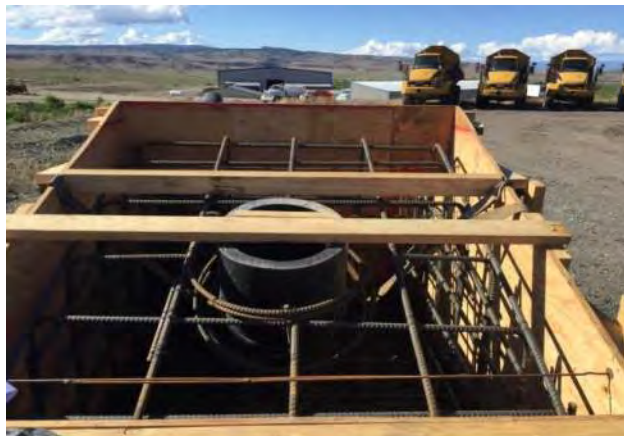
One #6 bar was missing at top of inlet structure around sluice gate. Called for seven #6 EQ spaced. Only six bars placed. Contractor will add one #6 bar below sluice gate per drawings.

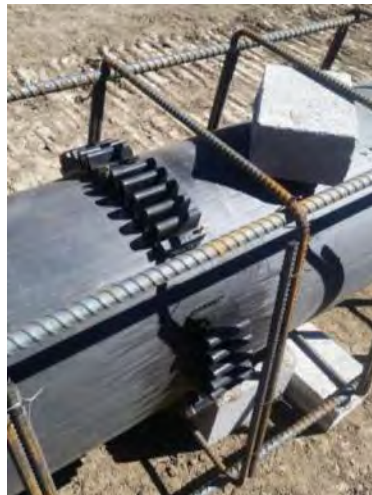
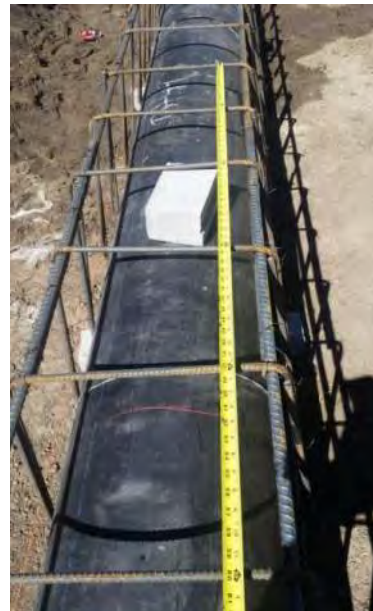
All "square hoops" - good cap and tie - good spacing - good form clearance on portion observed - will double check form clearance on day of concrete placement.

Observed the presence of the hoop bands mentioned in Note 3, Sheet 7, weld area appeared to have been properly prepared.

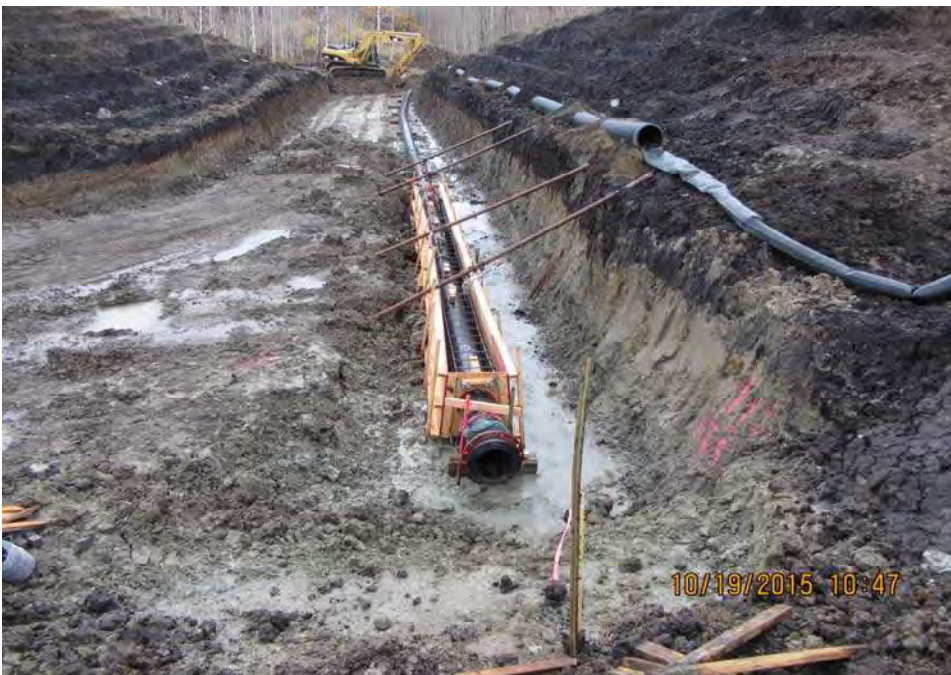
**Photograph 4:** Condition of excavation at the end of 2015.

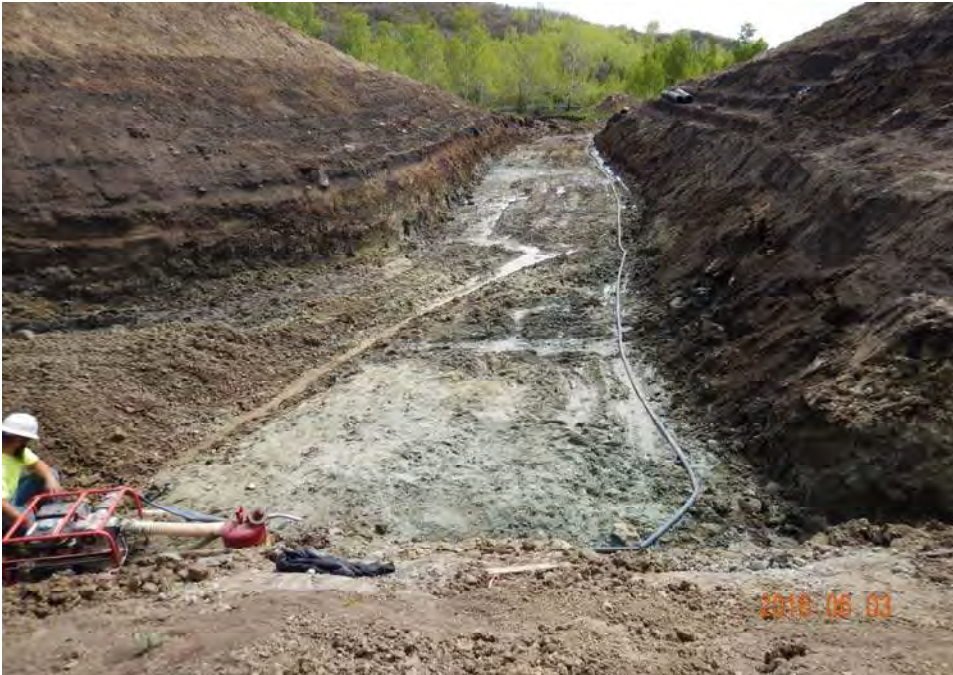
**Photograph 5:** Condition of excavation at the start of 2016.

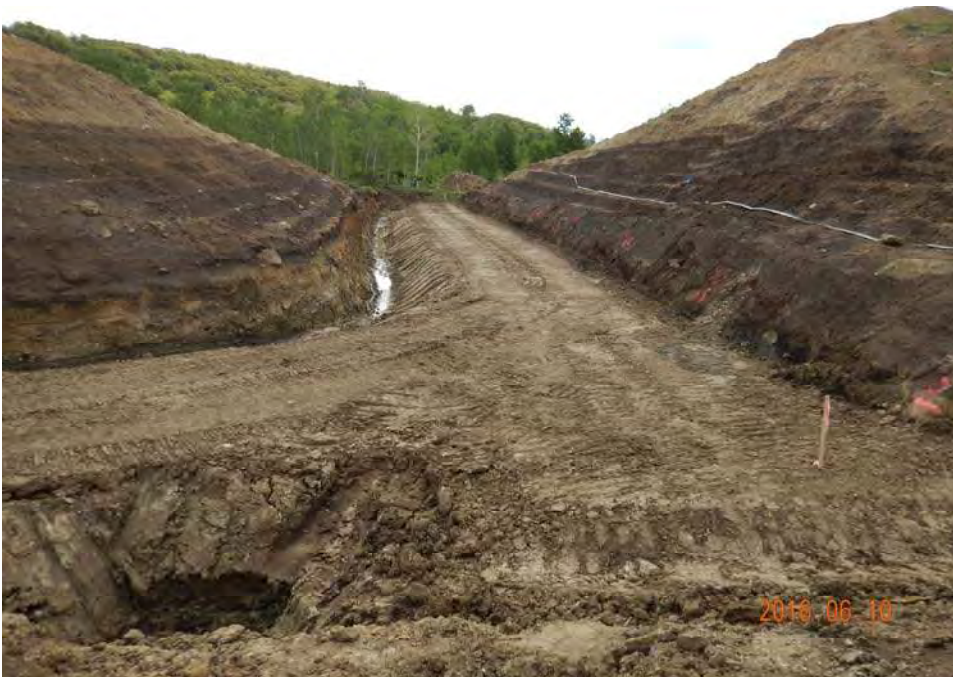
**Photograph 6:** Working platform constructed in 2016.

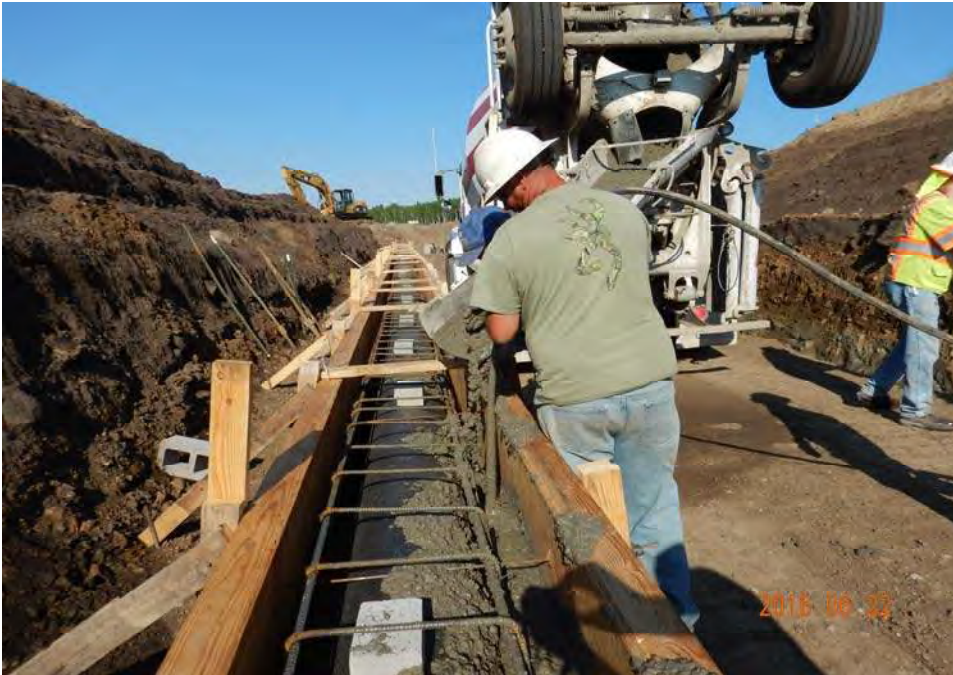
**Photograph 27:** Placing encasement concrete. Concrete placed and vibrated on one side of the pipe until flow under the conduit is observed.

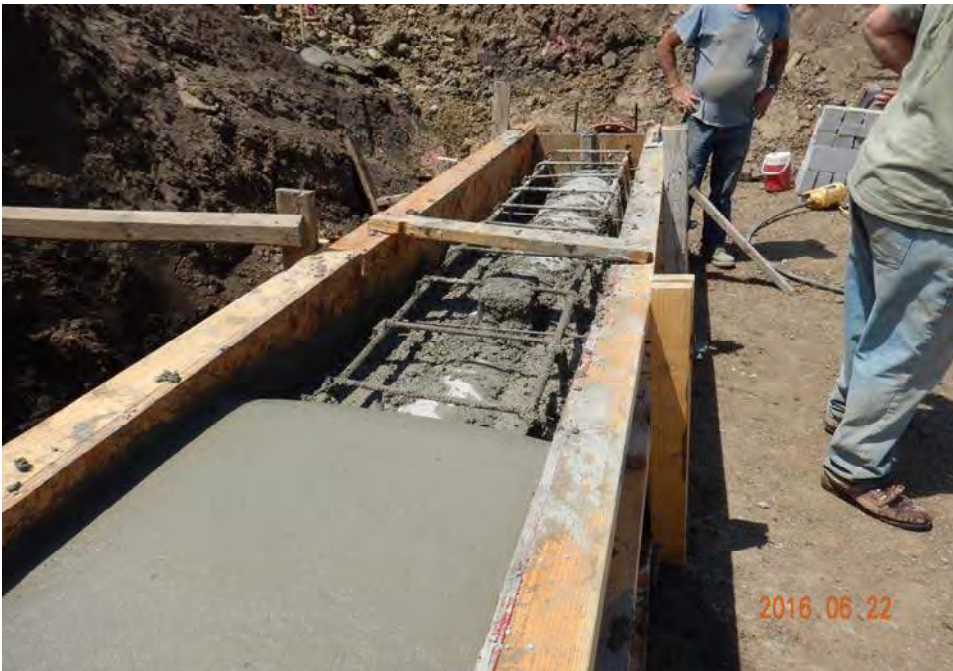
**Photograph 28:** Portion of the conduit encasement that was not complete with the rest of the encasement (OW Sta. 1+17 to OW Sta. 1+27).
