MOUNT PISGAH DAM/WRIGHTS RESERVOIR OUTLET WORKS REHABILITATION

CONSTRUCTION COMPLETION REPORT

MT. PISGAH DAM OUTLET WORKS REHABILITATION PROJECT

TELLER COUNTY, COLORADO

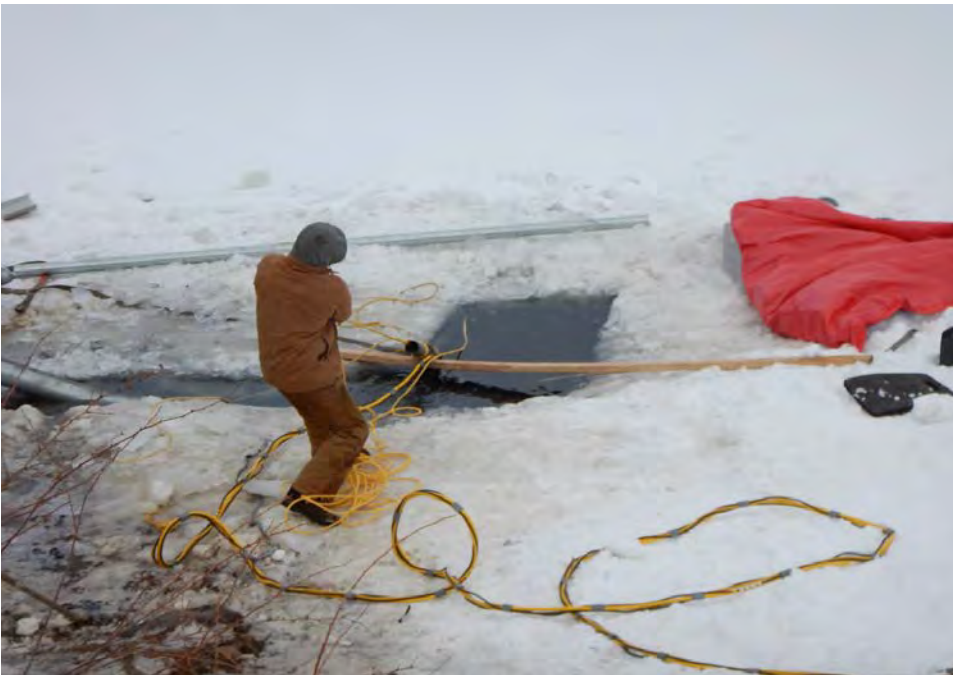
Photograph 2: February 6, 2016 Installation of flexible hydraulic tubing for the 30-inch slide gate.

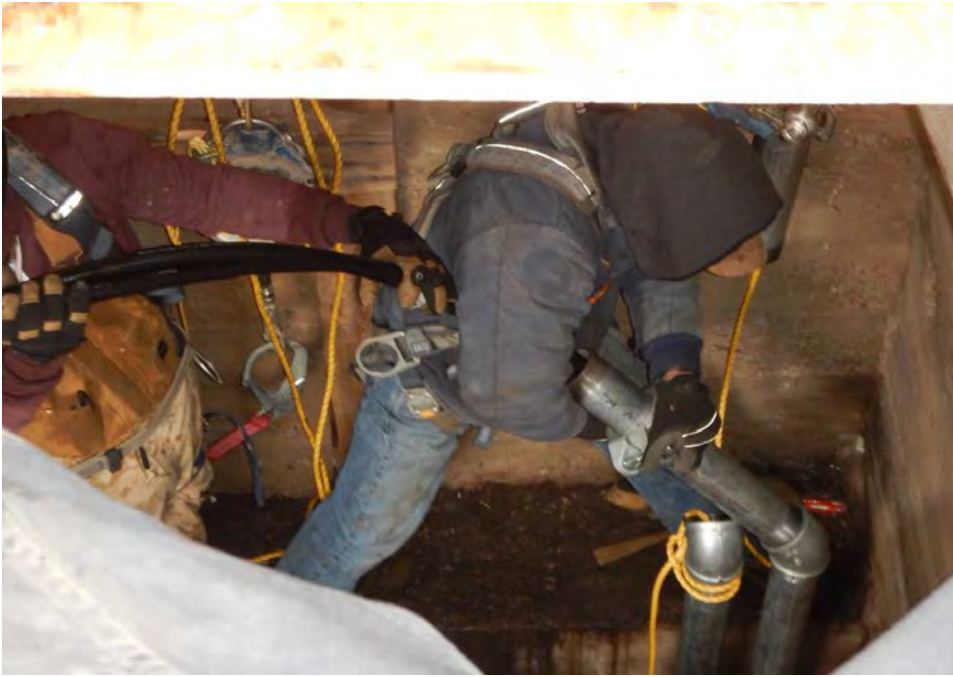
Photograph 3: January 31, 2016 Installation of flexible hydraulic tubing in the vertical rock-cut shaft.

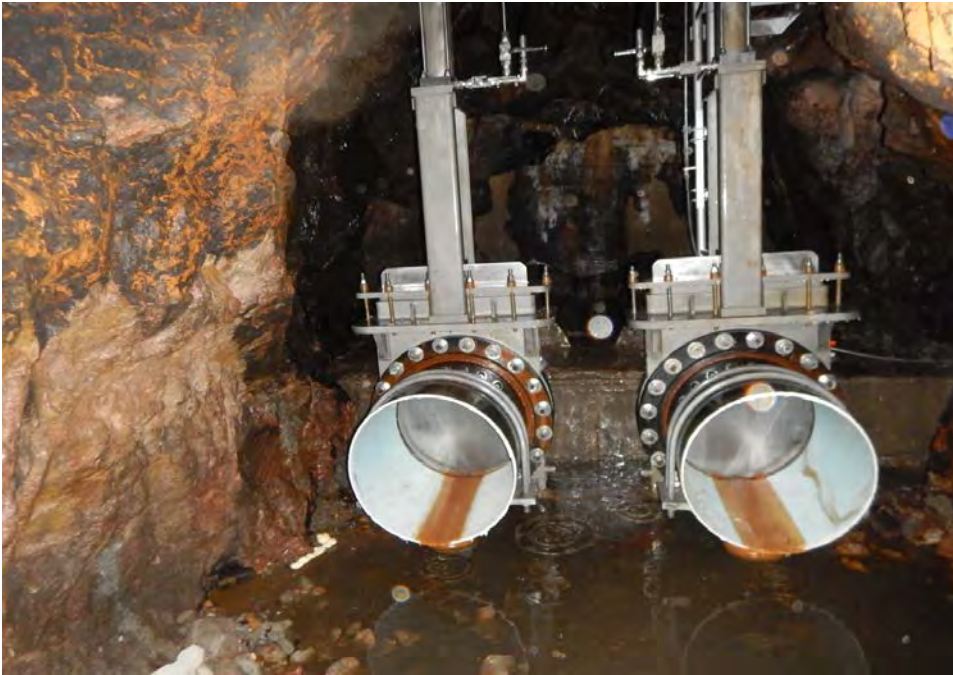
Photograph 7: March 2, 2016. 24-inch diameter pipes and concrete cradle.

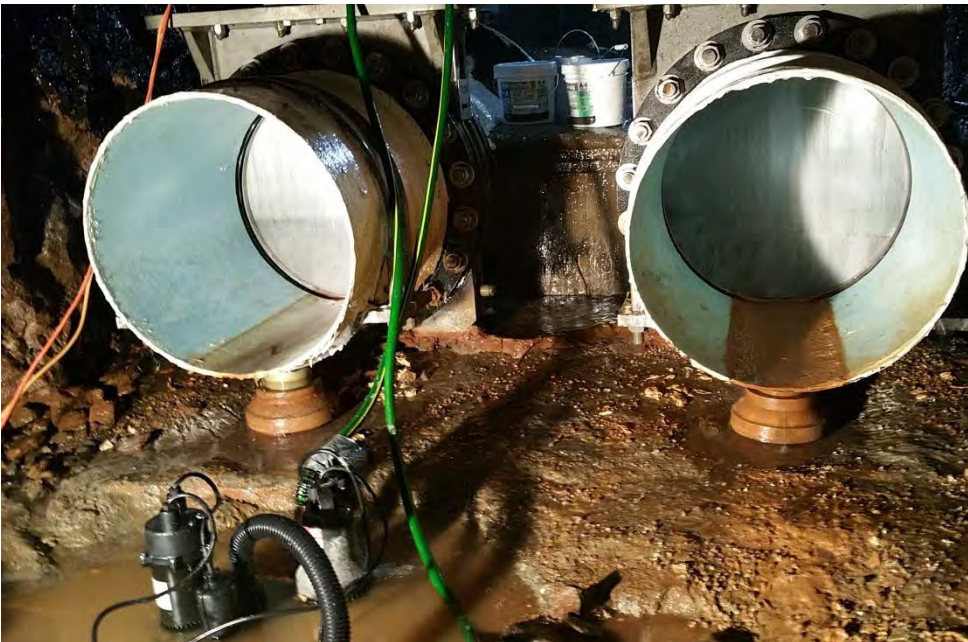
- 24-inch Steel Discharge Pipes - Stainless Steel Pipe Supports: Inland installed stainless steel pipe supports approximately 1 foot downstream of the 24-inch diameter knife gate valves. Pipe supports were installed by removing rock, placing concrete to level the rock subgrade, anchoring the pipe supports to the placed concrete, and attaching the pipe support to the 24-inch diameter pipes.

Photograph 8: June 14, 2016. Pipe supports and backfill concrete.

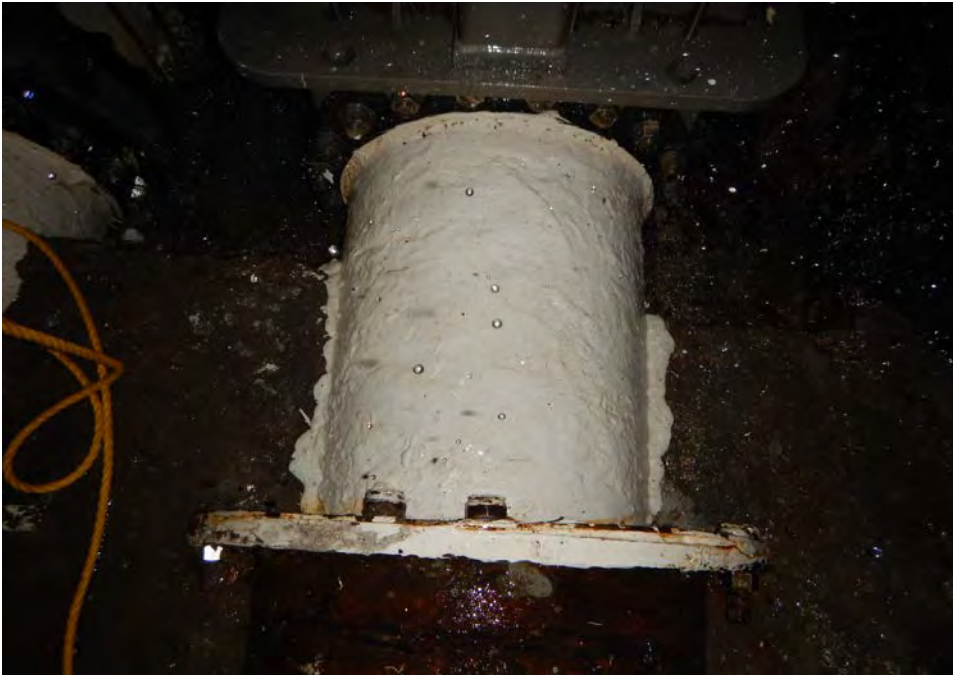
Photograph 9: June 7, 2016. 24-inch steel pipe coated with Aquatapoxy above the concrete cradle.

- Inspect epoxy coating of 24-inch diameter pipes.
 - The epoxy coating consists of three layers of epoxy with a minimum dry film thickness of 16-mils. The color of the epoxy from top to bottom is blue, then white, then red.
 - Record description of the epoxy coating condition and take photographs.

- Repair epoxy coating when red layer becomes visible to reduce the development of corrosion within the 24-inch diameter steel pipes. Refer to Attachment F for product information.
- Move to periodic inspections after several years of acceptable performance.
- Inspect waterproof epoxy, which forms the transition (taper) from the existing concrete bulkhead wall to the 24-inch diameter pipes.
 - Check for surface erosion, spalling, or pitted surface of waterproof epoxy. Record description of the taper and take photographs. Repair as appropriate. Refer to Attachment F for product information.
 - Move to periodic inspections after several years of acceptable performance.

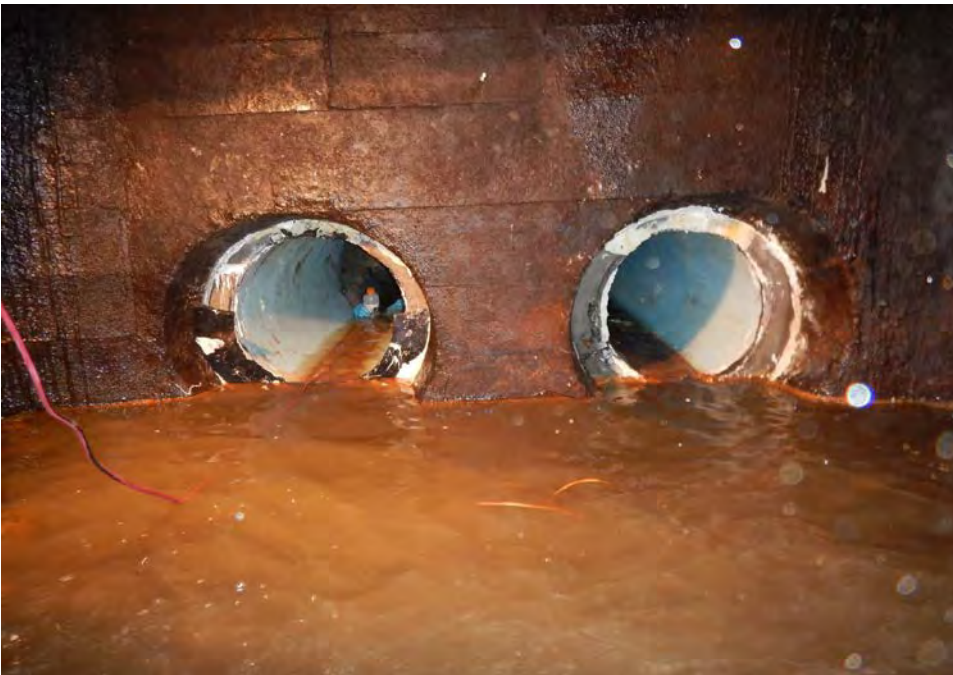
Photograph 10: February 19, 2016. Annular Space between 24-inch and 30-inch diameter pipes following secondary grouting.

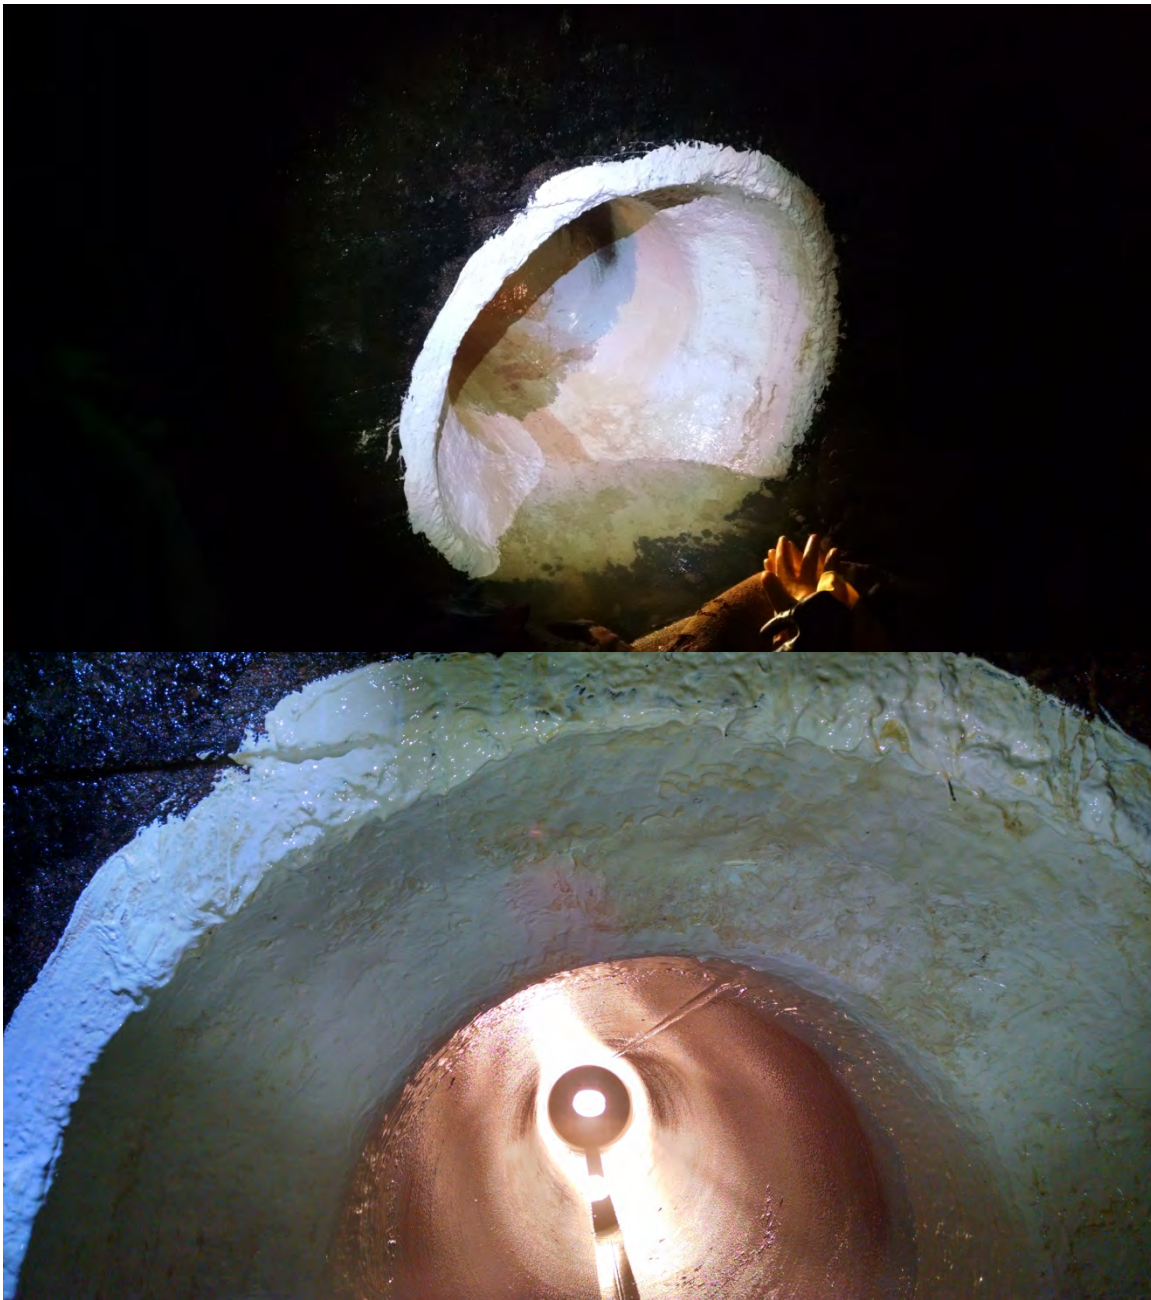
Photograph 11: June 21, 2016. Completed transition from the concrete bulkhead wall to the 24-inch diameter steel pipes.

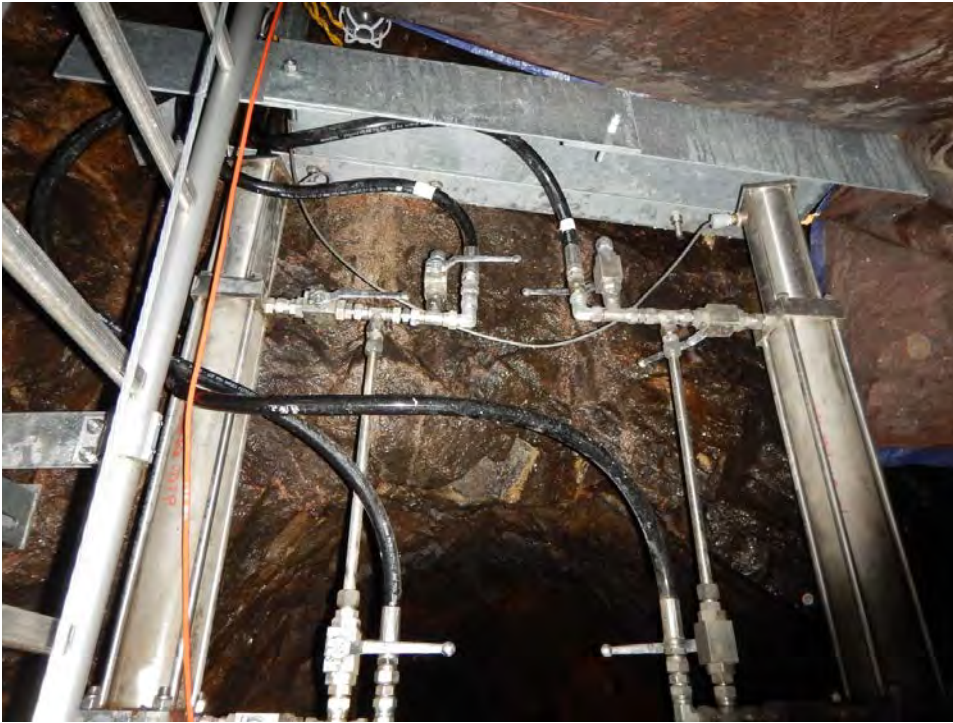
- **Valve Chamber Ice Fall Shield:** A stainless steel shield was installed in the vertical rock-cut shaft to protect critical outlet works components including the knife gate valves and hydraulic equipment from ice and falling debris. The shield was installed by a separate contractor under a separate agreement with Pisgah. The shield is removable to facilitate future removal of the knife gate valves.

Photograph 12: May 3, 2016. Knife gate valve hydraulic cylinders, hydraulic manifolds, flexible hydraulic control tubing, and removable shield.

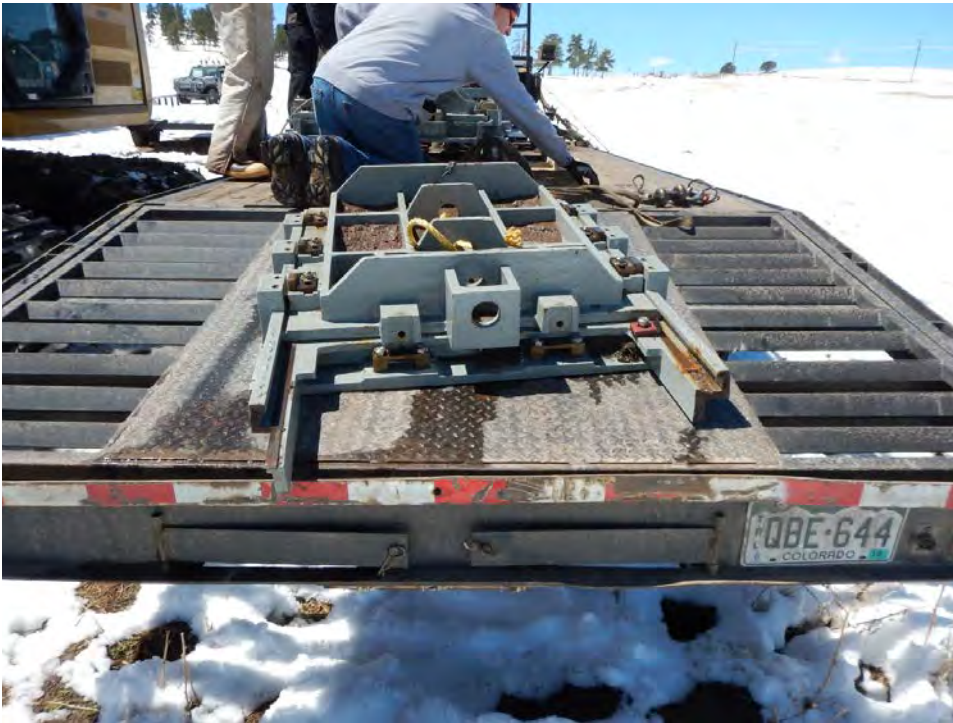
The 30-inch slide gate frame installed by Inland (first installation) in November 2015 failed in tension on March 1, 2016. The existing gate was removed and a replacement slide gate (second installation) was installed in May 2015. The failure surface of first slide occurred along the slide gate frame between the connection to the yoke and the slide approximately 15 inches above the upper most wedge. The thickness of the gate frame casting at the failure surface cross section differed as much as 5/16-inch between the left and right sides. Additionally, following the failure of the slide gate, the yoke anchor bolts were bent and pulled from the sluice gate attachment structure. The resulting voids were filled with Aquatapoxy and Oakum (Avanti 202 hydrophilic polyurethane resin mixed with jute fibers). The second slide gate was reinstalled between May 3 and May 4, 2016. Aquatapoxy was used to seal the slide gate to the thimble. The yoke was attached to a 3/4-inch stiffener plate that was attached to the steel form plate.

Photograph 13: May 2, 2016. Remains of the 30-inch slide gate (first installation) removed from the Reservoir.

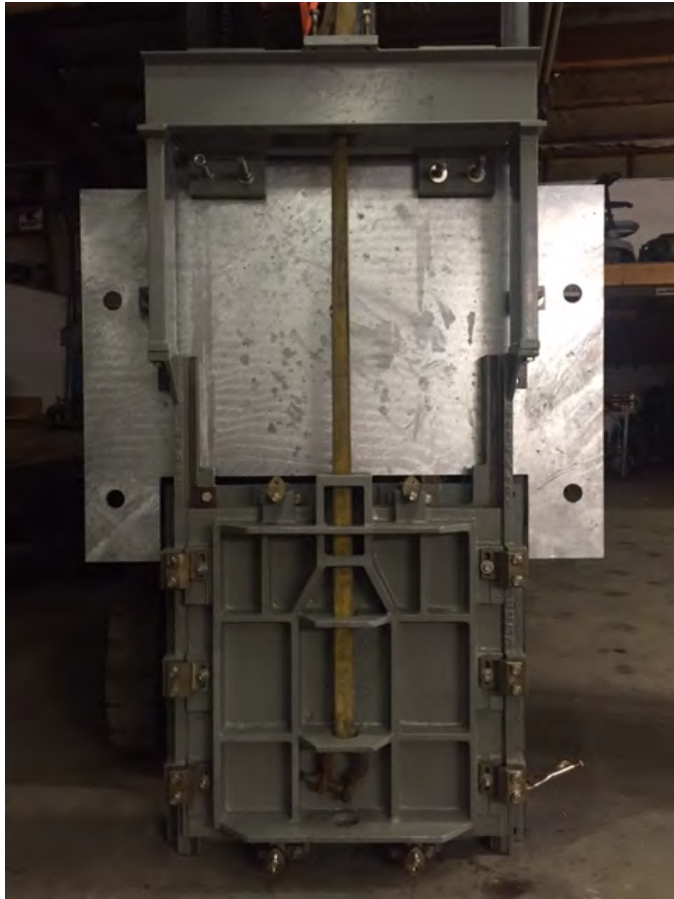
Photograph 14: April 27, 2016. 30-inch Slide Gate (Second installation) and Stiffener Plate.

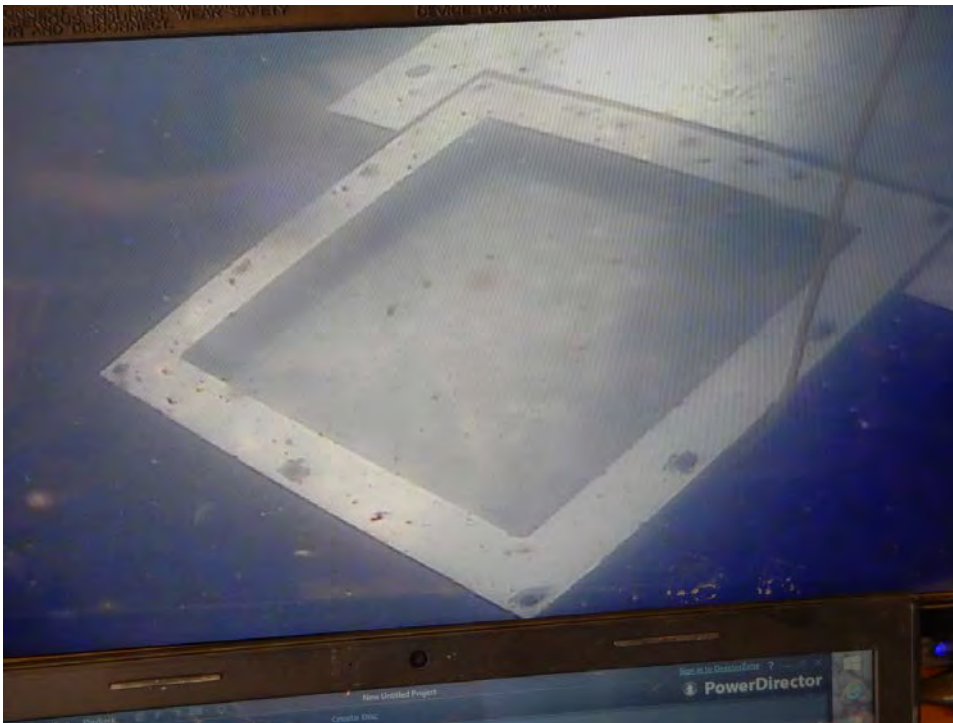
Photograph 15: May 4, 2016. 30-inch slide gate (second installation) coated with Aquatapox prior to installation.

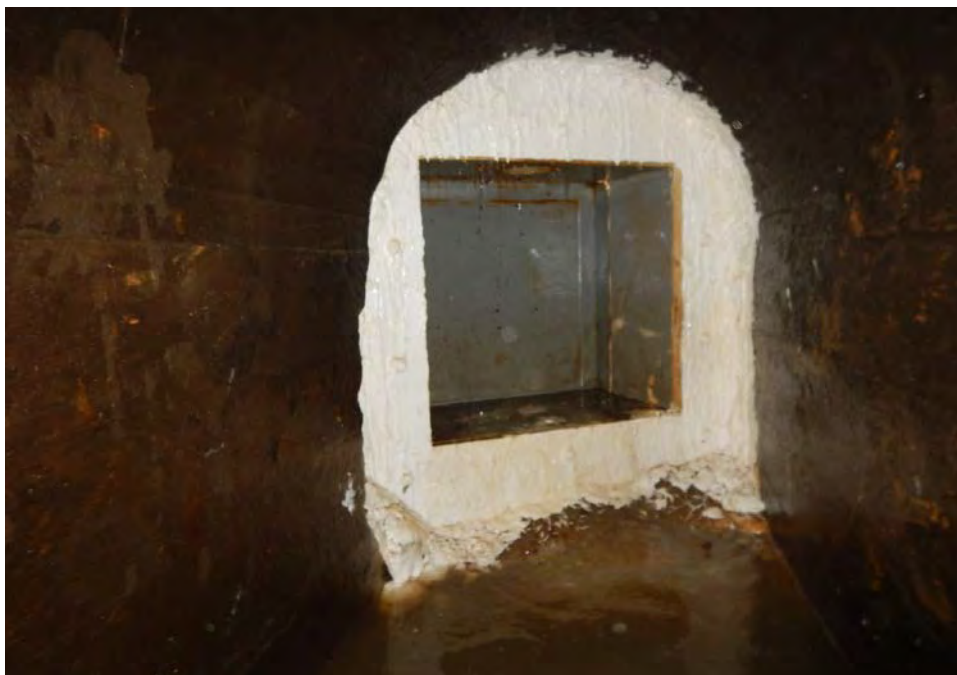
Photograph 16: March 2, 2016. Downstream face of the steel bulkhead plate, thimble, and 30-inch slide gate (first installation).

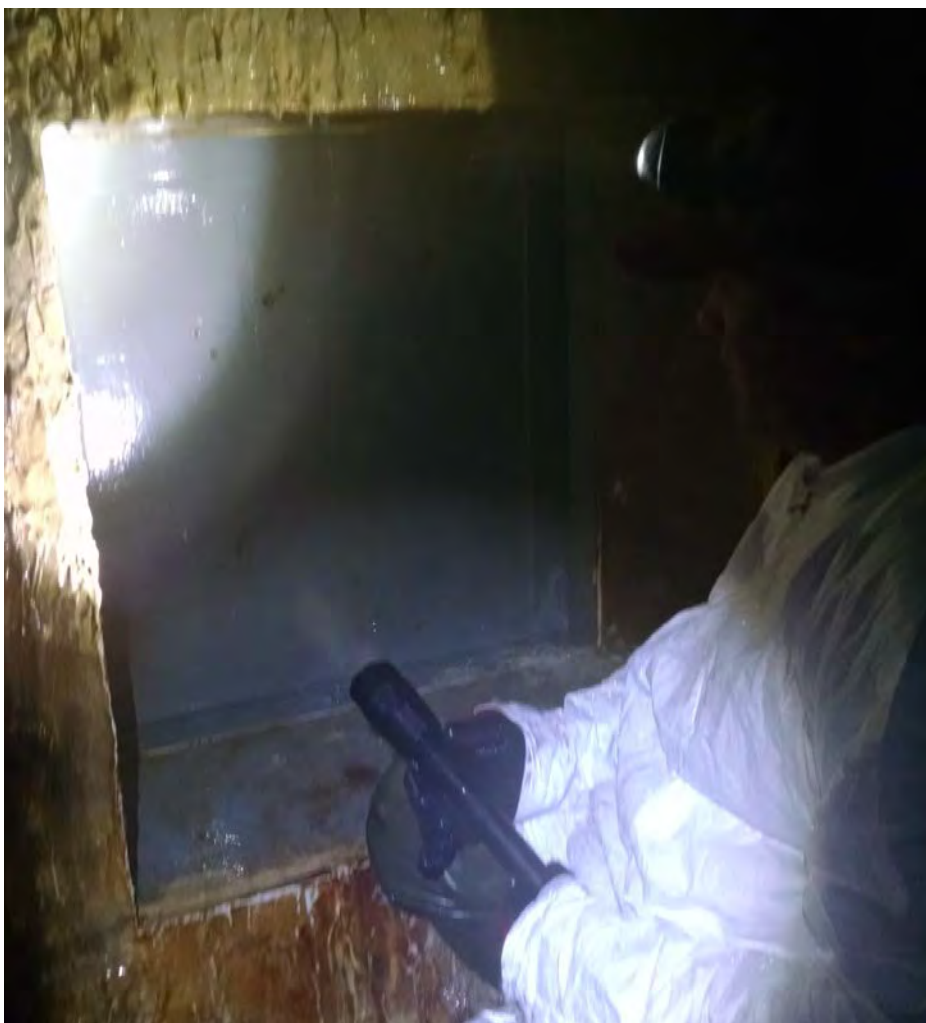
The second slide gate was tested in balanced head conditions and then the outlet works upstream of the knife gate valves was dewatered on May 7, 2016. Following dewatering of the tunnel, water was observed leaking into the outlet works between the slide gate and the thimble. Inland reduced the leaks by tightening the nuts connecting the slide gate to the thimble and installing Oakum in leaks. The slide gate was inspected on July 21, 2016

and leaks were not present. In our opinion, the completed slide gate was in general conformance with the contract documents.

Photograph 17: June 21, 2016. 30-inch slide gate under full reservoir head. Springer leaks have been sealed.

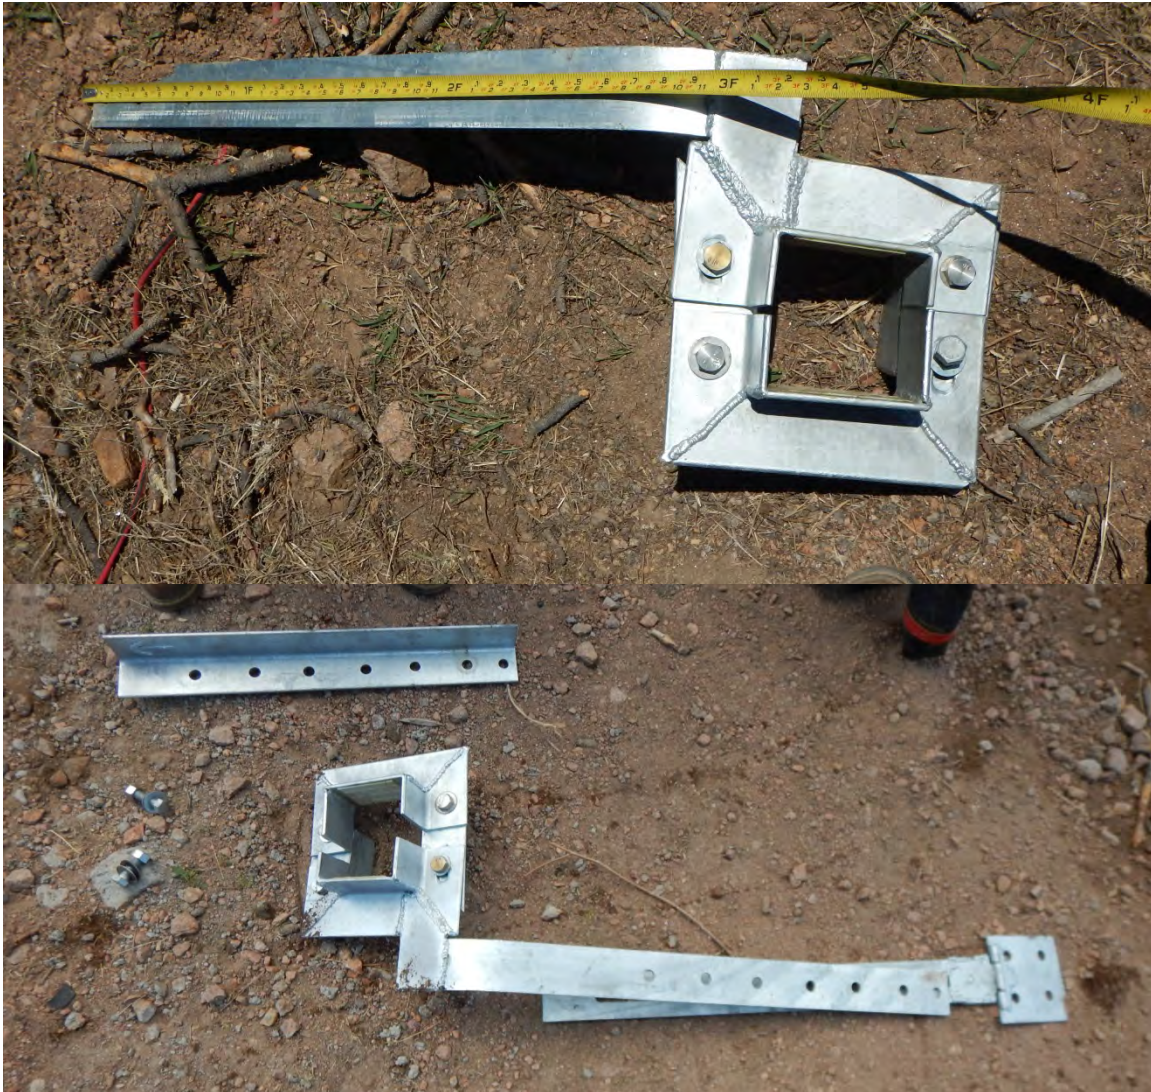
Photograph 18: May 12, 2016. Hydraulic cylinder support bracket (30-inch slide gate).

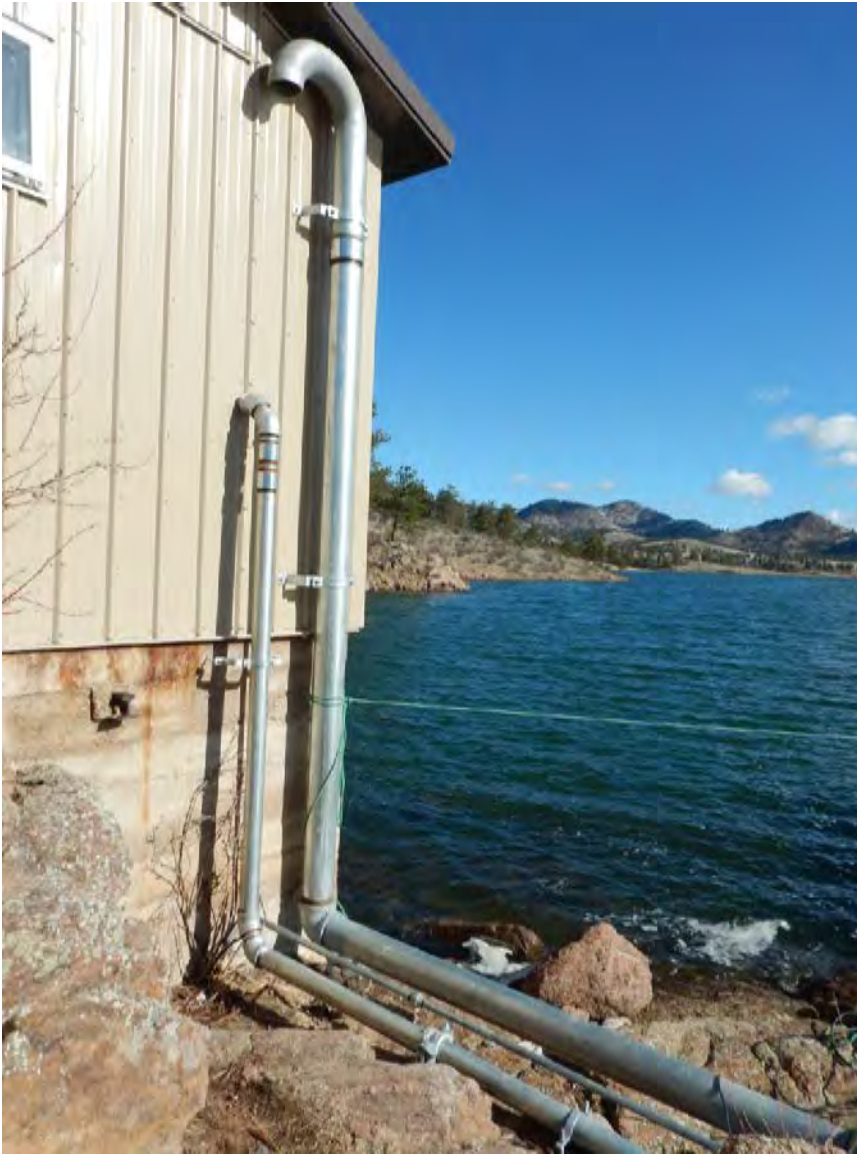
Photograph 19: May 3, 2016. Vent pipe and encasement pipe installed on the east wall of the valve house.
