FINAL REPORT

UPPER PLATTE AND BEAVER / DEUEL AND SNYDER FEASIBILITY STUDY

PRELIMINARY DESIGN REPORT

The Upper Platte & Beaver Canal Company
P.O. Box 205
Brush, Colorado 80723

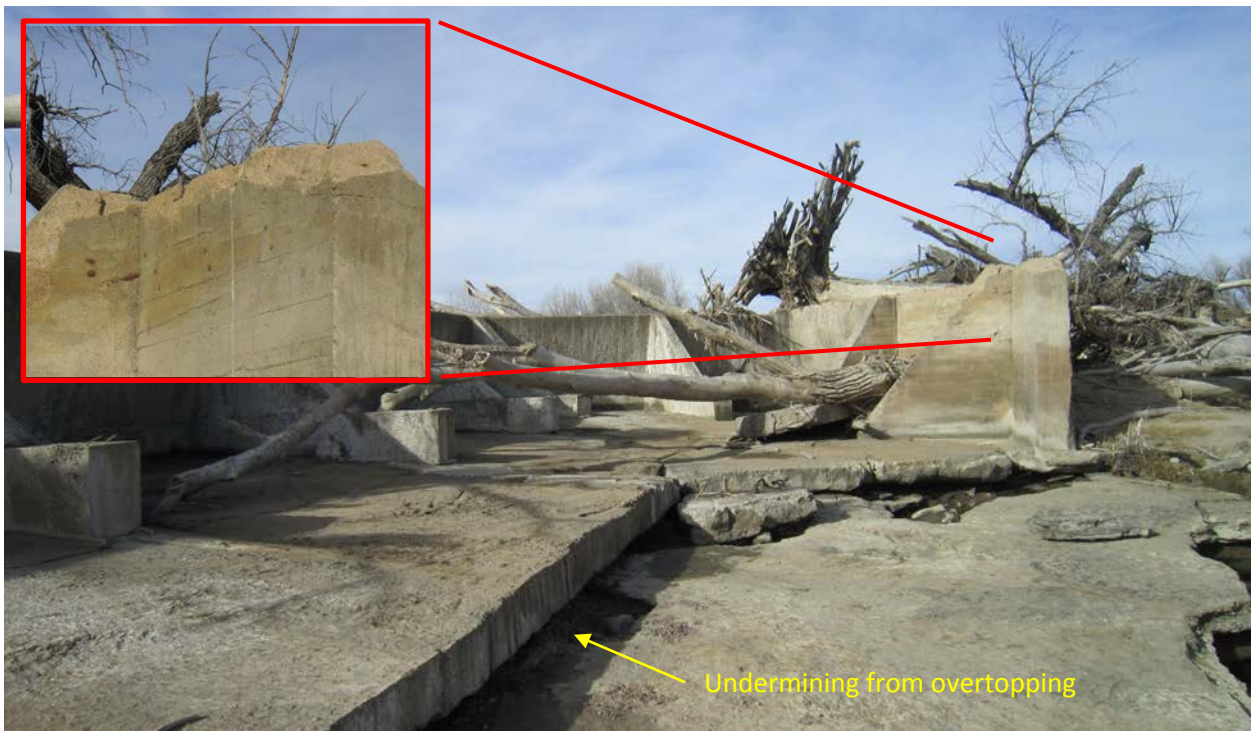
Photo No. 16 Transition Section. Deterioration and undermining on the transition section. Taken looking towards the north section. Inset shows close up view of typical deterioration along top of buttress and slab walls.

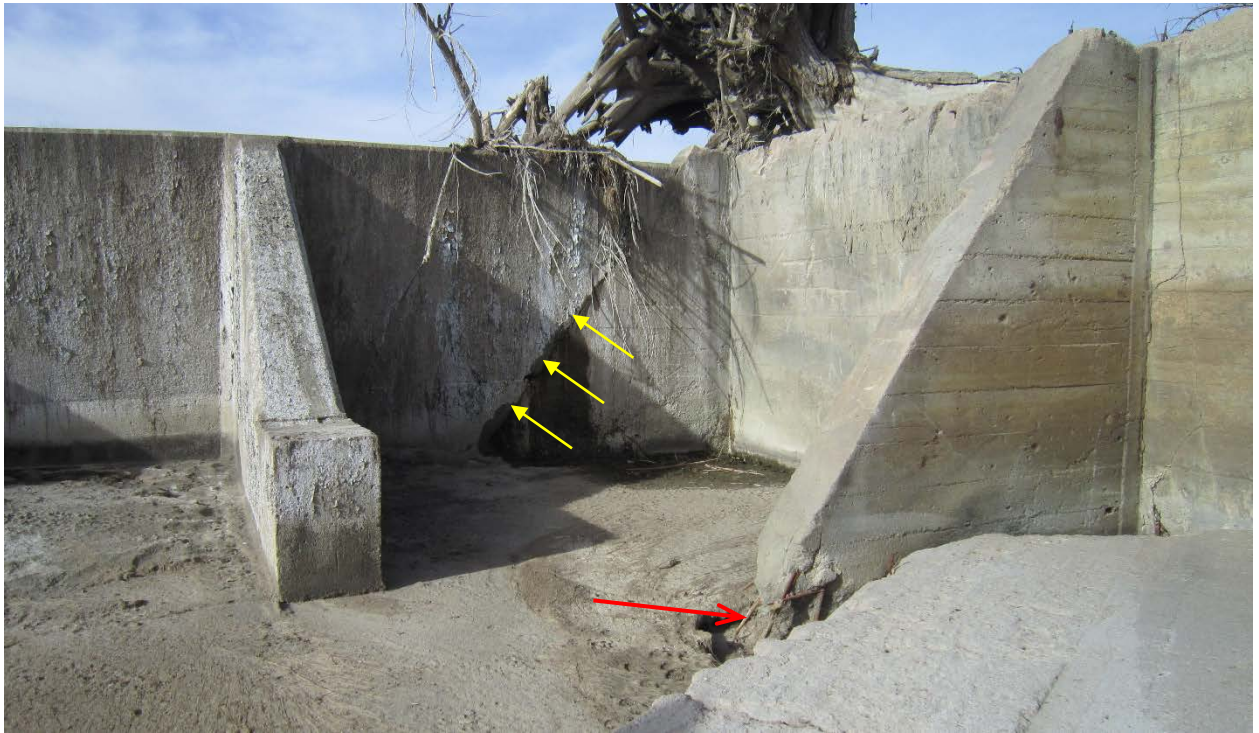
Photo No. 17 Transition Section. Seepage through construction joint in upstream slab, and deterioration at base of buttress.

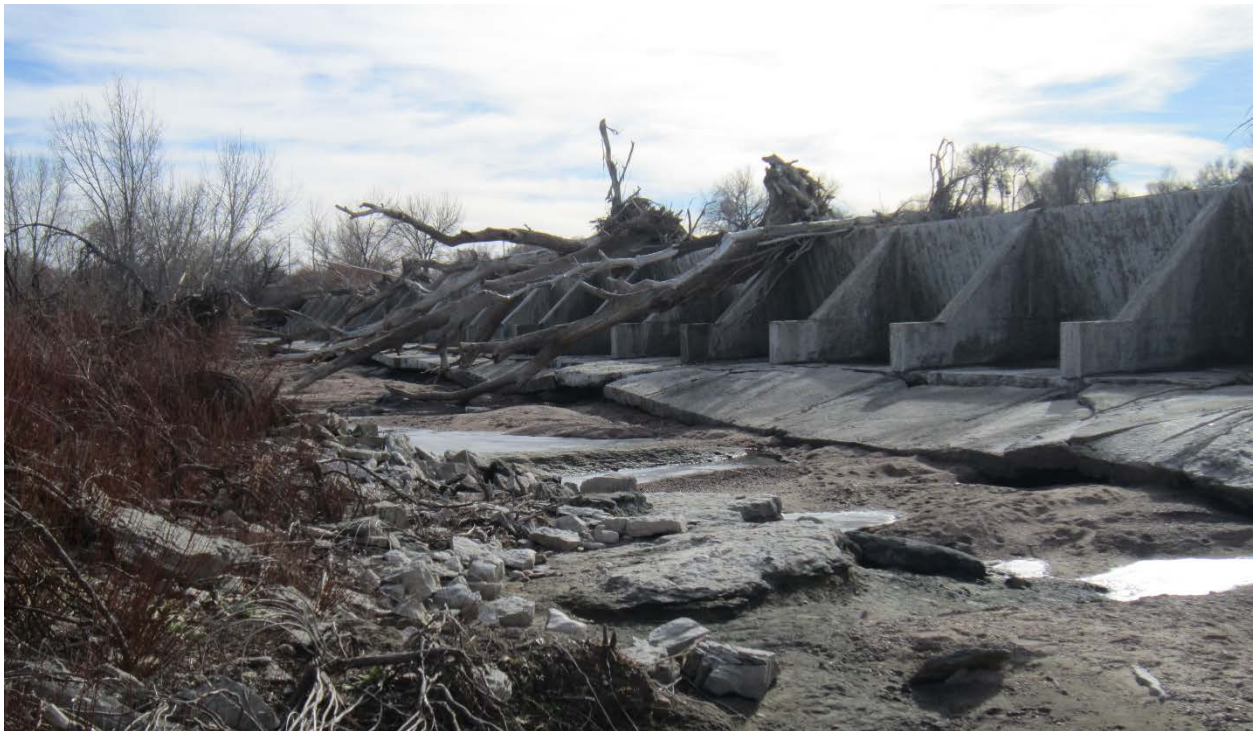
Photo No. 18 Diagonal Section. View shows typical undermining erosion that resulted in collapse of base slab.

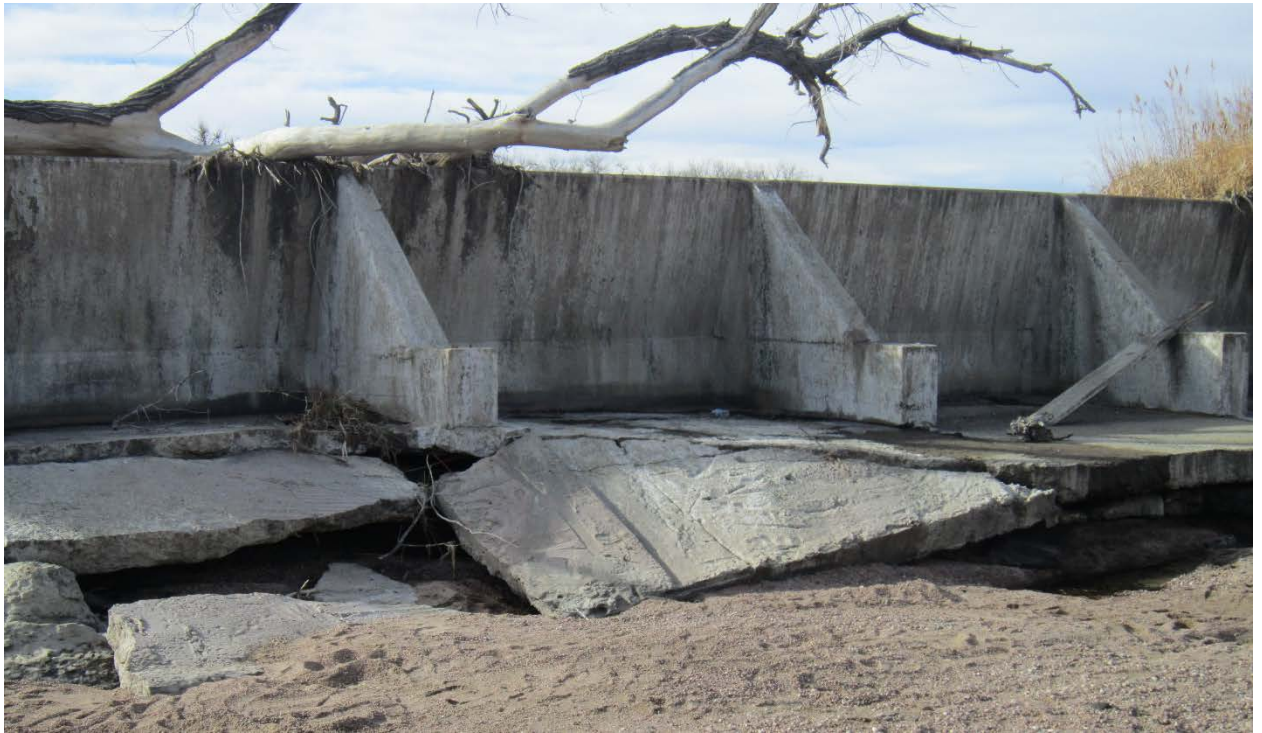
Photo No. 19 Diagonal Section. View of failed base slab, due to undermining (erosion) of foundation material from beneath the slab.

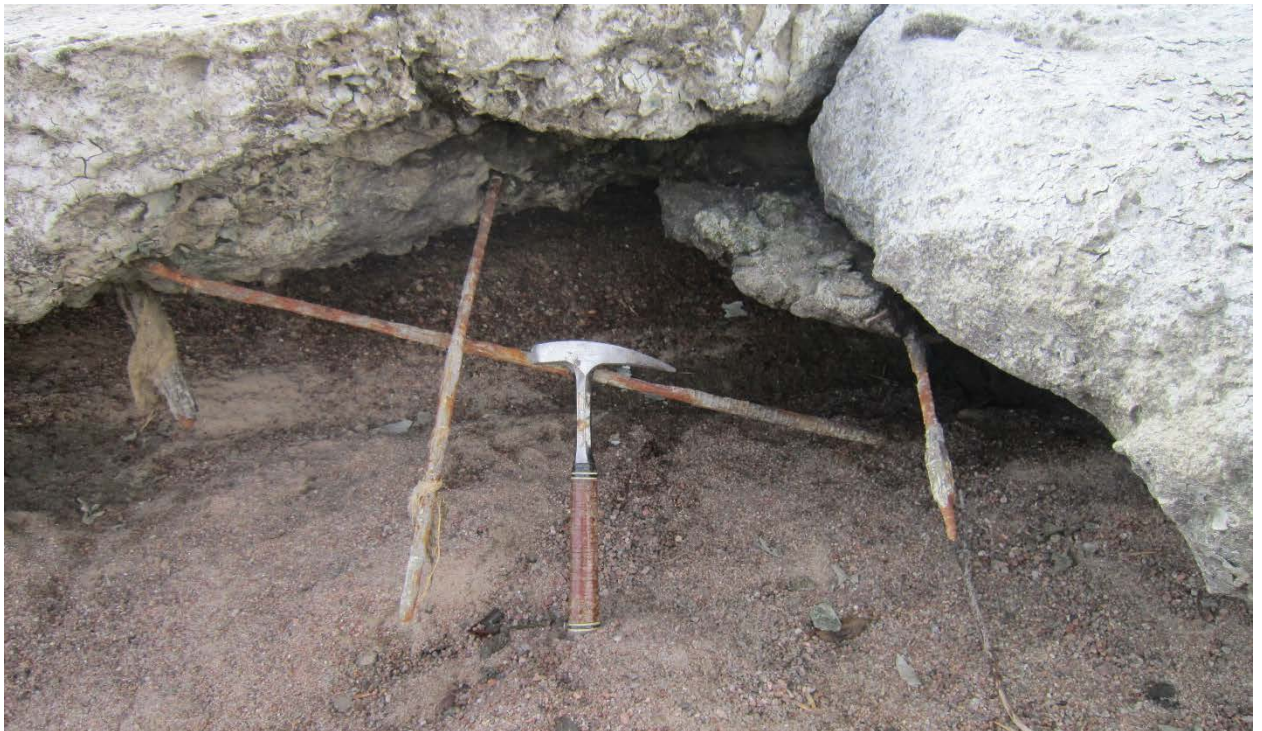
Photo No. 20 Diagonal Section. Closer view of the deterioration of base slab. Note, exposed and deteriorated reinforcement. .

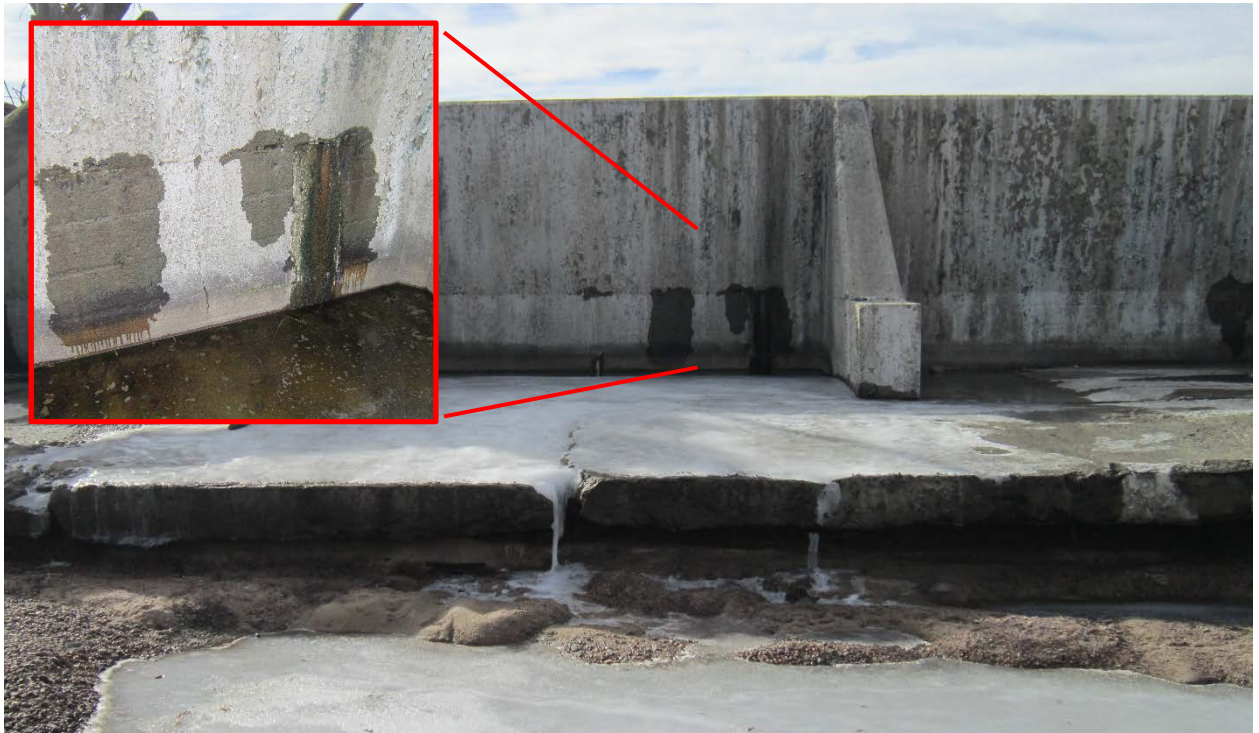
Photo No. 21 Diagonal Section. Inspection observed ice (from ponding) on the downstream slab in the central section as shown above. Inset photograph shows seepage through the upstream wall slab that caused the pool to develop.

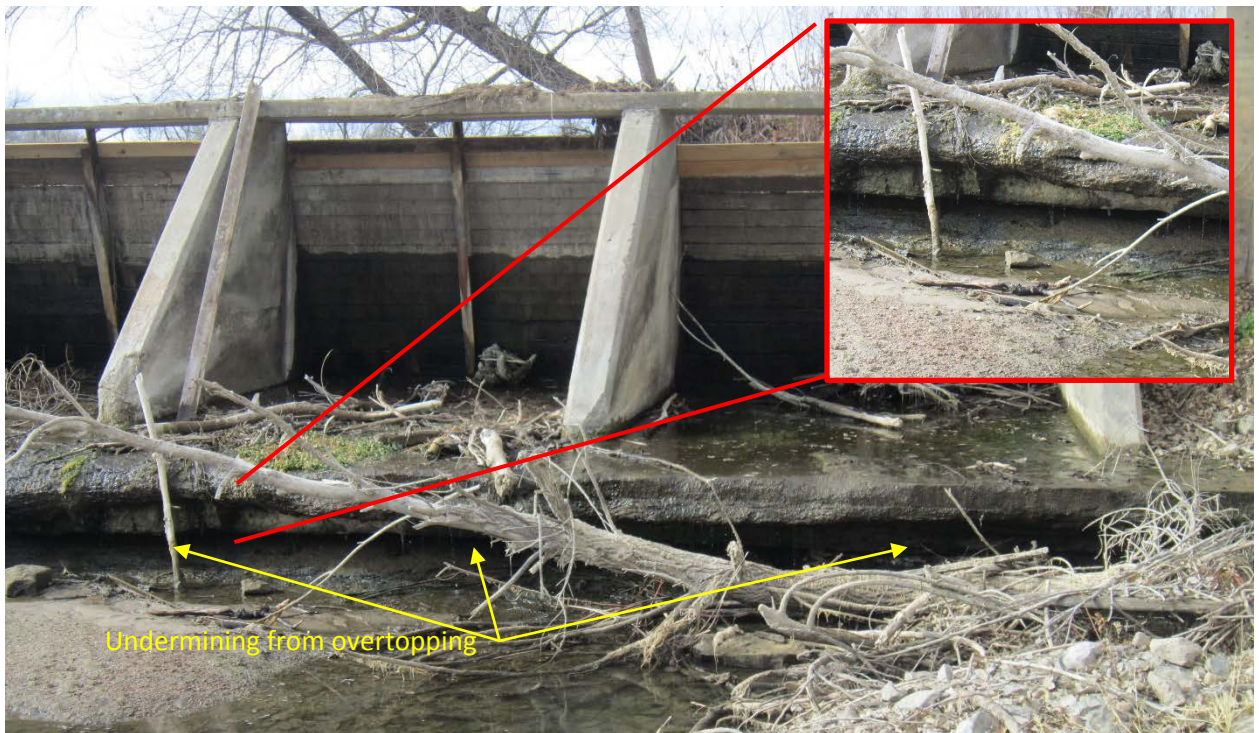
Photo No. 22 South Section. Closer view of the south buttress section, showing undermining (erosion) of foundation material beneath base slab. Note, the view shows exposed shear key (inset). .

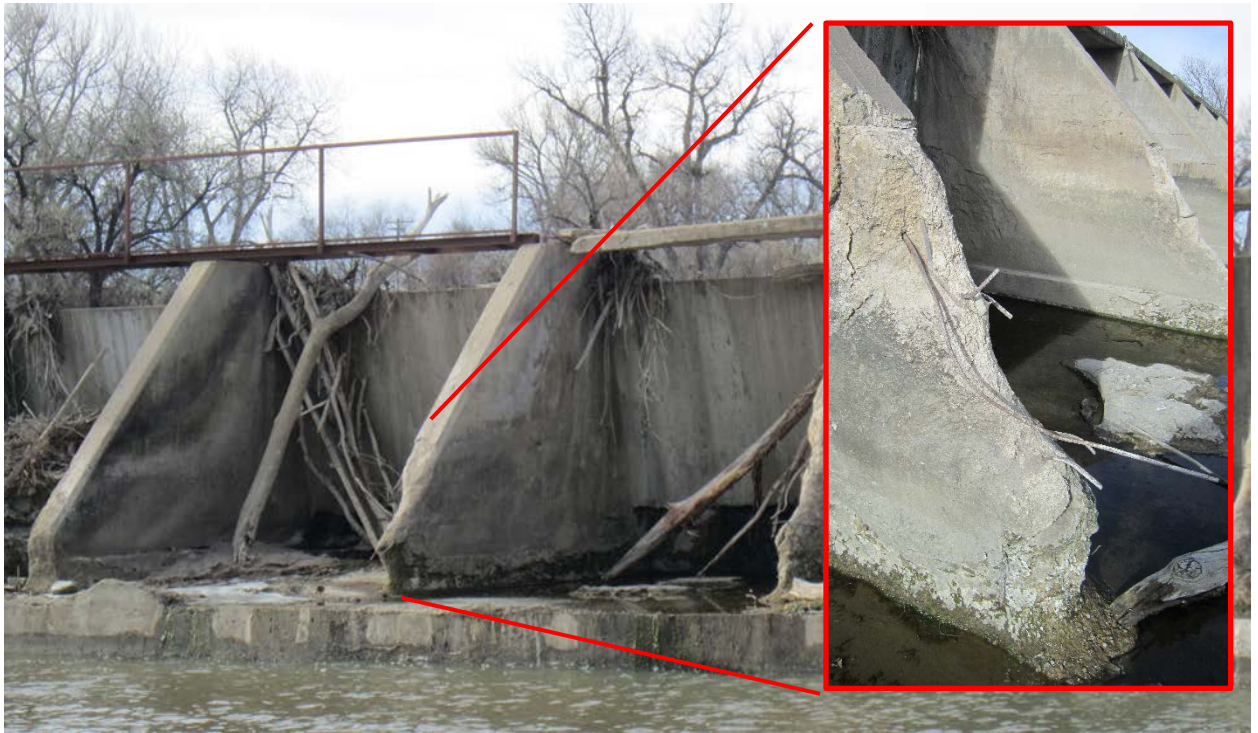
Photo No. 23 South Section. View shows concrete deterioration of buttress (inset).

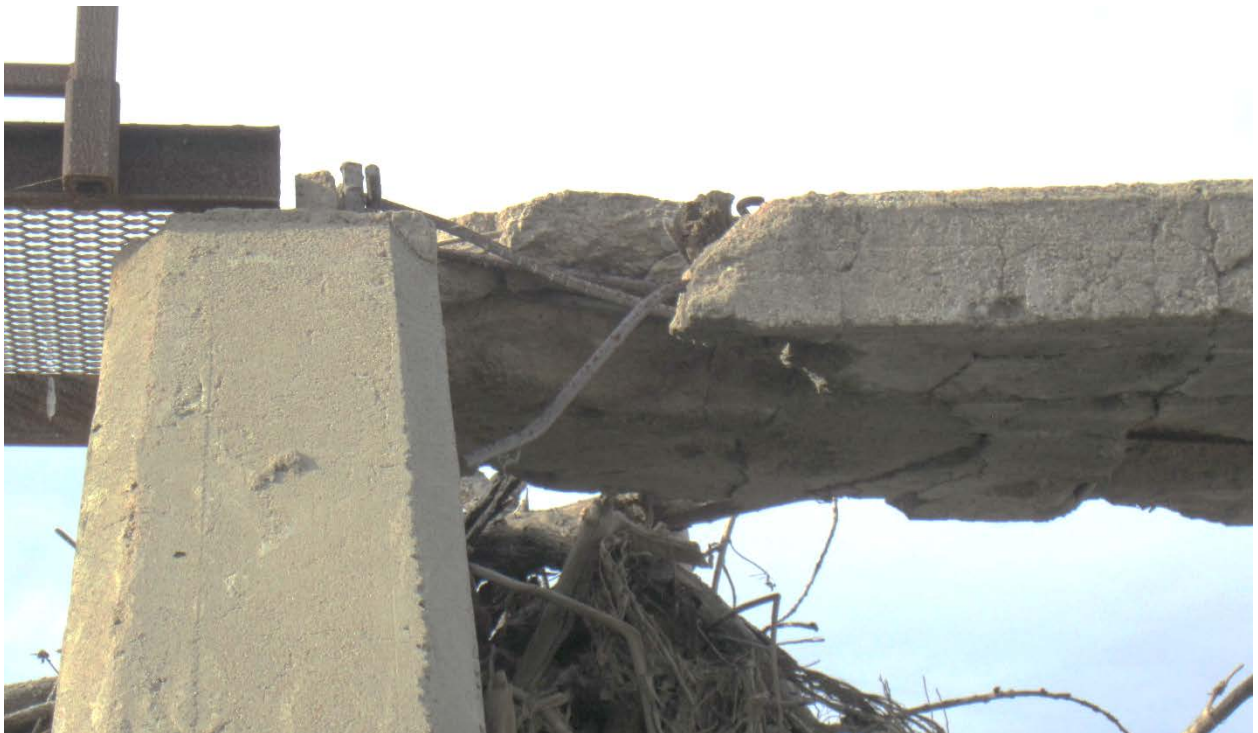
Photo No. 24 South Section. View showing deteriorated walkway that spans south buttresses and leads from the drop gate structure.
