## Hallenbeck No. 1 Reservoir Downstream Slope Repair Project

### Final Construction Report

C – 0356F

February, 2017

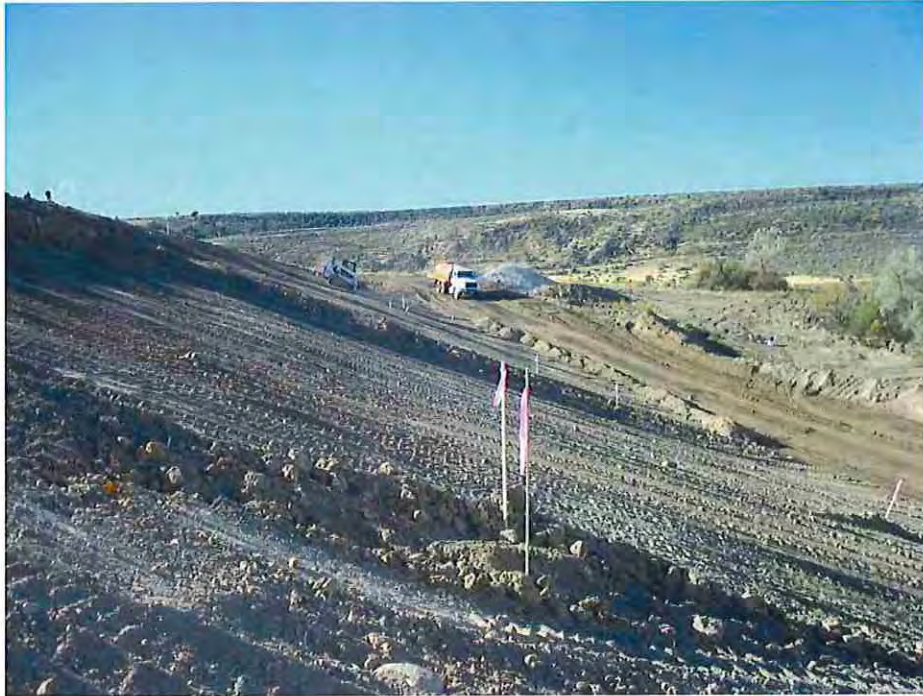
For unknown reasons, the old toe-drain system stopped collecting seepage water and essentially dried up in year 2014. In the summer of 2014, the downstream slope of the dam structure developed surface cracks towards the center of the dam, possibly due to the increase in hydrostatic pressure within the dam structure, because the old toe-drain was no longer able to collect the seepage water and convey the water out away from the structure. The reservoir pool was immediately drained upon discovering the cracks.

Photo #5: September 9, 2016 – Photo looking at the 2-ft deep over-excavation of the dam slope (Sta. 2+89 to 3+79). This area corresponds to the area of the dam that developed the downstream crack(s).

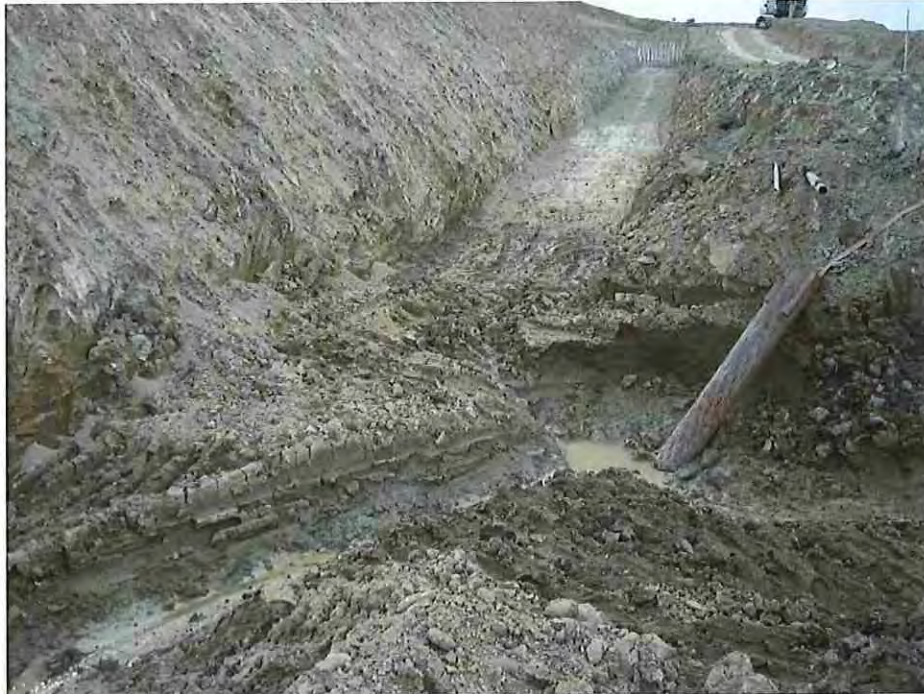
Problems encountered during construction were minimal, and the largest problem that resulted in a change to the construction plans was encountering soft and saturated subgrade soils in the toe-drain excavation between station 2+50 to 3+25 +/- and also in the location of the concrete retaining wall. The soft subgrade soils wouldn't allow the contractor to successfully install the new toe-drain system, and the soft subgrade didn't provide a firm platform to allow proper compaction of the filter sand media, and wasn't an acceptable foundation for the retaining wall to be constructed on. The soft and saturated soils

were located at the foundation of the dam elevation where the existing natural drainage channel once existed.

Photo #9: September 20, 2016 – The toe-drain excavation encountered wet and soft subgrade conditions between toe-drain stations 2+50 to 3+25 +/- . Stabilization rock and geogrid would be used to stabilize this area for placement of the filter sand, drain gravel and toe-drain pipe. Photo shows contractor pumping out the ground water/seepage water.

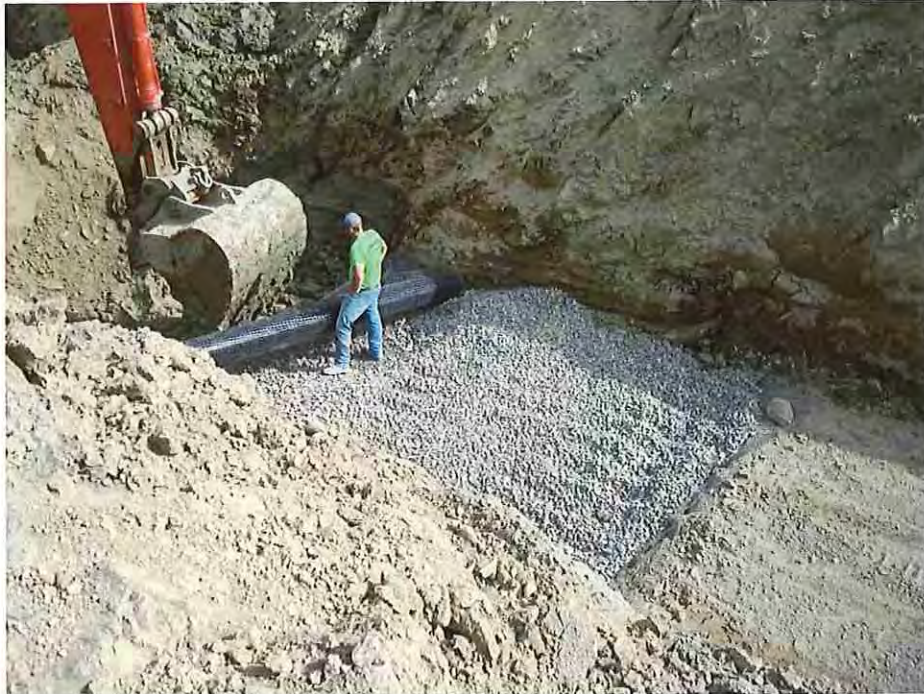
Photo #11: September 21, 2016 – Installation of the stabilization rock and geogrid in the toe-drain excavation between stations 2+50 to 3+25 +/- . Stabilization rock was a 1-1/2" crushed rock and a 2-foot thick layer of rock was placed above the soft subgrade material. Geogrid was placed in the middle of the 2-foot thick rock layer.

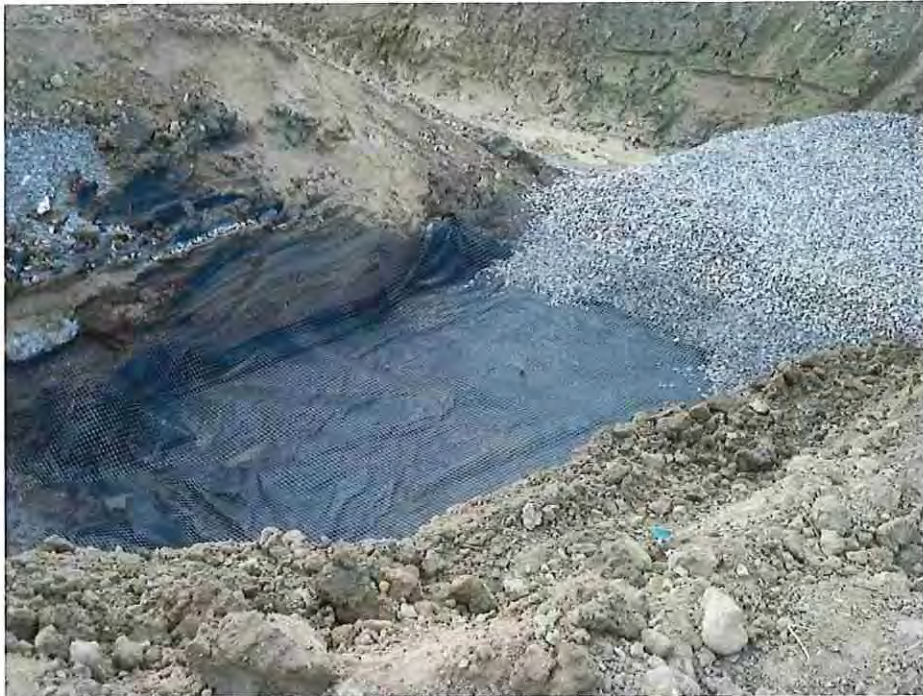
Photo #13: September 22, 2016 – Concrete retaining wall excavation. Soft subgrade conditions existed here as well. Photo shows a separation fabric placed directly on the soft subgrade with geogrid and stabilization rock placed on top. As-built detail of retaining wall subgrade shown within the As-Built set of construction plans.

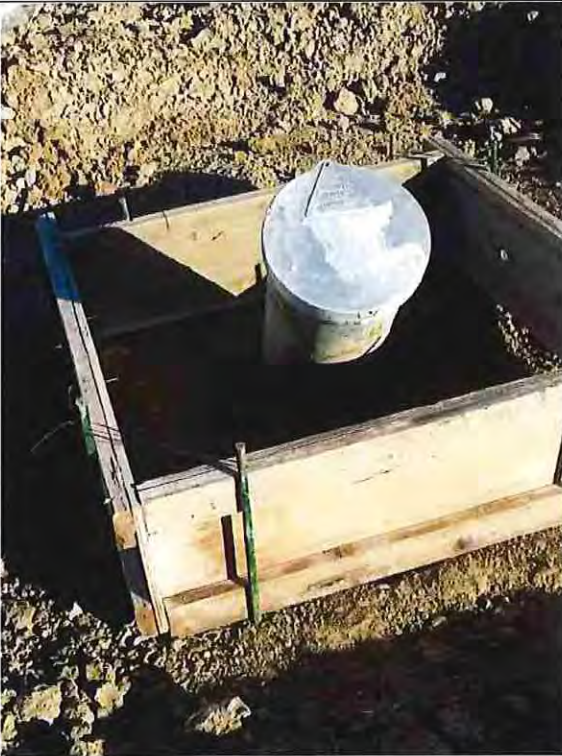
Toe drain riser with cap.  
Concrete surface protection has not been placed in forms yet.

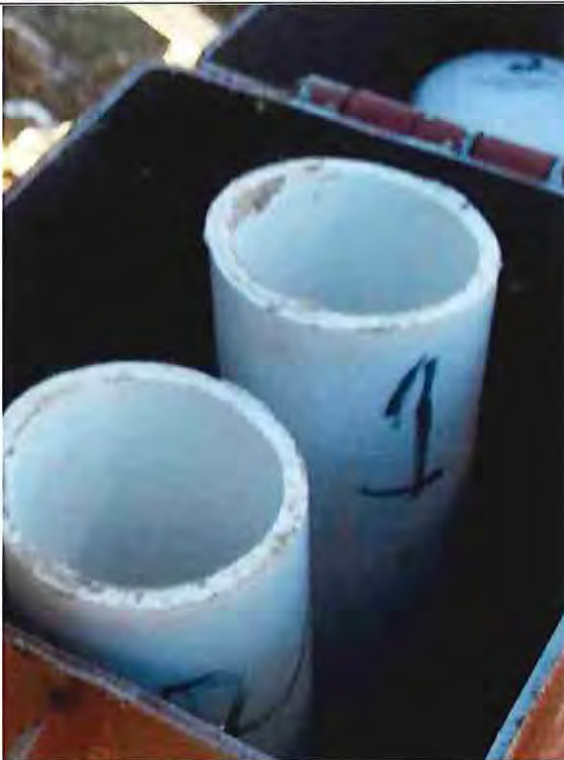
Piezometers 1 and 2 near the maximum section. Casings will be marked for consistent monitoring.

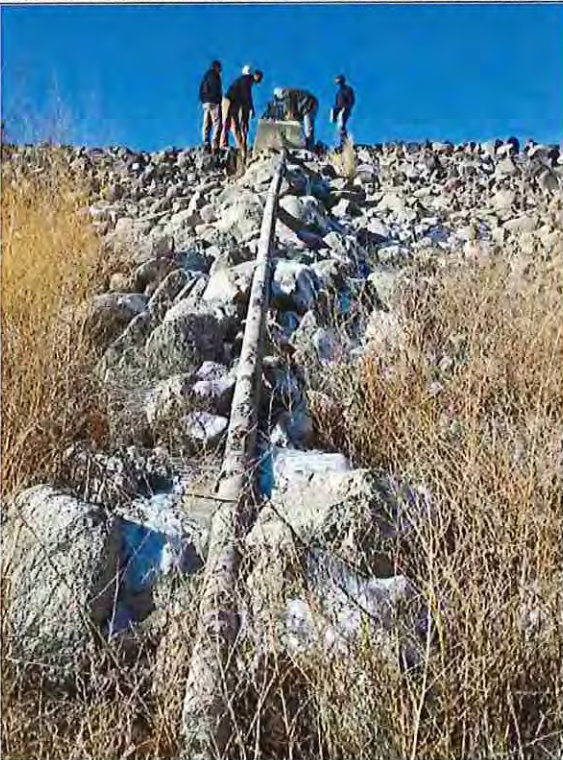
Gate stem guide has been badly bent by ice, gate will not close.
