RE: Final Deliverable Report: POGG1 2017-491 – 48 Inch Culvert Replacement Project

The Animas Consolidated Ditch Company has completed the replacement of an 84 foot long 4 foot diameter culvert referenced in WSRF Grant POGG1 2017-491.

# ANIMAS CONSOLIDATED DITCH COMPANY CULVERT REPLACEMENT PROJECT (CONCEPTUAL LAYOUT)

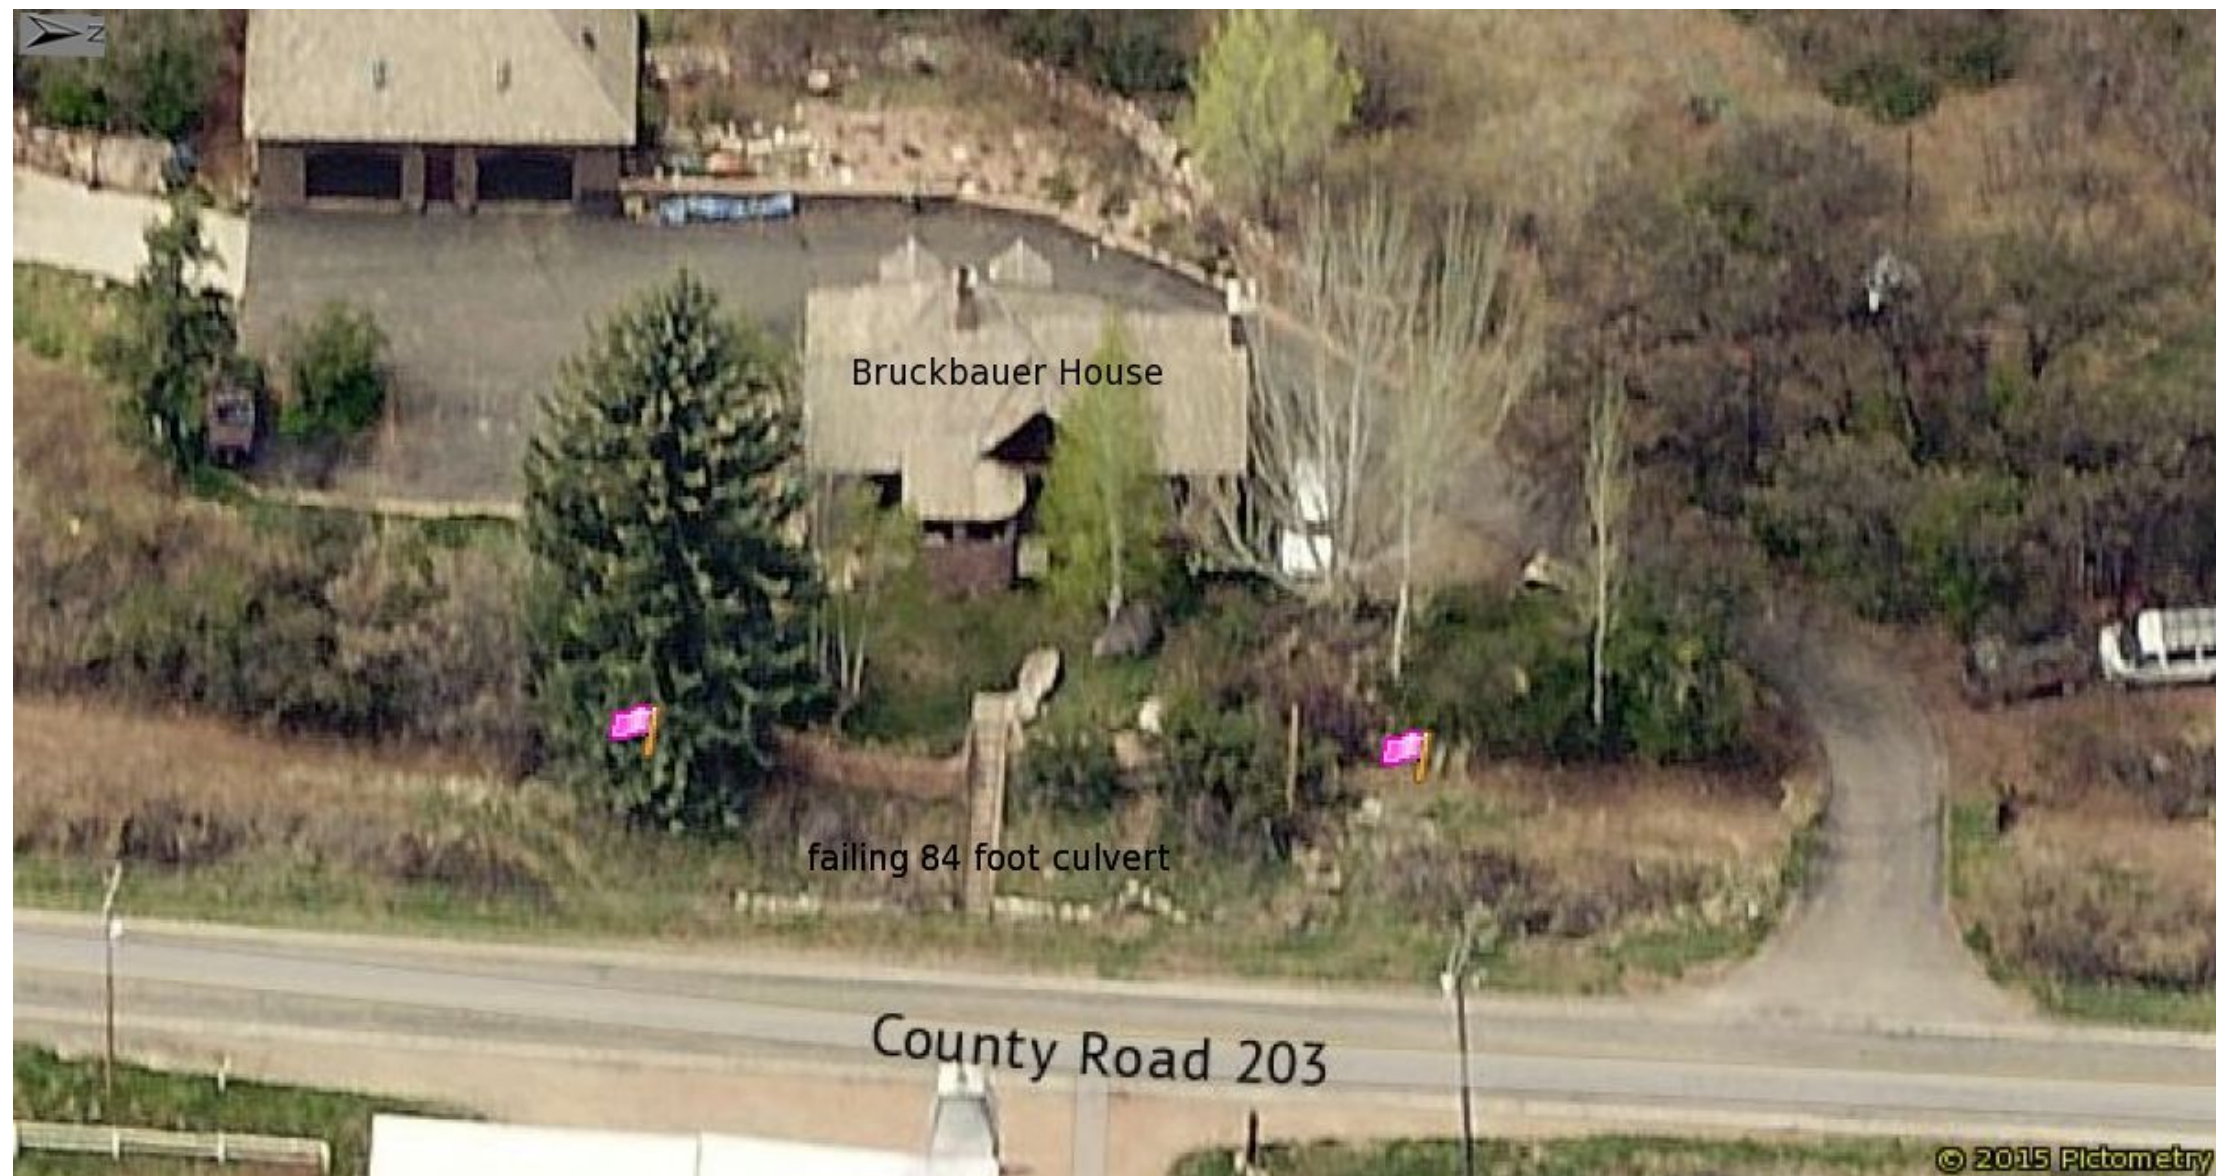
# Bruckbauer - 2015

Distance from up-stream end in feet	height in inches	width in inches	observations about condition of pipe in December of 2015 after water was turned off for the winter, Ed and Jud
0	37	57	Near normal profile for a "squash" pipe, overburden comes right to end of pipe, no wing walls
5	23	60	pipe top being pushed down by 8 or 10 feet of overburden, center of bottom heaving upward, bottom rusted through
10	22	60	same
15	22	62	same
20	18	62	same
23			a failing joint where two sections of pipe meet, space between joints 3 to 6 inches and somewhat out of alignment
25	22	62	pipe top being pushed down by 8 or 10 feet of overburden, center of bottom heaving upward, bottom rusted through
30	23	62	same
35	25	62	same
40	27	64	same
45			a failing joint where two sections of pipe meet
45	28	62	pipe top being pushed down by 8 or 10 feet of overburden, center of bottom heaving upward, bottom rusted through
50	28	62	same

55	28	62	same
60	31	60	same
64			a failing joint where two sections of pipe meet, changes direction toward the west, about 8 or 10 degrees
65	33	60	not much overburden and pipe near normal profile, still rusted out on the bottom
70	34	58	not much overburden, but a large spruce tree is on top of the pipe, pipe near normal profile, rusted out on the bottom
75	36	58	not much overburden and pipe near normal profile, still rusted out on the bottom
80	37	57	same
84	39	57	no overburden, pipe near normal profile for a squash pipe, no wing walls
			Notes: the pipe is essentially level from one end to the other, except for the rising of the bottom via heaving
			The pipe is quite rusted, and in most of the length the bottom of the pipe is cracking and breaking as it heaves upward. In some places there is no longer any metal along the bottom
			The rough and jagged bottom easily catches trash, so in some places the clearance between the trash and the top of pipe was as little as 12 or 15 inches

I have no knowledge of when the pipe was installed, but in checking around the community the old timers agree that it was already in place in the 1950's when Kenneth Logan was living there
