Design Report Swede Lake Dam Rehabilitation Boulder County, Colorado

Water Division 1, Water District 5, C-2064
DAMID:050304

Project No. 110480

April 24, 2018

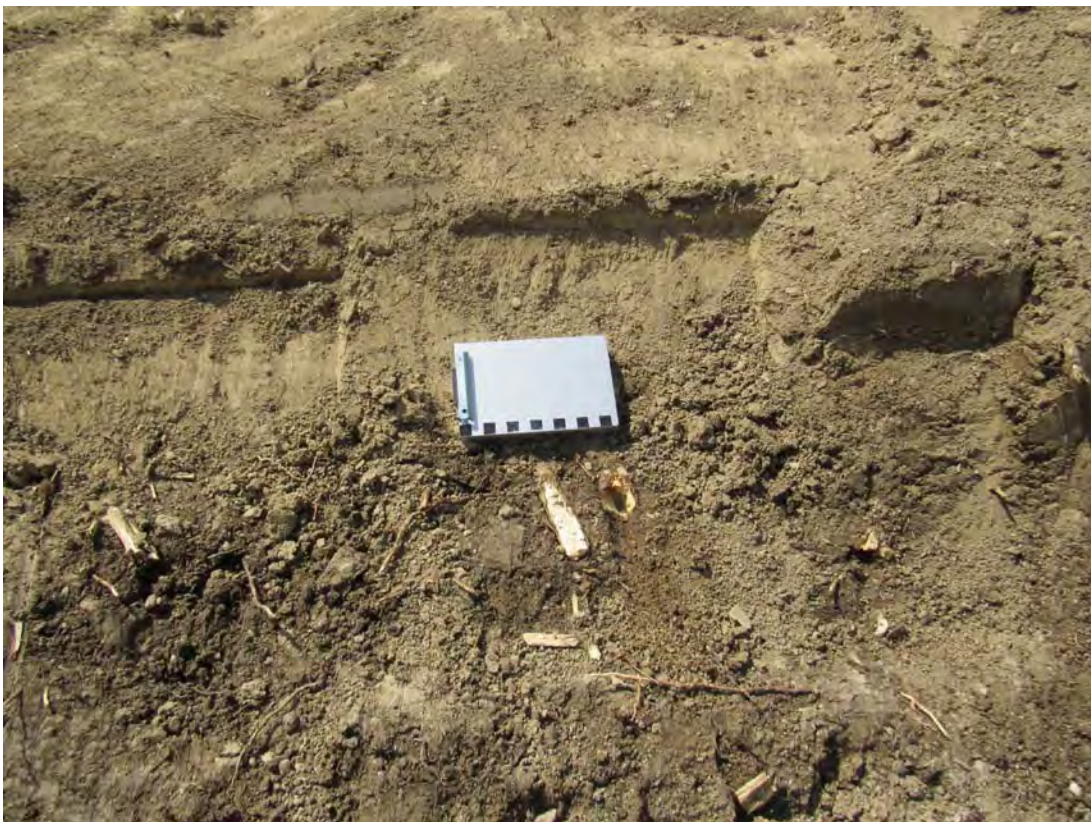
Photo 02 (08-22-2017) Roots in embankment by primary spillway (1)

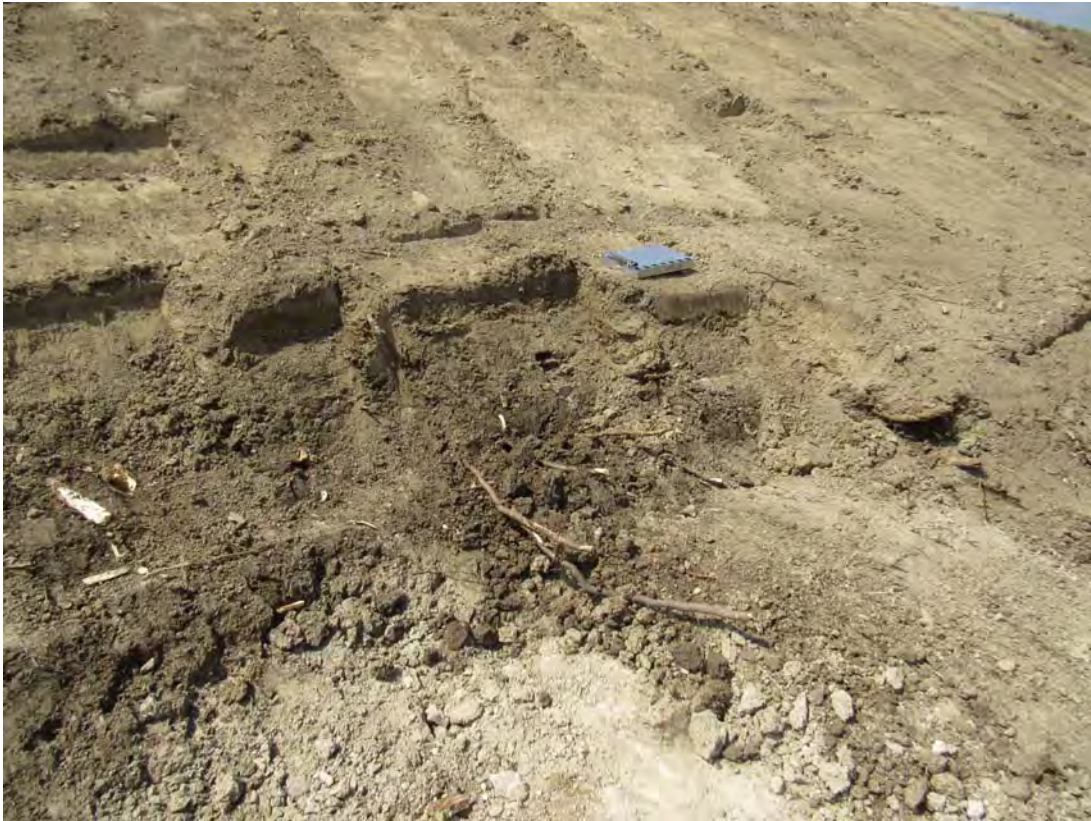
Photo 03 (08-22-2017) Roots in embankment by primary spillway (2)

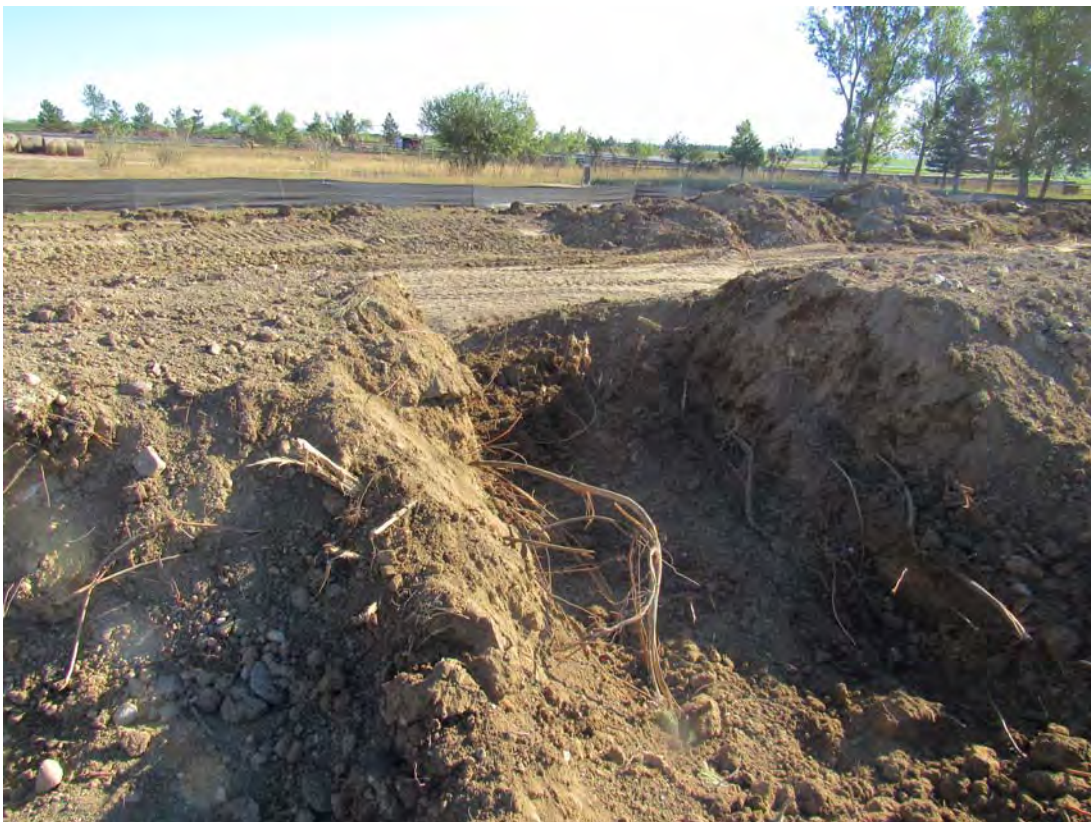
One change order was submitted to the SEO requesting the complete replacement of the dam embankment. It was determined that the existing embankment was inadequate due to the extent of roots through the embankment and the damage caused by the roots. Also, the sand blanket was removed from the design. The only reason the blanket was included in the original design was due to the uncertainty of potential roots in the embankment, which is now removed. The Change Order Requested dated October 4, 2017 outlines the changes to the original Construction Drawings. No changes to the Construction Specifications were required.

Photo 04 (08-25-2017) Roots in north dam embankment

The embankment required complete removal and replacement. The Contractor excavated the existing embankment and segregated out material with large quantities of roots for disposal in the reservoir bottom. Approved material was moisture conditioned and placed in the new embankment.

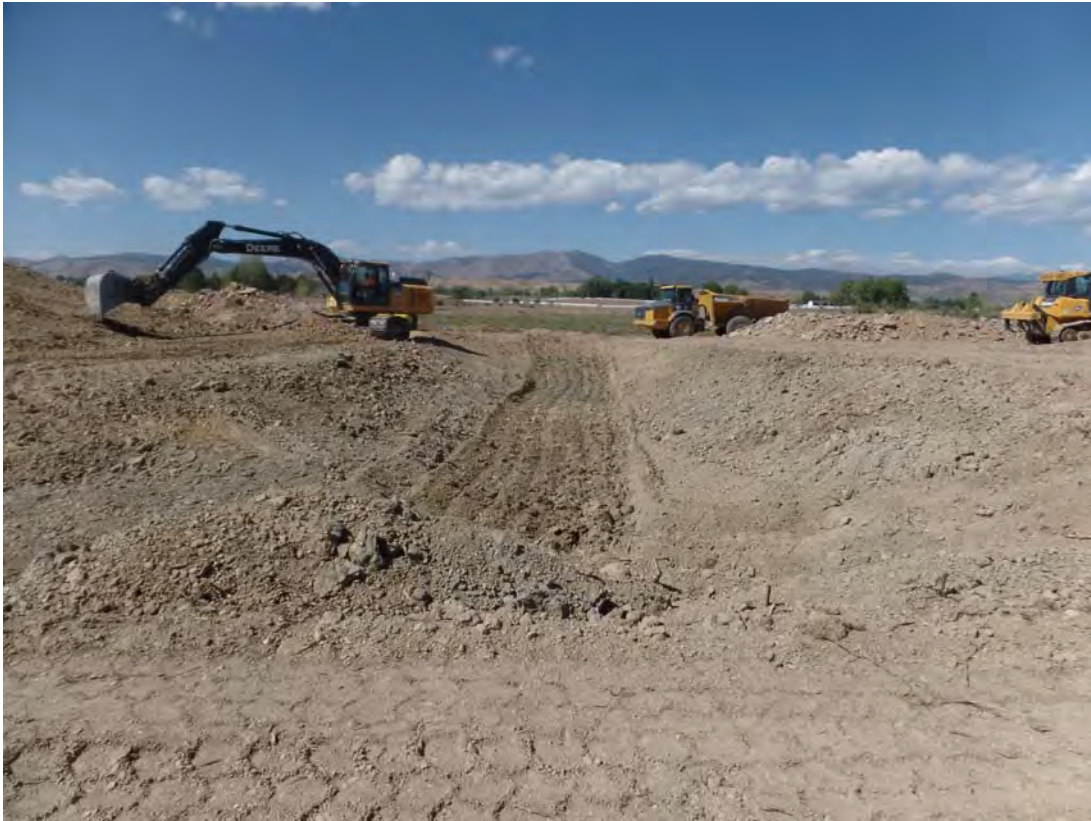
The two outlet locations were excavated according to the excavation detail on the drawings. The foundation of the outlet was excavated until good material was found, and then was filled with clay and compacted to meet grade, in accordance to the specifications. Photo 5 shows the excavation for the primary outlet pipe.

Photo 05 (09-20-2017) Outlet excavation
