Water Supply Reserve Fund – Grant and Loan Program
Water Activity Summary Sheet
September 18-20, 2018
Agenda Item 12(a)

Applicant & Grantee: Surface Creek Ditch & Reservoir Company

Water Activity Name: Deep Ward Dam Repair Project

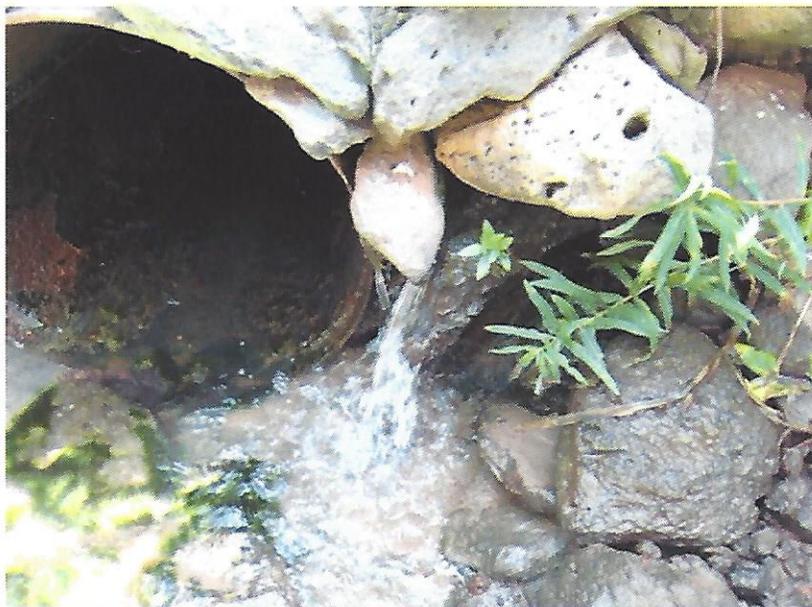
Following is a collection of recent and historic file photos of seepage occurring along the left side (as looking in the downstream direction) of the outlet pipe.

August 21, 2015
Reservoir gage height (GH) = 15.5 ft

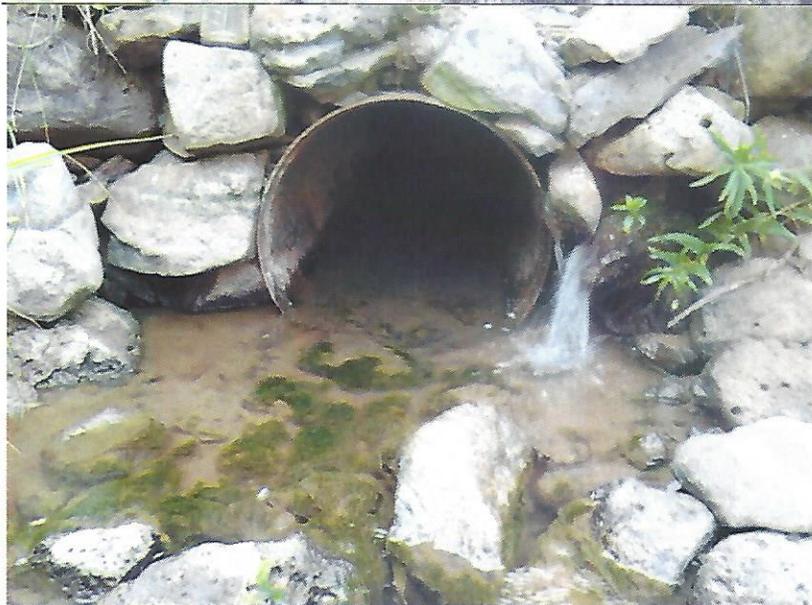
August 24, 2015 (three days after current inspection)
Reservoir GH = 15.5 ft

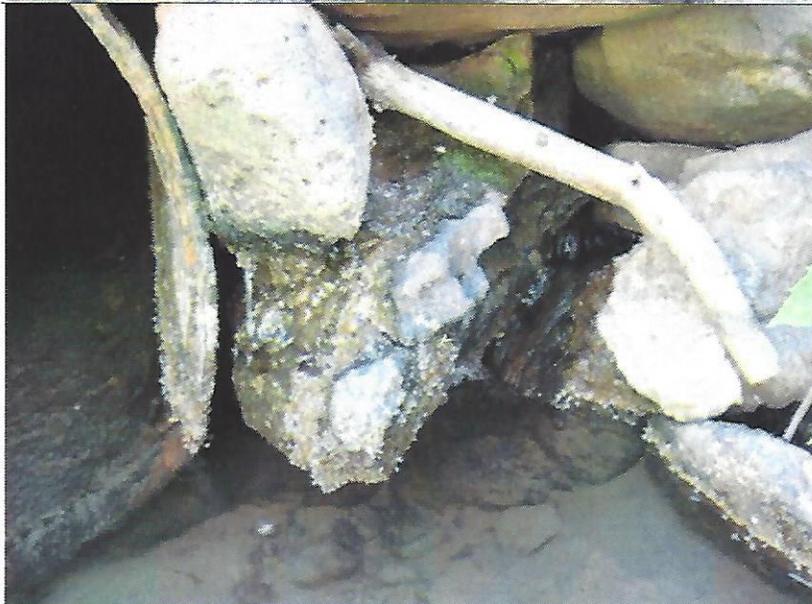
September 20, 2011
Reservoir GH = 18.5 ft

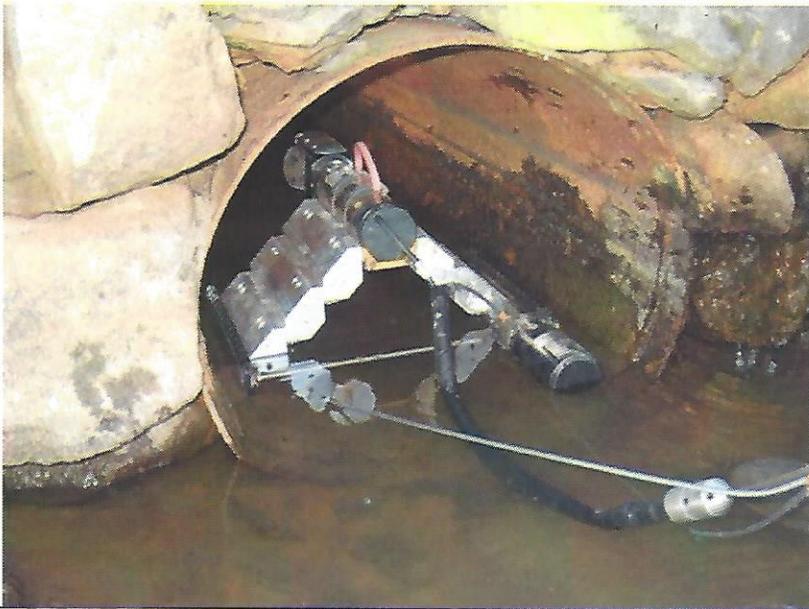
August 12, 2009 (Outlet Inspection)
Reservoir GH = less than 8.0 ft

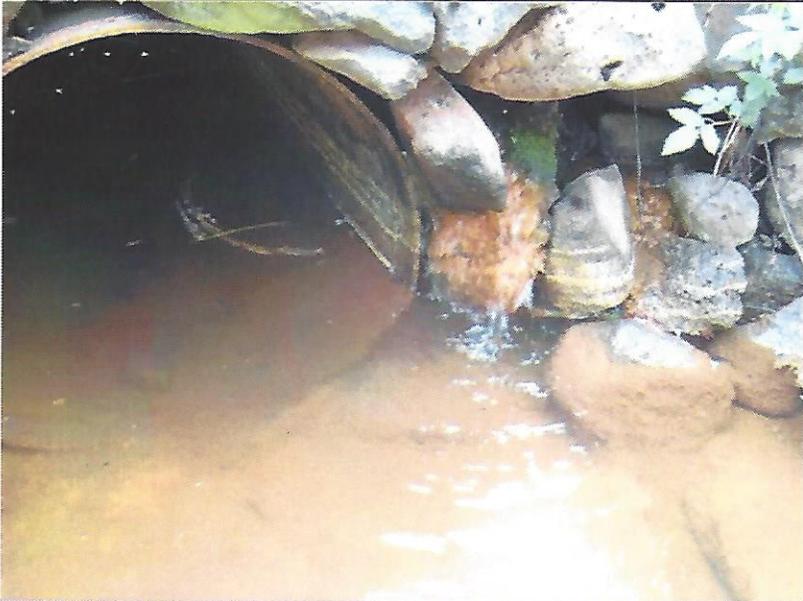
July 14, 2008
Reservoir GH = 21.50 ft

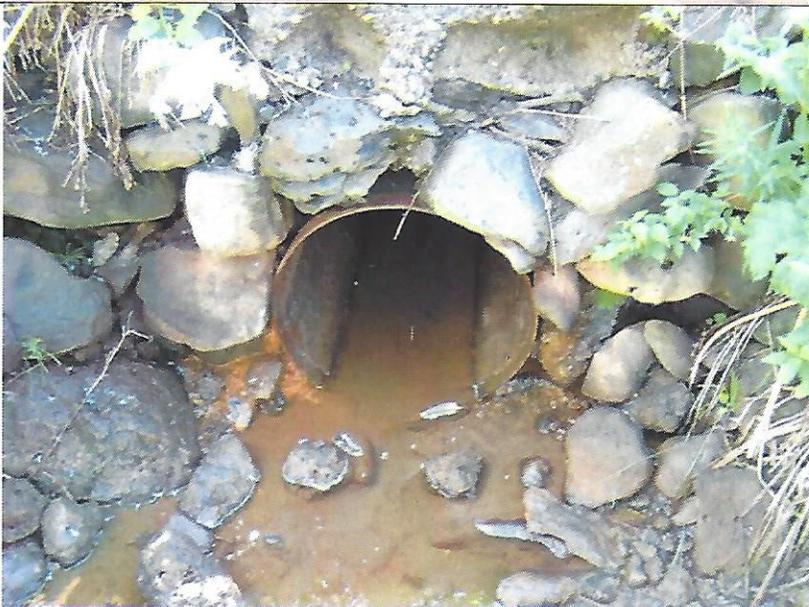
July 12, 2006
Reservoir GH = 21.35 ft

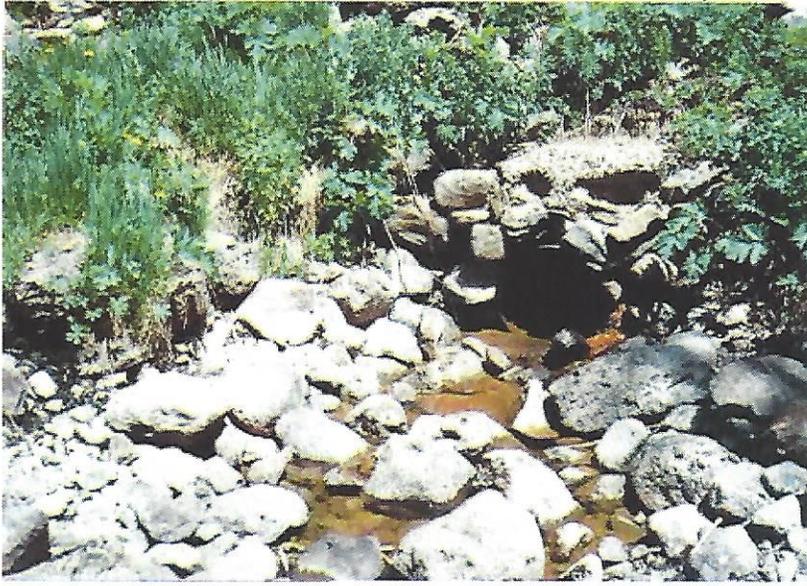
July 25, 1995
Reservoir GH = 21.0 ft

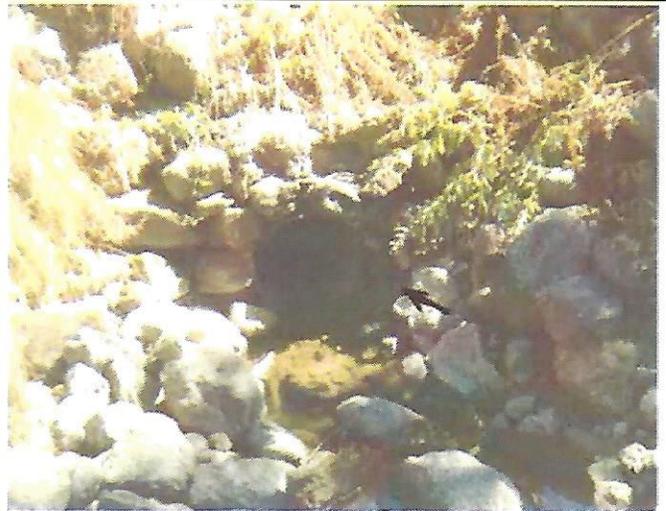
September 20, 1998
Reservoir GH = 7.5 ft

Outlet discharge - seep enters channel adjacent to outlet pipe at arrow

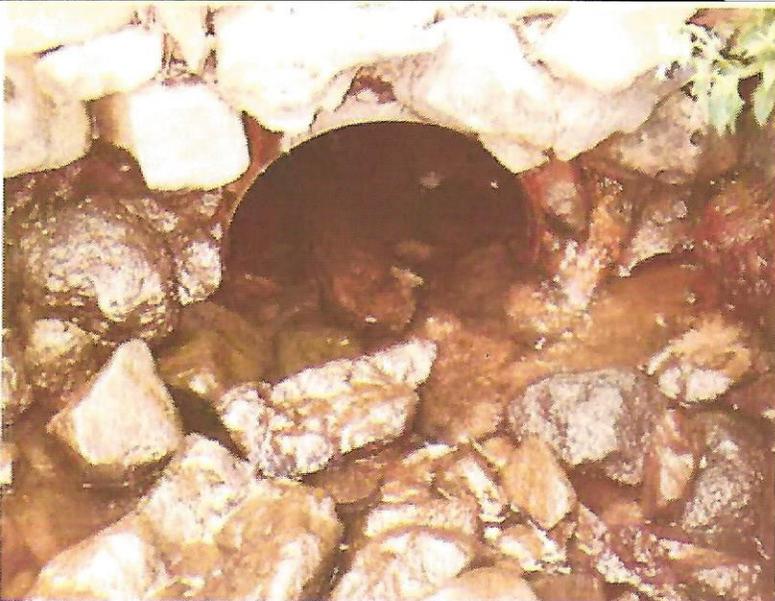
August 11, 1983
Reservoir GH = 18 ft (estimated)

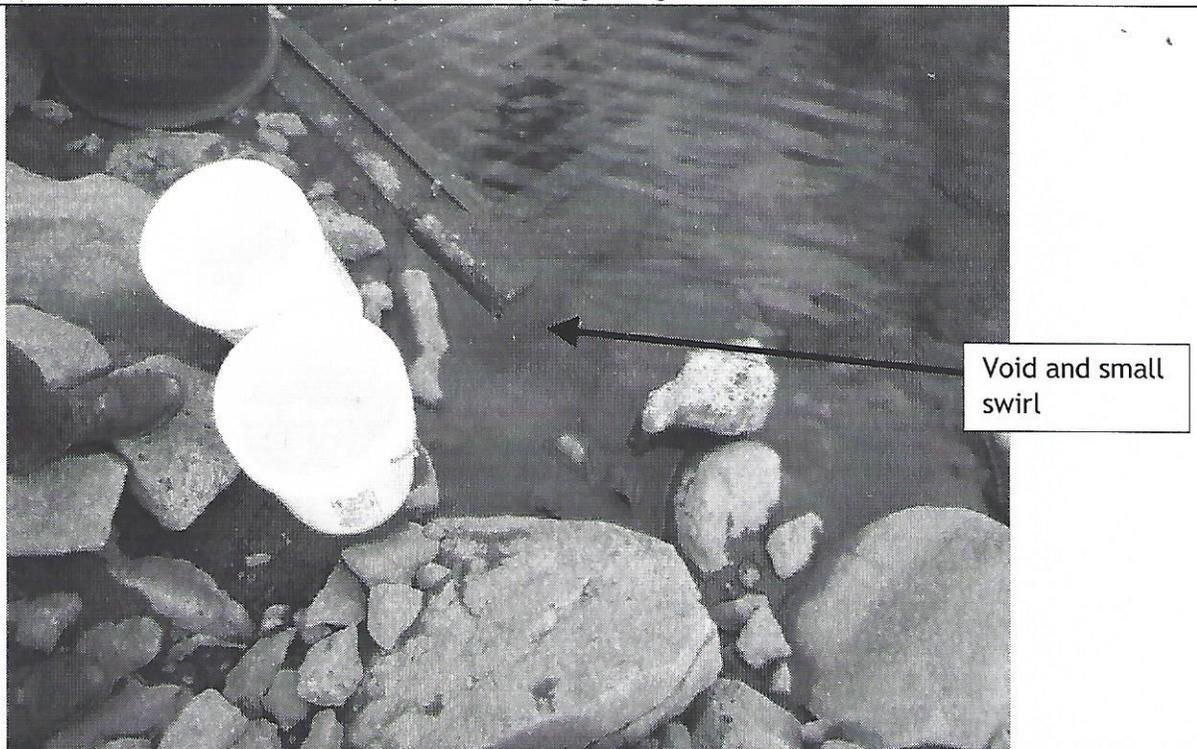
- The reservoir level was estimated at approximately 2.4 feet above the invert of the outlet valve.
- The outlet valve was discharging prior to arrival, but closed for the inspection and dye test.
 - A small amount of nuisance flow (30 gpm?) continued due to inability to fully close the valve.
- A small swirl of debris was observed just outside the upper left edge of the outlet intake structure (Photo 3).
- Seepage flow from the collection pipe was estimated at 8 gpm.

Photo 3: Left upper edge of upstream intake structure and preparation for dye test, September 18, 2017. Reservoir at gage height approximately 2.4 feet.

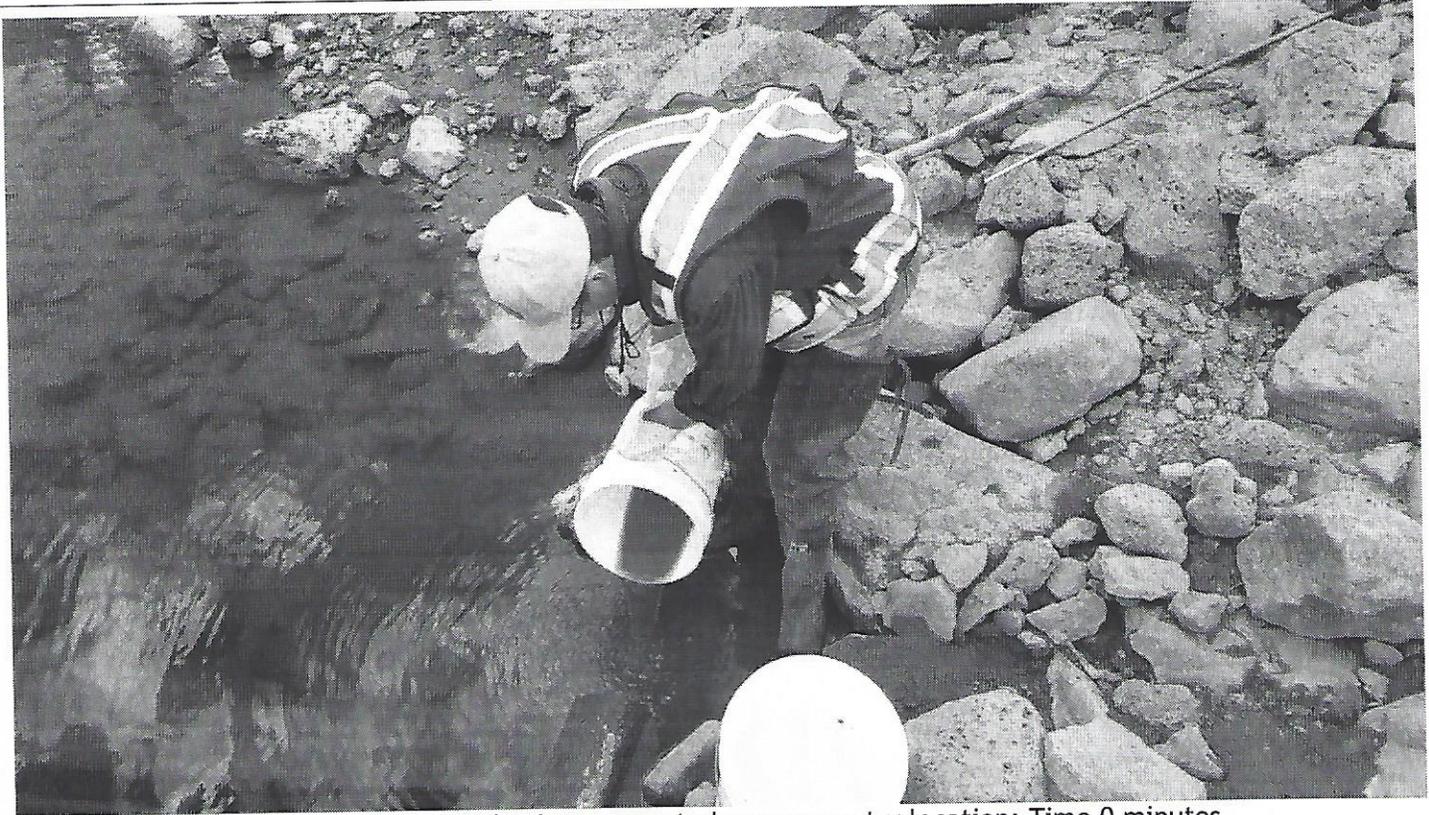
Photo 4: Introducing dye into suspected seepage entry location; Time 0 minutes.

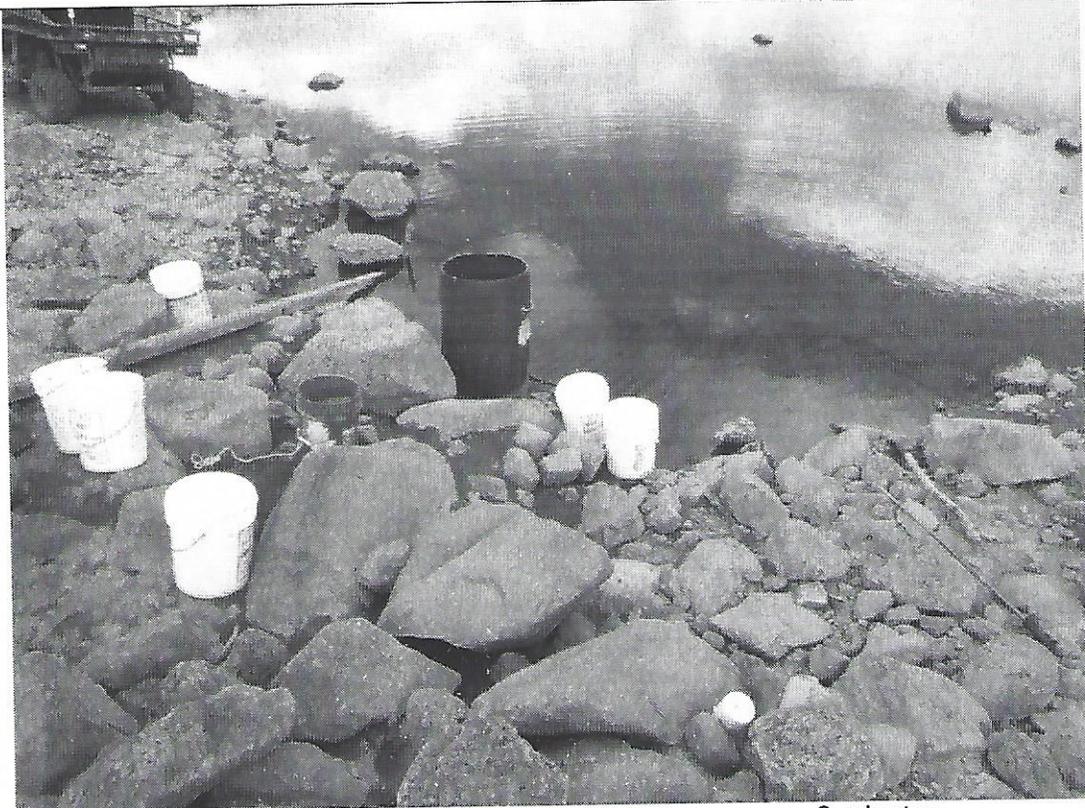
Photo 5: Overall view of dye test site; Time approx. 2 minutes.

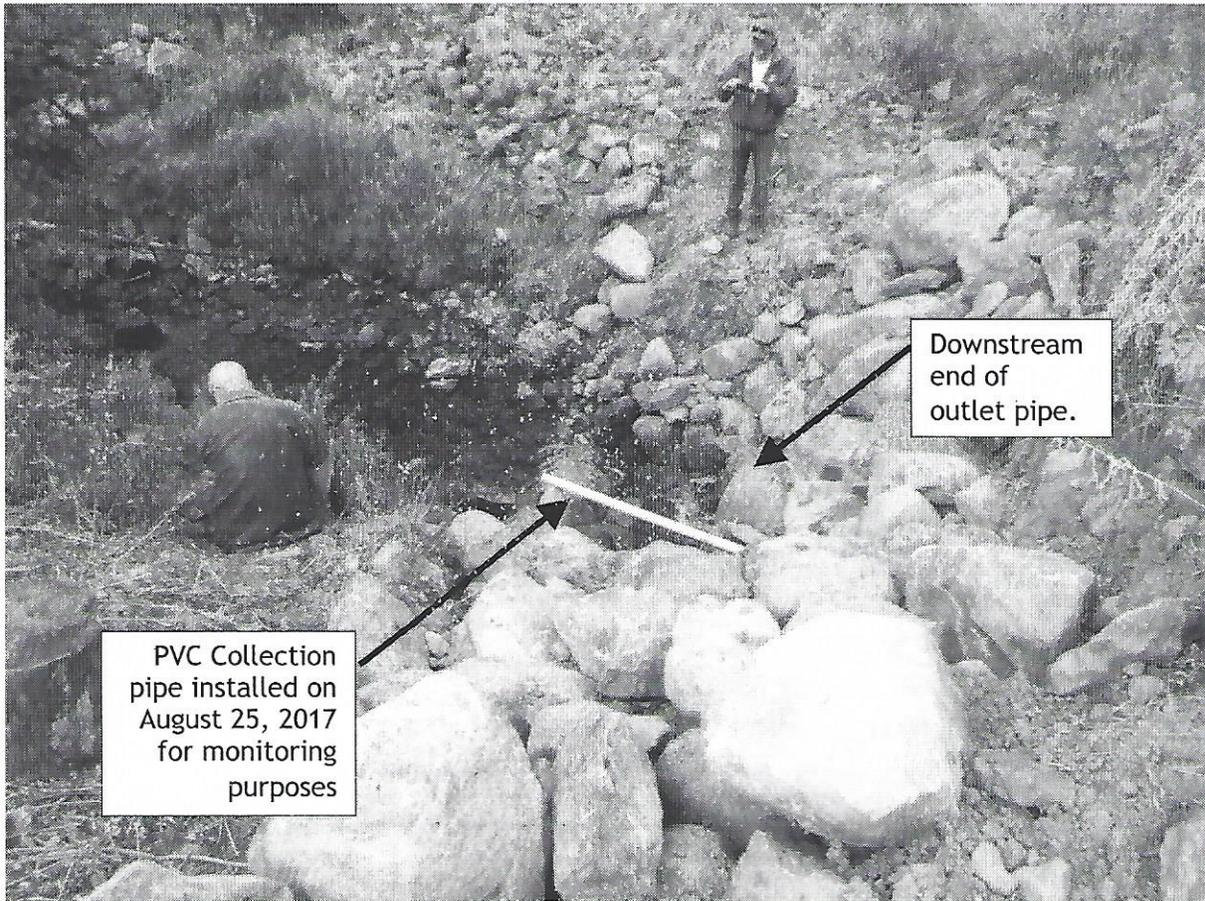
PVC Collection pipe installed on August 25, 2017 for monitoring purposes

Downstream end of outlet pipe.

Photo 6: Monitoring of seepage flow for dye at downstream toe of dam.

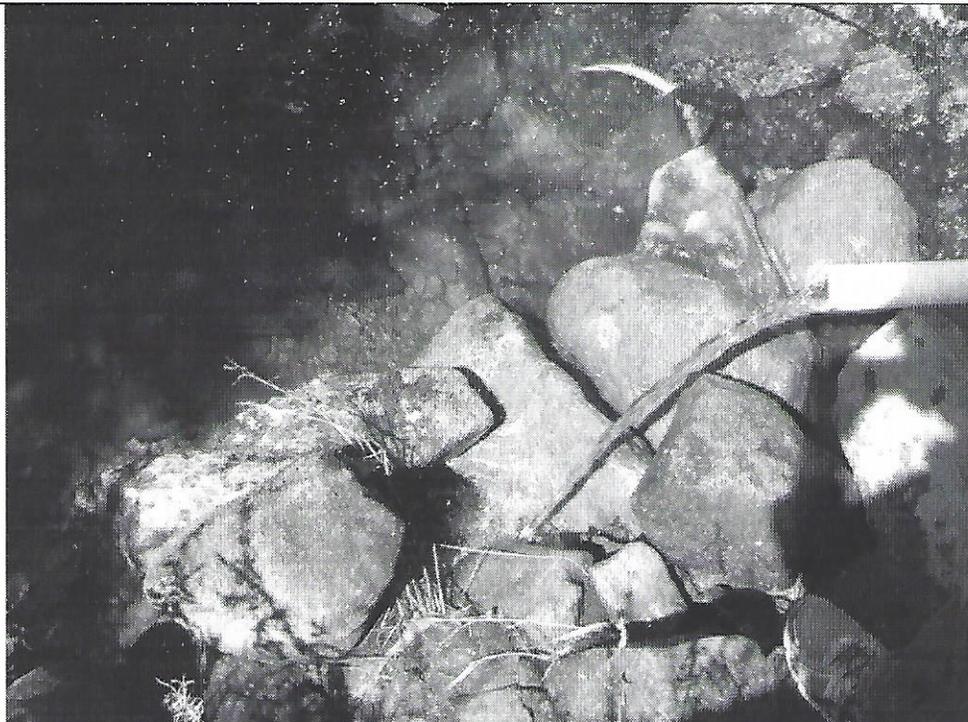
Photo 7: First visual detection of dye from monitoring pipe; Time approx. 18 minutes

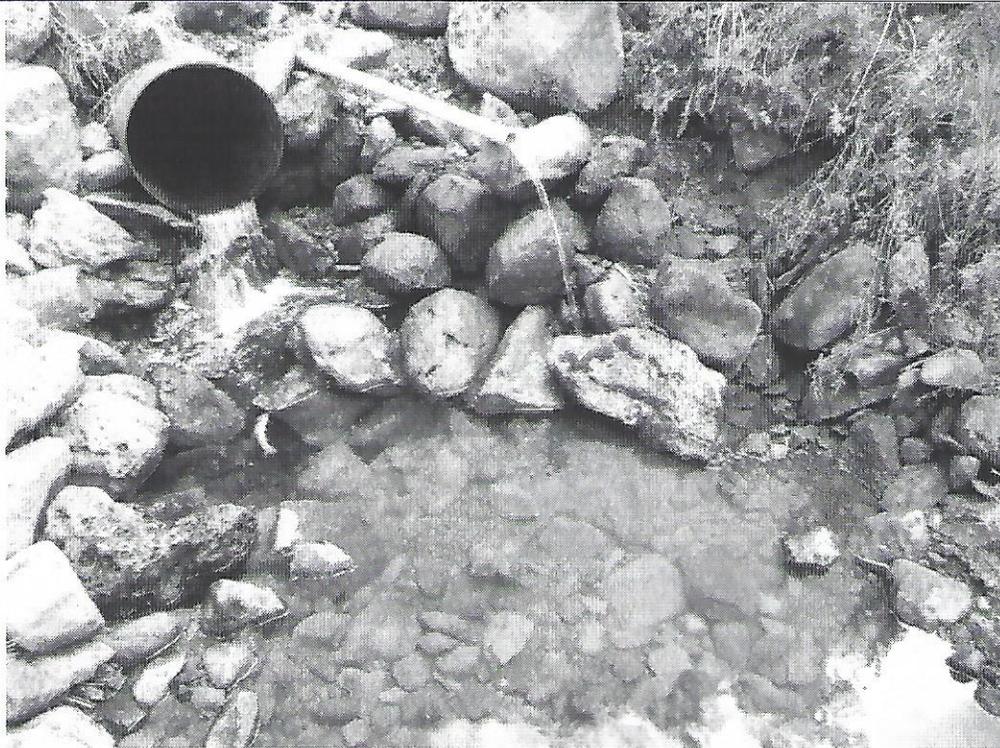
The overall condition rating for seepage is considered Poor due to clear evidence of a concentrated leak along the outlet pipe.

Photos 8 & 9 View looking upstream and across at outlet pipe and seepage collection pipe with visibly dye;
Time approx. 20 minutes

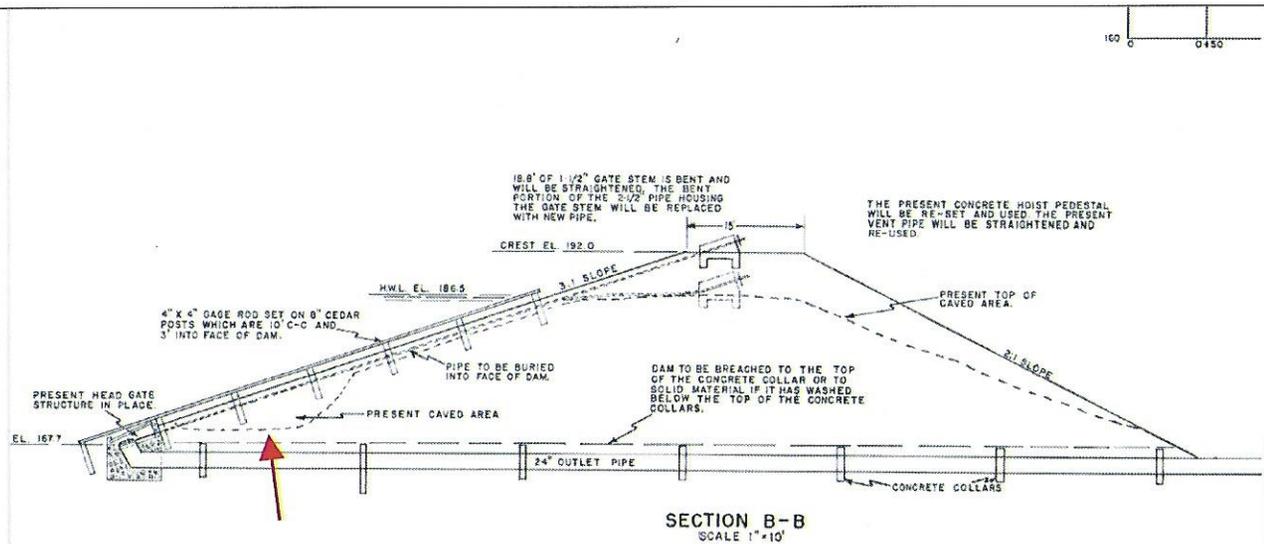
Summary

- 1958 Repairs called for placement in the cut and cover zone with mixture of clay, sand, and gravel, with no stones larger than 5-inches allowed in fill (possible POSITIVE FACTOR).
- Care was to be taken to stitch old and new fill together and for the roller to not negatively impact the concrete collars and pipe, ref C-888 Specifications (POSITIVE AND ADVERSE FACTORS).
- Cut and cover was only to the top of the concrete collars. The concrete collars, outlet pipe, and zoned fill (See C-0590) were largely intended to be left in place with minimal disturbance (ADVERSE FACTOR)
- Area of little to no collapse could relate to bonding trench construction/progression node (POSITIVE FACTOR).

- Note collapsed dashed line in screen capture above from this drawing set.
- Large zone of collapse could relate to filter incompatibility and extents of coarse downstream zone.
- Large zone of collapse would indicate either a more granular soil or shifting of matrix supported large rocks as opposed to clayey zone downstream.
- Upstream caved area showed definite connection to reservoir.

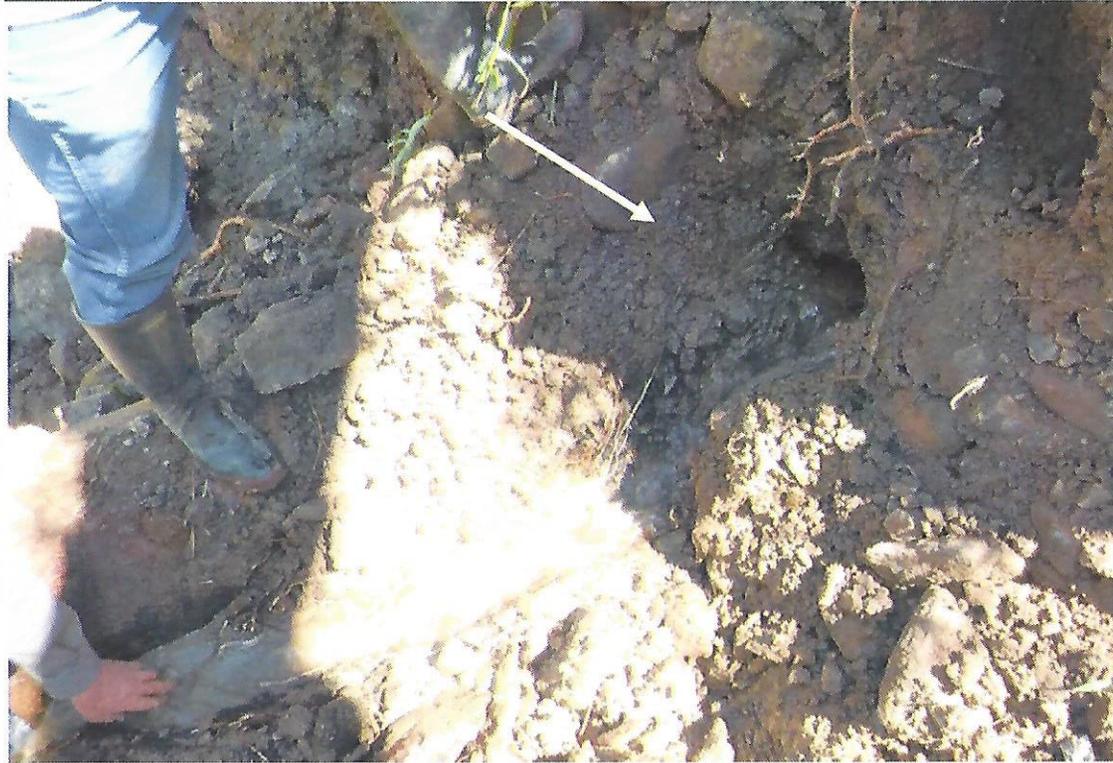
2017

Photo supports well-defined concentrated exit point indicating possible erosion pipe formation (ADVERSE FACTOR).
