# **FINAL CONSTRUCTION REPORT FOR MOUNTAIN LAKE DAM SPILLWAY REPLACEMENT PROJECT**

**CONSTRUCTION FILE NO. C-2076A  
MOUNTAIN LAKE DAM - DAM ID: 110107  
WATER DIVISION 2 – WATER DISTRICT 11  
LAKE COUNTY, COLORADO**

**October, 2018**

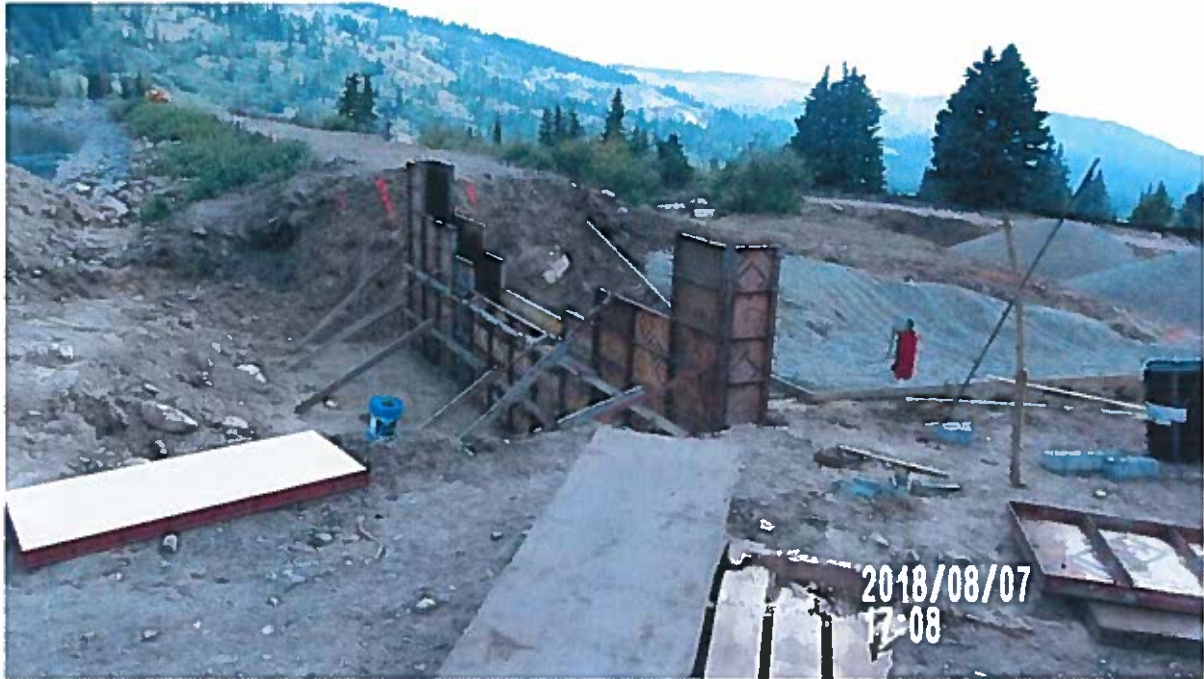
Concrete form work for Control Wall, View to Southwest

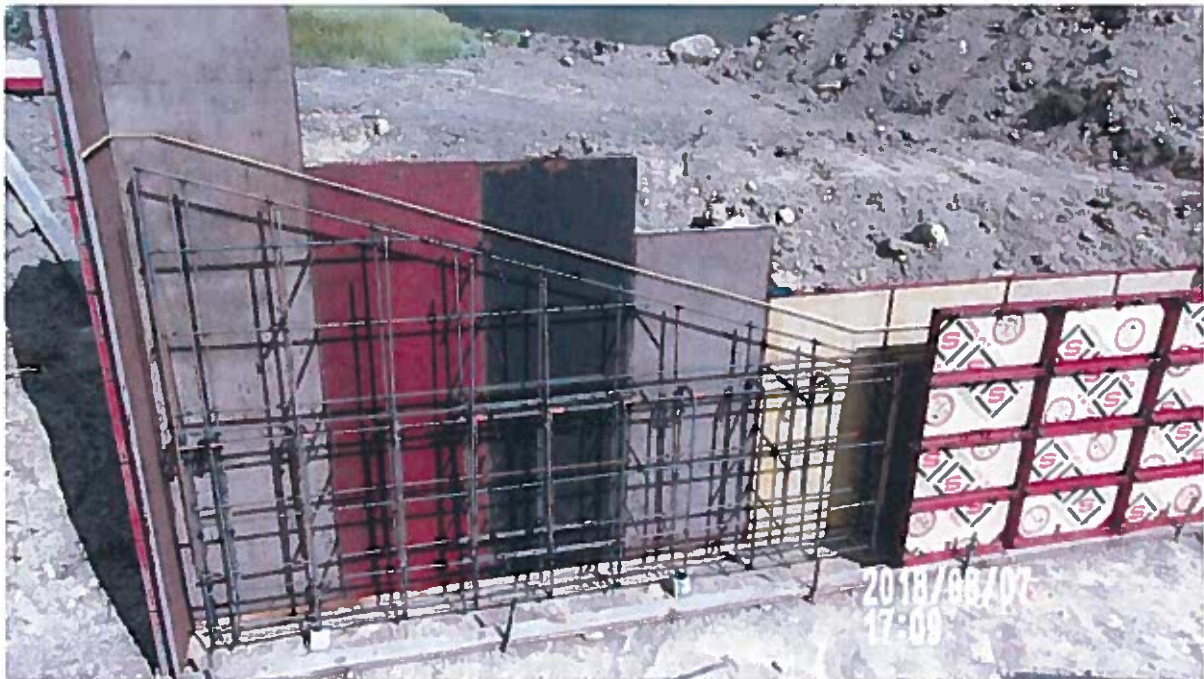
Rebar for Control Wall being installed, view to East

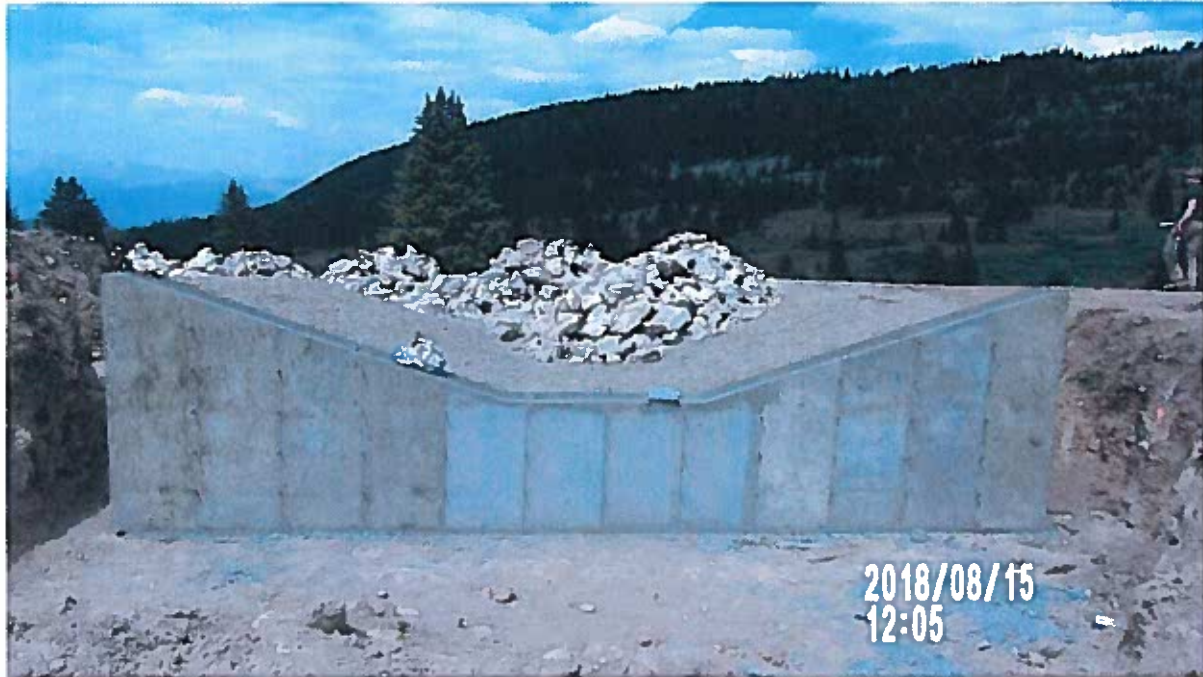
Completed Control Wall before backfilling, View to West

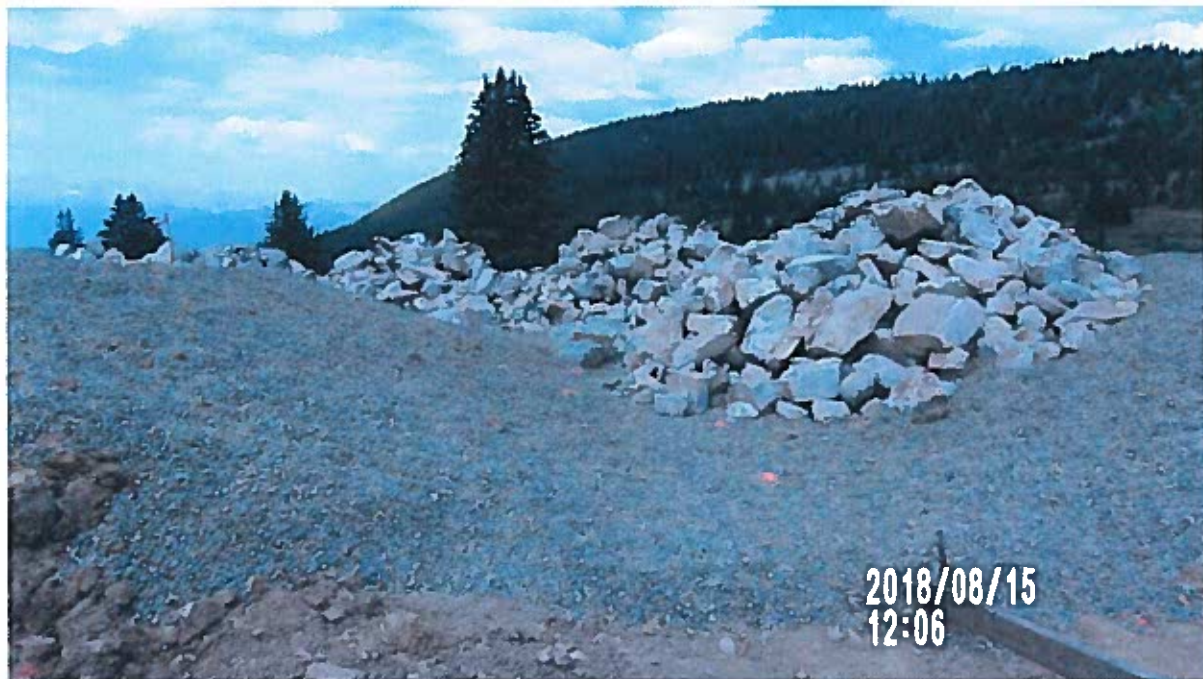
View of spillway channel downstream of Control Wall showing bedding and riprap before placement, View to West

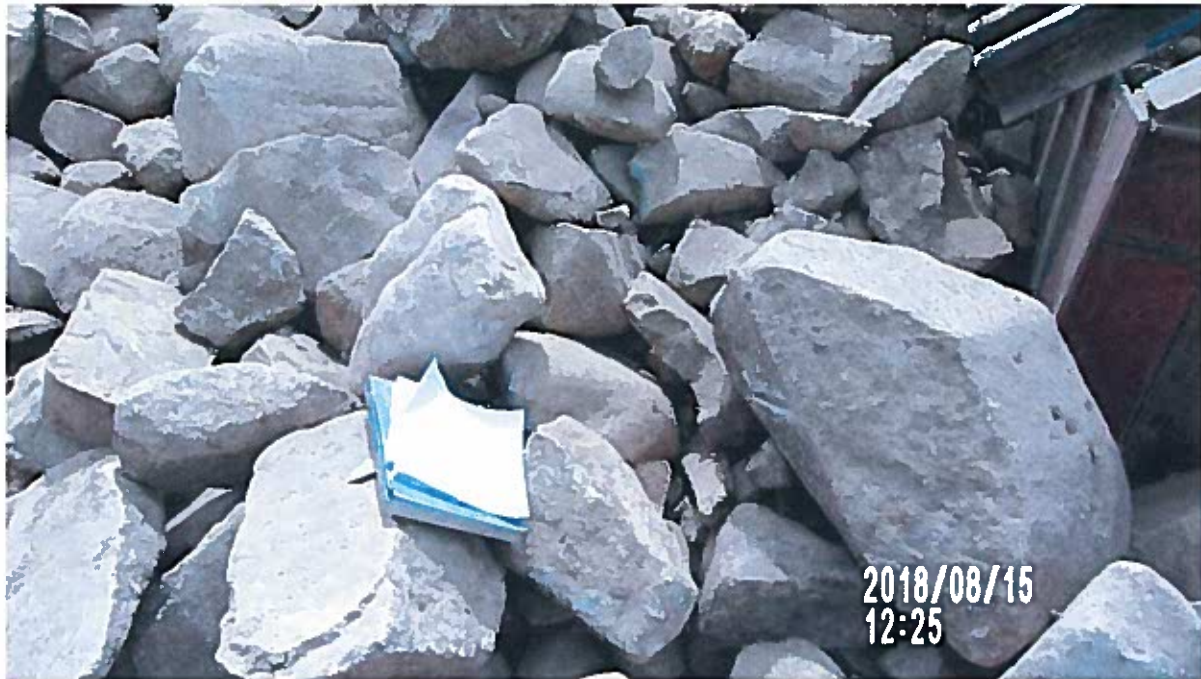
In addition, the purchased riprap was sometimes over-sized for what was requested. The supplier provided a submittal gradation for the riprap material (9-inch D50) that was acceptable for the project. Some of the received material was larger than indicated by the gradation provided. The larger material was more difficult to handle and place than the more properly sized material.

Picture showing riprap size, note clipboard for scale

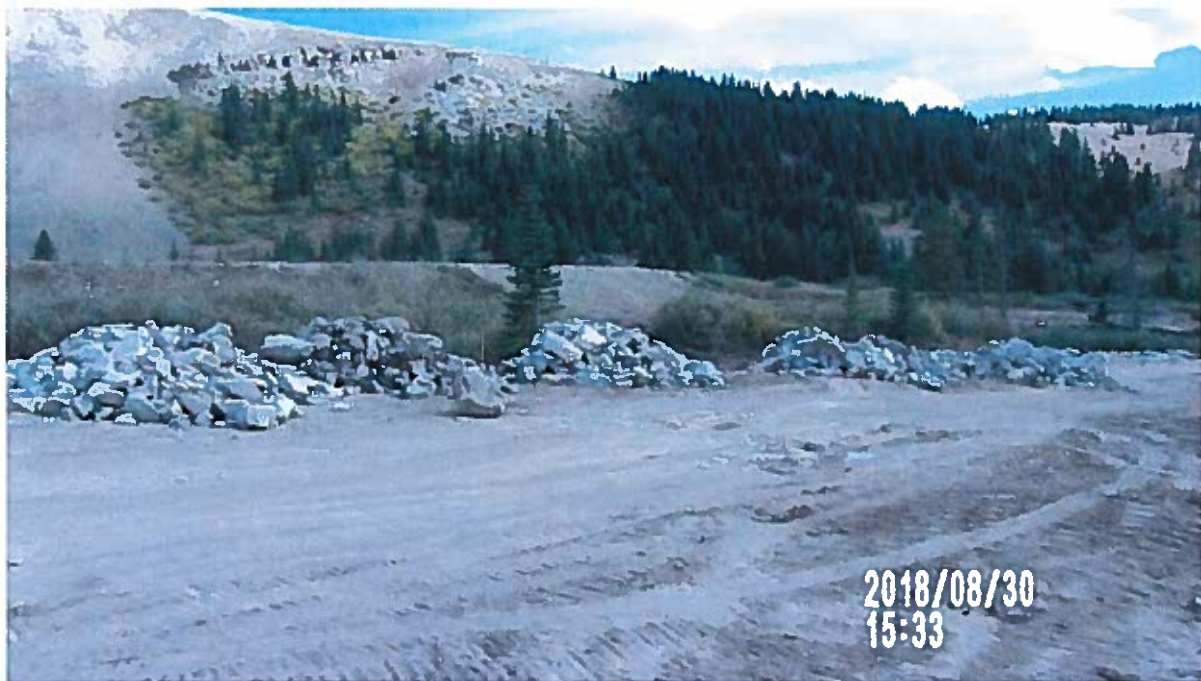
Riprap staged by spillway channel prior to placement, View to Southeast

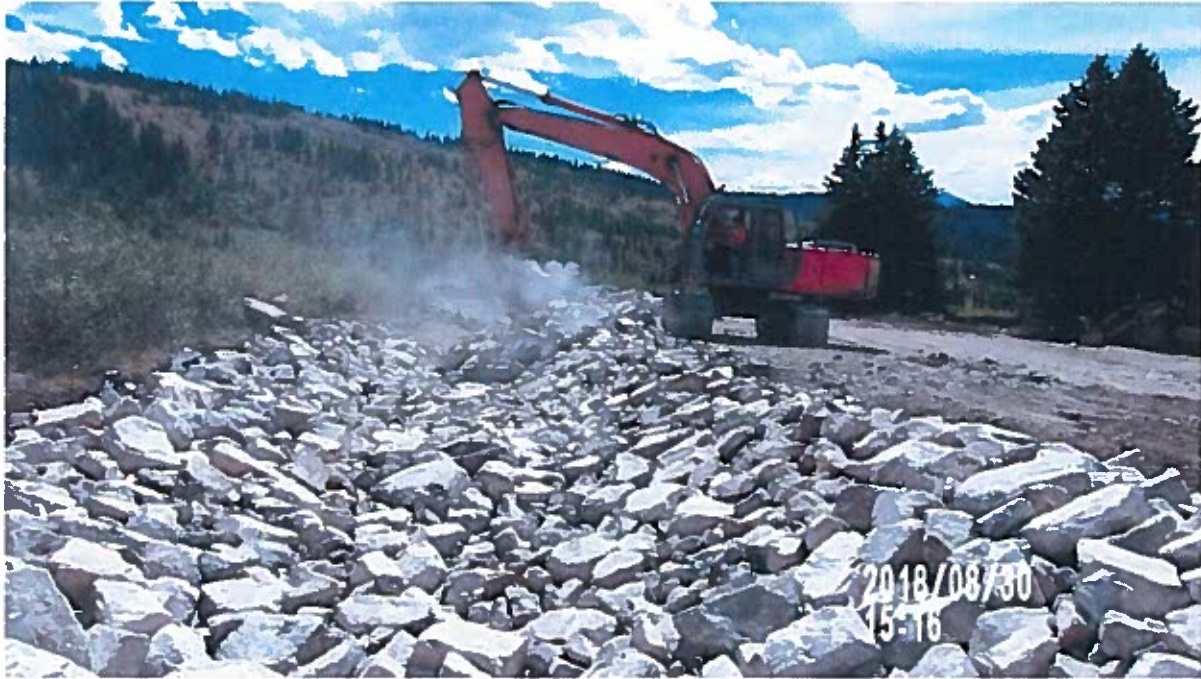
Riprap being placed in spillway channel, View to South

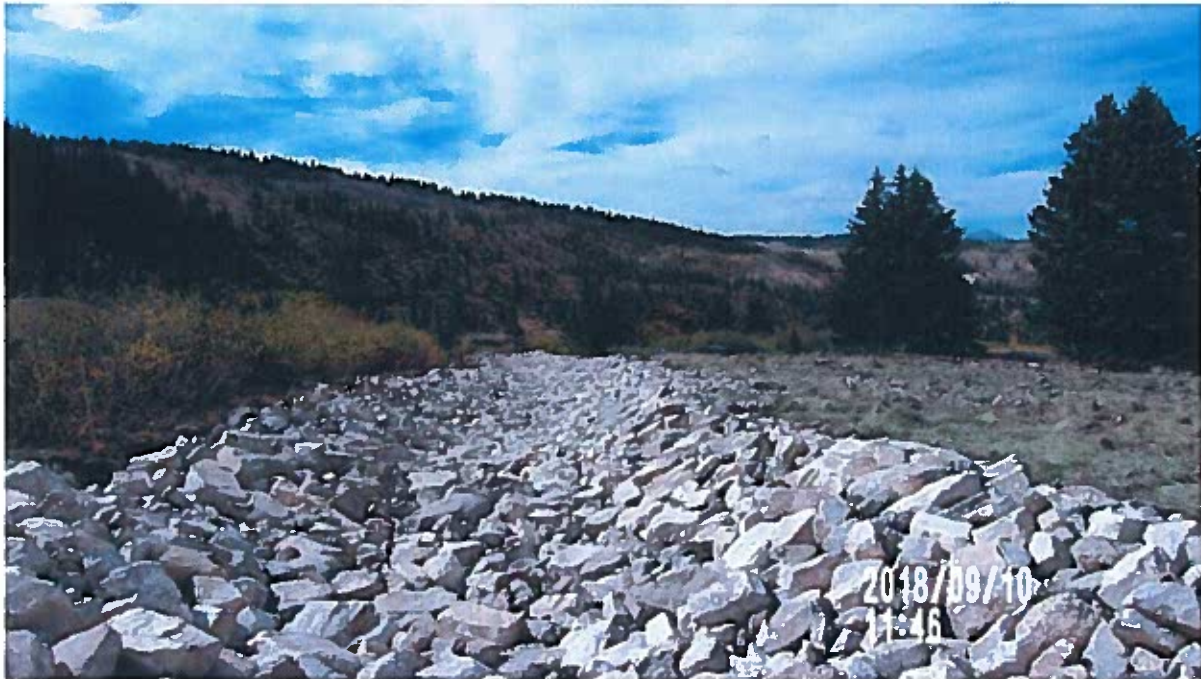
Completed Riprap Channel, View to South

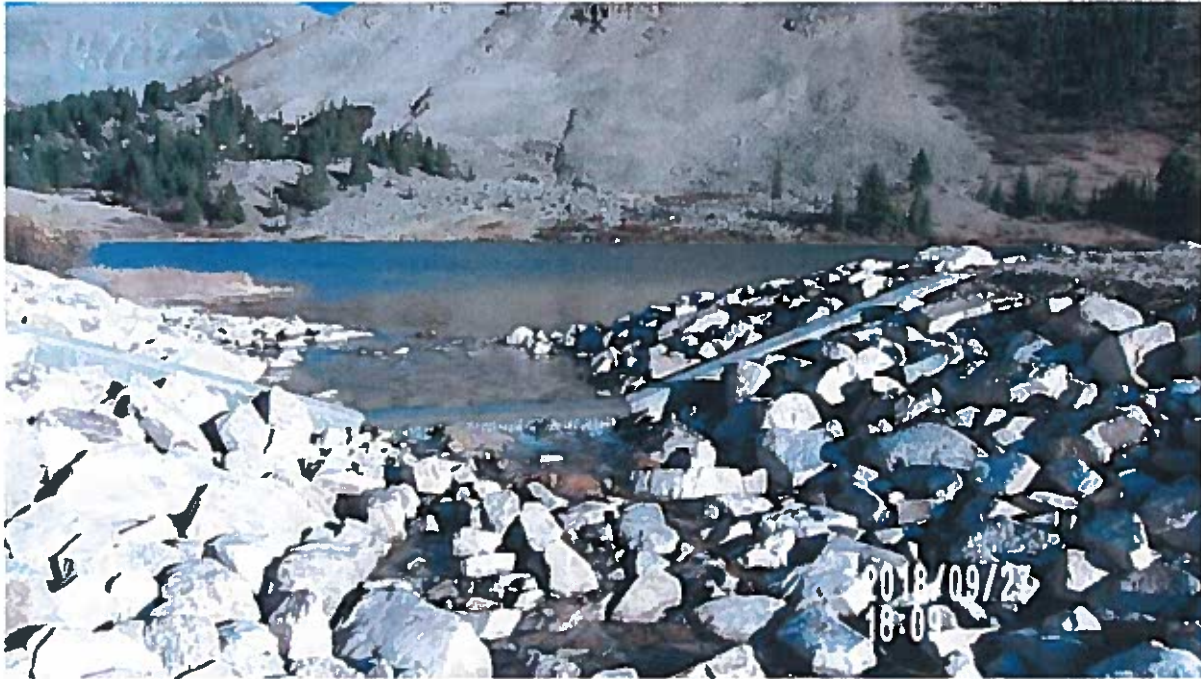
Completed spillway in operation, View to East

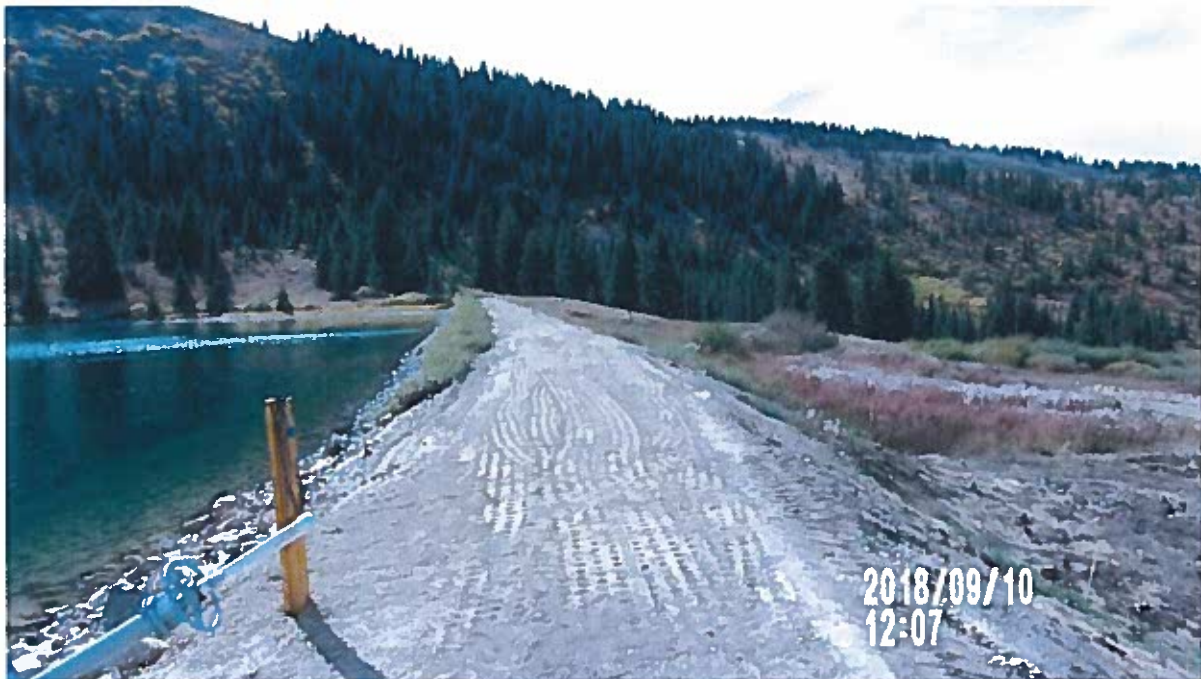
5. Placement of road base material on the dam crest to fill in some low spots that were noted last year during the outlet works project. This brought up the entire dam crest to the minimum crest elevation (11,392.0 feet). The fill was only a few inches in depth, so no compaction specification was used. The material was well compacted by a sheep foot roller.

Dam crest with new fill, View to South
