# **FINAL CONSTRUCTION REPORT** for **MACFARLANE DAM** **REHABILITATION PROJECT**

**CONSTRUCTION FILE NO. C-1031B**  
**COLORADO DAM ID: 470202**  
**NID: CO-00997**  
**WATER DIVISION 6 – WATER DISTRICT 47**  
**JACKSON COUNTY, COLORADO**

## Executive Summary

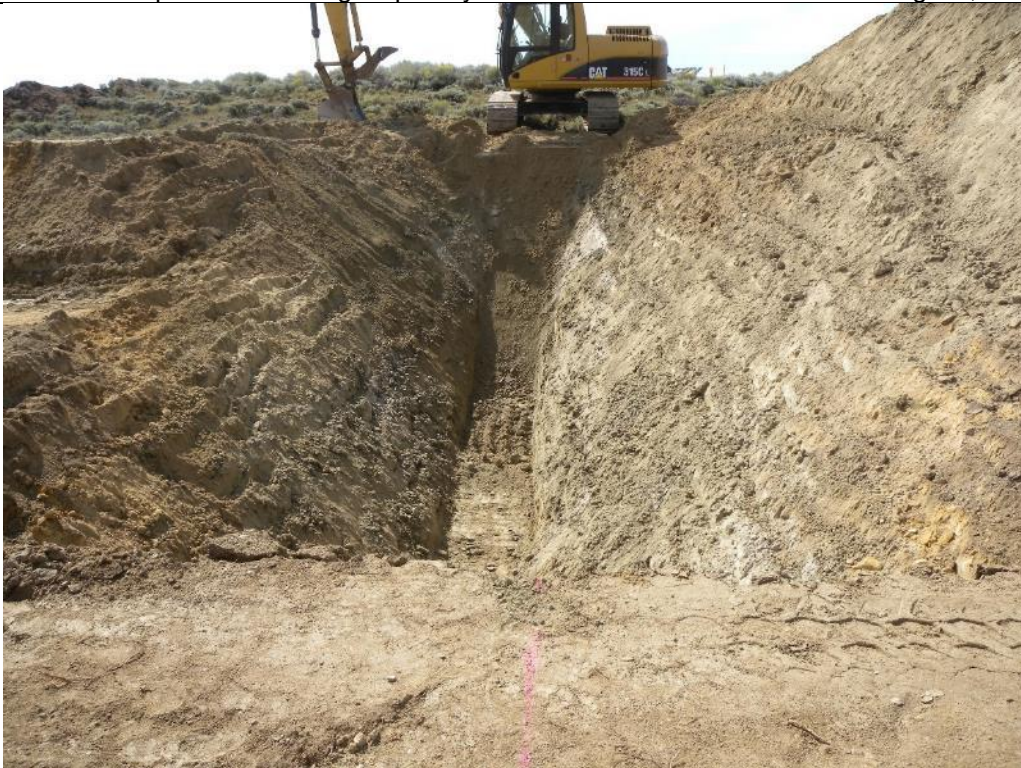
Photo 12. View looking right of the excavated foundation for the upstream spillway cutoff wall at ES Sta. 2+20. Aug. 14, 2017

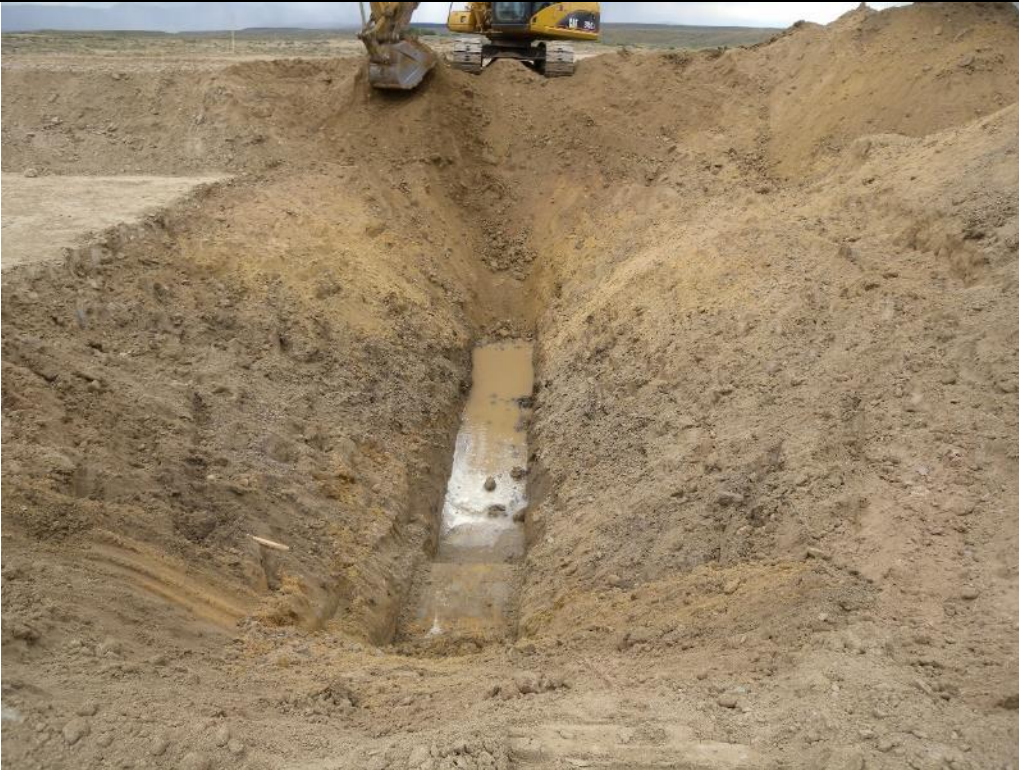
Photo 15. View looking left at the foundation excavation of the downstream spillway cutoff wall at ES Sta. 5+20. Note the seepage in the excavated foundation. Aug. 14, 2017

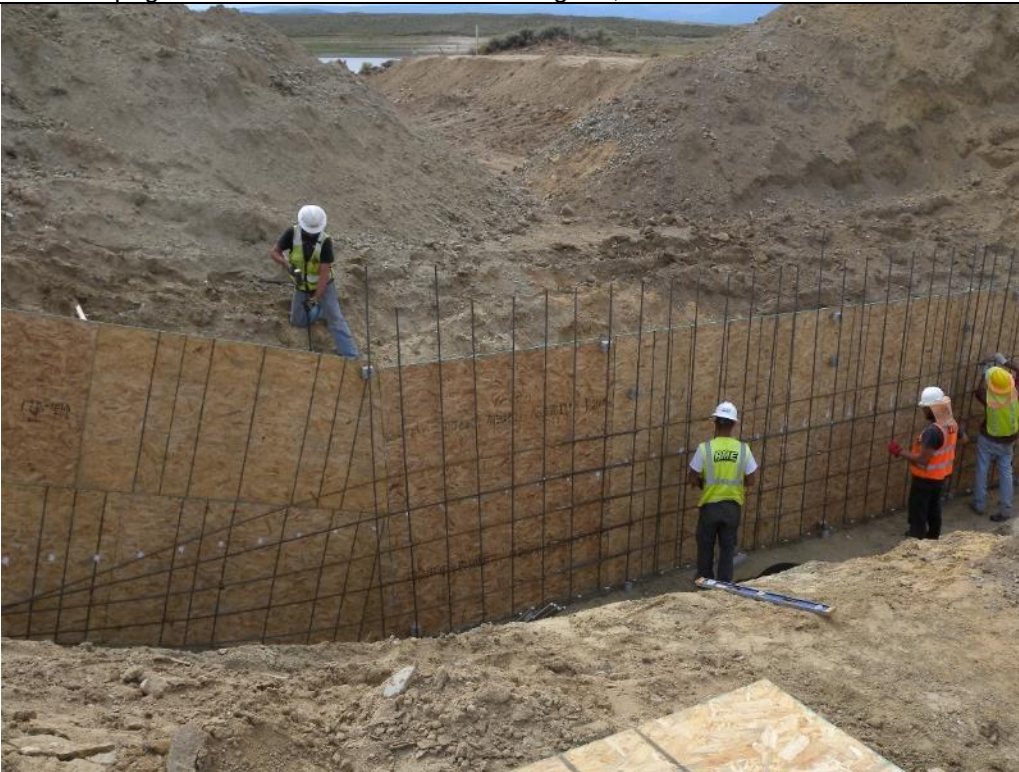
Photo 16. View of the formwork and rebar installation for the upstream spillway cutoff wall at ES Sta. 2+20. Aug. 15, 2017.

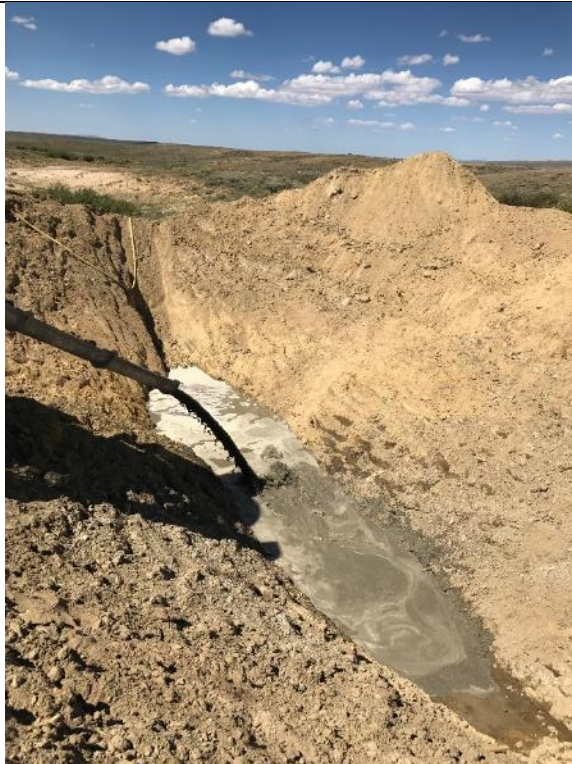
Photo 20. View looking left of the mud-mat placement in the foundation of the downstream spillway cutoff wall at ES Sta. 5+20. Aug. 18, 2017.

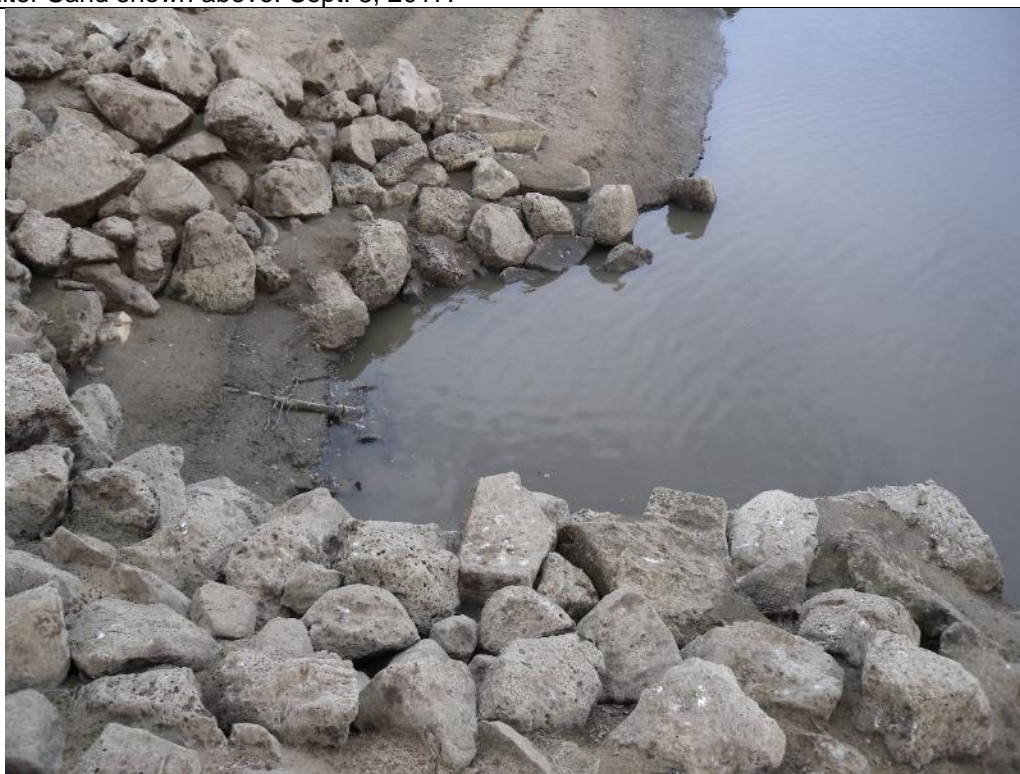
Photo 38. View looking left at the outlet works inlet and closed slide gate. Reservoir draining operations have resulted in the reservoir pool at the level of the upstream slide gate. Sept 8, 2017.

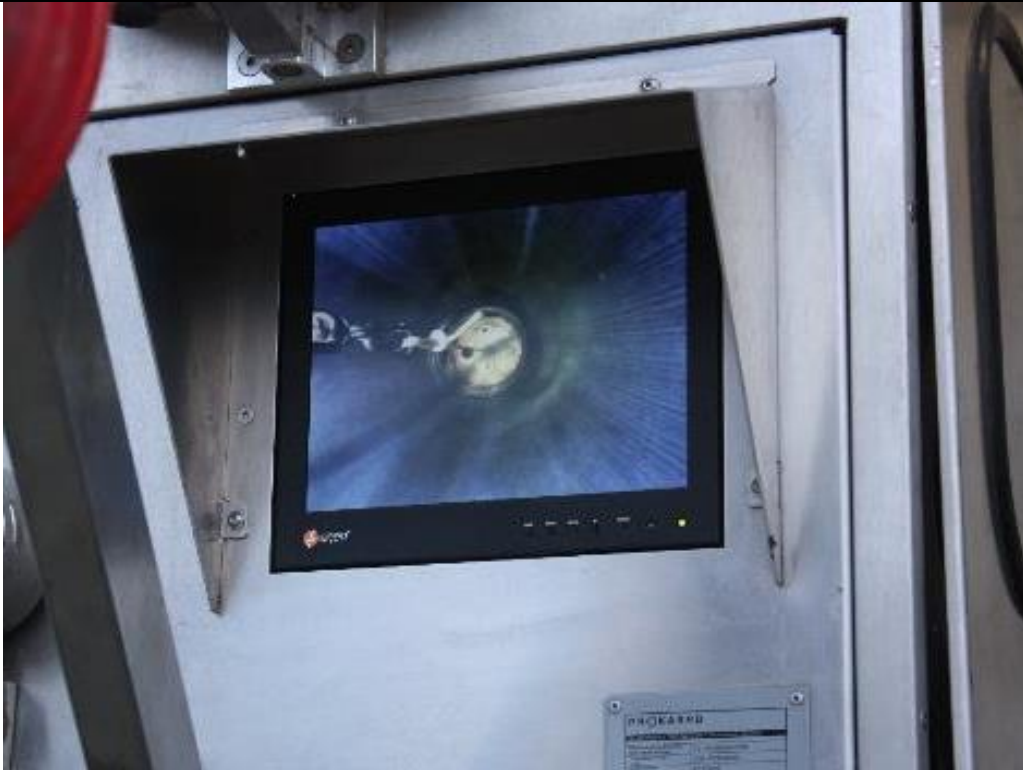
Photo 100. Once the internal pressure in the CIPP was achieved, C&L pulled the roller device which houses the UV lamps from the downstream side to the upstream side of the outlet pipe. During this time, C&L used an attached video camera to observe the condition of the CIPP. No issues were found within the inflated CIPP liner, so C&L then turned on the UV lamps to cure the CIPP pipe. The curing process lasted approximately 2.5 hours. Nov. 1, 2017.

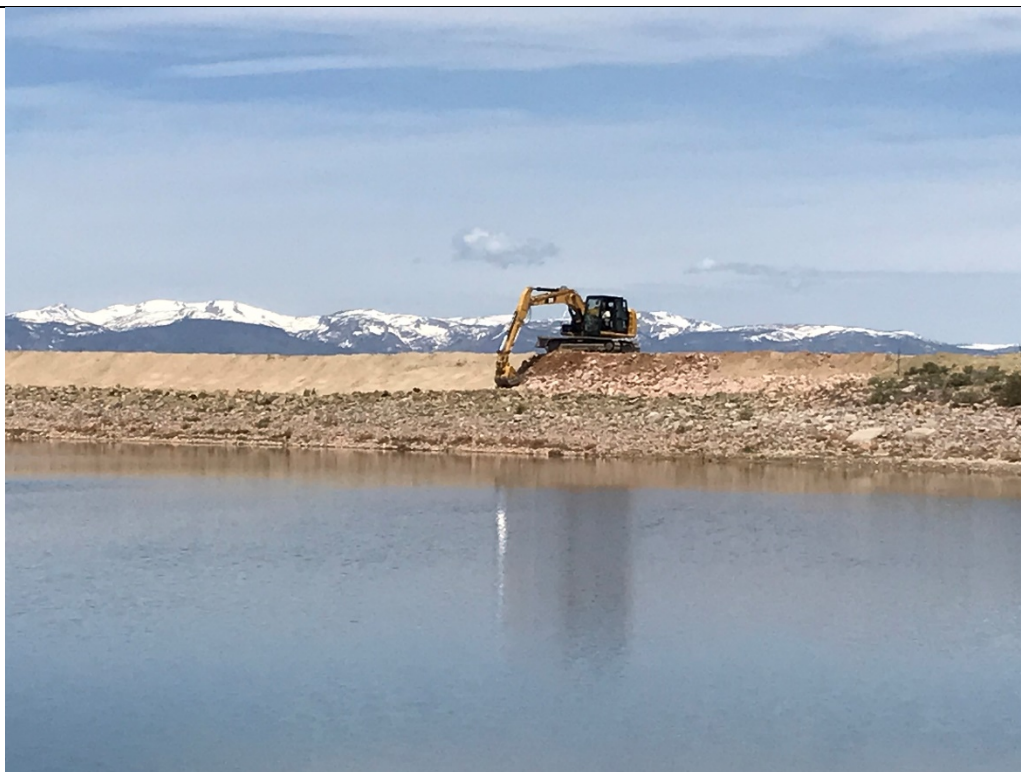
Photo 125. View looking left from the outlet works operator at the North upstream slope riprap repair being completed by the FWS maintenance crew. May 22, 2018.
