**Green Ditch Diversion Rehabilitation and Fish Passage Project**  
Final Report

April 12, 2018

Grant Recipient: The Green Ditch Company

Final Report Prepared by: Marianne Giolitto,  
City of Boulder Open Space and Mountain Parks Department

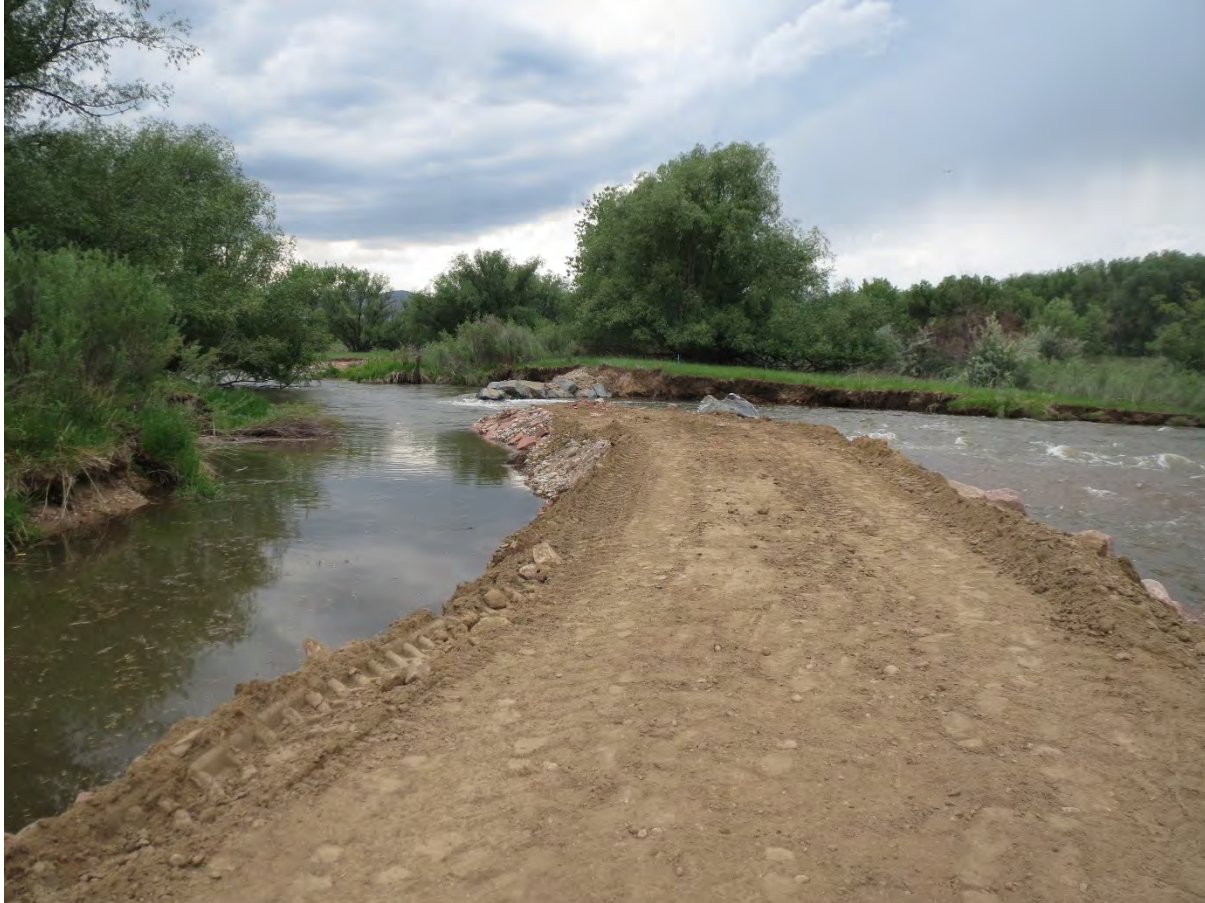
***Photo 1. Temporary berm being constructed across the Boulder Creek breach to redirect the creek back into its pre-flood channel.***

In 2014, the Green Ditch Company constructed a temporary berm across the breached left bank of Boulder Creek, directing creek water back into its pre-flood channel (Photo 1). This temporary repair provided time for the Green Ditch Company and the City of Boulder, who owns the property immediately upstream of the Green Ditch headgate, to develop a restoration plan to restore the Green Ditch Company's ability to divert water while protecting and enhancing the ecological values of city-owned property.

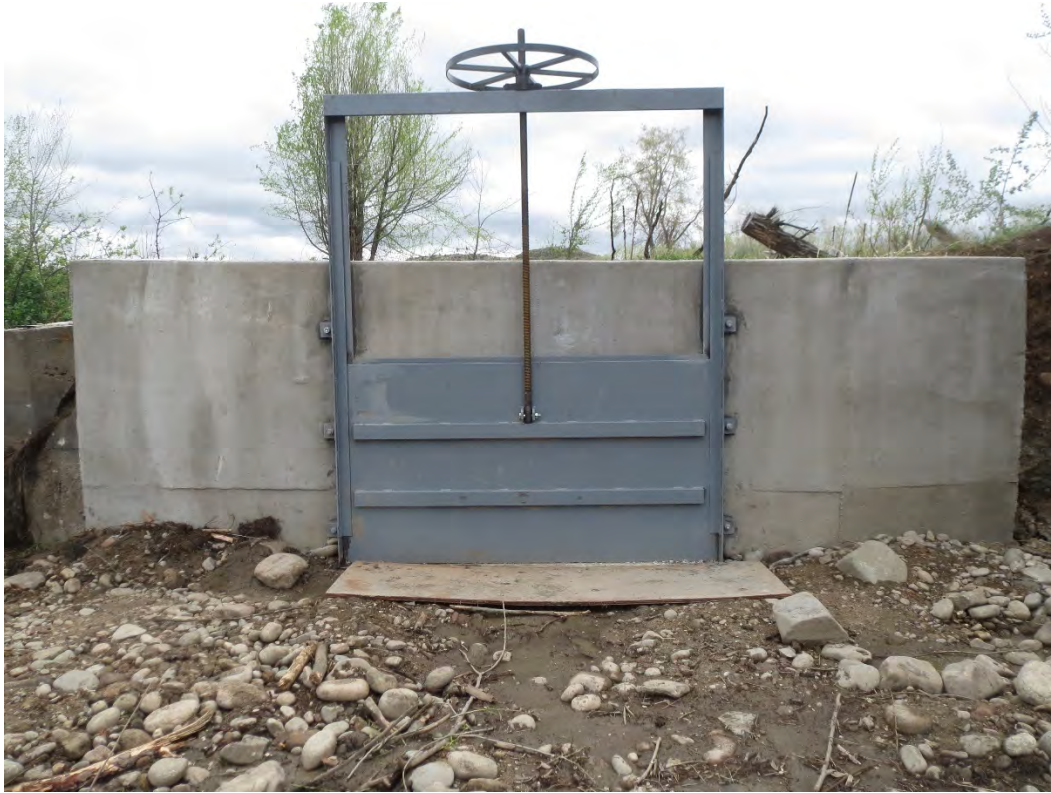
downstream of the point of diversion. During low flows, this mode of operation dewatered 600 feet of Boulder Creek, fragmenting fish habitat. Installation of the new head gate at the point of diversion and removal of the return flow channel (i.e. the wasteway) eliminated this dewatering.

***Photo 2. New Green Ditch headgate.***

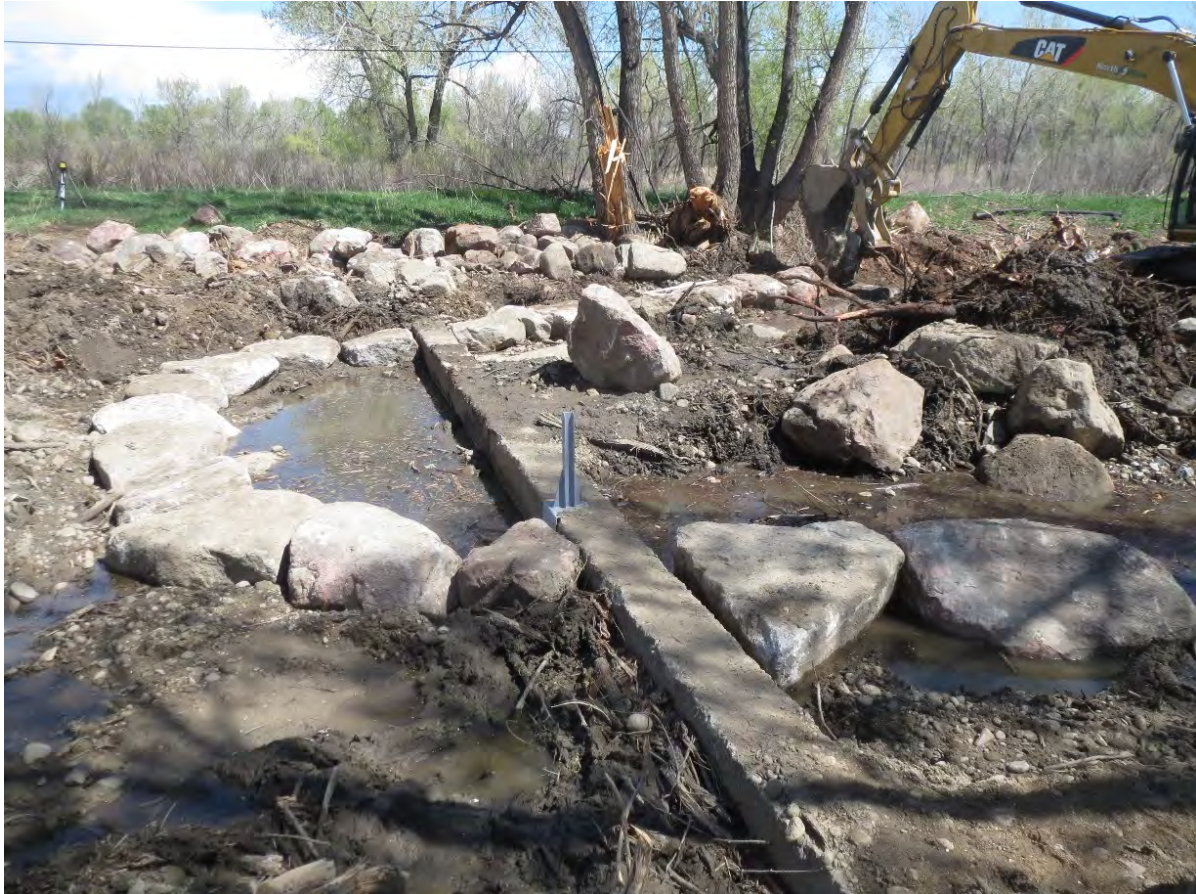
The final fish passage work included installation of a rock “A” cross vane to divert the Green Ditch Company’s adjudicated water (Photo 7). As seen in the photos, the cross vane incorporated the existing low head dam. With guidance from Bill Rice, the Mountain Prairie Region Fish Passage Coordinator for the USFWS National Fish Passage Program, the cross vane included a small opening in the vane near the new headgate to provide an escape path for fish in danger of being entrained in the Green Ditch (Photo 8). Photos 9 and 10 show the completed cross vane and raised stream bed below the cross vane under higher flow.

***Photo 7. Constructing the rock “A” cross vane that will allow diversion. Note existing low head diversion dam around which the cross vane is being built. View looking right bank to left bank.***

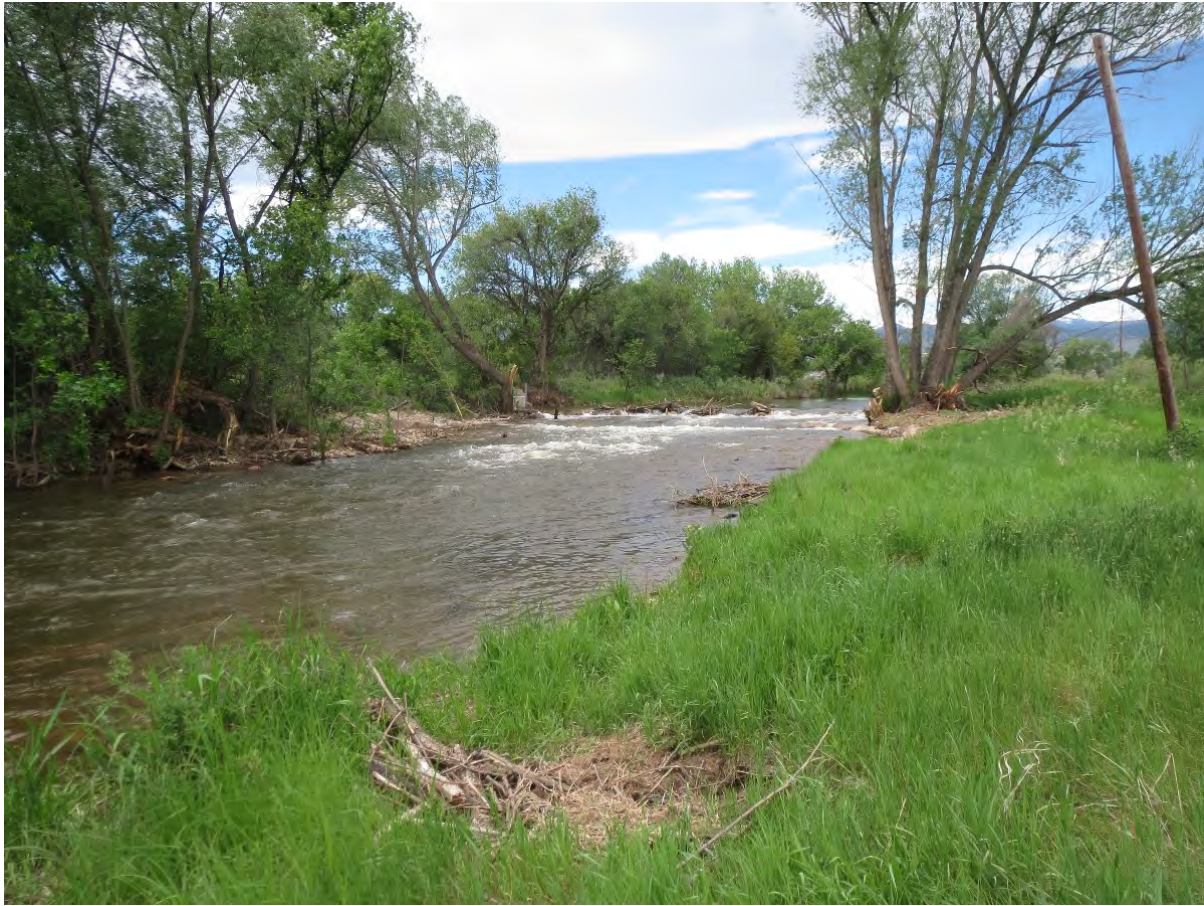
***Photo 10. Rock cross vane and raised creek bed. View facing upstream.***

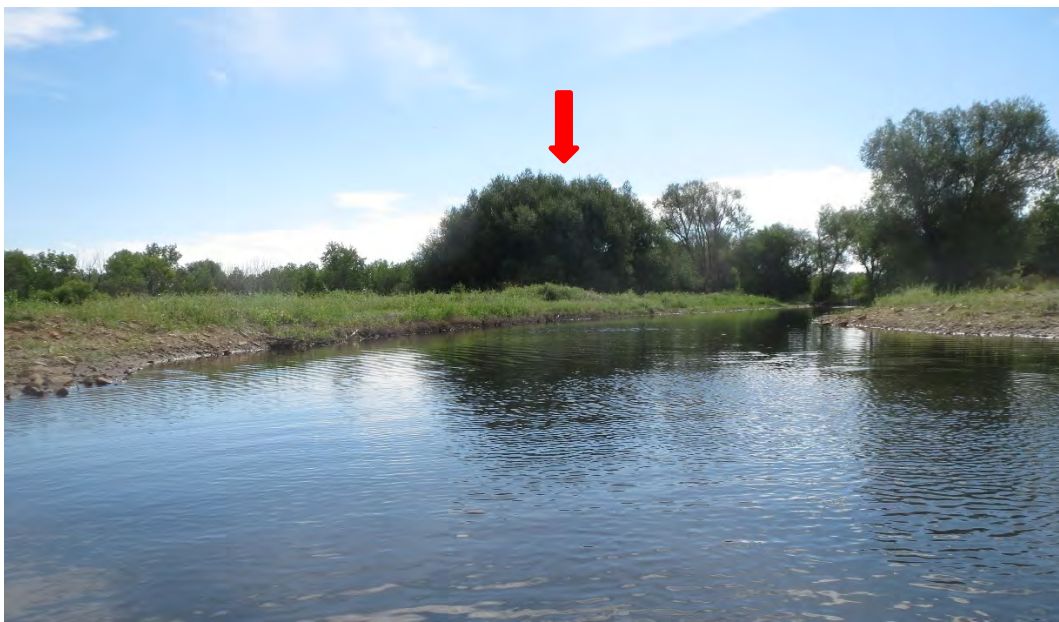
***Photo 21. Following restoration wood toe replaces riprap and creek channel dimensions more closely approximate reference conditions. View facing downstream August 17, 2017.***

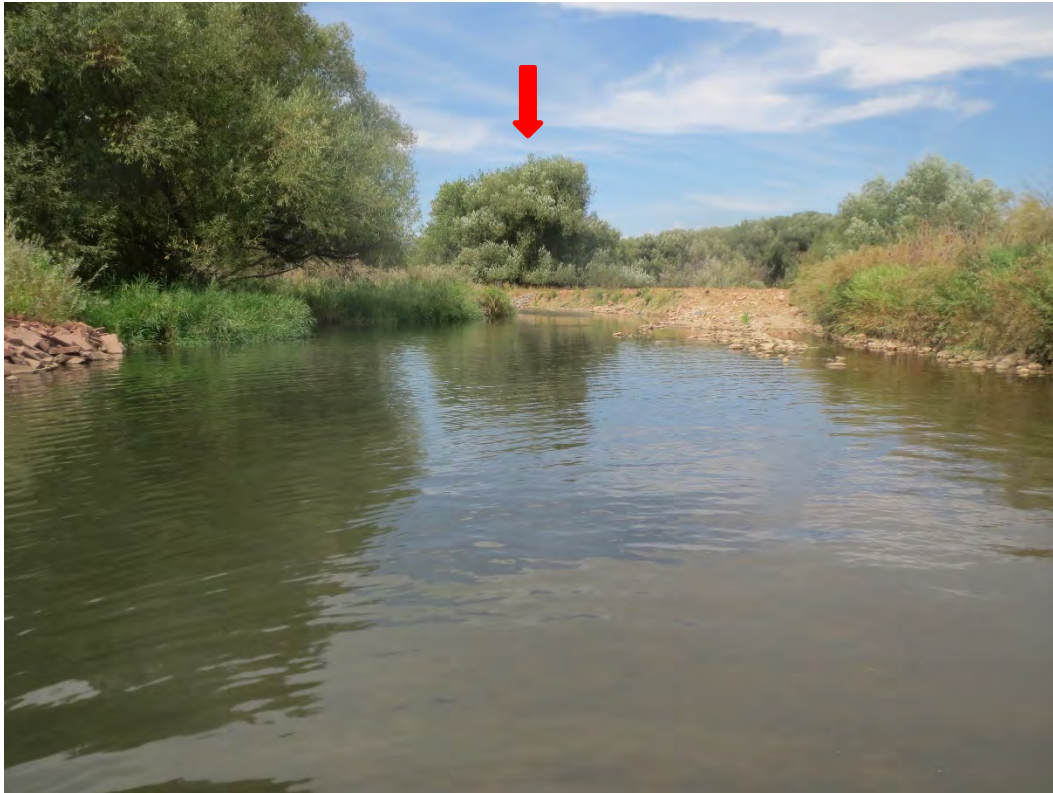
***Photo 22. Second view of temporary riprap and entrenched channel. View facing upstream September 7, 2016.***

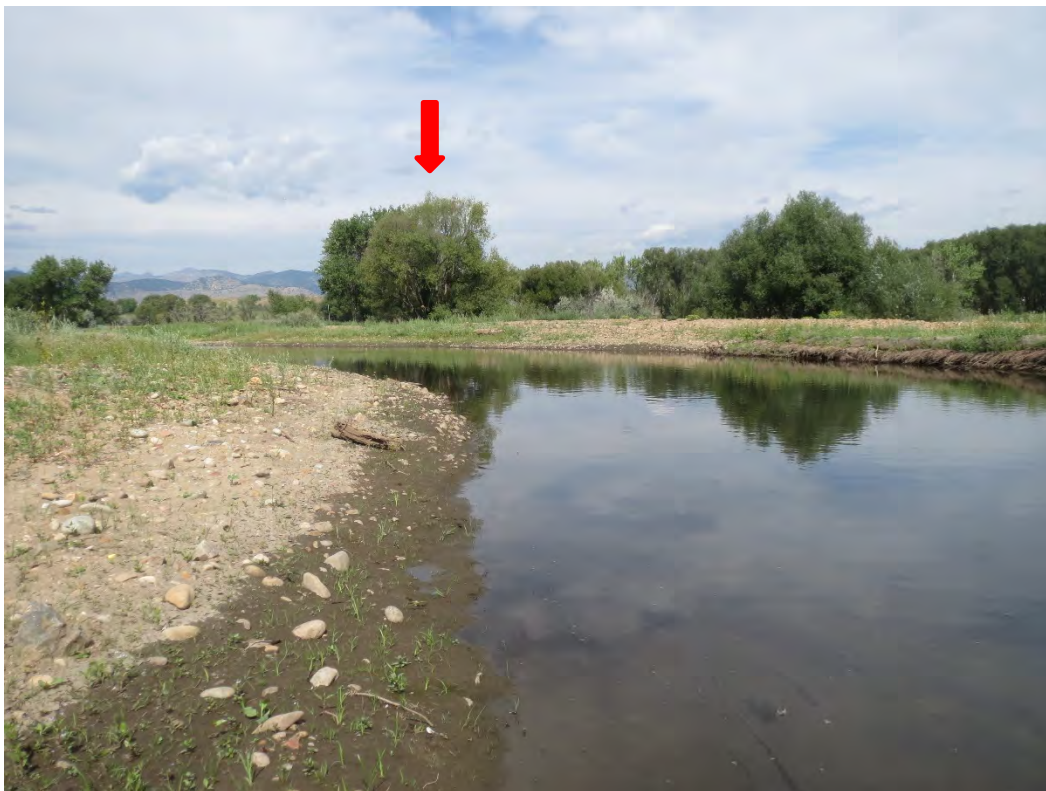
***Photo 23. Following restoration wood toe replaces riprap and creek channel dimensions more closely approximate reference conditions. View facing upstream August 17, 2017.***

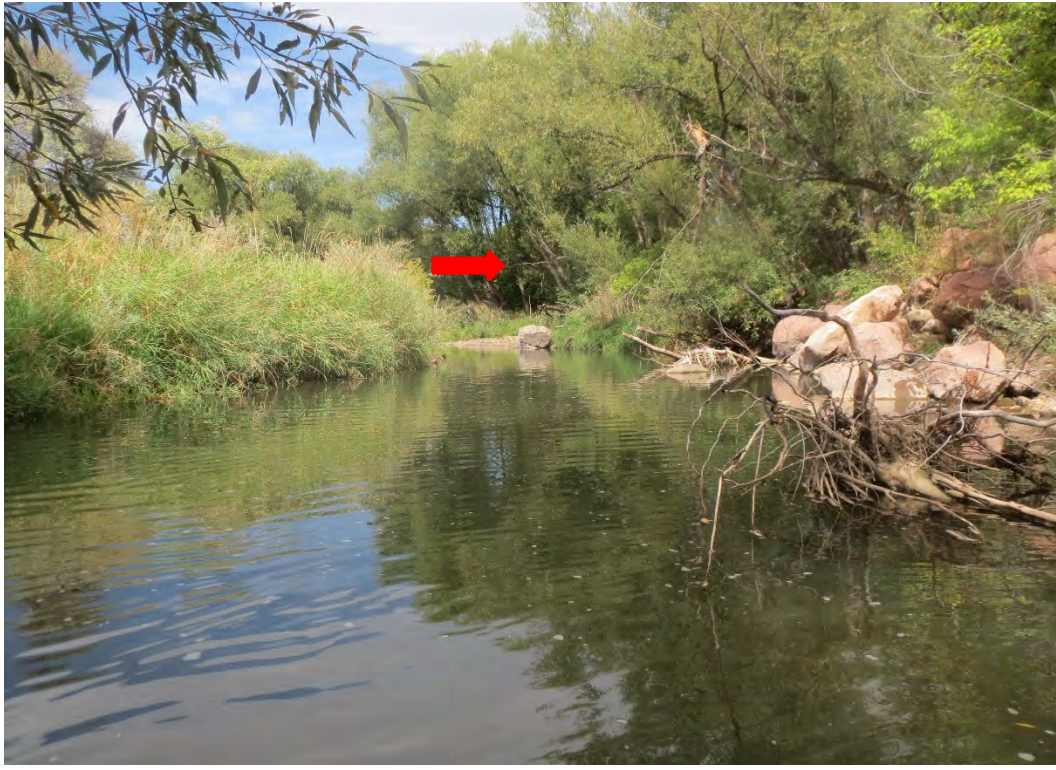
***Photo 24. Prior to restoration riprap on left bank provides poor habitat and extensive cover of non-native vegetation (reed canary grass and crack willow). View facing upstream September 7, 2016.***

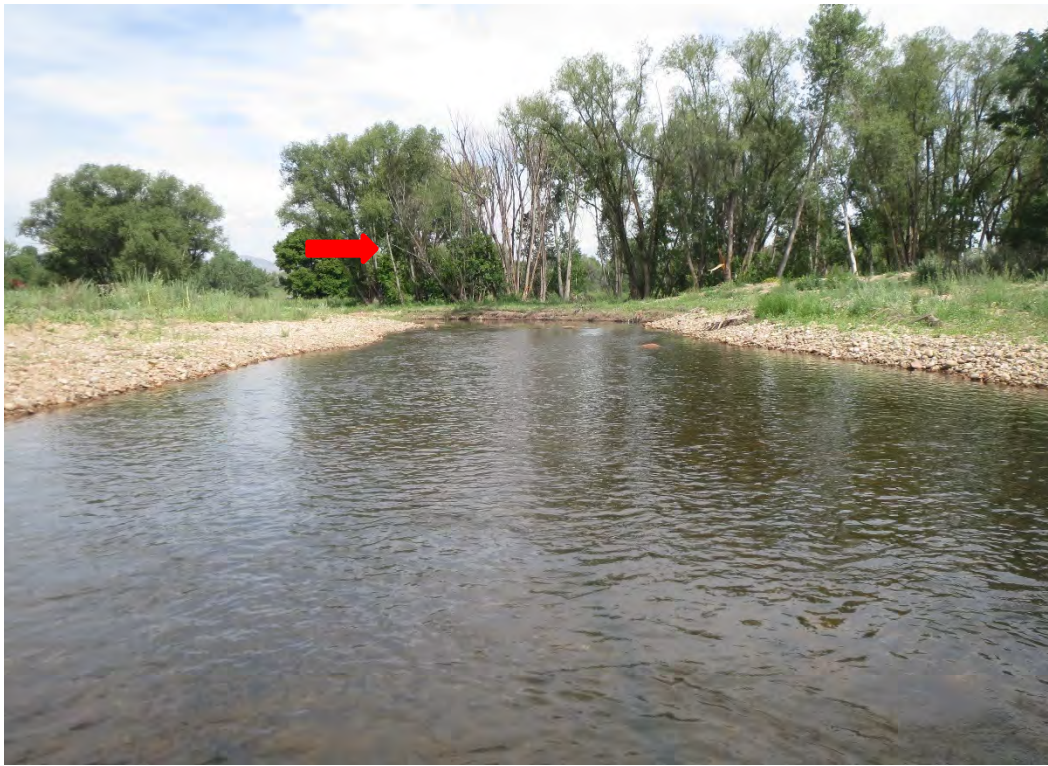
***Photo 25. Following restoration wood toe replaces riprap (left bank), creek channel dimensions more closely approximate reference conditions, and riparian corridor seeded and planted with native vegetation. View facing upstream August 17, 2017.***

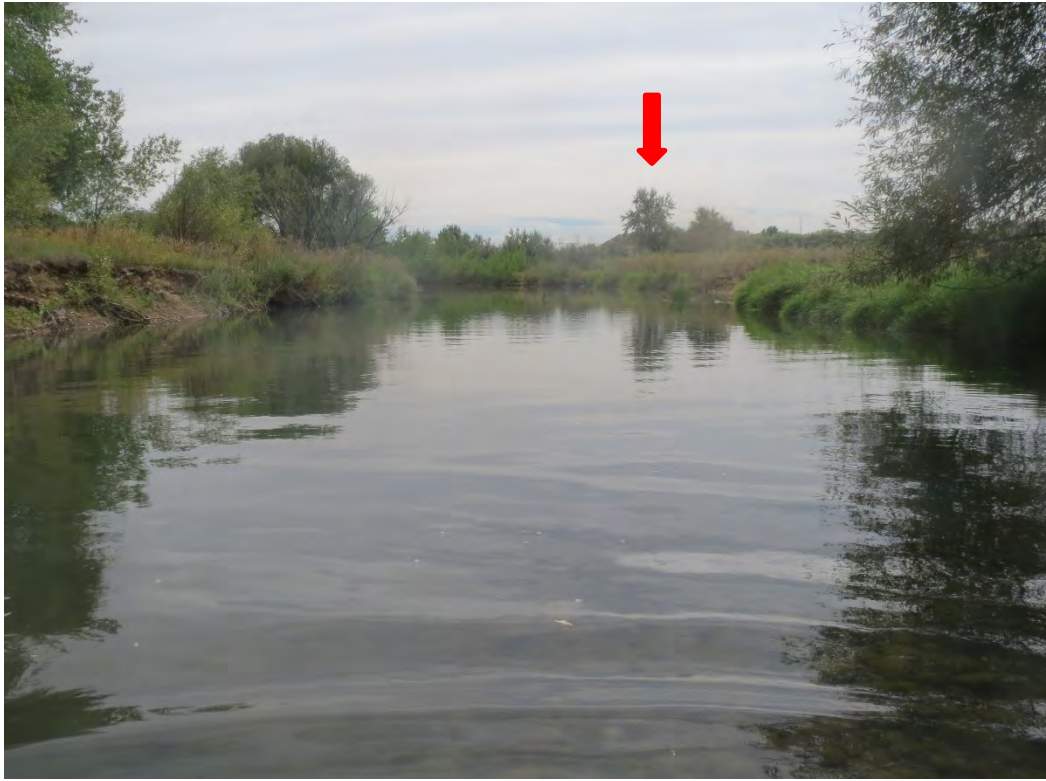
***Photo 26. Prior to restoration steep cut banks on both banks (left bank most visible). View facing downstream September 7, 2016.***

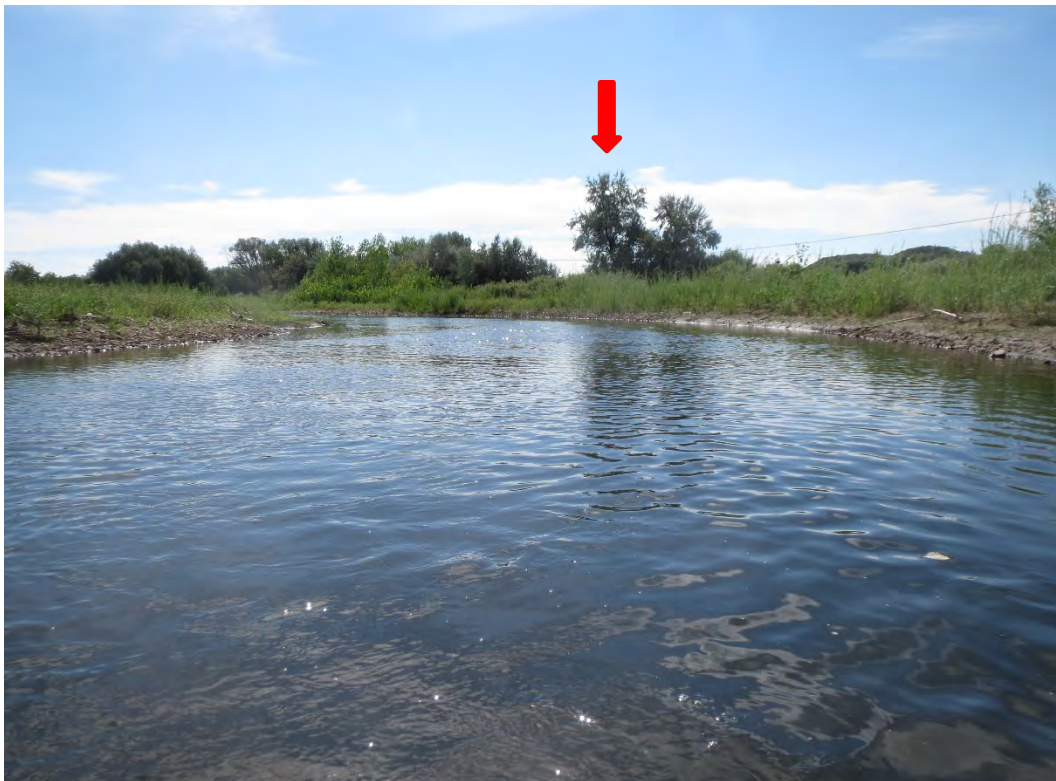
***Photo 27. Following restoration banks reshaped and seeded and planted with native vegetation. View facing downstream August 17, 2017.***

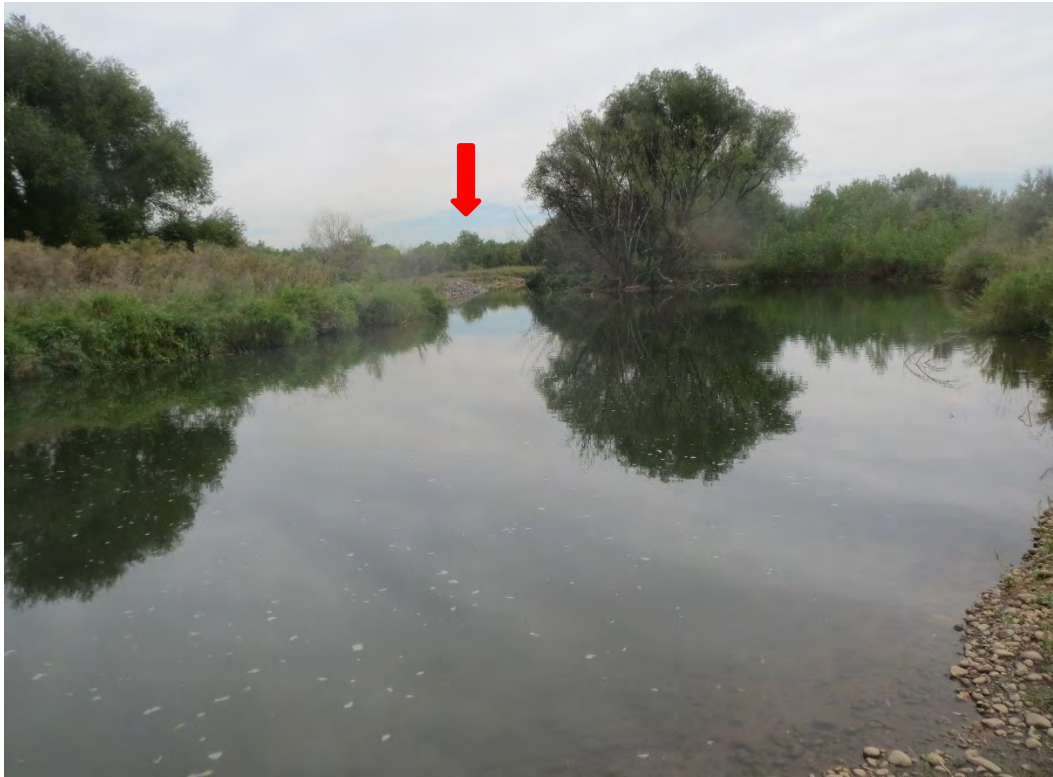
***Photo 28. Prior to restoration creek was actively eroding the right bank to the right of the large crack willow. If left unaddressed, the creek would split flows here. Temporary berm also visible on the left bank immediately below the red arrow. View facing downstream September 7, 2016.***

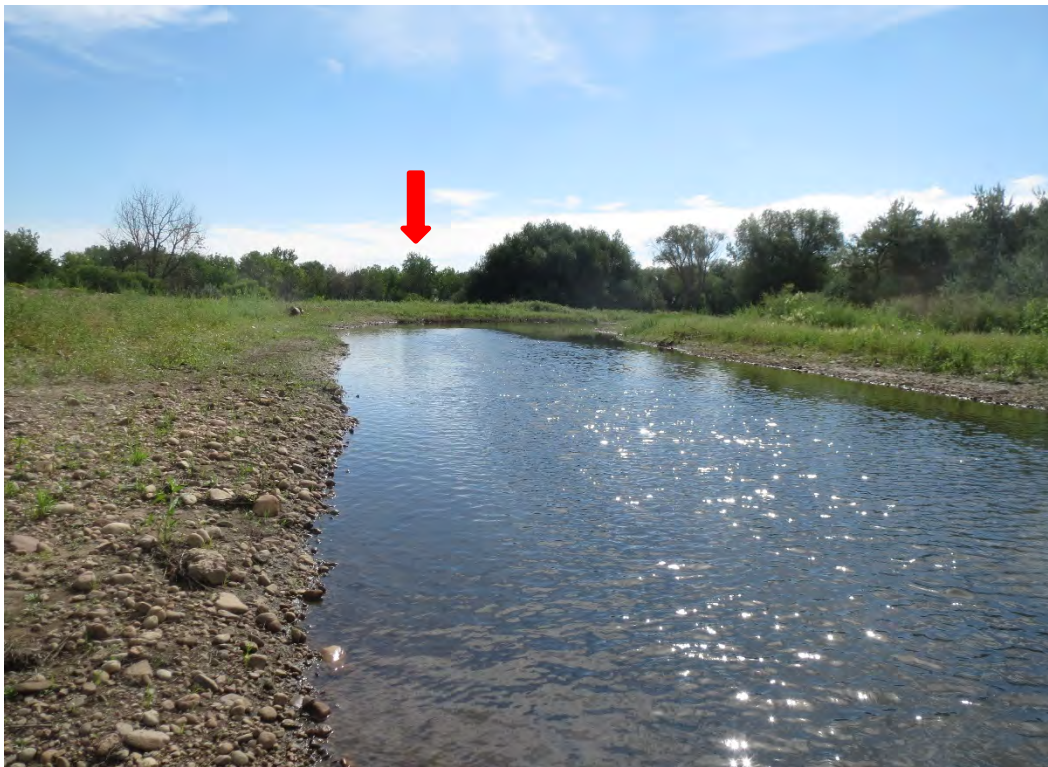
***Photo 29. Creek restored to a more stable plan view and dimension. Wood toe visible where temporary berm was located. View facing downstream August 17, 2017.***

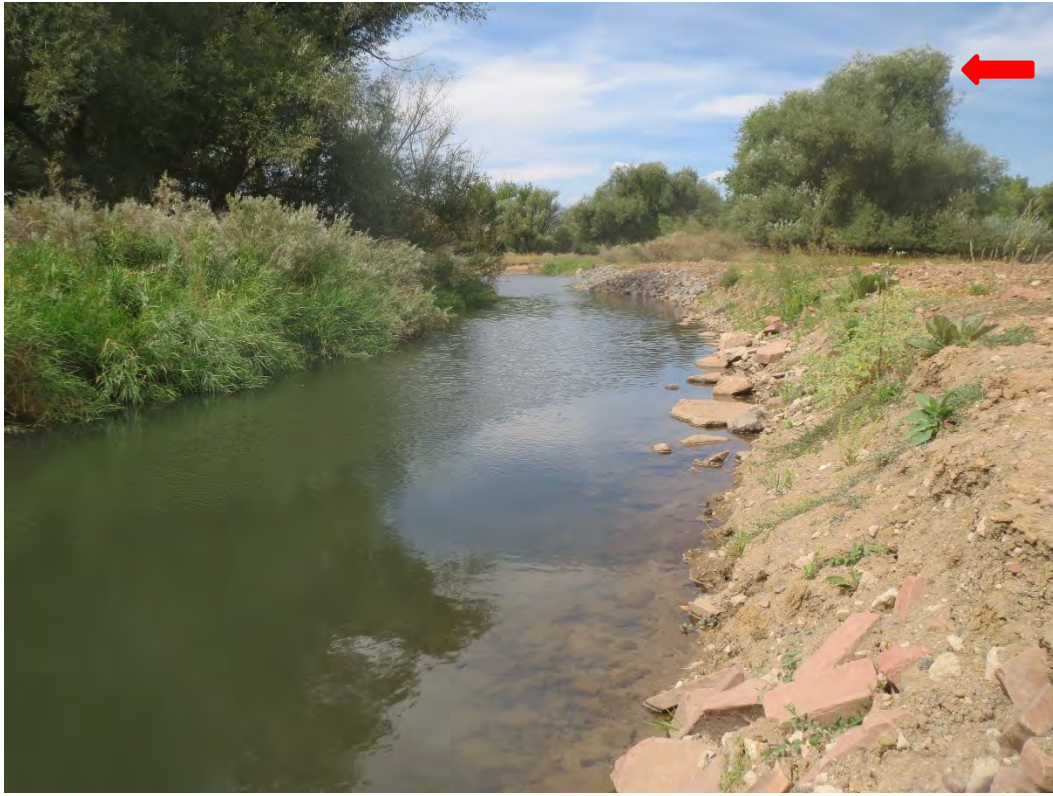
***Photo 30. Close up of temporary riprap berm. View facing upstream September 7, 2016.***

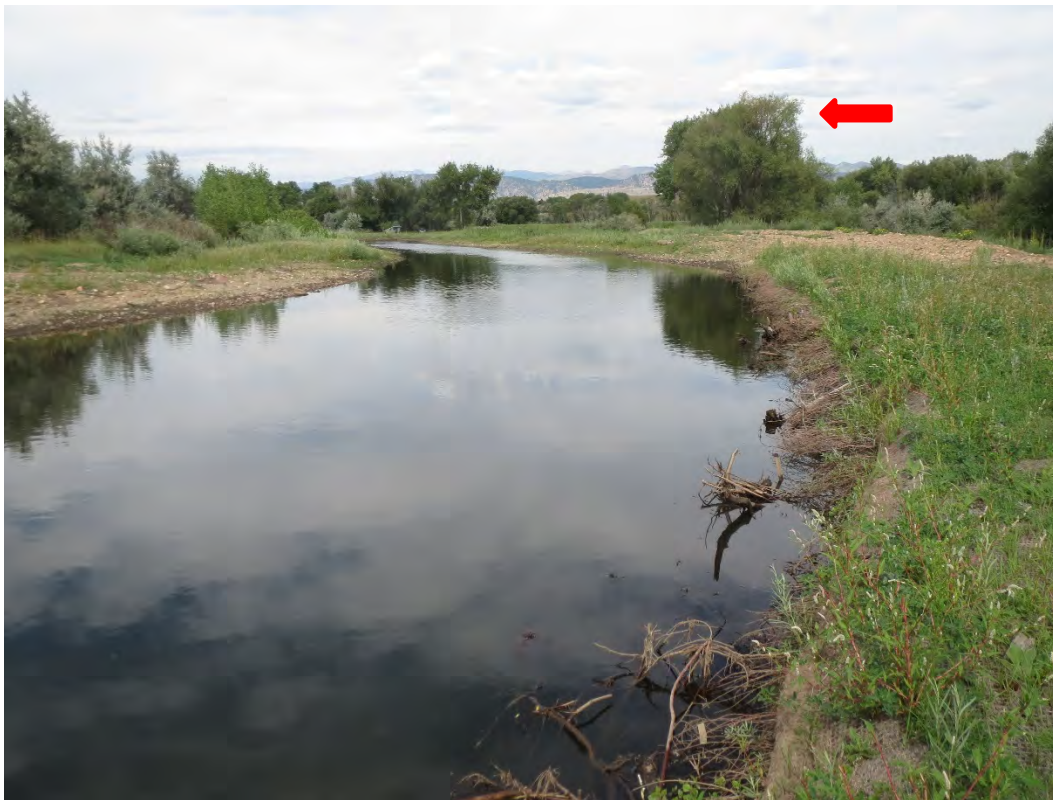
***Photo 31. Close up of wood toe and realigned plan form of restored creek. View facing upstream August 17, 2017.***
