## PURGATOIRE RIVER WATER CONSERVANCY DISTRICT

Re: WSRA Grant – POGG1-774 Purgatoire River Water Conservancy District – Infrastructure  
Repair Project – Final Report

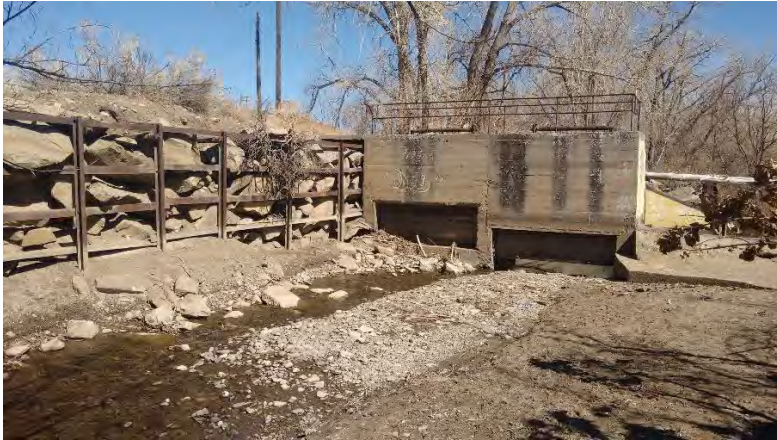
**TASK NO. 1 - PICKETWIRE DITCH HEADGATE**

Under this task a new concrete “floor” was installed on the bed of the Purgatoire River in front of the existing headgate. The purpose of this floor was to prevent seepage and erosion under the headgate frame area and to assist in keeping the area in front of the gates free from river debris and sediment. A vertical concrete wall was also constructed along the north bank of the river at this headgate location to prevent erosion around the headgate frame. This new wall section is anchored into existing boulders and railroad rail framework at this location. Lastly, a catwalk was installed on the face of the headgate frame to allow ditch personnel to safely remove any debris from in front of the headgates. For safety purposes metal railings and security fencing were installed atop of the headgate structure. As a highway rest stop or welcome center is being constructed adjacent to this headgate location, this additional safety fencing was deemed necessary to keep unauthorized persons from entering upon the headgate structure.

Picketwire Ditch headgate – pre-construction.

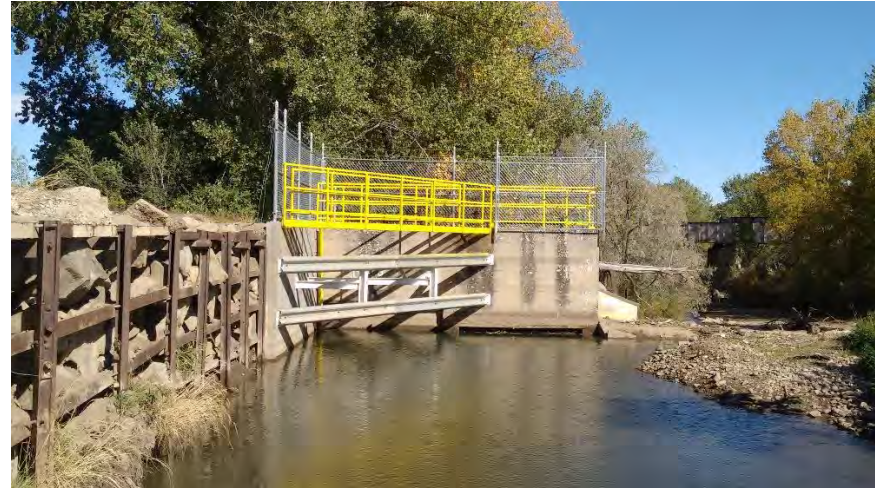
Picketwire Ditch headgate – post-construction.

The concrete phase of this task was completed in the spring of 2018 and functioned well and as planned during the irrigation season. The metal work was completed in August of 2018.

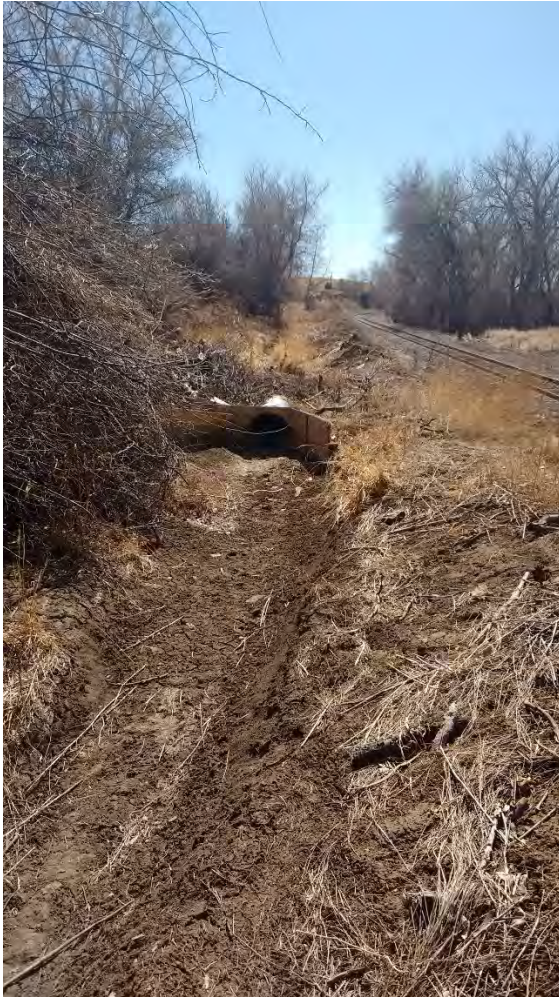
**TASK NO. 2 - CHILILI DITCH PIPELINE SECTION**

This task consisted of the removal of several old ditch culverts in a section of the Chilili Ditch and the installation of approximately 650 feet of new 27” diameter plastic pipe. The purpose of this Project was to prevent soil and other material from falling into this ditch section from an adjacent steep slope area, plugging the ditch and then causing the ditch to overtop and fail. If this ditch section were to fail or overtop, water would flood onto an adjacent set of active railroad tracks.

Chilili Ditch section – pre-construction.

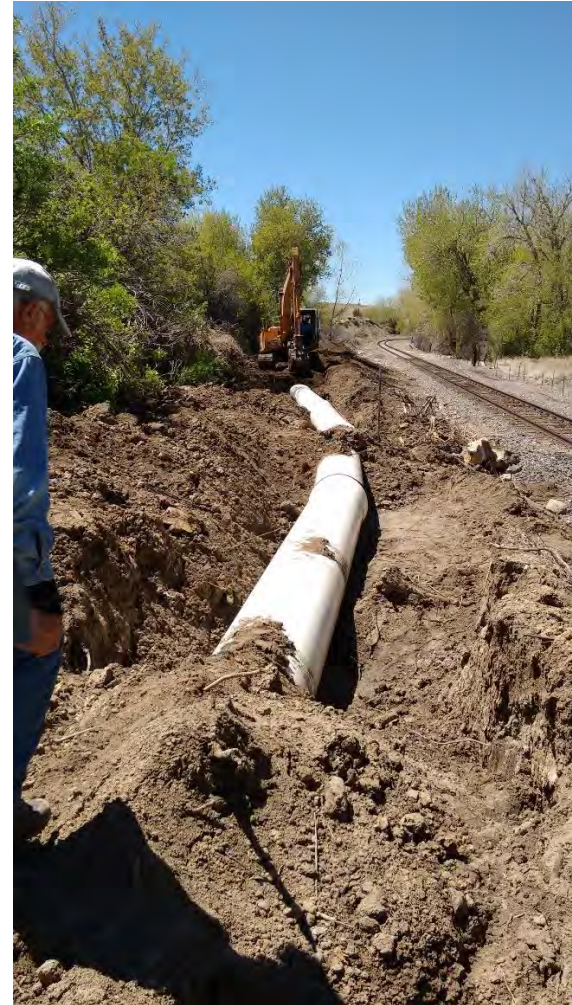
Chilili Ditch section – 30" diameter pipe construction.

This new piped ditch section was completed in May 2017 and functioned well and as planned during the 2017 and 2018 irrigation seasons.

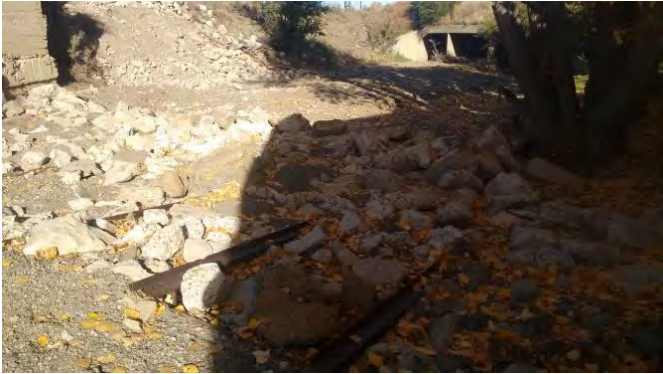
| TASK NO. 3 - BACA DITCH SIPHON PROTECTION | |

The Baca Ditch crosses the Powell Arroyo just northeast of Trinidad, Colorado by means of a ditch concrete siphon under the bed of this natural arroyo. Rain runoff events over the years have eroded this arroyo bed down to the point of exposing part of the top of this siphon. The purpose of this Project task was to key in a new layer of concrete above the siphon to vertically control the arroyo bed elevation and prevent further exposure of the siphon.

| TASK NO. 3 - BACA DITCH SIPHON PROTECTION | |
|---|---|
| Baca Ditch Siphon – Pre-construction. Exposed railroad rail and siphon. | Baca Ditch Siphon – During construction. Key wall beginning to be formed. |

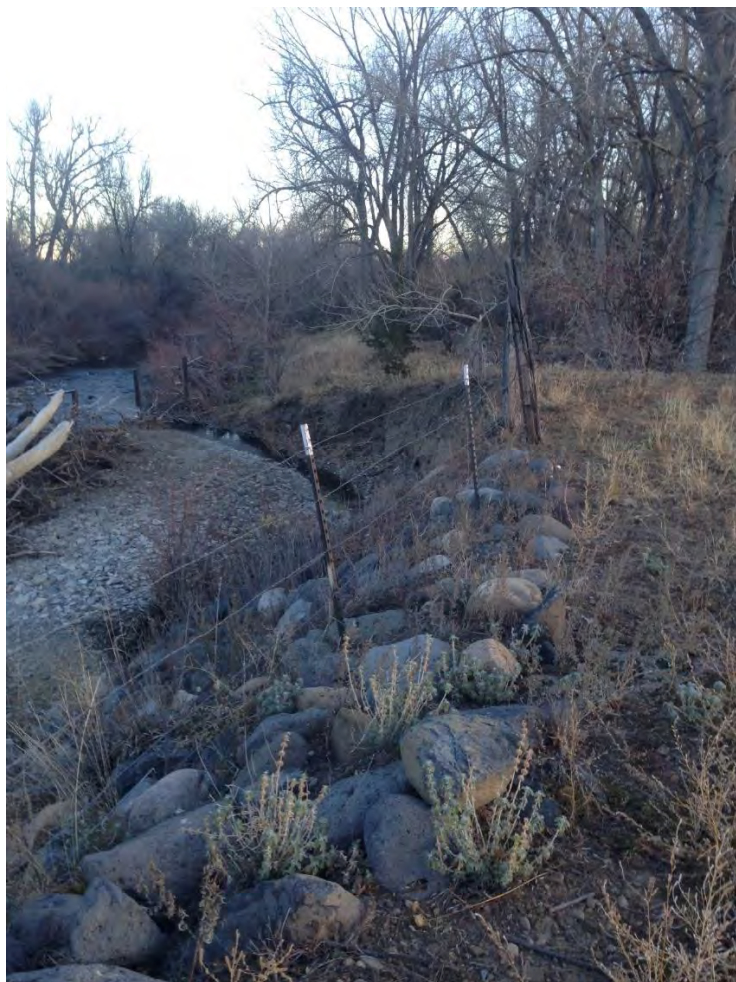
**TASK NO. 4 - ENLARGED SOUTHSIDE IRRIGATION DITCH DIVERSION EROSION REPAIR**

The Enlarged Southside Irrigation Ditch diverts from the right bank of the Purgatoire River east of Trinidad Colorado. The right bank of this river was eroding to the south immediately downstream of the headgate and threatening the ditch itself. Task No. 4 was designed to remove some old existing erosion protection (old car bodies) and re-grade and re-slope this river bank area with new erosion protection material.

Southside Ditch headgate downstream area – pre-construction.

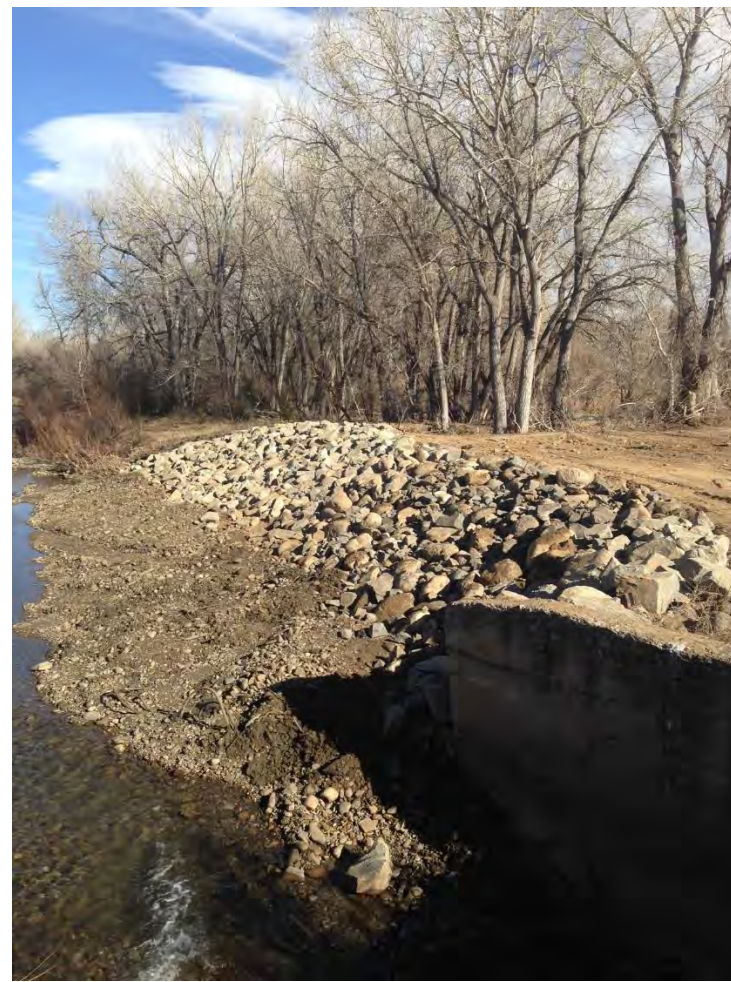
Southside Ditch headgate downstream area – post-construction.

Work under this task consisted of removing any existing debris and old protection materials, re-sloping the area, installation of a fabric liner, installation of gravel, installation of boulders and finally regrading of the river bed and bank up onto the lower level of this reworked area.

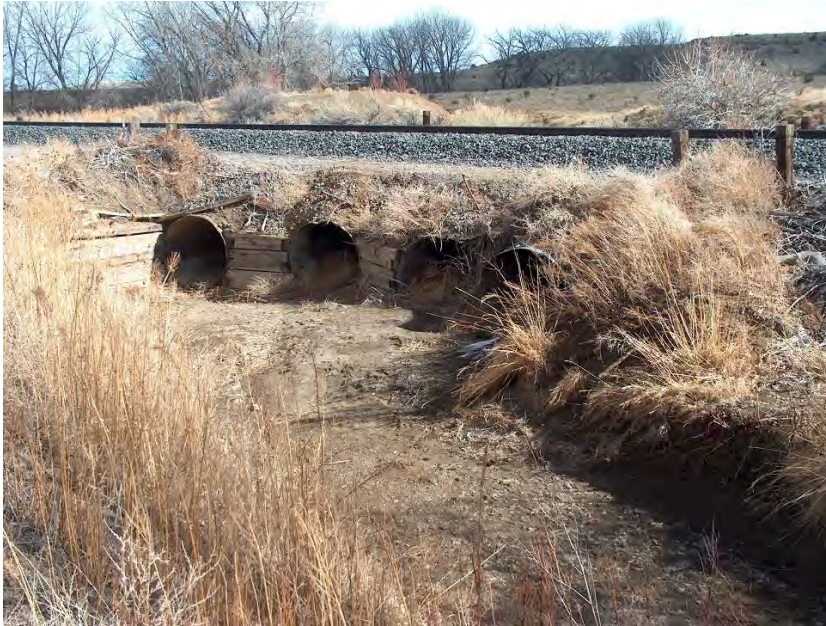
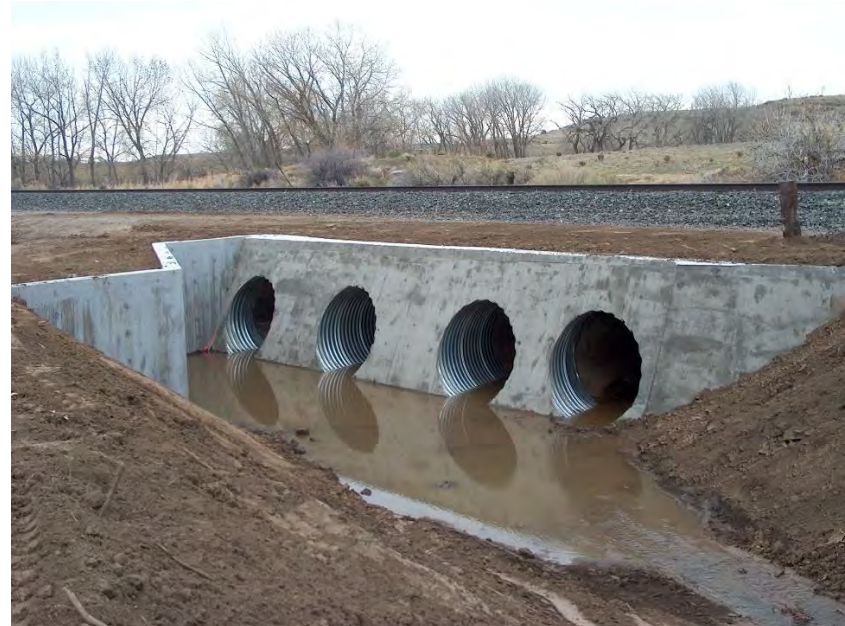
**TASK NO. 5 - ENLARGED SOUTHSIDE IRRIGATION DITCH RAILROAD CROSSING**

Prior to leaving the immediate area of the Purgatoire River, the Enlarged Southside Irrigation Ditch crosses under a set of active railroad tracks by means of four large metal culverts and two 90° turns in the course of the ditch. The length of these culverts was minimal for the width of the railroad bed at this location such that any erosion around these culverts could endanger the railroad tracks. These 90° ditch course turns additionally induced deposition of sediments at this location.

Enlarged Southside Irrigation Ditch Railroad Crossing, pre-construction and post-construction.

Work under this task consisted of cleaning out existing sediments from the ditch, placing a concrete floor on the bottom of the ditch leading into the culverts and placing a vertical concrete wall on the left side of the ditch to protect against erosion. This new concrete ditch floor and wall was placed to both protect the culverts from erosion and to induce higher water velocities to reduce sediment deposition. Extensions were also installed on the up-ditch end of the culverts to move this area further from the railroad bed and finally encasing the culverts in a new concrete headwall, again to protect against erosion.

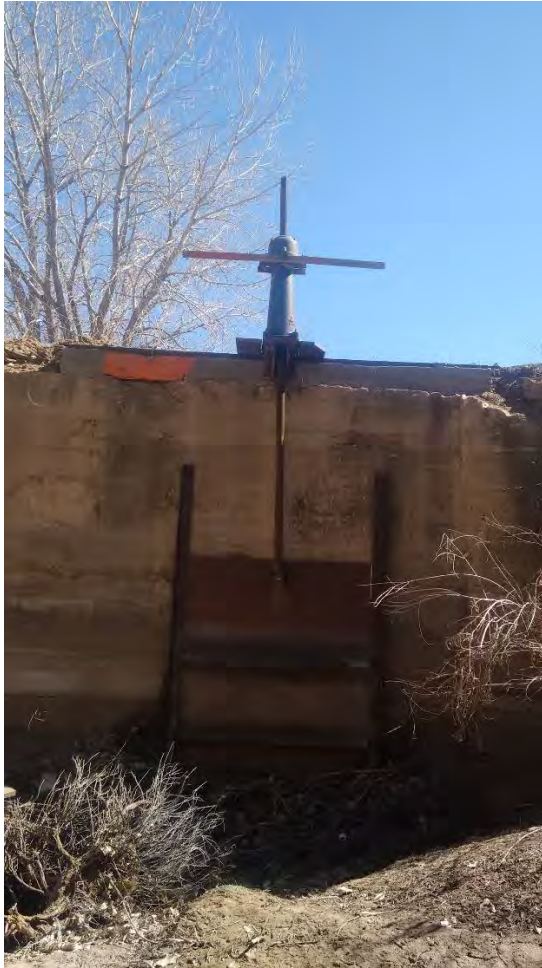
**TASK NO. 7 - NEW JOHN FLOOD DITCH HEADGATE**

The New John Flood Ditch takes delivery of its water right water from a lateral off of the Model Canal. This lateral headgate no longer was able to close fully thus allowing Model Canal water to leak into the New John Flood Ditch.

John Flood Ditch headgate pre-reconstruction.

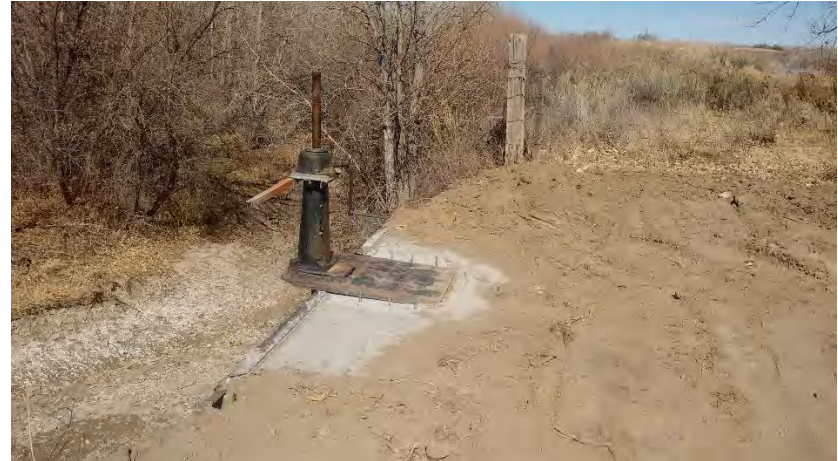
John Flood Ditch headgate, reconstructed with new concrete pad (mostly covered with soil) and new gate floor (not visible).

Work under this task consisted of providing a new gate base and re-seating the gate to allow for full closure of this ditch gate. A new concrete pad was also placed upon the headgate area along with a new safety railing at the gate control wheel to prevent anyone from falling into the Model Canal.

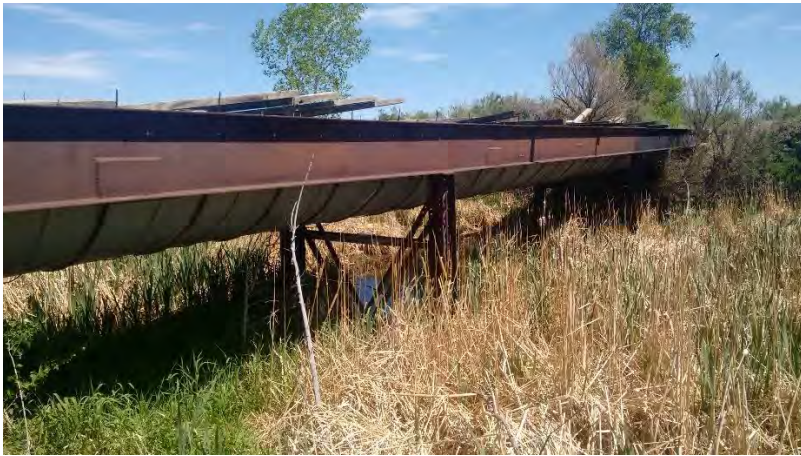
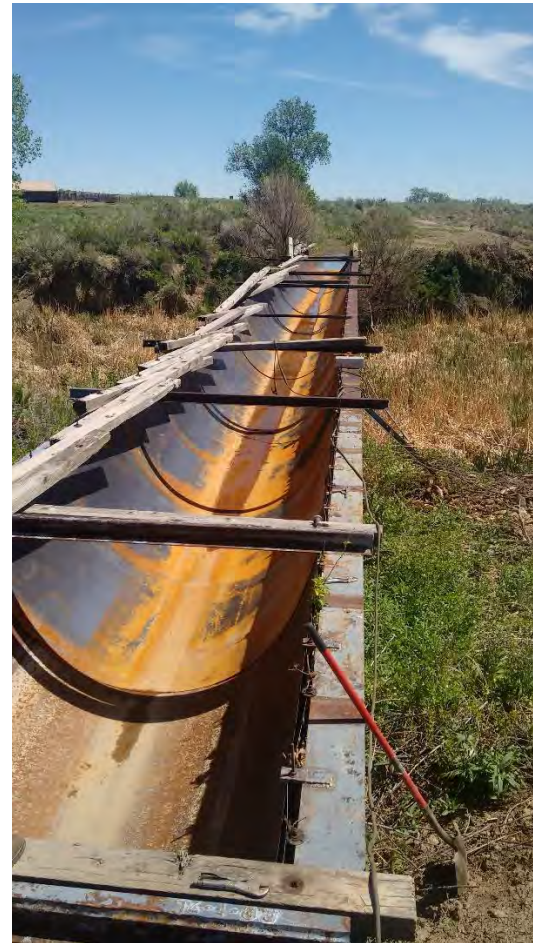
**TASK NO. 8 - NEW JOHN FLOOD DITCH LIETZENDORFER ARROYO FLUME**

Task Number 8 under this grant was for the relining of the New John Flood Ditch Company's irrigation water flume over the Lietzendorfer Arroyo. The abrasive nature of sediments carried in this ditch's water eventually eroded the lining of this flume. Eventually leaks developed and water supplies were being lost.

John Flood Ditch Lietzendorfer Arroyo flume. New sheet layer of steel lining being placed (bright orange rust area).

This task consisted of placing and welding new sheet metal over the existing sheet metal bottom of this flume during April and May of 2017. This work was completed by the middle of May

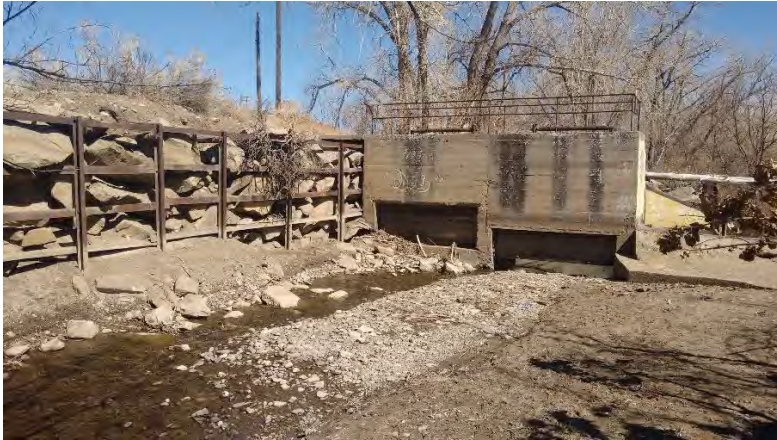
**TASK NO. 1 - PICKETWIRE DITCH HEADGATE**

Picketwire Ditch headgate – pre-construction.

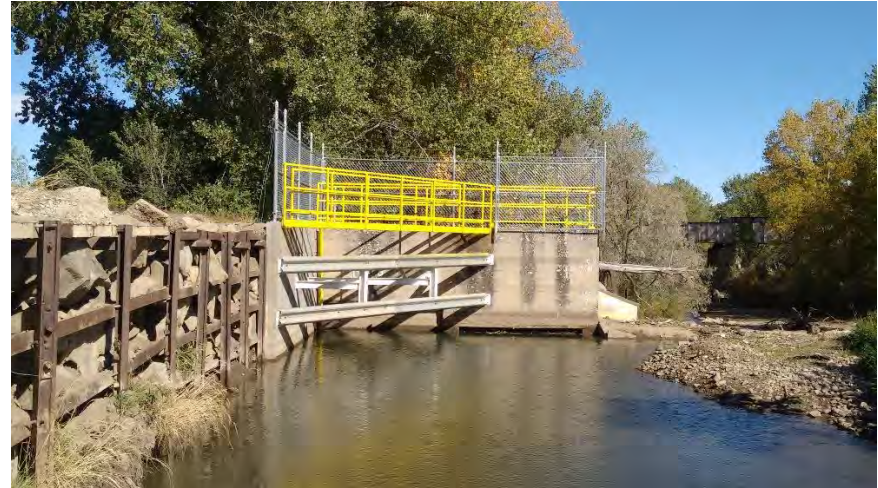
Picketwire Ditch headgate – post-construction.

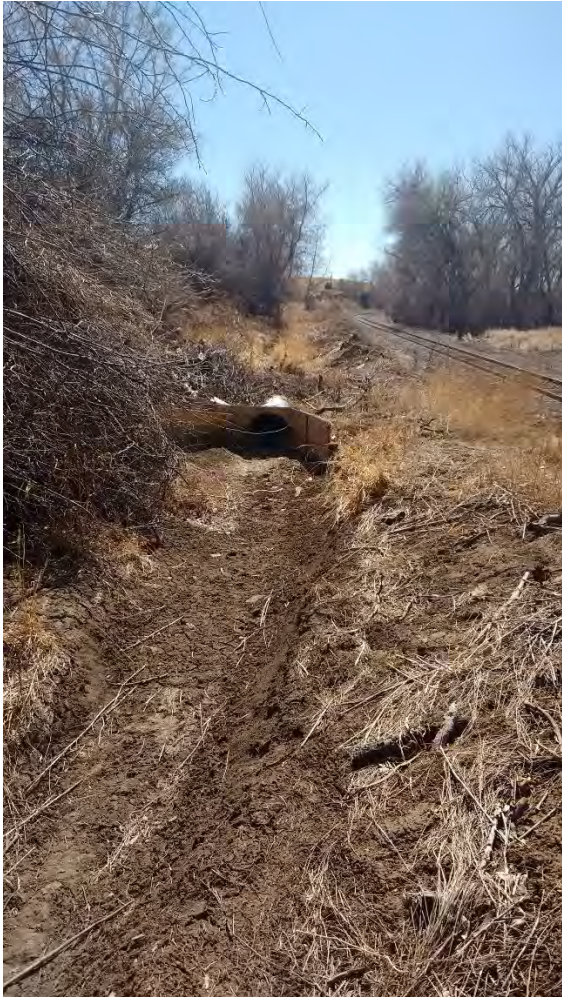
**TASK NO. 2 - CHILILI DITCH PIPELINE SECTION**

Chilili Ditch section – pre-construction.

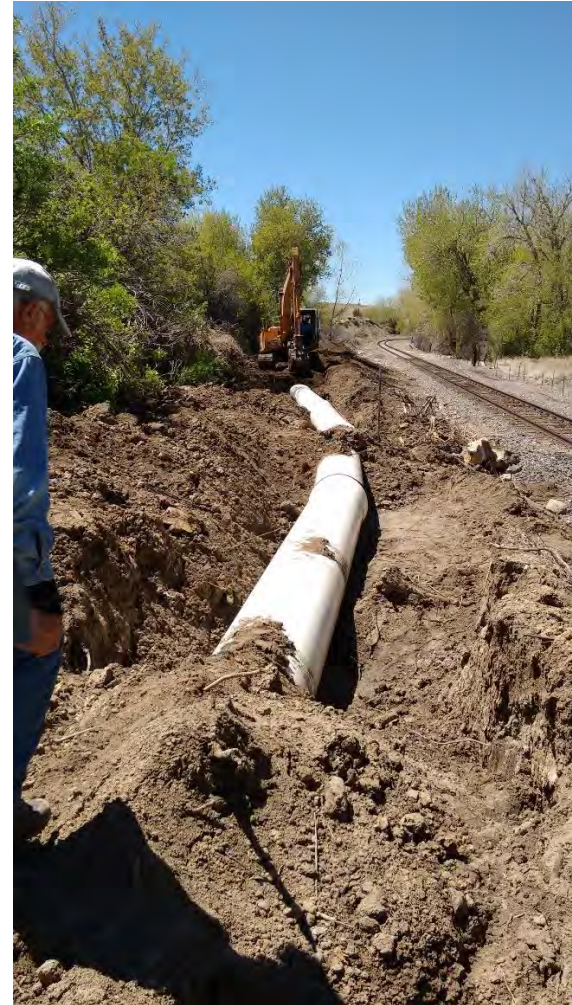
Chilili Ditch section – 30" diameter pipe construction.

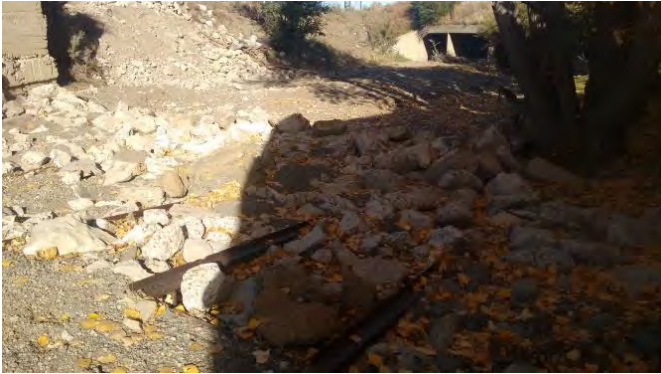
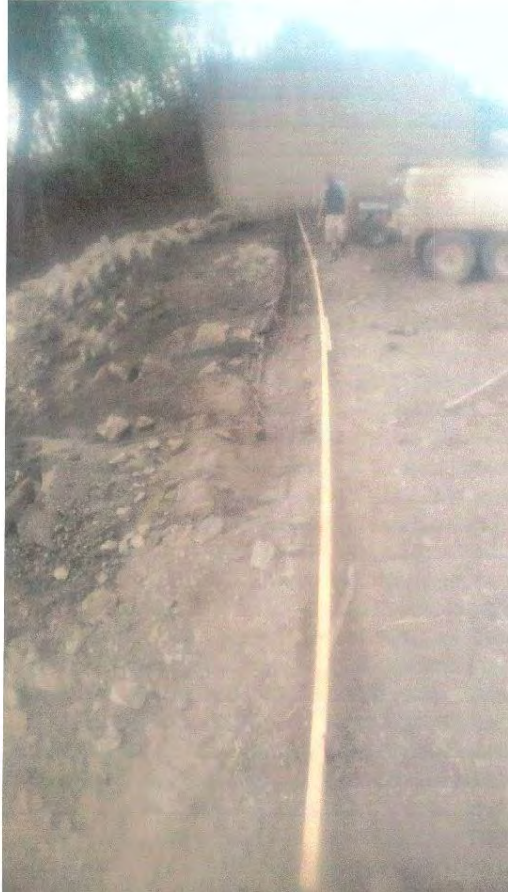
| TASK NO. 3 - BACA DITCH SIPHON PROTECTION | |

| TASK NO. 3 - BACA DITCH SIPHON PROTECTION | |
|---|---|
| Baca Ditch Siphon – Pre-construction. Exposed railroad rail and siphon. | Baca Ditch Siphon – During construction. Key wall beginning to be formed. |

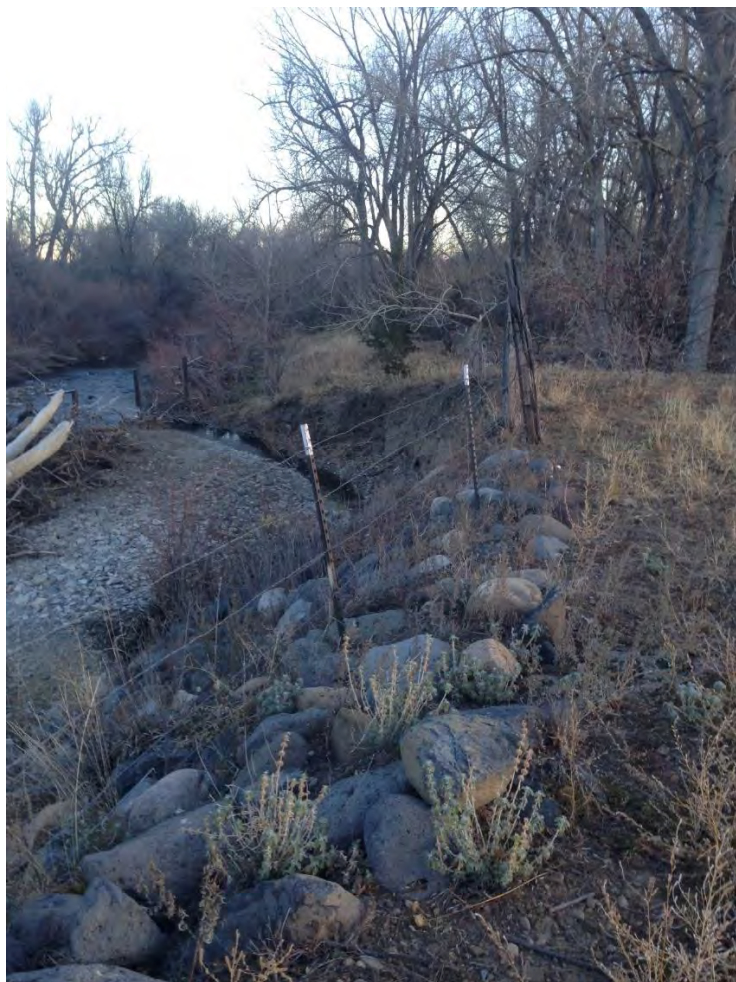
**TASK NO. 4 - ENLARGED SOUTHSIDE IRRIGATION DITCH DIVERSION EROSION REPAIR**

Southside Ditch headgate downstream area – pre-construction.

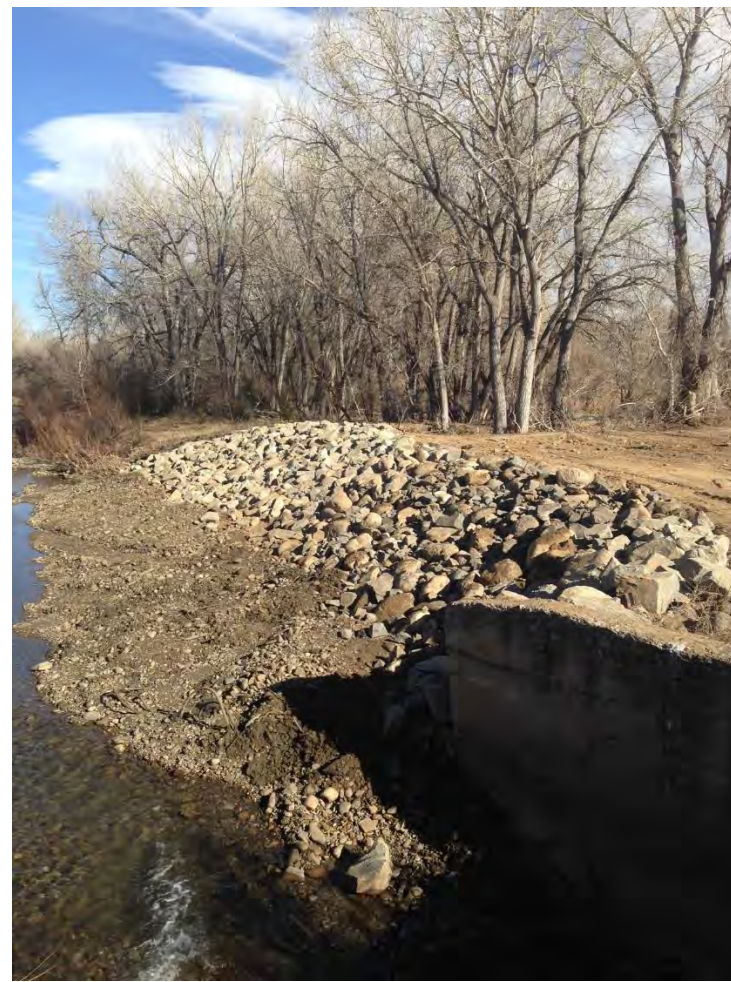
Southside Ditch headgate downstream area – post-construction.

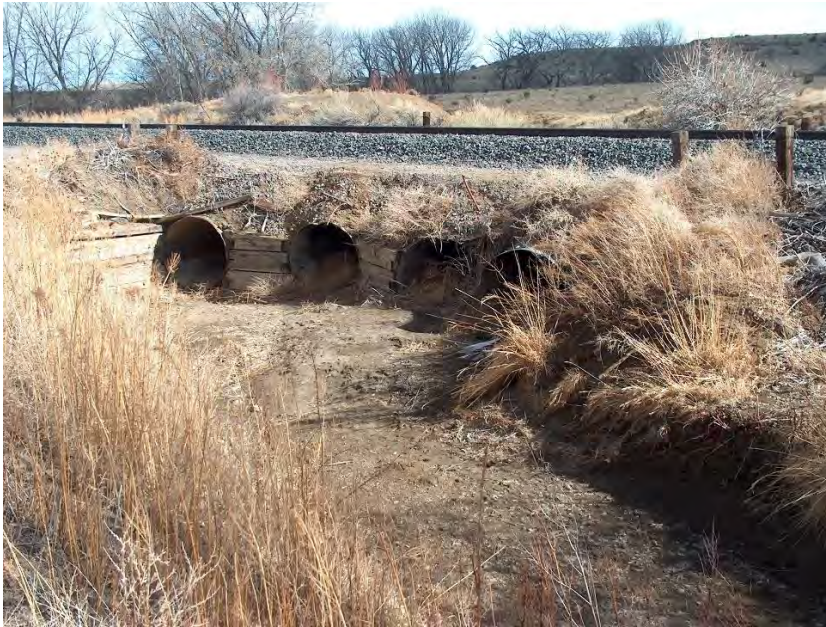
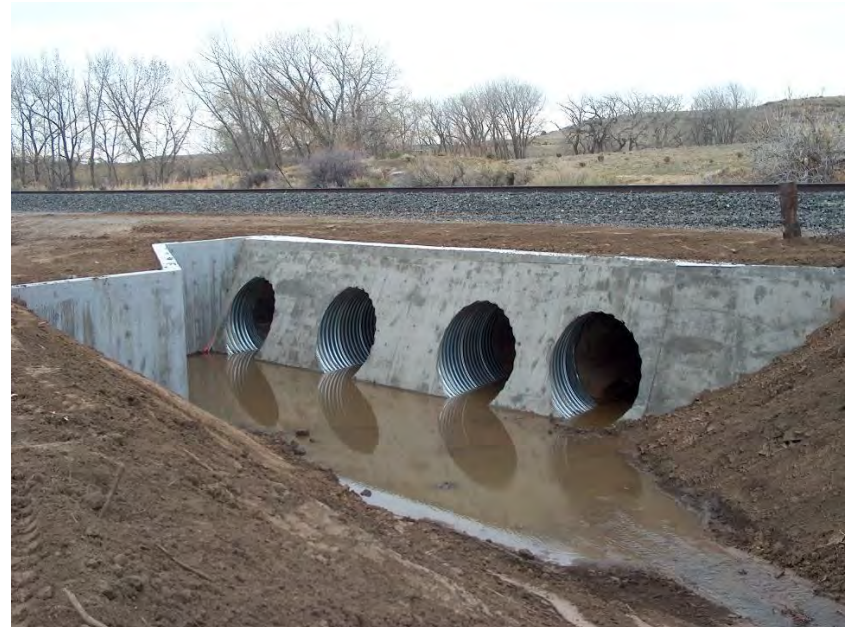
**TASK NO. 5 - ENLARGED SOUTHSIDE IRRIGATION DITCH RAILROAD CROSSING**

Enlarged Southside Irrigation Ditch Railroad Crossing, pre-construction and post-construction.

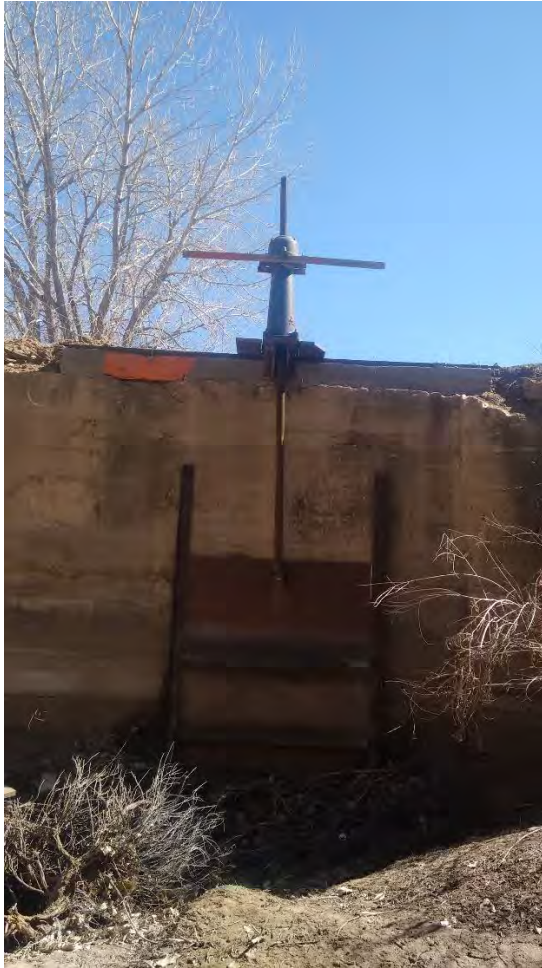
**TASK NO. 7 - NEW JOHN FLOOD DITCH HEADGATE**

John Flood Ditch headgate pre-reconstruction.

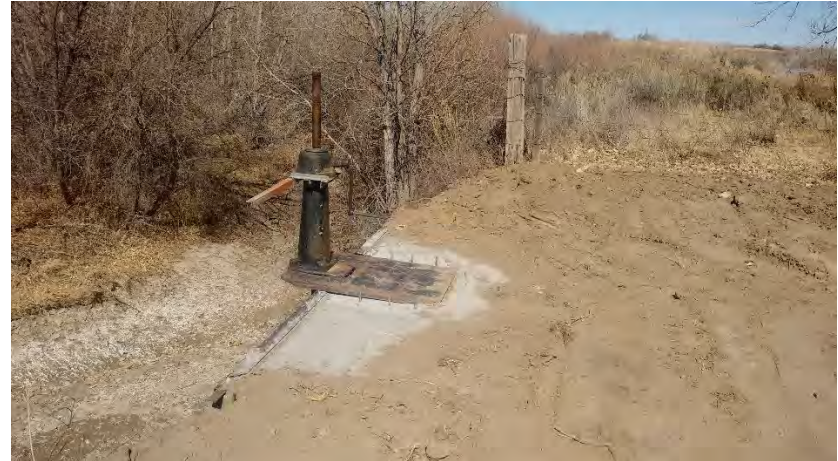
John Flood Ditch headgate, reconstructed with new concrete pad (mostly covered with soil) and new gate floor (not visible).

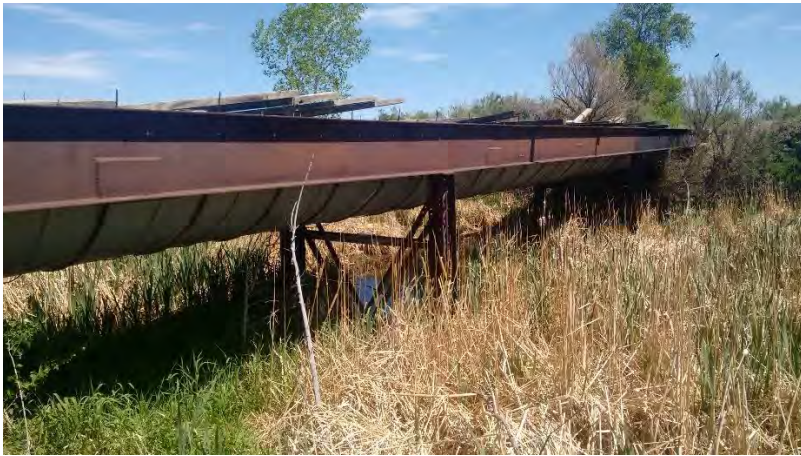
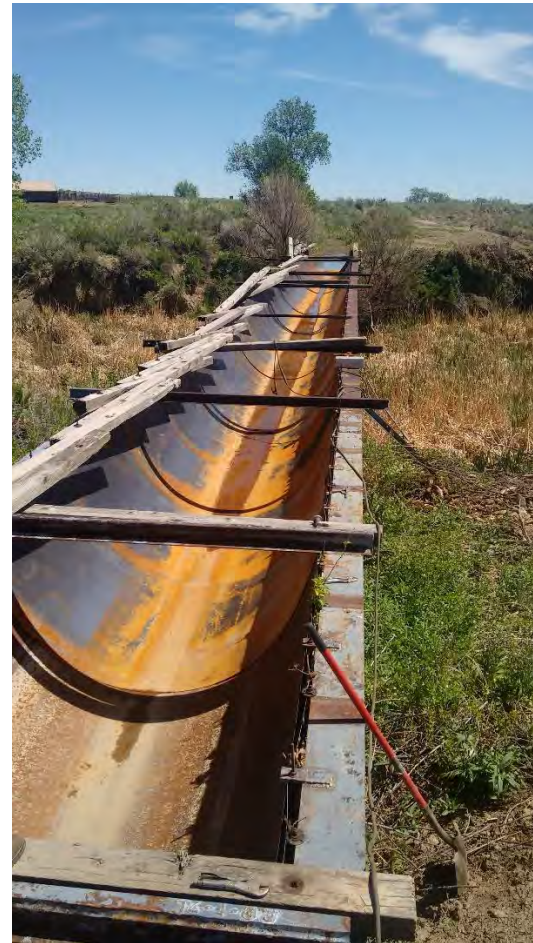
**TASK NO. 8 - NEW JOHN FLOOD DITCH LIETZENDORFER ARROYO FLUME**

John Flood Ditch Lietzendorfer Arroyo flume. New sheet layer of steel lining being placed (bright orange rust area).
