# UPPER RIO GRANDE WATERSHED ASSESSMENT

FINAL December 2018

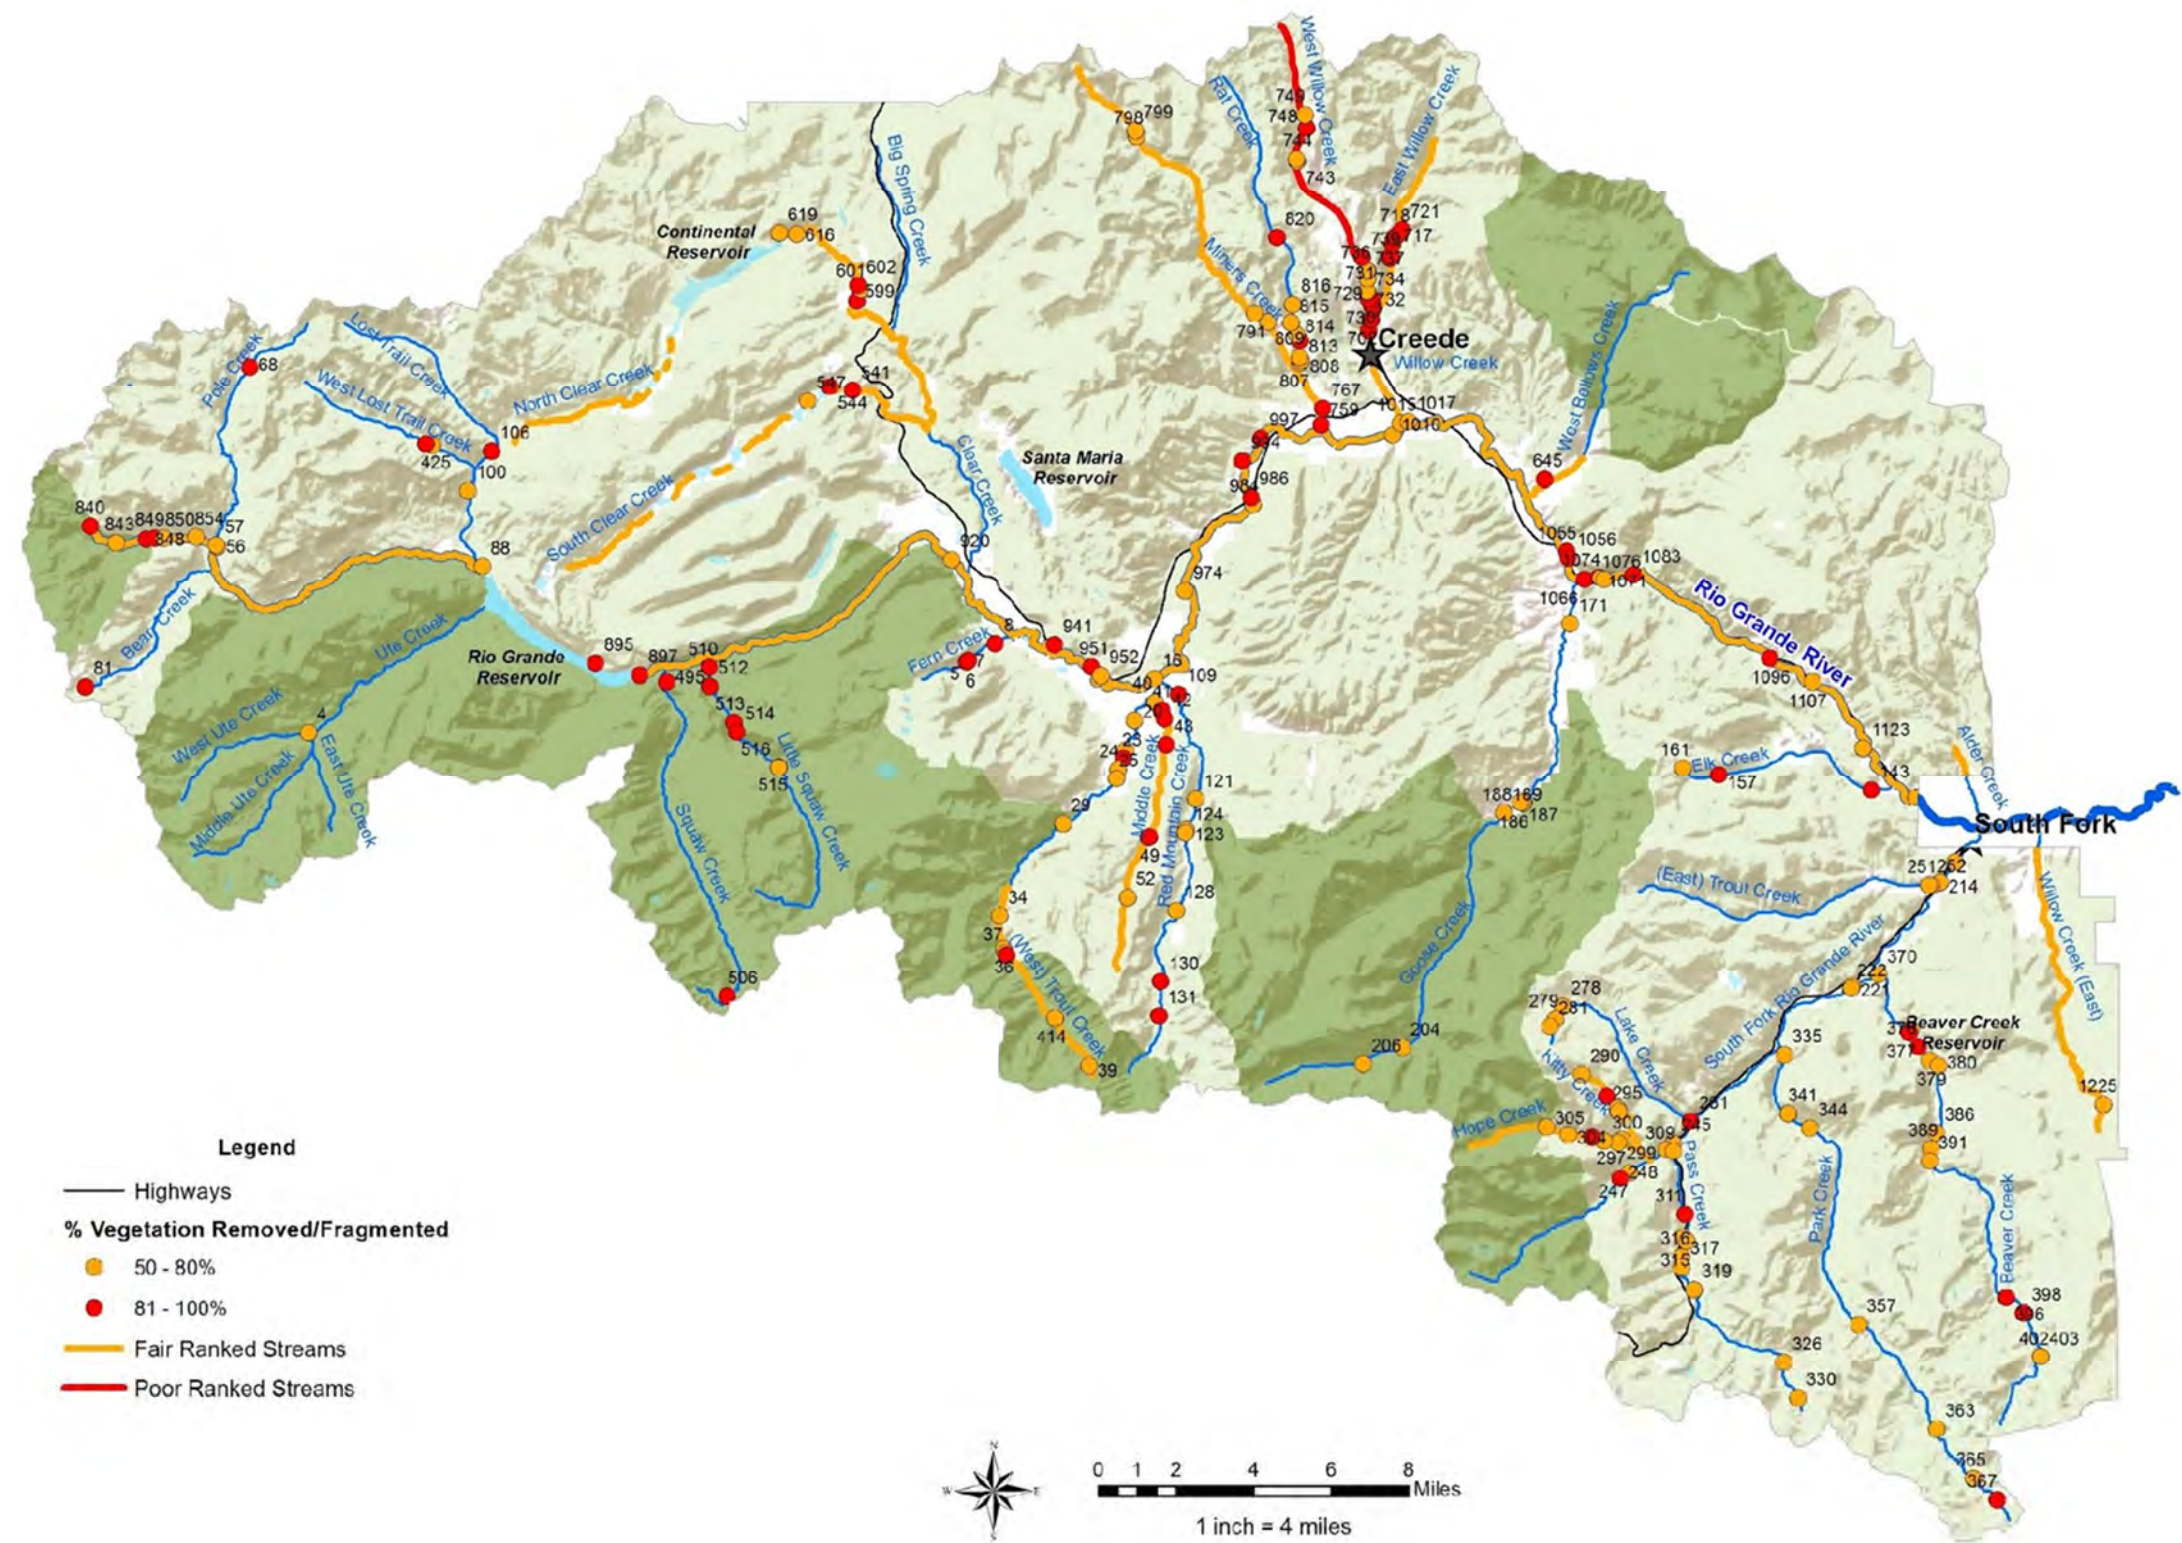
Figure 4-2. Riparian Impacts

The extent of impacts to riparian areas within the watershed depends greatly on the location of the riparian area and the proximity to roads and existing infrastructure. Much of the watershed is USFS land and designated wilderness, both of which have restrictions on the use of the areas that generally reduce the potential for impacts, especially for wilderness areas.

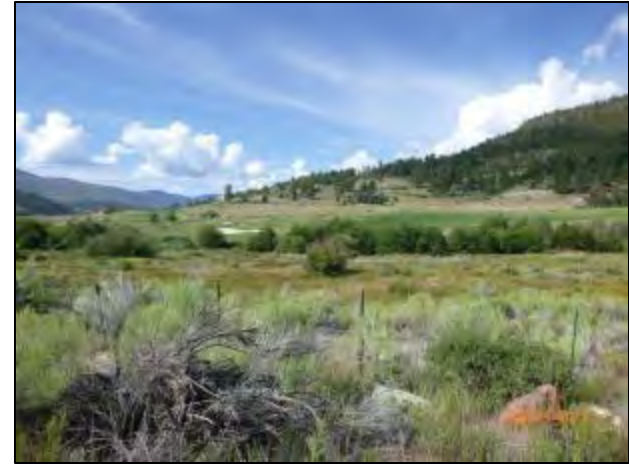
Photo 2. Photo taken within the vicinity of the site. Dispersed recreation impacts from golf course.

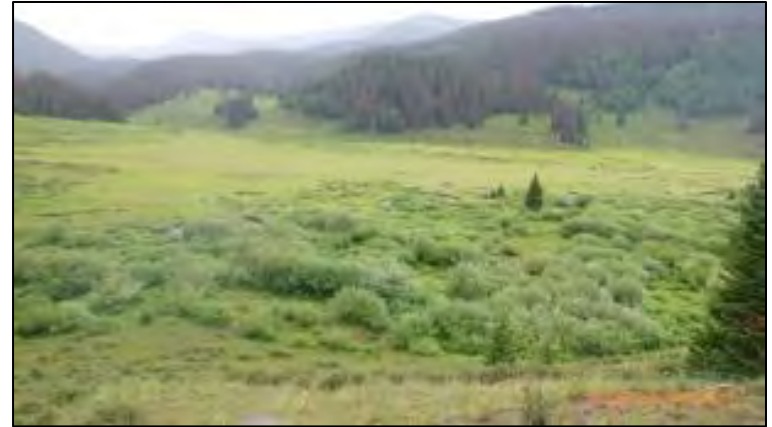
Photo 5. Beetle kill impacts in the upland areas.

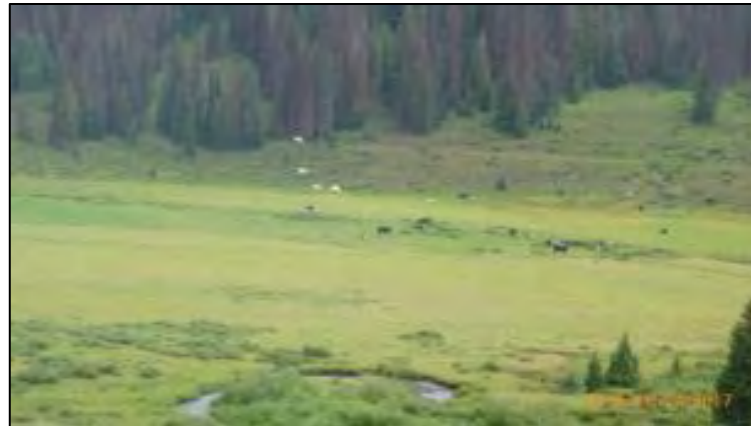
Photo 6. Some grazing impacts.

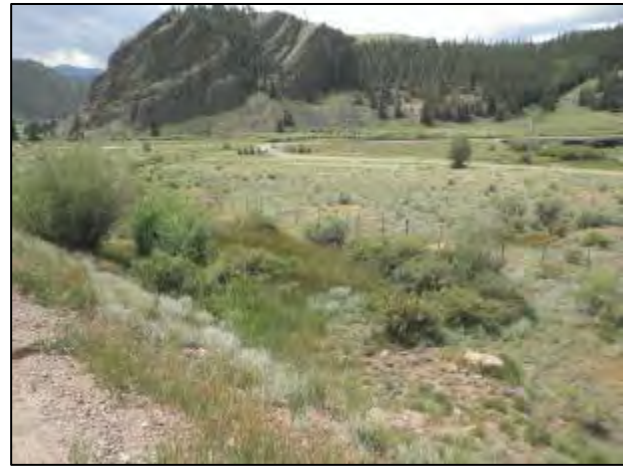
Photo 8. Unable to access site on Bellows Creek due to private land.

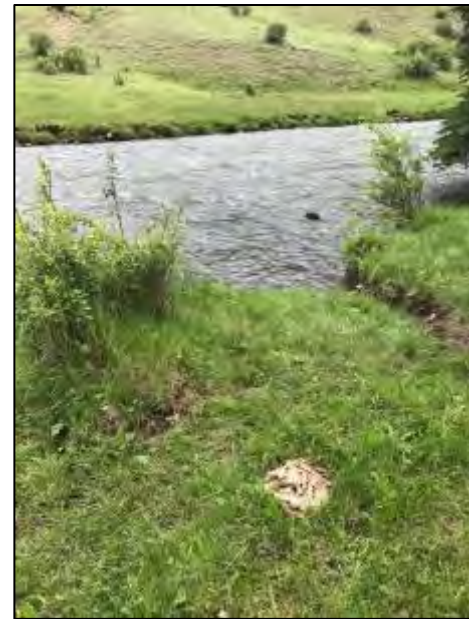
Photo 10. Dispersed recreation and grazing impacts along Clear Creek.

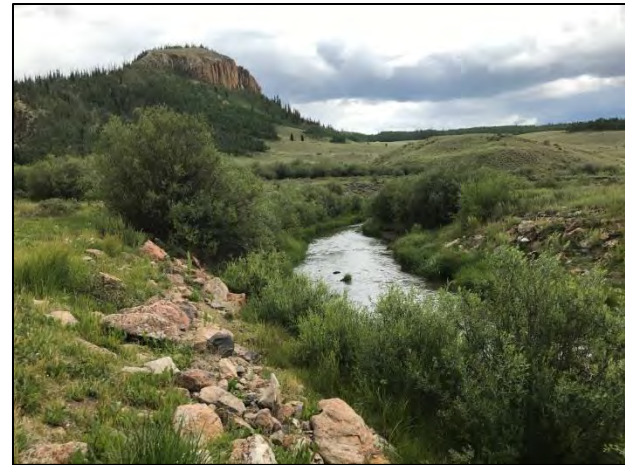
Photo 22. Dispersed recreation and beetle kill impacts.
