June 27, 2019

Re: Terrace Reservoir Outlet Inspection and Outlet Works Pipe Repair Concepts; D&A Job No. CG-0526.002.00

OUTLET WORKS TUNNEL AND 48-INCH DIAMETER PIPE INSPECTION

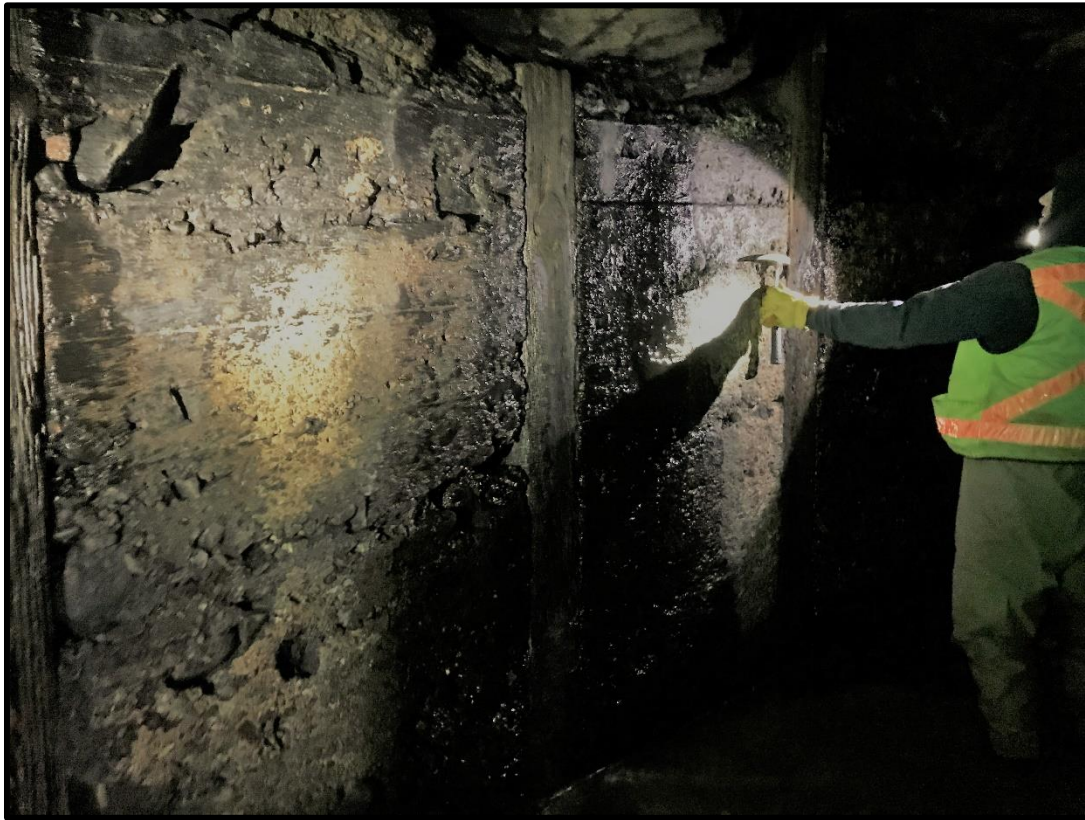
Photo 1. Concrete and timber bulkhead near abandoned access adit.

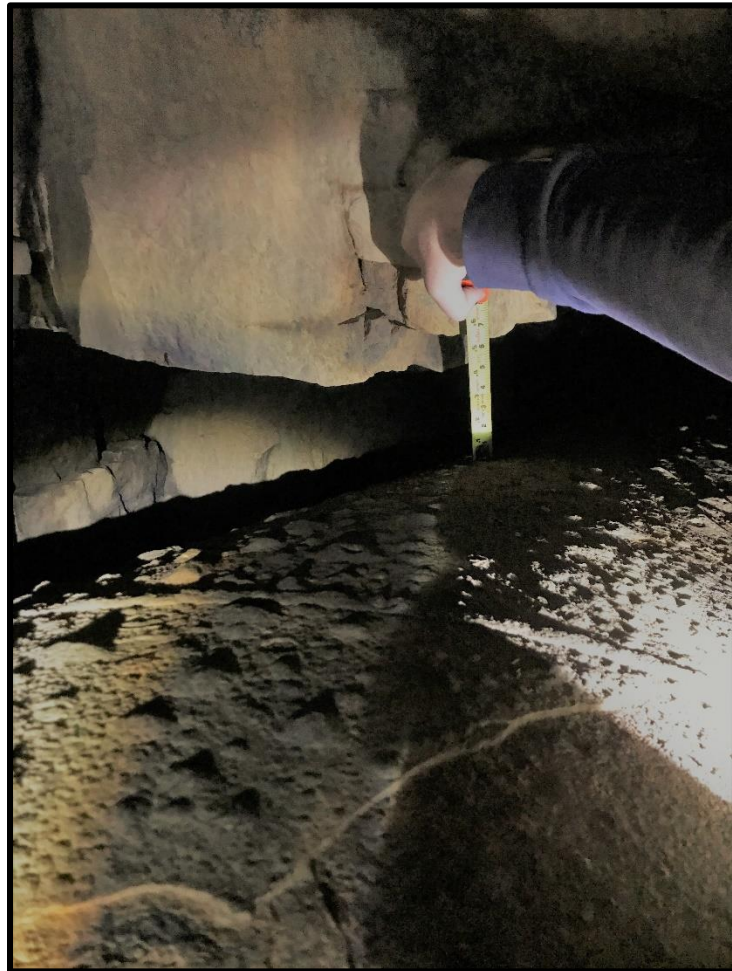
The 48-inch diameter outlet pipe generally follows the east side of the tunnel. At the tunnel bend the pipe is encased and enclosed by a post tensioned, cast-in-place, concrete thrust block that extends from the tunnel invert to the tunnel crown. The thrust block is approximately 4-foot long and is reinforced with horizontal tensioned rock anchors. The opening between the concrete thrust block and west tunnel rib is approximately 30-inches. In places the steel pipe is within a few inches of the tunnel crown, particularly near and upstream of the concrete thrust block. Also, in areas along the tunnel, the east side of the pipe is within 12-inches of the east tunnel rib.

Photo 2. 5-inch clearance between pipe crown and tunnel back.

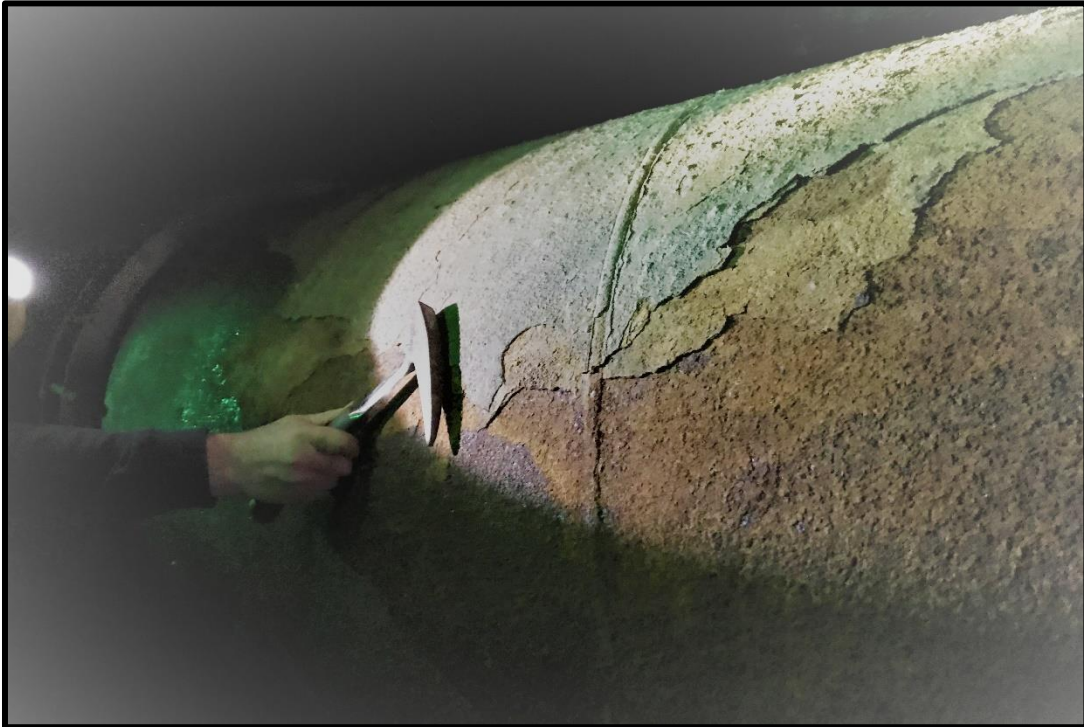
The pipe's exterior shows signs of rusting throughout its length but is notably bad approximately 150 feet upstream of the tunnel outlet. In many areas from this distance to the concrete outlet gate structure the pipe has a notable layer of iron oxide up to 1/8-inch thick. The following photographs show examples of corrosion on the west and under sides of the pipe in these areas.

Photo 3. 48-inch diameter welded steel pipe, showing corrosion and iron oxide layers.

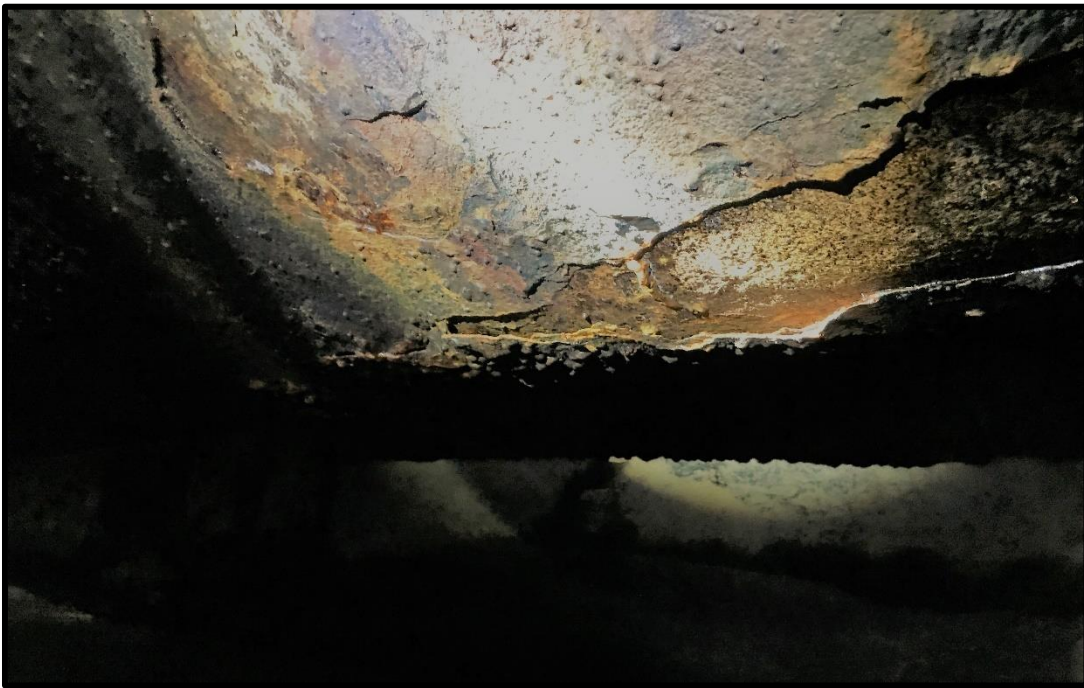
Photo 4. Underside of the 48-inch diameter welded steel pipe showing corrosion and iron oxide layers.

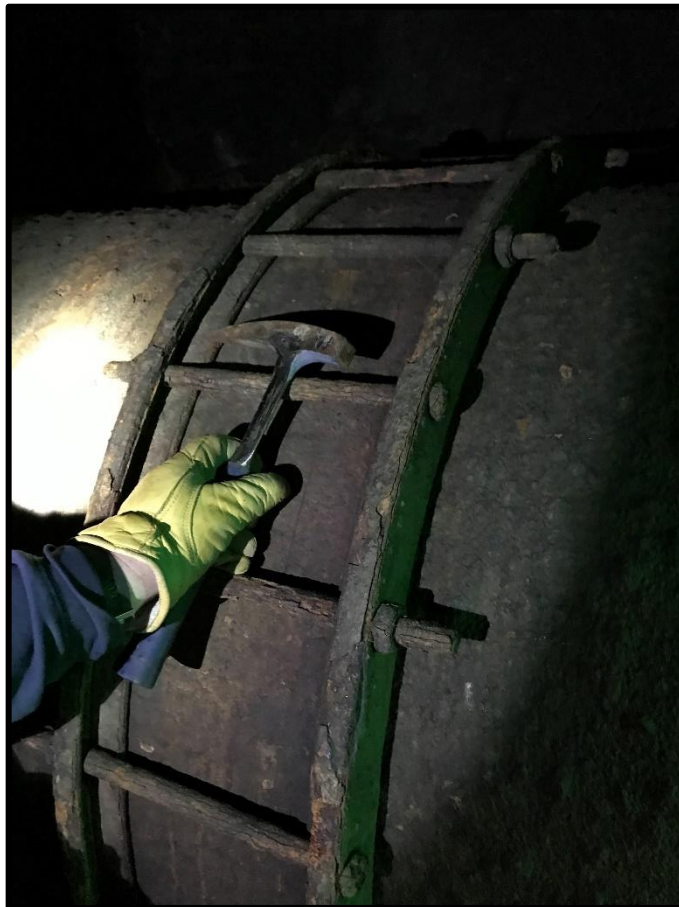
The bolts for the expansion couplings are severely corroded. No signs of leakage from the pipe was apparent at the expansion couplings. Factory coatings are still partially visible on one of the couplers. The threaded steel anchors cast into the concrete supports were severely corroded as well, with two of the straps no longer being connected. This is shown in the following photo.

Photo 5. Expansion Coupling

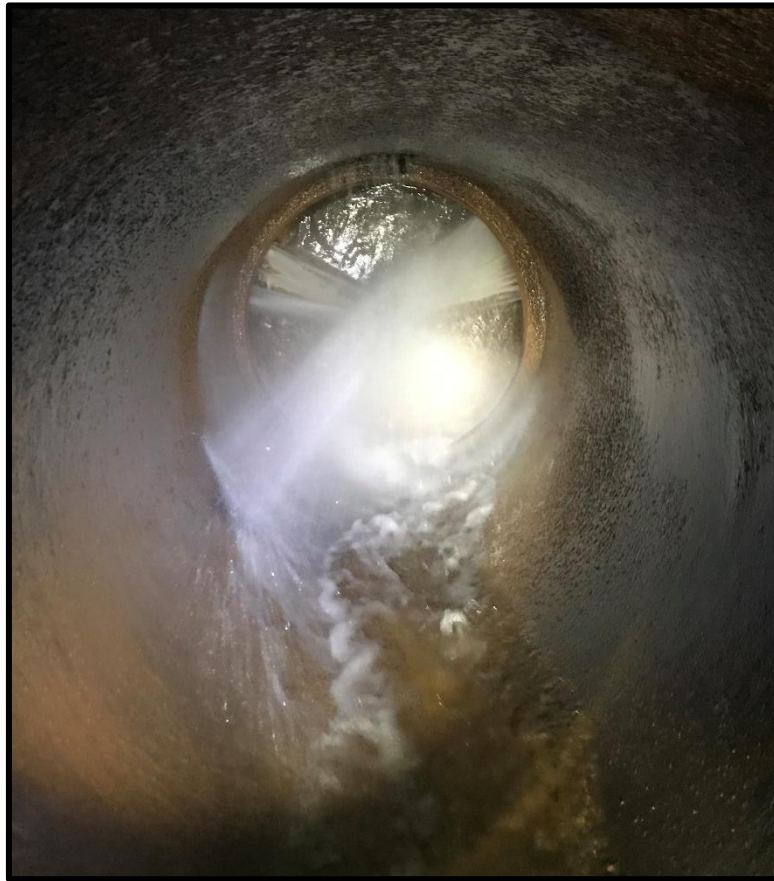
The existing west gate valve leakage was observed during our tunnel inspection. With approximately 60 feet of head it was estimated 1 cfs was spraying between the seats on the valve. The leaks are located at the ten o'clock and two o'clock position as show in in the following photo.

Photo 6. Downstream view of West Gate Valve Leakage

We understand that the west gate valve leaf was broken while in service. It was removed and a new matching leaf was cast and the brass settings were replaced or repaired by Brimhall Industrial. After the new leaf was attached the valve leaked similar to what was observed during the inspection. Based on our observation it appears the leaks are located most likely between the seals.

- Inspect the west gate valve during the outlet inspection. The leakage should be monitored during outlet inspections and documented if changes do occur, the gate valve should be reevaluated. In our experience the gate valve leaf should be operated in either closed or fully open position. This will minimize the potential for vibrations that may lead to cracks in the leaf.
