SIMON NO. 1 DAM (AKA CROSHO)
Outlet Replacement Project
Construction Completion Report
August 27, 2019

Prepared for:
Crosho Lake Corporation
22840 CR 15
Yampa, CO 80483

Prepared by:
Applegate Group, Inc.
1490 W 121st Ave, Suite 100
Denver, Colorado 80234

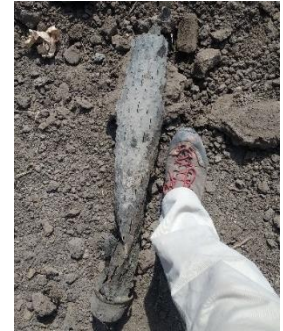
FIGURE 1
EXCAVATED DRAIN
PIPE

Initial excavation of the existing outlet began in August of 2017. Originally the excavation was constructed with steeper slide slopes than indicated on the plans and the contractor was directed to lay them back further. Small sections of a smaller steel pipe were excavated from the vicinity of the old outlet vault. While it was impossible to determine the exact extents of the pipe it did not appear that it was very long and it did not exit the embankment. It may have been placed as part of a drain that was used during construction of the original outlet pipe. The existing pipe broke into many pieces during removal and many sections were noted to have small to large perforations. As noted in Figure 2 some sections had deteriorated to the point they resembled a ribcage with the tops of the corrugations being completely corroded.

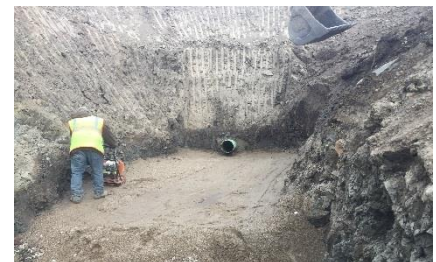
FIGURE 3 FOUNDATION DRAIN
CONSTRUCTION

In 2018, the downstream section of pipe had to be excavated again due to grade issues and during this time significant ground water was again encountered. After waiting a week for flows to subside it was determined that a better course of action would be to control and collect the seepage. The selected method required excavation of the trench beneath the pipeline down to firm bedrock. Coarse gravel was then placed on top of the shale bedrock and covered with a minimum of 12 inches of filter compatible sand. This provided a firm foundation for the outlet and allowed the water to drain continuously to a temporary sump placed in the bottom of the gravel layer. It was further determined that a 6 inch perforated pipe would be placed in the foundation gravel downstream of the filter collar and made to daylight in the manhole. Gravel would further be placed between the outlet manhole and the shale bedrock in order to provide a firm foundation for the manhole. The section of CMP downstream of the

manhole would be completely backfilled with native clay soils in order to force water collected in the foundation gravels to exit through the 6 inch pipe where it could be monitored and controlled.

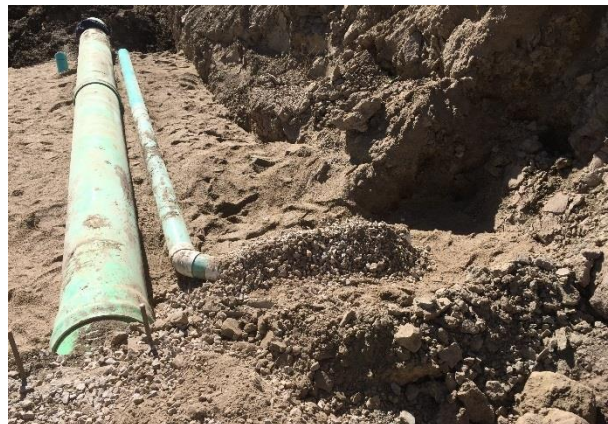
FIGURE 4 FILTER COLLAR DRAIN CONSTRUCTION

Two new sections of 18 inch PVC were purchased by Anson to replace those damaged during removal of

the flowfill in 2018. The remaining two sections were tested with compressed air and reused below the filter collar. The flowfill for the replaced pipe was poured on September 24, 2018. The filter collar, drain pipe, and remaining 18 inch outlet pipe were placed on September 27, 2018.

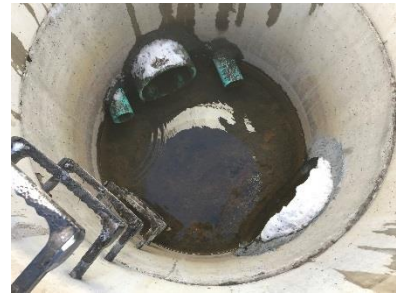
FIGURE 5 OUTLET MANHOLE

The outlet manhole and CMP section of pipe were constructed by October 12, 2017. It was noted that a significant amount of water was observed ponding in the manhole. At this point Anson stated that they had surveyed the outlet invert and that it was within the allowable tolerances. A full as-built survey of the pipe inverts on November 3rd and again on the 6th, 2017 revealed that the pipe had again been placed at the wrong elevation. The downstream end of the pipeline in the manhole was significantly lower than the proposed elevation. At this time Anson used a level loop to check their survey instrument and found that it had apparently been damaged and this had likely resulted in the problems with the pipeline grade. This necessitated the partial removal of the pipe as described in the section above.

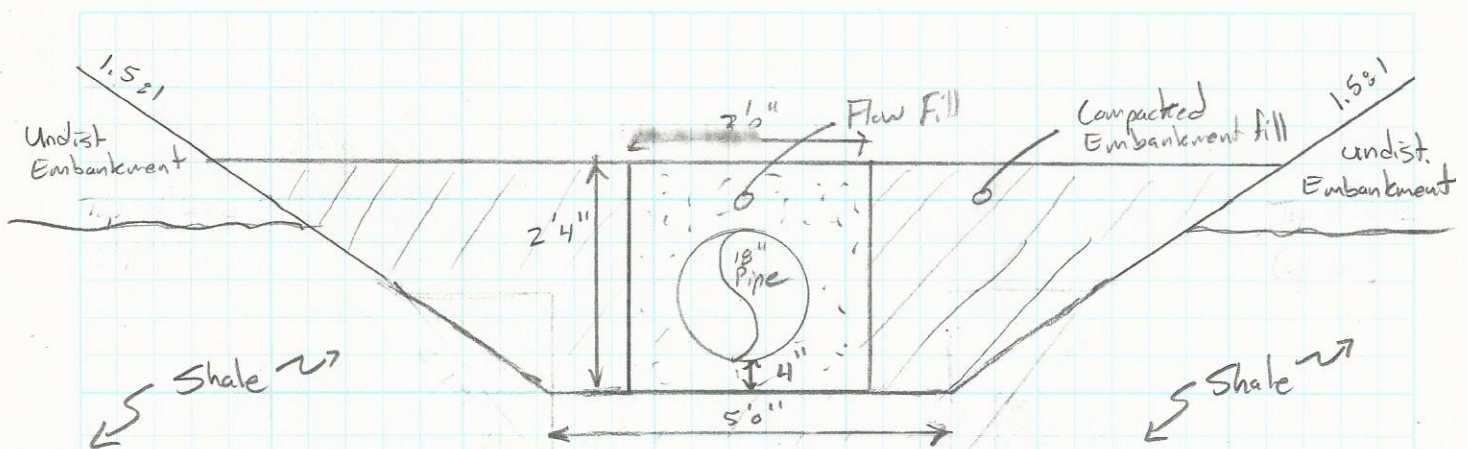
Not Constructed, groundwater subsided in 2017 and an alternate foundation drain design was constructed in 2018 as reflected on the As Built Drawings

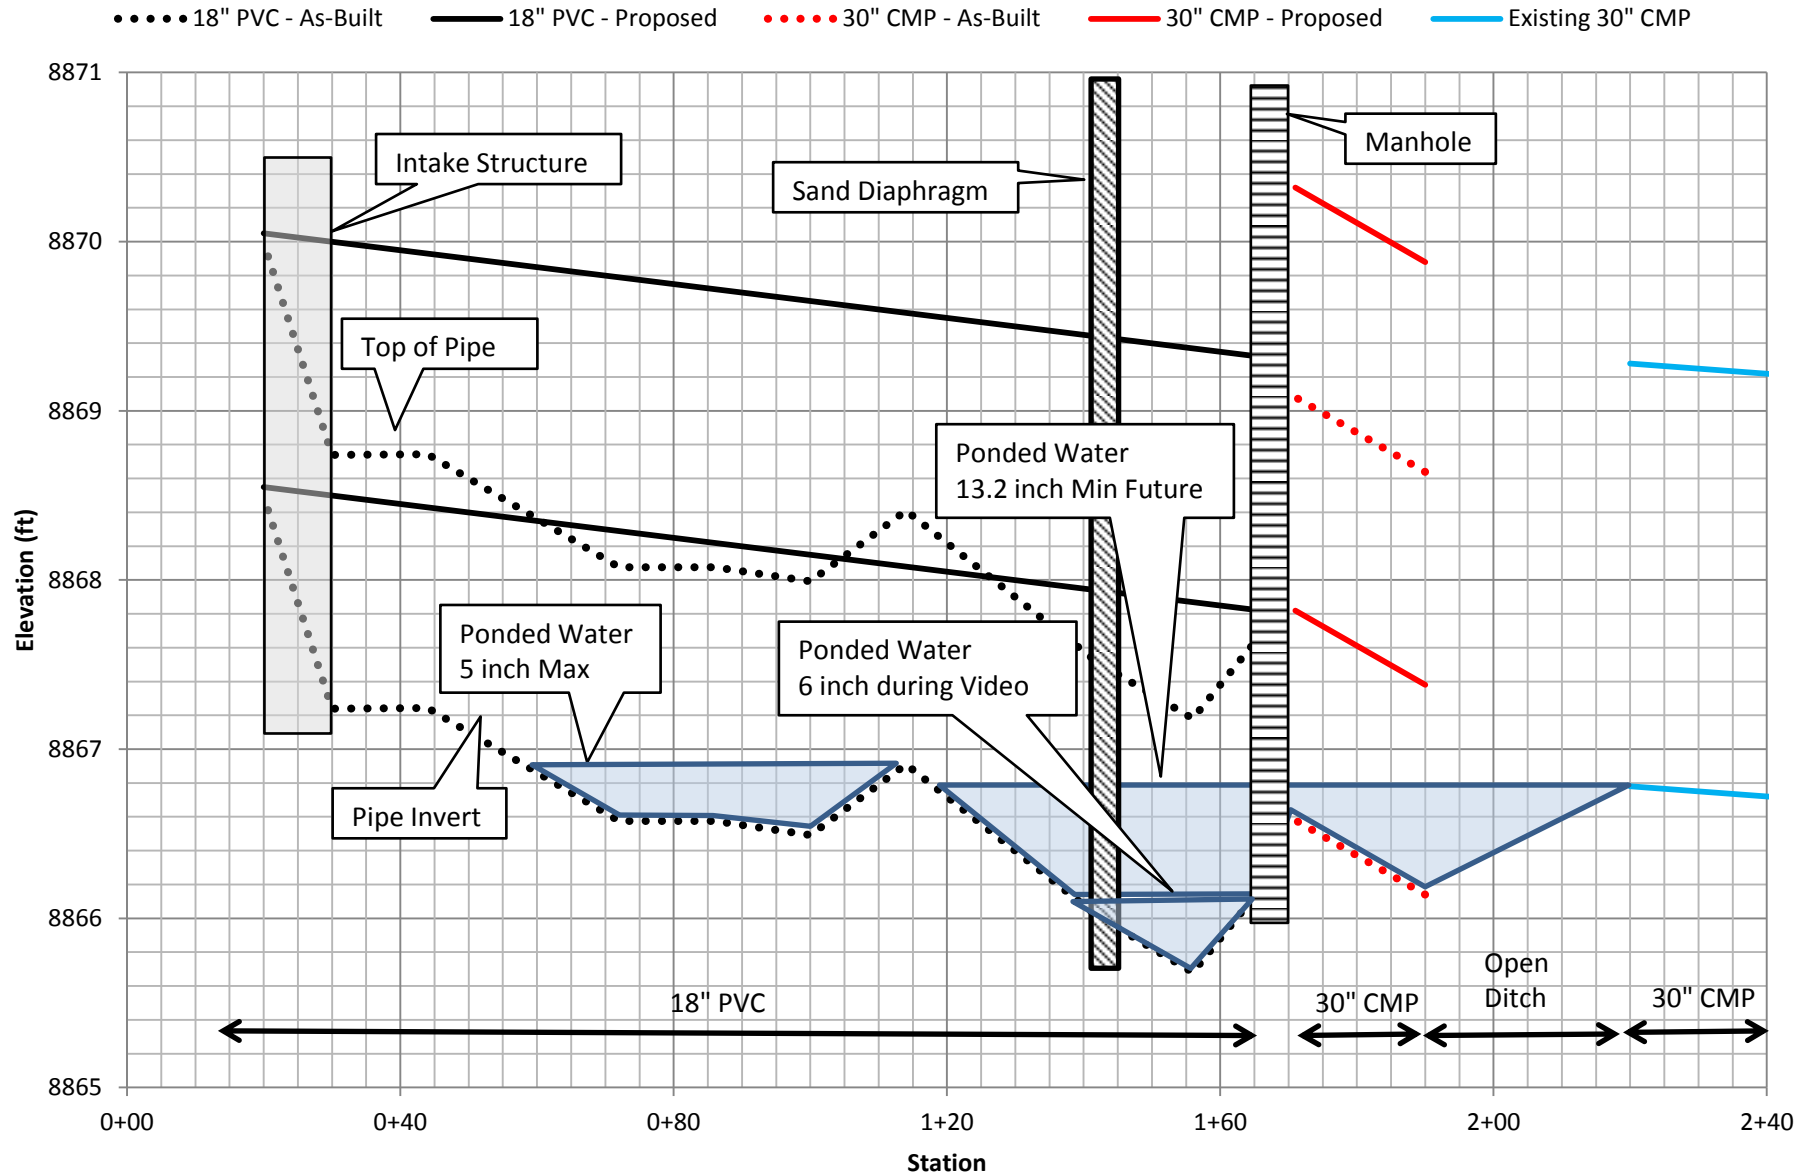
Crosho Lake Outlet - As-Built - 11/27/2017

Estimated from Anson Survey and Internal Video Inspection

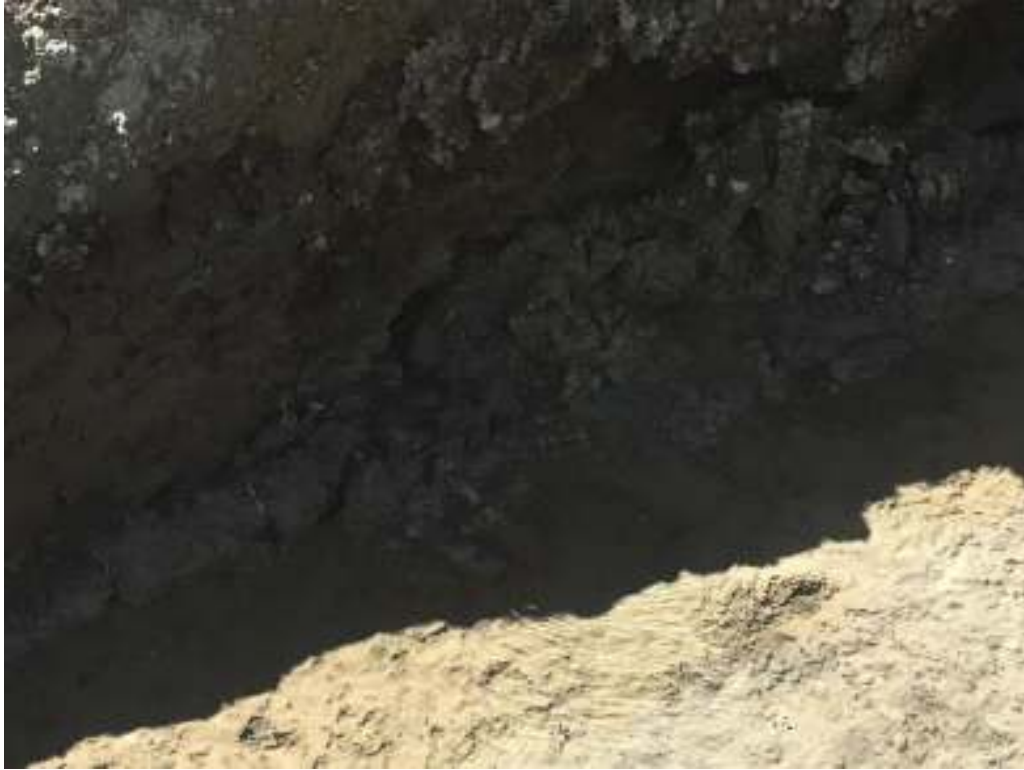
Concerned about amount of water in trench and passing through cracks in shale bedrock. Primary source appears to be the downstream 1/3 of the conduit. Will assess after excavation has been opened up for a few days. Additional drainage may be necessary. Discussed conceptual ideas for a drainage system with Dana Miller, will determine if necessary once excavation is complete

Photo 3 Seepage from sides of Excavation

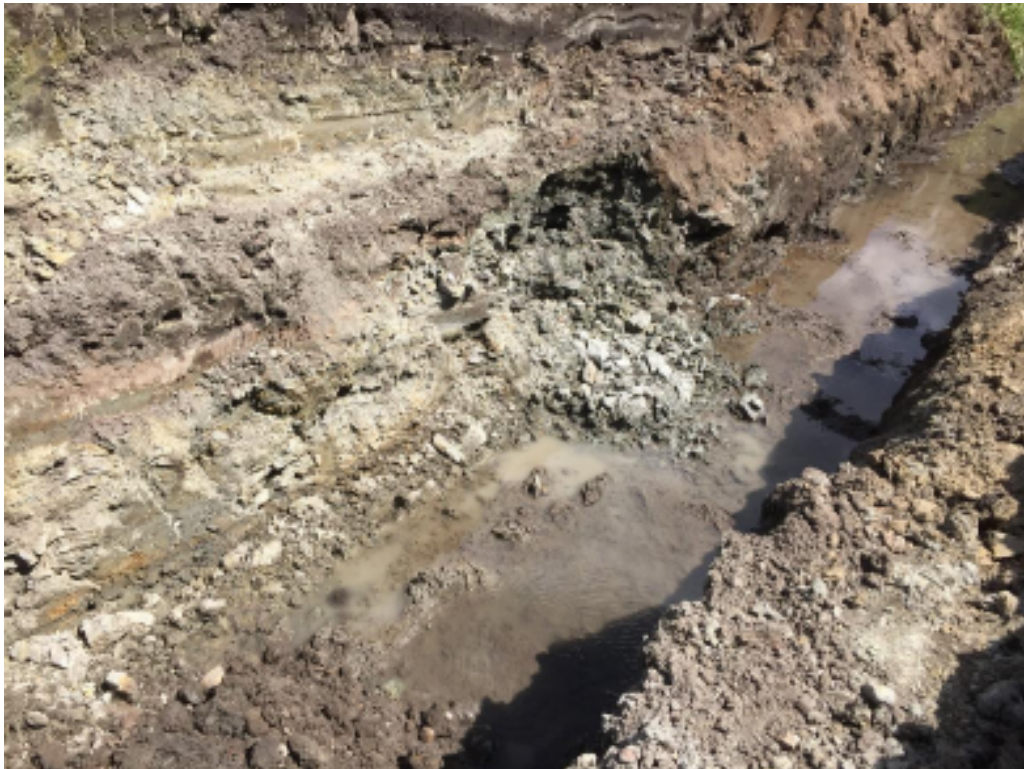
Photo 4 Seepage/Slump in Excavation

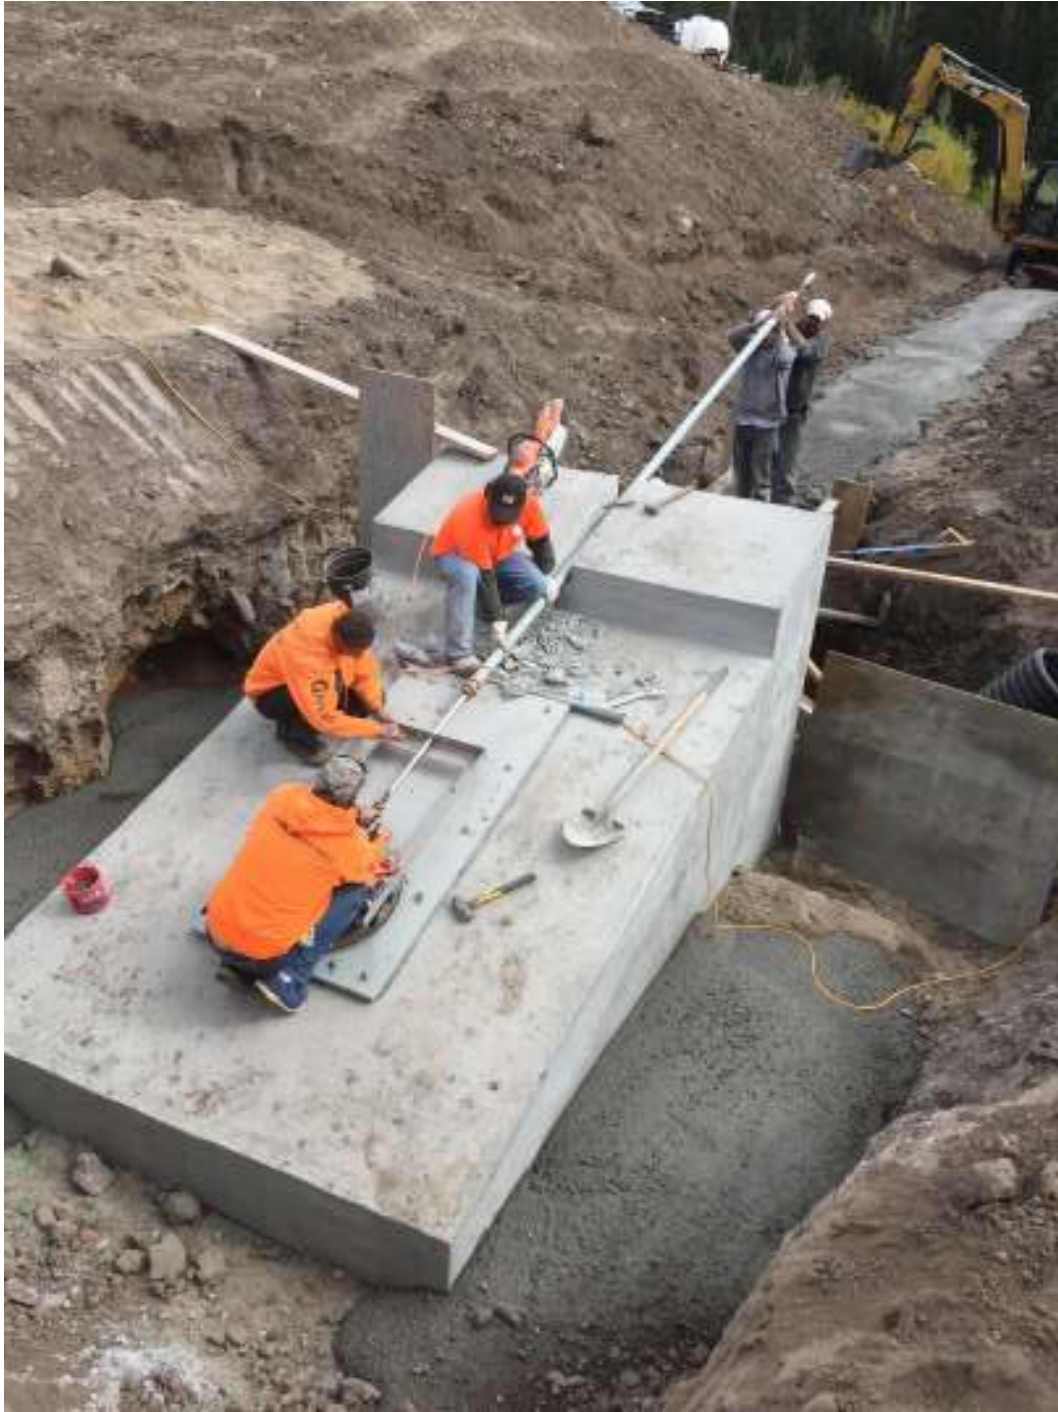
Photo 4 resetting gate stem

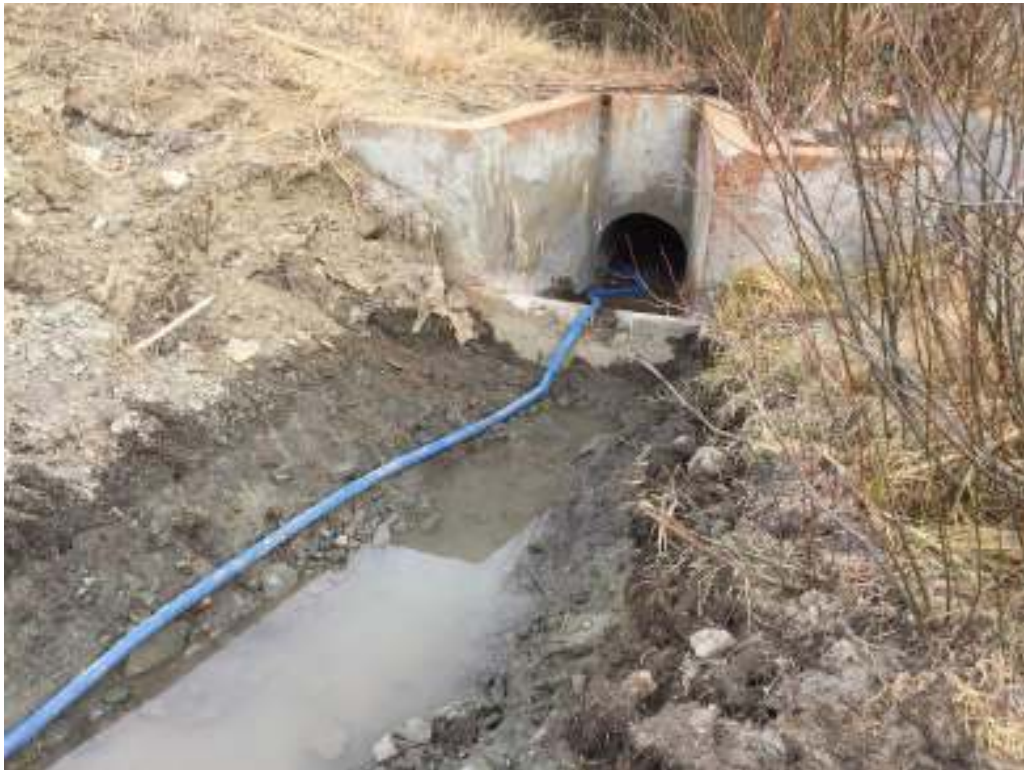
Photo 2 Existing 30" CMP Downstream, note concrete lip in front of pipe.

The inlet to the existing CMP downstream of the dam was also modified to eliminate the concrete lip at the entrance. Concrete was removed from the bottom of this structure such that the elevation of the concrete was at or below the elevation of the existing CMP.

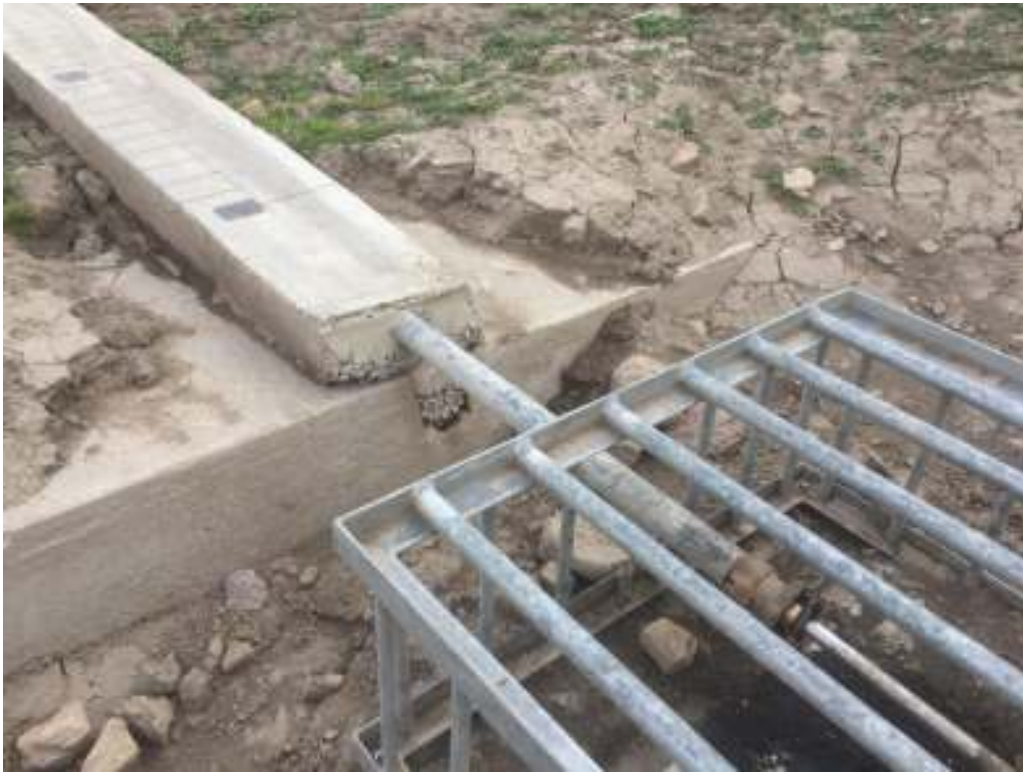
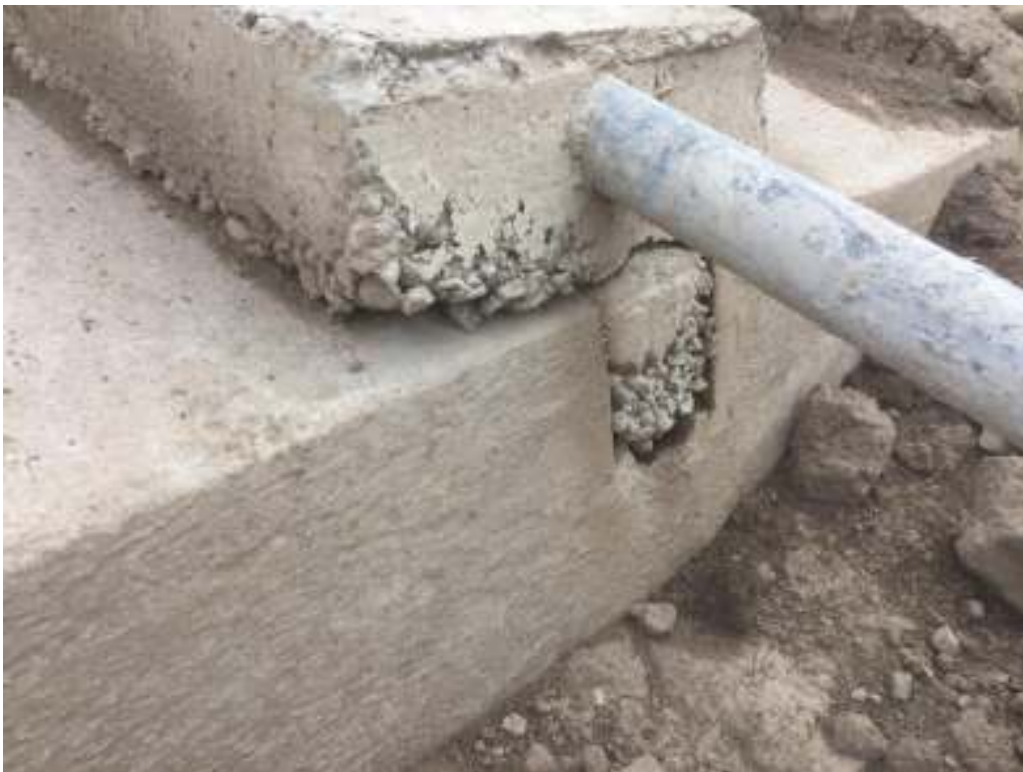
FIGURE 6 GRADE BEAM The concrete grade beam was poured in November of 2017. Due to the incorrect angle of the inlet structure concrete, discussed above, the lower end of the grade beam was poured overlapping a section of the inlet structure. This thin layer of concrete did not serve any purpose as the structural connection between the grade beam and the inlet structure was achieved through rebar on the back face of the inlet structure. This thin layer did not bond well to the inlet structure and in 2018 it was noted that this concrete had cracked near the back edge of the inlet structure. Since this section did not serve any purposed it was sawcut near the back edge of the inlet structure and removed. The staff gage was then marked below this point with a demo saw.

Photo 1 Grade beam/inlet structure overlap

Photo 2 Grade beam/inlet structure overlap

<i>Grade Beam</i>		
12	Notches need to be placed in the concrete to continue to the staff gage down to the invert of the gate. A demo saw should be able to mark the inlet structure adjacent to the gate and trashrack.	11/16/2018
13	There are a few spots of honeycombing at the top of the grade beam where the pedestal bolts on that will need repaired.	2019
13	Bolts on gate pedestal need tightened	11/16/2018
<i>Miscellaneous</i>		
14	Remove all closure signs and gates	11/21/2018
15	Remove all debris and equipment from site	11/16/2018
16	Supply any/all site photos to Applegate	11/21/2018
17	Supply any/all construction redlines to Applegate	11/16/2018
18	Perform Final Camera Inspection of Outlet pipes	2019
19	Remove sufficient concrete from the inlet to the existing 30" CMP so that the concrete is level with the CMP invert	11/16/2018
20	Place large rocks on the west side of the parking area and the access to the 2018 stockpile. Rocks should be partially buried in soil to prevent them from being moved.	11/1/2018

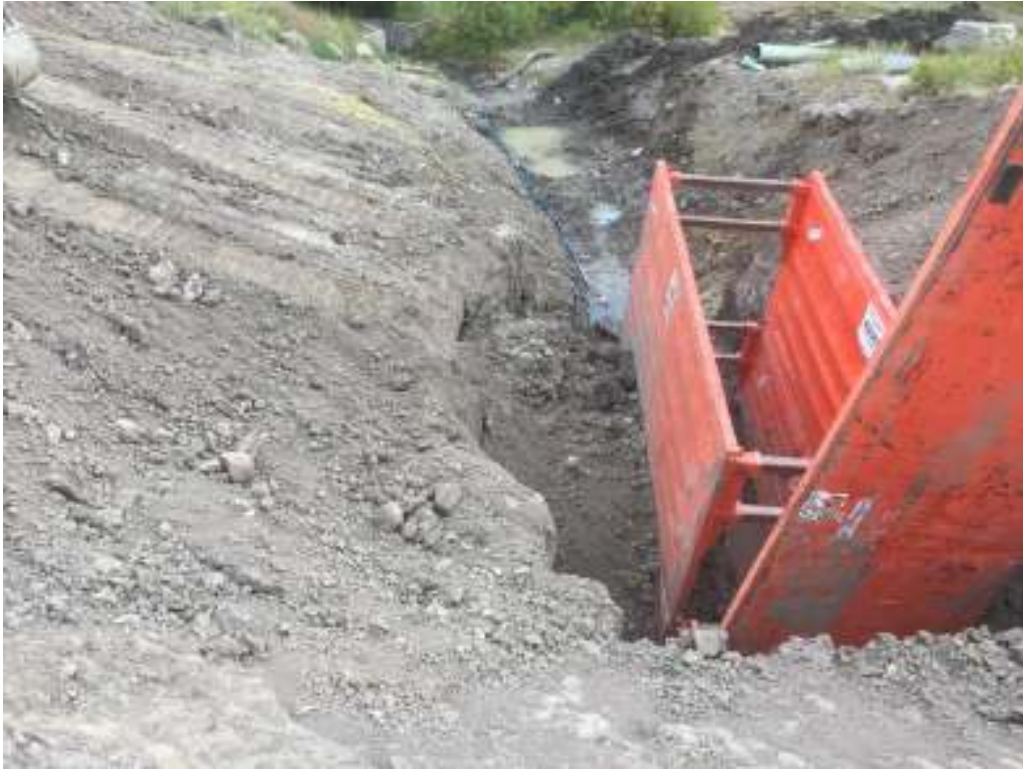
Photo 5 Trench boxes and near vertical adjacent slopes

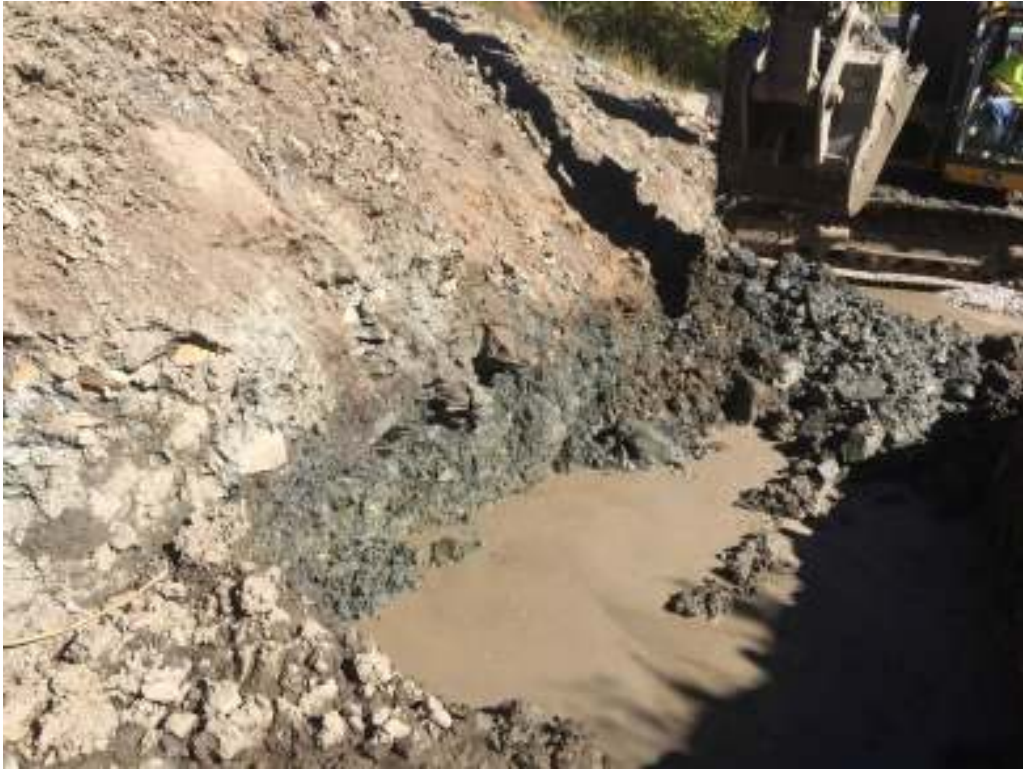
Photo 5 Cleaning trench stat 1+44 to 1+66, collapsing on sides, lots of water

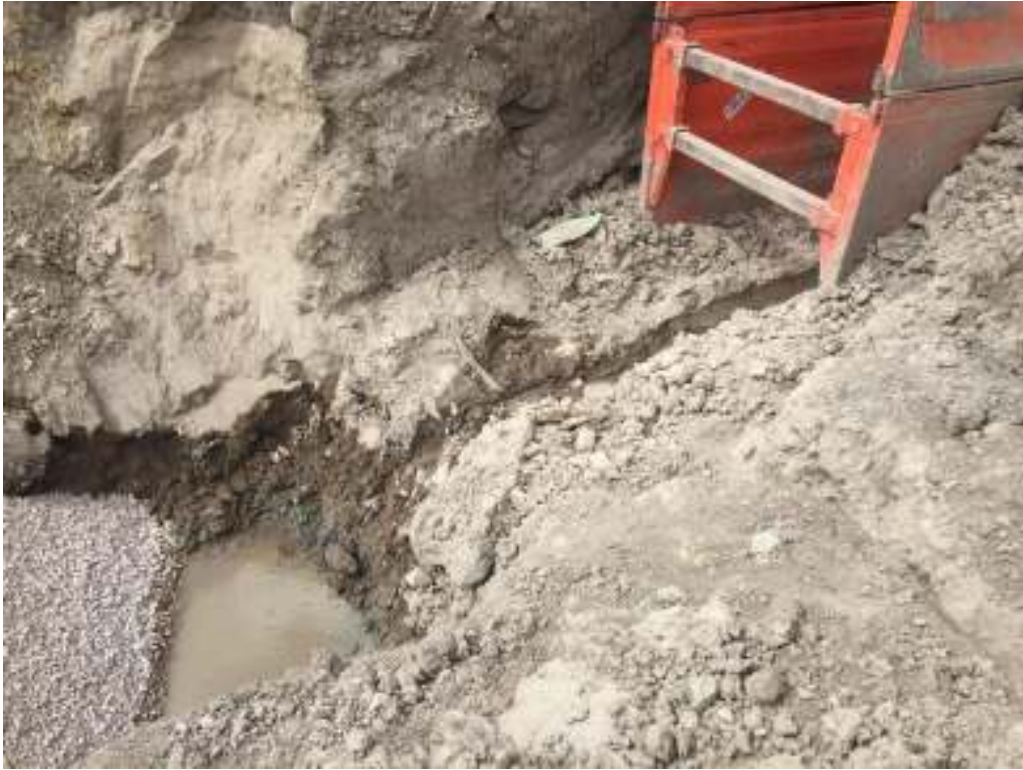
Photo 3 Gravel Placement near sta 1+44 - note lack of seepage from trench box area

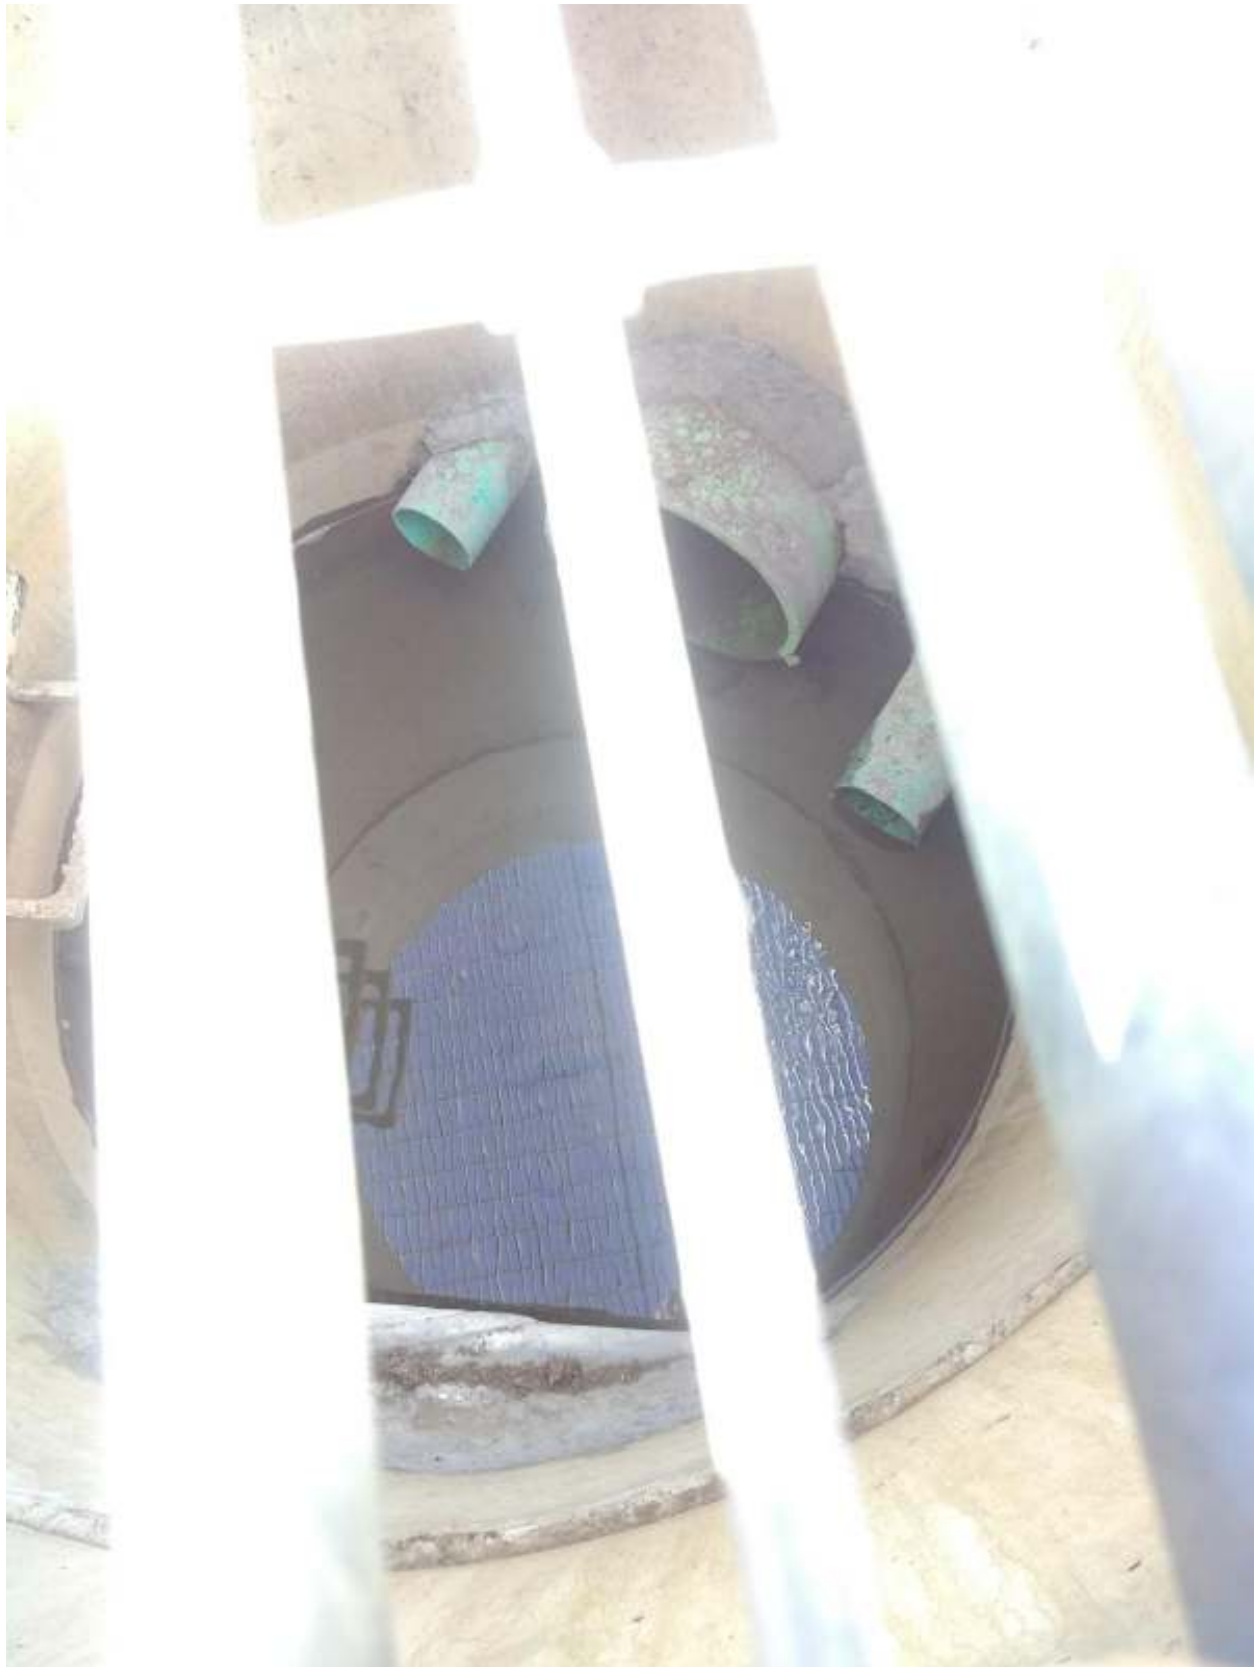
- East drain pipe has water to a depth of about 2" inside the manhole
- Clarified grade beam punch items with foreman while onsite

Figure 4: View Inside Downstream Manhole, Notice Water Levels Inside Pipes

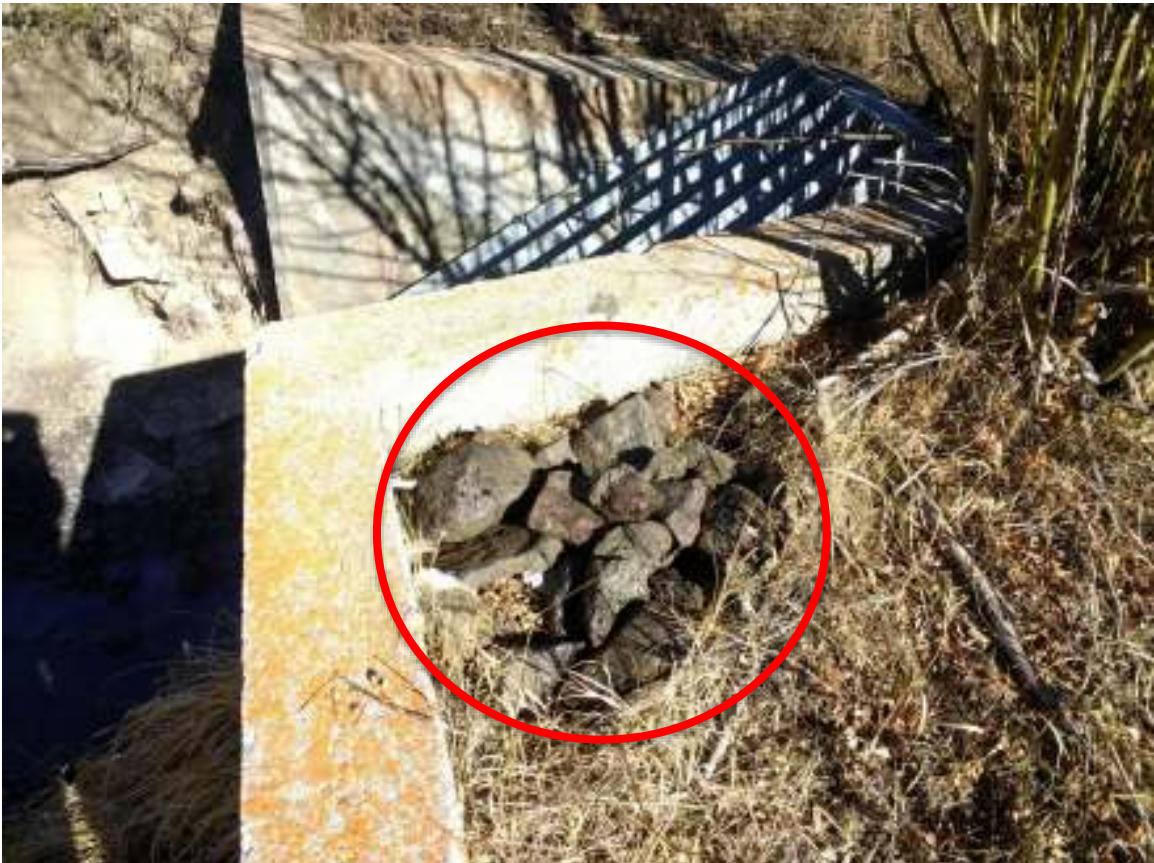
Figure 6: Rocks Removed from 30" CMP
