## **Final Report**

Riprap on the face of the dam of the Kehmeier Reservoir  
WSRF grant PO/contract POGG1 2019-2026  
Approved by CWCB board May 24, 2018

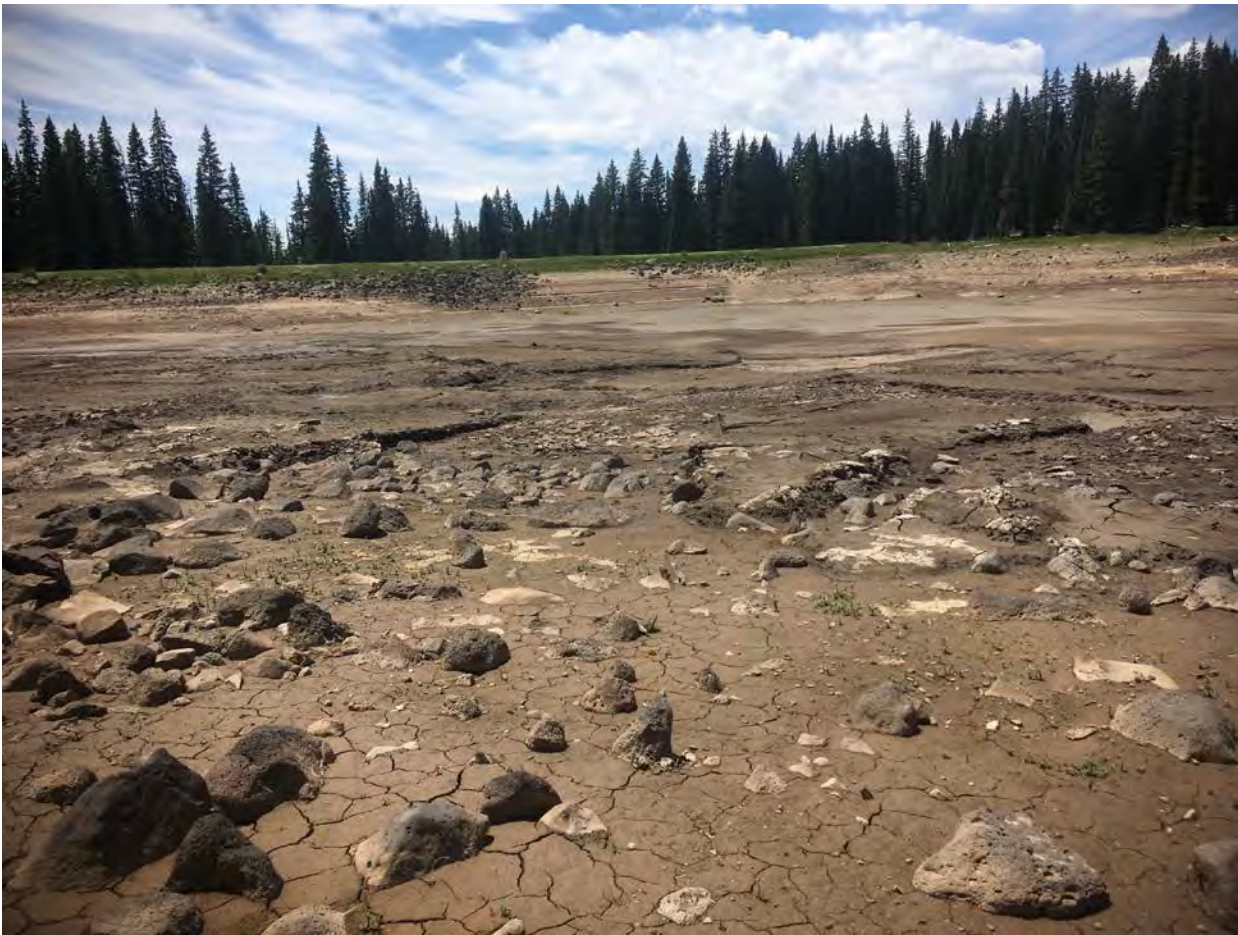
Distance view before work started

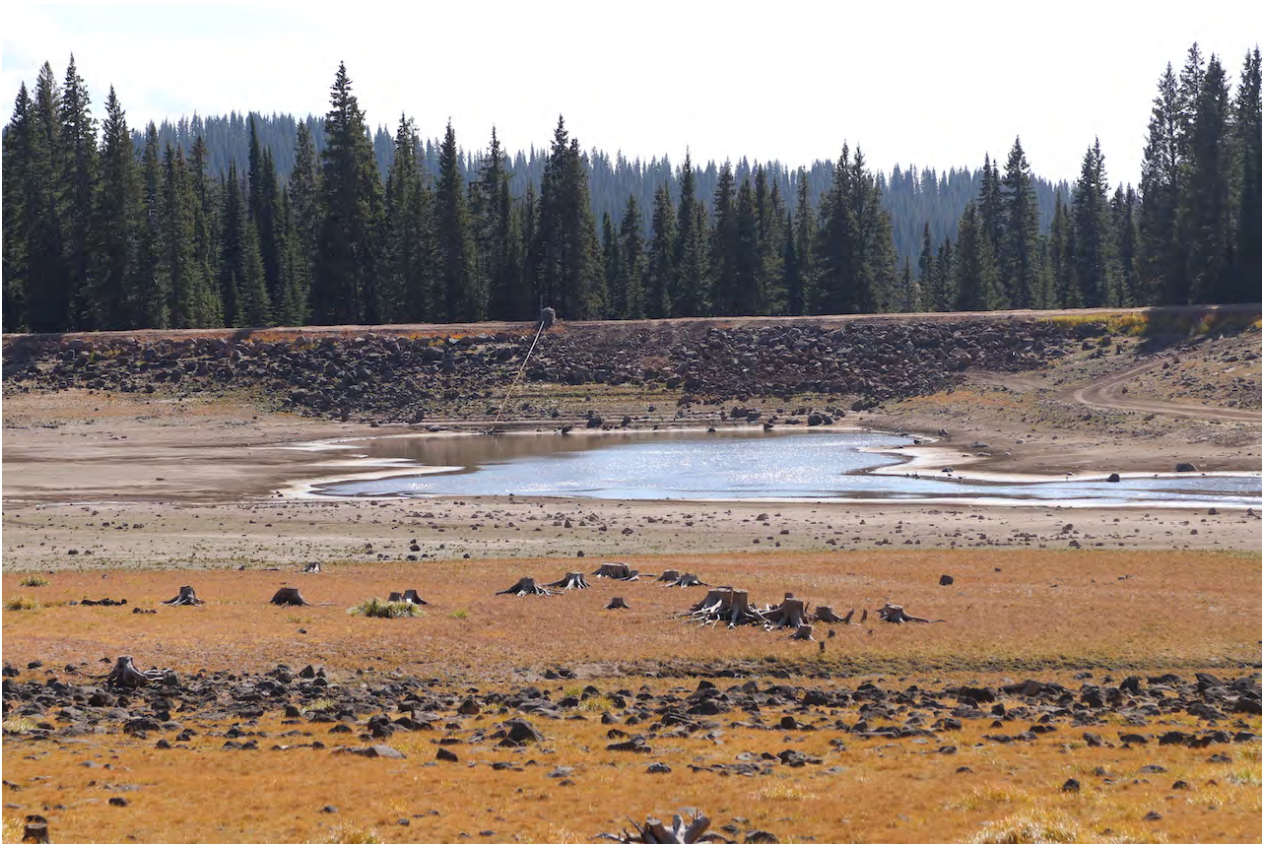
Distance view after work was completed

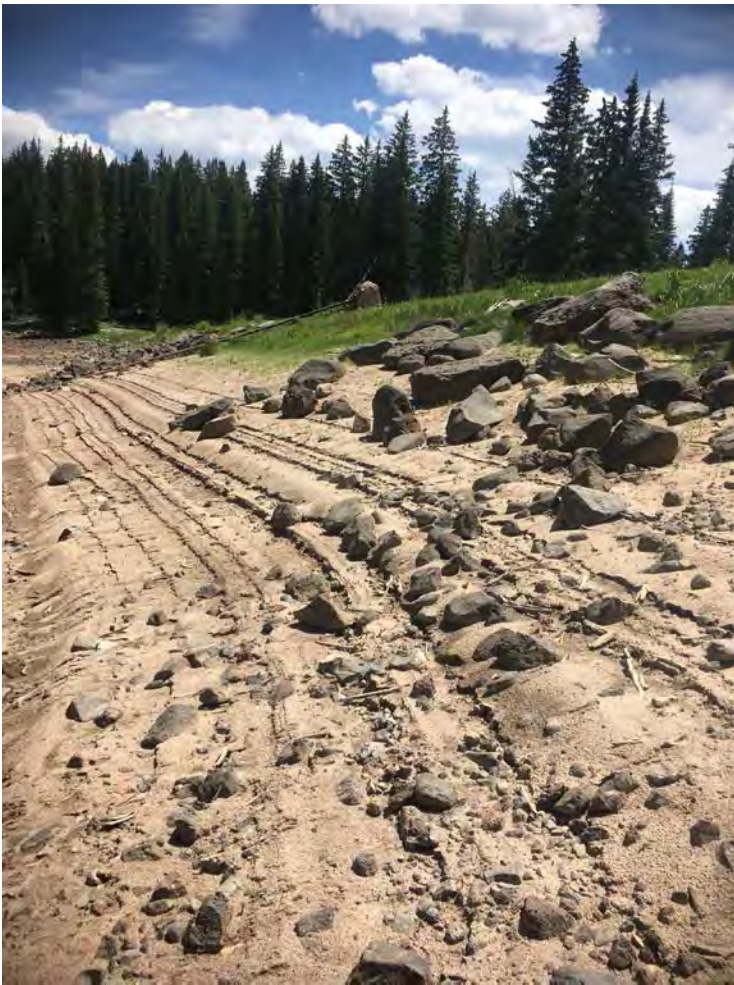
During the 1940's expansion of the some riprap was placed on the face of the dam, but it covered only a portion of the face. An inspection of the dam in 2013 by the State of Colorado dam inspector noted wave erosion on the face of the dam, mainly at the highwater line. Erosion on the crest of the dam was also noted. The dam received a Conditional Full Storage rating. The work described in this final report was conducted to correct the erosion problems with the goal of achieving a Full Storage Without Conditions rating on the next dam inspection.

West dam face before work started

Action Taken: Permits and authorization were obtained from the U.S. Forest Service and the U.S. Army Corps of engineers. A local contractor experienced in dam maintenance on public lands excavated 167 cubic yards of rocks near the dam and placed them as riprap on the upper part of the face of the dam. No obstacles of significance were encountered.

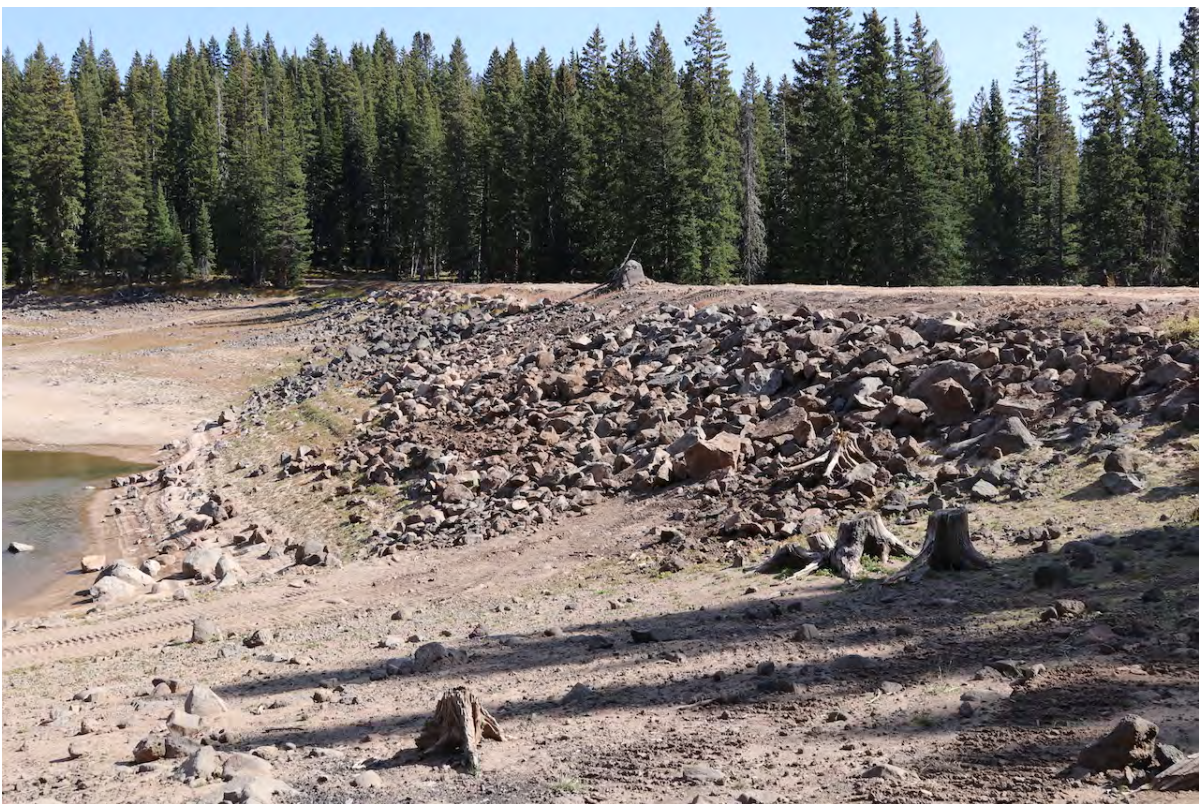
West dam face after work was completed

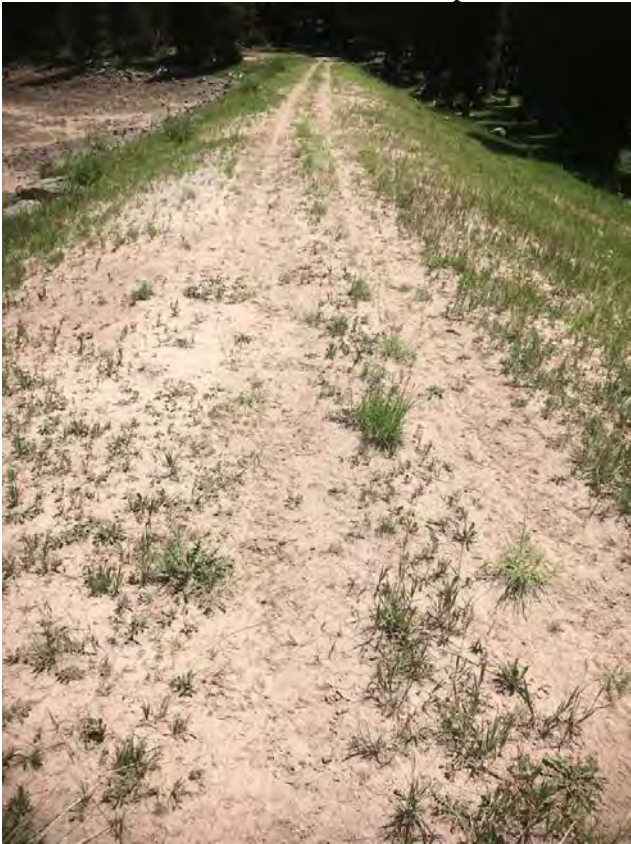
Crest before work started

Action Taken: Permits and authorization were obtained from the U.S. Forest Service and the U.S. Army Corps of engineers. A local contractor experienced in dam maintenance on public lands excavated 70 cubic yards of fill material near the dam, placed it on the crest of the dam, and compacted it. The contractor then graded the crest to have slight slope towards the face of the dam. No obstacles of significance were encountered.

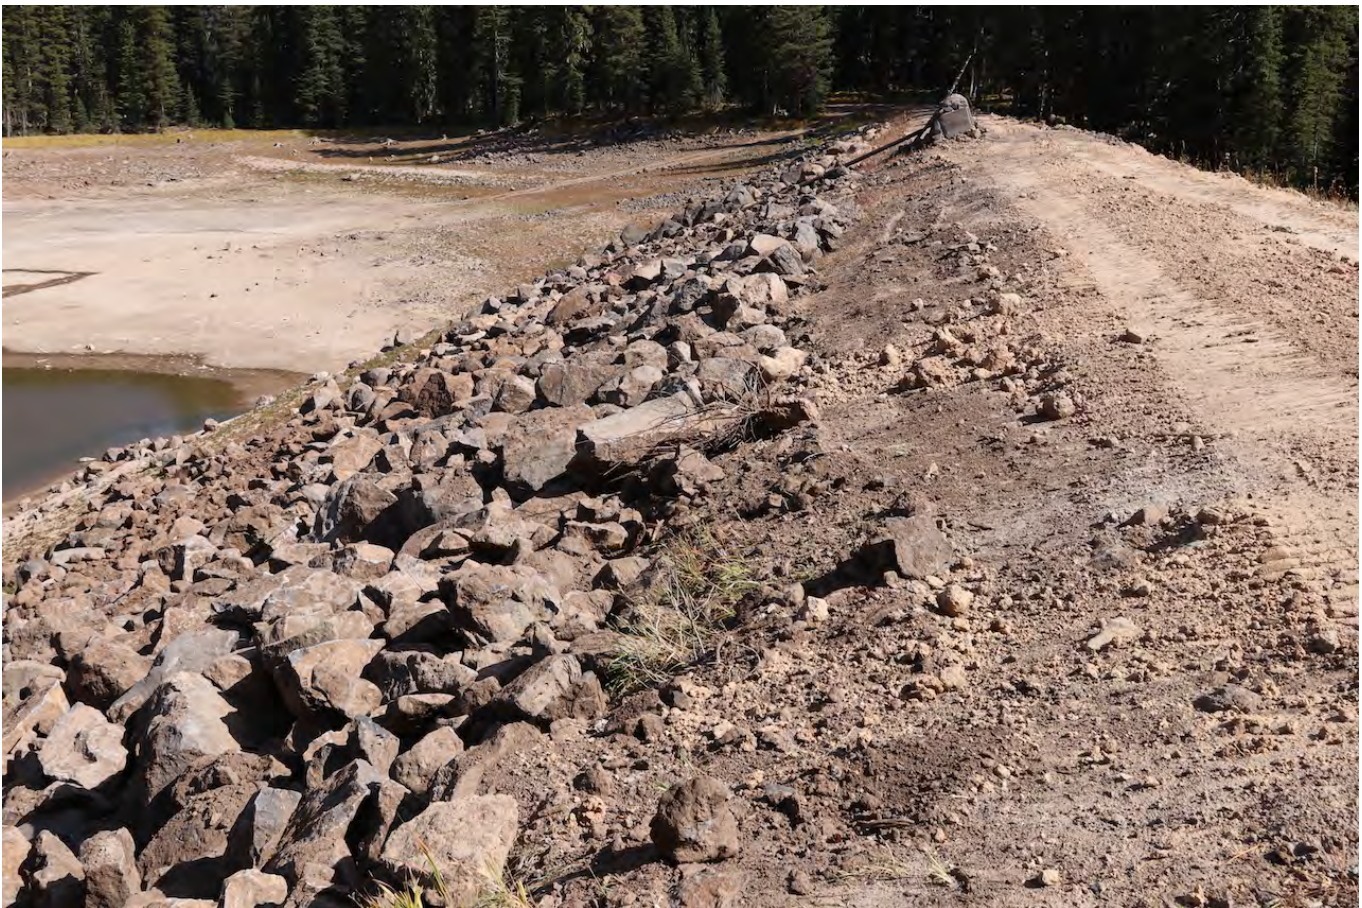
Crest after work was completed
